**NYC Department of Education**  
**Building Condition Assessment Survey 2023 - 2024**

Architectural Inspection

**Asset: P.S. 213 MINISCHOOL - BROOKLYN, 1965 LINDEN BOULEVARD, New York, 11207**

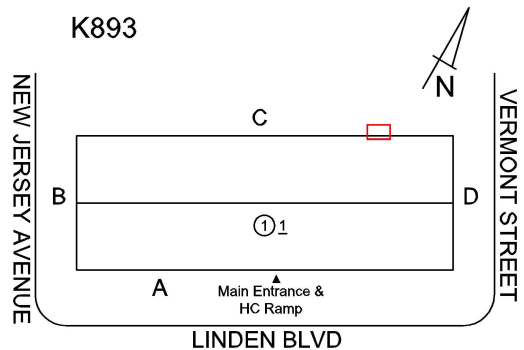
Deficiency METAL: DETERIORATED DOOR - MAJOR DETERIORATION  
 Roof Plan reference

Deficiency Quantity 1  
 Quantity Uom EACH  
 Potential Action REPLACE  
 Urgency of Action PRIORITY 4  
 Purpose of Action LEVEL 2

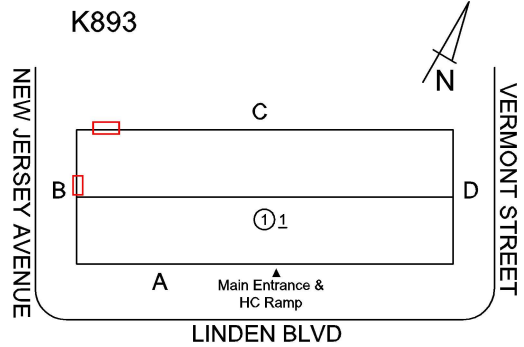
Deficiency	METAL PANEL: SEVERE DENTS
Roof Plan reference

Deficiency Quantity	30
Quantity Uom	S.F.
Potential Action	REPLACE
Urgency of Action	PRIORITY 4
Purpose of Action	LEVEL 2
Deficiency Photo1

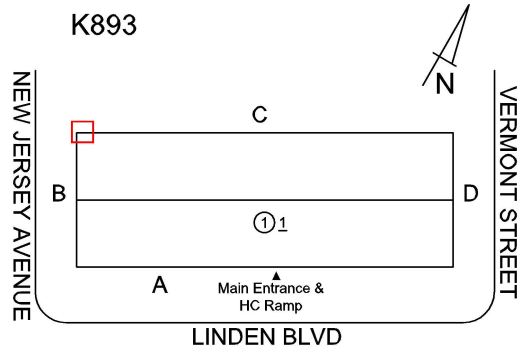
Roof Plan reference

Deficiency	DAMAGED/MISSING
------------	-----------------

10

REPLACE

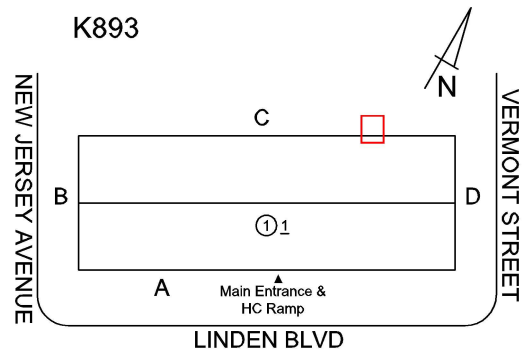
Roof Plan reference

<b>RAILINGS</b>	Inspected
Condition	3 - Fair
Deficiency	RUST - MAJOR

10  
 L.F.  
 REPLACE  
 PRIORITY 4  
 LEVEL 2

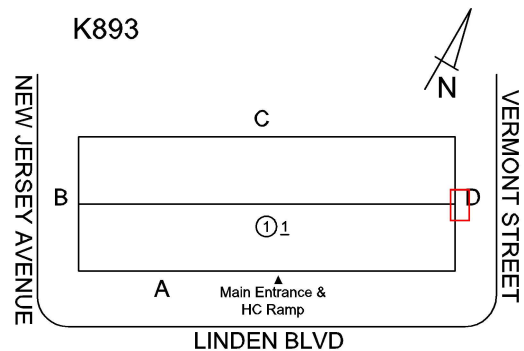
Roof Plan reference

CONCRETE: CRACKS/SPALLING - MAJOR

20  
 S.F.  
 REPLACE  
 PRIORITY 4  
 LEVEL 2

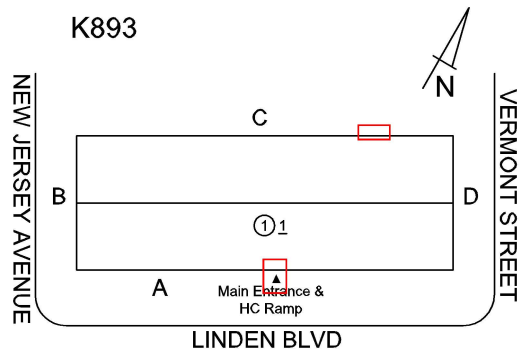
Roof Plan reference

CONCRETE: CRACKS/SPALLING - MINOR

30

REPAIR
