NYC Department of Education
Building Condition Assessment Survey 2023 - 2024

Architectural Inspection

Asset: P.S. 321 MINISCHOOL - BROOKLYN, 180 7TH AVENUE, New York, 11215

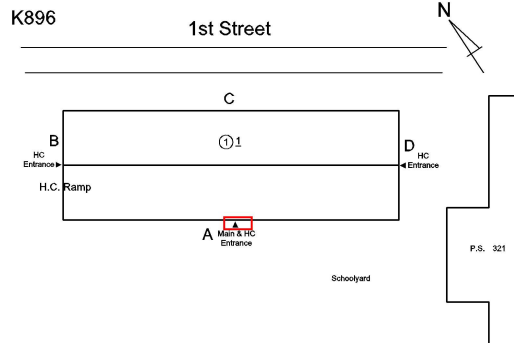
Roof Plan reference

Question	Response
Architectural	
EXTERIOR	Inspected
AREAWAY	Does not Exist
AWNINGS AND CANOPIES	Does not Exist
CHIMNEY	Does not Exist
COPING	Does not Exist
CORNICE	Does not Exist
DOORS	Inspected
DOORS AND FRAMES	Inspected
Condition	4 - Between Fair and Poor
Deficiency	METAL CLAD: DETERIORATED DOOR - MAJOR DETERIORATION

1
EACH
REPLACE
PRIORITY 4
LEVEL 2

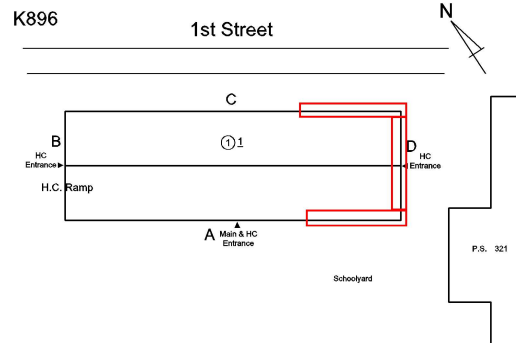
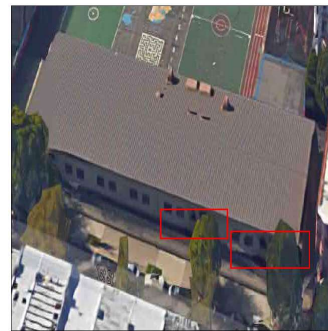
Roof Plan reference

METAL PANEL: WATER INFILTRATION IN INSTRUCTIONAL SPACE

REPAIR

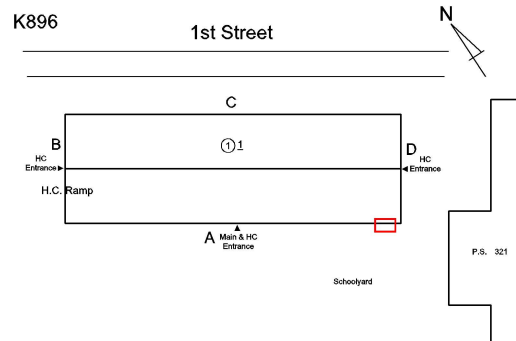
Roof Plan reference

METAL PANEL: DAMAGED TRIM

Question	Response
EXTERIOR	
EXTERIOR WALLS	
Elevation	 
Deficiency Quantity	10
Quantity Uom	L.F.
Potential Action	REPLACE
Urgency of Action	PRIORITY 4
Purpose of Action	LEVEL 2
Deficiency Photo1	 
Violations	Facade A No violations recorded.
EXTERIOR SOFFITS	Inspected
Condition	2 - Between Good and Fair
Deficiency	No deficiencies recorded
LOADING DOCK	Does not Exist
LOUVER	Inspected
Condition	2 - Between Good and Fair
Deficiency	No deficiencies recorded
PARAPETS	Does not Exist
PLAZA DECK	Does not Exist
ROOF	Inspected
Roofing	Inspected
Replacement Quantity	13,500
Replacement Uom	S.F.
ROOF HATCH/SMOKE HATCH	Does not Exist
LEADERS, GUTTERS, DOWNSPOUTS, SCUPPERS	Inspected
Condition	2 - Between Good and Fair
Deficiency	No deficiencies recorded
ROOF BARRIER/FENCE	Does not Exist
ROOF CAGE	Does not Exist
ROOFING	Inspected
Instance on Metal: Roof 1	Inspected
Instance Condition	2 - Between Good and Fair
