NYC Department of Education
Building Condition Assessment Survey 2023 - 2024

Architectural Inspection

Asset: P.S. 77 ANNEX - BROOKLYN, 62 PARK PLACE, New York, 11217

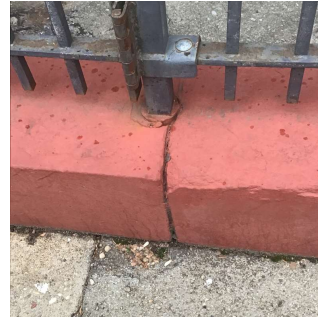
AW2

AREAWAY WALLS: DETERIORATED JOINTS

REPAIR

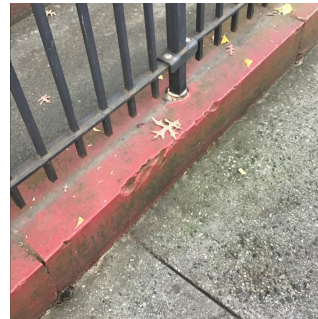
AW3

AREAWAY SLAB: CRACKS AND SPALLING

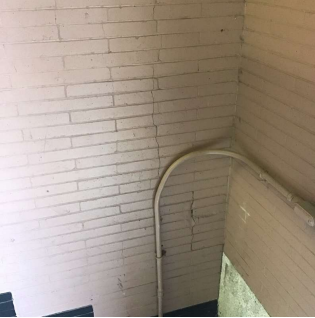
<p>Facade A - Main Entrance</p>
Violations	No violations recorded.
Deficiency	BRICK: DETERIORATED JOINTS

Question	Response
EXTERIOR	
EXTERIOR WALLS	
Instance Quantity	30,000
Instance Quantity Uom	S.F.
Deficiency	BRICK: MINOR CRACKS AND SPALLING
Roof Plan reference	<p>K902 Sterling Place</p>

Deficiency Quantity	10
Quantity Uom	S.F.
Potential Action	RESTITCH
Urgency of Action	PRIORITY 3
Purpose of Action	LEVEL 2
Deficiency Photo1

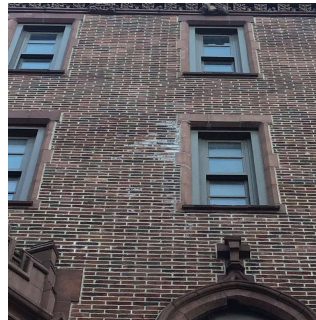
Facade A

BRICK: EFFLORESCENCE

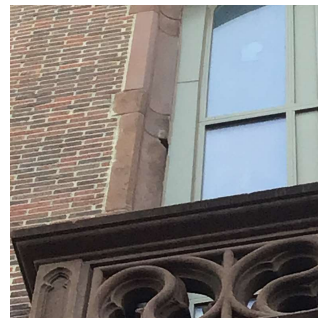
Facade A

STONE: CHIPPED/SPALLED/BROKEN PIECES - MAJOR

REPLACE

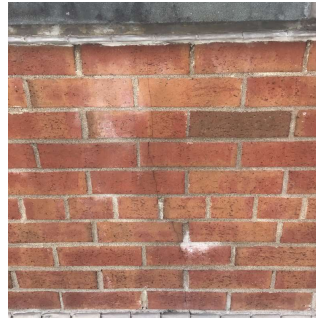
Roof 1 - Facade F

Deficiency **BRICK: MINOR CRACKS, SPALLING**

REPAIR

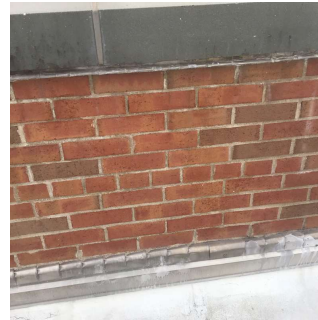
Roof 1 - Facade D

Deficiency	BRICK: DETERIORATED JOINTS
------------	-----------------------------------

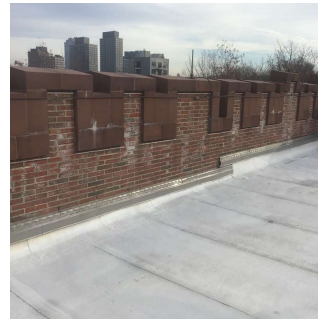
Roof 7 - Facade A

BRICK: EFFLORESCENCE

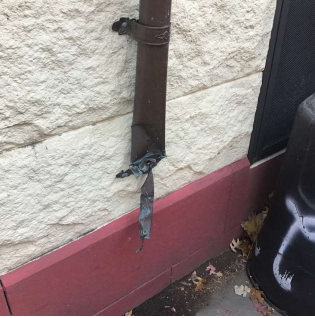
Question	Response
EXTERIOR	
ROOF	
Roofing	
LEADERS, GUTTERS, DOWNSPOUTS, SCUPPERS	
Deficiency	DAMAGED/MISSING
Roof Plan reference	K902 Sterling Place

Deficiency Quantity	10
Quantity Uom	L.F.
Potential Action	REPLACE
Urgency of Action	PRIORITY 5
Purpose of Action	LEVEL 6
Deficiency Photo1

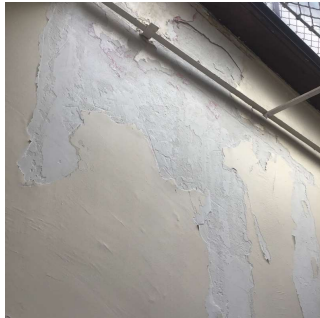
Deficiency **BULKHEAD/PENTHOUSE WALLS/INTERIOR: PLASTER CRACKS/SPALLING**

150
S.F.
REPLACE
PRIORITY 3
LEVEL 2

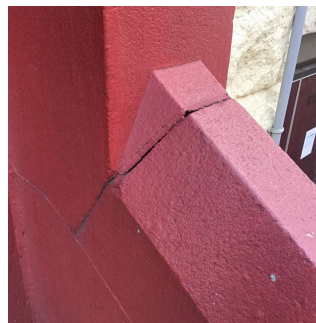
Facade A

STONE: DETERIORATED JOINTS AT COPING STONES

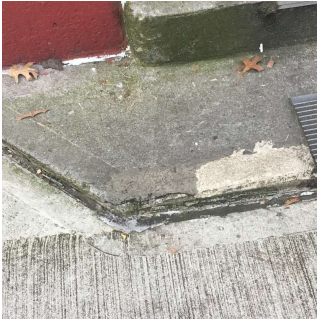
Violations	Facade A - Main Entrance No violations recorded.
WINDOWS	Inspected
Replacement Quantity	12,000
Replacement Uom	S.F.
EXTERIOR GUARDS	Inspected
Condition	3 - Fair
Deficiency	DETERIORATED/TORN-OUT/MISSING

Violations	Facade A No violations recorded.
Deficiency	CONCRETE: CRACKS/SPALLING - MINOR
Roof Plan reference	K902 Sterling Place

Deficiency Quantity	30
Quantity Uom	S.F.
Potential Action	REPAIR
Urgency of Action	PRIORITY 3
Purpose of Action	LEVEL 2
Deficiency Photo1

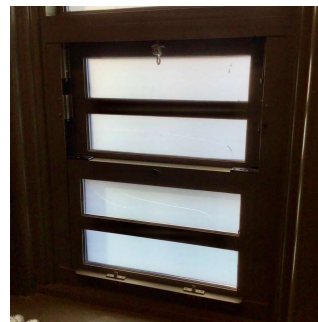
Facade E - 3rd Floor Girls
No violations recorded.

ALUMINUM - DOUBLE HUNG: BROKEN PANE

30
S.F.
MAINTENANCE
PRIORITY 3
LEVEL 2

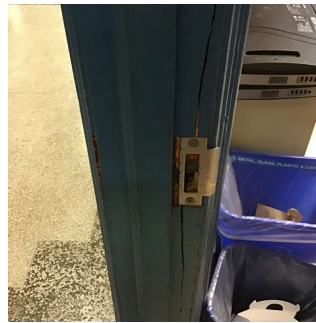
Room 302

Question	Response
INTERIOR	
CAFETERIA	
Sliding-folding Partition	
Instance on Basement	Does not Exist
Stage	
Instance on Basement	Does not Exist
Walls	
Instance on Basement	Inspected
Condition	2 - Between Good and Fair
Deficiency	No deficiencies recorded
Window Curtains/Shades/Blinds	
Instance on Basement	Does not Exist
CLASSROOMS/CORRIDORS/ADMIN SPACES	
	Inspected
Ceiling	
Condition	2 - Between Good and Fair
Deficiency	No deficiencies recorded
Door(s)	
Condition	5 - Poor
Deficiency	WOOD: MISSING DOOR
Deficiency Location/Instance	Room 317, Corridor near Room 318
Deficiency Quantity	2
Quantity Uom	EACH
Potential Action	MAINTENANCE
Urgency of Action	PRIORITY 3
Purpose of Action	LEVEL 2
Deficiency Photo1	 
	Corridor near Room 318
Violations	No violations recorded.
<hr/>	
Deficiency	WOOD: DETERIORATED DOOR AND FRAME
Deficiency Location/Instance	Rooms 409,407,302
Deficiency Quantity	3
Quantity Uom	EACH
Potential Action	MAINTENANCE

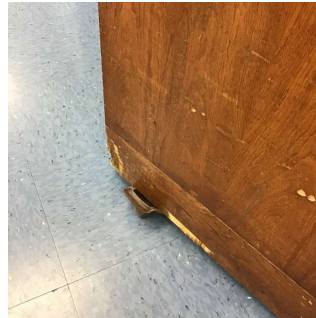
Room 410

WOOD: DETERIORATED DOOR

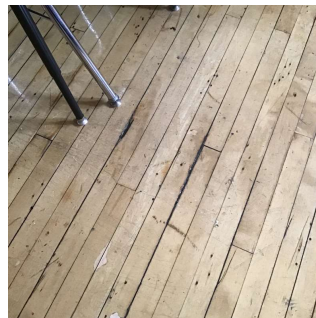
WOOD: DAMAGED/DETERIORATED

REPLACE

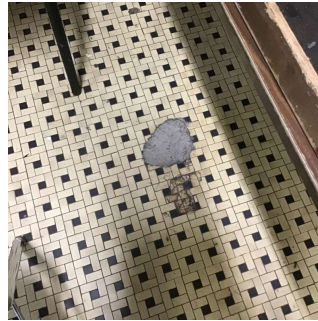
Question	Response
INTERIOR	
CLASSROOMS/CORRIDORS/ADMIN SPACES	
Floor Finish	
Violations	Room 407 No violations recorded.
Deficiency	VINYL TILES: BROKEN/DETERIORATED/MISSING TILES
Deficiency Location/Instance	Rooms 317,213,110, Corridor near Room T6
Deficiency Quantity	50
Quantity Uom	S.F.
Potential Action	REPLACE
Urgency of Action	PRIORITY 3
Purpose of Action	LEVEL 2
Deficiency Photo1	 
Violations	Corridor near Room T6 No violations recorded.
Deficiency	TERRAZZO: CRACKS
Deficiency Location/Instance	Corridor near Rooms 411,410,110, By Multipurpose Room, Corridor between Stair A/2 and B/2 and others
Deficiency Quantity	550
Quantity Uom	S.F.
Potential Action	REPLACE
Urgency of Action	PRIORITY 3
Purpose of Action	LEVEL 2
Deficiency Photo1	 
Violations	Corridor near Room 110 No violations recorded.
Deficiency	CERAMIC TILE: BROKEN/MISSING TILES
Deficiency Location/Instance	Staff Lounge near Gymnasium
Deficiency Quantity	40

Quantity Uom	S.F.
Potential Action	REPLACE
Urgency of Action	PRIORITY 3
Purpose of Action	LEVEL 2

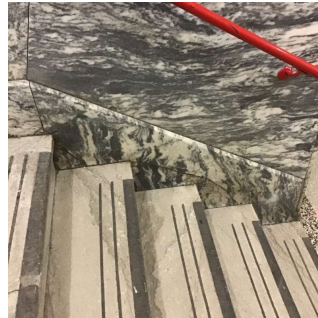
Corridor near Room 304

STONE MOLDINGS: CRACKS/SPALLING

REPLACE

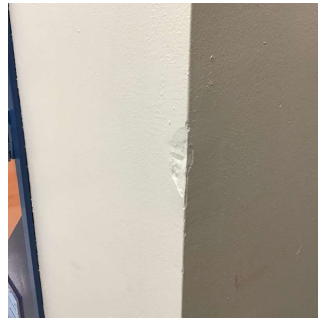
PLASTER: CRACKS/SPALLING

REPLACE

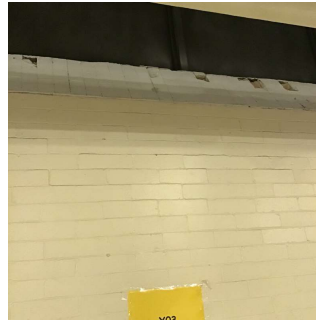
Near Right Side Windows

Question	Response
INTERIOR	
GYMNASIUM	
Floor Finish	
Purpose of Action	LEVEL 2
Deficiency Photo1	 
Violations	Near Windows No violations recorded.
Deficiency	VINYL TILES: BROKEN/DETERIORATED/MISSING TILES
Deficiency Location/Instance	Gymnasium Office
Deficiency Quantity	10
Quantity Uom	S.F.
Potential Action	REPLACE
Urgency of Action	PRIORITY 3
Purpose of Action	LEVEL 2
Deficiency Photo1	 
Violations	Gymnasium Office No violations recorded.
Seating	
Instance on Basement	Does not Exist
Sliding-folding Partition	
Instance on Basement	Does not Exist
Stage	
Instance on Basement	Does not Exist
Walls	
Instance on Basement	Inspected
Condition	3 - Fair
Deficiency	BRICK: CRACKS/SPALLING
Deficiency Location/Instance	Near Right Side Windows, By Exit B
Deficiency Quantity	40
Quantity Uom	S.F.
Potential Action	REPLACE
Urgency of Action	PRIORITY 3
Purpose of Action	LEVEL 2

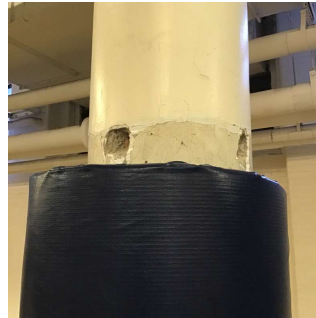
Column

PLASTER: CRACKS/SPALLING

REPLACE

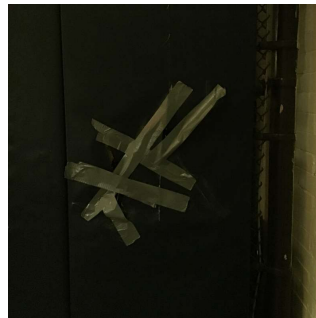
Near Exit D

WALL PADDING: DETERIORATED

REPLACE

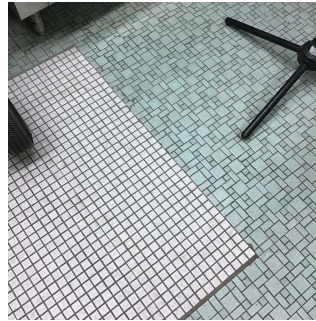
Preparation Area

Violations	Mop Room No violations recorded.
Floor Finish	
Instance on Basement	Inspected
Condition	2 - Between Good and Fair
Deficiency	CERAMIC TILE: BROKEN/MISSING TILES
Deficiency Location/Instance	Preparation Area, near Sink, By fridges

Deficiency Quantity	30
Quantity Uom	S.F.
Potential Action	REPLACE
Urgency of Action	PRIORITY 3
Purpose of Action	LEVEL 2

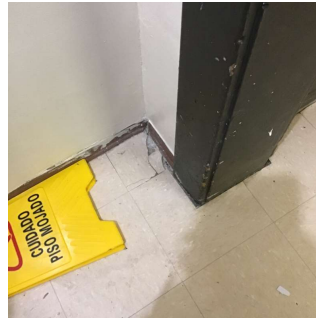
Deficiency	VINYL TILES: BROKEN/DETERIORATED/MISSING TILES
Deficiency Location/Instance	Near Entrance
Deficiency Quantity	10
Quantity Uom	S.F.
Potential Action	REPLACE
Urgency of Action	PRIORITY 3
Purpose of Action	LEVEL 2
Deficiency Photo1

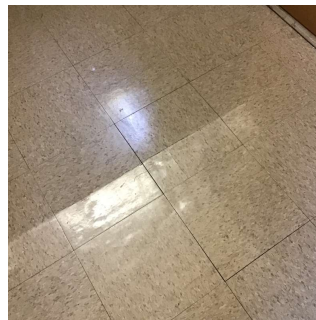
Right Side Exit Vestibule

VINYL TILES: DETERIORATED SUBSTRATE

REPLACE

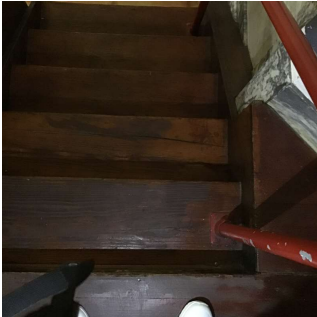
Center
Violations	No violations recorded.
Deficiency	DAMAGED STEPS
Deficiency Location/Instance	Right and Left Side
Deficiency Quantity	30
Quantity Uom	S.F.
Potential Action	REPLACE
Urgency of Action	PRIORITY 3
Purpose of Action	LEVEL 2
Deficiency Photo1

Right Side
Violations	No violations recorded.
Stage Curtain Rigging	Inspected
Instance on 1st Floor	Inspected
Condition	2 - Between Good and Fair
Deficiency	No deficiencies recorded
Stage Curtains	Inspected
Instance on 1st Floor	Inspected
Condition	2 - Between Good and Fair
Deficiency	No deficiencies recorded
Walls	
Instance on 1st Floor	Inspected
Condition	2 - Between Good and Fair
Deficiency	STONE MOLDINGS: CRACKS/SPALLING
Deficiency Location/Instance	Left Side Exit Corridor, Left Side near Stage
Deficiency Quantity	40
Quantity Uom	L.F.
Potential Action	REPLACE
Urgency of Action	PRIORITY 3

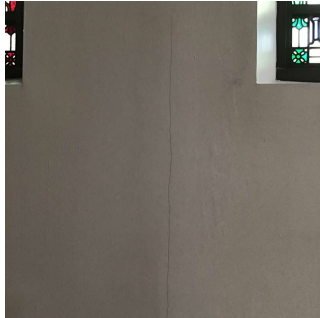
Violations	Left Side Exit Corridor No violations recorded.
Deficiency	PLASTER: CRACKS/SPALLING
Deficiency Location/Instance	Right and Left Side
Deficiency Quantity	20
Quantity Uom	S.F.
Potential Action	REPLACE
Urgency of Action	PRIORITY 3
Purpose of Action	LEVEL 2
Deficiency Photo1

Violations	Left Side No violations recorded.
Window Curtains/Shades/Blinds	
Instance on 1st Floor	Does not Exist
SCIENCE DEMO ROOM	
Instance on Room 302	Inspected
Alternative use	No
Fixed Equipment	
Instance on Room 302	Inspected
Condition	2 - Between Good and Fair
Deficiency	No deficiencies recorded
SCIENCE LAB	
Does not Exist	
SCIENCE PREP ROOM	
Does not Exist	
SHOWER ROOM	
Does not Exist	
STAIRS/RAMPS: INTERIOR	
Do Letter Stair Signs Exist?	Yes
Ceiling	
Condition	Inspected 2 - Between Good and Fair

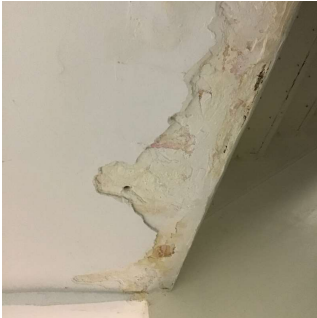
Question	Response
INTERIOR	
STAIRS/RAMPS: INTERIOR	
Ceiling	
Deficiency	PLASTER: CRACKS/SPALLING
Deficiency Location/Instance	Stairs A/Basement, C/4,Basement
Deficiency Quantity	70
Quantity Uom	S.F.
Potential Action	REPLACE
Urgency of Action	PRIORITY 3
Purpose of Action	LEVEL 2
Deficiency Photo1

Violations	Stair A/Basement No violations recorded.
Door(s)	Inspected
Condition	5 - Poor
Deficiency	WOOD: DETERIORATED DOOR
Deficiency Location/Instance	Stair C Exit Vestibule
Deficiency Quantity	2
Quantity Uom	EACH
Potential Action	MAINTENANCE
Urgency of Action	PRIORITY 3
Purpose of Action	LEVEL 2
Deficiency Photo1

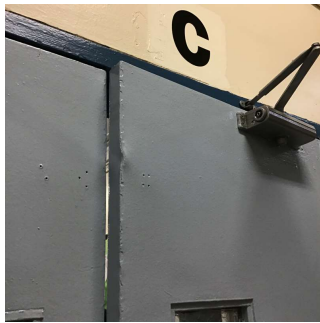
Violations	Stair C Exit Vestibule No violations recorded.
Deficiency	METAL: DETERIORATED DOOR
Deficiency Location/Instance	Stairs A/2,3, C/1
Deficiency Quantity	4
Quantity Uom	EACH
Potential Action	MAINTENANCE
Urgency of Action	PRIORITY 3
Purpose of Action	LEVEL 2

Violations	Stair C/1 No violations recorded.
Partition	Does not Exist
Railings	Inspected
Condition	5 - Poor
Deficiency	METAL: MISSING
Deficiency Location/Instance	Stair B/3, Corridor near Rooms 312,318
Deficiency Quantity	40
Quantity Uom	L.F.
Potential Action	REPLACE
Urgency of Action	PRIORITY 5
Purpose of Action	LEVEL 6
Deficiency Photo1

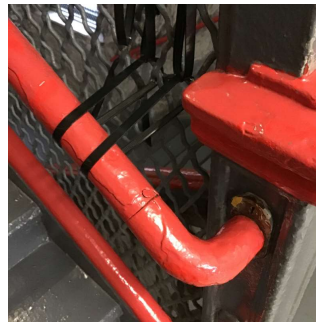
Stair A/2

Violations	Stair B/3 No violations recorded.
Deficiency	METAL: BROKEN BRACKET
Deficiency Location/Instance	Stairs A/2, C/Basement
Deficiency Quantity	2
Quantity Uom	EACH
Potential Action	REPLACE
Urgency of Action	PRIORITY 3
Purpose of Action	LEVEL 2

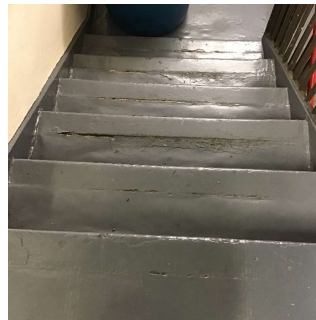
Stair E/Basement

CONCRETE: CRACKS/SPALLING - MAJOR

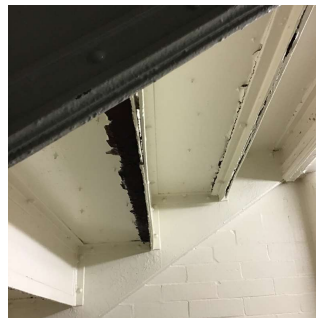
METAL: RUST - MAJOR

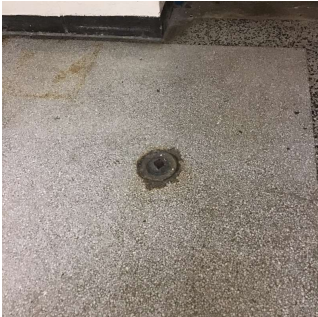
Question	Response
INTERIOR	
STAIRS/RAMPS: INTERIOR	
Stairs and Landings	Inspected
	Stair D/Basement
Violations	No violations recorded.
Deficiency	TERRAZZO: CRACKS
Deficiency Location/Instance	Stair C/Basement
Deficiency Quantity	10
Quantity Uom	S.F.
Potential Action	REPLACE
Urgency of Action	PRIORITY 5
Purpose of Action	LEVEL 6
Deficiency Photo1

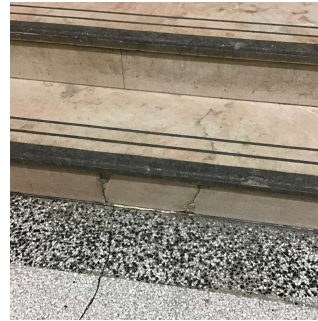
Corridor near Room 312

Stair C/1
Violations	No violations recorded.
Deficiency	STONE: BROKEN/MISSING
Deficiency Location/Instance	Corridor near Rooms 312,304, Stairs A/1, B/1, C/4 and others
Deficiency Quantity	150
Quantity Uom	S.F.
Potential Action	REPLACE
Urgency of Action	PRIORITY 3
Purpose of Action	LEVEL 2

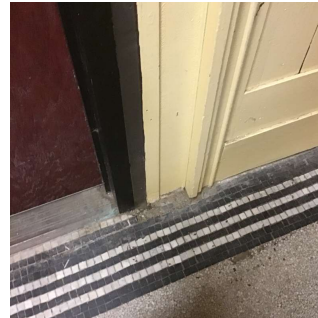
Exit 2 - Vestibule

CERAMIC TILE: BROKEN/MISSING

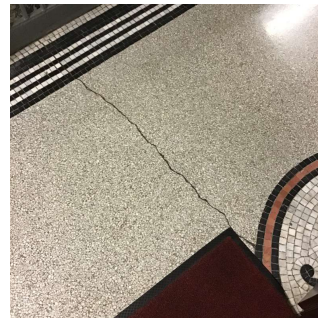
Stair A/1

TERRAZZO: CRACKS

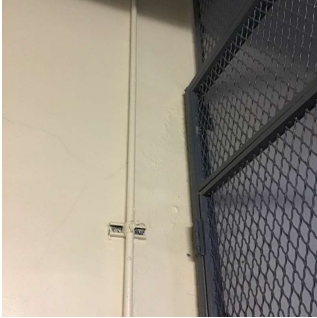
Question	Response
INTERIOR	
STAIRS/RAMPS: INTERIOR	
Walls	Inspected
Condition	2 - Between Good and Fair
Deficiency	PLASTER: CRACKS/SPALLING
Deficiency Location/Instance	Stair A/4
Deficiency Quantity	10
Quantity Uom	S.F.
Potential Action	REPLACE
Urgency of Action	PRIORITY 4
Purpose of Action	LEVEL 4
Deficiency Photo1

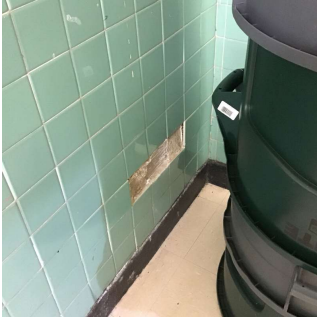
Violations	Stair A/4 35663333N
Deficiency	CERAMIC TILE: BROKEN/ MISSING
Deficiency Location/Instance	Stair E/Basement
Deficiency Quantity	10
Quantity Uom	S.F.
Potential Action	REPLACE
Urgency of Action	PRIORITY 3
Purpose of Action	LEVEL 2
Deficiency Photo1

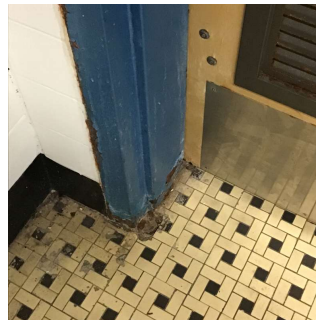
Men Toilet Room - in Gymnasium

WOOD: DETERIORATED DOOR AND FRAME

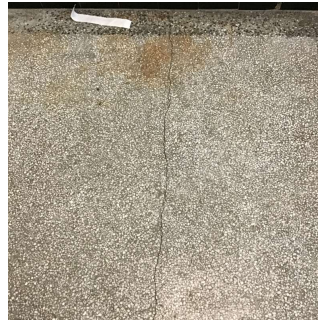
In Room 200

TERRAZZO: CRACKS

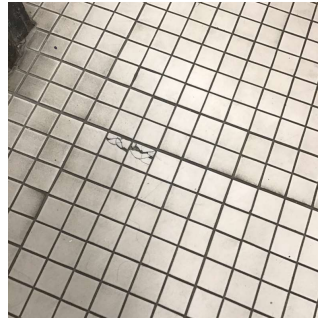
Room T10

CERAMIC TILE: BROKEN/MISSING TILES

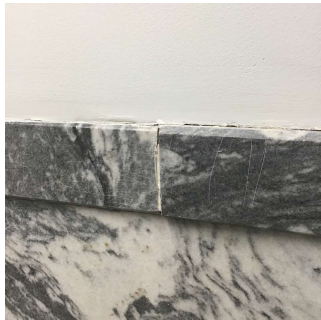
Question	Response
INTERIOR	
TOILET ROOMS - STAFF	
Stalls	Inspected
	Women Toilet Room - in Gymnasium
Violations	No violations recorded.
Walls	Inspected
Condition	2 - Between Good and Fair
Deficiency	STONE MOLDINGS: CRACKS/SPALLING
Deficiency Location/Instance	Room T10
Deficiency Quantity	10
Quantity Uom	L.F.
Potential Action	REPLACE
Urgency of Action	PRIORITY 3
Purpose of Action	LEVEL 2
Deficiency Photo1

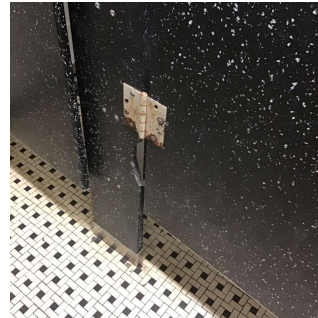
Room T1

BROKEN/MISSING

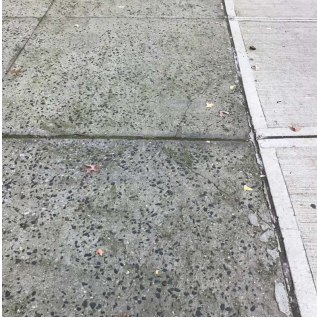
Question	Response
SITE	
PAVING	
Site Sidewalks & Walkways	
Concrete	
Condition	3 - Fair
Deficiency	CRACKS - MAJOR
Deficiency Location/Instance	Park Avenue, Courtyard
Deficiency Quantity	200
Quantity Uom	S.F.
Potential Action	REPLACE
Urgency of Action	PRIORITY 3
Purpose of Action	LEVEL 2
Deficiency Photo1

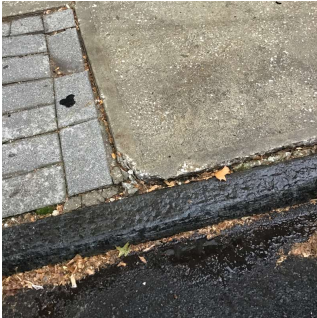
Violations	Park Avenue No violations recorded.
Pavers	Does not Exist
DOT Sidewalk	Inspected
Asphalt	Does not Exist
Concrete	Inspected
Condition	4 - Between Fair and Poor
Deficiency	HEAVING
Deficiency Location/Instance	Sterling Avenue
Deficiency Quantity	25
Quantity Uom	S.F.
Potential Action	REPLACE
Urgency of Action	PRIORITY 3
Purpose of Action	LEVEL 2
Deficiency Photo1

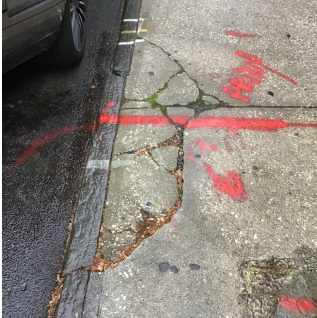
Violations	Sterling Avenue No violations recorded.
Deficiency	DAMAGED/DETERIORATED/MISSING SECTIONS
Deficiency Location/Instance	Sterling Avenue
Deficiency Quantity	50
Quantity Uom	S.F.

Question	Response
SITE	
PAVING	
DOT Sidewalk	
Concrete	
Potential Action	REPLACE
Urgency of Action	PRIORITY 5
Purpose of Action	LEVEL 6
Deficiency Photo1

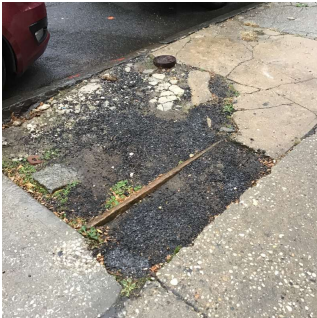
Sterling Avenue
Violations	No violations recorded.
Deficiency	DAMAGED/DETERIORATED/MISSING SECTIONS
Deficiency Location/Instance	Park Avenue, Sterling Avenue
Deficiency Quantity	350
Quantity Uom	S.F.
Potential Action	REPLACE
Urgency of Action	PRIORITY 3
Purpose of Action	LEVEL 2
Deficiency Photo1

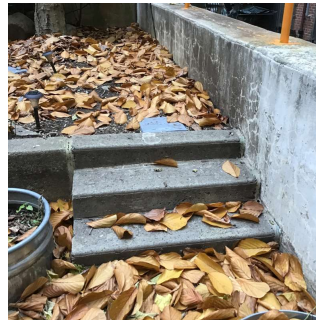
Courtyard

CAST IN PLACE CONCRETE: CRACKS/SPALLING - MAJOR
