NYC Department of Education
Building Condition Assessment Survey 2023 - 2024

Architectural Inspection

K907

Asset: BROWNSVILLE DIPLOMA PLUS HS - K, 1150 EAST NEW YORK AVE, New York, 11212

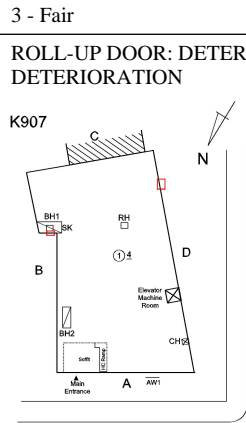
Violations	Roof 1 No violations recorded.
CORNICE	Does not Exist
DOORS	Inspected
DOORS AND FRAMES	Inspected
Condition	3 - Fair
Deficiency	ROLL-UP DOOR: DETERIORATED DOOR - MINOR DETERIORATION
Roof Plan reference

Deficiency Quantity	60
Quantity Uom	S.F.
Potential Action	MAINTENANCE
Urgency of Action	PRIORITY 3
Purpose of Action	LEVEL 2

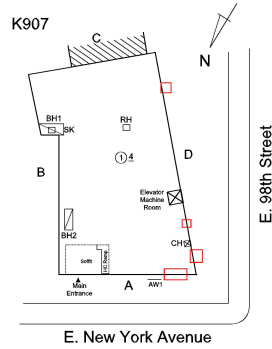
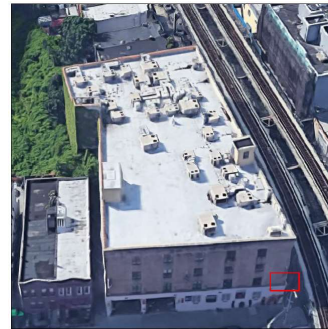
Elevation	 
Deficiency Quantity	30
Quantity Uom	L.F.
Potential Action	REMOVE AND REPLACE
Urgency of Action	PRIORITY 4
Purpose of Action	LEVEL 2
Deficiency Photo1	 
Violations	Facade B No violations recorded.
Deficiency	BRICK: MINOR CRACKS AND SPALLING

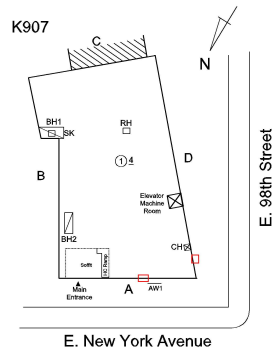
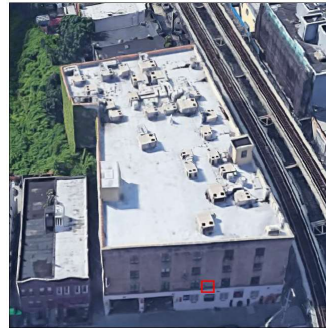
TERRA COTTA: CHIPPED/SPALLED/BROKEN PIECES - MINOR

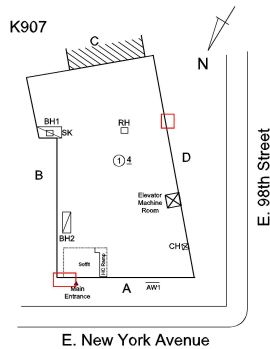
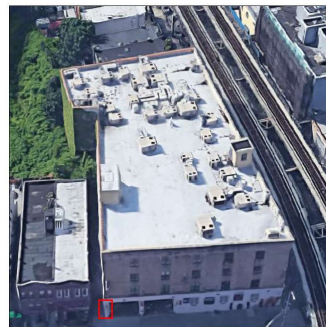
BRICK: MAJOR / THRU CRACKS

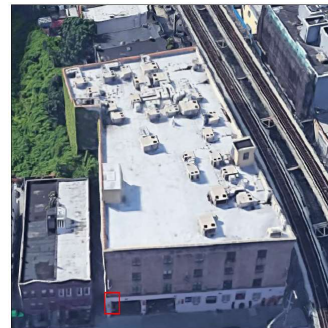
STUCCO CEMENT SURFACE: CRACKS, SPALLING

20
S.F.
REPLACE
PRIORITY 4
LEVEL 2

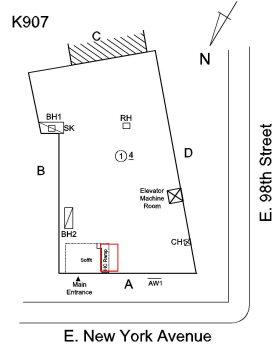
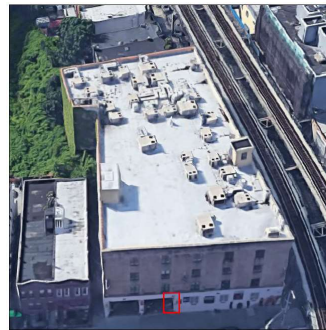
CONCRETE MASONRY UNIT: MAJOR / THRU CRACKS

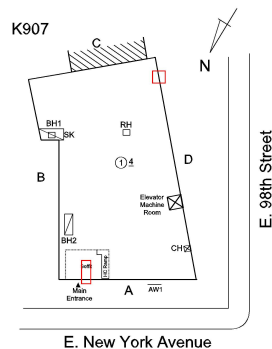
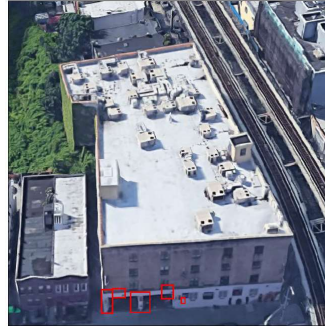
BRICK: DETERIORATED JOINTS

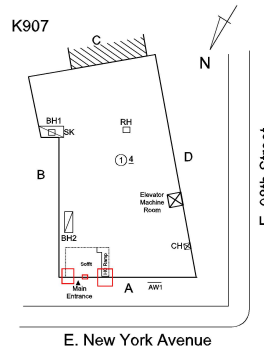
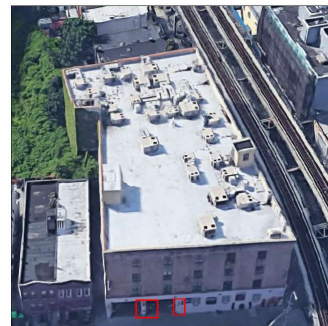
BRICK: CRACKS/DISPLACED/SPALLED BRICK AT BUILDING CORNERS

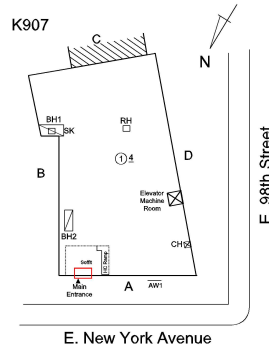
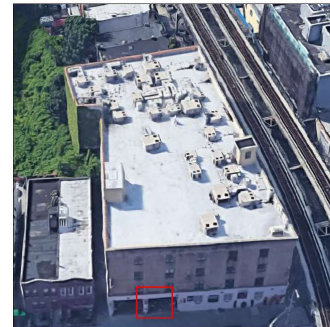
STUCCO/PLASTER: MINOR CRACKS/SPALLING

10
S.F.
REPAIR
PRIORITY 3
LEVEL 2

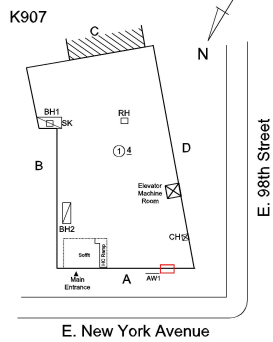
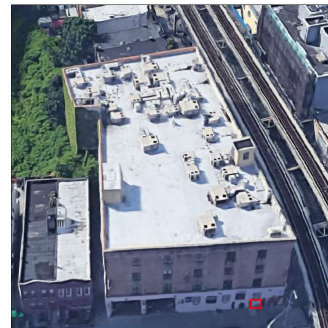
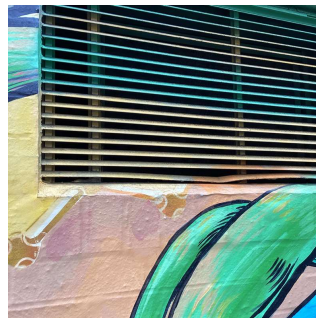
BROKEN/ DENTED BLADES

REPLACE

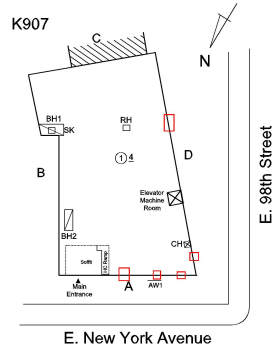
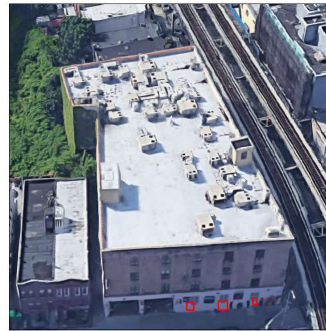
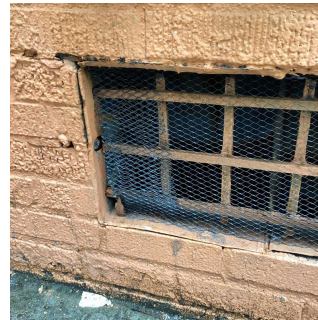
MISSING/DAMAGED SCREEN

REPLACE

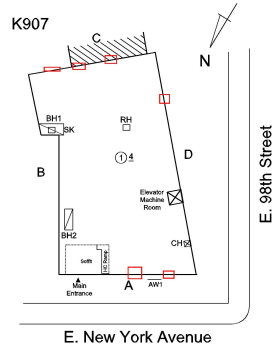
CONCRETE: MINOR CRACKS, SPALLING

30
S.F.
REPAIR
PRIORITY 3
LEVEL 2

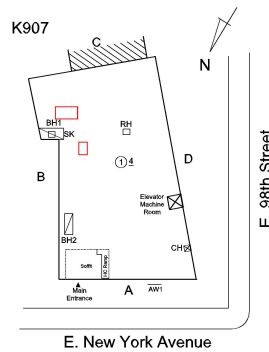
Deficiency	MODIFIED BITUMEN: ROOFING: DELAMINATION
------------	---

Deficiency Quantity	20
Quantity Uom	S.F.
Potential Action	REPLACE ROOFING WITHOUT MAJOR EQUIPMENT REMOVAL
Urgency of Action	PRIORITY 4
Purpose of Action	LEVEL 2

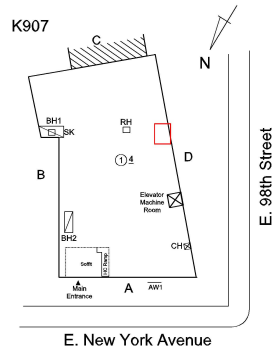
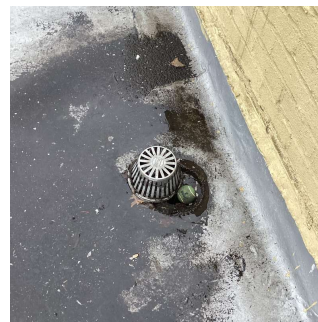
Condition	3 - Fair
Deficiency	DETERIORATED

1
EACH
REPLACE
PRIORITY 4
LEVEL 2

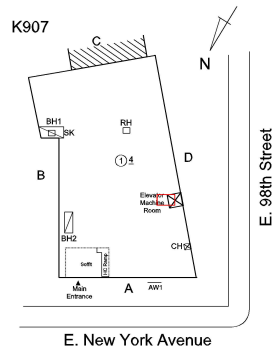
BULKHEAD/PENTHOUSE DOORS: DETERIORATED DOOR AND FRAME

1
EACH
REPLACE DOOR AND FRAME
PRIORITY 4
LEVEL 2

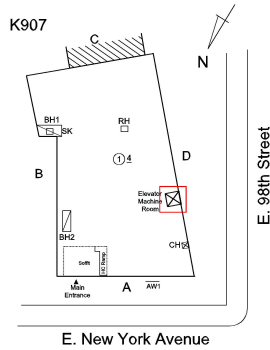
BULKHEAD/PENTHOUSE WINDOWS: DAMAGED, DETERIORATED WINDOWS

REPLACE

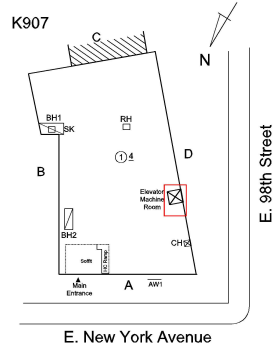
BULKHEAD/PENTHOUSE WALLS/INTERIOR: BRICK DETERIORATED JOINTS

50
S.F.
REPOINT
PRIORITY 3
LEVEL 2

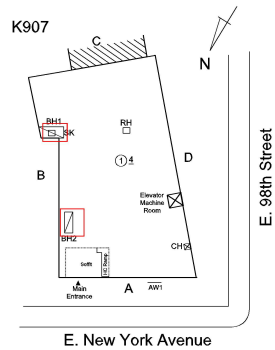
**BULKHEAD/PENTHOUSE WALLS/EXTERIOR:
CRACKS/SPALLING - MAJOR**

50
S.F.
REPLACE
PRIORITY 4
LEVEL 2

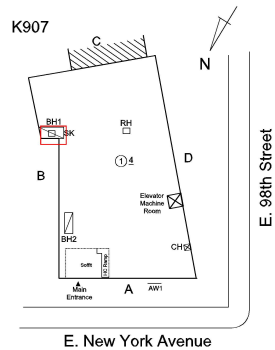
BROKEN GLASS

10
S.F.
MAINTENANCE
PRIORITY 3
LEVEL 2

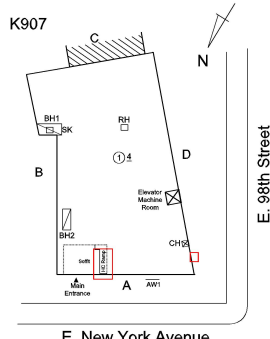
Question	Response
EXTERIOR	
STAIRS/RAMPS: EXTERIOR	
STAIRS/RAMPS	
Condition	3 - Fair
Deficiency	CONCRETE: CRACKS/SPALLING - MINOR
Roof Plan reference

Deficiency Quantity	15
Quantity Uom	S.F.
Potential Action	REPAIR
Urgency of Action	PRIORITY 3
Purpose of Action	LEVEL 2
Deficiency Photo1

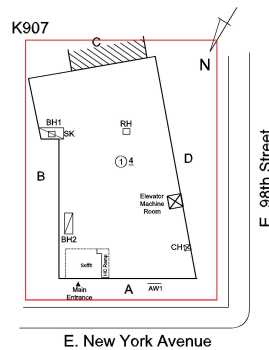
ALUMINUM - DOUBLE HUNG: INOPERABLE BALANCE

Question	Response
EXTERIOR	
WINDOWS	
WINDOWS	
Elevation	 
Deficiency Quantity	5
Quantity Uom	EACH
Potential Action	REPLACE BALANCES
Urgency of Action	PRIORITY 3
Purpose of Action	LEVEL 2
Deficiency Photo1	No photo recorded
Violations	No violations recorded.
INTERIOR	Inspected
POOLS	Does not Exist
STRUCTURAL	Inspected
COLUMNS/BEAMS/BEARING WALLS	Inspected
Condition	3 - Fair
Deficiency	STEEL COLUMNS/BEAMS: DETERIORATED CONCRETE FIREPROOFING
Deficiency Location/Instance	Stair D/3, Basement - Pump Room, Room C2, Electrical Room
Deficiency Quantity	60
Quantity Uom	S.F.
Potential Action	REPLACE
Urgency of Action	PRIORITY 3
Purpose of Action	LEVEL 5
Deficiency Photo1	 
Violations	Stair D/3 No violations recorded.
FLOOR STRUCTURE	Inspected
Condition	3 - Fair
Deficiency	CONCRETE SLAB ON GRADE: THRU CRACKS
Deficiency Location/Instance	Basement - Mechanical Room
Deficiency Quantity	10
Quantity Uom	S.F.
Potential Action	REPLACE

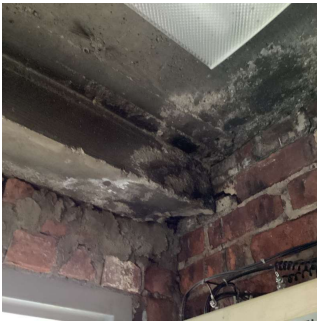
Question	Response
INTERIOR	
STRUCTURAL	
ROOF STRUCTURE	
Deficiency Photo1

Violations	Roof 1 - Elevator Machine Room No violations recorded.
VAULTS-BUNKERS	Does not Exist
AUDITORIUM	Does not Exist
CAFETERIA	Inspected
Instance on Basement - Staff (600 SF)	Inspected
Instance on Basement - Students	Inspected
Ceiling	
Instance on Basement - Students	Inspected
Condition	2 - Between Good and Fair
Deficiency	ACOUSTIC TILES: DAMAGED/MISSING
Deficiency Location/Instance	Near Servery
Deficiency Quantity	40
Quantity Uom	S.F.
Potential Action	REPLACE
Urgency of Action	PRIORITY 3
Purpose of Action	LEVEL 2
Deficiency Photo1	 
Violations	Near Servery No violations recorded.
Door(s)	
Instance on Basement - Students	Inspected
Condition	2 - Between Good and Fair
Deficiency	No deficiencies recorded
Instance on Basement - Staff (600 SF)	Inspected
Condition	2 - Between Good and Fair
Deficiency	No deficiencies recorded
Fixed Equipment

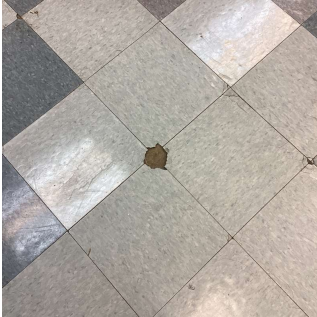
Question	Response
INTERIOR	
CAFETERIA	
Fixed Equipment	
Floor Finish	
Instance on Basement - Students	Inspected
Condition	5 - Poor
Deficiency	VINYL TILES: BROKEN/DETERIORATED/MISSING TILES
Deficiency Location/Instance	Near Center
Deficiency Quantity	30
Quantity Uom	S.F.
Potential Action	REPLACE
Urgency of Action	PRIORITY 3
Purpose of Action	LEVEL 2
Deficiency Photo1

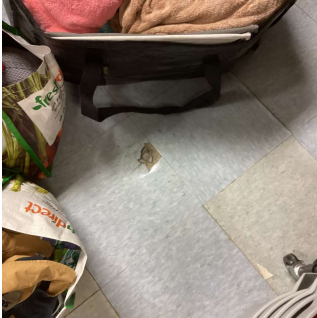
Violations	No violations recorded.
Instance on Basement - Staff (600 SF)	Inspected
Condition	2 - Between Good and Fair
Deficiency	VINYL TILES: BROKEN/DETERIORATED/MISSING TILES
Deficiency Location/Instance	Right Side
Deficiency Quantity	10
Quantity Uom	S.F.
Potential Action	REPLACE
Urgency of Action	PRIORITY 3
Purpose of Action	LEVEL 2
Deficiency Photo1

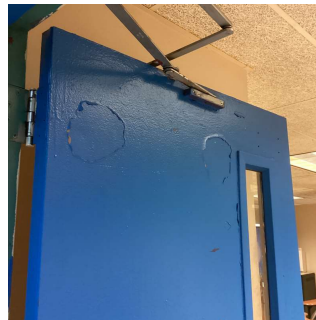
Room 309

METAL: DETERIORATED DOOR

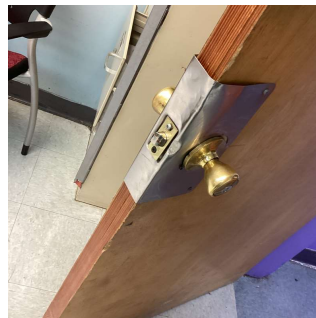
WOOD: DETERIORATED DOOR

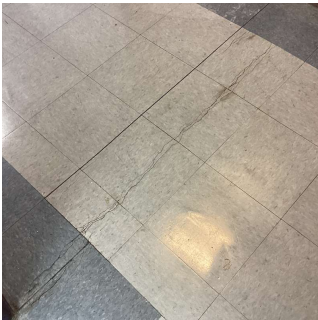
Question	Response
INTERIOR	
CLASSROOMS/CORRIDORS/ADMIN SPACES	
Door(s)	Inspected Room 107
Violations	No violations recorded.
Floor Finish	Inspected
Condition	3 - Fair
Deficiency	VINYL TILES: DETERIORATED SUBSTRATE
Deficiency Location/Instance	Corridor near Rooms 401, 211, 104, 102, By Elevator/1 and others
Deficiency Quantity	800
Quantity Uom	S.F.
Potential Action	REPLACE
Urgency of Action	PRIORITY 3
Purpose of Action	LEVEL 2
Deficiency Photo1

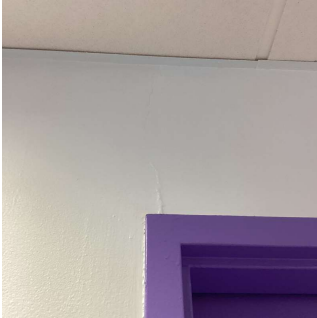
Violations	Corridor near Room 104 No violations recorded.
Deficiency	VINYL TILES: BROKEN/DETERIORATED/MISSING TILES
Deficiency Location/Instance	Main Entrance - Vestibule, Rooms 302, 115, 107, Corridor near Room 210 and others
Deficiency Quantity	200
Quantity Uom	S.F.
Potential Action	REPLACE
Urgency of Action	PRIORITY 3
Purpose of Action	LEVEL 2
Deficiency Photo1	 
Violations	Room 302 No violations recorded.
Walls	Inspected
Condition	2 - Between Good and Fair
Deficiency	PLASTER: CRACKS/SPALLING

Deficiency Location/Instance	Corridor near Rooms 111, 109, by Stair B/Basement, next to Girls Toilet Room - 1st Floor
Deficiency Quantity	40

Question	Response
INTERIOR	
CLASSROOMS/CORRIDORS/ADMIN SPACES	
Walls	
Quantity Uom	S.F.
Potential Action	REPLACE
Urgency of Action	PRIORITY 3
Purpose of Action	LEVEL 2
Deficiency Photo1

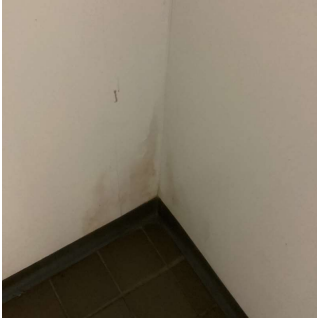
Question	Response
INTERIOR	
KITCHEN	
Walls	
Deficiency Location/Instance	Near Men Toilet Room and Women Toilet Room, Women Locker Room
Deficiency Quantity	40
Quantity Uom	S.F.
Potential Action	REPLACE
Urgency of Action	PRIORITY 3
Purpose of Action	LEVEL 2
Deficiency Photo1

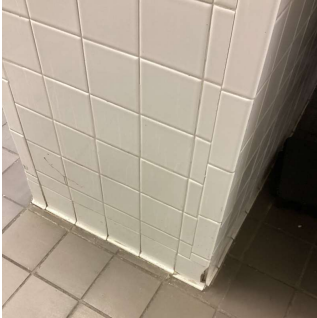
Violations	Near Men Toilet Room No violations recorded.
Deficiency	CERAMIC TILE: BROKEN/ MISSING
Deficiency Location/Instance	Near Main Entrance
Deficiency Quantity	10
Quantity Uom	S.F.
Potential Action	REPLACE
Urgency of Action	PRIORITY 3
Purpose of Action	LEVEL 2
Deficiency Photo1

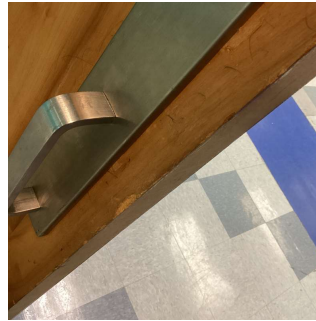
Instance on Room 300 (2000 SF)	Inspected
Condition	4 - Between Fair and Poor
Deficiency	WOOD: DETERIORATED DOOR
Deficiency Location/Instance	Main Entrance
Deficiency Quantity	2
Quantity Uom	EACH
Potential Action	MAINTENANCE
Urgency of Action	PRIORITY 3
Purpose of Action	LEVEL 2

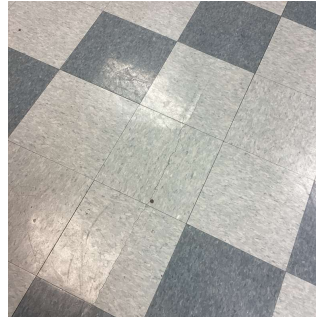
Near Main Entrance

Deficiency VINYL TILES: DETERIORATED SUBSTRATE

Deficiency Location/Instance Near Main Entrance, by Exit, Right Side

Deficiency Quantity 40

Potential Action REPLACE

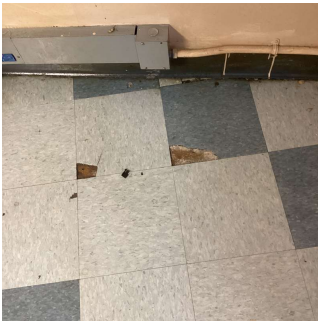
Deficiency VINYL TILES: BROKEN/DETERIORATED/MISSING TILES

Deficiency Location/Instance Near Left Side Windows

Deficiency Quantity 10

Potential Action REPLACE

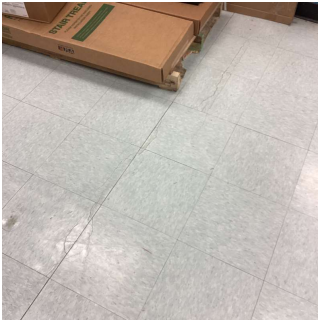
Violations	Near Left Side Windows No violations recorded.
Walls	
Instance on Room 300 (2000 SF)	Inspected
Condition	2 - Between Good and Fair
Deficiency	No deficiencies recorded
LOCKER ROOM	
Instance on Room 101 (156 Lockers)	Inspected
Alternative use	Yes
Ceiling	
Instance on Room 101 (156 Lockers)	Inspected
Condition	2 - Between Good and Fair
Deficiency	No deficiencies recorded
Door(s)	
Instance on Room 101 (156 Lockers)	Inspected
Condition	2 - Between Good and Fair
Deficiency	No deficiencies recorded
Floor Finish	
Instance on Room 101 (156 Lockers)	Inspected
Condition	3 - Fair
Deficiency	VINYL TILES: DETERIORATED SUBSTRATE
Deficiency Location/Instance	Center, near Main Entrance
Deficiency Quantity	50
Quantity Uom	S.F.
Potential Action	REPLACE
Urgency of Action	PRIORITY 3
Purpose of Action	LEVEL 2
Deficiency Photo1

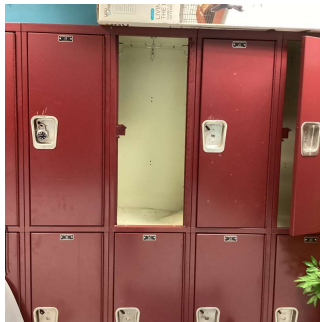
Question	Response
INTERIOR	
LOCKER ROOM	
Locker Room Lockers	
Instance on Room 101 (156 Lockers)	Inspected
Condition	2 - Between Good and Fair
Deficiency	DAMAGED UNITS
Deficiency Location/Instance	Locker 19
Deficiency Quantity	1
Quantity Uom	EACH
Potential Action	REPLACE
Urgency of Action	PRIORITY 3
Purpose of Action	LEVEL 2
Deficiency Photo1

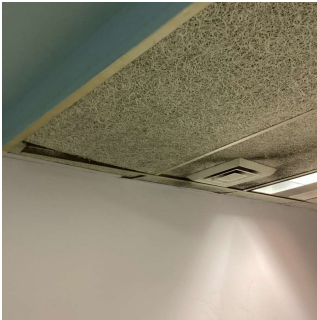
Question	Response
INTERIOR	
STAIRS/RAMPS: INTERIOR	Inspected
Do Letter Stair Signs Exist?	Yes
Ceiling	Inspected
Condition	2 - Between Good and Fair
Deficiency	TECTUM: DAMAGED/MISSING
Deficiency Location/Instance	Stair D/1
Deficiency Quantity	20
Quantity Uom	S.F.
Potential Action	REPLACE
Urgency of Action	PRIORITY 3
Purpose of Action	LEVEL 2
Deficiency Photo1

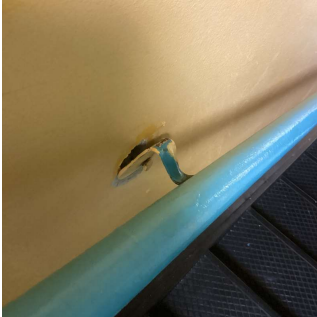
Violations	Stair D/1 No violations recorded.
Door(s)	Inspected
Condition	2 - Between Good and Fair
Deficiency	No deficiencies recorded
Partition	Does not Exist
Railings	Inspected
Condition	5 - Poor
Deficiency	METAL: BROKEN BRACKET
Deficiency Location/Instance	Stairs C/1, 2
Deficiency Quantity	4
Quantity Uom	EACH
Potential Action	REPLACE
Urgency of Action	PRIORITY 3
Purpose of Action	LEVEL 2
Deficiency Photo1

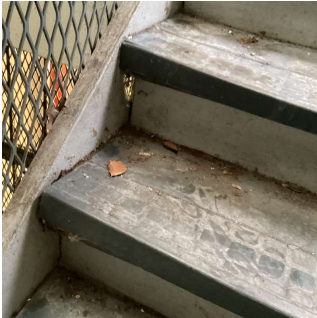
Question	Response
INTERIOR	
STAIRS/RAMPS: INTERIOR	
Railings	
Quantity Uom	L.F.
Potential Action	REPLACE
Urgency of Action	PRIORITY 5
Purpose of Action	LEVEL 6
Deficiency Photo1	 
	Stair D/2
Violations	No violations recorded.
Stairs and Landings	Inspected
Condition	3 - Fair
Deficiency	SHEET VINYL: BROKEN/DETERIORATED
Deficiency Location/Instance	Stairs D/Bulkhead, 3, 2
Deficiency Quantity	40
Quantity Uom	S.F.
Potential Action	REPLACE
Urgency of Action	PRIORITY 3
Purpose of Action	LEVEL 2
Deficiency Photo1

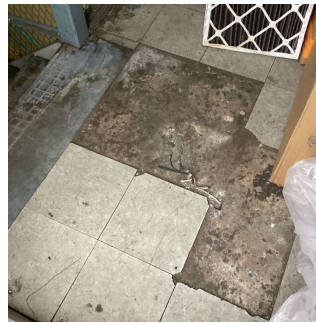
Stair D/Bulkhead
Violations	No violations recorded.
Deficiency	VINYL TILES: BROKEN/DETERIORATED/MISSING TILES
Deficiency Location/Instance	Stairs B/2, 1, Basement, D/Bulkhead, 4 and others
Deficiency Quantity	200
Quantity Uom	S.F.
Potential Action	REPLACE
Urgency of Action	PRIORITY 3
Purpose of Action	LEVEL 2

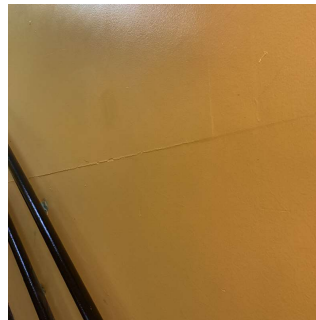
Stair B/3

GYPSON BOARD: DETERIORATED

REPLACE

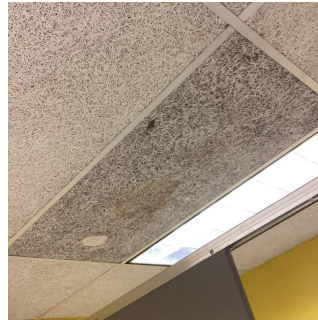
Boys Toilet Room - 4th Floor
No violations recorded.

Question	Response
INTERIOR	
TOILET ROOMS - STAFF	
Ceiling	
Deficiency Photo1	 
Violations	Men Toilet Room - 3rd No violations recorded.
Door(s)	Inspected
Condition	5 - Poor
Deficiency	WOOD: DETERIORATED DOOR
Deficiency Location/Instance	Staff Toilet Room - 2nd Floor
Deficiency Quantity	1
Quantity Uom	EACH
Potential Action	MAINTENANCE
Urgency of Action	PRIORITY 3
Purpose of Action	LEVEL 2
Deficiency Photo1	 
Violations	Staff Toilet Room - 2nd Floor No violations recorded.
Floor Finish	Inspected
Condition	2 - Between Good and Fair
Deficiency	No deficiencies recorded
Stalls	Does not Exist
Walls	Inspected
Condition	2 - Between Good and Fair
Deficiency	No deficiencies recorded
TOILET ROOMS - STUDENTS	
Ceiling	Inspected
Condition	2 - Between Good and Fair
Deficiency	TECTUM: DAMAGED/MISSING
Deficiency Location/Instance	Boys Toilet Room - 4th Floor
Deficiency Quantity	10
Quantity Uom	S.F.
Potential Action	REPLACE
Urgency of Action	PRIORITY 3

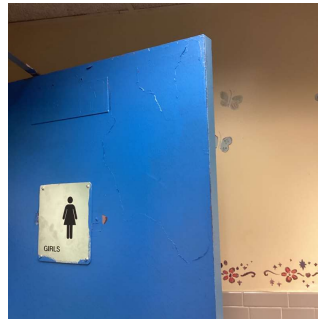
Girls Toilet Room - 3rd Floor
No violations recorded.

METAL: DETERIORATED DOOR

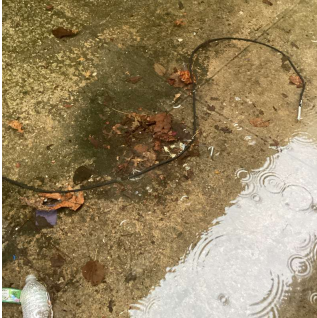
Question	Response
INTERIOR	
TOILET ROOMS - STUDENTS	
Floor Finish	
Deficiency Photo1	 
Violations	Boys Toilet Room - 1st Floor No violations recorded.
Stalls	Inspected
Condition	3 - Fair
Deficiency	BROKEN/MISSING
Deficiency Location/Instance	Boys Toilet Room - 4th, 3rd Floor
Deficiency Quantity	2
Quantity Uom	EACH
Potential Action	REPLACE
Urgency of Action	PRIORITY 3
Purpose of Action	LEVEL 2
Deficiency Photo1	 
Violations	Boys Toilet Room - 4th Floor No violations recorded.
Walls	Inspected
Condition	2 - Between Good and Fair
Deficiency	No deficiencies recorded
LIFE SAFETY	Inspected
F.D. HOLDING AREA	Does not Exist
STEEL STAIRS	Does not Exist
SITE	Inspected
CONTAINERIZATION	Does not Exist
Drainage System for Asphalt	Does not Exist
Drainage System for Concrete	Inspected
Catch Basins/Manhole - Surrounded by concrete	Inspected
Condition	3 - Fair
Deficiency	DAMAGED COVER
Deficiency Location/Instance	Near Exit 4
Deficiency Quantity	1

Question	Response
SITE	
Drainage System for Concrete	
Catch Basins/Manhole - Surrounded by concrete	
Quantity Uom	EACH
Potential Action	REPLACE
Urgency of Action	PRIORITY 3
Purpose of Action	LEVEL 2
Deficiency Photo1

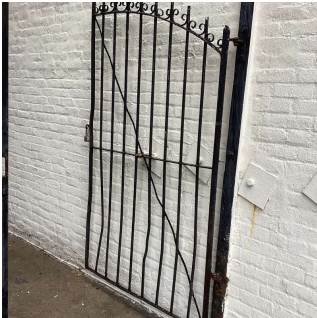
Near Exit 4
Violations	No violations recorded.
Culverts - Concrete Covering	
	Does not Exist
Drainage System for Soil	
	Does not Exist
DRINKING FOUNTAINS	
	Does not Exist
FENCES	
Condition	Inspected
	3 - Fair
Deficiency	WROUGHT IRON: DAMAGED/DETERIORATED
Deficiency Location/Instance	East New York Avenue
Deficiency Quantity	80
Quantity Uom	S.F.
Potential Action	REPLACE
Urgency of Action	PRIORITY 3
Purpose of Action	LEVEL 2
Deficiency Photo1

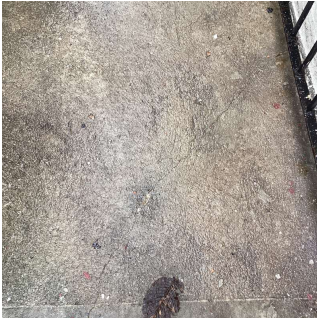
Question	Response
SITE	
PAVING	
Site Sidewalks & Walkways	
Concrete	
Deficiency	DAMAGED/DETERIORATED/MISSING SECTIONS
Deficiency Location/Instance	East New York Avenue, near Exit 4
Deficiency Quantity	425
Quantity Uom	S.F.
Potential Action	REPLACE
Urgency of Action	PRIORITY 3
Purpose of Action	LEVEL 2
Deficiency Photo1

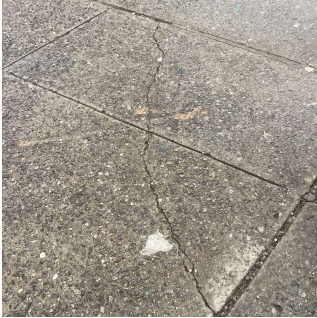
Violations	East New York Avenue No violations recorded.
Pavers	Does not Exist
DOT Sidewalk	Inspected
Asphalt	Does not Exist
Concrete	Inspected
Condition	4 - Between Fair and Poor
Deficiency	DAMAGED/DETERIORATED/MISSING SECTIONS
Deficiency Location/Instance	E 98th Street, East New York Avenue
Deficiency Quantity	1,175
Quantity Uom	S.F.
Potential Action	REPLACE
Urgency of Action	PRIORITY 3
Purpose of Action	LEVEL 2
Deficiency Photo1

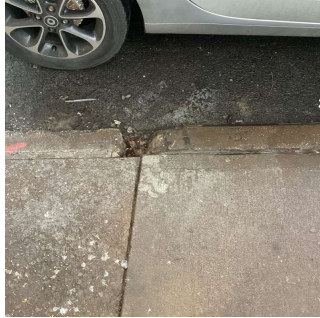
Violations	E 98th Street No violations recorded.
Deficiency	DAMAGED CURBS
Deficiency Location/Instance	E 98th Street, East New York Avenue
Deficiency Quantity	180
Quantity Uom	L.F.

Question	Response
SITE	
PAVING	
DOT Sidewalk	
Concrete	
Urgency of Action	PRIORITY 3
Purpose of Action	LEVEL 2
Deficiency Photo1

Potential Action	REPLACE
