NYC Department of Education
Building Condition Assessment Survey 2023 - 2024

Architectural Inspection

Asset: ACORN COMMUNITY HS - K, 561 GRAND AVENUE, New York, 11238

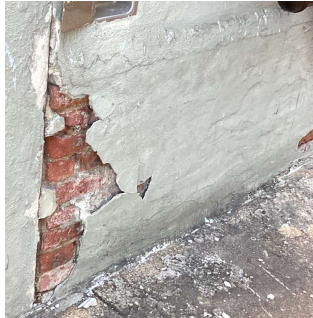
Facade D

STUCCO CEMENT SURFACE: CRACKS, SPALLING

REPLACE

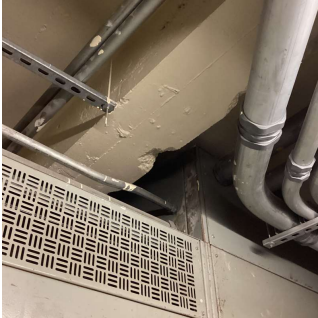
Question	Response
EXTERIOR	
WINDOWS	
WINDOWS	
Are these windows insulated	Yes
Installation Year	1998
Source of Installation	Custodial Staff
Deficiency	No deficiencies recorded
INTERIOR	Inspected
POOLS	Does not Exist
STRUCTURAL	Inspected
COLUMNS/BEAMS/BEARING WALLS	Inspected
Condition	3 - Fair
Deficiency	STEEL COLUMNS/BEAMS: DETERIORATED CONCRETE FIREPROOFING
Deficiency Location/Instance	Stair B\5, Basement - Electrical Room
Deficiency Quantity	30
Quantity Uom	S.F.
Potential Action	REPLACE
Urgency of Action	PRIORITY 4
Purpose of Action	LEVEL 5
Deficiency Photo1

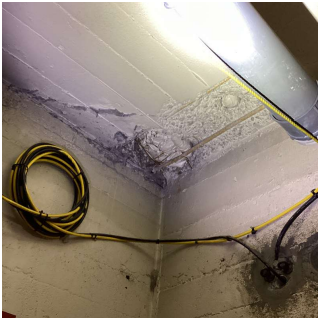
Question	Response
INTERIOR	
STRUCTURAL	
FLOOR STRUCTURE	
Violations	No violations recorded.
Deficiency	CONCRETE: CRACKS/SPALLED/REINFORCEMENT EXPOSED
Deficiency Location/Instance	Basement - Boiler Room
Deficiency Quantity	50
Quantity Uom	S.F.
Potential Action	REPAIR
Urgency of Action	PRIORITY 4
Purpose of Action	LEVEL 5
Deficiency Photo1

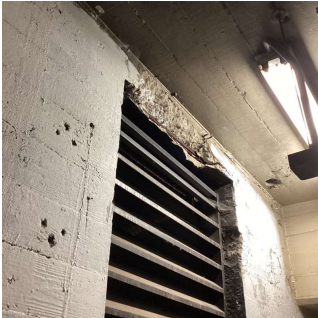
Violations	Basement - Boiler Room No violations recorded.
FOUNDATION WALLS	
Material Type(s)	Inspected Concrete
Condition	3 - Fair
Deficiency	CONCRETE: CRACKED/SPALLED/REINFORCEMENT EXPOSED
Deficiency Location/Instance	Basement - Boiler Room
Deficiency Quantity	50
Quantity Uom	S.F.
Potential Action	REPAIR
Urgency of Action	PRIORITY 4
Purpose of Action	LEVEL 5
Deficiency Photo1

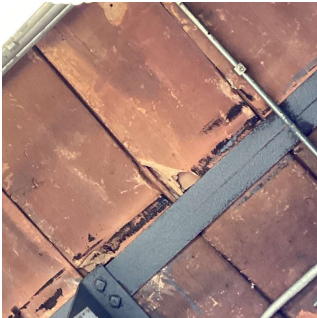
Violations	BH2 No violations recorded.
Deficiency	CLAY/CONCRETE TILES: MISSING/CRACKED/SPALLED
Deficiency Location/Instance	PH
Deficiency Quantity	10
Quantity Uom	S.F.
Potential Action	REPLACE
Urgency of Action	PRIORITY 4
Purpose of Action	LEVEL 5
Deficiency Photo1

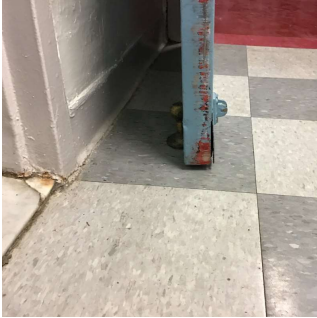
Question	Response
INTERIOR	
STRUCTURAL	
VAULTS-BUNKERS	
Foundation Walls	
Deficiency Photo1	 
Violations	Basement - Boiler Room No violations recorded.
Slab Structure	Inspected
Condition	3 - Fair
Deficiency	CONCRETE: CRACKS/SPALLED/REINFORCEMENT EXPOSED
Deficiency Location/Instance	Basement - Boiler Room
Deficiency Quantity	10
Quantity Uom	S.F.
Potential Action	REPAIR
Urgency of Action	PRIORITY 4
Purpose of Action	LEVEL 5
Deficiency Photo1	 
Violations	Basement - Boiler Room No violations recorded.
Vault/Ash Hoist Doors and Framing	Inspected
Condition	1 - Good
Deficiency	No deficiencies recorded
AUDITORIUM	
Does not Exist	
CAFETERIA	
Inspected	
Instance on 1st Floor	Inspected
Ceiling	
Instance on 1st Floor	Does not Exist
Door(s)	
Instance on 1st Floor	Inspected
Condition	3 - Fair
Deficiency	METAL: DETERIORATED DOOR
Deficiency Location/Instance	Entrance near kitchen
Deficiency Quantity	1
Quantity Uom	EACH

Question	Response
INTERIOR	
CAFETERIA	
Door(s)	
Potential Action	MAINTENANCE
Urgency of Action	PRIORITY 3
Purpose of Action	LEVEL 2
Deficiency Photo1

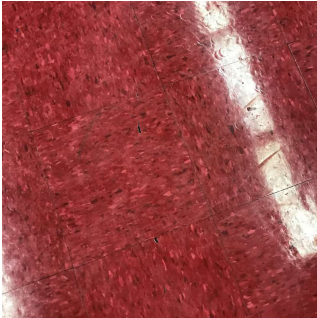
Violations	Entrance near kitchen No violations recorded.
Fixed Equipment	
Instance on 1st Floor	Does not Exist
Floor Finish	
Instance on 1st Floor	Inspected
Condition	2 - Between Good and Fair
Deficiency	VINYL TILES: BROKEN/DETERIORATED/MISSING TILES
Deficiency Location/Instance	Near Servery
Deficiency Quantity	10
Quantity Uom	S.F.
Potential Action	REPLACE
Urgency of Action	PRIORITY 3
Purpose of Action	LEVEL 2
Deficiency Photo1

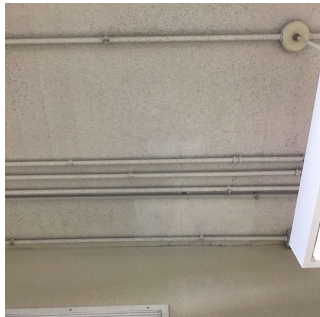
Room 615
Violations	No violations recorded.
Deficiency	PLASTER: CRACKS/SPALLING - ACTIVE LEAK
Deficiency Location/Instance	Room 619,619B,617
Deficiency Quantity	40
Quantity Uom	S.F.
Potential Action	REPLACE
Urgency of Action	PRIORITY 5
Purpose of Action	LEVEL 2

Question	Response
INTERIOR	
CAFETERIA	
Walls	
Quantity Uom	S.F.
Potential Action	REPLACE
Urgency of Action	PRIORITY 3
Purpose of Action	LEVEL 2
Deficiency Photo1	 
	Near Windows
Violations	No violations recorded.
Window Curtains/Shades/Blinds	
Instance on 1st Floor	Does not Exist
CLASSROOMS/CORRIDORS/ADMIN SPACES	
Ceiling	
Condition	2 - Between Good and Fair
Deficiency	PLASTER: CRACKS/SPALLING
Deficiency Location/Instance	Rooms 615,505,503
Deficiency Quantity	20
Quantity Uom	S.F.
Potential Action	REPLACE
Urgency of Action	PRIORITY 3
Purpose of Action	LEVEL 2
Deficiency Photo1

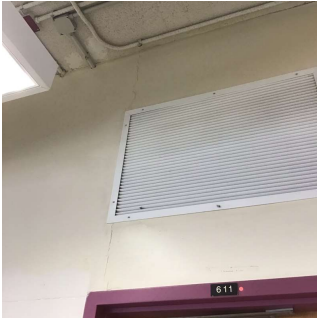
Question	Response
INTERIOR	
CLASSROOMS/CORRIDORS/ADMIN SPACES	
Door(s)	Inspected
	Room 619
Violations	No violations recorded.
Floor Finish	Inspected
Condition	2 - Between Good and Fair
Deficiency	VINYL TILES: DETERIORATED SUBSTRATE
Deficiency Location/Instance	Corridor near Room 614,609, Stair A/6,1,B/4, and others
Deficiency Quantity	100
Quantity Uom	S.F.
Potential Action	REPLACE
Urgency of Action	PRIORITY 3
Purpose of Action	LEVEL 2
Deficiency Photo1	 
Violations	Corridor near Room 609 No violations recorded.
Walls	Inspected
Condition	2 - Between Good and Fair
Deficiency	PLASTER: CRACKS/SPALLING
Deficiency Location/Instance	Corridor near Room 611
Deficiency Quantity	10
Quantity Uom	S.F.
Potential Action	REPLACE
Urgency of Action	PRIORITY 3
Purpose of Action	LEVEL 2
Deficiency Photo1

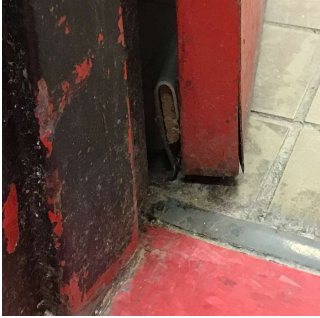
Question	Response
INTERIOR	
KITCHEN	
Ceiling	
Violations	No violations recorded.
Door(s)	
Instance on 1st Floor	Inspected
Condition	3 - Fair
Deficiency	METAL: DETERIORATED DOOR
Deficiency Location/Instance	Entrance
Deficiency Quantity	1
Quantity Uom	EACH
Potential Action	MAINTENANCE
Urgency of Action	PRIORITY 3
Purpose of Action	LEVEL 2
Deficiency Photo1

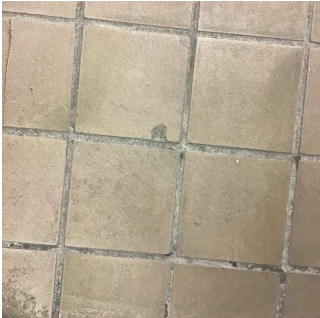
Violations	Entrance No violations recorded.
Floor Finish	
Instance on 1st Floor	Inspected
Condition	2 - Between Good and Fair
Deficiency	QUARRY TILE: BROKEN/MISSING TILES
Deficiency Location/Instance	Near Entrance, Room 107
Deficiency Quantity	10
Quantity Uom	S.F.
Potential Action	REPLACE
Urgency of Action	PRIORITY 3
Purpose of Action	LEVEL 2
Deficiency Photo1

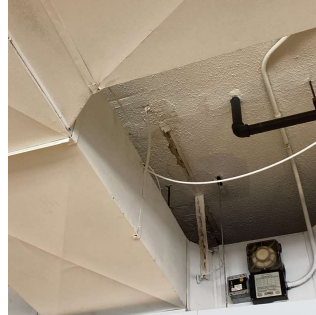
Near Entrance

Urgency of Action	PRIORITY 5
Purpose of Action	LEVEL 2
Deficiency Photo1

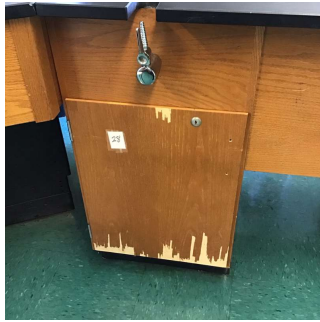
Question	Response
INTERIOR	
MULTI-PURPOSE ROOM	
Sliding-folding Partition	
Instance on 2nd Floor	Does not Exist
Stage	
Instance on 2nd Floor	Does not Exist
Walls	
Instance on 2nd Floor	Inspected
Condition	2 - Between Good and Fair
Deficiency	No deficiencies recorded
Window Curtains/Shades/Blinds	
Instance on 2nd Floor	Does not Exist
SCIENCE DEMO ROOM	
Instance on Rooms 511,521	Inspected
Alternative use	Yes
Fixed Equipment	
Instance on Rooms 511,521	Inspected
Condition	2 - Between Good and Fair
Deficiency	No deficiencies recorded
SCIENCE LAB	
Instance on Room 423	Inspected
Alternative use	No
Fixed Equipment	
Instance on Room 423	Inspected
Condition	5 - Poor
Deficiency	CABINETRY: MISSING/DAMAGED
Deficiency Location/Instance	Room 423
Deficiency Quantity	30
Quantity Uom	L.F.
Potential Action	REPLACE
Urgency of Action	PRIORITY 3
Purpose of Action	LEVEL 2
Deficiency Photo1

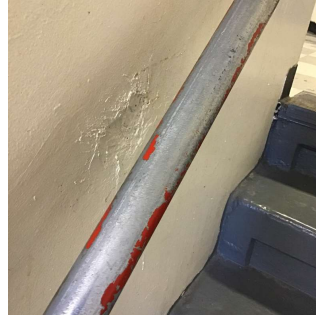
Stair B/2

Urgency of Action	PRIORITY 3
Purpose of Action	LEVEL 2
Deficiency Photo1

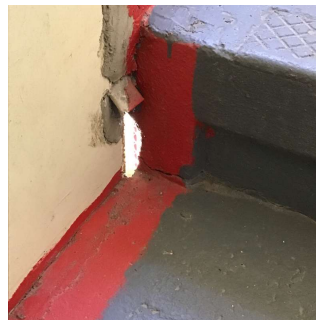
Stair B/Bulkhead

Deficiency	CONCRETE: CRACKS/SPALLING - MAJOR
Deficiency Location/Instance	Stair A/Bulkhead,B/Bulkhead, A/4, B/6
Deficiency Quantity	40
Quantity Uom	S.F.
Potential Action	REPLACE
Urgency of Action	PRIORITY 3
Purpose of Action	LEVEL 2
Deficiency Photo1

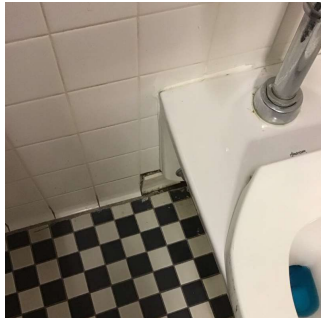
Question	Response
INTERIOR	
TOILET ROOMS - STAFF	
Stalls	Does not Exist
Walls	Inspected
Condition	2 - Between Good and Fair
Deficiency	CERAMIC TILE: BROKEN/ MISSING
Deficiency Location/Instance	Room 216
Deficiency Quantity	10
Quantity Uom	S.F.
Potential Action	REPLACE
Urgency of Action	PRIORITY 3
Purpose of Action	LEVEL 2
Deficiency Photo1

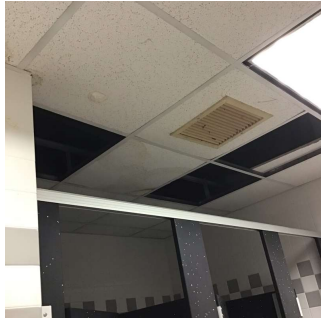
Violations	Room 216 No violations recorded.
TOILET ROOMS - STUDENTS	
Ceiling	Inspected
Condition	2 - Between Good and Fair
Deficiency	ACOUSTIC TILES: DAMAGED/MISSING
Deficiency Location/Instance	Room 120
Deficiency Quantity	10
Quantity Uom	S.F.
Potential Action	REPLACE
Urgency of Action	PRIORITY 3
Purpose of Action	LEVEL 2
Deficiency Photo1

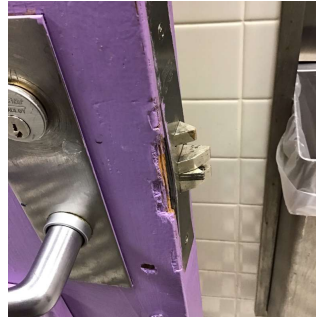
Room 514

Deficiency

WOOD: DETERIORATED DOOR

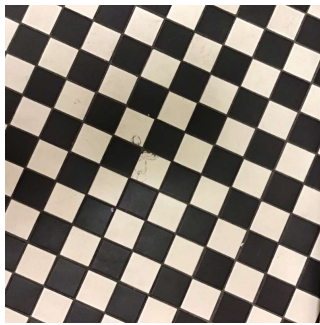
Deficiency

CERAMIC TILE: BROKEN/MISSING TILES

REPLACE

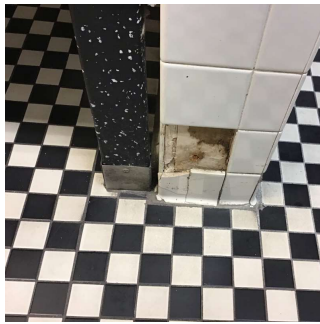
Violations	Room 514 No violations recorded.
Stalls	Inspected
Condition	2 - Between Good and Fair
Deficiency	No deficiencies recorded
Walls	Inspected
Condition	2 - Between Good and Fair
Deficiency	CERAMIC TILE: BROKEN/ MISSING
Deficiency Location/Instance	Room 514,114
Deficiency Quantity	20
Quantity Uom	S.F.
Potential Action	REPLACE
Urgency of Action	PRIORITY 3
Purpose of Action	LEVEL 2
Deficiency Photo1

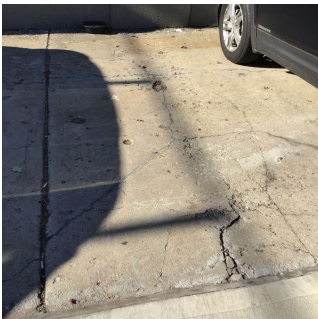
Question	Response
SITE	
Drainage System for Concrete	Inspected
Catch Basins/Manhole - Surrounded by concrete	Inspected
Condition	2 - Between Good and Fair
Deficiency	No deficiencies recorded
Culverts - Concrete Covering	Does not Exist
Drainage System for Soil	Does not Exist
DRINKING FOUNTAINS	Does not Exist
FENCES	Inspected
Condition	2 - Between Good and Fair
Deficiency	No deficiencies recorded
IRRIGATION SYSTEM	Does not Exist
PAVING	Inspected
Student Non-Use	Inspected
Gravel Exists?	No
Asphalt	Inspected
Condition	1 - Good
Deficiency	No deficiencies recorded
Concrete	Inspected
Condition	4 - Between Fair and Poor
Deficiency	DAMAGED/DETERIORATED/MISSING SECTIONS
Deficiency Location/Instance	Parking area, Alleyway
Deficiency Quantity	850
Quantity Uom	S.F.
Potential Action	REPLACE
Urgency of Action	PRIORITY 4
Purpose of Action	LEVEL 4
Deficiency Photo1

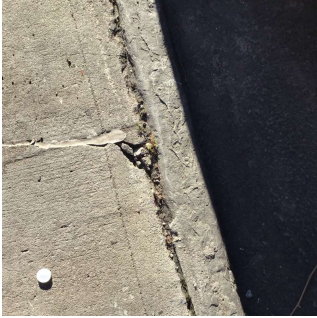
Along Grand Avenue
Violations	No violations recorded.
Deficiency	DAMAGED CURBS
Deficiency Location/Instance	Along Grand Avenue, Dean Street
Deficiency Quantity	20
Quantity Uom	L.F.
Potential Action	REPLACE
Urgency of Action	PRIORITY 3
Purpose of Action	LEVEL 2
Deficiency Photo1

Site Sidewalks & Walkways	Does not Exist
DOT Sidewalk	Inspected
Asphalt	Does not Exist
Concrete	Inspected
Condition	4 - Between Fair and Poor
Deficiency	DAMAGED/DETERIORATED/MISSING SECTIONS
Deficiency Location/Instance	Along Grand Avenue, Dean Street
Deficiency Quantity	625
Quantity Uom	S.F.
Potential Action	REPLACE

Question	Response
SITE	
PAVING	
DOT Sidewalk	
Concrete	
Urgency of Action	PRIORITY 3
Purpose of Action	LEVEL 2
Deficiency Photo1

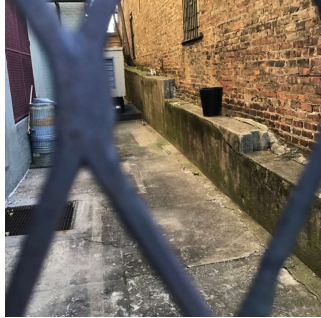
Alleyway
Violations	No violations recorded.
SEATING	Does not Exist
SITE WALLS (NOT RETAINING WALLS)	Inspected
Condition	3 - Fair
Deficiency	CAST IN PLACE CONCRETE: CRACKS/SPALLING - MAJOR
Deficiency Location/Instance	Near Exit 3/4, Play Area
Deficiency Quantity	60
Quantity Uom	S.F.

Question	Response
SITE	
PLAYGROUNDS	
Play Equipment	
Instance on Schoolyard	Does not Exist
Safety Surfacing	
Instance on Schoolyard	Inspected
Condition	1 - Good
Deficiency	No deficiencies recorded
Unpaved Area	
Instance on Schoolyard	Does not Exist
PLAYING SURFACE	Does not Exist
RETAINING WALLS	Inspected
Are there any Retaining Walls 6' OR higher facing public street/sidewalk?	No
Condition	3 - Fair
Deficiency	CAST IN PLACE CONCRETE: CRACKS/SPALLING - MAJOR
Deficiency Location/Instance	Alleyway, Parking Lot
Deficiency Quantity	60
Quantity Uom	S.F.
Potential Action	REPLACE
Urgency of Action	PRIORITY 3
Purpose of Action	LEVEL 2
Deficiency Photo1

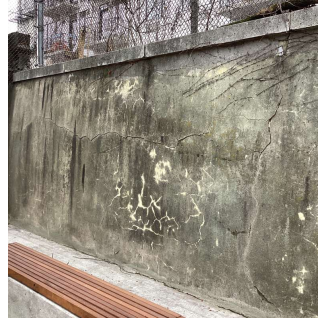
Play Area

SITE WALLS (NOT RETAINING WALLS)

Potential Action	REPLACE
Urgency of Action	PRIORITY 3
Purpose of Action	LEVEL 2
