**NYC Department of Education
Building Condition Assessment Survey 2023 - 2024**

Architectural Inspection

K913

Asset: EBC HS FOR PUB. SERV. - BUSHWICK-K, 1155 DEKALB AVENUE, New York, 11221

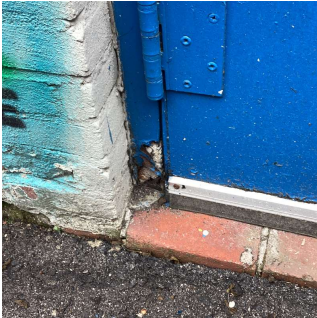
Violations	Roof 5 - Facade A No violations recorded.
CORNICE	Inspected
Condition	2 - Between Good and Fair
Deficiency	No deficiencies recorded
DOORS	Inspected
DOORS AND FRAMES	Inspected
Condition	5 - Poor
Deficiency	METAL CLAD: DETERIORATED DOOR AND FRAME - MAJOR DETERIORATION
Roof Plan reference

Violations	Facade C - Exit 3 No violations recorded.
Deficiency	METAL: DETERIORATED DOOR AND FRAME - MAJOR DETERIORATION

Deficiency Quantity	2
Quantity Uom	EACH
Potential Action	REPLACE
Urgency of Action	PRIORITY 4
Purpose of Action	LEVEL 2
Deficiency Photo1

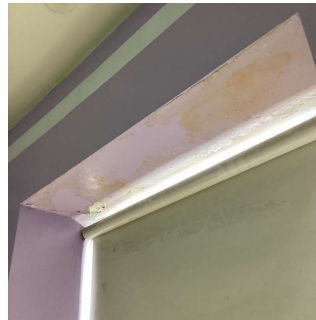
BRICK: WATER INFILTRATION IN INSTRUCTIONAL SPACE

Facade D - Room 337A shown, Facade D - Rooms 229, 239, 329, 339, 431 similar

REPAIR

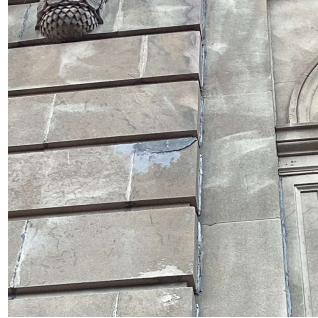
Facade A
35672024Y

TERRA COTTA: CHIPPED/SPALLED/BROKEN PIECES - MAJOR

Potential Action	REPLACE
Urgency of Action	PRIORITY 4
Purpose of Action	LEVEL 4
Deficiency Photo1

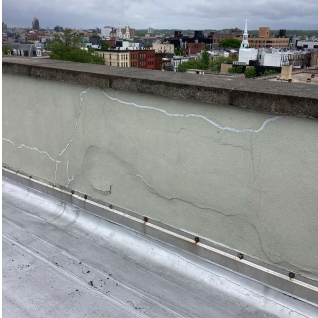
Violations	Roof 3 - Facade B No violations recorded.
Deficiency	CONCRETE: MAJOR DETERIORATION/CRACKS
Roof Plan reference

<p>K913</p> <p align="center">Dekalb Avenue</p> <p align="right">Bushwick Avenue</p>
Deficiency Quantity	80
Quantity Uom	S.F.
Potential Action	REMOVE AND REBUILD
Urgency of Action	PRIORITY 4
Purpose of Action	LEVEL 2
Deficiency Photo1

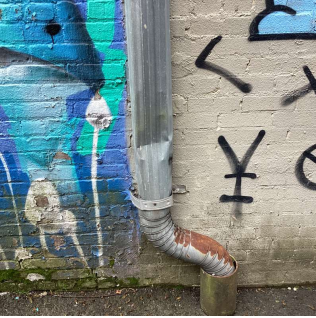
Question	Response
EXTERIOR	
ROOF	
Roofing	
LEADERS, GUTTERS, DOWNSPOUTS, SCUPPERS	
Deficiency	DAMAGED/MISSING
Roof Plan reference	<p>K913</p>

<p align="center">Dekalb Avenue</p>
Deficiency Quantity	20
Quantity Uom	L.F.
Potential Action	REPLACE
Urgency of Action	PRIORITY 4
Purpose of Action	LEVEL 2
Deficiency Photo1

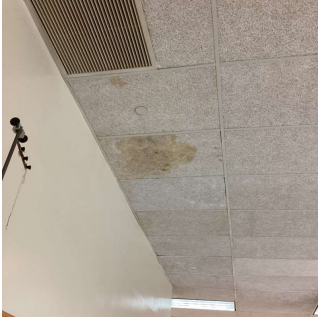
MODIFIED BITUMEN: ROOFING: MAJOR ACTIVE ROOF LEAKS IN INSTRUCTIONAL SPACE

Roof 6 - Room 431 shown, Roof 1 - Room 431, Roof 2 - Room 205 similar

Deficiency Quantity	300
Quantity Uom	S.F.
Potential Action	REPLACE ROOFING WITHOUT MAJOR EQUIPMENT REMOVAL
Urgency of Action	PRIORITY 5
Purpose of Action	LEVEL 2
Deficiency Photo1

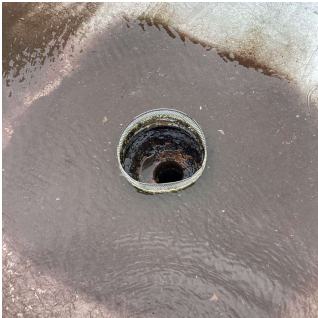
Roof 6

Deficiency	DETERIORATED
------------	--------------

Deficiency Quantity	1
Quantity Uom	EACH
Potential Action	REPLACE
Urgency of Action	PRIORITY 4
Purpose of Action	LEVEL 2
Deficiency Photo1

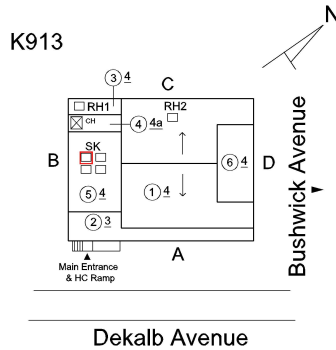
Question	Response
EXTERIOR	
ROOF	
Specialties	Inspected
BULKHEAD/PENTHOUSE	Does not Exist
CUPOLA/ SPIRES/ TOWERS	Does not Exist
DORMER	Does not Exist
DUNNAGE STEEL	Inspected
Condition	2 - Between Good and Fair
Deficiency	No deficiencies recorded
SKYLIGHT/ROOF VENT	Inspected
Material Type(s)	Glass
Condition	3 - Fair
Deficiency	WATER INFILTRATION
Roof Plan reference

Deficiency Quantity	100
Quantity Uom	S.F.
Potential Action	MAINTENANCE
Urgency of Action	PRIORITY 3
Purpose of Action	LEVEL 2
Deficiency Photo1

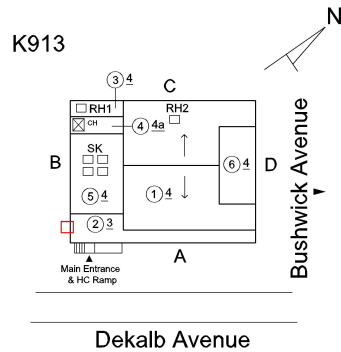
Violations	No violations recorded.
ROOF/GRAVITY TANK	Does not Exist
STAIRS/RAMPS: EXTERIOR	Inspected
BUILDING CHEEK/FLANK WALLS	Does not Exist
RAILINGS	Inspected
Condition	2 - Between Good and Fair
Deficiency	No deficiencies recorded
STAIRS/RAMPS	Inspected
Condition	5 - Poor
Deficiency	CONCRETE: DETERIORATED SUBSTRATE

10
 S.F.
 REPLACE SUBSTRATE AND RESET
 PRIORITY 4
 LEVEL 2

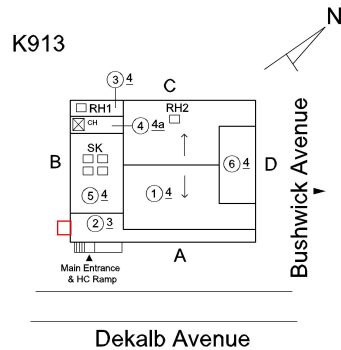
CONCRETE: CRACKS/SPALLING - MAJOR

10
 S.F.
 REPLACE
 PRIORITY 5
 LEVEL 6

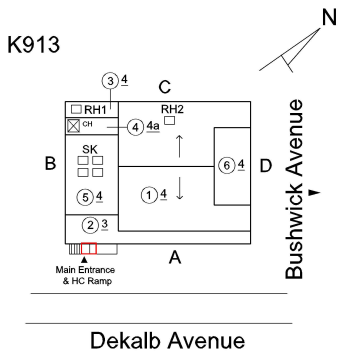
Violations	Facade B No violations recorded.
Deficiency	CONCRETE: CRACKS/SPALLING - MAJOR
Roof Plan reference	<p>K913</p>

Deficiency Quantity	75
Quantity Uom	S.F.
Potential Action	REPLACE
Urgency of Action	PRIORITY 4
Purpose of Action	LEVEL 2
Deficiency Photo1

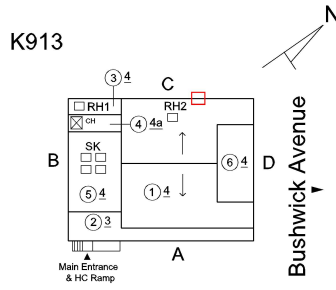
Question	Response
EXTERIOR	
WINDOWS	
WINDOWS	Inspected
Material Type(s)	Aluminum
Instance on Aluminum - Double Hung: All Facades	Inspected
Instance Condition	3 - Fair
Instance Quantity	6,000
Instance Quantity Uom	S.F.
Are these windows insulated	Yes
Installation Year	1998
Source of Installation	Custodial Staff
Deficiency	ALUMINUM - DOUBLE HUNG: BROKEN PANE
Roof Plan reference

Elevation	 
Deficiency Quantity	30
Quantity Uom	S.F.
Potential Action	MAINTENANCE
Urgency of Action	PRIORITY 3
Purpose of Action	LEVEL 2
Deficiency Photo1

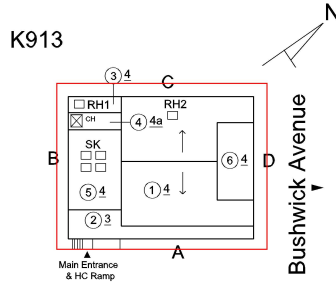
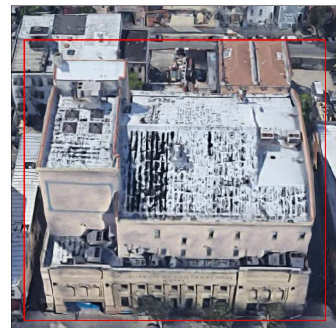
Violations	No violations recorded.
Deficiency	ALUMINUM - DOUBLE HUNG: INOPERABLE BALANCE

Deficiency Quantity	20
Quantity Uom	EACH
Potential Action	REPLACE BALANCES
Urgency of Action	PRIORITY 3
Purpose of Action	LEVEL 2
Deficiency Photo1	No photo recorded
Violations	No violations recorded.
Instance on Aluminum - Other: Facades A, D	Inspected
Instance Condition	3 - Fair
Instance Quantity	1,000
Instance Quantity Uom	S.F.
Are these windows insulated	Yes
Installation Year	1998
Source of Installation	Custodial Staff
Deficiency	No deficiencies recorded
INTERIOR	Inspected
POOLS	Does not Exist
STRUCTURAL	Inspected
COLUMNS/BEAMS/BEARING WALLS	Inspected
Condition	2 - Between Good and Fair
Deficiency	No deficiencies recorded
FLOOR STRUCTURE	Inspected
Condition	2 - Between Good and Fair
Deficiency	CONCRETE SLAB ON GRADE: THRU CRACKS
Deficiency Location/Instance	Room 119A
Deficiency Quantity	20
Quantity Uom	S.F.

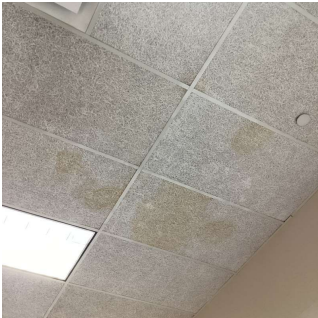
Question	Response
INTERIOR	
CLASSROOMS/CORRIDORS/ADMIN SPACES	
Ceiling	
Violations	No violations recorded.
Deficiency	TECTUM: DAMAGED/MISSING - ACTIVE LEAK
Deficiency Location/Instance	Rooms 431, 205
Deficiency Quantity	130
Quantity Uom	S.F.
Potential Action	REPLACE
Urgency of Action	PRIORITY 5
Purpose of Action	LEVEL 2
Deficiency Photo1

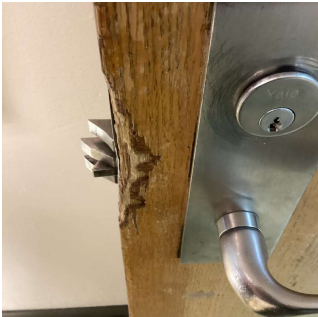
Room 205
Violations	No violations recorded.
Floor Finish	Inspected
Condition	2 - Between Good and Fair
Deficiency	VINYL TILES: DETERIORATED SUBSTRATE
Deficiency Location/Instance	Room 241, Corridor near Stair B/1, by Rooms 106, 223, next to Stair A/2 and others

Room 431
Violations	No violations recorded.
Door(s)	Inspected
Condition	5 - Poor
Deficiency	WOOD: DETERIORATED DOOR
Deficiency Location/Instance	Rooms 106, 205, 227, 229, 237 and others
Deficiency Quantity	20
Quantity Uom	EACH
Potential Action	MAINTENANCE
Urgency of Action	PRIORITY 3
Purpose of Action	LEVEL 2
Deficiency Photo1

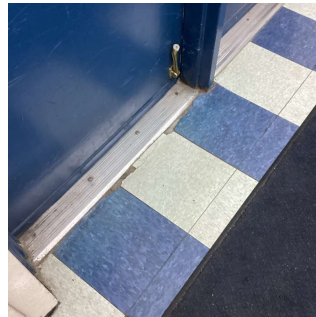
Main Entrance

VINYL TILES: BROKEN/DETERIORATED/MISSING TILES

REPLACE

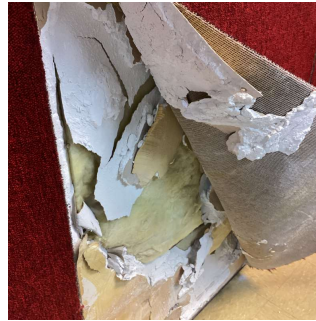
Room 209

WALL PADDING: DETERIORATED

REPLACE

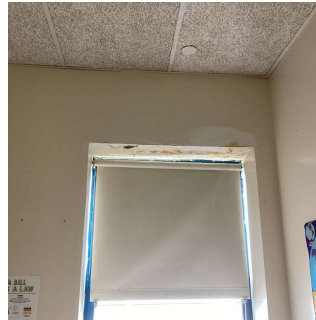
Room 329

GYPSUM BOARD: DETERIORATED - ACTIVE LEAK

REPLACE

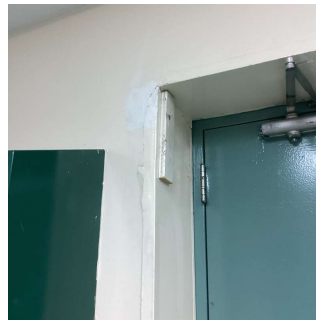
Corridor near Gymnasium

GYPSUM BOARD: DETERIORATED

REPLACE

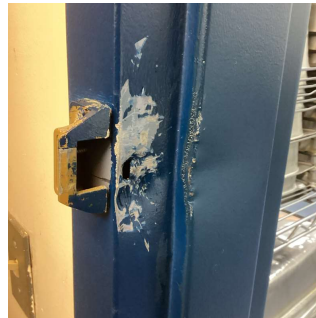
METAL: DETERIORATED DOOR AND FRAME
Storage Room
1
EACH
MAINTENANCE
PRIORITY 3
LEVEL 2

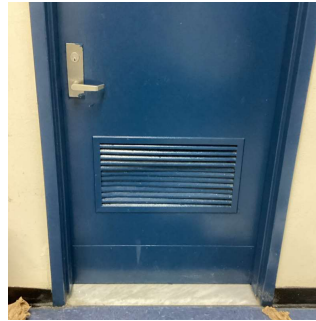
METAL: DAMAGED LOUVER
Room 121
1
EACH
MAINTENANCE
PRIORITY 3
LEVEL 2

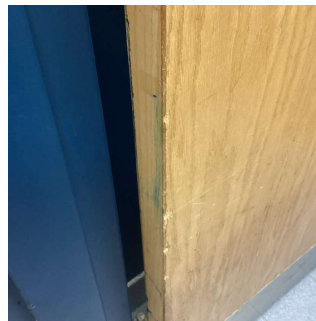
Office Room

WOOD: DETERIORATED DOOR

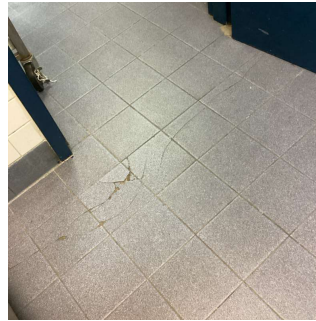
Servery

CERAMIC TILE: BROKEN/MISSING TILES

REPLACE

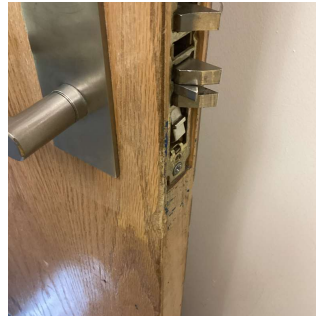
Room 115D

WOOD: DETERIORATED DOOR

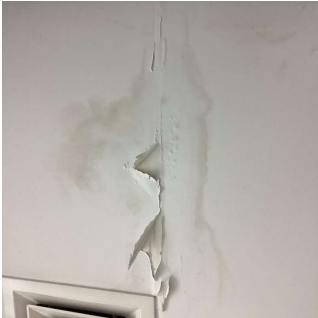
Question	Response
INTERIOR	
SCIENCE PREP ROOM	Inspected
Fixed Equipment	
Instance on Rooms 437, 437A	Inspected
Condition	2 - Between Good and Fair
Deficiency	No deficiencies recorded
SHOWER ROOM	Inspected
Instance on 4th Floor - Boys	Inspected
Alternative use	Yes
Instance on 4th Floor - Girls	Inaccessible
Ceiling	
Instance on 4th Floor - Boys	Inspected
Condition	5 - Poor
Deficiency	GYPSON BOARD: DAMAGED/DETERIORATED
Deficiency Location/Instance	Near Entrance, Right Side
Deficiency Quantity	30
Quantity Uom	S.F.
Potential Action	REPLACE
Urgency of Action	PRIORITY 3
Purpose of Action	LEVEL 2
Deficiency Photo1
