**NYC Department of Education**  
**Building Condition Assessment Survey 2023 - 2024**

Architectural Inspection

**K917**

**Asset:** **BKLYN COLL ACAD (BRIDGES TO K)-K, 350 CONEY ISLAND AVENUE, New York, 11218**

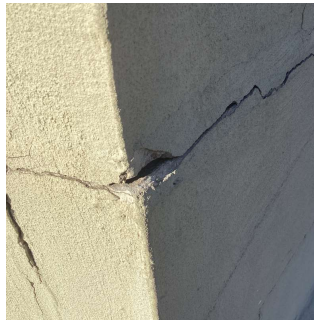
Facade A

STONE: CRACKS AT BUILDING CORNERS

REPLACE

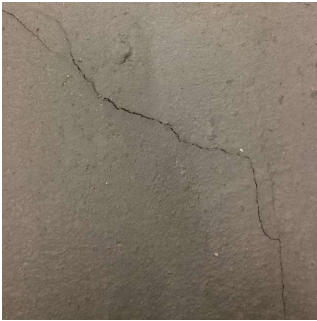
Question	Response
<b>INTERIOR</b>	
<b>STRUCTURAL</b>	
<b>FLOOR STRUCTURE</b>	
Deficiency Photo1

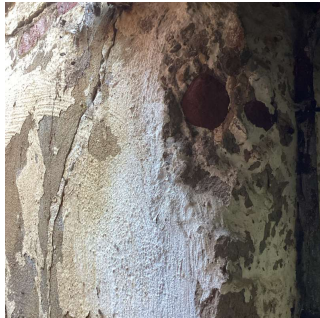
Question	Response
<b>INTERIOR</b>	
<b>STRUCTURAL</b>	
<b>FOUNDATION WALLS</b>	Inspected
Violations	No violations recorded.
<b>ROOF STRUCTURE</b>	Inspected
Condition	2 - Between Good and Fair
Deficiency	No deficiencies recorded
<b>VAULTS-BUNKERS</b>	Inspected
<b>Foundation Walls</b>	Inspected
Condition	3 - Fair
Deficiency	CRACKS, SPALLING
Deficiency Location/Instance	Basement - Vault
Deficiency Quantity	20
Quantity Uom	S.F.
Potential Action	REPAIR
Urgency of Action	PRIORITY 4
Purpose of Action	LEVEL 5
Deficiency Photo1

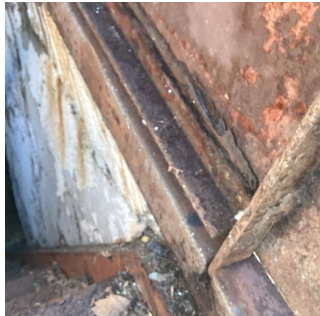
Violations	Basement - Vault No violations recorded.
<b>Slab Structure</b>	Inspected
Condition	2 - Between Good and Fair
Deficiency	No deficiencies recorded
<b>Vault/Ash Hoist Doors and Framing</b>	Inspected
Condition	5 - Poor
Deficiency	DETERIORATED/DAMAGED VAULT/ASH HOIST DOORS AND FRAMING
Deficiency Location/Instance	Basement - Ash Hoist Door
Deficiency Quantity	2
Quantity Uom	EACH
Potential Action	REPLACE

Urgency of Action	PRIORITY 4
Purpose of Action	LEVEL 2
Deficiency Photo1

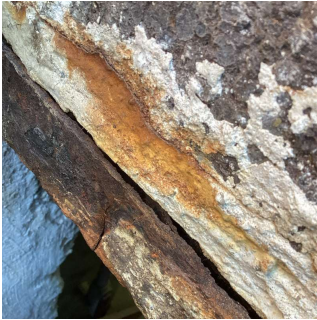
Question	Response
<b>INTERIOR</b>	
<b>STRUCTURAL</b>	
<b>VAULTS-BUNKERS</b>	
<b>Vault/Ash Hoist Doors and Framing</b>	
Violations	Basement - Ash Hoist Door No violations recorded.
Deficiency	WATER INFILTRATION
Deficiency Location/Instance	Basement - Ash Hoist Door
Deficiency Quantity	10
Quantity Uom	S.F.
Potential Action	REPAIR
Urgency of Action	PRIORITY 5
Purpose of Action	LEVEL 2
Deficiency Photo1

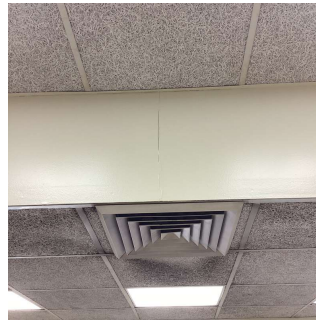
Main Entrance Stair Lobby

Deficiency Quantity	10
Quantity Uom	S.F.
Potential Action	REPLACE
Urgency of Action	PRIORITY 3
Purpose of Action	LEVEL 2
Deficiency Photo1

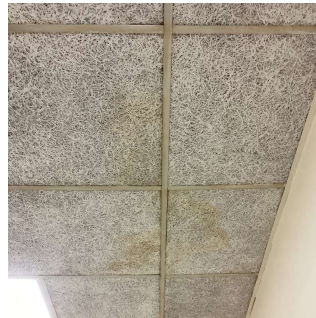
Corridor near Exit 2

Deficiency	TECTUM: DAMAGED/MISSING
Deficiency Location/Instance	Corridor near Exit 2, By Room 411-1
Deficiency Quantity	40
Quantity Uom	S.F.
Potential Action	REPLACE
Urgency of Action	PRIORITY 3
Purpose of Action	LEVEL 2
Deficiency Photo1

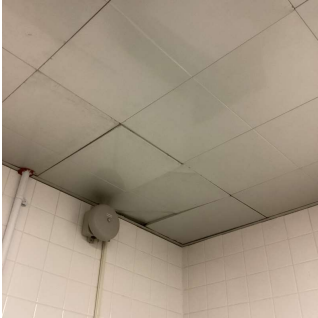
Question	Response
<b>INTERIOR</b>	
<b>KITCHEN</b>	
<b>Ceiling</b>	
Condition	2 - Between Good and Fair
Deficiency	METAL PAN: DAMAGED/MISSING
Deficiency Location/Instance	Near Sink
Deficiency Quantity	10
Quantity Uom	S.F.
Potential Action	REPLACE
Urgency of Action	PRIORITY 3
Purpose of Action	LEVEL 2
Deficiency Photo1

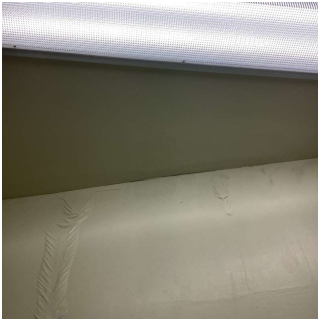
Violations	Stair A/5 No violations recorded.
<b>TOILET ROOMS - STAFF</b>	Inspected
<b>Ceiling</b>	Inspected
Condition	3 - Fair
Deficiency	GYPSUM BOARD: DAMAGED/DETERIORATED
Deficiency Location/Instance	In Room 405-1
Deficiency Quantity	10
Quantity Uom	S.F.
Potential Action	REPLACE
Urgency of Action	PRIORITY 3
Purpose of Action	LEVEL 2
Deficiency Photo1

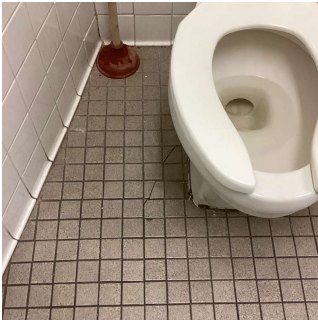
Violations	Room 325-1 No violations recorded.
<b>Floor Finish</b>	Inspected
Condition	3 - Fair
Deficiency	CERAMIC TILE: DETERIORATED SUBSTRATE
Deficiency Location/Instance	In Room 405-1
Deficiency Quantity	10
Quantity Uom	S.F.
Potential Action	REPLACE
Urgency of Action	PRIORITY 3
Purpose of Action	LEVEL 2
Deficiency Photo1

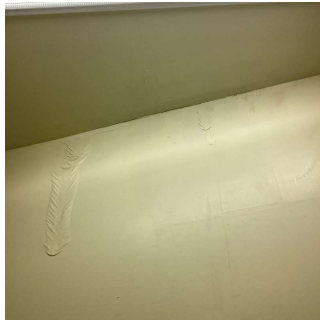
Violations	In Room 405-1 No violations recorded.
<b>Stalls</b>	Does not Exist
<b>Walls</b>	Inspected
Condition	2 - Between Good and Fair
Deficiency	GYPSUM BOARD: DETERIORATED - ACTIVE LEAK
Deficiency Location/Instance	Room 404-1
Deficiency Quantity	10
Quantity Uom	S.F.
Potential Action	REPLACE
Urgency of Action	PRIORITY 5
Purpose of Action	LEVEL 2

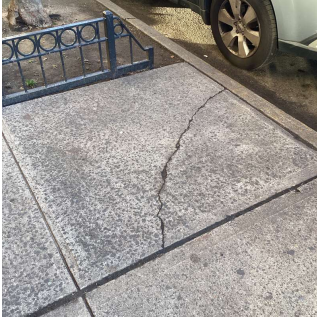
Question	Response
<b>SITE</b>	
<b>PAVING</b>	
<b>DOT Sidewalk</b>	
<b>Concrete</b>	
Urgency of Action	PRIORITY 3
Purpose of Action	LEVEL 2
Deficiency Photo1
