NYC Department of Education
Building Condition Assessment Survey 2023 - 2024

Architectural Inspection

K932

Asset: HIGH SCHOOL SUSPENSION CENTER - K, 619 BELMONT AVENUE, New York, 11207

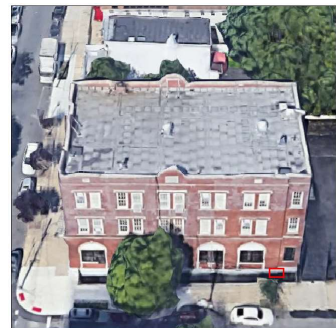
Elevation

Question	Response
EXTERIOR	
EXTERIOR WALLS	
Instance Condition	3 - Fair
Instance Quantity	12,000
Instance Quantity Uom	S.F.
Deficiency	STONE: DETERIORATED JOINTS
Roof Plan reference	<p>K932</p>

Deficiency Quantity	10
Quantity Uom	L.F.
Potential Action	REPOINT
Urgency of Action	PRIORITY 4
Purpose of Action	LEVEL 2
Deficiency Photo1

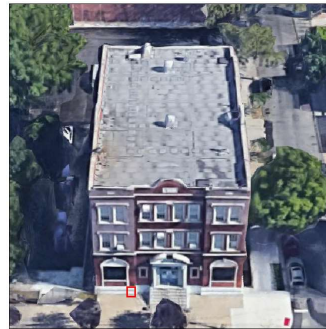
Elevation

Violations	Facade D No violations recorded.
Deficiency	STONE: CHIPPED/SPALLED/BROKEN PIECES - MINOR

REPAIR

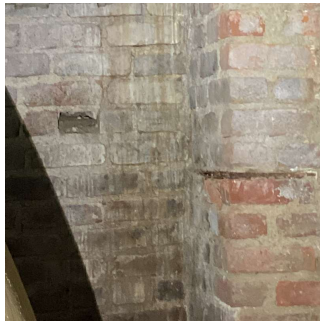
Lamp Storage Room (Room B5 similar)
Violations	No violations recorded.
FOUNDATION WALLS	
	Inspected
Material Type(s)	Masonry
Condition	3 - Fair
Deficiency	BRICK: CRACKED/SPALLED
Deficiency Location/Instance	Sub-Basement
Deficiency Quantity	20
Quantity Uom	S.F.
Potential Action	RESTITCH
Urgency of Action	PRIORITY 4
Purpose of Action	LEVEL 5

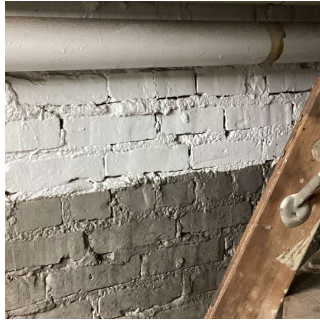
Violations	Oil Tank Room No violations recorded.
Deficiency	BRICK: DETERIORATED JOINTS
Deficiency Location/Instance	Sub-Basement
Deficiency Quantity	35
Quantity Uom	S.F.
Potential Action	REPOINT
Urgency of Action	PRIORITY 3
Purpose of Action	LEVEL 5
Deficiency Photo1

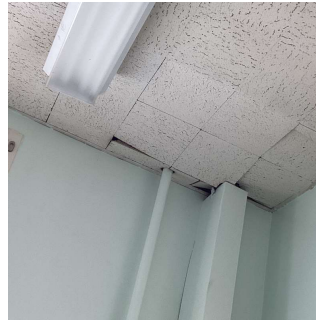
Violations	Boiler Room No violations recorded.
ROOF STRUCTURE	Inspected
Condition	2 - Between Good and Fair
Deficiency	No deficiencies recorded
VAULTS-BUNKERS	Does not Exist
AUDITORIUM	Does not Exist
CAFETERIA	Does not Exist
CLASSROOMS/CORRIDORS/ADMIN SPACES	Inspected
Ceiling	Inspected
Condition	2 - Between Good and Fair
Deficiency	ACOUSTIC TILES: DAMAGED/MISSING
Deficiency Location/Instance	Room 106
Deficiency Quantity	10
Quantity Uom	S.F.
Potential Action	REPLACE
Urgency of Action	PRIORITY 3
Purpose of Action	LEVEL 2

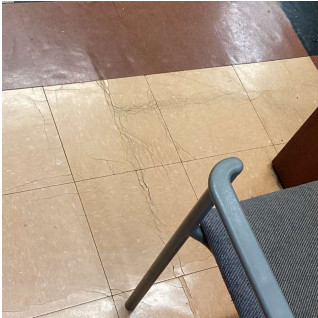
Question	Response
INTERIOR	
CLASSROOMS/CORRIDORS/ADMIN SPACES	
Door(s)	Inspected
	Room 304
Violations	No violations recorded.
Floor Finish	Inspected
Condition	2 - Between Good and Fair
Deficiency	VINYL TILES: DETERIORATED SUBSTRATE
Deficiency Location/Instance	Rooms 206, 204, 203, 201, 104 and others
Deficiency Quantity	400
Quantity Uom	S.F.
Potential Action	REPLACE
Urgency of Action	PRIORITY 3
Purpose of Action	LEVEL 2
Deficiency Photo1

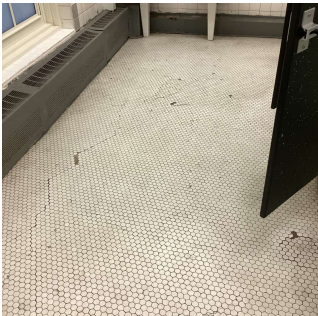
Violations	2nd Floor Staff No violations recorded.
Stalls	Inspected
Condition	2 - Between Good and Fair
Deficiency	No deficiencies recorded
Walls	Inspected
Condition	2 - Between Good and Fair
Deficiency	No deficiencies recorded
TOILET ROOMS - STUDENTS	
Ceiling	Inspected
Condition	2 - Between Good and Fair
Deficiency	No deficiencies recorded
Door(s)	Inspected
Condition	2 - Between Good and Fair
Deficiency	No deficiencies recorded
Floor Finish	Inspected
Condition	3 - Fair
Deficiency	CERAMIC TILE: DETERIORATED SUBSTRATE
Deficiency Location/Instance	Basement Girls
Deficiency Quantity	40
Quantity Uom	S.F.
Potential Action	REPLACE
Urgency of Action	PRIORITY 3
Purpose of Action	LEVEL 2
Deficiency Photo1

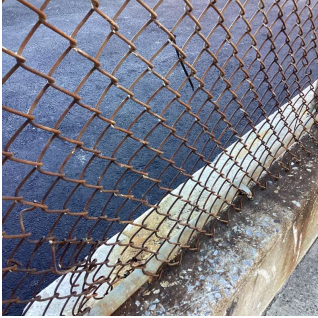
Question	Response
SITE	Inspected
CONTAINERIZATION	Does not Exist
Drainage System for Asphalt	Inspected
Catch Basins/Manhole - Surrounded by asphalt	Inspected
Condition	2 - Between Good and Fair
Deficiency	No deficiencies recorded
Culverts - Asphalt Covering	Does not Exist
Drainage System for Concrete	Inspected
Catch Basins/Manhole - Surrounded by concrete	Inspected
Condition	2 - Between Good and Fair
Deficiency	No deficiencies recorded
Culverts - Concrete Covering	Does not Exist
Drainage System for Soil	Does not Exist
DRINKING FOUNTAINS	Does not Exist
FENCES	Inspected
Condition	4 - Between Fair and Poor
Deficiency	CHAIN LINK: RUST - MAJOR
Deficiency Location/Instance	Jerome Avenue
Deficiency Quantity	900
Quantity Uom	S.F.
Potential Action	REPLACE
Urgency of Action	PRIORITY 3
Purpose of Action	LEVEL 2
Deficiency Photo1

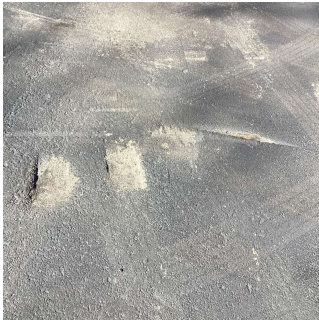
Jerome Avenue	No violations recorded.
Violations	
IRRIGATION SYSTEM	Does not Exist
PAVING	Inspected
Student Non-Use	Does not Exist
Student Use	Inspected
Gravel Exists?	No
Asphalt	Inspected
Condition	2 - Between Good and Fair
Deficiency	CRACKS - MAJOR
Deficiency Location/Instance	Schoolyard
Deficiency Quantity	20
Quantity Uom	S.F.
Potential Action	REPLACE
Urgency of Action	PRIORITY 3
Purpose of Action	LEVEL 2
Deficiency Photo1

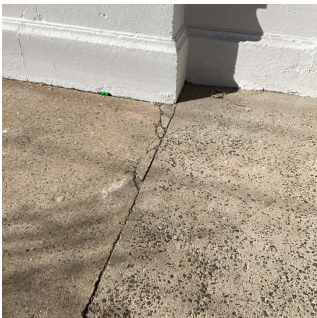
Schoolyard
Violations	No violations recorded.
Pavers	Does not Exist
Site Sidewalks & Walkways	Inspected
Asphalt	Does not Exist
Concrete	Inspected
Condition	3 - Fair
Deficiency	CRACKS - MAJOR
Deficiency Location/Instance	Near Main Entrance
Deficiency Quantity	75
Quantity Uom	S.F.
Potential Action	REPLACE
Urgency of Action	PRIORITY 3
Purpose of Action	LEVEL 2
Deficiency Photo1

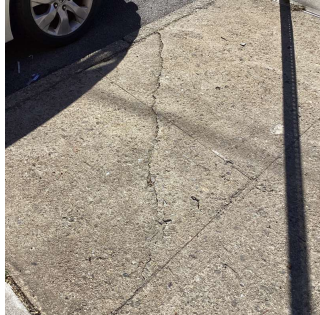
Question	Response
SITE	
PAVING	
DOT Sidewalk	
Concrete	
Purpose of Action	LEVEL 2
Deficiency Photo1	 
	Belmont Avenue
Violations	No violations recorded.
Deficiency	DAMAGED/DETERIORATED/MISSING SECTIONS
Deficiency Location/Instance	Belmont Avenue, Jerome Avenue
Deficiency Quantity	750
Quantity Uom	S.F.
Potential Action	REPLACE
Urgency of Action	PRIORITY 3
Purpose of Action	LEVEL 2
Deficiency Photo1
