NYC Department of Education
Building Condition Assessment Survey 2023 - 2024

Architectural Inspection

K940

Asset: I.S. 30 - BROOKLYN, 415 OVINGTON AVE, New York, 11209

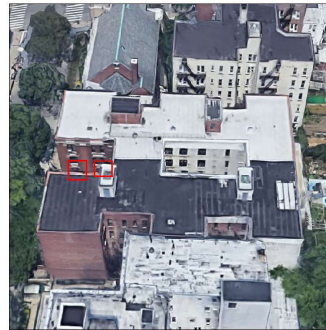
STONE: CHIPPED/SPALLED/BROKEN PIECES - MINOR

REPAIR

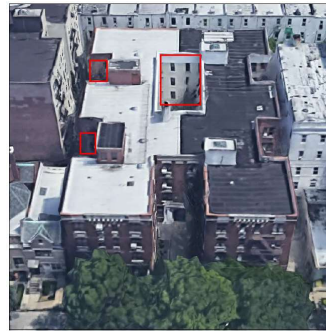
BRICK: DETERIORATED MASONRY SILLS - MINOR

REPAIR

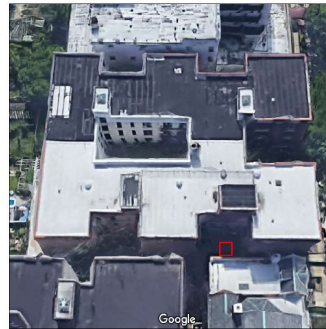
**CAST IN PLACE / PRE-CAST CONCRETE: MAJOR
CRACKS/SPALLING**

REPLACE

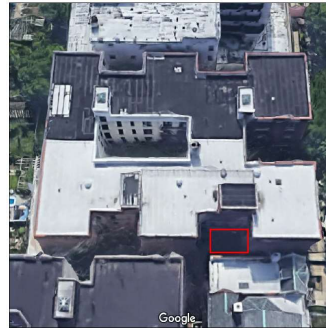
BRICK: MINOR CRACKS AND SPALLING

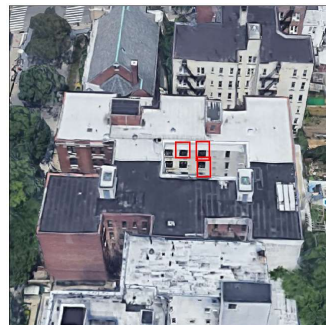
BRICK: DETERIORATED MASONRY SILLS - MAJOR

REMOVE AND REPLACE

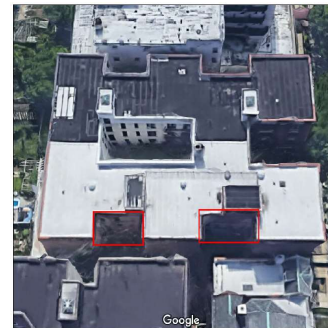
BRICK: DETERIORATED JOINTS

500
S.F.
REPOINT
PRIORITY 3
LEVEL 2

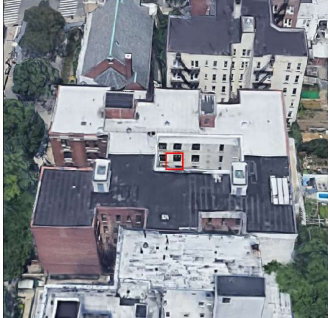
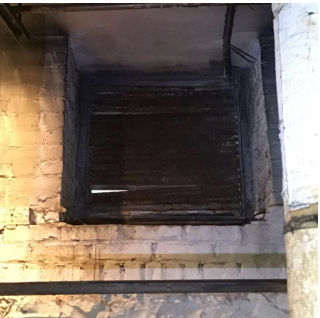
Question	Response
EXTERIOR	
EXTERIOR WALLS	Inspected
Violations	No violations recorded.
EXTERIOR SOFFITS	Inspected
Condition	2 - Between Good and Fair
Deficiency	No deficiencies recorded
LOADING DOCK	Does not Exist
LOUVER	Inspected
Condition	3 - Fair
Deficiency	BROKEN/ DENTED BLADES
Roof Plan reference	<p>K940</p>  
Elevation

Deficiency Quantity	10
Quantity Uom	S.F.
Potential Action	REPLACE
Urgency of Action	PRIORITY 4
Purpose of Action	LEVEL 2
Deficiency Photo1

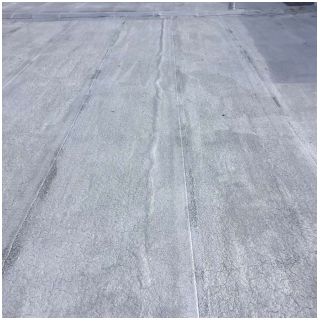
Roof 1
Instance Quantity	5,500
Instance Quantity Uom	S.F.
Does the roof have major mechanical equipment sitting on Dunnage Steel less than 18" above the Roofing?	No
Does this roof instance have a Sustainable Roof System?	Yes
Sustainable Roof Type	White Roof
Sustainable Roof Location (Roof Number)	Roof 1
Do solar panels exist on these roofs?	No
Is/Are the roof(s) suitable for Solar Panel installation?	No
Installation Year	2018
Source of Installation	Custodial Staff
Deficiency	MODIFIED BITUMEN: ROOFING: DELAMINATION
Roof Plan reference	<p>K940</p>

<p align="center">Ovington Avenue</p>
Deficiency Quantity	50
Quantity Uom	S.F.
Potential Action	REPLACE ROOFING WITHOUT MAJOR EQUIPMENT REMOVAL

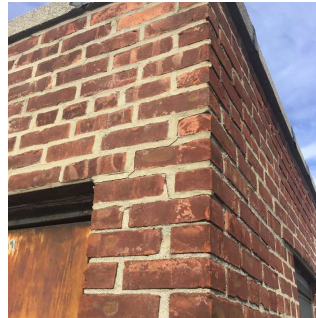
BH2

Deficiency **BULKHEAD/PENTHOUSE WALLS/EXTERIOR:
CRACKS/SPALLING - MINOR**

10
S.F.
REPAIR
PRIORITY 3
LEVEL 2

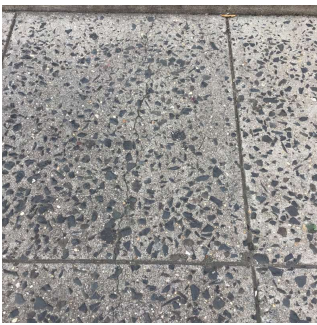
Question	Response
EXTERIOR	
STAIRS/RAMPS: EXTERIOR	
STAIRS/RAMPS	
Deficiency Photo1

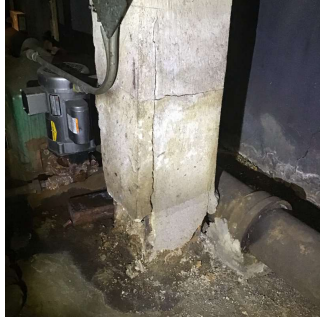
STRUCTURAL	Inspected
COLUMNS/BEAMS/BEARING WALLS	Inspected
Condition	3 - Fair
Deficiency	STEEL COLUMNS/BEAMS: DETERIORATED CONCRETE FIREPROOFING
Deficiency Location/Instance	Basement - Boiler Room
Deficiency Quantity	20
Quantity Uom	S.F.

Question	Response
INTERIOR	
STRUCTURAL	
COLUMNS/BEAMS/BEARING WALLS	
Potential Action	REPLACE
Urgency of Action	PRIORITY 4
Purpose of Action	LEVEL 5
Deficiency Photo1

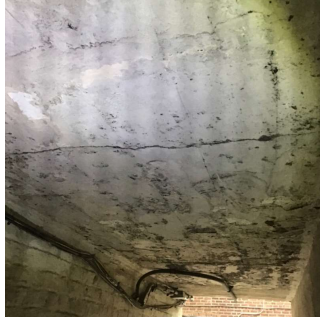
Boiler Room
Violations	No violations recorded.
FLOOR STRUCTURE	
Condition	Inspected
	3 - Fair
Deficiency	CONCRETE: CRACKS/SPALLED/REINFORCEMENT EXPOSED
Deficiency Location/Instance	Facade B - West side passageway
Deficiency Quantity	60
Quantity Uom	S.F.
Potential Action	REPAIR
Urgency of Action	PRIORITY 3
Purpose of Action	LEVEL 5
Deficiency Photo1

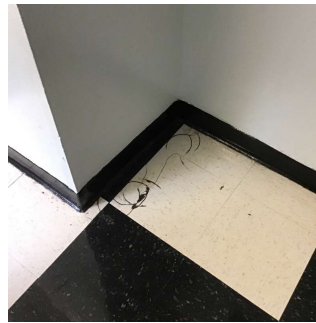
Corridor near Room 313

Question	Response
INTERIOR	
CLASSROOMS/CORRIDORS/ADMIN SPACES	
Ceiling	
Urgency of Action	PRIORITY 3
Purpose of Action	LEVEL 2
Deficiency Photo1	 
Violations	Corridor near Room 412 No violations recorded.
Door(s)	
Condition	Inspected 5 - Poor
Deficiency	WOOD: DETERIORATED DOOR
Deficiency Location/Instance	Rooms 414,411,323,313,213 and others
Deficiency Quantity	17
Quantity Uom	EACH
Potential Action	MAINTENANCE
Urgency of Action	PRIORITY 3
Purpose of Action	LEVEL 2
Deficiency Photo1	 
Violations	Room 213 No violations recorded.
Floor Finish	
Condition	Inspected 3 - Fair
Deficiency	VINYL TILES: DETERIORATED SUBSTRATE
Deficiency Location/Instance	Room 224, Corridor near Room 313, By Stair B/1, Next to Multipurpose Room - 1st Floor, Main Entrance Lobby and others
Deficiency Quantity	100
Quantity Uom	S.F.
Potential Action	REPLACE
Urgency of Action	PRIORITY 3
Purpose of Action	LEVEL 2

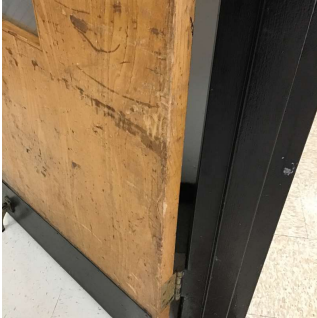
Question	Response
INTERIOR	
MULTI-PURPOSE ROOM	
Door(s)	
Instance on 1st Floor (1200 SF)	Inspected
Condition	4 - Between Fair and Poor
Deficiency	WOOD: DETERIORATED DOOR
Deficiency Location/Instance	Main Entrance
Deficiency Quantity	2
Quantity Uom	EACH
Potential Action	MAINTENANCE
Urgency of Action	PRIORITY 3
Purpose of Action	LEVEL 2
Deficiency Photo1

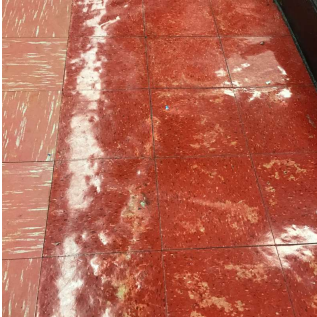
Violations	Main Entrance No violations recorded.
Fixed Equipment	
Instance on Basement (1500 SF)	Does not Exist
Instance on 1st Floor (1200 SF)	Does not Exist
Floor Finish	
Instance on Basement (1500 SF)	Inspected
Condition	3 - Fair
Deficiency	VINYL TILES: BROKEN/DETERIORATED/MISSING TILES
Deficiency Location/Instance	Right, Left and Center Side
Deficiency Quantity	80
Quantity Uom	S.F.
Potential Action	REPLACE
Urgency of Action	PRIORITY 3
Purpose of Action	LEVEL 2
Deficiency Photo1

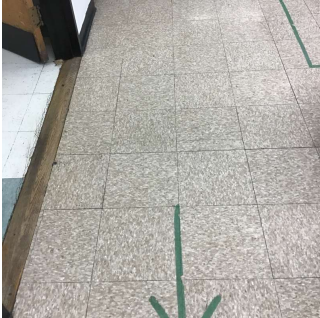
Question	Response
INTERIOR	
MULTI-PURPOSE ROOM	
Floor Finish	
Deficiency Location/Instance	Near Entrance, Center, By Sink, Next to Windows
Deficiency Quantity	50
Quantity Uom	S.F.
Potential Action	REPLACE
Urgency of Action	PRIORITY 3
Purpose of Action	LEVEL 2
Deficiency Photo1

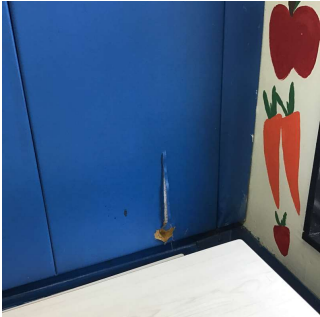
Violations	Near Entrance No violations recorded.
Sliding-folding Partition	
Instance on 1st Floor (1200 SF)	Does not Exist
Instance on Basement (1500 SF)	Does not Exist
Stage	
Instance on 1st Floor (1200 SF)	Does not Exist
Instance on Basement (1500 SF)	Does not Exist
Walls	
Instance on 1st Floor (1200 SF)	Inspected
Condition	2 - Between Good and Fair
Deficiency	WALL PADDING: DETERIORATED
Deficiency Location/Instance	Near Windows
Deficiency Quantity	20
Quantity Uom	S.F.
Potential Action	REPLACE
Urgency of Action	PRIORITY 3
Purpose of Action	LEVEL 2
Deficiency Photo1

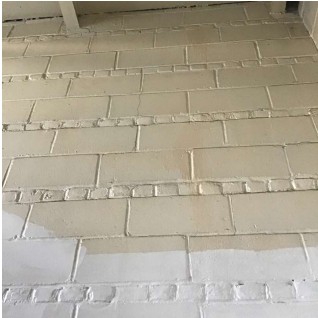
Question	Response
INTERIOR	
STAIRS/RAMPS: INTERIOR	
Stairs and Landings	Inspected
	Stair B/Basement
Violations	No violations recorded.
Walls	Inspected
Condition	2 - Between Good and Fair
Deficiency	MASONRY: CRACKS/SPALLING
Deficiency Location/Instance	Stair B/4
Deficiency Quantity	20
Quantity Uom	S.F.
Potential Action	REPLACE
Urgency of Action	PRIORITY 3
Purpose of Action	LEVEL 2
Deficiency Photo1

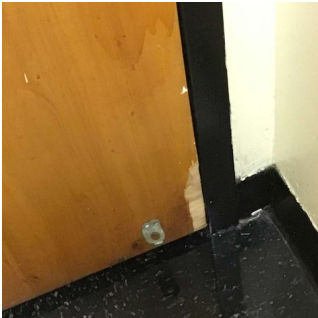
Violations	Stair B/4 No violations recorded.
TOILET ROOMS - STAFF	Inspected
Ceiling	Inspected
Condition	2 - Between Good and Fair
Deficiency	No deficiencies recorded
Door(s)	Inspected
Condition	5 - Poor
Deficiency	WOOD: DETERIORATED DOOR
Deficiency Location/Instance	Room 312, In Room 224
Deficiency Quantity	2
Quantity Uom	EACH
Potential Action	MAINTENANCE
Urgency of Action	PRIORITY 3
Purpose of Action	LEVEL 2
Deficiency Photo1

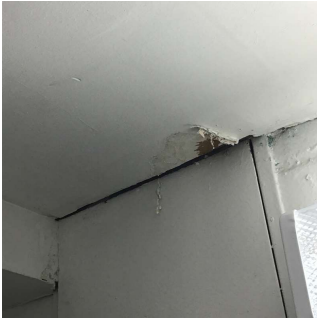
Room 421
Violations	No violations recorded.
Walls	Inspected
Condition	2 - Between Good and Fair
Deficiency	No deficiencies recorded
TOILET ROOMS - STUDENTS	
Ceiling	Inspected
Condition	2 - Between Good and Fair
Deficiency	GYP SUM BOARD: DAMAGED/DETERIORATED
Deficiency Location/Instance	In Multipurpose Room - Basement
Deficiency Quantity	10
Quantity Uom	S.F.
Potential Action	REPLACE
Urgency of Action	PRIORITY 3
Purpose of Action	LEVEL 2
Deficiency Photo1

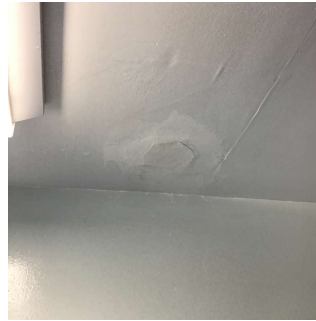
In Multipurpose Room - Basement
Violations	No violations recorded.
Deficiency	PLASTER: CRACKS/SPALLING
Deficiency Location/Instance	Room 210
Deficiency Quantity	10
Quantity Uom	S.F.
Potential Action	REPLACE
Urgency of Action	PRIORITY 3
Purpose of Action	LEVEL 2

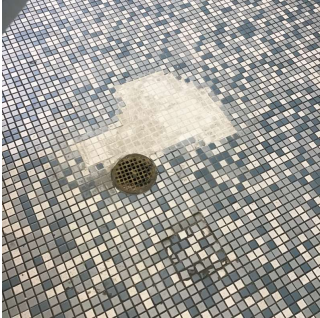
Question	Response
INTERIOR	
TOILET ROOMS - STUDENTS	
Door(s)	Inspected
	Room 410
Violations	No violations recorded.
Floor Finish	Inspected
Condition	3 - Fair
Deficiency	CERAMIC TILE: BROKEN/MISSING TILES
Deficiency Location/Instance	Rooms 415,410,210,113, In Multipurpose Room - Basement and others
Deficiency Quantity	60
Quantity Uom	S.F.
Potential Action	REPLACE
Urgency of Action	PRIORITY 3
Purpose of Action	LEVEL 2
Deficiency Photo1

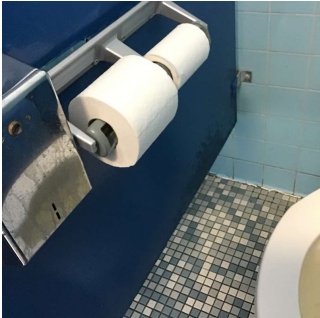
Room 210
Violations	No violations recorded.
Stalls	Inspected
Condition	5 - Poor
Deficiency	RUST - MAJOR
Deficiency Location/Instance	Rooms 410,310,210
Deficiency Quantity	5
Quantity Uom	EACH
Potential Action	REPLACE
Urgency of Action	PRIORITY 3
Purpose of Action	LEVEL 2
Deficiency Photo1

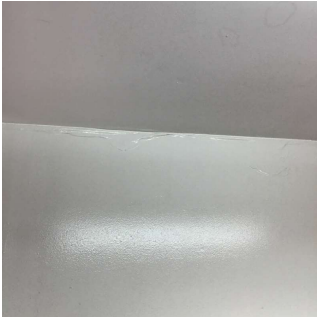
Room 410
Violations	No violations recorded.
Walls	Inspected
Condition	2 - Between Good and Fair
Deficiency	GYPSUM BOARD: DETERIORATED
Deficiency Location/Instance	Room 315

Question	Response
INTERIOR	
TOILET ROOMS - STUDENTS	
Walls	
Deficiency Quantity	10
Quantity Uom	S.F.
Potential Action	REPLACE
Urgency of Action	PRIORITY 3
Purpose of Action	LEVEL 2
Deficiency Photo1

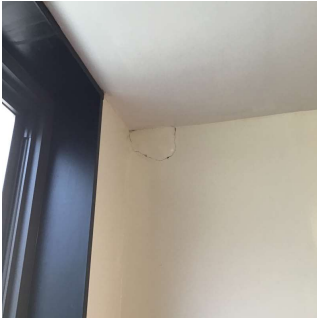
Room 315
Violations	No violations recorded.
Deficiency	PLASTER: CRACKS/SPALLING
Deficiency Location/Instance	Room 415
Deficiency Quantity	10
Quantity Uom	S.F.
Potential Action	REPLACE
Urgency of Action	PRIORITY 3
Purpose of Action	LEVEL 2
Deficiency Photo1

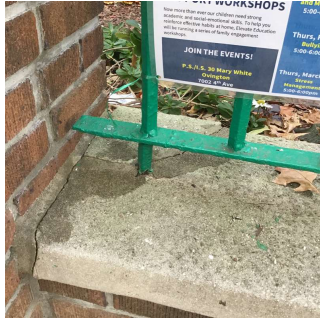
West Side of the Building
Violations	No violations recorded.
Deficiency	BRICK: DETERIORATED COPING STONE
Deficiency Location/Instance	Ovington Avenue
Deficiency Quantity	30
Quantity Uom	S.F.
Potential Action	REPLACE
Urgency of Action	PRIORITY 3
Purpose of Action	LEVEL 2
Deficiency Photo1
