**NYC Department of Education**  
**Building Condition Assessment Survey 2023 - 2024**

Architectural Inspection

**Asset: P.S. 95 TRANSPORTABLE - K, 345 VAN SICKLEN STREET, New York, 11223**

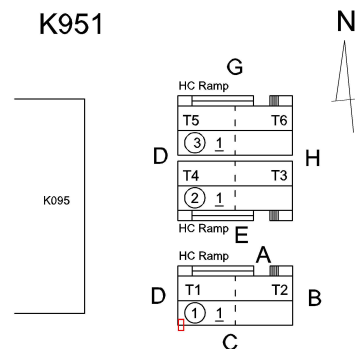
Question	Response
<b>Architectural</b>	
<b>EXTERIOR</b>	Inspected
<b>AWNINGS AND CANOPIES</b>	Does not Exist
<b>DOORS</b>	Inspected
<b>DOORS AND FRAMES</b>	Inspected
Condition	2 - Between Good and Fair
Deficiency	No deficiencies recorded
<b>DOOR HARDWARE</b>	Inspected
Condition	3 - Fair
Deficiency	No deficiencies recorded
<b>EXTERIOR WALLS</b>	Inspected
Material Type(s)	Steel
Replacement Quantity	4,300
Replacement Uom	S.F.
Instance on All Facades	Inspected
Instance Condition	5 - Poor
Instance Quantity	4,300
Instance Quantity Uom	S.F.
Deficiency	METAL PANEL: DAMAGED TRIM
Roof Plan reference	K951

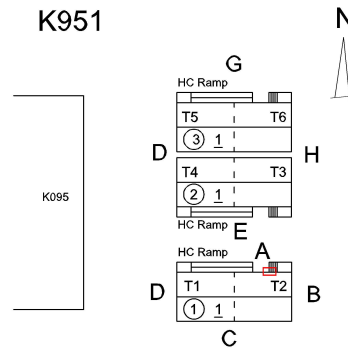
METAL PANEL: MAJOR RUSTING

REPLACE
