**NYC Department of Education**  
**Building Condition Assessment Survey 2023 - 2024**

Architectural Inspection

**Asset: P.S. 971 - BROOKLYN, 6214 4TH AVE, New York, 11220**

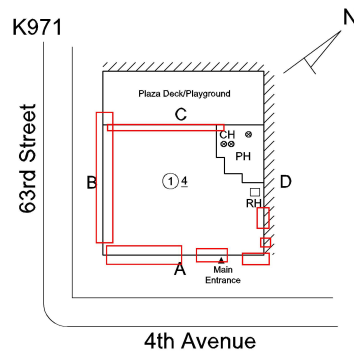
Question	Response
<b>Architectural</b>	
<b>EXTERIOR</b>	Inspected
<b>AREAWAY</b>	Does not Exist
<b>AWNINGS AND CANOPIES</b>	Inspected
Condition	2 - Between Good and Fair
Deficiency	No deficiencies recorded
<b>CHIMNEY</b>	Inspected
Material Type(s)	Metal
Condition	2 - Between Good and Fair
Deficiency	No deficiencies recorded
<b>COPING</b>	Inspected
Condition	4 - Between Fair and Poor
Deficiency	CAST STONE: DISINTEGRATING / FREEZE THAW
Roof Plan reference

200  
 L.F.  
 REPLACE-IN-KIND  
 PRIORITY 4  
 LEVEL 2

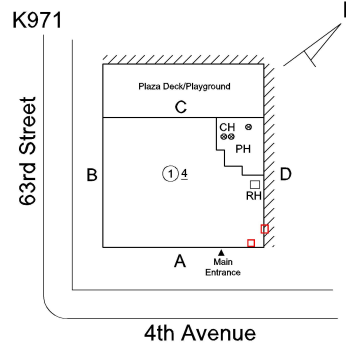
Roof Plan reference

CAST STONE: CRACKED/BROKEN PIECES

REPLACE-IN-KIND

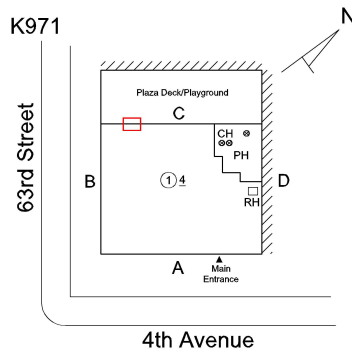
Question	Response
<b>EXTERIOR</b>	
<b>DOORS</b>	
<b>DOORS AND FRAMES</b>	
Roof Plan reference

METAL: DETERIORATED DOOR AND FRAME - MINOR DETERIORATION

Deficiency Quantity	2
Quantity Uom	EACH
Potential Action	MAINTENANCE
Urgency of Action	PRIORITY 3
Purpose of Action	LEVEL 2
Deficiency Photo1

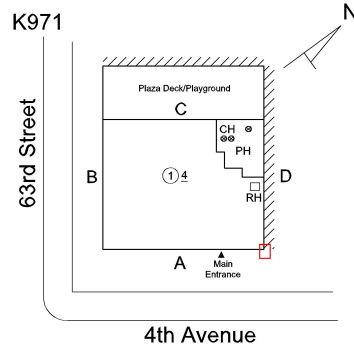
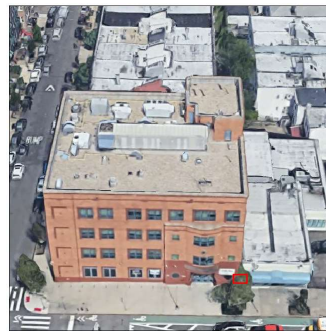
Roof Plan reference

Violations	Facade C No violations recorded.
<b>DOOR HARDWARE</b>	Inspected
Condition	3 - Fair
Deficiency	No deficiencies recorded
<b>LINTELS</b>	Inspected
Condition	2 - Between Good and Fair
Deficiency	No deficiencies recorded
<b>TRANSOM/SIDE LIGHT</b>	Inspected
Condition	2 - Between Good and Fair
Deficiency	No deficiencies recorded
<b>EXTERIOR WALLS</b>	Inspected
Material Type(s)	Masonry
Replacement Quantity	14,500
Replacement Uom	S.F.
Instance on All Facades	Inspected
Instance Condition	2 - Between Good and Fair
Instance Quantity	14,500
Instance Quantity Uom	S.F.
Deficiency	BRICK: DETERIORATED CONTROL/EXPANSION JOINTS

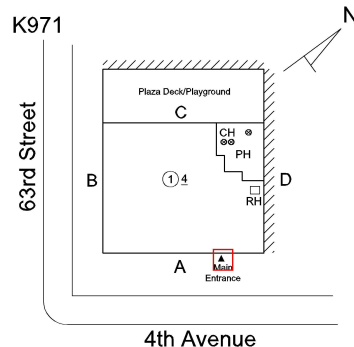
Roof Plan reference

STUCCO/PLASTER: MINOR CRACKS/SPALLING

Question	Response
<b>EXTERIOR</b>	
<b>EXTERIOR SOFFITS</b>	
Elevation	 
Deficiency Quantity	10
Quantity Uom	S.F.
Potential Action	REPAIR
Urgency of Action	PRIORITY 3
Purpose of Action	LEVEL 2
Deficiency Photo1	 
Violations	Facade A No violations recorded.
<b>LOADING DOCK</b>	Does not Exist
<b>LOUVER</b>	Inspected
Condition	2 - Between Good and Fair
Deficiency	No deficiencies recorded
<b>PARAPETS</b>	Inspected
Material Type(s)	Masonry
Replacement Quantity	3,500
Replacement Uom	C.F.
Instance on All Facades	Inspected
Instance Condition	2 - Between Good and Fair
Instance Quantity	3,400
Instance Quantity Uom	C.F.
Deficiency	No deficiencies recorded
Instance on Plaza Deck	Inspected
Instance Condition	2 - Between Good and Fair
Instance Quantity	100
Instance Quantity Uom	C.F.
Deficiency	No deficiencies recorded
<b>PLAZA DECK</b>	Inspected
Instance on Asphalt: Playground	Inspected
Instance Condition	3 - Fair
Instance Quantity	1,500

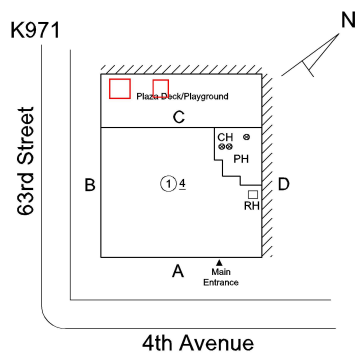
Question	Response
<b>EXTERIOR</b>	
<b>PLAZA DECK</b>	
Instance Quantity Uom	S.F.
Installation Year	2010
Source of Installation	Custodial Staff
Deficiency	ASPHALT: MINOR CRACKS
Roof Plan reference

Deficiency Quantity	20
Quantity Uom	S.F.
Potential Action	REPAIR
Urgency of Action	PRIORITY 3
Purpose of Action	LEVEL 2
Deficiency Photo1

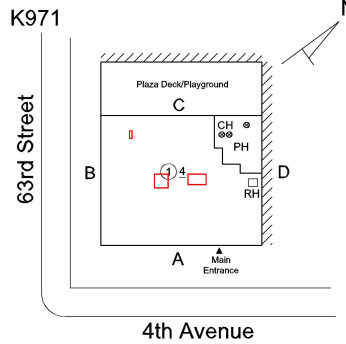
Roof Plan reference

IRMA: ROOFING: DETERIORATED PAVERS WITH INTEGRAL INSULATION

REPLACE

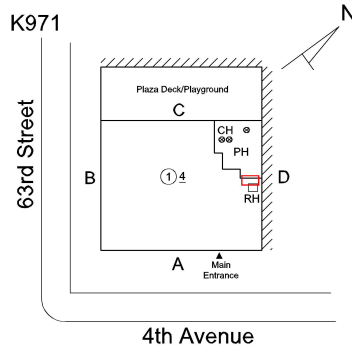
Question	Response
<b>EXTERIOR</b>	
<b>ROOF</b>	
<b>Specialties</b>	Inspected
<b>BULKHEAD/PENTHOUSE</b>	Inspected
Condition	4 - Between Fair and Poor
Deficiency	BULKHEAD/PENTHOUSE WALLS/INTERIOR: CMU CRACKS/SPALLING
Roof Plan reference	K971

Deficiency Quantity	10
Quantity Uom	S.F.
Potential Action	REPLACE
Urgency of Action	PRIORITY 3
Purpose of Action	LEVEL 2
Deficiency Photo1

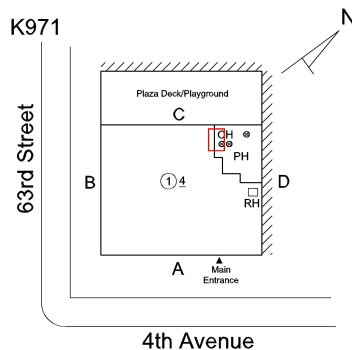
Violations	PH No violations recorded.
Deficiency	BULKHEAD/PENTHOUSE DOORS: DETERIORATED DOOR AND FRAME
Roof Plan reference	K971

Deficiency Quantity	2
Quantity Uom	EACH
Potential Action	REPLACE DOOR AND FRAME
Urgency of Action	PRIORITY 4
Purpose of Action	LEVEL 2
