NYC Department of Education
Building Condition Assessment Survey 2023 - 2024

Architectural Inspection

Asset: P.S. 261 TRANSPORTABLE - K, 314 PACIFIC STREET, New York, 11210

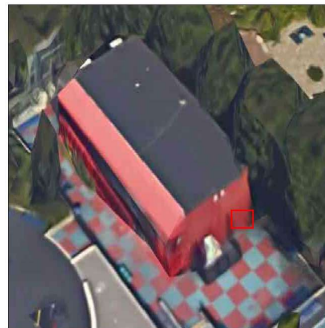
Elevation

Question	Response
EXTERIOR	
AWNINGS AND CANOPIES	
Violations	No violations recorded.
DOORS	
DOORS AND FRAMES	
Condition	2 - Between Good and Fair
Deficiency	No deficiencies recorded
DOOR HARDWARE	
Condition	2 - Between Good and Fair
Deficiency	No deficiencies recorded
EXTERIOR WALLS	
Material Type(s)	Steel
Replacement Quantity	1,500
Replacement Uom	S.F.
Instance on All Facades	Inspected
Instance Condition	5 - Poor
Instance Quantity	1,500
Instance Quantity Uom	S.F.
Deficiency	METAL PANEL: DAMAGED TRIM
Roof Plan reference

20
 L.F.
 REPLACE
 PRIORITY 4
 LEVEL 2
