**NYC Department of Education**  
**Building Condition Assessment Survey 2023 - 2024**

Architectural Inspection

**K987**

**Asset: ACORN SCHOOL FOR SOCIAL JUSTICE-K, 1396 BROADWAY, New York, 11221**

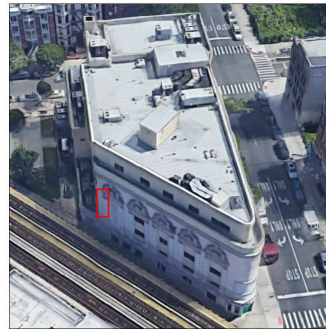
Deficiency Quantity	2
Quantity Uom	EACH
Potential Action	MAINTENANCE
Urgency of Action	PRIORITY 3
Purpose of Action	LEVEL 2
Deficiency Photo1	No photo recorded
Violations	No violations recorded.
<b>DOOR HARDWARE</b>	Inspected
Condition	3 - Fair
Deficiency	No deficiencies recorded
<b>LINTELS</b>	Inspected
Condition	2 - Between Good and Fair
Deficiency	No deficiencies recorded
<b>TRANSOM/SIDE LIGHT</b>	Does not Exist
<b>EXTERIOR WALLS</b>	Inspected
Material Type(s)	Masonry
Replacement Quantity	29,000
Replacement Uom	S.F.
Instance on All Facades	Inspected
Instance Condition	4 - Between Fair and Poor
Instance Quantity	29,000
Instance Quantity Uom	S.F.
Deficiency	STONE: CRACKS AT BUILDING CORNERS

TERRA COTTA: CHIPPED/SPALLED/BROKEN PIECES - MAJOR

REPLACE

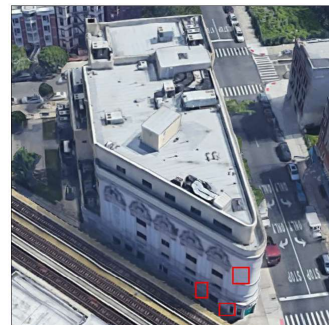
STONE: DETERIORATED JOINTS

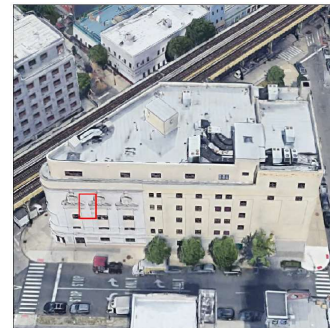
STONE: CHIPPED/SPALLED/BROKEN PIECES - MAJOR

REPLACE

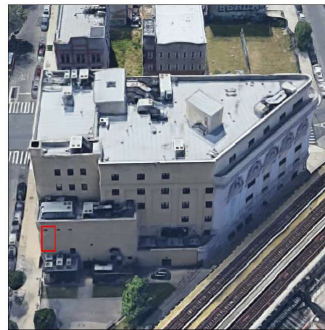
**BRICK: MAJOR / THRU CRACKS**

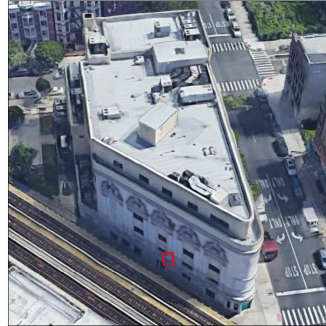
**STONE: CHIPPED/SPALLED/BROKEN PIECES - MAJOR**

REPLACE

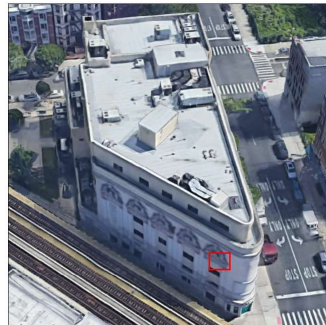
STONE: CHIPPED/SPALLED/BROKEN PIECES - MINOR

REPAIR

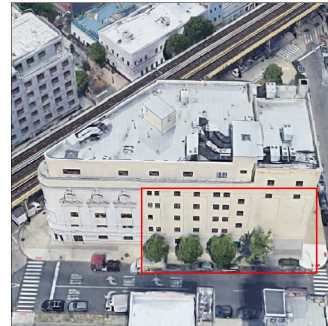
**BRICK: MINOR CRACKS AND SPALLING**

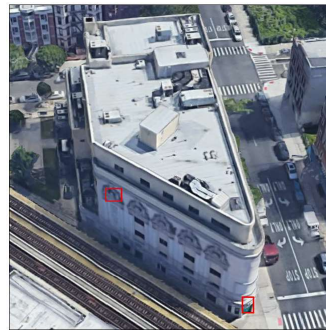
TERRA COTTA: CHIPPED/SPALLED/BROKEN PIECES - MINOR

REPAIR

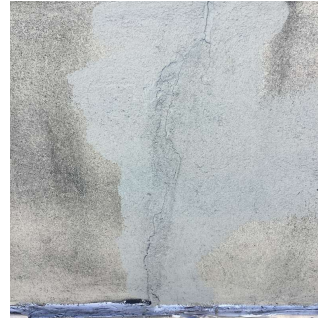
Roof 2

Violations	Facade C No violations recorded.
<b>EXTERIOR SOFFITS</b>	Inspected
Condition	2 - Between Good and Fair
Deficiency	No deficiencies recorded
<b>LOADING DOCK</b>	Does not Exist
<b>LOUVER</b>	Inspected
Condition	2 - Between Good and Fair
Deficiency	No deficiencies recorded
<b>PARAPETS</b>	Inspected
Material Type(s)	Masonry, Concrete
Replacement Quantity	5,800
Replacement Uom	C.F.
Instance on All Roofs	Inspected
Instance Condition	4 - Between Fair and Poor
Instance Quantity	5,800
Instance Quantity Uom	C.F.
Deficiency	CONCRETE: MINOR CRACKS, SPALLING

REPAIR

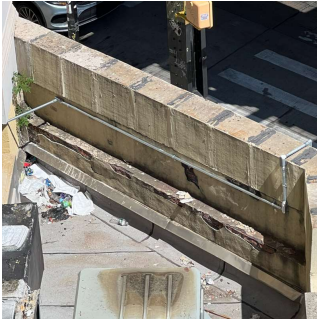
Violations	Roof 4 No violations recorded.
Deficiency	<b>CONCRETE: MAJOR DETERIORATION/CRACKS</b>
Roof Plan reference

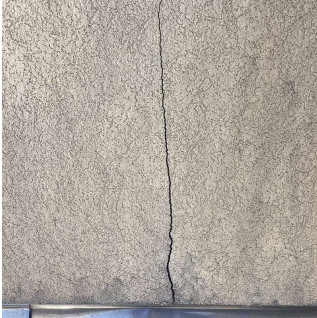
Deficiency Quantity	20
Quantity Uom	S.F.
Potential Action	REMOVE AND REBUILD
Urgency of Action	PRIORITY 4
Purpose of Action	LEVEL 2
Deficiency Photo1

Violations	Roof 1 No violations recorded.
<b>PLAZA DECK</b>	Does not Exist
<b>ROOF</b>	Inspected
<b>Roofing</b>	Inspected
Replacement Quantity	14,500
Replacement Uom	S.F.
<b>ROOF HATCH/SMOKE HATCH</b>	Does not Exist
<b>LEADERS, GUTTERS, DOWNSPOUTS, SCUPPERS</b>	Inspected
Condition	3 - Fair
Deficiency	DAMAGED/MISSING

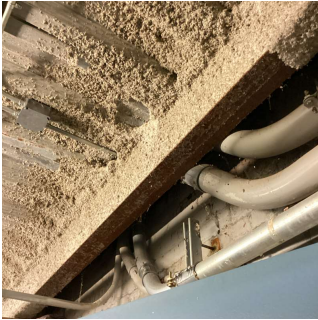
Question	Response
<b>EXTERIOR</b>	
<b>WINDOWS</b>	
<b>WINDOWS</b>	Inspected
Material Type(s)	Aluminum
Instance on Aluminum - Double Hung: All Facades	Inspected
Instance Condition	3 - Fair
Instance Quantity	2,000
Instance Quantity Uom	S.F.
Are these windows insulated	Yes
Installation Year	2003
Source of Installation	Custodial Staff
Deficiency	No deficiencies recorded
<b>INTERIOR</b>	Inspected
<b>POOLS</b>	Does not Exist
<b>STRUCTURAL</b>	Inspected
<b>COLUMNS/BEAMS/BEARING WALLS</b>	Inspected
Condition	3 - Fair
Deficiency	STEEL COLUMNS/BEAMS: DETERIORATED/MISSING SPRAY-ON FIREPROOFING
Deficiency Location/Instance	Rooms 218M, 227M, Boiler Room B38, Stair D/Cellar, Rooms B30, B37, B40, B41
Deficiency Quantity	160
Quantity Uom	S.F.
Potential Action	REPLACE
Urgency of Action	PRIORITY 3
Purpose of Action	LEVEL 5
Deficiency Photo1

Violations	Basement - Room B41 No violations recorded.
<b>FLOOR STRUCTURE</b>	Inspected
Condition	3 - Fair

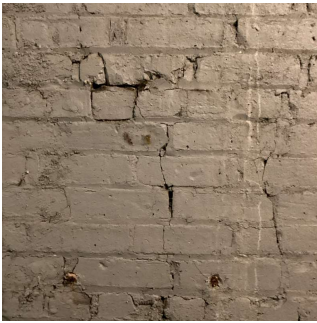
Violations	Basement - Gas Meter Room B40 No violations recorded.
Deficiency	BRICK: WATER INFILTRATION IN NON- INSTRUCTIONAL SPACE
Deficiency Location/Instance	Basement - Fire Pump Room B30, near Gas Meter Room B40
Deficiency Quantity	200
Quantity Uom	S.F.
Potential Action	INSTALL WATERPROOFING
Urgency of Action	PRIORITY 5
Purpose of Action	LEVEL 5
Deficiency Photo1

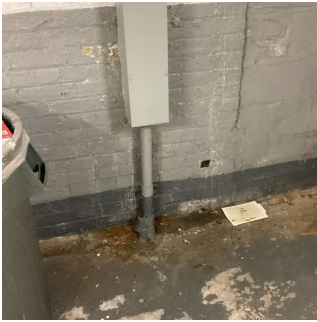
Violations	Basement - near Gas Meter Room B40 No violations recorded.
<b>ROOF STRUCTURE</b>	Inspected
Condition	2 - Between Good and Fair
Deficiency	No deficiencies recorded
<b>VAULTS-BUNKERS</b>	Does not Exist
<b>AUDITORIUM</b>	Does not Exist
<b>CAFETERIA</b>	Inspected
Instance on 1st Floor	Inspected
<b>Ceiling</b>	
Instance on 1st Floor	Inspected
Condition	2 - Between Good and Fair
Deficiency	No deficiencies recorded
<b>Door(s)</b>	
Instance on 1st Floor	Inspected

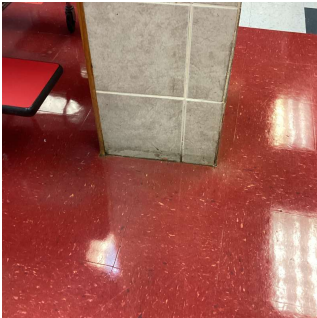
Question	Response
<b>INTERIOR</b>	
<b>CAFETERIA</b>	
<b>Walls</b>	
Deficiency Quantity	10
Quantity Uom	S.F.
Potential Action	REPLACE
Urgency of Action	PRIORITY 3
Purpose of Action	LEVEL 2
Deficiency Photo1

Violations	Center Columns No violations recorded.
Deficiency	GYPSUM BOARD: DETERIORATED
Deficiency Location/Instance	Exit 4 Vestibule, Near Windows
Deficiency Quantity	30
Quantity Uom	S.F.
Potential Action	REPLACE
Urgency of Action	PRIORITY 3
Purpose of Action	LEVEL 2
Deficiency Photo1

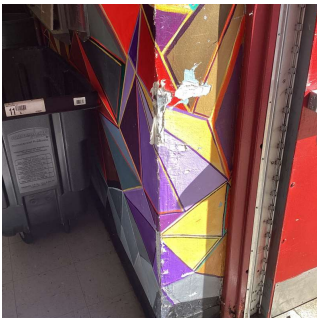
Violations	Exit 4 Vestibule No violations recorded.
<b>Window Curtains/Shades/Blinds</b>	
Instance on 1st Floor	Does not Exist
<b>CLASSROOMS/CORRIDORS/ADMIN SPACES</b>	
<b>Ceiling</b>	Inspected
Condition	2 - Between Good and Fair
Deficiency	TECTUM: DAMAGED/MISSING
Deficiency Location/Instance	Rooms 414, 510, 600, 620, 622, and others
Deficiency Quantity	120
Quantity Uom	S.F.
Potential Action	REPLACE
Urgency of Action	PRIORITY 3

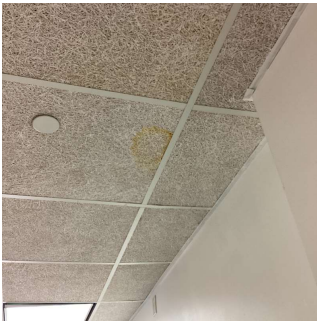
Room 620
Violations	No violations recorded.
<b>Door(s)</b>	
Condition	Inspected
	3 - Fair
Deficiency	METAL: DETERIORATED DOOR
Deficiency Location/Instance	Room 210
Deficiency Quantity	2
Quantity Uom	EACH
Potential Action	MAINTENANCE
Urgency of Action	PRIORITY 3
Purpose of Action	LEVEL 2
Deficiency Photo1

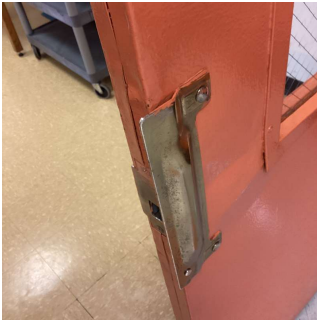
Room 210
Violations	No violations recorded.
<b>Floor Finish</b>	
Condition	Inspected
	2 - Between Good and Fair
Deficiency	CERAMIC TILE: BROKEN/MISSING TILES
Deficiency Location/Instance	Room 116
Deficiency Quantity	10
Quantity Uom	S.F.
Potential Action	REPLACE
Urgency of Action	PRIORITY 3
Purpose of Action	LEVEL 2

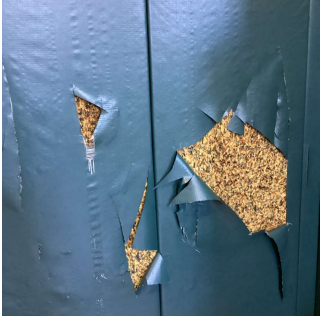
Question	Response
<b>INTERIOR</b>	
<b>GYMNASIUM</b>	
<b>Sliding-folding Partition</b>	
Instance on 3rd Floor	Does not Exist
<b>Stage</b>	
Instance on 3rd Floor	Does not Exist
<b>Walls</b>	
Instance on 3rd Floor	Inspected
Condition	4 - Between Fair and Poor
Deficiency	GYP SUM BOARD: DETERIORATED
Deficiency Location/Instance	Near Entrance, Near Windows
Deficiency Quantity	80
Quantity Uom	S.F.
Potential Action	REPLACE
Urgency of Action	PRIORITY 3
Purpose of Action	LEVEL 2
Deficiency Photo1	 
Violations	Near Entrance No violations recorded.
Deficiency	WALL PADDING: DETERIORATED
Deficiency Location/Instance	Near Entrance, Near Windows, Left Side, Right Side
Deficiency Quantity	360
Quantity Uom	S.F.
Potential Action	REPLACE
Urgency of Action	PRIORITY 3
Purpose of Action	LEVEL 2
Deficiency Photo1

Violations	Near Entrance No violations recorded.
<b>Window Curtains/Shades/Blinds</b>	
Instance on 3rd Floor	Does not Exist
<b>INTERIOR DOOR HARDWARE</b>

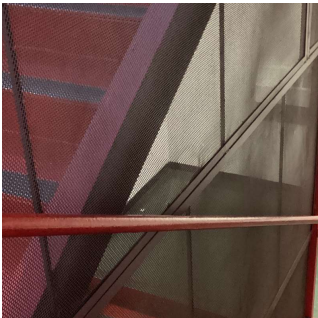
Question	Response
<b>INTERIOR</b>	
<b>INTERIOR GUARDS</b>	Inspected
Condition	2 - Between Good and Fair
Deficiency	DETERIORATED/TORN-OUT/MISSING
Deficiency Location/Instance	Stair A/4,5
Deficiency Quantity	20
Quantity Uom	S.F.
Potential Action	REPLACE
Urgency of Action	PRIORITY 3
Purpose of Action	LEVEL 2
Deficiency Photo1

Violations	Stair A/5 No violations recorded.
<b>KITCHEN</b>	Inspected
Instance on 1st Floor	Inspected
<b>Ceiling</b>	Inspected
Instance on 1st Floor	Inspected
Condition	3 - Fair
Deficiency	METAL PAN: DAMAGED/MISSING
Deficiency Location/Instance	Near Exit 4
Deficiency Quantity	10
Quantity Uom	S.F.
Potential Action	REPLACE
Urgency of Action	PRIORITY 3
Purpose of Action	LEVEL 2
Deficiency Photo1

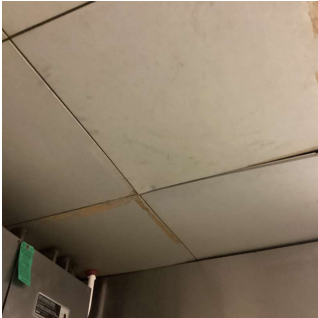
Violations	Near Exit 4 No violations recorded.
Deficiency	TECTUM: DAMAGED/MISSING
Deficiency Location/Instance	Office, Store Room 125M
Deficiency Quantity	25
Quantity Uom	S.F.
Potential Action	REPLACE
Urgency of Action	PRIORITY 3

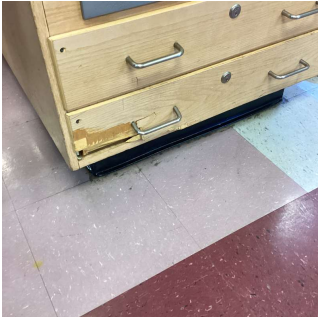
Question	Response
<b>INTERIOR</b>	
<b>SCIENCE DEMO ROOM</b>	
<b>Fixed Equipment</b>	
Instance on Room 600	Inspected
Condition	3 - Fair
Deficiency	CABINETRY: MISSING/DAMAGED
Deficiency Location/Instance	Room 600
Deficiency Quantity	10
Quantity Uom	L.F.
Potential Action	REPLACE
Urgency of Action	PRIORITY 3
Purpose of Action	LEVEL 2
Deficiency Photo1	No photo recorded
Violations	No violations recorded.
<b>SCIENCE LAB</b>	
Instance on Rooms 620, 629	Inspected
Alternative use	No
<b>Fixed Equipment</b>	
Instance on Rooms 620, 629	Inspected
Condition	3 - Fair
Deficiency	CABINETRY: MISSING/DAMAGED
Deficiency Location/Instance	Rooms 620, 629
Deficiency Quantity	10
Quantity Uom	L.F.
Potential Action	REPLACE
Urgency of Action	PRIORITY 3
Purpose of Action	LEVEL 2
Deficiency Photo1

Violations	Room 620 No violations recorded.
<b>SCIENCE PREP ROOM</b>	
Instance on Room 622	Inspected
Alternative use	No
<b>Fixed Equipment</b>	
Instance on Room 622	Inspected

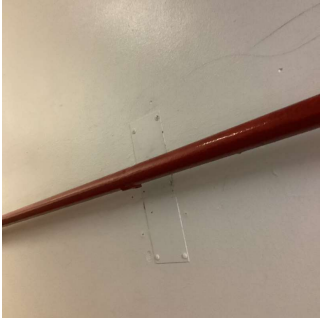
Question	Response
<b>INTERIOR</b>	
<b>STAIRS/RAMPS: INTERIOR</b>	
<b>Ceiling</b>	Inspected
Condition	2 - Between Good and Fair
Deficiency	GYPSUM BOARD: DAMAGED/DETERIORATED
Deficiency Location/Instance	Stair B/6
Deficiency Quantity	10
Quantity Uom	S.F.
Potential Action	REPLACE
Urgency of Action	PRIORITY 3
Purpose of Action	LEVEL 2
Deficiency Photo1	 
Violations	Stair B/6 No violations recorded.
<b>Door(s)</b>	Inspected
Condition	2 - Between Good and Fair
Deficiency	No deficiencies recorded
<b>Partition</b>	Does not Exist
<b>Railings</b>	Inspected
Condition	3 - Fair
Deficiency	METAL: BROKEN BRACKET
Deficiency Location/Instance	Stair A/5
Deficiency Quantity	1
Quantity Uom	EACH
Potential Action	REPLACE
Urgency of Action	PRIORITY 3
Purpose of Action	LEVEL 2
Deficiency Photo1

Violations	Stair A/5 No violations recorded.
<b>Stairs and Landings</b>	Inspected
Condition	3 - Fair
Deficiency	VINYL TILES: BROKEN/DETERIORATED/MISSING TILES

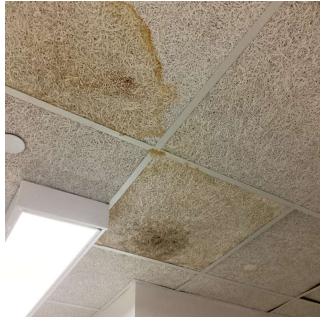
Question	Response
<b>INTERIOR</b>	
<b>TOILET ROOMS - STUDENTS</b>	
<b>Ceiling</b>	
Purpose of Action	LEVEL 2
Deficiency Photo1

Room 219
Violations	No violations recorded.
<b>Door(s)</b>	
Condition	Inspected
Deficiency	5 - Poor
Deficiency Location/Instance	METAL: DAMAGED LOUVER
Deficiency Quantity	Rooms 219, 223, 423, 519
Quantity Uom	4
Potential Action	EACH
Urgency of Action	MAINTENANCE
Purpose of Action	PRIORITY 3
Deficiency Photo1	LEVEL 2

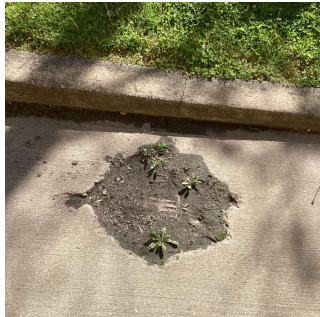
Question	Response
<b>SITE</b>	
<b>Drainage System for Concrete</b>	
<b>Catch Basins/Manhole - Surrounded by concrete</b>	
Purpose of Action	LEVEL 2
Deficiency Photo1

Near Exit 5
Violations	No violations recorded.
<b>Culverts - Concrete Covering</b>	
	Does not Exist
<b>Drainage System for Soil</b>	
	Does not Exist
<b>DRINKING FOUNTAINS</b>	
	Does not Exist
<b>FENCES</b>	
Condition	Inspected
	3 - Fair
Deficiency	WROUGHT IRON: DAMAGED/DETERIORATED
Deficiency Location/Instance	Broadway
Deficiency Quantity	40
Quantity Uom	S.F.
Potential Action	REPLACE
Urgency of Action	PRIORITY 3
Purpose of Action	LEVEL 2
Deficiency Photo1

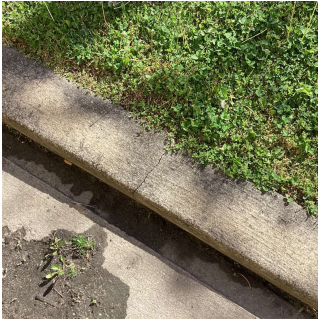
Broadway
Violations	No violations recorded.
Deficiency	CONCRETE CURB: DAMAGED/DETERIORATED
Deficiency Location/Instance	Schoolyard, Madison Street, Broadway
Deficiency Quantity	60
Quantity Uom	S.F.
Potential Action	REPLACE
Urgency of Action	PRIORITY 3
Purpose of Action	LEVEL 2

Violations	Schoolyard No violations recorded.
<b>IRRIGATION SYSTEM</b>	Does not Exist
<b>PAVING</b>	Inspected
<b>Student Non-Use</b>	Inspected
Gravel Exists?	No
<b>Asphalt</b>	Does not Exist
<b>Concrete</b>	Inspected
Condition	2 - Between Good and Fair
Deficiency	No deficiencies recorded
<b>Pavers</b>	Does not Exist
<b>Student Use</b>	Inspected
Gravel Exists?	No
<b>Asphalt</b>	Does not Exist
<b>Concrete</b>	Inspected
Condition	3 - Fair
Deficiency	DAMAGED/DETERIORATED/MISSING SECTIONS
Deficiency Location/Instance	Schoolyard
Deficiency Quantity	75
Quantity Uom	S.F.
Potential Action	REPLACE
Urgency of Action	PRIORITY 3
Purpose of Action	LEVEL 2
Deficiency Photo1

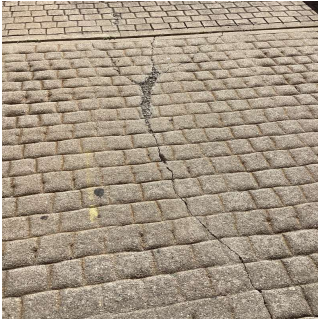
Violations	Schoolyard No violations recorded.
<b>Pavers</b>	Does not Exist
<b>Site Sidewalks &amp; Walkways</b>	Inspected
<b>Asphalt</b>	Does not Exist
<b>Concrete</b>	Inspected

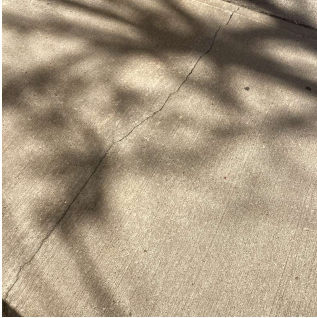
Question	Response
<b>SITE</b>	
<b>PAVING</b>	
<b>Site Sidewalks &amp; Walkways</b>	
<b>Concrete</b>	
Condition	3 - Fair
Deficiency	DAMAGED/DETERIORATED/MISSING SECTIONS
Deficiency Location/Instance	Near Exit 5, Near Exit 4
Deficiency Quantity	125
Quantity Uom	S.F.
Potential Action	REPLACE
Urgency of Action	PRIORITY 3
Purpose of Action	LEVEL 2
Deficiency Photo1

Violations	Near Exit 5 No violations recorded.
<b>Pavers</b>	Does not Exist
<b>DOT Sidewalk</b>	Inspected
<b>Asphalt</b>	Does not Exist
<b>Concrete</b>	Inspected
Condition	4 - Between Fair and Poor
Deficiency	HEAVING
Deficiency Location/Instance	Madison Street, Howard Avenue
Deficiency Quantity	125
Quantity Uom	S.F.
Potential Action	REPLACE
Urgency of Action	PRIORITY 3
Purpose of Action	LEVEL 2
Deficiency Photo1

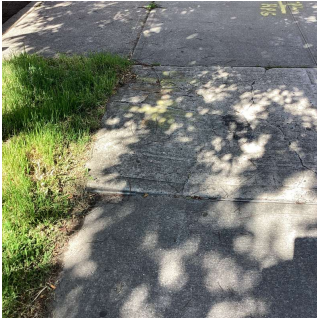
Violations	Madison Street No violations recorded.
Deficiency	DAMAGED CURBS
Deficiency Location/Instance	Madison Street, Howard Avenue
Deficiency Quantity	40

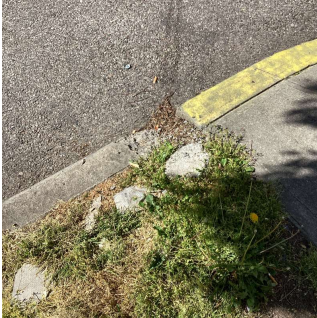
Question	Response
<b>SITE</b>	
<b>PAVING</b>	
<b>DOT Sidewalk</b>	
<b>Concrete</b>	
Potential Action	REPLACE
Urgency of Action	PRIORITY 3
Purpose of Action	LEVEL 2
Deficiency Photo1

Madison Street
Violations	No violations recorded.
Deficiency	DAMAGED/DETERIORATED/MISSING SECTIONS
Deficiency Location/Instance	Madison Street, Howard Avenue, Broadway
Deficiency Quantity	1,350
Quantity Uom	S.F.
Potential Action	REPLACE
Urgency of Action	PRIORITY 3
Purpose of Action	LEVEL 2
Deficiency Photo1
