NYC Department of Education
Building Condition Assessment Survey 2023 - 2024

Architectural Inspection

Asset: P.S. 104/P.S. 185 ANNEX-K, 415 89TH STREET, New York, 11209

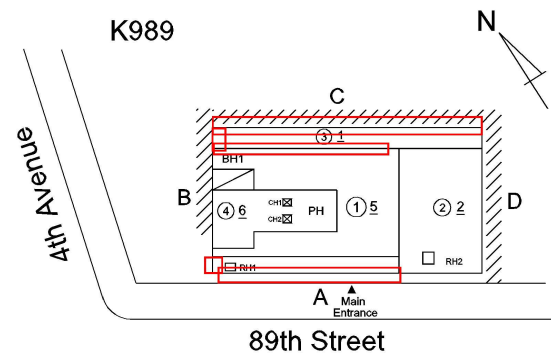
Question	Response
Architectural	
EXTERIOR	Inspected
AREAWAY	Does not Exist
AWNINGS AND CANOPIES	Does not Exist
CHIMNEY	Inspected
Material Type(s)	Metal
Condition	2 - Between Good and Fair
Deficiency	No deficiencies recorded
COPING	Inspected
Condition	3 - Fair
Deficiency	CAST STONE: DETERIORATED TRANSVERSE JOINTS
Roof Plan reference

100

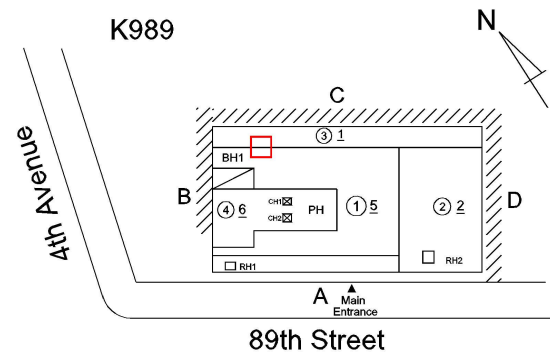
METAL: DETERIORATED DOOR - MAJOR DETERIORATION

1
EACH
REPLACE
PRIORITY 4
LEVEL 2

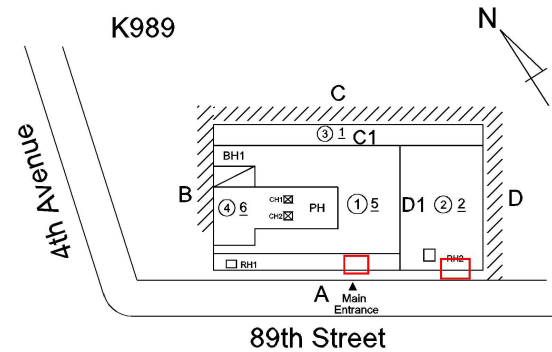
ROLL-UP DOOR: DETERIORATED DOOR AND FRAME - MINOR DETERIORATION

240
S.F.
MAINTENANCE
PRIORITY 3
LEVEL 2

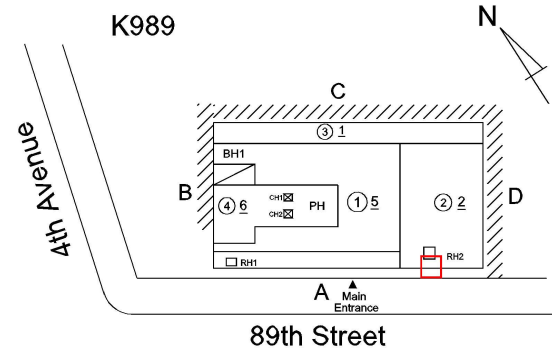
METAL CLAD: DETERIORATED DOOR AND FRAME - MAJOR DETERIORATION

2
EACH
REPLACE
PRIORITY 4
LEVEL 2

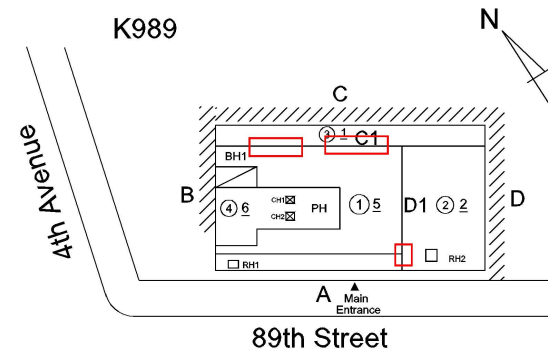
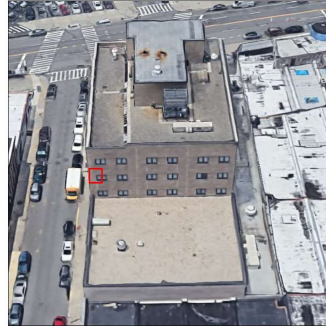
BRICK: DETERIORATED JOINTS

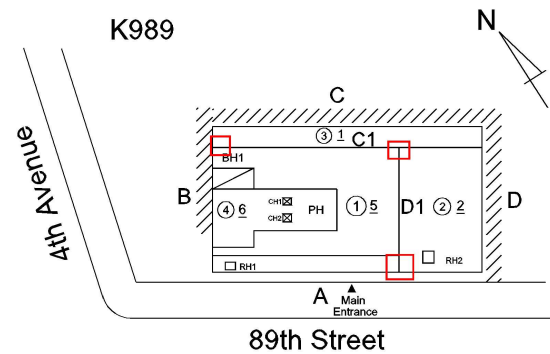
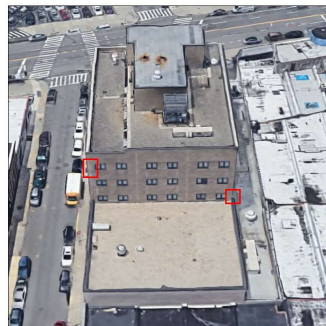
BRICK: CRACKS/DISPLACED/SPALLED BRICK AT BUILDING CORNERS

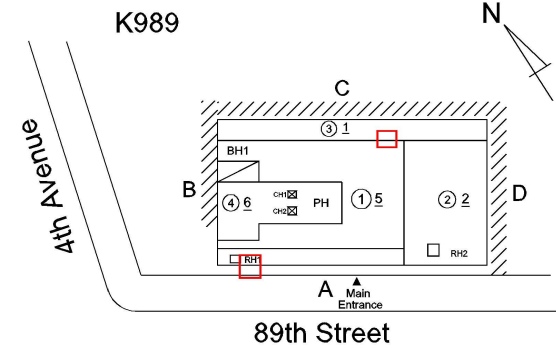
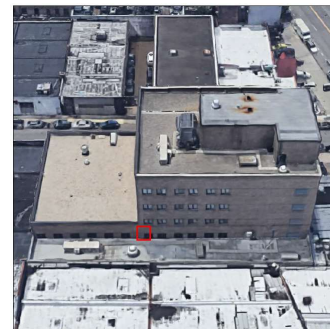
BRICK: MINOR CRACKS AND SPALLING

20
S.F.
RESTITCH
PRIORITY 3
LEVEL 2

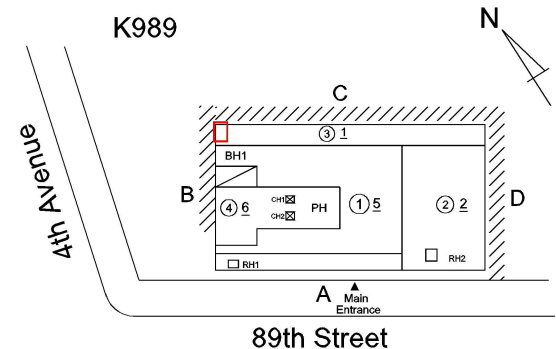
Deficiency	BRICK: DETERIORATED JOINTS
Roof Plan reference

Deficiency Quantity	20
Quantity Uom	S.F.
Potential Action	REPOINT
Urgency of Action	PRIORITY 3
Purpose of Action	LEVEL 2
Deficiency Photo1

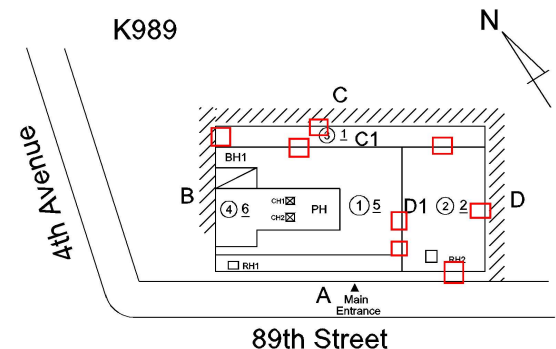
Deficiency	BRICK: MINOR CRACKS, SPALLING
Roof Plan reference

Deficiency Quantity	80
Quantity Uom	S.F.
Potential Action	REPAIR
Urgency of Action	PRIORITY 3
Purpose of Action	LEVEL 2

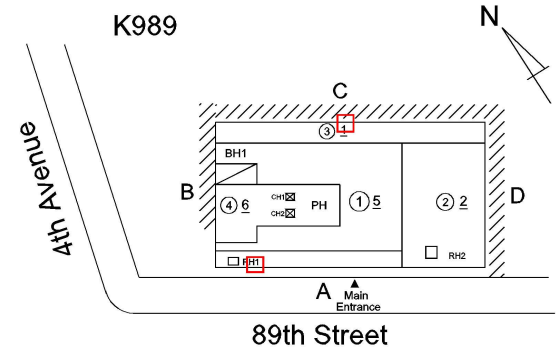
BRICK: MAJOR DETERIORATION/CRACKS

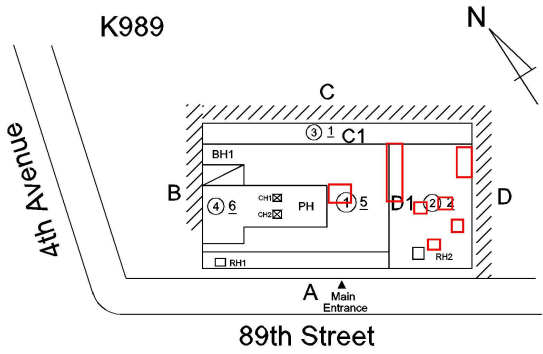
Roof 2
Instance Quantity	15,000
Instance Quantity Uom	S.F.
Does the roof have major mechanical equipment sitting on Dunnage Steel less than 18" above the Roofing?	No
Does this roof instance have a Sustainable Roof System?	No
Do solar panels exist on these roofs?	No
Is/Are the roof(s) suitable for Solar Panel installation?	No
Installation Year	2001
Source of Installation	Custodial Staff
Deficiency	IRMA: ROOFING: DAMAGED INSULATION
Roof Plan reference

Deficiency Quantity	100
Quantity Uom	S.F.
Potential Action	REPLACE
Urgency of Action	PRIORITY 4
Purpose of Action	LEVEL 2
Deficiency Photo1

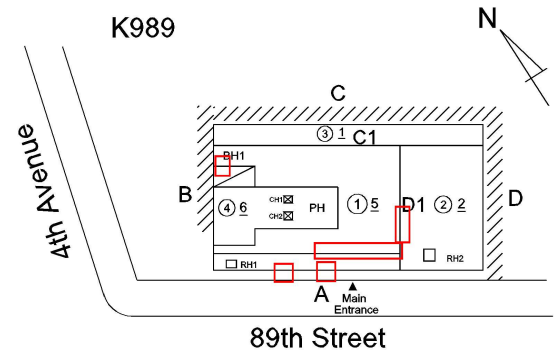
Roof 2
Violations	No violations recorded.
Deficiency	IRMA: FLASHING: CAP FLASHING DAMAGED

100
L.F.
REPLACE
PRIORITY 4
LEVEL 2

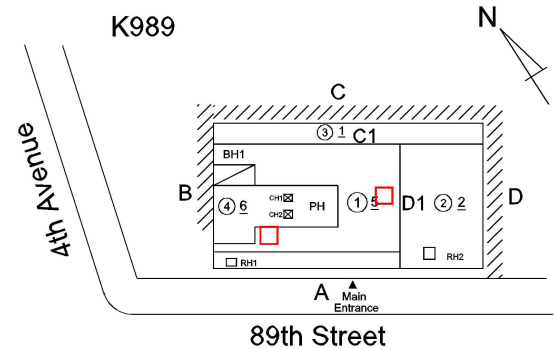
IRMA: ROOFING: MAJOR ACTIVE ROOF LEAKS IN INSTRUCTIONAL SPACE

200
S.F.
REPLACE ROOFING WITHOUT MAJOR EQUIPMENT REMOVAL
PRIORITY 5
LEVEL 2

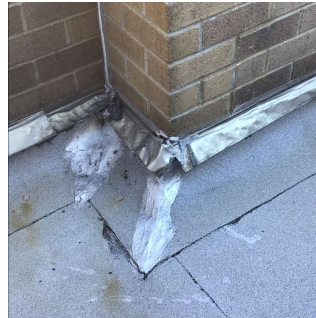
Roof 3 - Facade C

Question	Response
EXTERIOR	
ROOF	
Roofing	
ROOFING	
Deficiency Photo1	 
Violations	Roof 1 - Room 522 shown, Roof 1 - Room 507 similar No violations recorded.
Instance on Modified Bitumen: Roof 3	Inspected
Instance Condition	5 - Poor
Instance Photo	 
	Roof 3
Instance Quantity	2,000
Instance Quantity Uom	S.F.
Does the roof have major mechanical equipment sitting on Dunnage Steel less than 18" above the Roofing?	No
Does this roof instance have a Sustainable Roof System?	Yes
Sustainable Roof Type	White Roof
Sustainable Roof Location (Roof Number)	Roof 3
Do solar panels exist on these roofs?	No
Is/Are the roof(s) suitable for Solar Panel installation?	No
Installation Year	2005
Source of Installation	Custodial Staff
Deficiency	MODIFIED BITUMEN: FLASHING: CAP FLASHING DAMAGED
Roof Plan reference	 
Deficiency Quantity	50
Quantity Uom	L.F.
Potential Action	REPLACE
Urgency of Action	PRIORITY 4
Purpose of Action	LEVEL 2

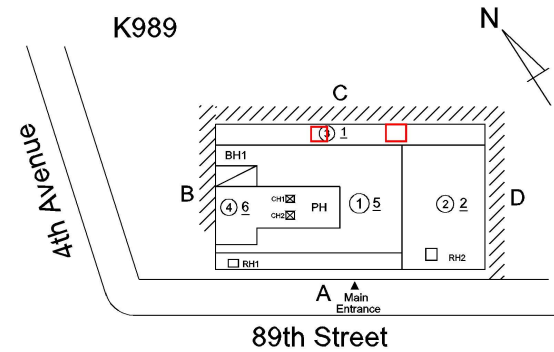
MODIFIED BITUMEN: ROOFING: DELAMINATION

REPLACE ROOFING WITHOUT MAJOR EQUIPMENT REMOVAL

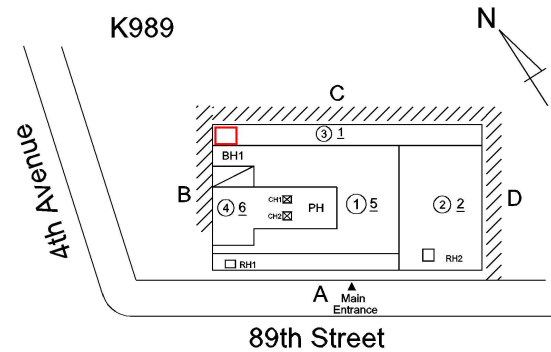
MODIFIED BITUMEN: ROOFING: MAJOR ACTIVE ROOF LEAKS IN INSTRUCTIONAL SPACE

100
S.F.
REPLACE ROOFING WITHOUT MAJOR EQUIPMENT
REMOVAL
PRIORITY 5
LEVEL 2

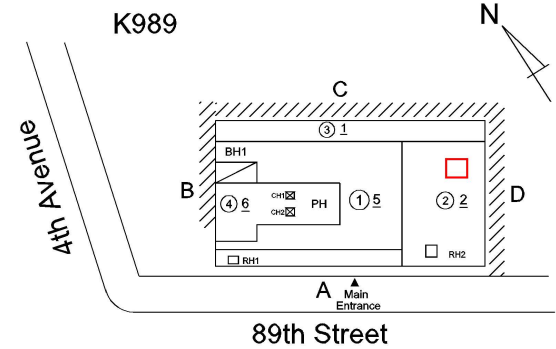
DETERIORATED

1
EACH
REPLACE
PRIORITY 4
LEVEL 2

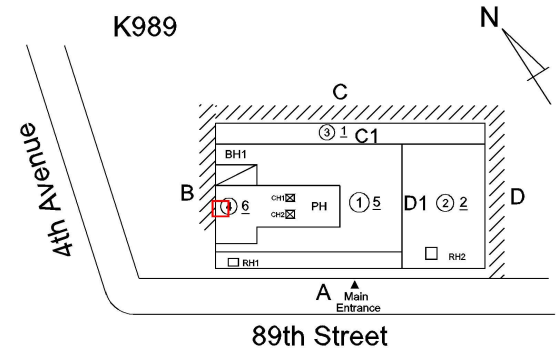
BULKHEAD/PENTHOUSE WALLS/INTERIOR: CMU
CRACKS/SPALLING

30
S.F.
REPLACE
PRIORITY 3

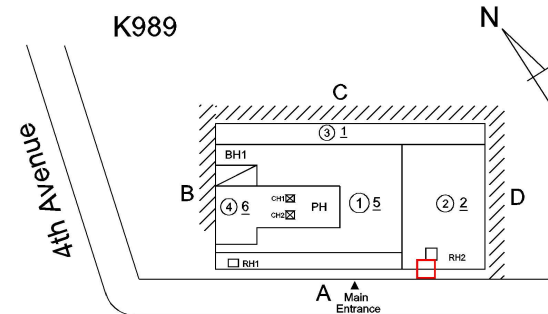
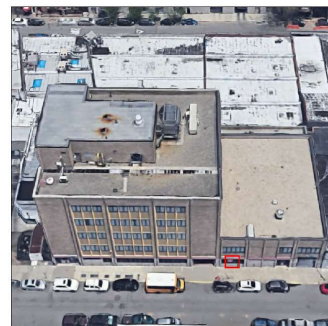
DETERIORATED/TORN-OUT/MISSING

Deficiency Quantity	30
Quantity Uom	S.F.
Potential Action	REPLACE
Urgency of Action	PRIORITY 4
Purpose of Action	LEVEL 2
Deficiency Photo1

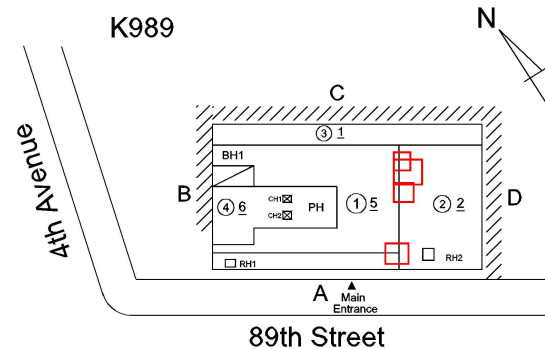
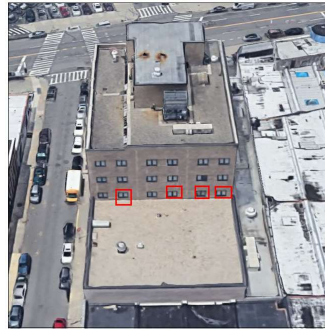
Material Type(s)	Inspected
	Aluminum
Instance on Aluminum - Other: Facades A, C, D	Inspected
Instance Condition	3 - Fair
Instance Quantity	2,200
Instance Quantity Uom	S.F.
Are these windows insulated	Yes
Installation Year	1999
Source of Installation	Custodial Staff
Deficiency	ALUMINUM - OTHER: DETERIORATED
Roof Plan reference

REPLACE WINDOW

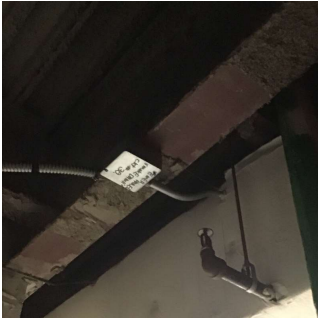
Question	Response
INTERIOR	
STRUCTURAL	
COLUMNS/BEAMS/BEARING WALLS	
Violations	Oil Tank Room No violations recorded.
Deficiency	STEEL COLUMNS/BEAMS: DETERIORATED/MISSING SPRAY-ON FIREPROOFING
Deficiency Location/Instance	Basement - Water Meter Room, Garage, 2nd Floor - Mechanical Equipment Room
Deficiency Quantity	50
Quantity Uom	S.F.
Potential Action	REPLACE
Urgency of Action	PRIORITY 3
Purpose of Action	LEVEL 5
Deficiency Photo1

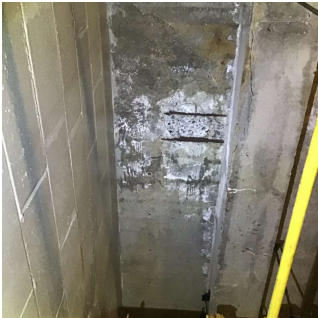
Violations	2nd Floor - Mechanical Equipment Room No violations recorded.
FLOOR STRUCTURE	
Condition	Inspected 3 - Fair
Deficiency	CONCRETE: CRACKS/SPALLED/REINFORCEMENT EXPOSED
Deficiency Location/Instance	Basement - Oil Tank Room
Deficiency Quantity	30
Quantity Uom	S.F.
Potential Action	REPAIR
Urgency of Action	PRIORITY 4
Purpose of Action	LEVEL 5
Deficiency Photo1

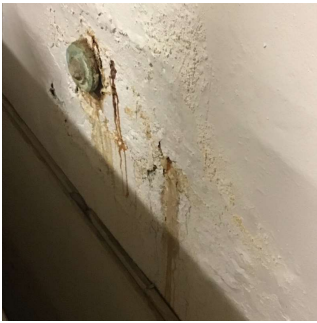
Question	Response
INTERIOR	
STRUCTURAL	
FLOOR STRUCTURE	Inspected
Violations	Penthouse No violations recorded.
FOUNDATION WALLS	Inspected
Material Type(s)	Concrete
Condition	4 - Between Fair and Poor
Deficiency	CONCRETE: WATER INFILTRATION IN NON- INSTRUCTIONAL SPACE
Deficiency Location/Instance	Basement - Garage near Oil Tank Room
Deficiency Quantity	100
Quantity Uom	S.F.
Potential Action	INSTALL WATERPROOFING
Urgency of Action	PRIORITY 5
Purpose of Action	LEVEL 5
Deficiency Photo1

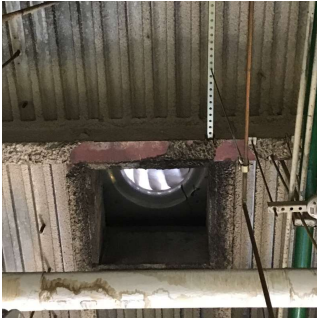
Violations	Garage near Oil Tank Room No violations recorded.
ROOF STRUCTURE	Inspected
Condition	2 - Between Good and Fair
Deficiency	STEEL COLUMNS/BEAMS: DETERIORATED/MISSING SPRAY-ON FIREPROOFING
Deficiency Location/Instance	Roof 3 - PH
Deficiency Quantity	20
Quantity Uom	S.F.
Potential Action	REPLACE
Urgency of Action	PRIORITY 3
Purpose of Action	LEVEL 5
Deficiency Photo1

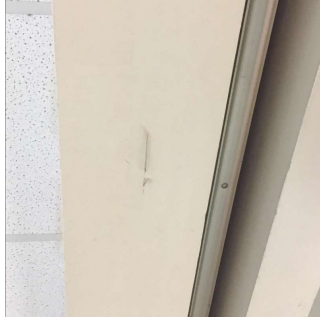
Question	Response
INTERIOR	
CAFETERIA	Inspected
Instance on 1st Floor	Inspected
Ceiling	
Instance on 1st Floor	Inspected
Condition	2 - Between Good and Fair
Deficiency	GYPSUM BOARD: DAMAGED/DETERIORATED
Deficiency Location/Instance	Near Servery
Deficiency Quantity	10
Quantity Uom	S.F.
Potential Action	REPLACE
Urgency of Action	PRIORITY 3
Purpose of Action	LEVEL 2
Deficiency Photo1

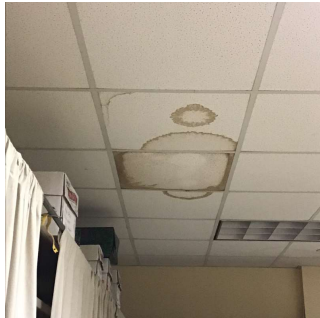
Near Servery
Violations	No violations recorded.
Deficiency	ACOUSTIC TILES: DAMAGED/MISSING
Deficiency Location/Instance	Room 104A, Near Servery
Deficiency Quantity	60
Quantity Uom	S.F.
Potential Action	REPLACE
Urgency of Action	PRIORITY 3
Purpose of Action	LEVEL 2
Deficiency Photo1

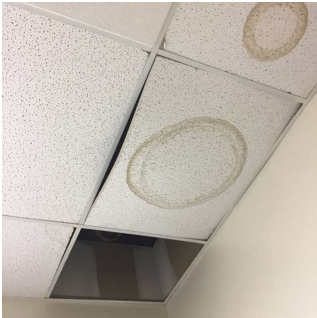
Right Side
Violations	No violations recorded.
Window Curtains/Shades/Blinds	
Instance on 1st Floor	Does not Exist
CLASSROOMS/CORRIDORS/ADMIN SPACES	
Ceiling	
Condition	3 - Fair
Deficiency	ACOUSTIC TILES: DAMAGED/MISSING - ACTIVE LEAK
Deficiency Location/Instance	Rooms 522,116
Deficiency Quantity	70
Quantity Uom	S.F.
Potential Action	REPLACE
Urgency of Action	PRIORITY 5
Purpose of Action	LEVEL 2
Deficiency Photo1

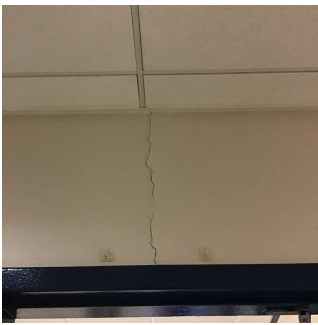
GYPSUM BOARD: DETERIORATED

REPLACE

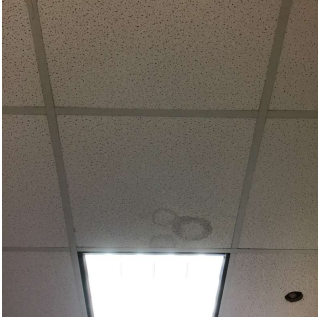
Instance on Room 108	Inspected
Built-in Furnishing	
Instance on Room 108	Does not Exist
Ceiling	
Instance on Room 108	Inspected
Condition	2 - Between Good and Fair
Deficiency	ACOUSTIC TILES: DAMAGED/MISSING
Deficiency Location/Instance	Right Side
Deficiency Quantity	10

Question	Response
INTERIOR	
LIBRARY	
Ceiling	
Quantity Uom	S.F.
Potential Action	REPLACE
Urgency of Action	PRIORITY 3
Purpose of Action	LEVEL 2
Deficiency Photo1

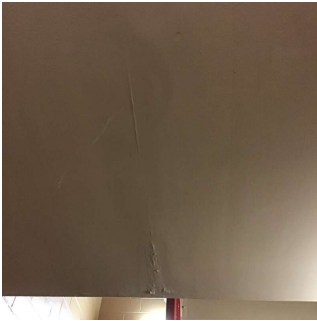
Right Side
Violations	No violations recorded.
Door(s)	
Instance on Room 108	Inspected
Condition	2 - Between Good and Fair
Deficiency	No deficiencies recorded
Floor Finish	
Instance on Room 108	Inspected
Condition	2 - Between Good and Fair
Deficiency	No deficiencies recorded
Walls	
Instance on Room 108	Inspected
Condition	2 - Between Good and Fair
Deficiency	No deficiencies recorded
LOCKER ROOM	Does not Exist
MULTI-PURPOSE ROOM	Does not Exist
SCIENCE DEMO ROOM	Does not Exist
SCIENCE LAB	Does not Exist
SCIENCE PREP ROOM	Does not Exist
SHOWER ROOM	Does not Exist
STAIRS/RAMPS: INTERIOR	
Do Letter Stair Signs Exist?	Yes
Ceiling	
Condition	2 - Between Good and Fair
Deficiency	GYPSUM BOARD: DAMAGED/DETERIORATED
Deficiency Location/Instance	Stairs A/5, C/1
Deficiency Quantity	20

Quantity Uom	S.F.
Potential Action	REPLACE
Urgency of Action	PRIORITY 3
Purpose of Action	LEVEL 2

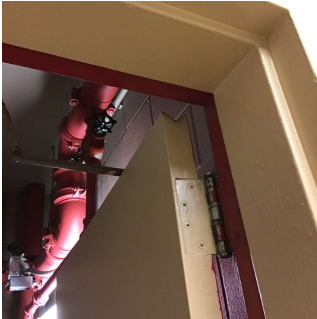
Violations	Stair C/1 No violations recorded.
Door(s)	Inspected
Condition	3 - Fair
Deficiency	METAL: DETERIORATED DOOR
Deficiency Location/Instance	Stair A/2
Deficiency Quantity	1
Quantity Uom	EACH
Potential Action	MAINTENANCE
Urgency of Action	PRIORITY 3
Purpose of Action	LEVEL 2
Deficiency Photo1

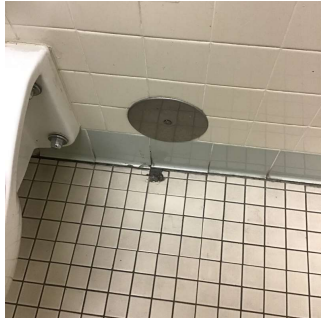
Question	Response
INTERIOR	
STAIRS/RAMPS: INTERIOR	Inspected
Walls	Inspected
Violations	Stair C/1 No violations recorded.
TOILET ROOMS - STAFF	Inspected
Ceiling	Inspected
Condition	2 - Between Good and Fair
Deficiency	No deficiencies recorded
Door(s)	Inspected
Condition	2 - Between Good and Fair
Deficiency	No deficiencies recorded
Floor Finish	Inspected
Condition	2 - Between Good and Fair
Deficiency	CERAMIC TILE: BROKEN/MISSING TILES
Deficiency Location/Instance	Room 310
Deficiency Quantity	10
Quantity Uom	S.F.
Potential Action	REPLACE
Urgency of Action	PRIORITY 3
Purpose of Action	LEVEL 2
Deficiency Photo1

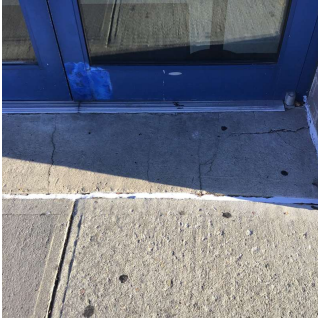
Question	Response
SITE	
CONTAINERIZATION	Does not Exist
Drainage System for Asphalt	Does not Exist
Drainage System for Concrete	Does not Exist
Drainage System for Soil	Does not Exist
DRINKING FOUNTAINS	Does not Exist
FENCES	Does not Exist
IRRIGATION SYSTEM	Does not Exist
PAVING	Inspected
Student Non-Use	Does not Exist
Student Use	Does not Exist
Site Sidewalks & Walkways	Inspected
Asphalt	Does not Exist
Concrete	Inspected
Condition	3 - Fair
Deficiency	DAMAGED/DETERIORATED/MISSING SECTIONS
Deficiency Location/Instance	89th Street
Deficiency Quantity	75
Quantity Uom	S.F.
Potential Action	REPLACE
Urgency of Action	PRIORITY 3
Purpose of Action	LEVEL 2
Deficiency Photo1

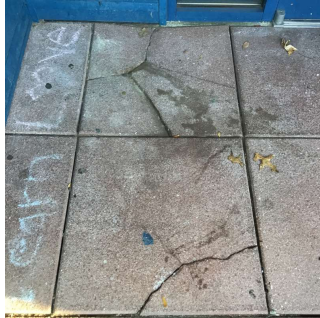
89th Street
Violations	No violations recorded.
Pavers	Inspected
Condition	2 - Between Good and Fair
Deficiency	DAMAGED/MISSING
Deficiency Location/Instance	89th Street
Deficiency Quantity	10
Quantity Uom	S.F.
Potential Action	REPLACE
Urgency of Action	PRIORITY 3

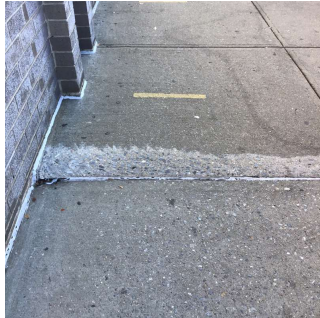
Violations	89th Street No violations recorded.
DOT Sidewalk	Inspected
Asphalt	Does not Exist
Concrete	Inspected
Condition	4 - Between Fair and Poor
Deficiency	HEAVING
Deficiency Location/Instance	89th Street
Deficiency Quantity	25
Quantity Uom	S.F.
Potential Action	REPLACE
Urgency of Action	PRIORITY 3
Purpose of Action	LEVEL 2
Deficiency Photo1
