NYC Department of Education
Building Condition Assessment Survey 2023 - 2024

Architectural Inspection

K990

Asset: PAVE ACADEMY CHARTER SCHOOL - BROOKLYN, 732 HENRY STREET, New York, 11231

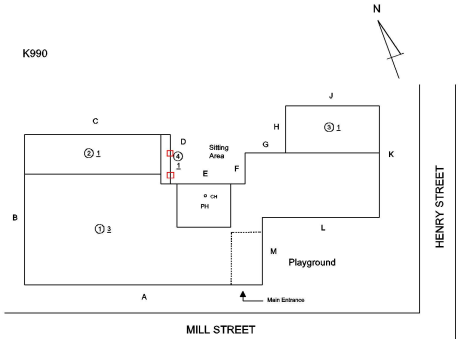
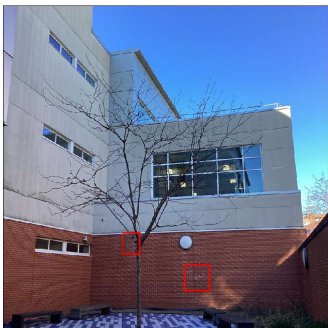
Question	Response
EXTERIOR	
EXTERIOR WALLS	
Instance Condition	3 - Fair
Instance Quantity	22,500
Instance Quantity Uom	S.F.
Deficiency	BRICK: EFFLORESCENCE
Roof Plan reference

Deficiency Quantity	20
Quantity Uom	S.F.
Potential Action	MAINTENANCE
Urgency of Action	PRIORITY 1
Purpose of Action	LEVEL 1
Deficiency Photo1

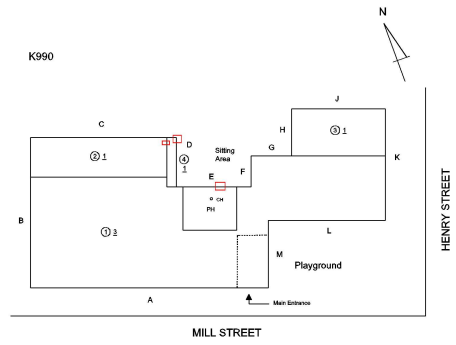
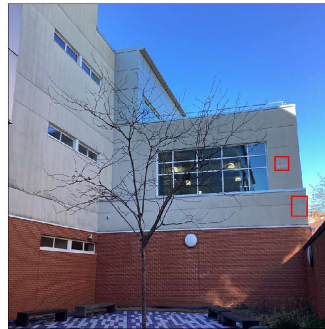
Violations	Facade D No violations recorded.
Deficiency	STUCCO CEMENT SURFACE: CRACKS, SPALLING

Deficiency Quantity

30

REPLACE

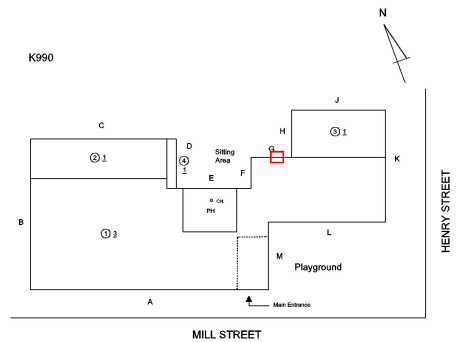
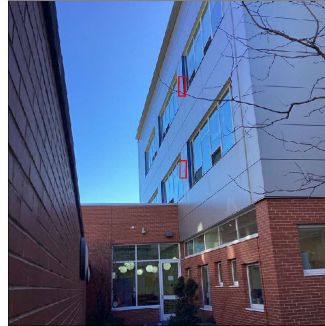
METAL PANEL: DETERIORATED JOINTS

Deficiency Quantity

20

REPAIR

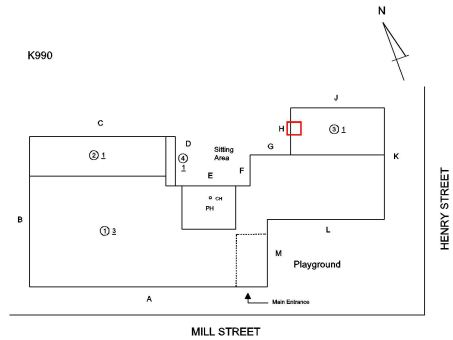
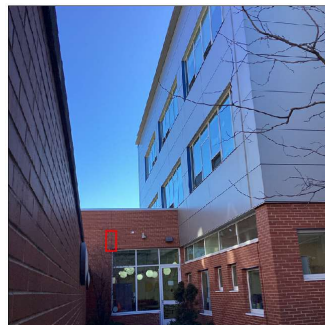
BRICK: DETERIORATED CONTROL/EXPANSION JOINTS

Deficiency Quantity

10

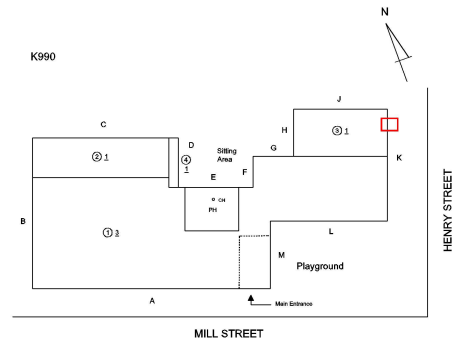
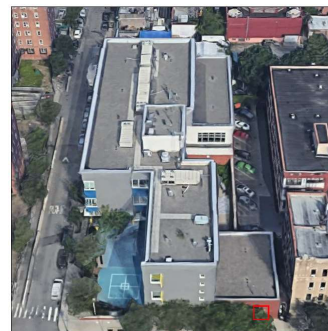
CONCRETE: MINOR CRACKS/SPALLING

Deficiency Quantity
Quantity Uom
Potential Action
Urgency of Action
Purpose of Action

10
S.F.
REPAIR
PRIORITY 3
LEVEL 2
