**NYC Department of Education**  
**Building Condition Assessment Survey 2023 - 2024**

Architectural Inspection

**K995**

**Asset: LEARNING SUPPORT CENTER - BROOKLYN, 5613 FLATLANDS AVE, New York, 11234**

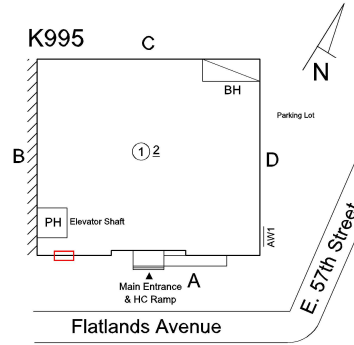
Roof Plan reference

Question	Response
<b>Architectural</b>	
<b>EXTERIOR</b>	Inspected
<b>AREAWAY</b>	Inspected
Instance on AW1	Inspected
Instance Condition	2 - Between Good and Fair
Instance Quantity	1
Instance Quantity Uom	EACH
Deficiency	No deficiencies recorded
<b>AWNINGS AND CANOPIES</b>	Inspected
Condition	2 - Between Good and Fair
Deficiency	No deficiencies recorded
<b>CHIMNEY</b>	Does not Exist
<b>COPING</b>	Inspected
Condition	3 - Fair
Deficiency	CAST STONE: CRACKED/BROKEN PIECES

10  
L.F.  
REPLACE-IN-KIND  
PRIORITY 4  
LEVEL 2

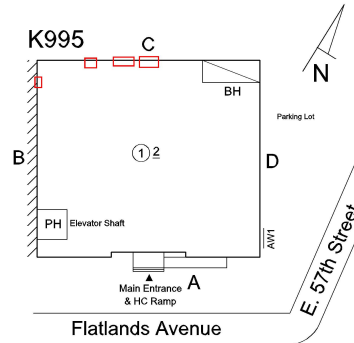
Roof Plan reference

TERRA COTTA: CRACKED/BROKEN PIECES

40  
L.F.  
REPLACE-IN-KIND  
PRIORITY 4  
LEVEL 2

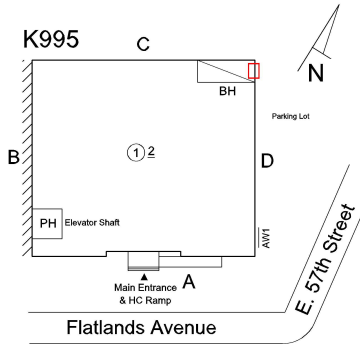
Violations	Roof 1 No violations recorded.
<b>CORNICE</b>	
Condition	Inspected
Deficiency	2 - Between Good and Fair No deficiencies recorded
<b>DOORS</b>	
<b>DOORS AND FRAMES</b>	
Condition	Inspected
Deficiency	4 - Between Fair and Poor METAL CLAD: DETERIORATED DOOR AND FRAME - MAJOR DETERIORATION
Roof Plan reference

Deficiency Quantity	1
Quantity Uom	EACH
Potential Action	REPLACE
Urgency of Action	PRIORITY 4
Purpose of Action	LEVEL 2
Deficiency Photo1

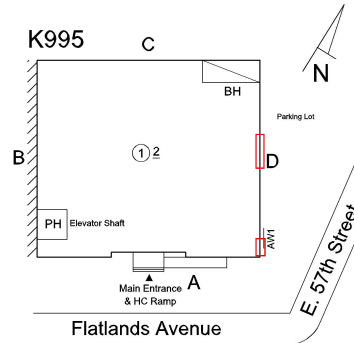
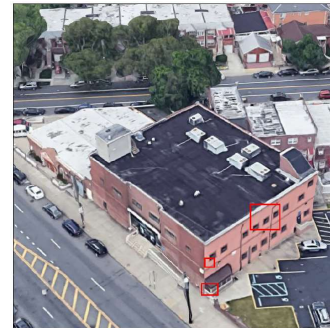
Roof Plan reference

STUCCO CEMENT SURFACE: CRACKS, SPALLING

50

REPLACE

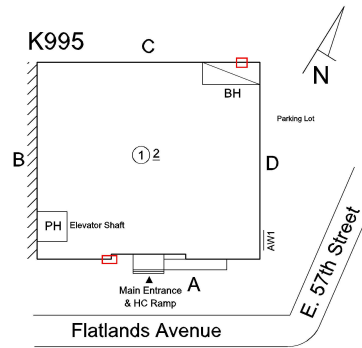
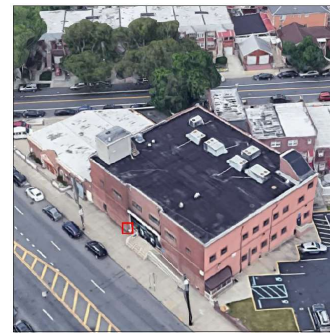
Roof Plan reference

BRICK: MINOR CRACKS AND SPALLING

20

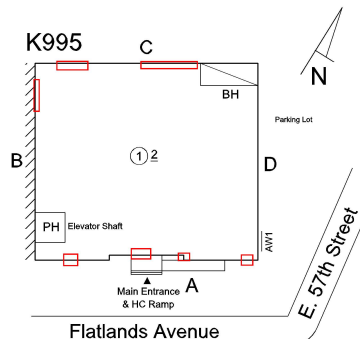
Question	Response
<b>EXTERIOR</b>	
<b>PARAPETS</b>	
Replacement Uom	C.F.
Instance on All Facades	Inspected
Instance Condition	3 - Fair
Instance Quantity	2,000
Instance Quantity Uom	C.F.
Deficiency	CONCRETE: MINOR CRACKS, SPALLING
Roof Plan reference

Deficiency Quantity	80
Quantity Uom	S.F.
Potential Action	REPAIR
Urgency of Action	PRIORITY 3
Purpose of Action	LEVEL 2
Deficiency Photo1

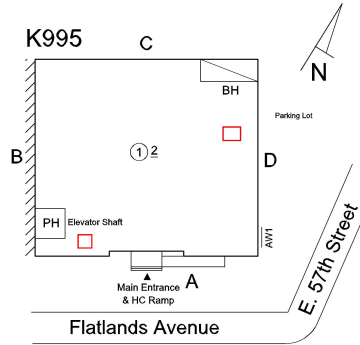
Roof Plan reference	
---------------------	--

Deficiency	MODIFIED BITUMEN: ROOFING: DELAMINATION
------------	---

Deficiency Quantity	60
---------------------	----

Potential Action	REPLACE ROOFING WITHOUT MAJOR EQUIPMENT REMOVAL
------------------	---

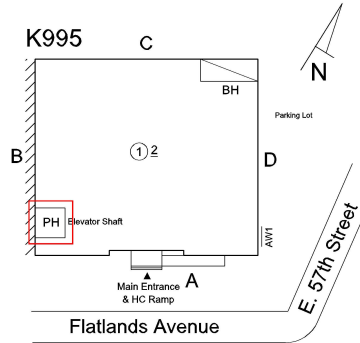
Roof Plan reference

Deficiency	BULKHEAD/PENTHOUSE WALLS/EXTERIOR: CRACKS/SPALLING - MINOR
------------	---

30

REPAIR

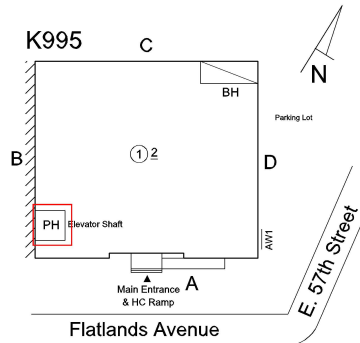
Roof Plan reference

Deficiency	BULKHEAD/PENTHOUSE CEILING: GYPSUM BOARD DAMAGED/DETERIORATED
------------	--

20

REPLACE

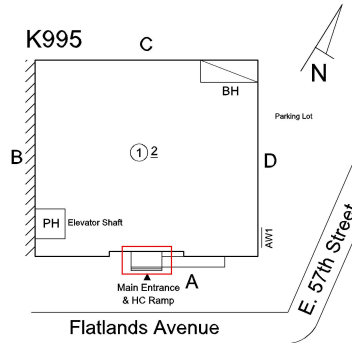
Roof Plan reference

STONE: DETERIORATED JOINTS

10

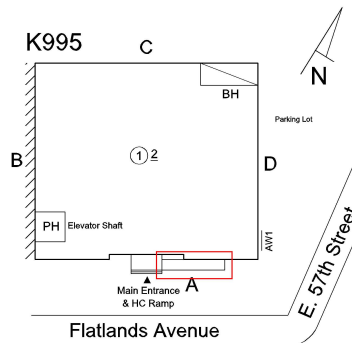
Roof Plan reference

CONCRETE: CRACKS/SPALLING - MAJOR

20

REPLACE

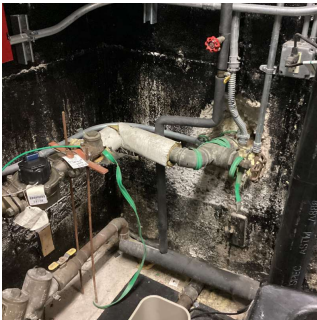
Question	Response
<b>INTERIOR</b>	
<b>STRUCTURAL</b>	
<b>FLOOR STRUCTURE</b>	
Deficiency Photo1	 
Violations	PH No violations recorded.
<b>FOUNDATION WALLS</b>	
Material Type(s)	Inspected Concrete
Condition	4 - Between Fair and Poor
Deficiency	CONCRETE: CRACKED/SPALLED/REINFORCEMENT EXPOSED
Deficiency Location/Instance	Basement - Electrical Panel Room
Deficiency Quantity	20
Quantity Uom	S.F.
Potential Action	REPAIR
Urgency of Action	PRIORITY 3
Purpose of Action	LEVEL 5
Deficiency Photo1
