NYC Department of Education
Building Condition Assessment Survey 2023 - 2024

Architectural Inspection

K997

Asset: BROOKLYN HS SUPERINTENDENT - K, 1780 OCEAN AVENUE, New York, 11230

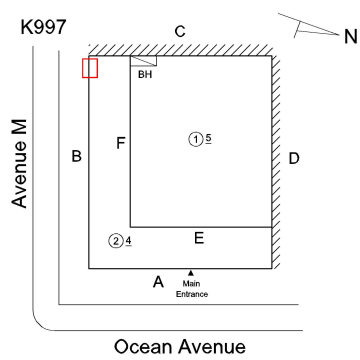
Question	Response
EXTERIOR	
DOORS	
DOORS AND FRAMES	
Roof Plan reference

Question	Response
Architectural	
EXTERIOR	Inspected
AREAWAY	Does not Exist
AWNINGS AND CANOPIES	Does not Exist
CHIMNEY	Does not Exist
COPING	Inspected
Condition	2 - Between Good and Fair
Deficiency	No deficiencies recorded
CORNICE	Does not Exist
DOORS	Inspected
DOORS AND FRAMES	Inspected
Condition	3 - Fair
Deficiency	METAL: DETERIORATED DOOR AND FRAME - MINOR DETERIORATION

Deficiency Quantity	1
Quantity Uom	EACH
Potential Action	MAINTENANCE
Urgency of Action	PRIORITY 3
Purpose of Action	LEVEL 2
Deficiency Photo1

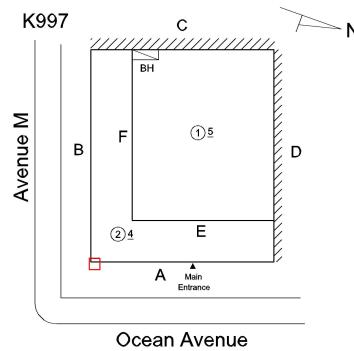
Roof Plan reference

Violations	Facade B No violations recorded.
DOOR HARDWARE	Inspected
Condition	2 - Between Good and Fair
Deficiency	No deficiencies recorded
LINTELS	Inspected
Condition	2 - Between Good and Fair
Deficiency	No deficiencies recorded
TRANSOM/SIDE LIGHT	Inspected
Condition	2 - Between Good and Fair
Deficiency	No deficiencies recorded
EXTERIOR WALLS	Inspected
Material Type(s)	Masonry
Replacement Quantity	13,400
Replacement Uom	S.F.
Instance on All Facades	Inspected
Instance Condition	3 - Fair
Instance Quantity	13,400
Instance Quantity Uom	S.F.
Deficiency	BRICK: CRACKS/DISPLACED/SPALLED BRICK AT BUILDING CORNERS

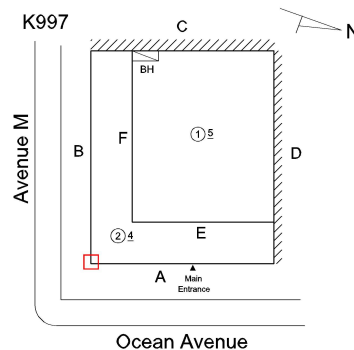
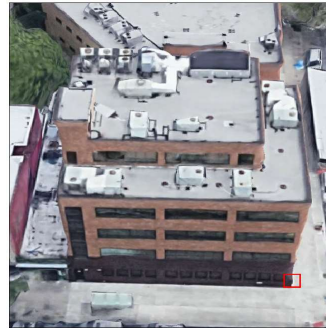
Roof Plan reference

BRICK: MAJOR / THRU CRACKS

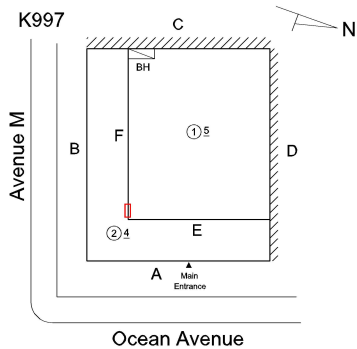
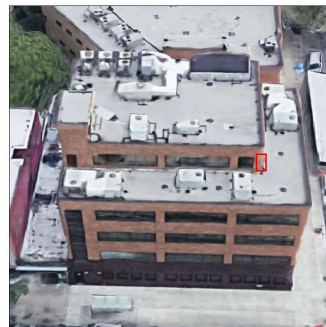
Roof Plan reference

BRICK: MINOR CRACKS AND SPALLING

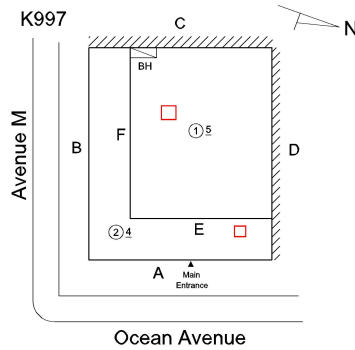
Roof Plan reference

MODIFIED BITUMEN: ROOFING: MAJOR ACTIVE ROOF LEAKS IN INSTRUCTIONAL SPACE

REPLACE ROOFING WITHOUT MAJOR EQUIPMENT REMOVAL

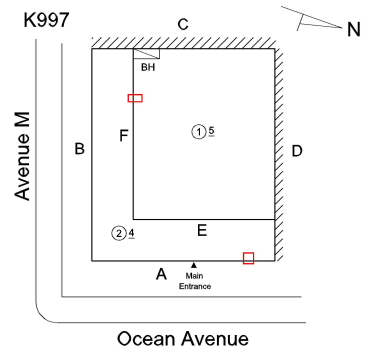
Deficiency	ALUMINUM - OTHER: BROKEN PANE
Roof Plan reference
