**NYC Department of Education
Building Condition Assessment Survey 2023-2024**

Architectural Inspection

M005

Asset: P.S. 5 - MANHATTAN, 3703 TENTH AVENUE, MANHATTAN, NY, 10034

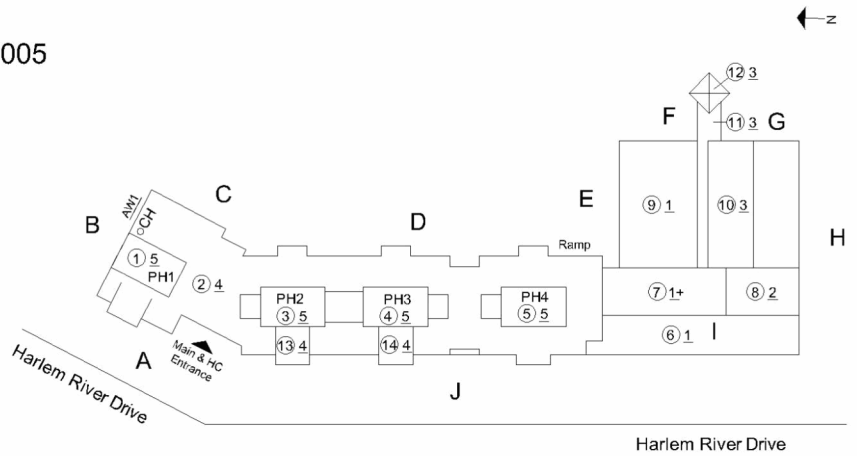
Question	Response
Architectural	
EXTERIOR	Inspected
AREAWAY	Inspected
Instance on AW1	Inspected
Instance Condition	3- Fair
Instance Quantity	1
Instance Quantity Uom	EACH
Deficiency	AREAWAY WALLS:DETERIORATED JOINTS AT COPING STONES
