**NYC Department of Education
Building Condition Assessment Survey 2023-2024**

Architectural Inspection

M884

Asset: P.S. 18 ANNEX (GYM) - MANHATTAN, 4130 9TH AVENUE, MANHATTAN, NY, 10034

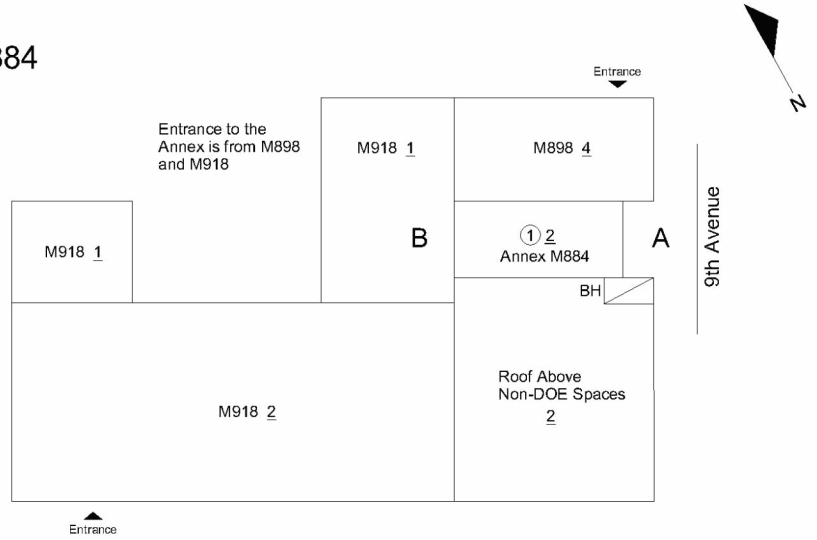
Question	Response
Architectural	
EXTERIOR	Inspected
AREAWAY	Does not exist
AWNINGS AND CANOPIES	Does not exist
CHIMNEY	Does not exist
COPING	Inspected
Condition	2- Between Good and Fair
Deficiency	No deficiencies recorded
CORNICE	Does not exist
DOORS	Inspected
DOORS AND FRAMES	Inspected
Condition	3- Fair
Deficiency	METAL CLAD:DETERIORATED DOOR AND FRAME - MINOR DETERIORATION
Deficiency Location/Instance

Deficiency Quantity	1
Quantity Uom	EACH
Potential Action	MAINTENANCE
Urgency of Action	PRIORITY 3
Purpose of Action	LEVEL 2
Deficiency Photo 1
