NYC Department of Education
Building Condition Assessment Survey 2023 - 2024

Architectural Inspection

Asset: P.S. 303 ADDITION - QUEENS, 108-55 69TH AVENUE, New York, 11375

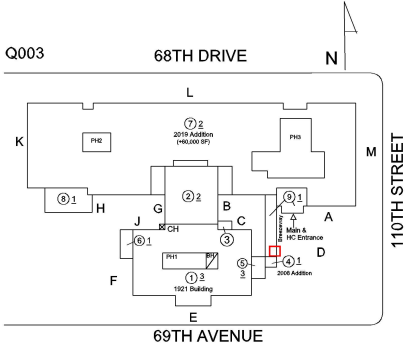
Question	Response
EXTERIOR	
ROOF	
Roofing	
ROOFING	
Roof Plan reference

Does this roof instance have a Sustainable Roof System?	No
Do solar panels exist on these roofs?	No
Is/Are the roof(s) suitable for Solar Panel installation?	Yes
Installation Year	2019
Source of Installation	Custodial Staff
Deficiency	IRMA: ROOFING: MAJOR ACTIVE ROOF LEAKS IN INSTRUCTIONAL SPACE

Deficiency Quantity	100
Quantity Uom	S.F.
Potential Action	REPLACE ROOFING WITHOUT MAJOR EQUIPMENT REMOVAL
Urgency of Action	PRIORITY 5
Purpose of Action	LEVEL 2
Deficiency Photo1
