**NYC Department of Education**  
**Building Condition Assessment Survey 2023 - 2024**

Architectural Inspection

Q007

**Asset:** P.S. 7 - QUEENS, 80-55 CORNISH AVE, New York, 11373

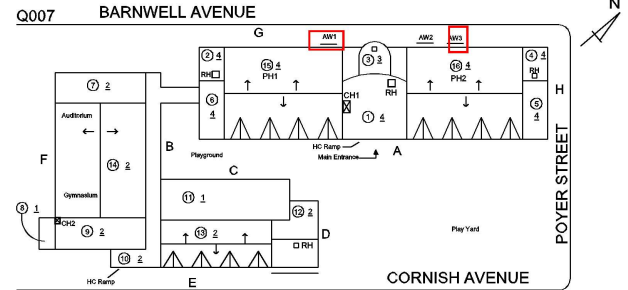
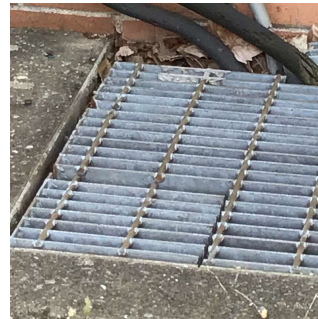
AW3  
 No violations recorded.

**AREAWAY GRATINGS: MAJOR RUSTING / OR BROKEN**

20  
 S.F.  
 REPLACE  
 PRIORITY 4  
 LEVEL 2

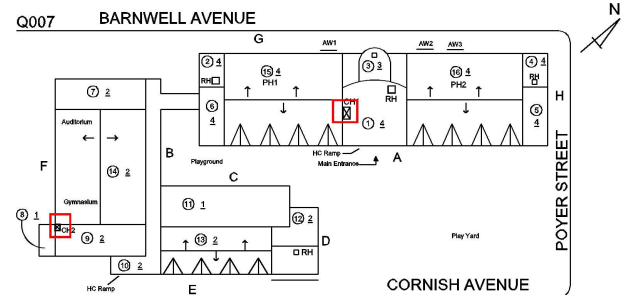
**BRICK: DETERIORATED JOINTS**

50  
 S.F.  
 REPOINT  
 PRIORITY 3  
 LEVEL 2

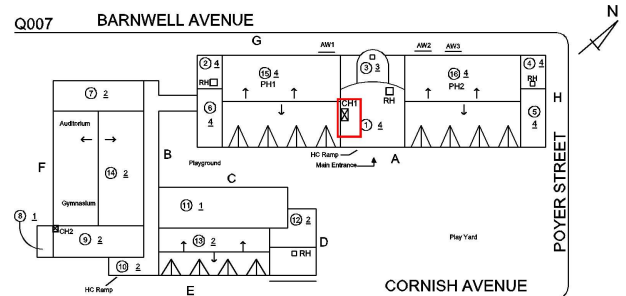
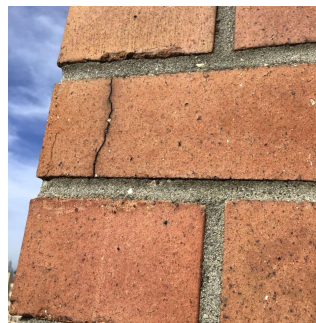
CHI

**BRICK: MINOR CRACKS AND SPALLING**

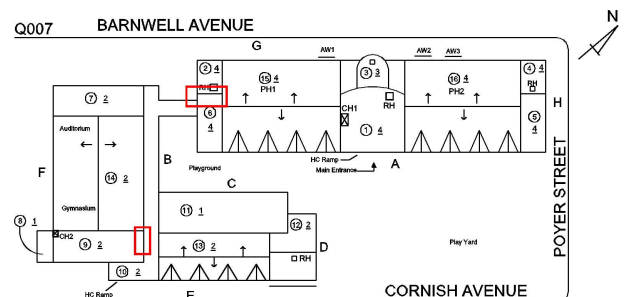
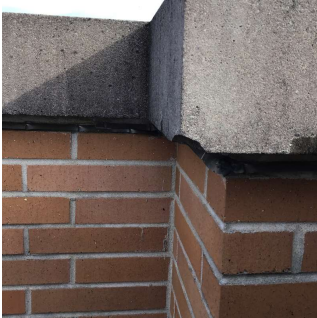
**CAST STONE: CRACKED/BROKEN PIECES**

Question	Response
<b>EXTERIOR</b>	
<b>COPING</b>	
Deficiency Quantity	20
Quantity Uom	L.F.
Potential Action	REPLACE-IN-KIND
Urgency of Action	PRIORITY 4
Purpose of Action	LEVEL 2
Deficiency Photo1

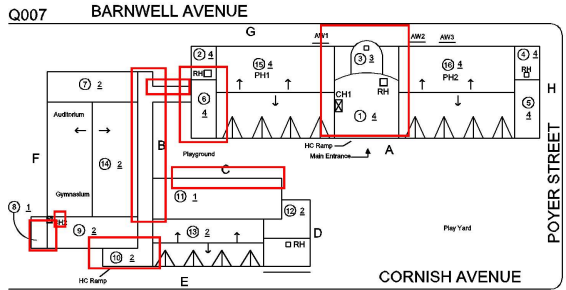
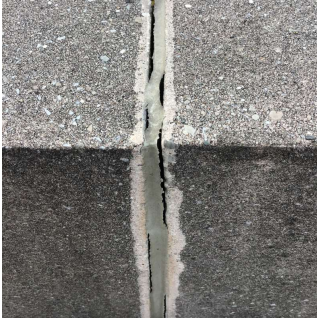
Violations	Roof 6 No violations recorded.
Deficiency	CAST STONE: DETERIORATED TRANSVERSE JOINTS
Roof Plan reference	Q007 BARNWELL AVENUE

Deficiency Quantity	280
Quantity Uom	L.F.
Potential Action	MAINTENANCE
Urgency of Action	PRIORITY 3
Purpose of Action	LEVEL 2
Deficiency Photo1

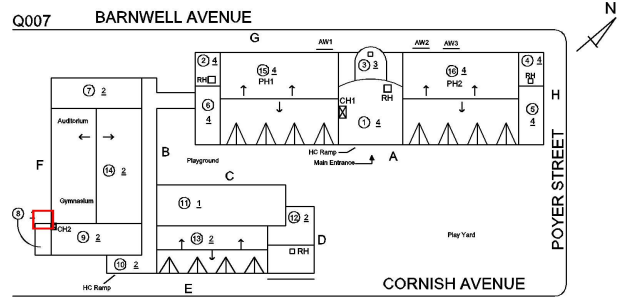
Violations	Roof 3 No violations recorded.
<b>CORNICE</b>	Does not Exist
<b>DOORS</b>	Inspected
<b>DOORS AND FRAMES</b>	Inspected
Condition	4 - Between Fair and Poor
Deficiency	ROLL-UP DOOR: DETERIORATED DOOR - MAJOR DETERIORATION

300  
S.F.  
REPLACE  
PRIORITY 4  
LEVEL 2

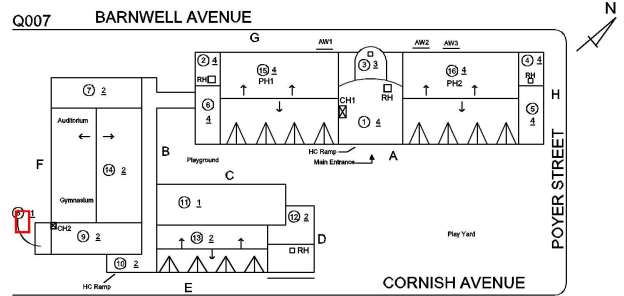
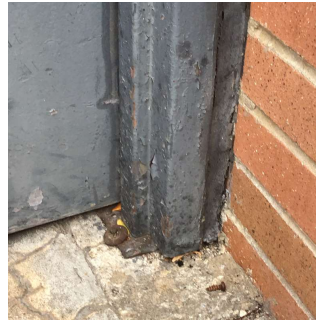
Facade F

**METAL: AIR/WATER INFILTRATION, DETERIORATED JOINTS WITH DAMAGED CAULKING**

10  
L.F.  
MAINTENANCE  
PRIORITY 3  
LEVEL 2

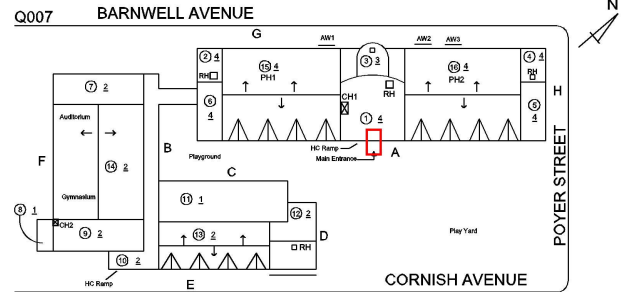
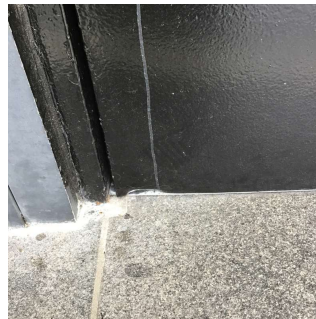
Facade A

**METAL: DETERIORATED DOOR - MINOR DETERIORATION**

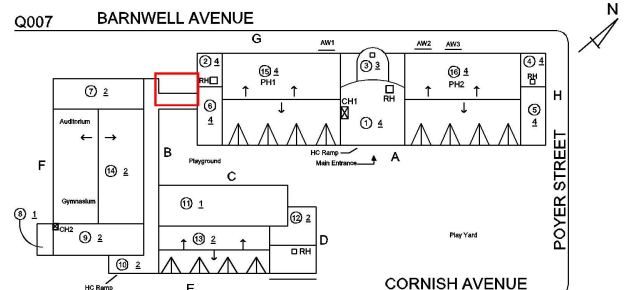
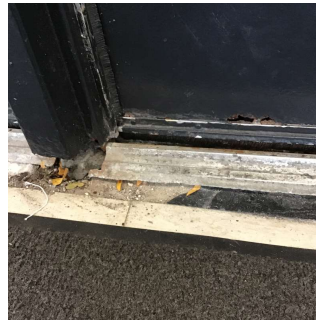
Facade G

**METAL: DETERIORATED DOOR AND FRAME - MAJOR DETERIORATION**

Deficiency Quantity	4
Quantity Uom	EACH
Potential Action	REPLACE
Urgency of Action	PRIORITY 4
Purpose of Action	LEVEL 2
Deficiency Photo1

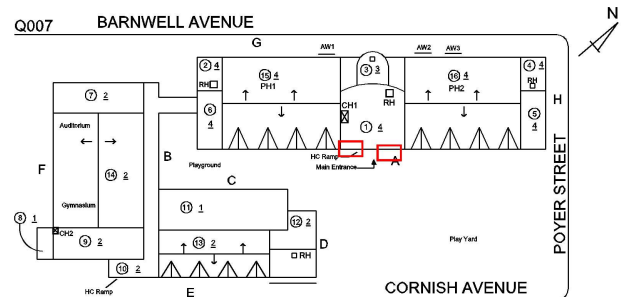
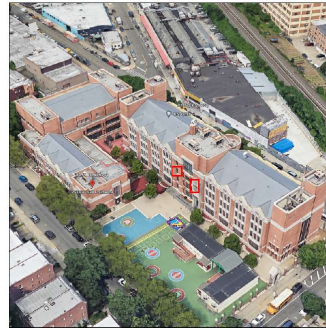
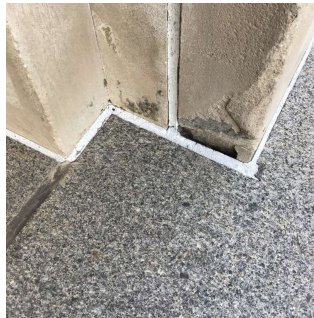
Facade A

Deficiency STONE: CHIPPED/SPALLED/BROKEN PIECES - MAJOR

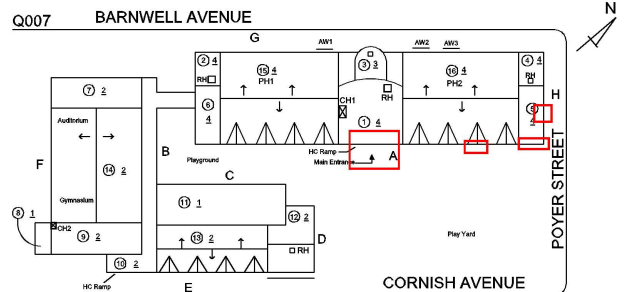
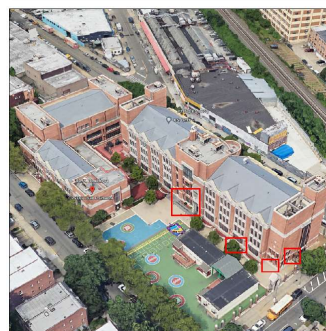
STONE: DETERIORATED JOINTS

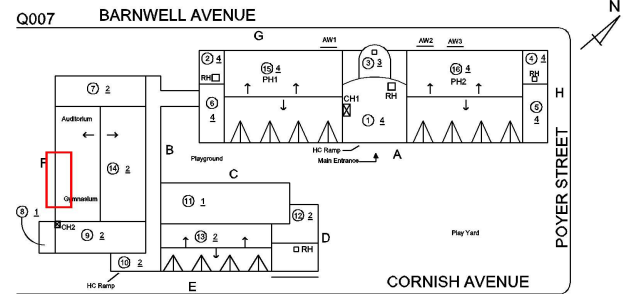
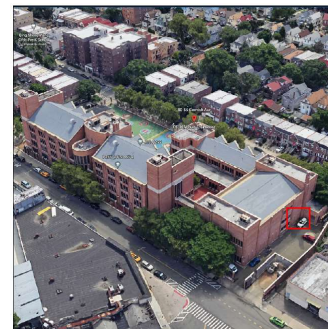
**BRICK: DETERIORATED JOINTS**

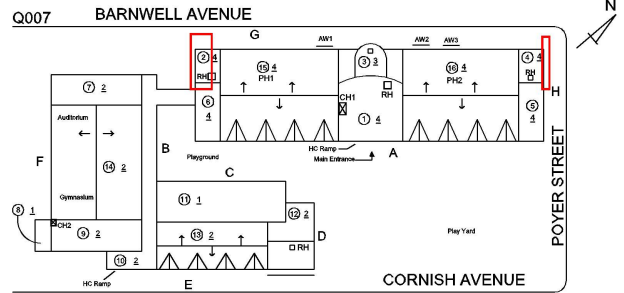
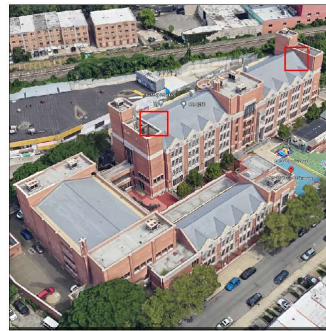
**STUCCO CEMENT SURFACE: CRACKS, SPALLING**

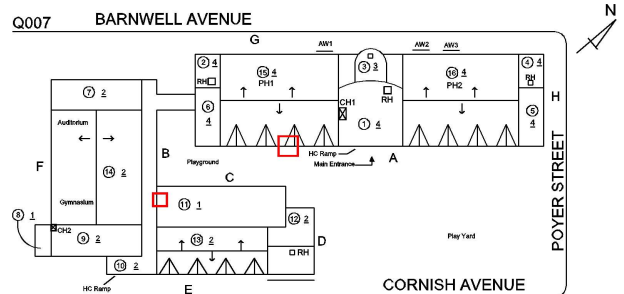
BRICK: WATER INFILTRATION IN INSTRUCTIONAL SPACE

Question	Response
<b>EXTERIOR</b>	
<b>EXTERIOR WALLS</b>	
Elevation	 
Deficiency Quantity	200
Quantity Uom	S.F.
Potential Action	REPAIR
Urgency of Action	PRIORITY 5
Purpose of Action	LEVEL 2
Deficiency Photo1	 
	Facade A - Room 329, Facade B - Corridor exterior wall near Gymnasium
Violations	No violations recorded.
<b>EXTERIOR SOFFITS</b>	Inspected
Condition	2 - Between Good and Fair
Deficiency	No deficiencies recorded
<b>LOADING DOCK</b>	Does not Exist
<b>LOUVER</b>	Inspected
Condition	2 - Between Good and Fair
Deficiency	No deficiencies recorded
<b>PARAPETS</b>	Inspected
Material Type(s)	Masonry
Replacement Quantity	12,000
Replacement Uom	C.F.
Instance on All Roofs	Inspected
Instance Condition	3 - Fair
Instance Quantity	12,000
Instance Quantity Uom	C.F.
Deficiency	BRICK: DETERIORATED JOINTS

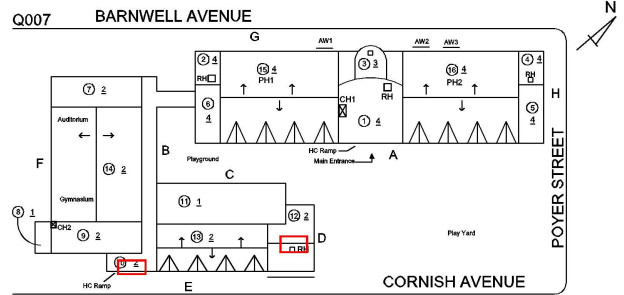
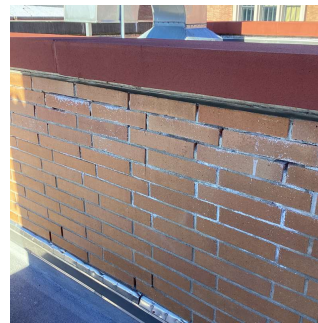
Roof 12  
 No violations recorded.

60  
 S.F.  
 REPOINT  
 PRIORITY 4  
 LEVEL 2

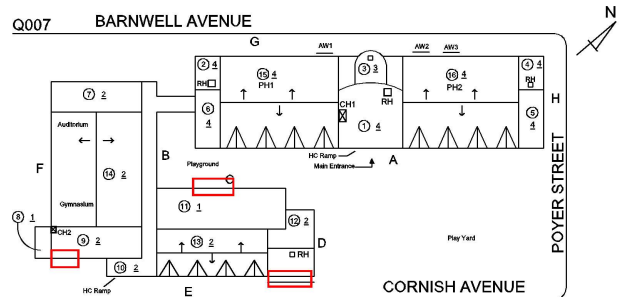
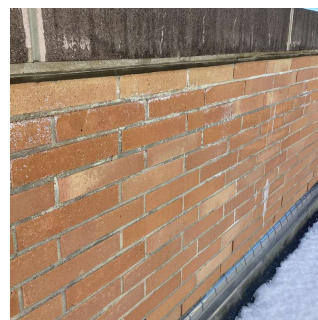
Facade E  
 No violations recorded.

**BRICK: DETERIORATED JOINTS**

100  
 S.F.  
 REPOINT  
 PRIORITY 3  
 LEVEL 2

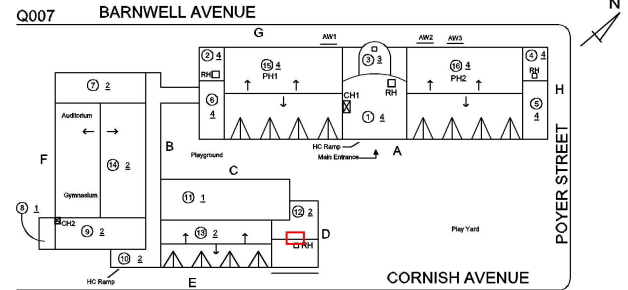
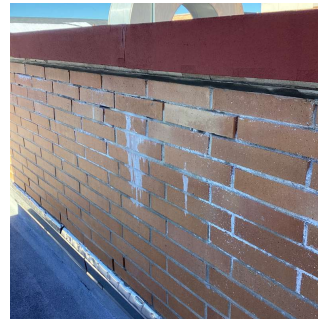
Roof 12  
 No violations recorded.

**BRICK: EFFLORESCENCE**

10  
 S.F.  
 MAINTENANCE  
 PRIORITY 3  
 LEVEL 2

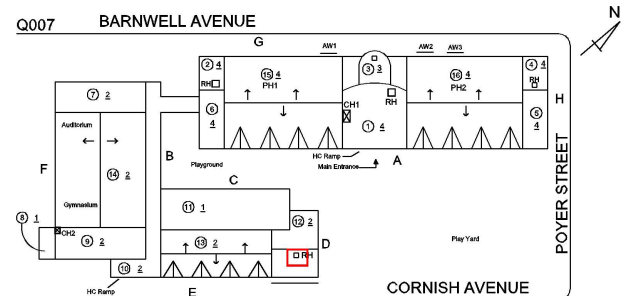
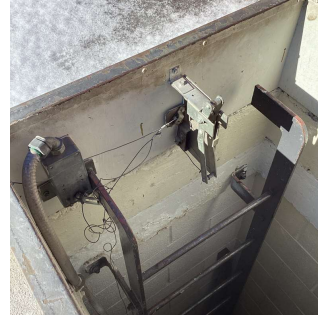
Stair E/2

DETERIORATED

1  
 EACH  
 REPLACE  
 PRIORITY 4

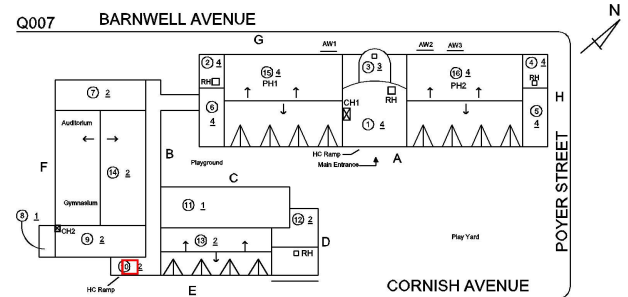
**WATER INFILTRATION**

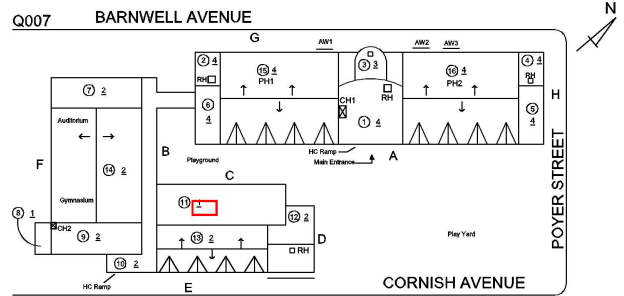
**REPLACE ROOFING WITHOUT MAJOR EQUIPMENT REMOVAL**

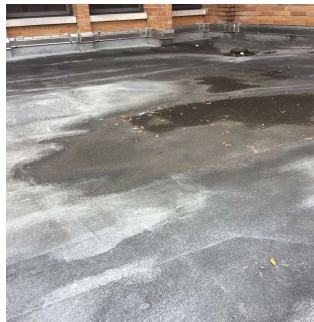
Roof 11

**MODIFIED BITUMEN: ROOFING: MAJOR ACTIVE ROOF LEAKS IN INSTRUCTIONAL SPACE**

**PRIORITY 4**

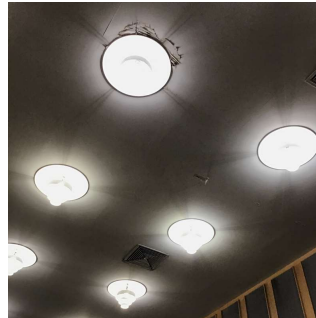
Roof 14 - Auditorium shown, Roof 14 - Gymnasium similar  
No violations recorded.

CLOGGED

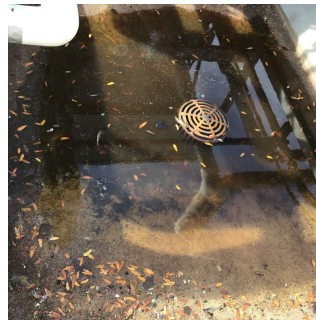
Roof 9

DETERIORATED

4  
 EACH  
 REPLACE  
 PRIORITY 4  
 LEVEL 2

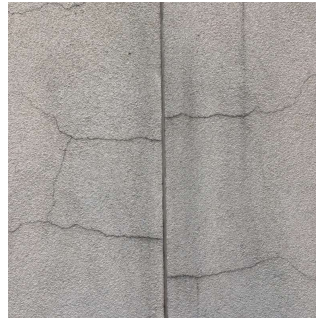
PH2

**BULKHEAD/PENTHOUSE WALLS/EXTERIOR:  
 CRACKS/SPALLING - MAJOR**

50  
 S.F.  
 REPLACE  
 PRIORITY 4  
 LEVEL 2

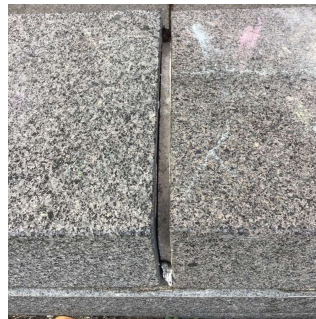
Facade A

STONE: DETERIORATED JOINTS AT COPING STONES

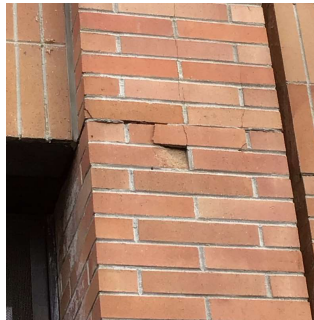
Facade G

BRICK: CRACKS/SPALLING - MAJOR

10  
 S.F.  
 REPLACE  
 PRIORITY 4  
 LEVEL 2

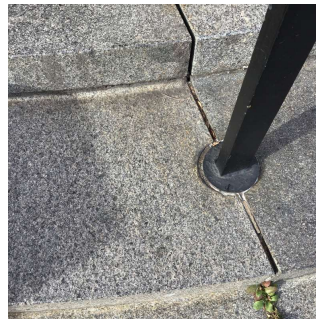
Facade A

**STONE: DETERIORATED JOINTS**

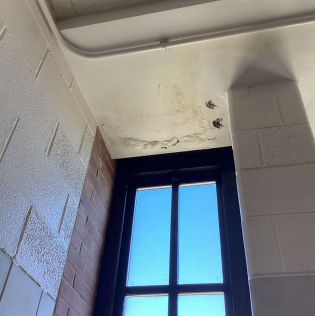
ALUMINUM - OTHER: AIR/WATER INFILTRATION

Facade H - Corridor near Stair C/3 shown, Facade E - Corridor near Room 282 (Gymnasium), Facade H - Corridors near Stair C/1, 2, 4 similar
Violations	No violations recorded.
<b>INTERIOR</b>	Inspected
<b>POOLS</b>	Does not Exist
<b>STRUCTURAL</b>	Inspected
<b>COLUMNS/BEAMS/BEARING WALLS</b>	Inspected
Condition	3 - Fair
Deficiency	STEEL COLUMNS/BEAMS: DETERIORATED/MISSING PLASTER FIREPROOFING
Deficiency Location/Instance	Corridor between Auditorium and Gymnasium
Deficiency Quantity	30
Quantity Uom	S.F.
Potential Action	REPLACE
Urgency of Action	PRIORITY 3
Purpose of Action	LEVEL 5

Deficiency Quantity	200
Quantity Uom	L.F.
Potential Action	REPLACE TRIM, SILLS OR WEATHERSTRIPPING
Urgency of Action	PRIORITY 5
Purpose of Action	LEVEL 2
Deficiency Photo1

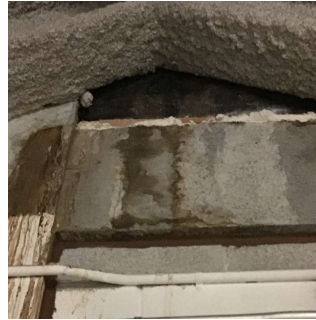
Mechanical Room Unit 6

CONCRETE COLUMNS/BEAMS:  
CRACKED/SPALLED/REINFORCEMENT EXPOSED

REPLACE

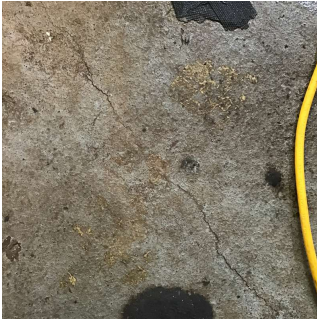
Violations	Basement - Electrical Room No violations recorded.
Deficiency	CONCRETE: CRACKS/SPALLED/REINFORCEMENT EXPOSED
Deficiency Location/Instance	Mechanical Room Unit 8, Basement - Storage Room, Boiler Room, Oil Tank Room
Deficiency Quantity	70
Quantity Uom	S.F.
Potential Action	REPAIR
Urgency of Action	PRIORITY 4
Purpose of Action	LEVEL 5
Deficiency Photo1

Violations	Mechanical Room Unit 8, Basement - Electrical Room No violations recorded.
<b>FOUNDATION WALLS</b>	
Material Type(s)	Inspected Concrete
Condition	4 - Between Fair and Poor
Deficiency	CONCRETE: WATER INFILTRATION IN NON- INSTRUCTIONAL SPACE
Deficiency Location/Instance	Basement - Storage Room, Boiler Room
Deficiency Quantity	200
Quantity Uom	S.F.
Potential Action	INSTALL WATERPROOFING
Urgency of Action	PRIORITY 5
Purpose of Action	LEVEL 5

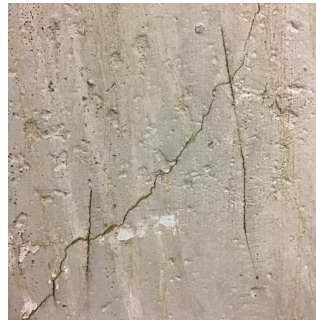
Basement - Electrical Room, Gas Meter Room, Fire Pump Room

**CONCRETE: CRACKED/SPALLED/REINFORCEMENT EXPOSED**

REPAIR

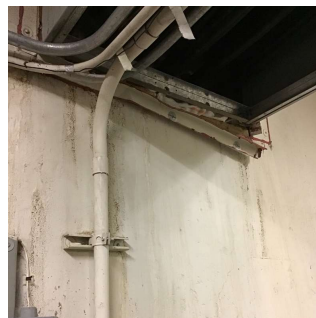
Basement - Electrical Room

**CONCRETE: WATER INFILTRATION IN ELECTRICAL PANEL ROOM**

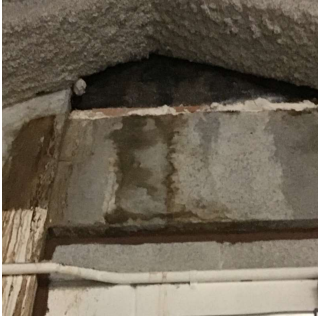
Question	Response
<b>INTERIOR</b>	
<b>STRUCTURAL</b>	
<b>FOUNDATION WALLS</b>	Inspected
Violations	No violations recorded.
<b>ROOF STRUCTURE</b>	Inspected
Condition	3 - Fair
Deficiency	CONCRETE COLUMNS AND BEAMS: CRACKED/SPALLED/REINFORCEMENT EXPOSED
Deficiency Location/Instance	Mechanical Room Unit 6
Deficiency Quantity	10
Quantity Uom	S.F.
Potential Action	REPLACE
Urgency of Action	PRIORITY 4
Purpose of Action	LEVEL 5
Deficiency Photo1

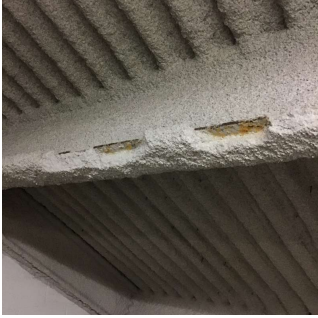
Violations	Mechanical Room Unit 6 No violations recorded.
Deficiency	STEEL COLUMNS/BEAMS: DETERIORATED/MISSING SPRAY- ON FIREPROOFING
Deficiency Location/Instance	PH2, Mechanical Room Units 6 and 8
Deficiency Quantity	70
Quantity Uom	S.F.
Potential Action	REPLACE
Urgency of Action	PRIORITY 3
Purpose of Action	LEVEL 5
Deficiency Photo1

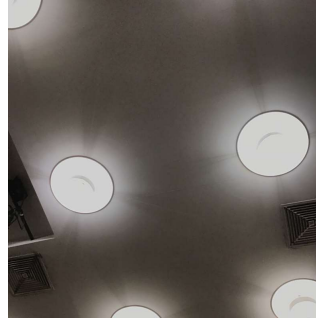
Deficiency	GYP SUM BOARD: DAMAGED/DETERIORATED
Deficiency Location/Instance	Near center , Entrances, Back.
Deficiency Quantity	120
Quantity Uom	S.F.
Potential Action	REPLACE
Urgency of Action	PRIORITY 3
Purpose of Action	LEVEL 2
Deficiency Photo1

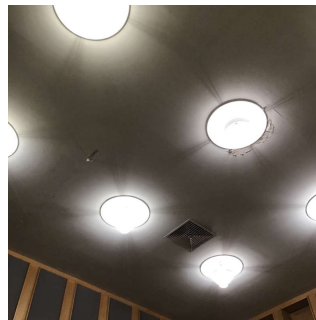
Near center

Deficiency	ACOUSTIC TILES: DAMAGED/MISSING - ACTIVE LEAK
Deficiency Location/Instance	Near Center
Deficiency Quantity	50
Quantity Uom	S.F.
Potential Action	REPLACE
Urgency of Action	PRIORITY 5
Purpose of Action	LEVEL 2
Deficiency Photo1

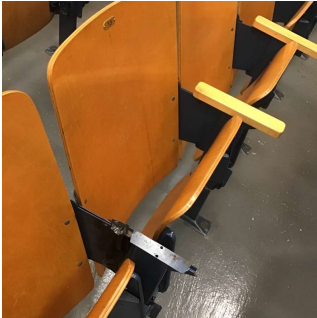
Question	Response
<b>INTERIOR</b>	
<b>AUDITORIUM</b>	
<b>Fixed Seating</b>	
Deficiency	DAMAGED/BROKEN/INOPERABLE
Deficiency Location/Instance	Seat C/13
Deficiency Quantity	1
Quantity Uom	EACH
Potential Action	REPLACE
Urgency of Action	PRIORITY 5
Purpose of Action	LEVEL 6
Deficiency Photo1

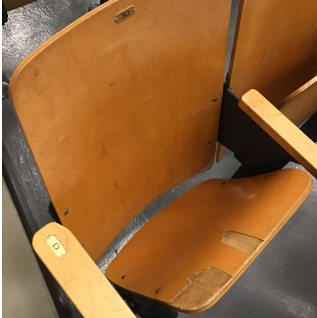
Violations	Seat D/30 No violations recorded.

Violations	Seat C/13 No violations recorded.
Deficiency	IMPROPERLY ANCHORED
Deficiency Location/Instance	Seats F/3, 5, H/20, 22
Deficiency Quantity	4
Quantity Uom	EACH
Potential Action	MAINTENANCE
Urgency of Action	PRIORITY 3
Purpose of Action	LEVEL 2
Deficiency Photo1	No photo recorded
Violations	No violations recorded.
Deficiency	DAMAGED/BROKEN/INOPERABLE
Deficiency Location/Instance	Seats D/30, H/5, 18, J/7, K/22
Deficiency Quantity	4
Quantity Uom	EACH
Potential Action	REPLACE
Urgency of Action	PRIORITY 3
Purpose of Action	LEVEL 2
Deficiency Photo1

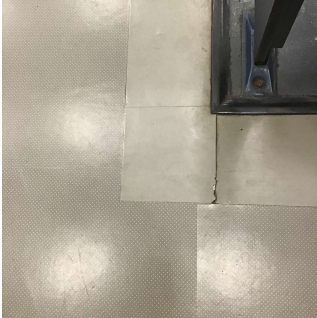
Question	Response
<b>INTERIOR</b>	
<b>AUDITORIUM</b>	
<b>Floor Finish</b>	
Condition	2 - Between Good and Fair
Deficiency	SHEET VINYL: BROKEN/DETERIORATED
Deficiency Location/Instance	Near Seat A/1, Steps Right Side.
Deficiency Quantity	20
Quantity Uom	S.F.
Potential Action	REPLACE
Urgency of Action	PRIORITY 3
Purpose of Action	LEVEL 2
Deficiency Photo1

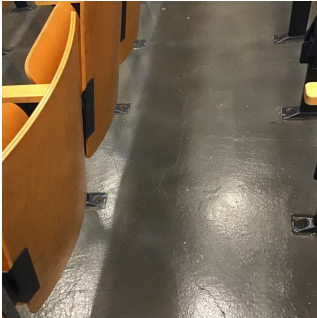
Violations	Near Seat A/1 No violations recorded.
Deficiency	CONCRETE: CRACKS
Deficiency Location/Instance	Near Seats A/7, B/12, E/8, K/24
Deficiency Quantity	40
Quantity Uom	S.F.
Potential Action	REPLACE
Urgency of Action	PRIORITY 3
Purpose of Action	LEVEL 2
Deficiency Photo1

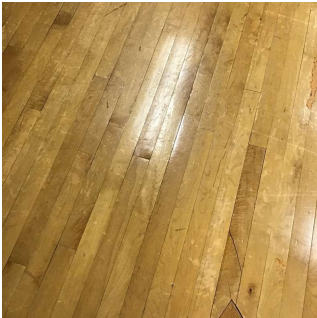
Question	Response
<b>INTERIOR</b>	
<b>AUDITORIUM</b>	
<b>Stage</b>	
<b>Stage</b>	
Quantity Uom	S.F.
Potential Action	REPLACE
Urgency of Action	PRIORITY 3
Purpose of Action	LEVEL 2
Deficiency Photo1	 
	Steps Left Side
Violations	No violations recorded.
Deficiency	DAMAGED FLOOR
Deficiency Location/Instance	Near Steps Right Side, Center
Deficiency Quantity	20
Quantity Uom	S.F.
Potential Action	REPLACE
Urgency of Action	PRIORITY 3
Purpose of Action	LEVEL 2
Deficiency Photo1

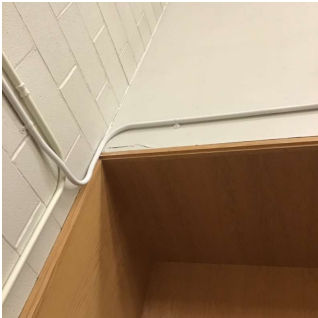
Question	Response
<b>INTERIOR</b>	
<b>AUDITORIUM</b>	
<b>Walls</b>	
Deficiency Quantity	40
Quantity Uom	S.F.
Potential Action	REPLACE
Urgency of Action	PRIORITY 3
Purpose of Action	LEVEL 2
Deficiency Photo1

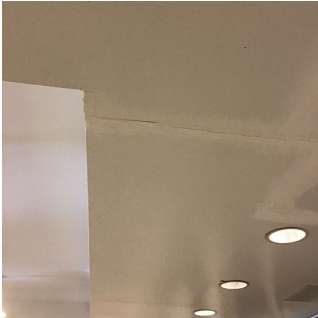
Violations	Near Entrances No violations recorded.
<b>Window Curtains/Shades/Blinds</b>	
Instance on 2nd Floor (402 Seats)	Inspected
Condition	2 - Between Good and Fair
Deficiency	No deficiencies recorded
<b>CAFETERIA</b>	
Instance on 1st Floor - Staff (600 SF)	Inspected
Instance on 1st Floor - Students (Room 1100)	Inspected
Instance on 1st Floor - Students (Room 185)	Inspected
<b>Ceiling</b>	
Instance on 1st Floor - Students (Room 185)	Inspected
Condition	2 - Between Good and Fair
Deficiency	GYPSUM BOARD: DAMAGED/DETERIORATED
Deficiency Location/Instance	Near room 190, Entrance, center, windows.
Deficiency Quantity	180
Quantity Uom	S.F.
Potential Action	REPLACE
Urgency of Action	PRIORITY 3
Purpose of Action	LEVEL 2

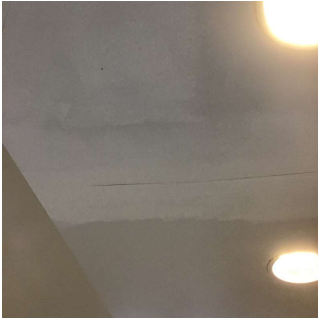
Question	Response
<b>INTERIOR</b>	
<b>CAFETERIA</b>	
<b>Ceiling</b>	
Deficiency	GYP SUM BOARD: DAMAGED/DETERIORATED
Deficiency Location/Instance	Near Entrance, Center, Windows, Kitchen.
Deficiency Quantity	150
Quantity Uom	S.F.
Potential Action	REPLACE
Urgency of Action	PRIORITY 3
Purpose of Action	LEVEL 2
Deficiency Photo1

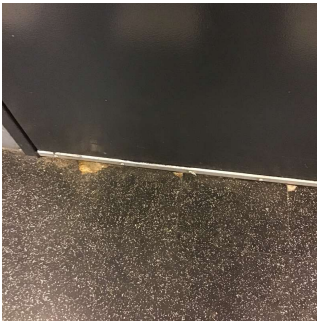
<b>Floor Finish</b>	
Instance on 1st Floor - Students (Room 185)	Inspected
Condition	2 - Between Good and Fair
Deficiency	VINYL TILES: BROKEN/DETERIORATED/MISSING TILES
Deficiency Location/Instance	Near Room 19, Entrance, Drinking Fountain.
Deficiency Quantity	20
Quantity Uom	S.F.
Potential Action	REPLACE
Urgency of Action	PRIORITY 3
Purpose of Action	LEVEL 2

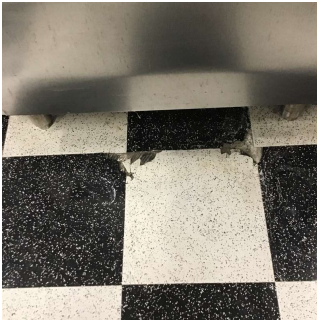
Violations	Near Room 190 No violations recorded.
Instance on 1st Floor - Staff (600 SF)	Inspected
Condition	2 - Between Good and Fair
Deficiency	VINYL TILES: BROKEN/DETERIORATED/MISSING TILES
Deficiency Location/Instance	Near Entrance, Kitchen.
Deficiency Quantity	20
Quantity Uom	S.F.
Potential Action	REPLACE
Urgency of Action	PRIORITY 3
Purpose of Action	LEVEL 2
Deficiency Photo1

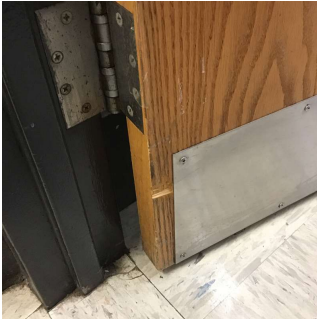
Question	Response
<b>INTERIOR</b>	
<b>CLASSROOMS/CORRIDORS/ADMIN SPACES</b>	
<b>Ceiling</b>	Inspected
Violations	No violations recorded.
<b>Door(s)</b>	Inspected
Condition	5 - Poor
Deficiency	WOOD: DETERIORATED DOOR
Deficiency Location/Instance	Rooms 166, 168, 267, 318, 431, and others
Deficiency Quantity	23
Quantity Uom	EACH
Potential Action	MAINTENANCE
Urgency of Action	PRIORITY 3
Purpose of Action	LEVEL 2
Deficiency Photo1

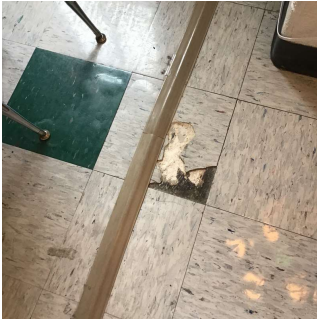
Violations	Room 431 No violations recorded.
<b>Floor Finish</b>	Inspected
Condition	2 - Between Good and Fair
Deficiency	VINYL TILES: BROKEN/DETERIORATED/MISSING TILES
Deficiency Location/Instance	Rooms 166, 412, 423, Near Rooms 172, 190, 282, and others
Deficiency Quantity	350
Quantity Uom	S.F.
Potential Action	REPLACE
Urgency of Action	PRIORITY 3
Purpose of Action	LEVEL 2
Deficiency Photo1

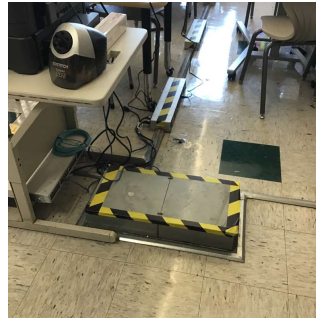
Violations	Room 423 No violations recorded.
Deficiency	VINYL TILES: TRIPPING HAZARD - ELECTRICAL OUTLET

Deficiency Location/Instance	Room 422
Deficiency Quantity	40
Quantity Uom	S.F.
Potential Action	REMOVE
Urgency of Action	PRIORITY 5

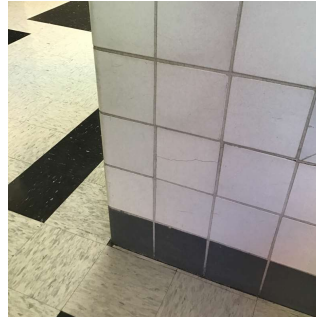
Corridor near Room 295

GLAZED BLOCK: CRACKS/SPALLING

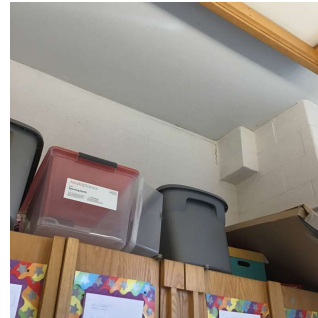
Room 430

**MASONRY: CRACKS/SPALLING**

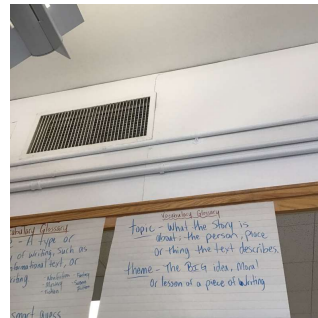
Room 430

**GYPSON BOARD: DETERIORATED**

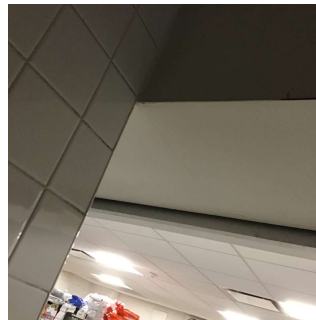
Deficiency	GYPSON BOARD: DAMAGED/DETERIORATED
Deficiency Location/Instance	Serving Area Staff Cafeteria
Deficiency Quantity	10
Quantity Uom	S.F.
Potential Action	REPLACE
Urgency of Action	PRIORITY 3
Purpose of Action	LEVEL 2
Deficiency Photo1

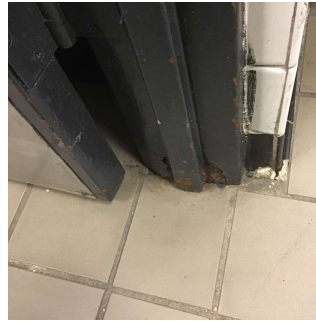
Deficiency	METAL: DETERIORATED DOOR AND FRAME
Deficiency Location/Instance	Moped room
Deficiency Quantity	1
Quantity Uom	EACH
Potential Action	MAINTENANCE
Urgency of Action	PRIORITY 3
Purpose of Action	LEVEL 2

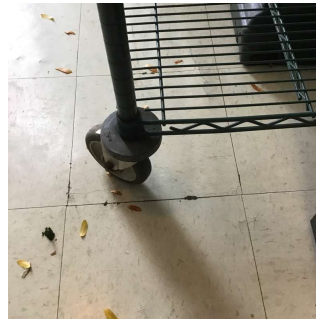
Instance on 1st Floor	Inspected
Condition	2 - Between Good and Fair
Deficiency	VINYL TILES: BROKEN/DETERIORATED/MISSING TILES
Deficiency Location/Instance	Near Exit 13
Deficiency Quantity	10
Quantity Uom	S.F.
Potential Action	REPLACE
Urgency of Action	PRIORITY 3
Purpose of Action	LEVEL 2
Deficiency Photo1

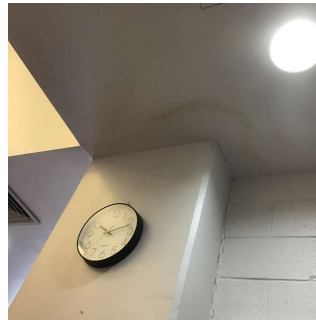
Deficiency	GYPSUM BOARD: DAMAGED/DETERIORATED - ACTIVE LEAK
Deficiency Location/Instance	Near Entrance
Deficiency Quantity	20
Quantity Uom	S.F.
Potential Action	REPLACE
Urgency of Action	PRIORITY 5
Purpose of Action	LEVEL 2
Deficiency Photo1

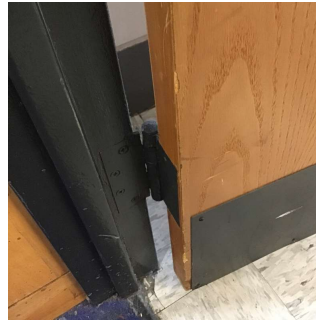
Instance on Room 43	Inspected
Condition	3 - Fair
Deficiency	WOOD: DETERIORATED DOOR
Deficiency Location/Instance	Entrance
Deficiency Quantity	1
Quantity Uom	EACH
Potential Action	MAINTENANCE
Urgency of Action	PRIORITY 3
Purpose of Action	LEVEL 2

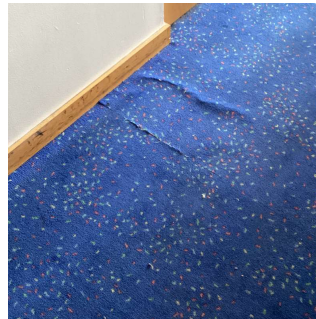
Near Entrance

CARPET: WORN/DETERIORATED

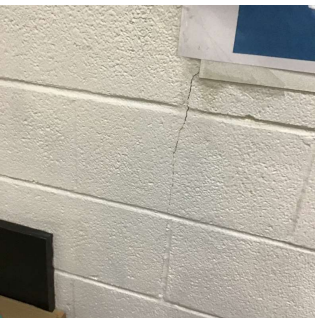
<p>Near Entrance</p> <p>No violations recorded.</p>
<p>Deficiency</p> <p>Deficiency Location/Instance</p> <p>Deficiency Quantity</p> <p>Quantity Uom</p> <p>Potential Action</p> <p>Urgency of Action</p> <p>Purpose of Action</p> <p>Deficiency Photo1</p>           <p>Violations</p>	<p>MASONRY: CRACKS/SPALLING</p> <p>Near Entrance</p> <p>10</p> <p>S.F.</p> <p>REPLACE</p> <p>PRIORITY 3</p> <p>LEVEL 2</p>

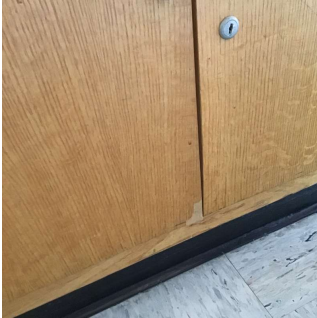
Question	Response
<b>INTERIOR</b>	
<b>SCIENCE DEMO ROOM</b>	
<b>Fixed Equipment</b>	
Condition	3 - Fair
Deficiency	CABINETS: MISSING/DAMAGED
Deficiency Location/Instance	Room 423
Deficiency Quantity	10
Quantity Uom	L.F.
Potential Action	REPLACE
Urgency of Action	PRIORITY 3
Purpose of Action	LEVEL 2
Deficiency Photo1

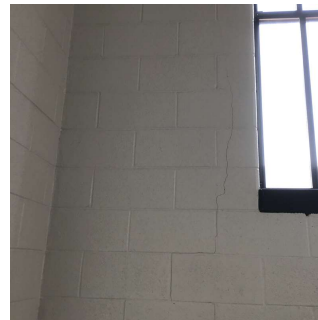
Stair G/1

MASONRY: CRACKS/SPALLING

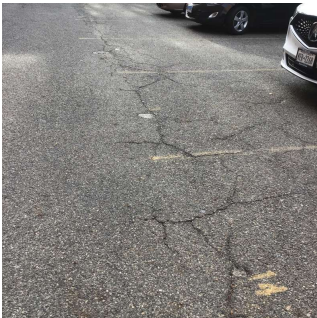
Question	Response
<b>SITE</b>	
<b>PAVING</b>	
<b>Student Non-Use</b>	
<b>Asphalt</b>	
Deficiency Location/Instance	Entrance Parking Lot
Deficiency Quantity	20
Quantity Uom	S.F.
Potential Action	REPLACE
Urgency of Action	PRIORITY 5
Purpose of Action	LEVEL 6
Deficiency Photo1	 
Violations	Entrance Parking Lot No violations recorded.
Deficiency	CRACKS - MAJOR
Deficiency Location/Instance	Parking Area
Deficiency Quantity	550
Quantity Uom	S.F.
Potential Action	REPLACE
Urgency of Action	PRIORITY 3
Purpose of Action	LEVEL 2
Deficiency Photo1

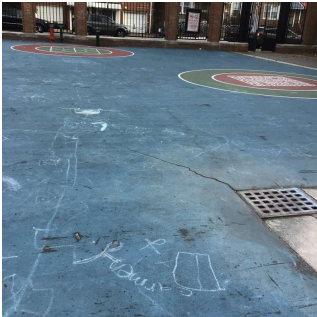
Question	Response
<b>SITE</b>	
<b>PAVING</b>	
<b>Student Non-Use</b>	
<b>Concrete</b>	
Deficiency Photo1	 
Violations	Parking Area No violations recorded.
<b>Pavers</b>	Does not Exist
<b>Student Use</b>	Inspected
Gravel Exists?	No
<b>Asphalt</b>	Inspected
Condition	3 - Fair
Deficiency	CRACKS - MAJOR
Deficiency Location/Instance	Near Main Entrance, Center, street Entrances.
Deficiency Quantity	400
Quantity Uom	S.F.
Potential Action	REPLACE
Urgency of Action	PRIORITY 3
Purpose of Action	LEVEL 2
Deficiency Photo1

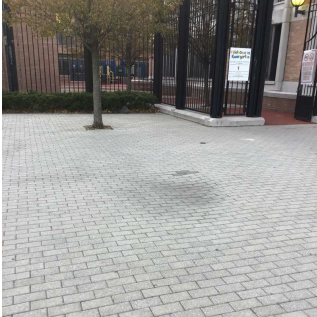
Violations	Near Main Entrance No violations recorded.
<b>Concrete</b>	Inspected
Condition	2 - Between Good and Fair
Deficiency	No deficiencies recorded
<b>Pavers</b>	Inspected
Condition	3 - Fair
Deficiency	DAMAGED/MISSING
Deficiency Location/Instance	Near Main Entrance
Deficiency Quantity	50
Quantity Uom	S.F.
Potential Action	REPLACE
Urgency of Action	PRIORITY 3
Purpose of Action	LEVEL 2

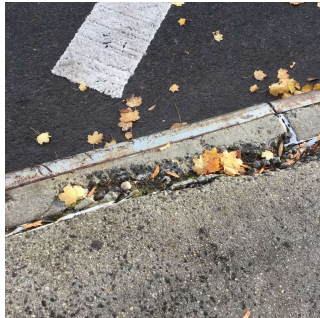
Poyer Street
Violations	No violations recorded.
Deficiency	DAMAGED CURBS
Deficiency Location/Instance	Barnwell Avenue, Cornish Avenue, Poyer Street
Deficiency Quantity	180
Quantity Uom	L.F.
Potential Action	REPLACE
Urgency of Action	PRIORITY 3
Purpose of Action	LEVEL 2
Deficiency Photo1

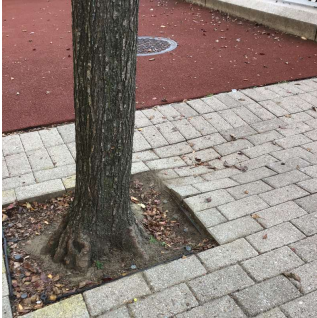
Question	Response
<b>SITE</b>	
<b>PLAYGROUNDS</b>	
<b>Pavement</b>	
Instance on Schoolyard-Main Playground	Inspected
Condition	3 - Fair
Deficiency	PAVERS: HEAVING
Deficiency Location/Instance	Near Exit 1, Play Equipment , Brick Benches.
Deficiency Quantity	40
Quantity Uom	S.F.
Potential Action	REPLACE
Urgency of Action	PRIORITY 5
Purpose of Action	LEVEL 6
Deficiency Photo1

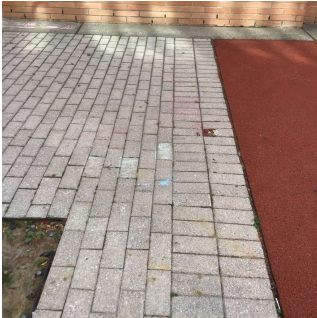
Violations	Near Exit 8 No violations recorded.
<b>Play Equipment</b>	
Instance on Schoolyard-Main Playground	Inspected
Condition	2 - Between Good and Fair
Deficiency	No deficiencies recorded
Instance on Exit 9	Does not Exist
Instance on Exit 1	Does not Exist
<b>Safety Surfacing</b>

Violations	Near Exit 1 No violations recorded.
Deficiency	PAVERS: DAMAGED/MISSING
Deficiency Location/Instance	Near Exit 8
Deficiency Quantity	10
Quantity Uom	S.F.
Potential Action	REPLACE
Urgency of Action	PRIORITY 3
Purpose of Action	LEVEL 2
Deficiency Photo1

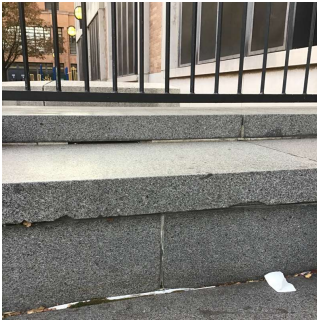
Violations	Near Center No violations recorded.
<b>Unpaved Area</b>	
Instance on Exit 9	Does not Exist
Instance on Schoolyard-Main Playground	Does not Exist
Instance on Exit 1	Does not Exist
<b>PLAYING SURFACE</b>	Does not Exist
<b>RETAINING WALLS</b>	Does not Exist
<b>SEATING</b>	Inspected
<b>Benches</b>	Inspected
<b>Concrete</b>	Inspected
Condition	3 - Fair
Deficiency	CRACKS/SPALLING - MAJOR
Deficiency Location/Instance	Schoolyard
Deficiency Quantity	1
Quantity Uom	EACH
Potential Action	REPLACE
Urgency of Action	PRIORITY 3
Purpose of Action	LEVEL 2
Deficiency Photo1

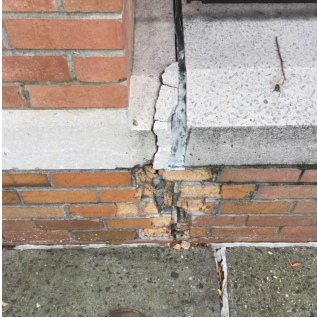
Violations	Barnwell Avenue No violations recorded.
Deficiency	BRICK: DETERIORATED COPING STONE
Deficiency Location/Instance	Near Exit 13
Deficiency Quantity	20
Quantity Uom	S.F.
Potential Action	REPLACE
Urgency of Action	PRIORITY 5
Purpose of Action	LEVEL 6
Deficiency Photo1

Violations	Schoolyard No violations recorded.
<b>Metal/Wood/Plastic</b>	Does not Exist
<b>Bleachers</b>	Does not Exist
<b>SITE WALLS (NOT RETAINING WALLS)</b>	Inspected
Condition	3 - Fair
Deficiency	BRICK: CRACKS/SPALLING - MAJOR
Deficiency Location/Instance	Poyer Street, Barnwell Avenue, Cornish Avenue.

Deficiency Quantity	100

Question	Response
<b>SITE</b>	
<b>SITE WALLS (NOT RETAINING WALLS)</b>	
Quantity Uom	S.F.
Potential Action	REPLACE
Urgency of Action	PRIORITY 3
Purpose of Action	LEVEL 2
Deficiency Photo1
