**NYC Department of Education**  
**Building Condition Assessment Survey 2023 - 2024**

Architectural Inspection

**Q008**

**Asset: J.H.S. 8 - QUEENS, 108-35 167 STREET, New York, 11433**

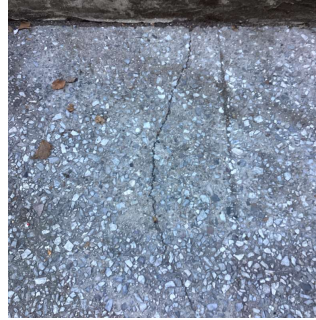
Facade A - AW1

AREAWAY SLAB: CRACKS AND SPALLING

REPAIR

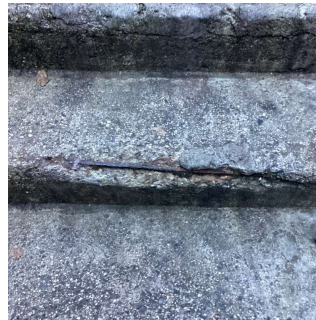
Facade A - AW1

AREAWAY STAIRS: DETERIORATED  
TREADS/RISERS/NOSINGS

REPLACE

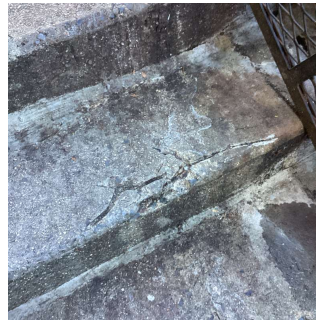
Facade A - AW1  
No violations recorded.

AREAWAY STAIRS: DETERIORATED  
TREADS/RISERS/NOSINGS

50  
S.F.  
REPAIR  
PRIORITY 3  
LEVEL 2

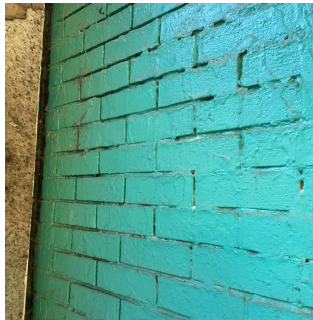
Facade K

BRICK: DETERIORATED JOINTS

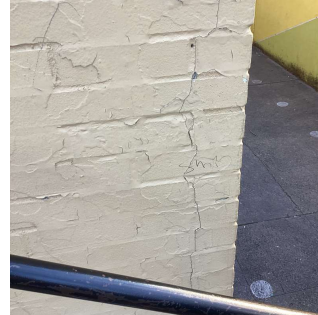
Facade A

BRICK: CRACKS/DISPLACED/SPALLED BRICK AT BUILDING CORNERS

REMOVE AND REBUILD  
PRIORITY 4  
LEVEL 2

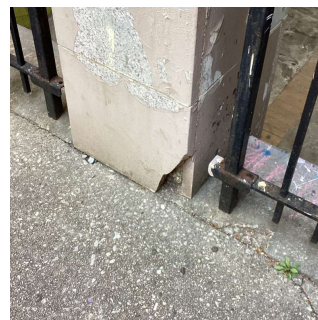
STONE: CHIPPED/SPALLED/BROKEN PIECES - MAJOR

30  
S.F.  
REPLACE  
PRIORITY 4  
LEVEL 2

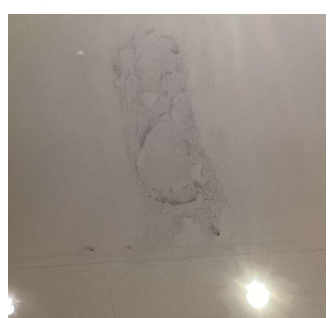
Question	Response
<b>EXTERIOR</b>	
<b>ROOF</b>	
<b>Roofing</b>	
<b>ROOFING</b>	
Instance Quantity	47,000
Instance Quantity Uom	S.F.
Does the roof have major mechanical equipment sitting on Dunnage Steel less than 18" above the Roofing?	No
Does this roof instance have a Sustainable Roof System?	Yes
Sustainable Roof Type	White Roof
Sustainable Roof Location (Roof Number)	All Roofs
Do solar panels exist on these roofs?	Yes
Solar Panel Location (Roof Number)	Roofs 1, 2
Installation Year	2014
Source of Installation	Custodial Staff
Deficiency	MODIFIED BITUMEN: ROOFING: MAJOR ACTIVE ROOF LEAKS IN INSTRUCTIONAL SPACE
Roof Plan reference	 
Deficiency Quantity	200
Quantity Uom	S.F.
Potential Action	REPLACE ROOFING WITHOUT MAJOR EQUIPMENT REMOVAL
Urgency of Action	PRIORITY 5
Purpose of Action	LEVEL 2
Deficiency Photo1

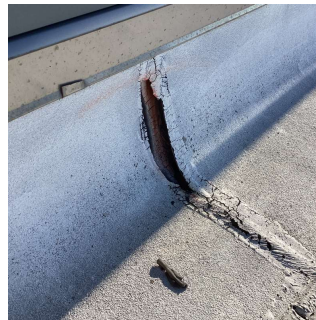
Roof 1  
No violations recorded.

Violations	No violations recorded.
Deficiency	MODIFIED BITUMEN: FLASHING: BASE FLASHING DETERIORATED

50  
S.F.  
REPAIR  
PRIORITY 3  
LEVEL 2

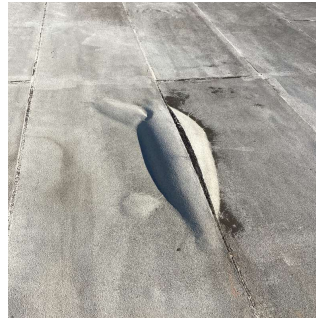
Roof 1

MODIFIED BITUMEN: ROOFING: DELAMINATION

500  
S.F.  
REPLACE ROOFING WITHOUT MAJOR EQUIPMENT  
REMOVAL  
PRIORITY 4  
LEVEL 2

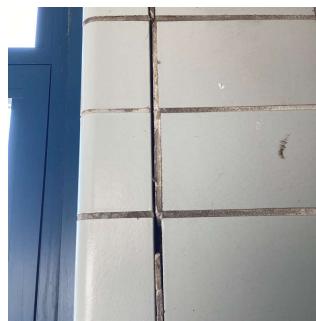
Roof 1 - Bulkhead 1

BULKHEAD/PENTHOUSE WALLS/INTERIOR: SALT GLAZED BRICK DETERIORATED JOINTS

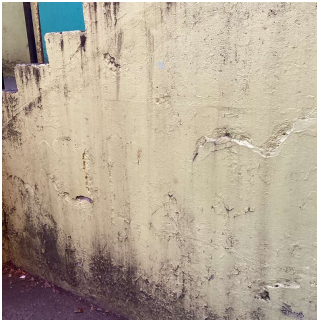
Facade A
Violations	No violations recorded.
<b>RAILINGS</b>	
Condition	Inspected
Deficiency	2 - Between Good and Fair
	No deficiencies recorded
<b>STAIRS/RAMPS</b>	
Condition	Inspected
Deficiency	5 - Poor
Roof Plan reference	CONCRETE: CRACKS/SPALLING - MINOR

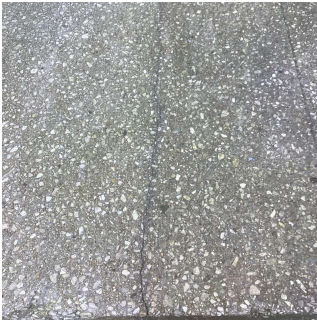
Facade D
Violations	No violations recorded.
Deficiency	CONCRETE: WORN-OUT TREAD/RISER/NOSING

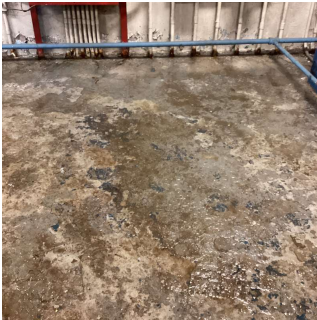
Violations	<p>Facade K</p> <p>No violations recorded.</p>
<b>FLOOR STRUCTURE</b>	
Condition	<p>Inspected</p> <p>5 - Poor</p>
Deficiency	<p>CONCRETE SLAB ON GRADE: WATER INFILTRATION IN NON-INSTRUCTIONAL SPACE</p>
Deficiency Location/Instance	<p>Basement - Boiler Room Pit</p>
Deficiency Quantity	<p>500</p>
Quantity Uom	<p>S.F.</p>
Potential Action	<p>INSTALL WATERPROOFING</p>
Urgency of Action	<p>PRIORITY 5</p>
Purpose of Action	<p>LEVEL 5</p>
Deficiency Photo1

Violations	<p>Basement - Boiler Room Pit</p> <p>No violations recorded.</p>
<b>FOUNDATION WALLS</b>	
Material Type(s)	<p>Inspected</p> <p>Concrete</p>
Condition	<p>4 - Between Fair and Poor</p>
Deficiency	<p>CONCRETE: WATER INFILTRATION IN NON- INSTRUCTIONAL SPACE</p>
Deficiency Location/Instance	<p>Basement - Boiler Room Pit</p>

Deficiency Quantity	<p>200</p>
Quantity Uom	<p>S.F.</p>
Potential Action	<p>INSTALL WATERPROOFING</p>
Urgency of Action	<p>PRIORITY 5</p>
Purpose of Action	<p>LEVEL 5</p>

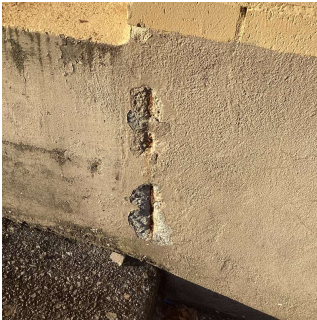
Basement - Boiler Room Pit
Violations	35657759J
Deficiency	CONCRETE: CRACKED/SPALLED/REINFORCEMENT EXPOSED
Deficiency Location/Instance	Facade G - AW3
Deficiency Quantity	10
Quantity Uom	S.F.
Potential Action	REPAIR
Urgency of Action	PRIORITY 3
Purpose of Action	LEVEL 5
Deficiency Photo1

Facade G - AW3
Violations	No violations recorded.
<b>ROOF STRUCTURE</b>	Inspected
Condition	2 - Between Good and Fair
Deficiency	No deficiencies recorded
<b>VAULTS-BUNKERS</b>	Inspected
<b>Foundation Walls</b>	Inaccessible
<b>Slab Structure</b>	Inaccessible
<b>Vault/Ash Hoist Doors and Framing</b>	Inspected
Condition	3 - Fair
Deficiency	NOT IN USE / DETERIORATED
Deficiency Location/Instance	Facade A
Deficiency Quantity	2
Quantity Uom	EACH
Potential Action	REMOVE AND SEAL
Urgency of Action	PRIORITY 3
Purpose of Action	LEVEL 2

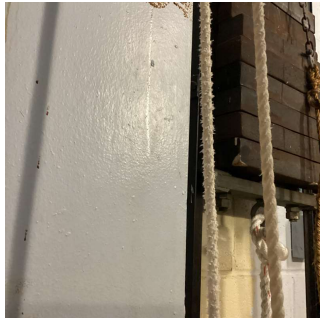
Violations	Main Right Side No violations recorded.
<b>Stage Curtains</b>	Inspected
Instance on 1st Floor ( 600 Seats)	Inspected
Condition	4 - Between Fair and Poor
Deficiency	WORN/DETERIORATED
Deficiency Location/Instance	Main Left Side, Lateral Right and Left Side, Back Left Side
Deficiency Quantity	800
Quantity Uom	S.F.
Potential Action	REPLACE
Urgency of Action	PRIORITY 3
Purpose of Action	LEVEL 2

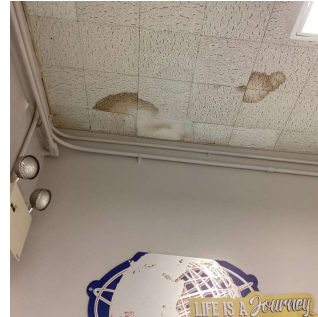
Near Entrance

ACOUSTIC TILES ON PLASTER: DAMAGED/MISSING

REPLACE

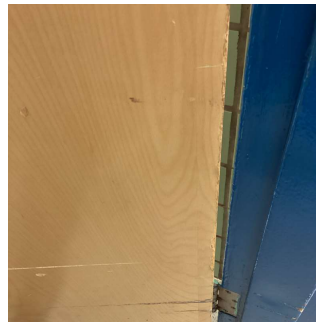
Entrance

WOOD: DETERIORATED DOOR

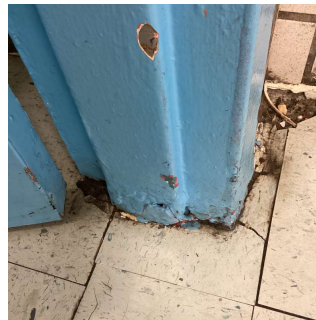
Entrance

METAL: DETERIORATED DOOR AND FRAME

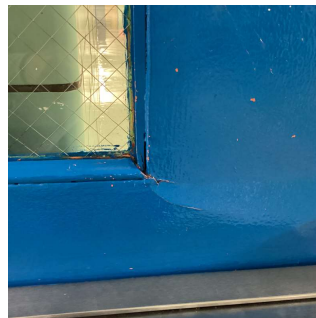
METAL: DETERIORATED DOOR

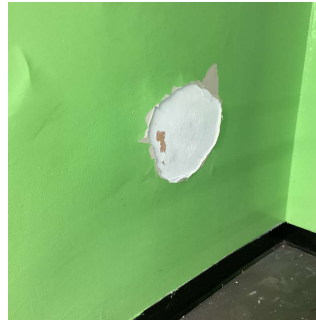
Near Exit 13

Condition	2 - Between Good and Fair
Deficiency	PLASTER: CRACKS/SPALLING
Deficiency Location/Instance	Near Exit 13, Column
Deficiency Quantity	20
Quantity Uom	S.F.
Potential Action	REPLACE
Urgency of Action	PRIORITY 3
Purpose of Action	LEVEL 2

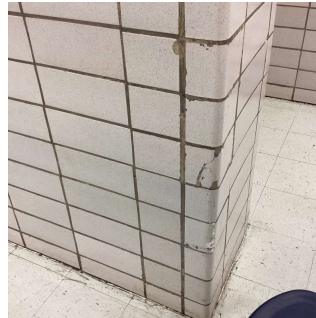
Near Drinking Fountain

GLAZED BLOCK: CRACKS/SPALLING

REPLACE

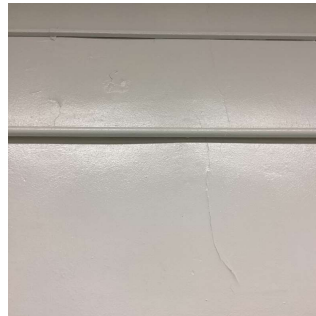
PLASTER: CRACKS/SPALLING

REPLACE

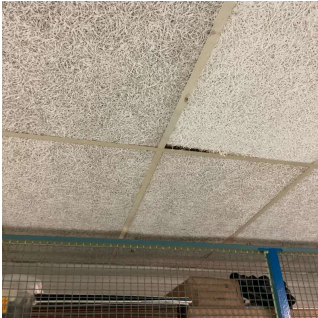
Violations	Corridor near Room B13 No violations recorded.
Deficiency	ACOUSTIC TILES: DAMAGED/MISSING
Deficiency Location/Instance	Room 302
Deficiency Quantity	40
Quantity Uom	S.F.
Potential Action	REPLACE
Urgency of Action	PRIORITY 3
Purpose of Action	LEVEL 2
Deficiency Photo1

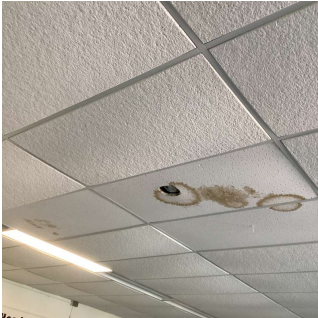
Violations	Room 302 No violations recorded.

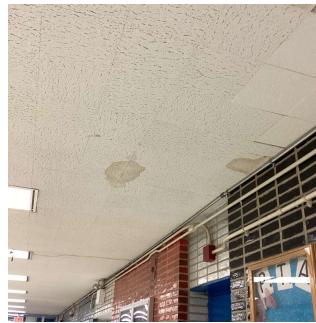
Near Vestibule Exit 3

Lobby near Auditorium Entrance
Violations	No violations recorded.
Deficiency	ACOUSTIC TILES ON PLASTER: DAMAGED/MISSING
Deficiency Location/Instance	Rooms B/1, B/4, B8, 201, Near Vestibule Exit 3, and others.
Deficiency Quantity	200
Quantity Uom	S.F.
Potential Action	REPLACE
Urgency of Action	PRIORITY 3
Purpose of Action	LEVEL 2

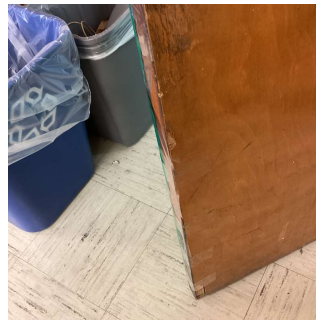
Room 303A

WOOD: DETERIORATED DOOR

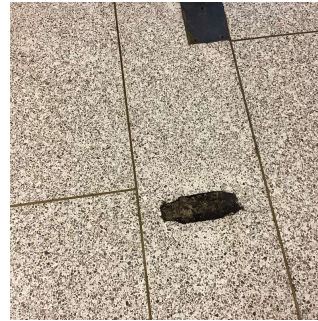
Corridor near Room 144

TERRAZZO: CRACKS

REPLACE

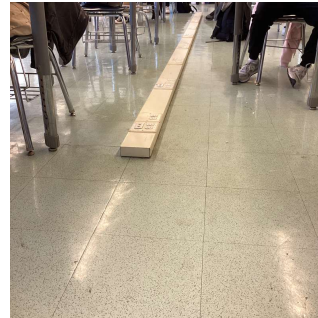
Room 201

VINYL TILES: TRIPPING HAZARD - ELECTRICAL OUTLET

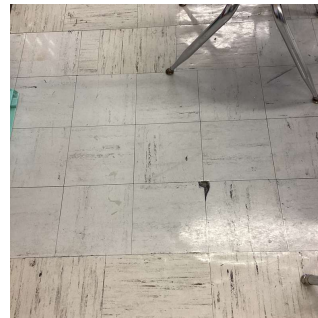
Room 305A

VINYL TILES: BROKEN/DETERIORATED/MISSING TILES

REPLACE

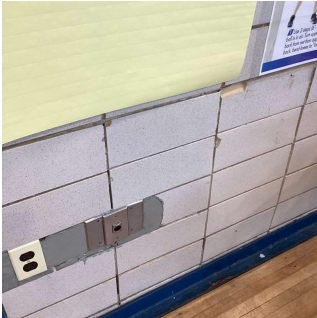
Violations	Near Room 138 No violations recorded.
Deficiency	PLASTER: CRACKS/SPALLING
Deficiency Location/Instance	Near Windows, Room 138
Deficiency Quantity	20
Quantity Uom	S.F.
Potential Action	REPLACE
Urgency of Action	PRIORITY 3
Purpose of Action	LEVEL 2

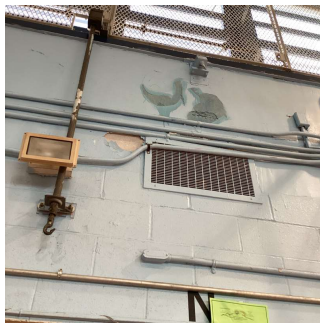
Violations	Near Windows No violations recorded.
Deficiency	GLAZED BLOCK: CRACKS/SPALLING
Deficiency Location/Instance	Drinking Fountain Areas
Deficiency Quantity	20
Quantity Uom	S.F.
Potential Action	REPLACE
Urgency of Action	PRIORITY 3
Purpose of Action	LEVEL 2
Deficiency Photo1

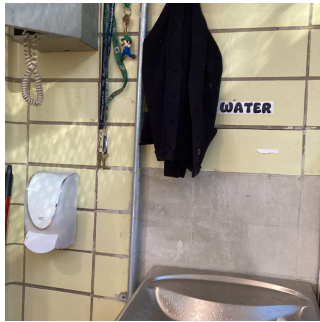
Violations	Drinking Fountain Area No violations recorded.
<b>Window Curtains/Shades/Blinds</b>	
Instance on 1st Floor	Does not Exist
<b>INTERIOR DOOR HARDWARE</b>	
Condition	Inspected
Deficiency	3 - Fair
Deficiency	No deficiencies recorded
<b>INTERIOR GUARDS</b>	
Condition	Inspected
Deficiency	2 - Between Good and Fair
Deficiency	No deficiencies recorded
<b>KITCHEN</b>	
Instance on Basement	Inspected
<b>Ceiling</b>	
Instance on Basement	Inspected
Condition	2 - Between Good and Fair
Deficiency	METAL PAN: DAMAGED/MISSING
Deficiency Location/Instance	Near Oven Area, Staff Serving Area, Center.

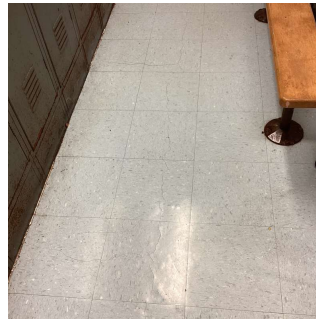
Room B34

Instance on Basement	Inspected
Condition	3 - Fair
Deficiency	VINYL TILES: DETERIORATED SUBSTRATE
Deficiency Location/Instance	Rooms B32, B34
Deficiency Quantity	30
Quantity Uom	S.F.
Potential Action	REPLACE
Urgency of Action	PRIORITY 3
Purpose of Action	LEVEL 2
Deficiency Photo1

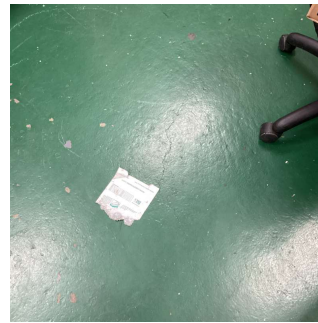
Storage Room

Deficiency	CONCRETE: CRACKS
Deficiency Location/Instance	Storage Room, Near Mop Room
Deficiency Quantity	20
Quantity Uom	S.F.
Potential Action	REPLACE
Urgency of Action	PRIORITY 3
Purpose of Action	LEVEL 2

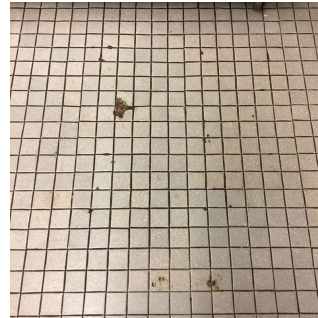
Serving Area

CERAMIC TILE: BROKEN/MISSING TILES

REPLACE

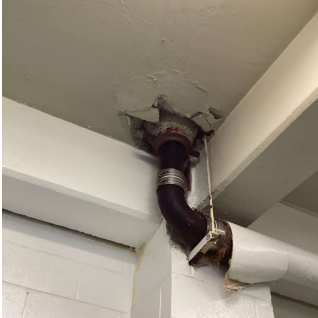
Question	Response
<b>INTERIOR</b>	
<b>LOCKER ROOM</b>	
<b>Ceiling</b>	
Condition	2 - Between Good and Fair
Deficiency	PLASTER: CRACKS/SPALLING
Deficiency Location/Instance	Near Storm Pipe
Deficiency Quantity	10
Quantity Uom	S.F.
Potential Action	REPLACE
Urgency of Action	PRIORITY 5
Purpose of Action	LEVEL 6
Deficiency Photo1

Violations	Near Storm Pipe No violations recorded.
Instance on 1st Floor - Boys (400 Lockers)	Inspected
Condition	3 - Fair
Deficiency	PLASTER: CRACKS/SPALLING
Deficiency Location/Instance	Near center
Deficiency Quantity	50
Quantity Uom	S.F.
Potential Action	REPLACE
Urgency of Action	PRIORITY 3
Purpose of Action	LEVEL 2
Deficiency Photo1

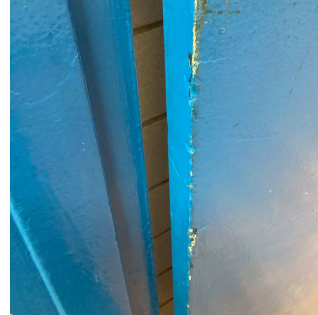
Violations	Near center No violations recorded.
<b>Door(s)</b>	
Instance on 1st Floor - Girls (410 Lockers)	Inspected
Condition	3 - Fair
Deficiency	WOOD: DETERIORATED DOOR
Deficiency Location/Instance	Entrance
Deficiency Quantity	1
Quantity Uom	EACH
Potential Action	MAINTENANCE

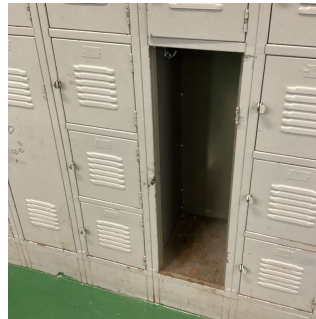
Instance on 1st Floor - Girls (410 Lockers)	Inspected
Condition	2 - Between Good and Fair
Deficiency	DAMAGED UNITS
Deficiency Location/Instance	Near Center
Deficiency Quantity	3
Quantity Uom	EACH
Potential Action	REPLACE
Urgency of Action	PRIORITY 3
Purpose of Action	LEVEL 2
Deficiency Photo1

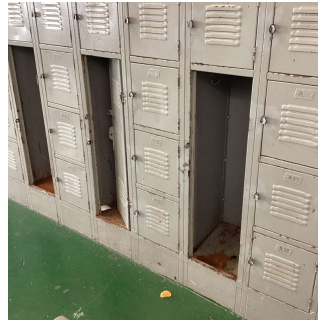
Locker A31

Instance on 1st Floor - Boys (400 Lockers)	Inspected
Condition	3 - Fair
Deficiency	DAMAGED UNITS
Deficiency Location/Instance	Lockers A31, A42, A50, A60, A105, and others.
Deficiency Quantity	21
Quantity Uom	EACH
Potential Action	REPLACE
Urgency of Action	PRIORITY 3
Purpose of Action	LEVEL 2

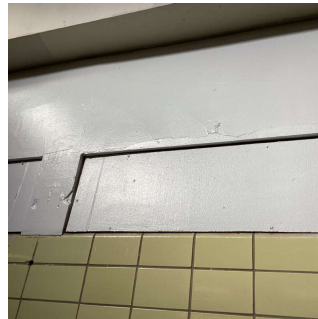
Deficiency	PLASTER: CRACKS/SPALLING
------------	--------------------------

Deficiency Location/Instance	Near Shower Room
------------------------------	------------------

Potential Action	REPLACE
------------------	---------

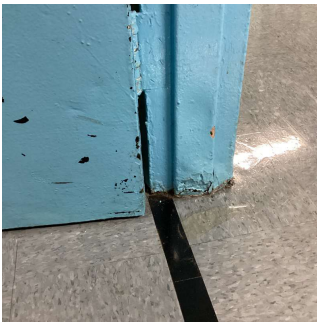
Room 405
Violations	No violations recorded.
<b>SCIENCE LAB</b>	Inspected
Instance on Rooms 302, 402	Inspected
Alternative use	No
<b>Fixed Equipment</b>	
Instance on Rooms 302, 402	Inspected
Condition	2 - Between Good and Fair
Deficiency	No deficiencies recorded
<b>SCIENCE PREP ROOM</b>	Inspected
Instance on Room 304	Inaccessible
Instance on Room 404	Inspected
Alternative use	No
<b>Fixed Equipment</b>	
Instance on Room 404	Inspected
Condition	2 - Between Good and Fair
Deficiency	No deficiencies recorded
<b>SHOWER ROOM</b>	Inspected
Instance on 1st Floor - Boys	Inaccessible
Instance on 1st Floor - Girls	Inaccessible
<b>STAIRS/RAMPS: INTERIOR</b>	Inspected
Do Letter Stair Signs Exist?	Yes
<b>Ceiling</b>	
Condition	2 - Between Good and Fair
Deficiency	No deficiencies recorded
<b>Door(s)</b>	
Condition	5 - Poor
Deficiency	METAL: DETERIORATED DOOR AND FRAME

Deficiency Location/Instance	Stair BC/Basement, DE/Basement
Deficiency Quantity	6
Quantity Uom	EACH
Potential Action	MAINTENANCE
Urgency of Action	PRIORITY 3
Purpose of Action	LEVEL 2

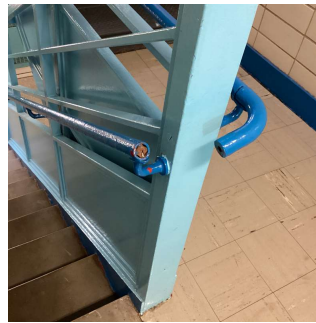
Violations	Stair BC/Basement No violations recorded.
<b>Partition</b>	Does not Exist
<b>Railings</b>	Inspected
Condition	4 - Between Fair and Poor
Deficiency	METAL: DAMAGED
Deficiency Location/Instance	Stair F/4
Deficiency Quantity	10
Quantity Uom	L.F.
Potential Action	REPLACE
Urgency of Action	PRIORITY 3
Purpose of Action	LEVEL 2

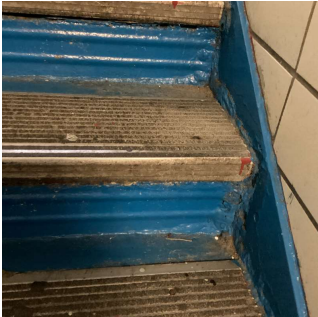
Question	Response
<b>INTERIOR</b>	
<b>STAIRS/RAMPS: INTERIOR</b>	
<b>Stairs and Landings</b>	
Violations	Stair DE/Basement No violations recorded.
Deficiency	METAL: WORN-OUT TREAD/NOSINGS
Deficiency Location/Instance	Stair A/1
Deficiency Quantity	10
Quantity Uom	S.F.
Potential Action	REPLACE
Urgency of Action	PRIORITY 3
Purpose of Action	LEVEL 2
Deficiency Photo1

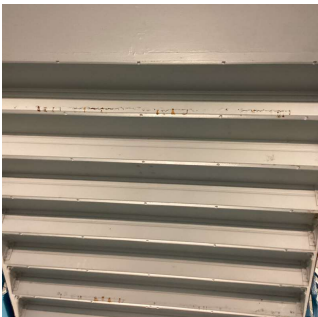
Violations	Stair A/1 No violations recorded.
Deficiency	METAL: RUST - MAJOR
Deficiency Location/Instance	Stair BC/Basement, DE/Basement, F/Basement, 1, 2
Deficiency Quantity	130
Quantity Uom	S.F.
Potential Action	REPLACE
Urgency of Action	PRIORITY 3
Purpose of Action	LEVEL 2
Deficiency Photo1

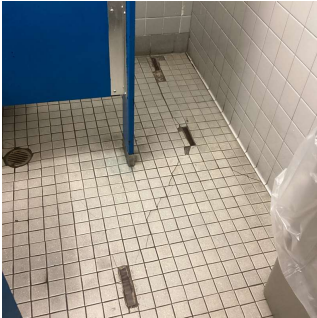
Question	Response
<b>INTERIOR</b>	
<b>TOILET ROOMS - STAFF</b>	
<b>Door(s)</b>	Inspected
	Room 317
Violations	No violations recorded.
<b>Floor Finish</b>	Inspected
Condition	3 - Fair
Deficiency	CERAMIC TILE: BROKEN/MISSING TILES
Deficiency Location/Instance	Rooms 223A, 217, 419, Neutral Gender 1st Floor
Deficiency Quantity	30
Quantity Uom	S.F.
Potential Action	REPLACE
Urgency of Action	PRIORITY 3
Purpose of Action	LEVEL 2
Deficiency Photo1

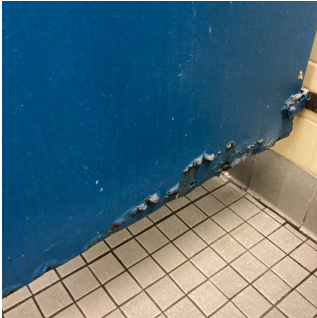
Room 317
Violations	No violations recorded.
<b>Stalls</b>	Inspected
Condition	5 - Poor
Deficiency	RUST - MAJOR
Deficiency Location/Instance	Rooms B16, 138, 223A, 321, 425A, and others.
Deficiency Quantity	7
Quantity Uom	EACH
Potential Action	REPLACE
Urgency of Action	PRIORITY 3
Purpose of Action	LEVEL 2
Deficiency Photo1

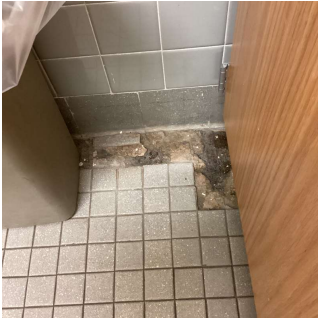
Question	Response
<b>INTERIOR</b>	
<b>TOILET ROOMS - STUDENTS</b>	
<b>Door(s)</b>	Inspected Room 421
Violations	No violations recorded.
<b>Floor Finish</b>	Inspected
Condition	2 - Between Good and Fair
Deficiency	CERAMIC TILE: BROKEN/MISSING TILES
Deficiency Location/Instance	Rooms 101, Neutral Gender 1st Floor
Deficiency Quantity	20
Quantity Uom	S.F.
Potential Action	REPLACE
Urgency of Action	PRIORITY 3
Purpose of Action	LEVEL 2
Deficiency Photo1

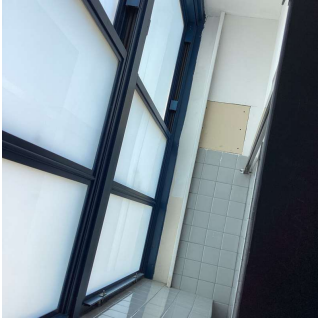
Violations	Room 101 No violations recorded.
<b>Stalls</b>	Inspected
Condition	2 - Between Good and Fair
Deficiency	No deficiencies recorded
<b>Walls</b>	Inspected
Condition	2 - Between Good and Fair
Deficiency	GYPSON BOARD: DETERIORATED
Deficiency Location/Instance	Rooms 113, 415, Boys Locker room. Room
Deficiency Quantity	30
Quantity Uom	S.F.
Potential Action	REPLACE
Urgency of Action	PRIORITY 3
Purpose of Action	LEVEL 2
Deficiency Photo1

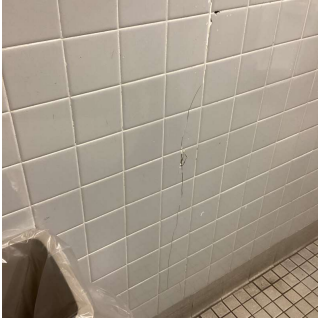
Question	Response
<b>INTERIOR</b>	
<b>TOILET ROOMS - STUDENTS</b>	
<b>Walls</b>	
Deficiency Location/Instance	Rooms B17, 113, 101, Neutral Gender 1st Floor, Boys Locker Room, and others.
Deficiency Quantity	40
Quantity Uom	S.F.
Potential Action	REPLACE
Urgency of Action	PRIORITY 3
Purpose of Action	LEVEL 2
Deficiency Photo1

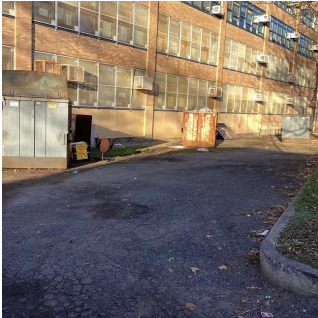
Neutral Gender 1st Floor
Violations	No violations recorded.
<b>LIFE SAFETY</b>	Inspected
<b>F.D. HOLDING AREA</b>	Does not Exist
<b>STEEL STAIRS</b>	Does not Exist
<b>SITE</b>	Inspected
<b>CONTAINERIZATION</b>	Inspected
Condition	5 - Poor
Deficiency	CONCRETE PAD MISSING
Deficiency Location/Instance	Containerization Area
Deficiency Quantity	500
Quantity Uom	S.F.
Potential Action	INSTALL NEW
Urgency of Action	PRIORITY 3
Purpose of Action	LEVEL 2
Deficiency Photo1

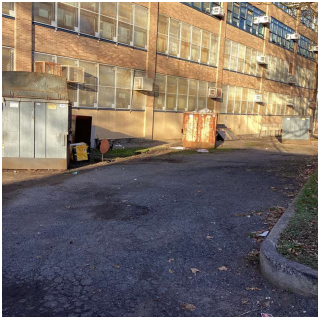
Containerization Area
Violations	No violations recorded.
Deficiency	CONTAINER DAMAGED
Deficiency Location/Instance	Containerization Area

Deficiency Quantity	5
Quantity Uom	EACH
Potential Action	REPLACE

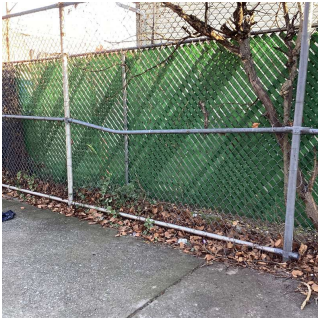
Condition	3 - Fair
Deficiency	CHAIN LINK: DAMAGED POST/RAIL
Deficiency Location/Instance	Near Containerization Area
Deficiency Quantity	30
Quantity Uom	L.F.
Potential Action	REPLACE
Urgency of Action	PRIORITY 3
Purpose of Action	LEVEL 2
Deficiency Photo1

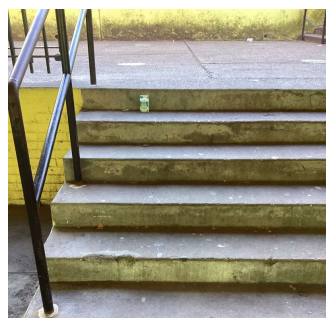
Deficiency	CAST IN PLACE CONCRETE: CRACKS/SPALLING - MAJOR
Deficiency Location/Instance	Near NYC Park

Question	Response
<b>SITE</b>	
<b>STAIRS/RAMPS: EXTERIOR</b>	
<b>Stairs/ramps</b>	
Deficiency Quantity	10
Quantity Uom	S.F.
Potential Action	REPLACE
Urgency of Action	PRIORITY 3
Purpose of Action	LEVEL 2
Deficiency Photo1
