**NYC Department of Education
Building Condition Assessment Survey 2023 - 2024**

Architectural Inspection

Asset: I.S. 10 - QUEENS, 45-11 31 AVENUE, New York, 11103

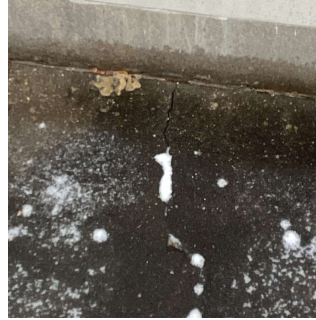
AW2

Question	Response
Architectural	
EXTERIOR	Inspected
AREAWAY	Inspected
Instance on AW1-AW10	Inspected
Instance Condition	3 - Fair
Instance Quantity	10
Instance Quantity Uom	EACH
Deficiency	AREAWAY SLAB: CRACKS AND SPALLING
Roof Plan reference

S.F.
REPAIR
PRIORITY 3
LEVEL 2

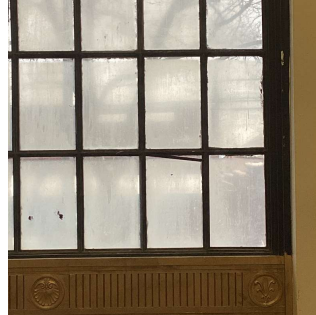
Facade J - Exit 1

METAL: DENTED, MAJOR RUSTING

20
S.F.
REPLACE

PRIORITY 4
LEVEL 2

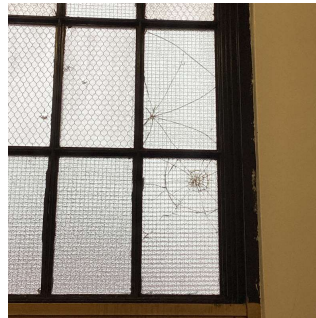
Facade A - Exit 6

METAL: BROKEN GLASS

60
S.F.
MAINTENANCE
PRIORITY 3
LEVEL 2

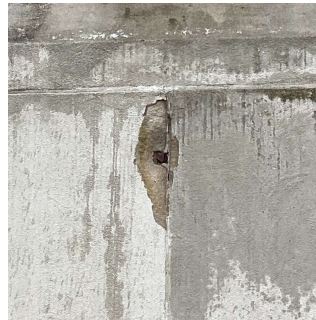
Facade J

STONE: CHIPPED/SPALLED/BROKEN PIECES - MAJOR

40

REPLACE

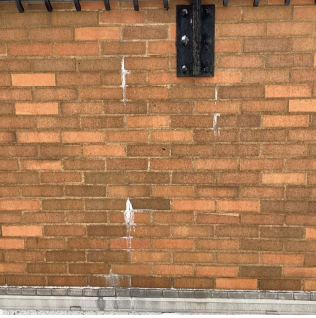
Question	Response
EXTERIOR	
PARAPETS	
Instance on All Facades	Inspected
Instance Condition	2 - Between Good and Fair
Instance Quantity	11,000
Instance Quantity Uom	C.F.
Deficiency	BRICK: EFFLORESCENCE
Roof Plan reference

Deficiency Quantity	10
Quantity Uom	S.F.
Potential Action	MAINTENANCE
Urgency of Action	PRIORITY 1
Purpose of Action	LEVEL 1
Deficiency Photo1

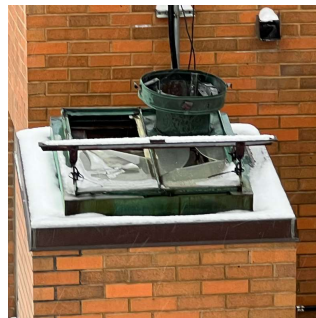
Roof 1

DAMAGED GUARDS

20

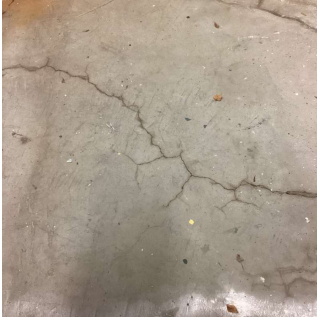
Violations	Boiler Room Pit No violations recorded.
FOUNDATION WALLS	Inspected
Material Type(s)	Concrete
Condition	4 - Between Fair and Poor
Deficiency	CONCRETE: WATER INFILTRATION IN INSTRUCTIONAL SPACE
Deficiency Location/Instance	Basement - Kitchen Staff Toilet Room, Cafeteria Staff Lounge

Violations	4th Floor Gymnasium Storage Room No violations recorded.
Deficiency	CONCRETE SLAB ON GRADE: THRU CRACKS
Deficiency Location/Instance	Boiler Room Pit
Deficiency Quantity	80
Quantity Uom	S.F.
Potential Action	REPAIR
Urgency of Action	PRIORITY 3
Purpose of Action	LEVEL 5
Deficiency Photo1

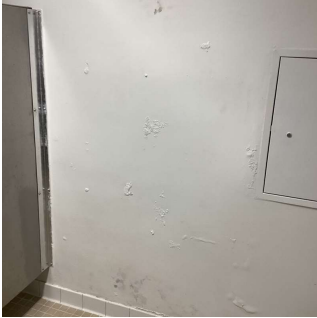
Deficiency Quantity	200
Quantity Uom	S.F.

Question	Response
INTERIOR	
STRUCTURAL	
FOUNDATION WALLS	
Potential Action	INSTALL WATERPROOFING
Urgency of Action	PRIORITY 5
Purpose of Action	LEVEL 5
Deficiency Photo1

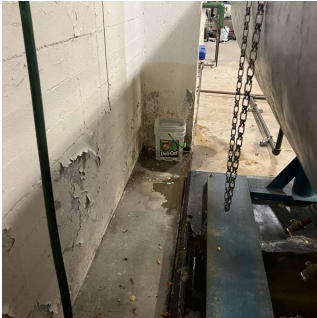
Kitchen Staff Toilet Room
Violations	No violations recorded.
Deficiency	CONCRETE: WATER INFILTRATION IN NON- INSTRUCTIONAL SPACE
Deficiency Location/Instance	Basement - Boiler Room
Deficiency Quantity	200
Quantity Uom	S.F.
Potential Action	INSTALL WATERPROOFING
Urgency of Action	PRIORITY 5
Purpose of Action	LEVEL 5
Deficiency Photo1

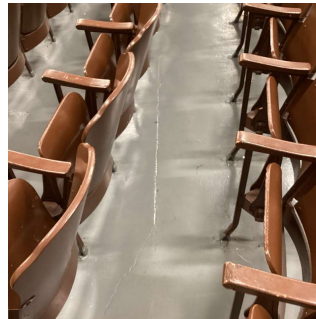
Near Seat N/28

Instance on 1st Floor (575 Seats)	Inspected
Condition	3 - Fair
Deficiency	CONCRETE: CRACKS
Deficiency Location/Instance	Near Seat N/28, H/2
Deficiency Quantity	150
Quantity Uom	S.F.
Potential Action	REPLACE
Urgency of Action	PRIORITY 3
Purpose of Action	LEVEL 2
Deficiency Photo1

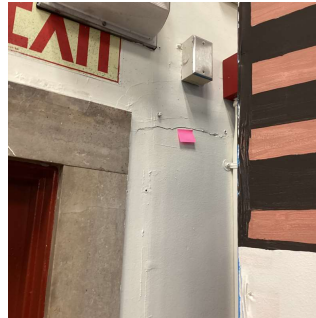
Left exit

PLASTER: CRACKS/SPALLING

REPLACE

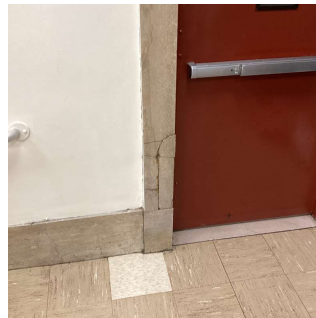
Left exit

STONE MOLDINGS: CRACKS/SPALLING

REPLACE

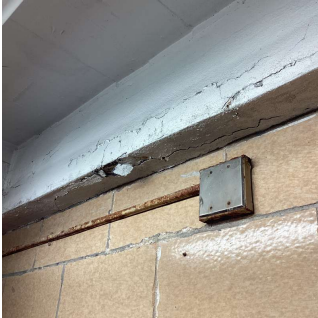
Violations	Near exit 8 No violations recorded.
Door(s)	
Instance on Basement	Inspected
Condition	3 - Fair
Deficiency	WOOD: DETERIORATED DOOR

Violations	Right side No violations recorded.
CAFETERIA	
Instance on Basement	Inspected
Condition	Inspected
Ceiling	
Instance on Basement	Inspected
Condition	2 - Between Good and Fair
Deficiency	PLASTER: CRACKS/SPALLING
Deficiency Location/Instance	Near exit 8
Deficiency Quantity	10
Quantity Uom	S.F.
Potential Action	REPLACE
Urgency of Action	PRIORITY 3
Purpose of Action	LEVEL 2
Deficiency Photo1

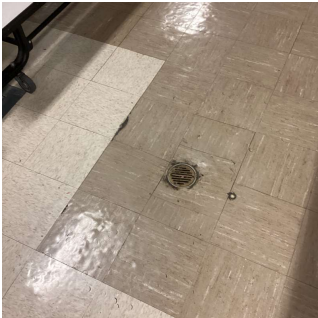
Violations	Rear No violations recorded.
Deficiency	VINYL TILES: BROKEN/DETERIORATED/MISSING TILES
Deficiency Location/Instance	Near Windows
Deficiency Quantity	80
Quantity Uom	S.F.
Potential Action	REPLACE
Urgency of Action	PRIORITY 3
Purpose of Action	LEVEL 2

Violations	Door to Elevator Lobby No violations recorded.
Fixed Equipment	
Instance on Basement	Does not Exist
Floor Finish	
Instance on Basement	Inspected
Condition	2 - Between Good and Fair
Deficiency	VINYL TILES: DETERIORATED SUBSTRATE
Deficiency Location/Instance	Rear
Deficiency Quantity	10
Quantity Uom	S.F.
Potential Action	REPLACE
Urgency of Action	PRIORITY 3
Purpose of Action	LEVEL 2
Deficiency Photo1

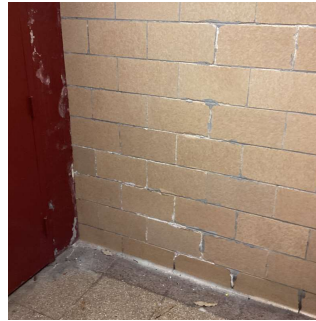
Near exit 8

GLAZED BLOCK: CRACKS/SPALLING

REPLACE

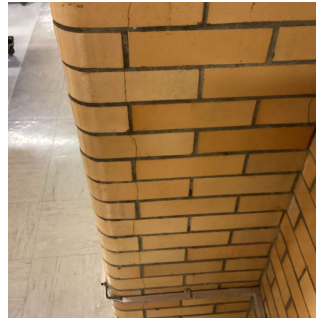
Near Windows

SALT GLAZED BRICK: CRACKS/SPALLING

REPLACE

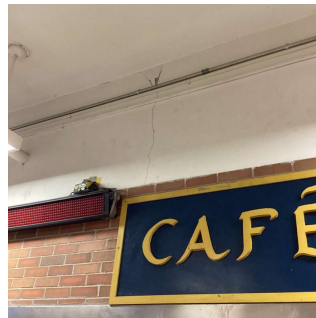
Near servery

PLASTER: CRACKS/SPALLING

REPLACE

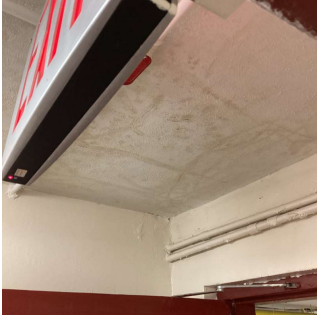
Violations	Corridor near Stair E/Basement No violations recorded.
Deficiency	PLASTER: CRACKS/SPALLING
Deficiency Location/Instance	Corridor near Room 306, 406
Deficiency Quantity	20
Quantity Uom	S.F.
Potential Action	REPLACE
Urgency of Action	PRIORITY 3
Purpose of Action	LEVEL 2
Deficiency Photo1

Question	Response
INTERIOR	
CAFETERIA	Inspected
Window Curtains/Shades/Blinds	
Instance on Basement	Does not Exist
CLASSROOMS/CORRIDORS/ADMIN SPACES	
Ceiling	Inspected
Condition	2 - Between Good and Fair
Deficiency	PLASTER: CRACKS/SPALLING - ACTIVE LEAK
Deficiency Location/Instance	Corridor near Stair E/Basement
Deficiency Quantity	25
Quantity Uom	S.F.
Potential Action	REPLACE
Urgency of Action	PRIORITY 5
Purpose of Action	LEVEL 2
Deficiency Photo1

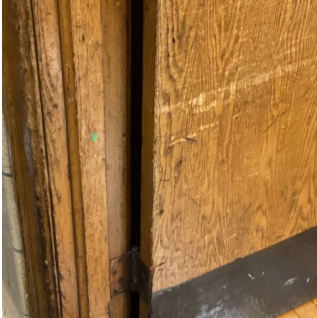
Room 302
Violations	No violations recorded.
Deficiency	WOOD: DETERIORATED DOOR AND FRAME
Deficiency Location/Instance	Room 421
Deficiency Quantity	1
Quantity Uom	EACH
Potential Action	MAINTENANCE
Urgency of Action	PRIORITY 3
Purpose of Action	LEVEL 2
Deficiency Photo1

Violations	Corridor near Room 306 No violations recorded.
Door(s)	Inspected
Condition	5 - Poor
Deficiency	WOOD: DETERIORATED DOOR
Deficiency Location/Instance	Rooms 420, 319, 302, 217, 131 and others

Deficiency Quantity	6
Quantity Uom	EACH
Potential Action	MAINTENANCE

Question	Response
INTERIOR	
CLASSROOMS/CORRIDORS/ADMIN SPACES	Inspected
Door(s)	
Urgency of Action	PRIORITY 3
Purpose of Action	LEVEL 2
Deficiency Photo1

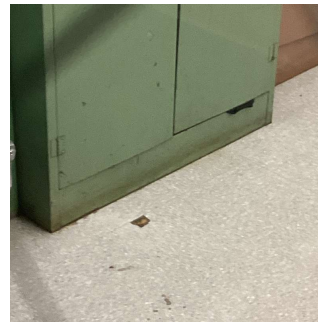
Room 430

Room 421
Violations	No violations recorded.
Floor Finish	Inspected
Condition	2 - Between Good and Fair
Deficiency	VINYL TILES: BROKEN/DETERIORATED/MISSING TILES
Deficiency Location/Instance	Rooms 430, 115, 107
Deficiency Quantity	30
Quantity Uom	S.F.
Potential Action	REPLACE
Urgency of Action	PRIORITY 3
Purpose of Action	LEVEL 2

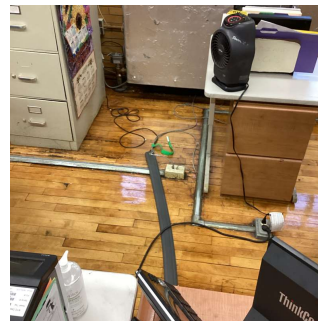
Main Office

WOOD: TRIPPING HAZARD - ELECTRICAL OUTLET

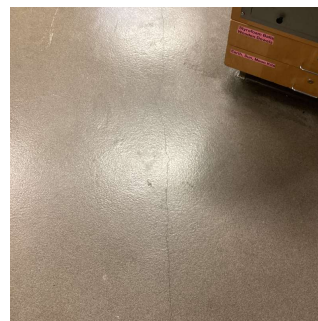
Room 411

EPOXY FLOORING: CRACKS/SPALLING

REPLACE

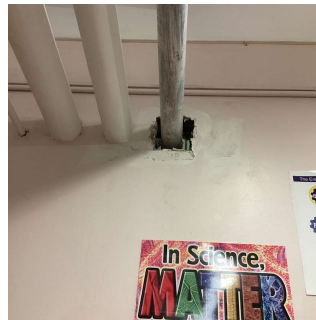
Room 319

PLASTER: CRACKS/SPALLING - ACTIVE LEAK

REPLACE

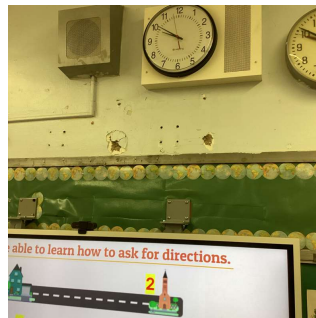
PLASTER: CRACKS/SPALLING

REPLACE

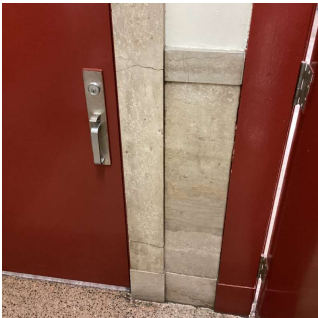
Violations	Auditorium lobby No violations recorded.
Specialties	Inspected
Classroom Locker(s)	Inspected
Condition	2 - Between Good and Fair
Deficiency	No deficiencies recorded
Fixed Seating	Does not Exist
GYMNASIUM	Inspected
Instance on 4th Floor	Inspected
Instance on 3rd Floor	Inspected

Violations	Near Exit 1 No violations recorded.
Deficiency	STONE MOLDINGS: CRACKS/SPALLING
Deficiency Location/Instance	Auditorium lobby, near Exit 1
Deficiency Quantity	20
Quantity Uom	L.F.
Potential Action	REPLACE
Urgency of Action	PRIORITY 3
Purpose of Action	LEVEL 2
Deficiency Photo1

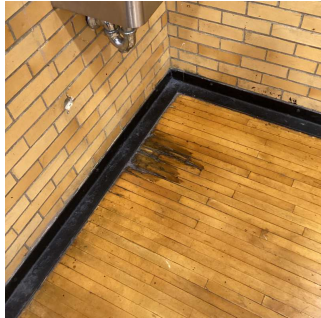
Near Drinking Fountain
Violations	No violations recorded.
Seating

Storage Room
Violations	No violations recorded.
Fixed Equipment	
Instance on 4th Floor	Inspected
Condition	2 - Between Good and Fair
Deficiency	No deficiencies recorded
Instance on 3rd Floor	Inspected
Condition	2 - Between Good and Fair
Deficiency	No deficiencies recorded
Floor Finish	
Instance on 3rd Floor	Inspected
Condition	2 - Between Good and Fair
Deficiency	WOOD: DAMAGED/DETERIORATED
Deficiency Location/Instance	Near Drinking Fountain
Deficiency Quantity	10
Quantity Uom	S.F.
Potential Action	REPLACE
Urgency of Action	PRIORITY 3
Purpose of Action	LEVEL 2
Deficiency Photo1

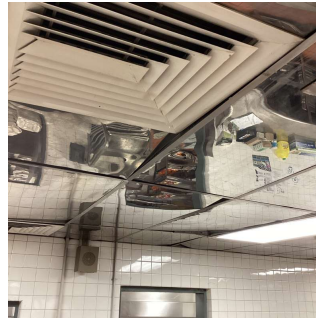
Center

WASHABLE TILE: DAMAGED/MISSING

REPLACE

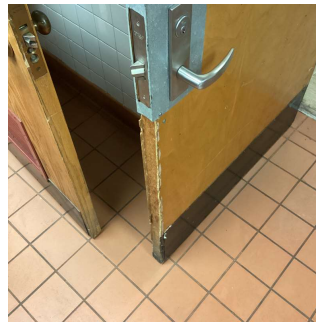
Entrance

Instance on Basement	Inspected
Condition	4 - Between Fair and Poor
Deficiency	WOOD: DETERIORATED DOOR
Deficiency Location/Instance	Entrance, Office
Deficiency Quantity	2
Quantity Uom	EACH
Potential Action	MAINTENANCE
Urgency of Action	PRIORITY 3
Purpose of Action	LEVEL 2

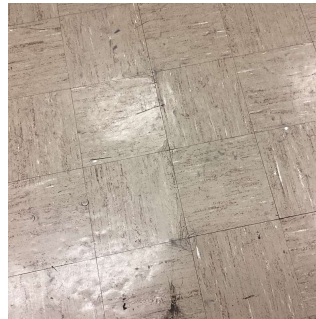
Condition	4 - Between Fair and Poor
-----------	---------------------------

Deficiency VINYL TILES: DETERIORATED SUBSTRATE

Deficiency Location/Instance Storage Room

Deficiency Quantity 20

Potential Action REPLACE

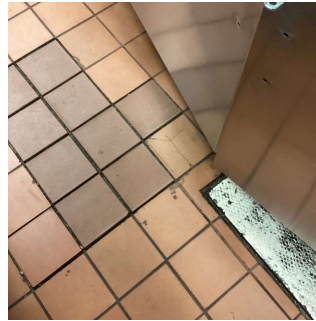
Near windows

Deficiency QUARRY TILE: BROKEN/MISSING TILES

Deficiency Location/Instance Near Windows

Deficiency Quantity 10

Potential Action REPLACE

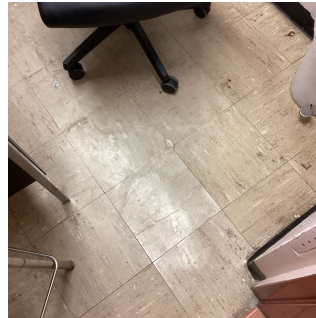
Deficiency	VINYL TILES: BROKEN/DETERIORATED/MISSING TILES
Deficiency Location/Instance	Storage Room , Office
Deficiency Quantity	50
Quantity Uom	S.F.
Potential Action	REPLACE
Urgency of Action	PRIORITY 3
Purpose of Action	LEVEL 2
Deficiency Photo1

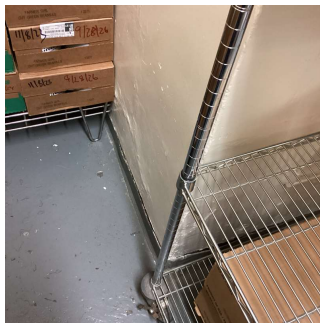
Storage Room
Violations	No violations recorded.
Deficiency	CERAMIC TILE: BROKEN/ MISSING
Deficiency Location/Instance	Near servery
Deficiency Quantity	10
Quantity Uom	S.F.
Potential Action	REPLACE
Urgency of Action	PRIORITY 3
Purpose of Action	LEVEL 2
Deficiency Photo1

Instance on Basement	Inspected
Condition	2 - Between Good and Fair
Deficiency	PLASTER: CRACKS/SPALLING
Deficiency Location/Instance	Storage Room
Deficiency Quantity	15
Quantity Uom	S.F.
Potential Action	REPLACE
Urgency of Action	PRIORITY 3
Purpose of Action	LEVEL 2

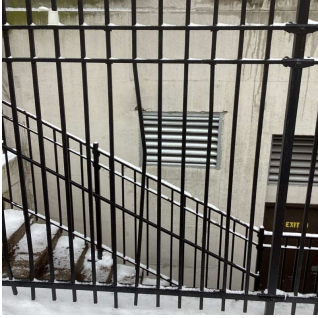
Question	Response
SITE	
Drainage System for Asphalt	Inspected
Culverts - Asphalt Covering	Does not Exist
Drainage System for Concrete	Inspected
Catch Basins/Manhole - Surrounded by concrete	Inspected
Condition	2 - Between Good and Fair
Deficiency	No deficiencies recorded
Culverts - Concrete Covering	Does not Exist
Drainage System for Soil	Does not Exist
DRINKING FOUNTAINS	Does not Exist
FENCES	Inspected
Condition	3 - Fair
Deficiency	WROUGHT IRON: DAMAGED/DETERIORATED
Deficiency Location/Instance	45th Street
Deficiency Quantity	80
Quantity Uom	S.F.
Potential Action	REPLACE
Urgency of Action	PRIORITY 3
Purpose of Action	LEVEL 2
Deficiency Photo1

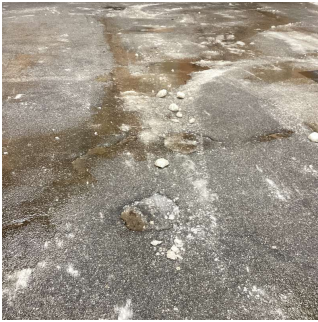
Question	Response
SITE	
PAVING	Inspected
Student Non-Use	Inspected
Gravel Exists?	No
Asphalt	Does not Exist
Concrete	Inspected
Condition	2 - Between Good and Fair
Deficiency	No deficiencies recorded
Pavers	Does not Exist
Student Use	Inspected
Gravel Exists?	No
Asphalt	Inspected
Condition	3 - Fair
Deficiency	LOCALIZED SINK AREA
Deficiency Location/Instance	Courtyard
Deficiency Quantity	250
Quantity Uom	S.F.
Potential Action	REPAIR
Urgency of Action	PRIORITY 3
Purpose of Action	LEVEL 2
Deficiency Photo1

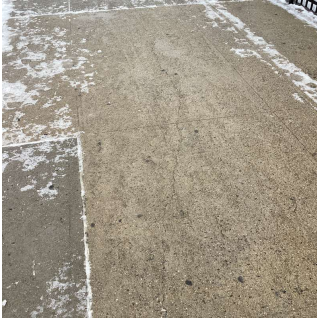
Violations	46th Street No violations recorded.
Pavers	Does not Exist
PLAYGROUNDS	Does not Exist
PLAYING SURFACE	Does not Exist
RETAINING WALLS	Does not Exist
SEATING	Does not Exist
SITE WALLS (NOT RETAINING WALLS)	Does not Exist
STAIRS/RAMPS: EXTERIOR	Does not Exist
ARTWORK	Does not Exist

Violations	No violations recorded.
Concrete	Does not Exist
Pavers	Does not Exist
Site Sidewalks & Walkways	Inspected
Asphalt	Inspected
Condition	2 - Between Good and Fair
Deficiency	No deficiencies recorded
Concrete	Inspected
Condition	2 - Between Good and Fair
Deficiency	No deficiencies recorded
Pavers	Does not Exist
DOT Sidewalk	Inspected
Asphalt	Does not Exist
Concrete	Inspected
Condition	4 - Between Fair and Poor
Deficiency	DAMAGED/DETERIORATED/MISSING SECTIONS

Deficiency Location/Instance	45th Street, 46th Street, 31st Avenue
Deficiency Quantity	750
Quantity Uom	S.F.

Question	Response
SITE	
PAVING	
DOT Sidewalk	
Concrete	
Potential Action	REPLACE
Urgency of Action	PRIORITY 3
Purpose of Action	LEVEL 2
Deficiency Photo1
