NYC Department of Education
Building Condition Assessment Survey 2023 - 2024

Architectural Inspection

Q011

Asset: P.S. 11 - QUEENS, 54-25 SKILLMAN AVENUE, New York, 11377

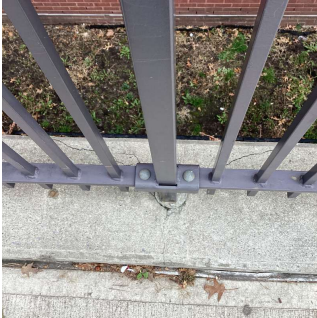
Question	Response
Architectural	
EXTERIOR	Inspected
AREAWAY	Inspected
Instance on AW1, AW3	Inspected
Instance Condition	2 - Between Good and Fair
Instance Quantity	2
Instance Quantity Uom	EACH
Deficiency	AREAWAY WALLS: DETERIORATED COPING STONE
Roof Plan reference

Deficiency Quantity	20
Quantity Uom	S.F.

Question	Response
EXTERIOR	
AREAWAY	
Potential Action	REPAIR
Urgency of Action	PRIORITY 3
Purpose of Action	LEVEL 2
Deficiency Photo1

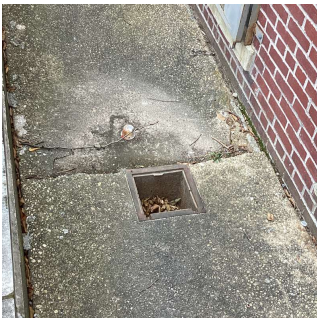
Violations	AW1 No violations recorded.
Instance on AW2	Inspected
Instance Condition	4 - Between Fair and Poor
Instance Quantity	1
Instance Quantity Uom	EACH
Deficiency	AREAWAY DRAINS: DETERIORATED
Roof Plan reference

Deficiency Quantity	1
Quantity Uom	EACH
Potential Action	REPLACE
Urgency of Action	PRIORITY 4
Purpose of Action	LEVEL 2
Deficiency Photo1

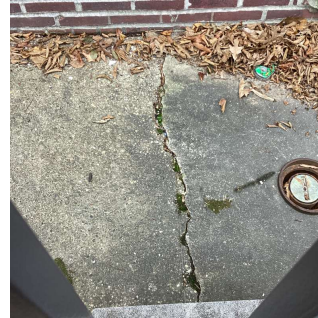
AW2

AREAWAY SLAB: CRACKS AND SPALLING

50

REPLACE

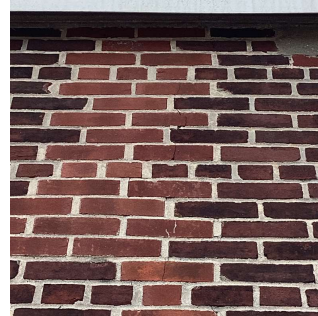
CHI
 No violations recorded.

BRICK: MINOR CRACKS AND SPALLING

40
 S.F.
 RESTITCH
 PRIORITY 3
 LEVEL 2

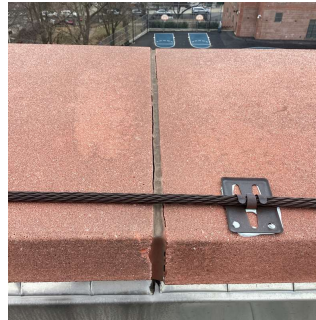
PH Roof

CAST STONE: DETERIORATED TRANSVERSE JOINTS

10
 L.F.
 MAINTENANCE
 PRIORITY 3
 LEVEL 2

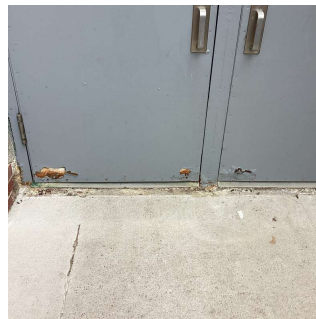
Facade E - Exit 13

METAL CLAD: DETERIORATED DOOR - MAJOR DETERIORATION

7

REPLACE

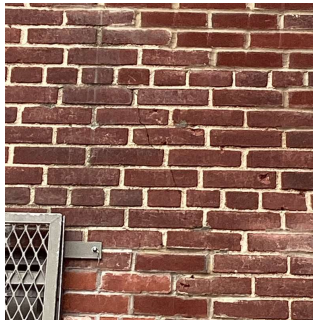
Facade E

Violations	Facade H No violations recorded.
Deficiency	BRICK: MINOR CRACKS AND SPALLING

10

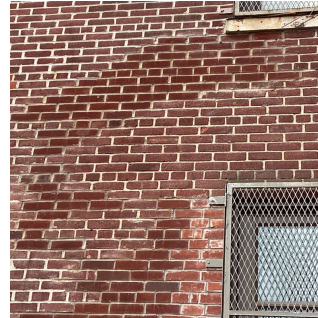
Facade E

BRICK: DETERIORATED JOINTS

50

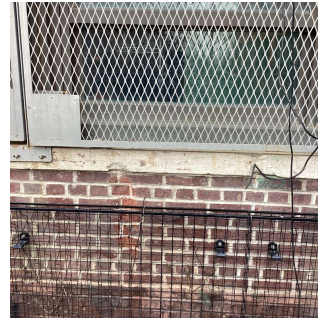
Facade E

BRICK: DETERIORATED MASONRY SILLS - MINOR

30

REPAIR

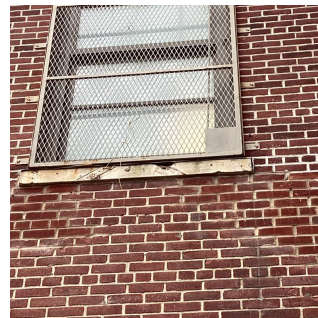
Facade E

BRICK: DETERIORATED MASONRY SILLS - MAJOR

20

REMOVE AND REPLACE

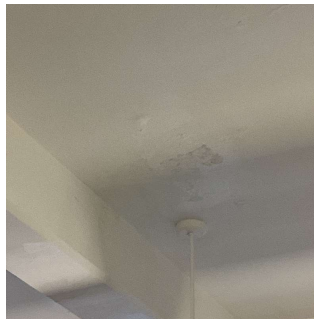
Roof 1 - Room 316

BUILT-UP: ROOFING: MAJOR ACTIVE ROOF LEAKS IN INSTRUCTIONAL SPACE

100
S.F.
REPLACE ROOFING WITHOUT MAJOR EQUIPMENT
REMOVAL
PRIORITY 5
LEVEL 2

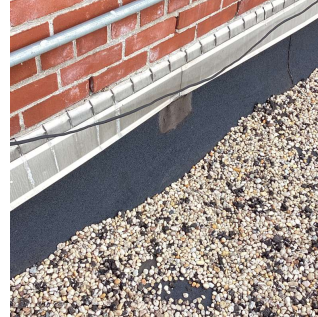
Roof 1

BUILT-UP: ROOFING: LOSS OF GRAVEL

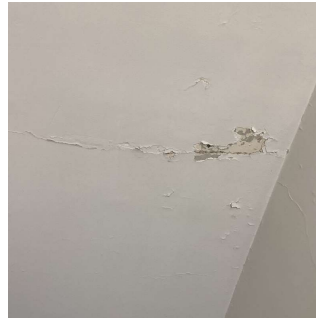
BH3

BULKHEAD/PENTHOUSE CEILING: PLASTER DAMAGED/DETERIORATED

REPLACE

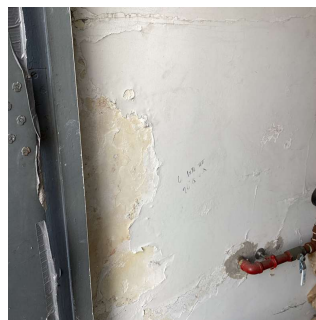
BH3

BULKHEAD/PENTHOUSE WALLS/INTERIOR: PLASTER CRACKS/SPALLING

REPLACE

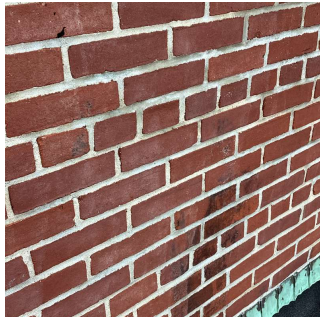
BULKHEAD/PENTHOUSE WALLS/EXTERIOR: DETERIORATED JOINTS

10
S.F.
REPOINT
PRIORITY 3
LEVEL 2

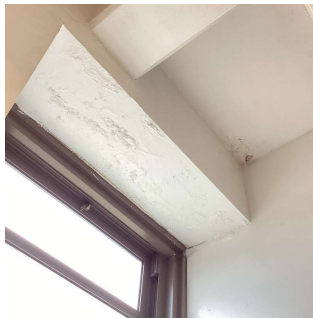
Facade A - Room 321 shown, Facade A - Room 317 similar

Question	Response
EXTERIOR	
WINDOWS	
WINDOWS	
Instance Quantity Uom	S.F.
Are these windows insulated	Yes
Installation Year	1998
Source of Installation	Custodial Staff
Deficiency	No deficiencies recorded
Instance on Aluminum - Double Hung: Original Building	Inspected
Instance Condition	3 - Fair
Instance Quantity	9,000
Instance Quantity Uom	S.F.
Are these windows insulated	Yes
Installation Year	1998
Source of Installation	Custodial Staff
Deficiency	ALUMINUM - DOUBLE HUNG: AIR/WATER INFILTRATION

60
L.F.
REPLACE TRIM, SILLS OR WEATHERSTRIPPING
PRIORITY 5
LEVEL 2

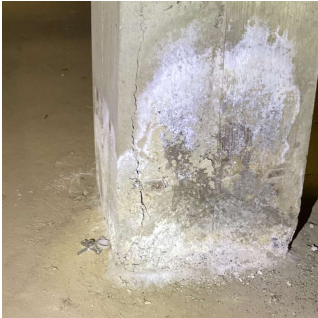
Question	Response
EXTERIOR	Inspected
WINDOWS	Inspected
WINDOWS	
Violations	No violations recorded.
INTERIOR	Inspected
POOLS	Does not Exist
STRUCTURAL	Inspected
COLUMNS/BEAMS/BEARING WALLS	Inspected
Condition	2 - Between Good and Fair
Deficiency	STEEL COLUMNS/BEAMS: DETERIORATED CONCRETE FIREPROOFING
Deficiency Location/Instance	Sub-Basement - Crawlspace
Deficiency Quantity	20
Quantity Uom	S.F.
Potential Action	REPLACE
Urgency of Action	PRIORITY 3
Purpose of Action	LEVEL 5
Deficiency Photo1

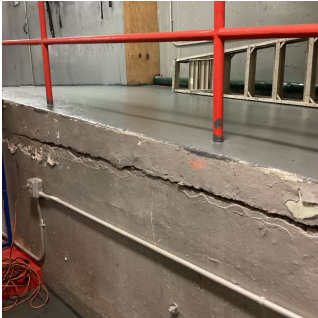
Violations	Sub-Basement - Crawlspace No violations recorded.
FLOOR STRUCTURE	Inspected
Condition	3 - Fair
Deficiency	CONCRETE SLAB ON GRADE: THRU CRACKS
Deficiency Location/Instance	Basement - Boiler Room, Sub- Basement - Mechanical Equipment Room
Deficiency Quantity	50
Quantity Uom	S.F.
Potential Action	REPAIR
Urgency of Action	PRIORITY 3
Purpose of Action	LEVEL 5
Deficiency Photo1

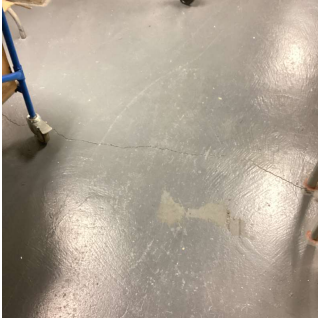
Deficiency	CONCRETE: CRACKS/SPALLED/REINFORCEMENT EXPOSED

Question	Response
INTERIOR	Inspected
STRUCTURAL	Inspected
FLOOR STRUCTURE	
Deficiency Location/Instance	Ground Floor - Rooms G27, G10, 3rd Floor - Fan Room 319
Deficiency Quantity	100
Quantity Uom	S.F.
Potential Action	REPAIR
Urgency of Action	PRIORITY 3
Purpose of Action	LEVEL 5
Deficiency Photo1

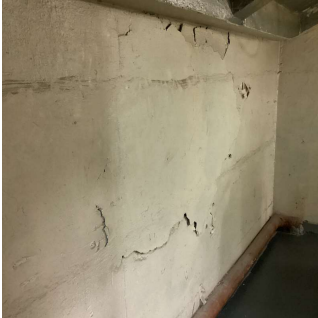
Fan Room 319
Violations	No violations recorded.
FOUNDATION WALLS	Inspected
Material Type(s)	Concrete, Masonry
Condition	3 - Fair
Deficiency	CONCRETE: CRACKED/SPALLED/REINFORCEMENT EXPOSED
Deficiency Location/Instance	Basement - Boiler Room
Deficiency Quantity	40
Quantity Uom	S.F.
Potential Action	REPAIR
Urgency of Action	PRIORITY 4
Purpose of Action	LEVEL 5
Deficiency Photo1

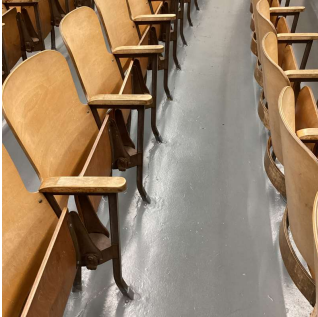
Question	Response
INTERIOR	
AUDITORIUM	
Fixed Seating	
Violations	No violations recorded.
Floor Finish	
Instance on Ground Floor (438 Seats)	Inspected
Condition	2 - Between Good and Fair
Deficiency	CONCRETE: CRACKS
Deficiency Location/Instance	Along Row J
Deficiency Quantity	100
Quantity Uom	S.F.
Potential Action	REPLACE
Urgency of Action	PRIORITY 3
Purpose of Action	LEVEL 2
Deficiency Photo1

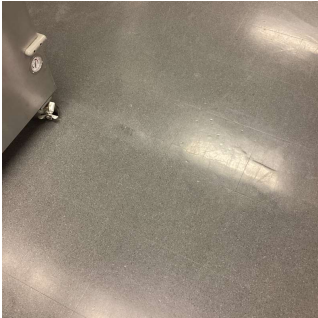
Question	Response
INTERIOR	
CAFETERIA	
Fixed Equipment	
Instance on Ground Floor	Does not Exist
Floor Finish	
Instance on Ground Floor	Inspected
Condition	2 - Between Good and Fair
Deficiency	VINYL TILES: DETERIORATED SUBSTRATE
Deficiency Location/Instance	Near Serving area
Deficiency Quantity	10
Quantity Uom	S.F.
Potential Action	REPLACE
Urgency of Action	PRIORITY 3
Purpose of Action	LEVEL 2
Deficiency Photo1

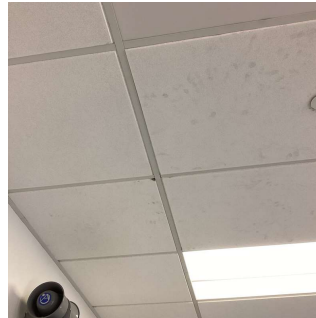
Corridor near Room 127

ACOUSTIC TILES: DAMAGED/MISSING

REPLACE

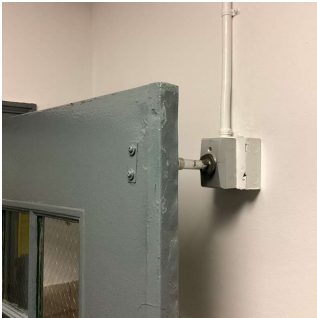
Question	Response
INTERIOR	
CLASSROOMS/CORRIDORS/ADMIN SPACES	
Door(s)	
Violations	Room 214 No violations recorded.
Deficiency	METAL: DETERIORATED DOOR
Deficiency Location/Instance	Corridor near Room 212
Deficiency Quantity	2
Quantity Uom	EACH
Potential Action	MAINTENANCE
Urgency of Action	PRIORITY 3
Purpose of Action	LEVEL 2
Deficiency Photo1

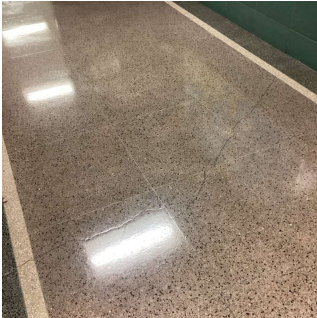
Violations	Corridor near Room 212 No violations recorded.
Floor Finish	Inspected
Condition	3 - Fair
Deficiency	TERRAZZO: CRACKS
Deficiency Location/Instance	Corridor near Room G17
Deficiency Quantity	40
Quantity Uom	S.F.
Potential Action	REPLACE
Urgency of Action	PRIORITY 3
Purpose of Action	LEVEL 2
Deficiency Photo1

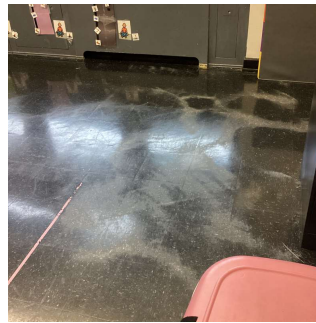
Room 316

Violations	Corridor near Room G17 No violations recorded.
Deficiency	VINYL TILES: BROKEN/DETERIORATED/MISSING TILES
Deficiency Location/Instance	Rooms 316, 215, 213, 212, 210 and others
Deficiency Quantity	4,200
Quantity Uom	S.F.
Potential Action	REPLACE
Urgency of Action	PRIORITY 3

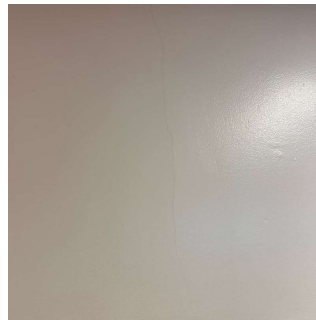
Corridor near Room 113

PLASTER: CRACKS/SPALLING

REPLACE

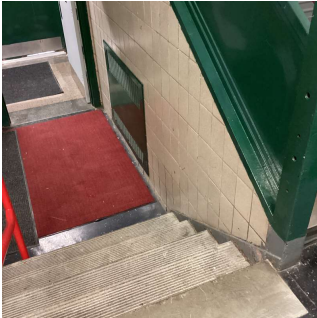
Question	Response
INTERIOR	
STAIRS/RAMPS: INTERIOR	
Railings	
Deficiency	METAL: MISSING
Deficiency Location/Instance	Stair E/1
Deficiency Quantity	10
Quantity Uom	L.F.
Potential Action	REPLACE
Urgency of Action	PRIORITY 5
Purpose of Action	LEVEL 6
Deficiency Photo1

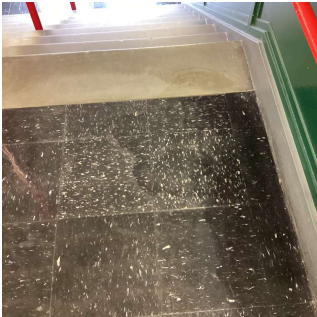
Stair F/1
Violations	No violations recorded.
Deficiency	TERRAZZO: CRACKS
Deficiency Location/Instance	Stairs B/1, Ground Floor, C/Ground Floor Vestibule
Deficiency Quantity	70
Quantity Uom	S.F.
Potential Action	REPLACE
Urgency of Action	PRIORITY 3
Purpose of Action	LEVEL 2

Stair E/1
Violations	No violations recorded.
Stairs and Landings	Inspected
Condition	2 - Between Good and Fair
Deficiency	VINYL TILES: DETERIORATED SUBSTRATE
Deficiency Location/Instance	Stair F/1
Deficiency Quantity	10
Quantity Uom	S.F.
Potential Action	REPLACE
Urgency of Action	PRIORITY 3
Purpose of Action	LEVEL 2
Deficiency Photo1

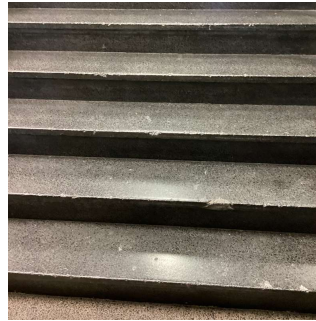
Stair B/1

STONE: BROKEN/MISSING

REPLACE

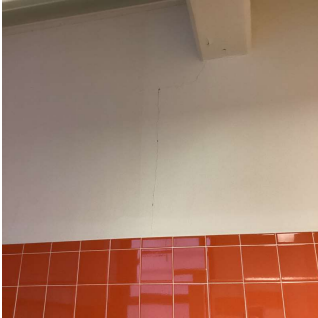
Question	Response
INTERIOR	
TOILET ROOMS - STUDENTS	
Door(s)	Inspected
Condition	1 - Good
Deficiency	No deficiencies recorded
Floor Finish	Inspected
Condition	1 - Good
Deficiency	No deficiencies recorded
Stalls	Inspected
Condition	1 - Good
Deficiency	No deficiencies recorded
Walls	Inspected
Condition	2 - Between Good and Fair
Deficiency	PLASTER: CRACKS/SPALLING
Deficiency Location/Instance	Rooms 112, 318
Deficiency Quantity	20
Quantity Uom	S.F.
Potential Action	REPLACE
Urgency of Action	PRIORITY 3
Purpose of Action	LEVEL 2
Deficiency Photo1

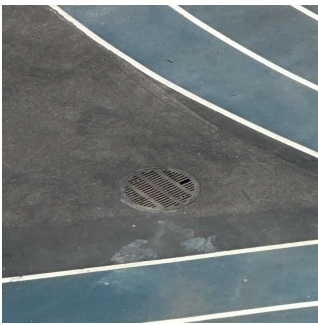
Violations	Room 112 No violations recorded.
LIFE SAFETY	Inspected
F.D. HOLDING AREA	Does not Exist
STEEL STAIRS	Does not Exist
SITE	Inspected
CONTAINERIZATION	Does not Exist
Drainage System for Asphalt	Inspected
Catch Basins/Manhole - Surrounded by asphalt	Inspected
Condition	3 - Fair
Deficiency	DAMAGED COVER
Deficiency Location/Instance	Schoolyard
Deficiency Quantity	1
Quantity Uom	EACH

Potential Action	REPLACE
Urgency of Action	PRIORITY 5
Purpose of Action	LEVEL 6

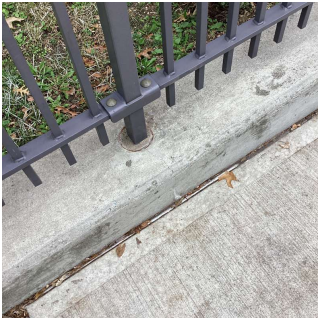
Violations	54th Street No violations recorded.

Violations	Schoolyard No violations recorded.
Culverts - Asphalt Covering	Does not Exist
Drainage System for Concrete	Inspected
Catch Basins/Manhole - Surrounded by concrete	Inspected
Condition	1 - Good
Deficiency	No deficiencies recorded
Culverts - Concrete Covering	Does not Exist
Drainage System for Soil	Inspected
Catch Basins/Manhole - Surrounded by Soil	Inspected
Condition	1 - Good
Deficiency	No deficiencies recorded
Culverts - Soil Covering	Does not Exist
DRINKING FOUNTAINS	Does not Exist
FENCES	Inspected
Condition	2 - Between Good and Fair
Deficiency	CONCRETE CURB: DAMAGED/DETERIORATED
Deficiency Location/Instance	54th Street
Deficiency Quantity	20
Quantity Uom	S.F.
Potential Action	REPLACE
Urgency of Action	PRIORITY 3
Purpose of Action	LEVEL 2
Deficiency Photo1

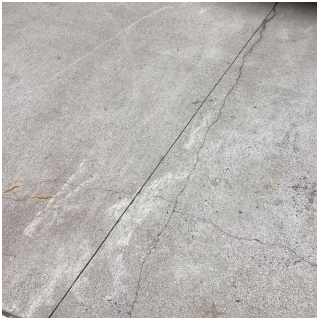
Question	Response
SITE	
PAVING	
Student Non-Use	
Gravel Exists?	No
Asphalt	Does not Exist
Concrete	Inspected
Condition	3 - Fair
Deficiency	CRACKS - MAJOR
Deficiency Location/Instance	54th Street
Deficiency Quantity	100
Quantity Uom	S.F.
Potential Action	REPLACE
Urgency of Action	PRIORITY 3
Purpose of Action	LEVEL 2
Deficiency Photo1

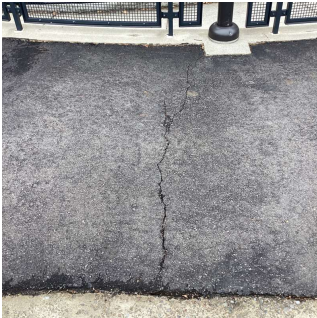
54th Street
Violations	No violations recorded.
Pavers	Does not Exist
Student Use	Inspected
Gravel Exists?	No
Asphalt	Inspected
Condition	3 - Fair
Deficiency	CRACKS - MAJOR
Deficiency Location/Instance	Schoolyard
Deficiency Quantity	100
Quantity Uom	S.F.
Potential Action	REPLACE
Urgency of Action	PRIORITY 3
Purpose of Action	LEVEL 2
Deficiency Photo1

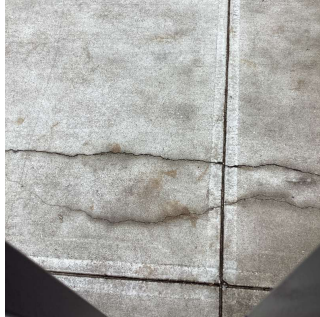
Question	Response
SITE	
PAVING	
Student Use	
Concrete	Inspected
Deficiency	No deficiencies recorded
Pavers	Inspected
Condition	1 - Good
Deficiency	No deficiencies recorded
Site Sidewalks & Walkways	Inspected
Asphalt	Does not Exist
Concrete	Inspected
Condition	3 - Fair
Deficiency	CRACKS - MAJOR
Deficiency Location/Instance	54th Street, near Exit 5, 6
Deficiency Quantity	125
Quantity Uom	S.F.
Potential Action	REPLACE
Urgency of Action	PRIORITY 3
Purpose of Action	LEVEL 2
Deficiency Photo1
