NYC Department of Education
Building Condition Assessment Survey 2023 - 2024

Architectural Inspection

Asset: P.S. 13 - QUEENS, 55-01 94 STREET, New York, 11373

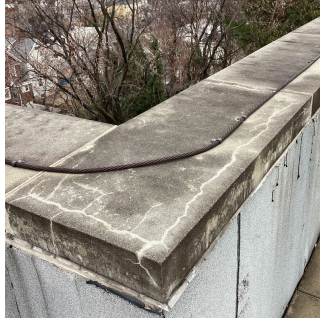
CAST STONE: DISINTEGRATING / FREEZE THAW

10
L.F.
REPLACE-IN-KIND

Question	Response
EXTERIOR	
COPING	
Urgency of Action	PRIORITY 4
Purpose of Action	LEVEL 2
Deficiency Photo1

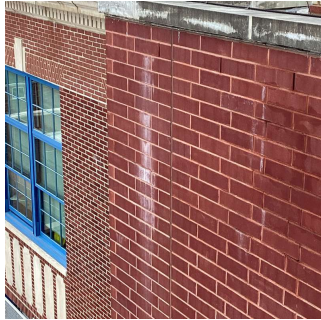
Facade B
Violations	No violations recorded.
EXTERIOR SOFFITS	
Condition	Inspected
Deficiency	2 - Between Good and Fair
	No deficiencies recorded
LOADING DOCK	
	Does not Exist
LOUVER	
Condition	Inspected
Deficiency	2 - Between Good and Fair
	No deficiencies recorded
PARAPETS	
Material Type(s)	Inspected
Replacement Quantity	Masonry, Concrete
Replacement Uom	13,000
	C.F.
Instance on All Facades	Inspected
Instance Condition	2 - Between Good and Fair
Instance Quantity	13,000
Instance Quantity Uom	C.F.
Deficiency	BRICK: EFFLORESCENCE
Roof Plan reference

Deficiency Quantity	20
Quantity Uom	S.F.
Potential Action	MAINTENANCE
Urgency of Action	PRIORITY 3
Purpose of Action	LEVEL 2

Question	Response
EXTERIOR	
PARAPETS	
Deficiency Photo1

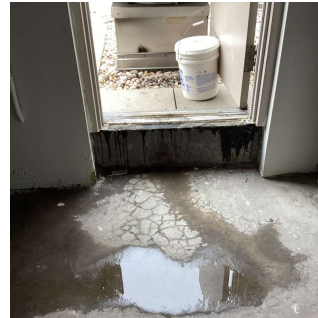
Violations	PH No violations recorded.
Deficiency	BULKHEAD/PENTHOUSE DOORS: AIR/WATER INFILTRATION WITH DAMAGED CAULKING
Roof Plan reference	 
Deficiency Quantity	10
Quantity Uom	L.F.
Potential Action	MAINTENANCE
Urgency of Action	PRIORITY 3
Purpose of Action	LEVEL 2

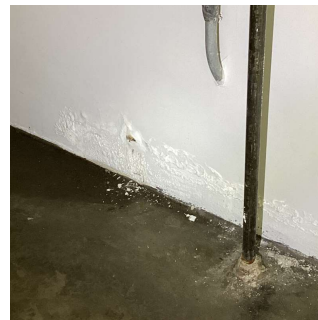
PH

**BULKHEAD/PENTHOUSE WALLS/INTERIOR: PLASTER
CRACKS/SPALLING**

REPLACE

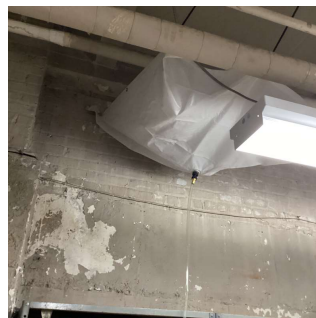
Room C61

BRICK: WATER INFILTRATION IN NON- INSTRUCTIONAL SPACE

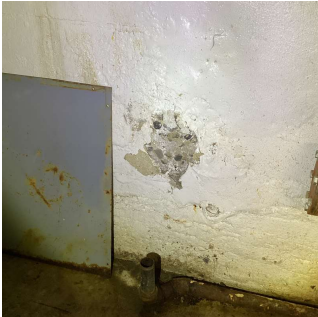
Question	Response
INTERIOR	
STRUCTURAL	
FOUNDATION WALLS	Inspected
Violations	No violations recorded.
ROOF STRUCTURE	Inspected
Condition	2 - Between Good and Fair
Deficiency	No deficiencies recorded
VAULTS-BUNKERS	Inspected
Foundation Walls	Inspected
Condition	3 - Fair
Deficiency	CRACKS, SPALLING
Deficiency Location/Instance	Basement - Ash Hoist Vault
Deficiency Quantity	30
Quantity Uom	S.F.
Potential Action	REPAIR
Urgency of Action	PRIORITY 3
Purpose of Action	LEVEL 5
Deficiency Photo1

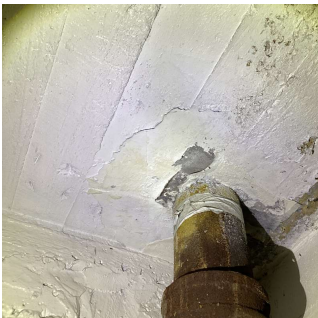
Violations	Basement - Ash Hoist Vault No violations recorded.
Slab Structure	Inspected
Condition	2 - Between Good and Fair
Deficiency	CONCRETE: CRACKS/SPALLED/REINFORCEMENT EXPOSED
Deficiency Location/Instance	Basement - Ash Hoist Vault
Deficiency Quantity	10
Quantity Uom	S.F.
Potential Action	REPAIR
Urgency of Action	PRIORITY 3
Purpose of Action	LEVEL 5
Deficiency Photo1

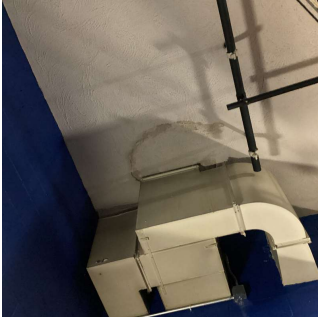
Question	Response
INTERIOR	
AUDITORIUM	Inspected
Instance on 1st Floor (257 Seats)	Inspected
Ceiling	
Instance on 1st Floor (257 Seats)	Inspected
Condition	2 - Between Good and Fair
Deficiency	PLASTER: CRACKS/SPALLING
Deficiency Location/Instance	Right Side of Stage
Deficiency Quantity	20
Quantity Uom	S.F.
Potential Action	REPLACE
Urgency of Action	PRIORITY 3
Purpose of Action	LEVEL 2
Deficiency Photo1

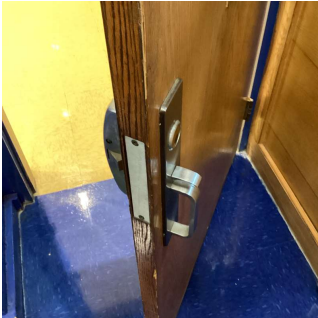
Right Side of Stage
Violations	No violations recorded.
Door(s)	
Instance on 1st Floor (257 Seats)	Inspected
Condition	3 - Fair
Deficiency	WOOD: DETERIORATED DOOR
Deficiency Location/Instance	Exit to Gymnasium
Deficiency Quantity	1
Quantity Uom	EACH
Potential Action	MAINTENANCE
Urgency of Action	PRIORITY 3
Purpose of Action	LEVEL 2
Deficiency Photo1

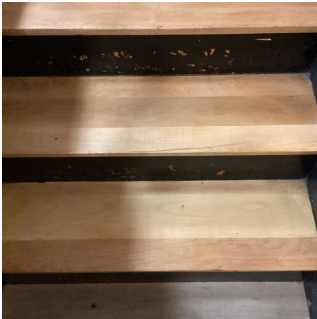
Question	Response
INTERIOR	
AUDITORIUM	
Fixed Seating	
Deficiency	No deficiencies recorded
Floor Finish	
Instance on 1st Floor (257 Seats)	Inspected
Condition	2 - Between Good and Fair
Deficiency	No deficiencies recorded
Sliding-folding Partition	
Instance on 1st Floor (257 Seats)	Not Required
Stage	
Instance on 1st Floor (257 Seats)	Inspected
Stage	
Instance on 1st Floor (257 Seats)	Inspected
Condition	2 - Between Good and Fair
Deficiency	DAMAGED STEPS
Deficiency Location/Instance	Left Side
Deficiency Quantity	10
Quantity Uom	S.F.
Potential Action	REPLACE
Urgency of Action	PRIORITY 3
Purpose of Action	LEVEL 2
Deficiency Photo1

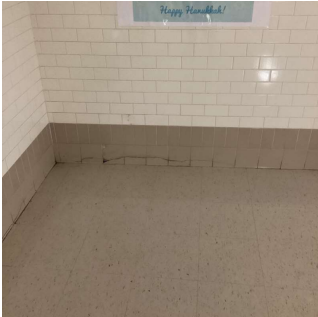
Question	Response
INTERIOR	
CAFETERIA	
Floor Finish	
Violations	No violations recorded.
Sliding-folding Partition	
Instance on Basement	Does not Exist
Stage	
Instance on Basement	Does not Exist
Walls	
Instance on Basement	Inspected
Condition	2 - Between Good and Fair
Deficiency	CERAMIC TILE: BROKEN/ MISSING
Deficiency Location/Instance	Columns Near Room 075B, Left and Right Side Near Windows, near serving area, Near Entrance and others
Deficiency Quantity	70
Quantity Uom	S.F.
Potential Action	REPLACE
Urgency of Action	PRIORITY 3
Purpose of Action	LEVEL 2
Deficiency Photo1

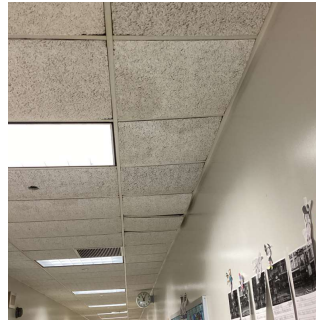
Corridor near Room 393

ACOUSTIC TILES: DAMAGED/MISSING

REPLACE

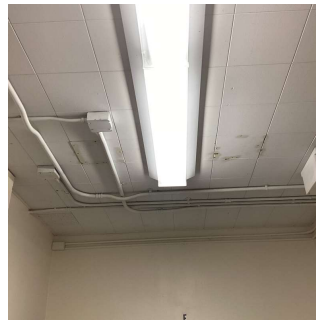
Corridor near Room 155

ACOUSTIC TILES ON PLASTER: DAMAGED/MISSING

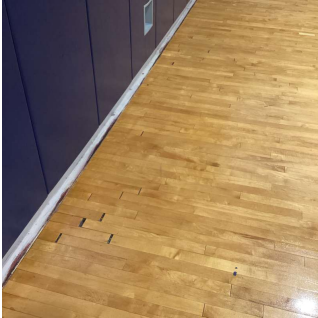
Question	Response
INTERIOR	
GYMNASIUM	
Floor Finish	
Urgency of Action	PRIORITY 3
Purpose of Action	LEVEL 2
Deficiency Photo1

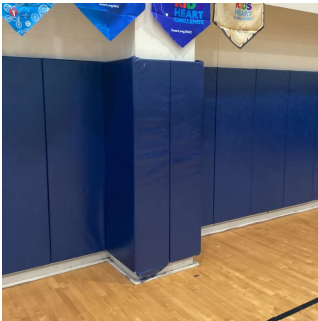
Violations	Near Windows No violations recorded.
Seating	
Instance on 2nd Floor	Does not Exist
Instance on 1st Floor	Does not Exist
Sliding-folding Partition	
Instance on 1st Floor	Inspected
Condition	1 - Good
Deficiency	No deficiencies recorded
Instance on 2nd Floor	Does not Exist
Stage	
Instance on 1st Floor	Does not Exist
Instance on 2nd Floor	Does not Exist
Walls	
Instance on 2nd Floor	Inspected
Condition	2 - Between Good and Fair
Deficiency	WALL PADDING: DETERIORATED
Deficiency Location/Instance	Near Windows, Right Side
Deficiency Quantity	60
Quantity Uom	S.F.
Potential Action	REPLACE
Urgency of Action	PRIORITY 3
Purpose of Action	LEVEL 2
Deficiency Photo1

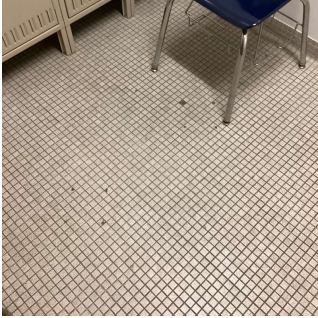
Question	Response
INTERIOR	
KITCHEN	
Door(s)	
Instance on Basement	Inspected
Condition	2 - Between Good and Fair
Deficiency	No deficiencies recorded
Floor Finish	
Instance on Basement	Inspected
Condition	2 - Between Good and Fair
Deficiency	CERAMIC TILE: BROKEN/MISSING TILES
Deficiency Location/Instance	Room 040
Deficiency Quantity	10
Quantity Uom	S.F.
Potential Action	REPLACE
Urgency of Action	PRIORITY 3
Purpose of Action	LEVEL 2
Deficiency Photo1

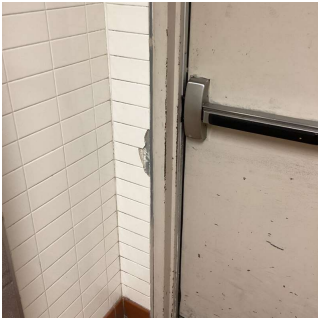
Room 040
Violations	No violations recorded.
Walls	
Instance on Basement	Inspected
Condition	2 - Between Good and Fair
Deficiency	CERAMIC TILE: BROKEN/ MISSING
Deficiency Location/Instance	Exit 8
Deficiency Quantity	10
Quantity Uom	S.F.
Potential Action	REPLACE
Urgency of Action	PRIORITY 3
Purpose of Action	LEVEL 2
Deficiency Photo1

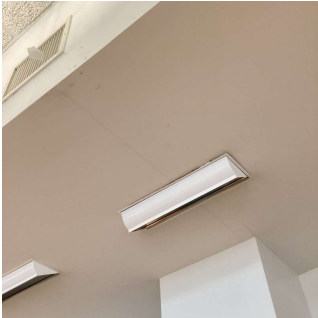
Question	Response
INTERIOR	
LIBRARY	
Built-in Furnishing	
Instance on Room 209	Does not Exist
Ceiling	
Instance on Room 209	Inspected
Condition	2 - Between Good and Fair
Deficiency	GYPSUM BOARD: DAMAGED/DETERIORATED
Deficiency Location/Instance	Left Side
Deficiency Quantity	10
Quantity Uom	S.F.
Potential Action	REPLACE
Urgency of Action	PRIORITY 3
Purpose of Action	LEVEL 2
Deficiency Photo1

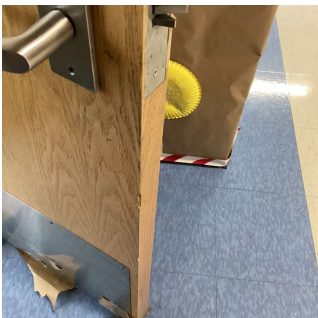
Violations	Left Side No violations recorded.
Door(s)	
Instance on Room 209	Inspected
Condition	3 - Fair
Deficiency	WOOD: DETERIORATED DOOR
Deficiency Location/Instance	Main Entrance
Deficiency Quantity	1
Quantity Uom	EACH
Potential Action	MAINTENANCE
Urgency of Action	PRIORITY 3
Purpose of Action	LEVEL 2
Deficiency Photo1

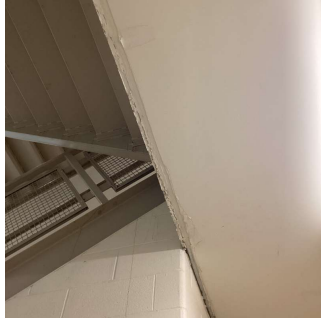
Do Letter Stair Signs Exist?	Yes
Ceiling	
Condition	Inspected 2 - Between Good and Fair
Deficiency	GYPSUM BOARD: DAMAGED/DETERIORATED
Deficiency Location/Instance	Stair J/Basement
Deficiency Quantity	10
Quantity Uom	S.F.

Potential Action	REPLACE
Urgency of Action	PRIORITY 3
Purpose of Action	LEVEL 2
Deficiency Photo1

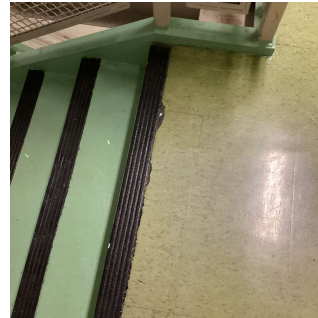
Stair G/2

VINYL TILES: BROKEN/DETERIORATED/MISSING TILES

REPLACE

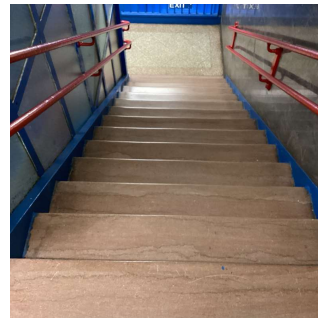
Stair DE/2

STONE: WORN-OUT TREAD/NOSINGS

REPLACE

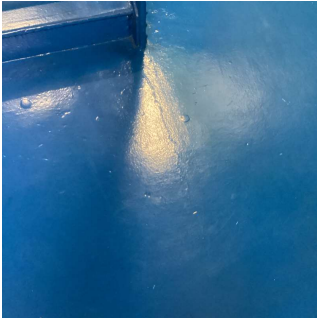
Question	Response
INTERIOR	
STAIRS/RAMPS: INTERIOR	
Stairs and Landings	
Deficiency	CONCRETE: CRACKS/SPALLING - MAJOR
Deficiency Location/Instance	Stairs BC/1, H/ Bulkhead
Deficiency Quantity	50
Quantity Uom	S.F.
Potential Action	REPLACE
Urgency of Action	PRIORITY 3
Purpose of Action	LEVEL 2
Deficiency Photo1

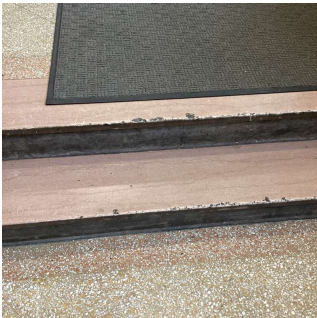
Stair BC/1
Violations	No violations recorded.
Deficiency	STONE: BROKEN/MISSING
Deficiency Location/Instance	Exit 1 Vestibule
Deficiency Quantity	10
Quantity Uom	S.F.
Potential Action	REPLACE
Urgency of Action	PRIORITY 3
Purpose of Action	LEVEL 2
Deficiency Photo1

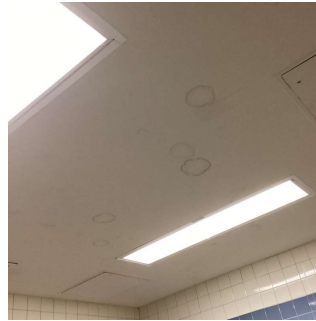
Room 387

Deficiency	GYPSUM BOARD: DAMAGED/DETERIORATED
Deficiency Location/Instance	Rooms 387, 381, 287, 187, 075B
Deficiency Quantity	60
Quantity Uom	S.F.
Potential Action	REPLACE
Urgency of Action	PRIORITY 3
Purpose of Action	LEVEL 2

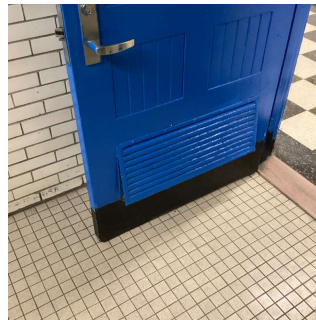
Room 158

WOOD: DAMAGED LOUVER

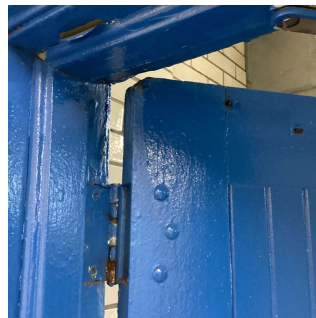
WOOD: DETERIORATED DOOR

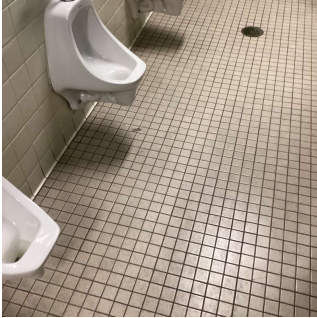
Question	Response
INTERIOR	
TOILET ROOMS - STUDENTS	
Door(s)	Inspected Room 158
Violations	No violations recorded.
Floor Finish	Inspected
Condition	2 - Between Good and Fair
Deficiency	CERAMIC TILE: BROKEN/MISSING TILES
Deficiency Location/Instance	Rooms 395A, 361, 261, 081, 158 and others
Deficiency Quantity	70
Quantity Uom	S.F.
Potential Action	REPLACE
Urgency of Action	PRIORITY 3
Purpose of Action	LEVEL 2
Deficiency Photo1

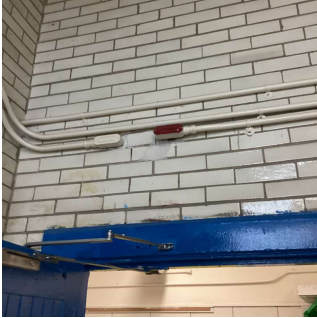
Violations	Room 158 No violations recorded.
Stalls	Inspected
Condition	2 - Between Good and Fair
Deficiency	No deficiencies recorded
Walls	Inspected
Condition	2 - Between Good and Fair
Deficiency	BRICK: CRACKS/SPALLING
Deficiency Location/Instance	Rooms 158, 164
Deficiency Quantity	20
Quantity Uom	S.F.
Potential Action	REPLACE
Urgency of Action	PRIORITY 3
Purpose of Action	LEVEL 2
Deficiency Photo1

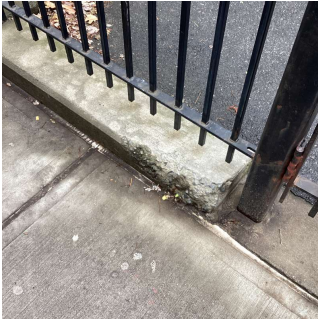
Question	Response
LIFE SAFETY	Inspected
F.D. HOLDING AREA	Does not Exist
STEEL STAIRS	Does not Exist
SITE	Inspected
CONTAINERIZATION	Does not Exist
Drainage System for Asphalt	Inspected
Catch Basins/Manhole - Surrounded by asphalt	Inspected
Condition	2 - Between Good and Fair
Deficiency	No deficiencies recorded
Culverts - Asphalt Covering	Does not Exist
Drainage System for Concrete	Inspected
Catch Basins/Manhole - Surrounded by concrete	Inspected
Condition	2 - Between Good and Fair
Deficiency	No deficiencies recorded
Culverts - Concrete Covering	Inspected
Condition	2 - Between Good and Fair
Deficiency	No deficiencies recorded
Drainage System for Soil	Inspected
Catch Basins/Manhole - Surrounded by Soil	Inspected
Condition	2 - Between Good and Fair
Deficiency	No deficiencies recorded
Culverts - Soil Covering	Does not Exist
DRINKING FOUNTAINS	Does not Exist
FENCES	Inspected
Condition	3 - Fair
Deficiency	CONCRETE CURB: DAMAGED/DETERIORATED

Deficiency Location/Instance	56th Avenue
Deficiency Quantity	20
Quantity Uom	S.F.
Potential Action	REPLACE
Urgency of Action	PRIORITY 3
Purpose of Action	LEVEL 2
Deficiency Photo1

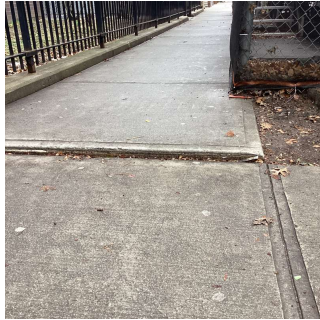
Question	Response
SITE	
PAVING	
DOT Sidewalk	
Concrete	
Deficiency	HEAVING
Deficiency Location/Instance	56th Avenue
Deficiency Quantity	75
Quantity Uom	S.F.
Potential Action	REPLACE
Urgency of Action	PRIORITY 3
Purpose of Action	LEVEL 2
Deficiency Photo1

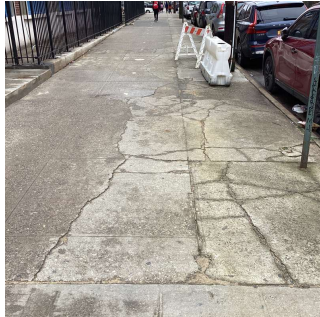
Violations	55th Avenue No violations recorded.
Deficiency	DAMAGED/DETERIORATED/MISSING SECTIONS
Deficiency Location/Instance	55th Avenue, 56th Avenue, 94th Street
Deficiency Quantity	3,050
Quantity Uom	S.F.
Potential Action	REPLACE
Urgency of Action	PRIORITY 3
Purpose of Action	LEVEL 2

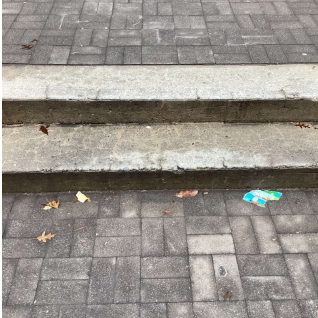
Question	Response
SITE	
SEATING	Does not Exist
SITE WALLS (NOT RETAINING WALLS)	Inspected
Condition	2 - Between Good and Fair
Deficiency	No deficiencies recorded
STAIRS/RAMPS: EXTERIOR	Inspected
Railings	Inspected
Condition	2 - Between Good and Fair
Deficiency	No deficiencies recorded
Site Cheek/flank Walls	Inspected
Condition	2 - Between Good and Fair
Deficiency	No deficiencies recorded
Stairs/ramps	Inspected
Condition	2 - Between Good and Fair
Deficiency	CAST IN PLACE CONCRETE: CRACKS/SPALLING - MAJOR
Deficiency Location/Instance	56th Avenue
Deficiency Quantity	10
Quantity Uom	S.F.
Potential Action	REPLACE
Urgency of Action	PRIORITY 3
Purpose of Action	LEVEL 2
Deficiency Photo1
