NYC Department of Education
Building Condition Assessment Survey 2023 - 2024

Architectural Inspection

Asset: P.S. 17 - QUEENS, 28-37 29 STREET, New York, 11102

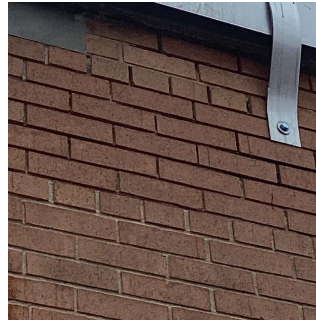
Roof 1

Question	Response
Architectural	
EXTERIOR	Inspected
AREAWAY	Inspected
Instance on AW1, AW2	Inspected
Instance Condition	2 - Between Good and Fair
Instance Quantity	2
Instance Quantity Uom	EACH
Deficiency	No deficiencies recorded
AWNINGS AND CANOPIES	Does not Exist
CHIMNEY	Inspected
Material Type(s)	Masonry
Condition	3 - Fair
Deficiency	BRICK: DETERIORATED LADDER

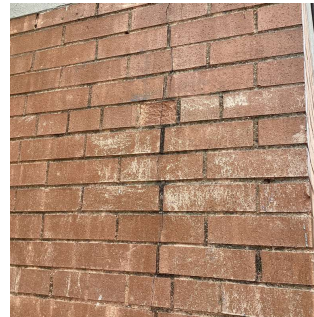
Facade E

BRICK: MINOR CRACKS AND SPALLING

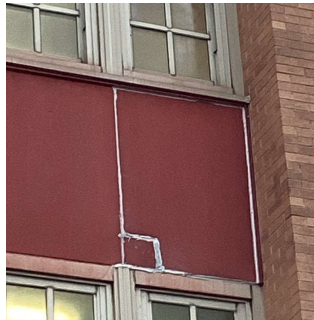
Facade H

**CAST IN PLACE / PRE-CAST CONCRETE: MAJOR
CRACKS/SPALLING**

REPLACE

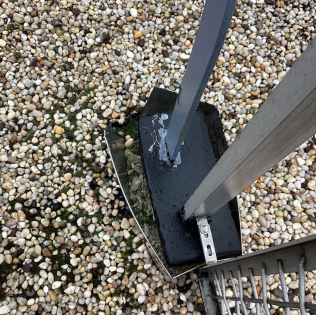
Question	Response
EXTERIOR	
ROOF	
Roofing	
ROOFING	
Source of Installation	Custodial Staff
Deficiency	BUILT-UP: FLASHING: PITCH POCKET DETERIORATED - MAJOR
Roof Plan reference	<p>Q017</p>

Deficiency Quantity	100
Quantity Uom	EACH
Potential Action	REPLACE
Urgency of Action	PRIORITY 4
Purpose of Action	LEVEL 2
Deficiency Photo1

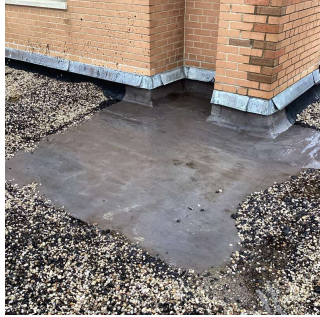
Violations	Roof 5 No violations recorded.
Deficiency	BUILT-UP: ROOFING: LOSS OF GRAVEL
Roof Plan reference	<p>Q017</p>

Deficiency Quantity	150
Quantity Uom	S.F.
Potential Action	INSTALL NEW GRAVEL
Urgency of Action	PRIORITY 3
Purpose of Action	LEVEL 2

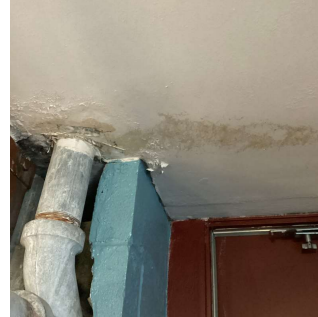
Roof 1 - Bulkhead 2

**BULKHEAD/PENTHOUSE WALLS/INTERIOR: PLASTER
CRACKS/SPALLING**

10
S.F.
REPLACE
PRIORITY 3
LEVEL 2

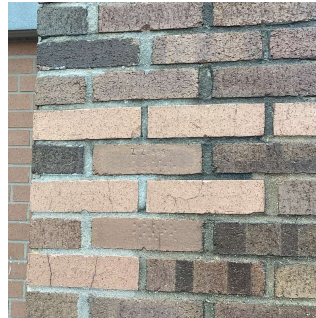
Roof 1 - Bulkhead 2

**BULKHEAD/PENTHOUSE WALLS/EXTERIOR:
CRACKS/SPALLING - MINOR**

30
S.F.
REPAIR
PRIORITY 3
LEVEL 2

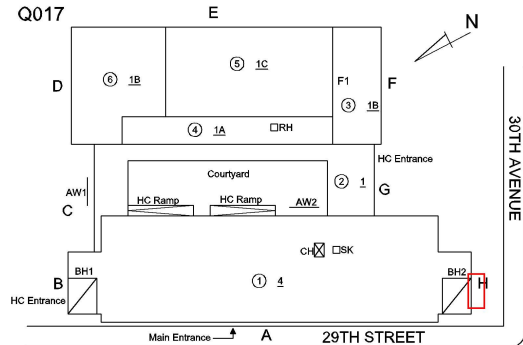
STONE: CRACKS/SPALLING - MINOR

10
S.F.
REPAIR
PRIORITY 3
LEVEL 2

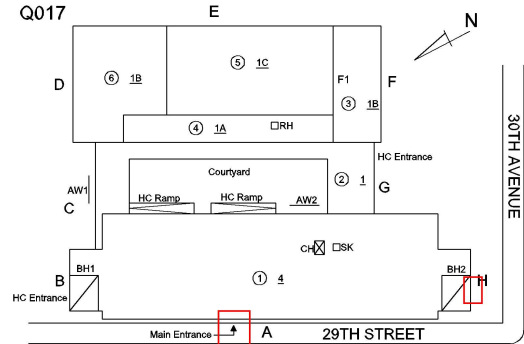
STONE: DETERIORATED JOINTS

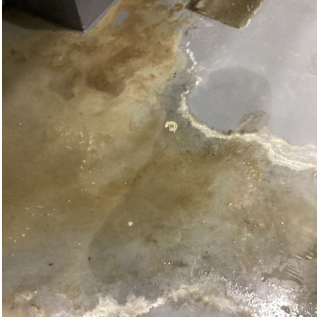
Question	Response
EXTERIOR	
WINDOWS	
WINDOWS	Inspected
Material Type(s)	Aluminum
Instance on Aluminum - Double Hung: All Facades	Inspected
Instance Condition	3 - Fair
Instance Quantity	10,400
Instance Quantity Uom	S.F.
Are these windows insulated	No
Installation Year	1998
Source of Installation	Custodial Staff
Deficiency	No deficiencies recorded
Instance on Aluminum - Other: All Facades at 1st Floor	Inspected
Instance Condition	3 - Fair
Instance Quantity	1,600
Instance Quantity Uom	S.F.
Are these windows insulated	No
Installation Year	1998
Source of Installation	Custodial Staff
Deficiency	No deficiencies recorded
INTERIOR	Inspected
POOLS	Does not Exist
STRUCTURAL	Inspected
COLUMNS/BEAMS/BEARING WALLS	Inspected
Condition	2 - Between Good and Fair
Deficiency	No deficiencies recorded
FLOOR STRUCTURE	Inspected
Condition	4 - Between Fair and Poor
Deficiency	CONCRETE SLAB ON GRADE: WATER INFILTRATION IN NON-INSTRUCTIONAL SPACE

Deficiency Location/Instance	Basement - Boiler Room Pit
Deficiency Quantity	100
Quantity Uom	S.F.
Potential Action	INSTALL WATERPROOFING
Urgency of Action	PRIORITY 5
Purpose of Action	LEVEL 5
Deficiency Photo1

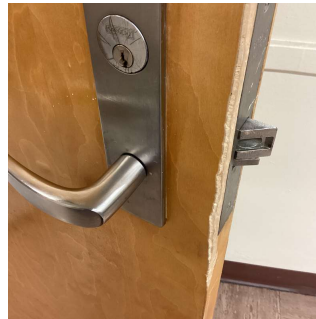
Instance on 1st Floor - Staff (600 SF)	Inspected
Condition	3 - Fair
Deficiency	WOOD: DETERIORATED DOOR
Deficiency Location/Instance	Entrance
Deficiency Quantity	1
Quantity Uom	EACH
Potential Action	MAINTENANCE
Urgency of Action	PRIORITY 3
Purpose of Action	LEVEL 2
Deficiency Photo1

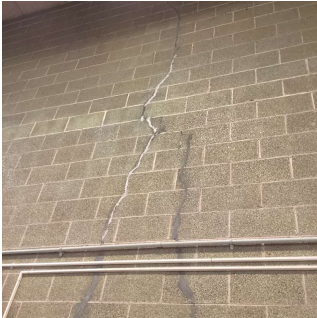
Question	Response
INTERIOR	
CAFETERIA	
Walls	
Deficiency	MASONRY: CRACKS/SPALLING
Deficiency Location/Instance	Near Serving Area, Sliding Folding Partition.
Deficiency Quantity	50
Quantity Uom	S.F.
Potential Action	REPLACE
Urgency of Action	PRIORITY 3
Purpose of Action	LEVEL 2
Deficiency Photo1

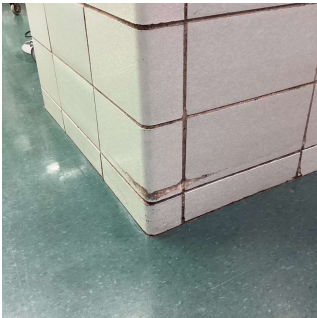
Violations	Near Serving Area No violations recorded.
Deficiency	GLAZED BLOCK: CRACKS/SPALLING
Deficiency Location/Instance	Near Serving Area, windows
Deficiency Quantity	10
Quantity Uom	S.F.
Potential Action	REPLACE
Urgency of Action	PRIORITY 3
Purpose of Action	LEVEL 2
Deficiency Photo1

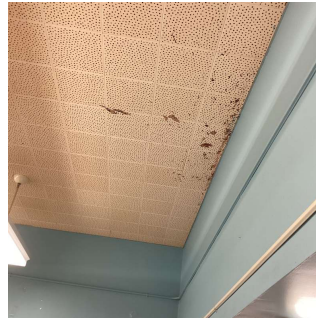
Room 109

ACOUSTIC TILES ON PLASTER: DAMAGED/MISSING

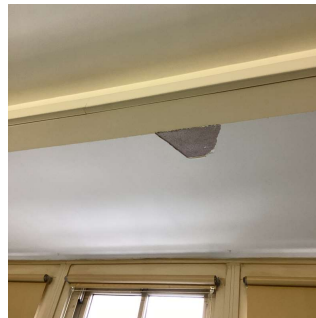
Room 300

PLASTER: CRACKS/SPALLING

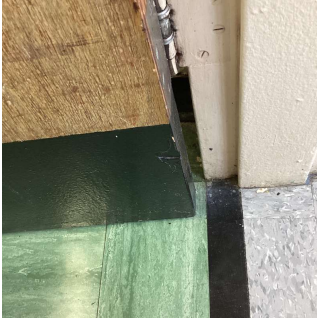
Question	Response
INTERIOR	
CLASSROOMS/CORRIDORS/ADMIN SPACES	
Door(s)	Inspected
Condition	5 - Poor
Deficiency	WOOD: DETERIORATED DOOR
Deficiency Location/Instance	Rooms 137, 154, 232, 313, 424, and others.
Deficiency Quantity	8
Quantity Uom	EACH
Potential Action	MAINTENANCE
Urgency of Action	PRIORITY 3
Purpose of Action	LEVEL 2
Deficiency Photo1

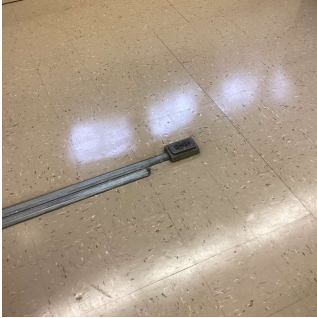
Room 137
Violations	No violations recorded.
Floor Finish	Inspected
Condition	2 - Between Good and Fair
Deficiency	VINYL TILES: TRIPPING HAZARD - ELECTRICAL OUTLET
Deficiency Location/Instance	Room 108
Deficiency Quantity	10
Quantity Uom	S.F.
Potential Action	REMOVE
Urgency of Action	PRIORITY 5
Purpose of Action	LEVEL 6
Deficiency Photo1

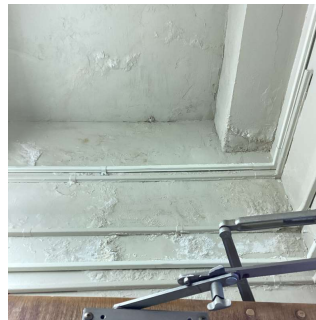
Room 137

PLASTER: CRACKS/SPALLING - ACTIVE LEAK

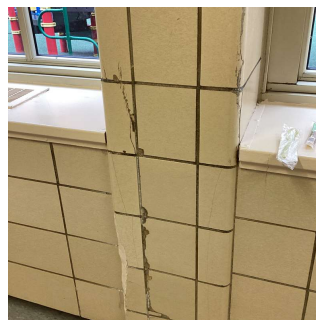
GLAZED BLOCK: CRACKS/SPALLING

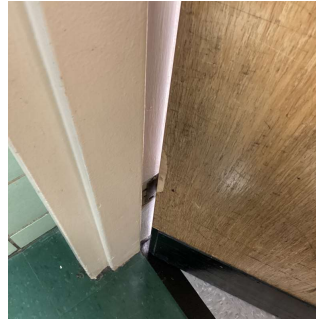
Entrance

Condition	5 - Poor
Deficiency	WOOD: DETERIORATED DOOR
Deficiency Location/Instance	Entrances, Office
Deficiency Quantity	3
Quantity Uom	EACH
Potential Action	MAINTENANCE
Urgency of Action	PRIORITY 3
Purpose of Action	LEVEL 2
Deficiency Photo1

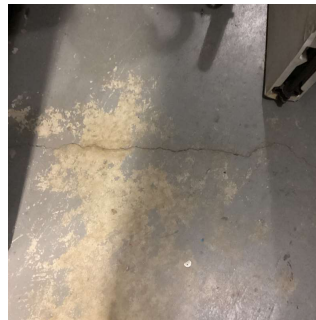
Instance on 1st Floor	Inspected
Condition	2 - Between Good and Fair
Deficiency	CONCRETE: CRACKS
Deficiency Location/Instance	Storage Room
Deficiency Quantity	20
Quantity Uom	S.F.
Potential Action	REPLACE
Urgency of Action	PRIORITY 3
Purpose of Action	LEVEL 2
Deficiency Photo1

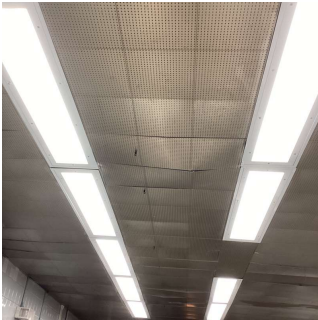
Question	Response
INTERIOR	
INTERIOR GUARDS	Inspected
Condition	2 - Between Good and Fair
Deficiency	No deficiencies recorded
KITCHEN	Inspected
Instance on 1st Floor	Inspected
Ceiling	
Instance on 1st Floor	Inspected
Condition	3 - Fair
Deficiency	METAL PAN: DAMAGED/MISSING
Deficiency Location/Instance	Near center
Deficiency Quantity	40
Quantity Uom	S.F.
Potential Action	REPLACE
Urgency of Action	PRIORITY 3
Purpose of Action	LEVEL 2
Deficiency Photo1

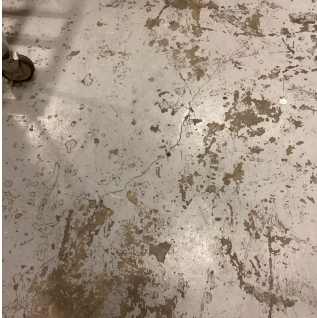
Question	Response
INTERIOR	
KITCHEN	
Floor Finish	
Condition	3 - Fair
Deficiency	CONCRETE: CRACKS
Deficiency Location/Instance	Storage Room
Deficiency Quantity	20
Quantity Uom	S.F.
Potential Action	REPLACE
Urgency of Action	PRIORITY 3
Purpose of Action	LEVEL 2
Deficiency Photo1

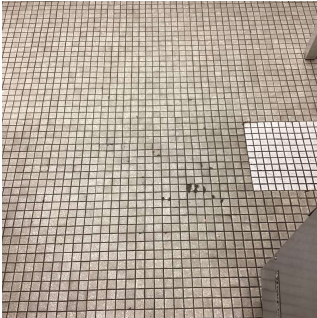
Violations	Storage Room No violations recorded.
Deficiency	CERAMIC TILE: BROKEN/MISSING TILES
Deficiency Location/Instance	Near Windows, Sink Area, Center
Deficiency Quantity	20
Quantity Uom	S.F.
Potential Action	REPLACE
Urgency of Action	PRIORITY 3
Purpose of Action	LEVEL 2
Deficiency Photo1

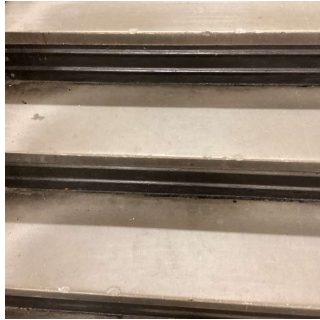
Question	Response
INTERIOR	
STAIRS/RAMPS: INTERIOR	
Stairs and Landings	
Potential Action	REPLACE
Urgency of Action	PRIORITY 3
Purpose of Action	LEVEL 2
Deficiency Photo1

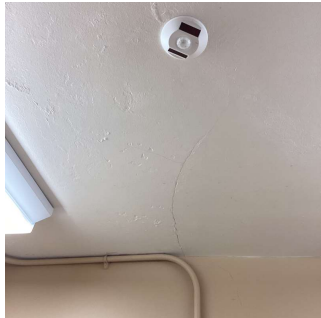
Question	Response
INTERIOR	
STAIRS/RAMPS: INTERIOR	
Walls	
Deficiency Photo1	 
Violations	Stair C/1 No violations recorded.
TOILET ROOMS - STAFF	
Ceiling	Inspected
Condition	3 - Fair
Deficiency	PLASTER: CRACKS/SPALLING
Deficiency Location/Instance	Room 153
Deficiency Quantity	20
Quantity Uom	S.F.
Potential Action	REPLACE
Urgency of Action	PRIORITY 3
Purpose of Action	LEVEL 2
Deficiency Photo1

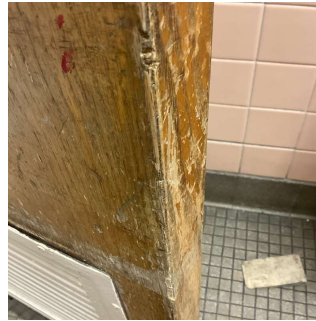
Violations	Room 153 No violations recorded.
Door(s)	
Condition	5 - Poor
Deficiency	WOOD: DETERIORATED DOOR
Deficiency Location/Instance	Rooms 153, 301, 401, 403, Kitchen Locker Room 139, and others
Deficiency Quantity	8
Quantity Uom	EACH
Potential Action	MAINTENANCE
Urgency of Action	PRIORITY 3
Purpose of Action	LEVEL 2

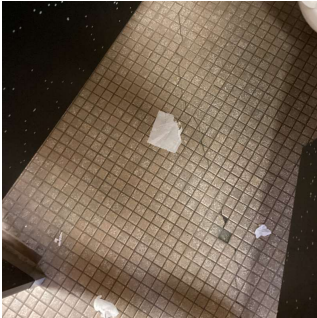
Question	Response
INTERIOR	
TOILET ROOMS - STUDENTS	
Door(s)	Inspected
	Room 331
Violations	No violations recorded.
Floor Finish	Inspected
Condition	2 - Between Good and Fair
Deficiency	CERAMIC TILE: DETERIORATED SUBSTRATE
Deficiency Location/Instance	Room 231
Deficiency Quantity	10
Quantity Uom	S.F.
Potential Action	REPLACE
Urgency of Action	PRIORITY 3
Purpose of Action	LEVEL 2
Deficiency Photo1

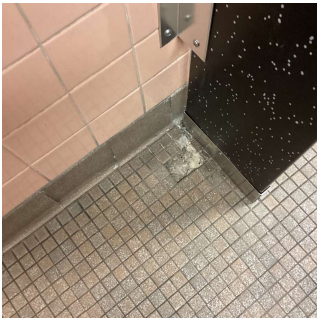
Room 231
Violations	No violations recorded.
Deficiency	CERAMIC TILE: BROKEN/MISSING TILES
Deficiency Location/Instance	Room 143
Deficiency Quantity	10
Quantity Uom	S.F.
Potential Action	REPLACE
Urgency of Action	PRIORITY 3
Purpose of Action	LEVEL 2
Deficiency Photo1

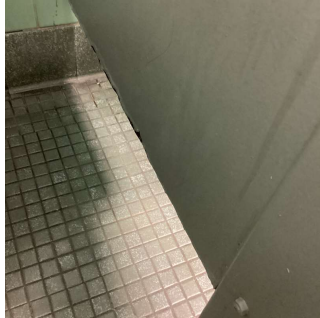
Room 143
Violations	No violations recorded.
Stalls	Inspected
Condition	4 - Between Fair and Poor
Deficiency	RUST - MAJOR
Deficiency Location/Instance	Room 201, Locker room
Deficiency Quantity	3
Quantity Uom	EACH
Potential Action	REPLACE

Question	Response
INTERIOR	
TOILET ROOMS - STUDENTS	
Stalls	
Urgency of Action	PRIORITY 3
Purpose of Action	LEVEL 2
Deficiency Photo1

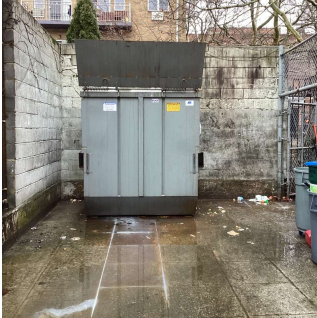
Question	Response
SITE	
CONTAINERIZATION	
Deficiency Photo1

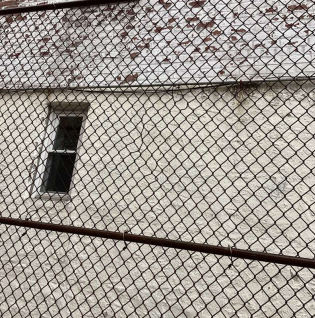
Violations	Near Exit 4 No violations recorded.
Drainage System for Asphalt	Inspected
Catch Basins/Manhole - Surrounded by asphalt	Inspected
Condition	2 - Between Good and Fair
Deficiency	No deficiencies recorded
Culverts - Asphalt Covering	Does not Exist
Drainage System for Concrete	Inspected
Catch Basins/Manhole - Surrounded by concrete	Inspected
Condition	5 - Poor
Deficiency	BLOCKED
Deficiency Location/Instance	Near Exits 4
Deficiency Quantity	1
Quantity Uom	EACH
Potential Action	MAINTENANCE
Urgency of Action	PRIORITY 3
Purpose of Action	LEVEL 2
Deficiency Photo1	No photo recorded
Violations	No violations recorded.
Culverts - Concrete Covering	Does not Exist
Drainage System for Soil	Does not Exist
DRINKING FOUNTAINS	Does not Exist
FENCES	Inspected
Condition	4 - Between Fair and Poor
Deficiency	CHAIN LINK: DAMAGED POST/RAIL
Deficiency Location/Instance	Near Exit 2

Deficiency Quantity	50
Quantity Uom	L.F.
Potential Action	REPLACE
Urgency of Action	PRIORITY 3
Purpose of Action	LEVEL 2

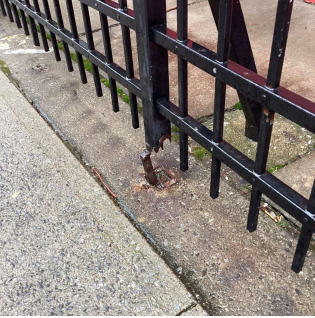
Violations	Near Exit 2 No violations recorded.
Deficiency	WROUGHT IRON: RUST - MAJOR
Deficiency Location/Instance	29th Street
Deficiency Quantity	200
Quantity Uom	S.F.
Potential Action	REPLACE
Urgency of Action	PRIORITY 3
Purpose of Action	LEVEL 2
Deficiency Photo1

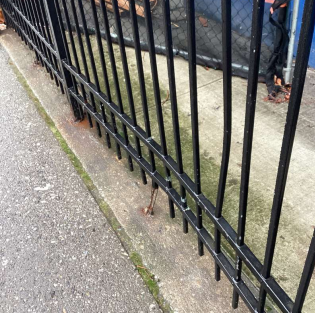
Violations	29th Street No violations recorded.
Deficiency	WROUGHT IRON: DAMAGED/DETERIORATED
Deficiency Location/Instance	29th Street
Deficiency Quantity	80
Quantity Uom	S.F.
Potential Action	REPLACE
Urgency of Action	PRIORITY 3
Purpose of Action	LEVEL 2
Deficiency Photo1

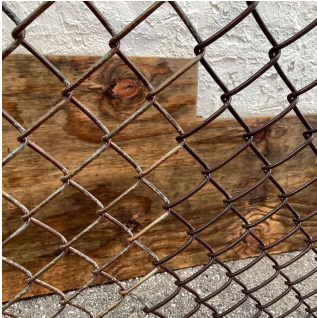
Violations	29th Street No violations recorded.
Deficiency	CHAIN LINK: RUST - MAJOR

Question	Response
SITE	
FENCES	
Deficiency Location/Instance	Near Exits 2, 4
Deficiency Quantity	1,800
Quantity Uom	S.F.
Potential Action	REPLACE
Urgency of Action	PRIORITY 3
Purpose of Action	LEVEL 2
Deficiency Photo1

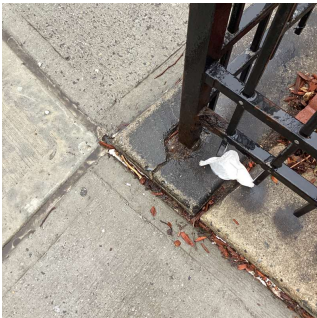
Violations	Near Exit 2 No violations recorded.
Deficiency	CONCRETE CURB: DAMAGED/DETERIORATED
Deficiency Location/Instance	29 Street, 30th Avenue, Near Exit 2, 4.
Deficiency Quantity	35
Quantity Uom	S.F.
Potential Action	REPLACE
Urgency of Action	PRIORITY 3
Purpose of Action	LEVEL 2
Deficiency Photo1

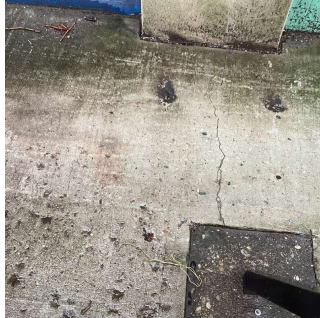
Violations	30th Avenue No violations recorded.
IRRIGATION SYSTEM	Does not Exist
PAVING	Inspected
Student Non-Use	Inspected
Gravel Exists?	No
Asphalt	Does not Exist
Concrete	Inspected
Condition	3 - Fair
Deficiency	DAMAGED/DETERIORATED/MISSING SECTIONS
Deficiency Location/Instance	29th Street, Near containerization Area.
Deficiency Quantity	100
Quantity Uom	S.F.
Potential Action	REPLACE
Urgency of Action	PRIORITY 3

Question	Response
SITE	
PAVING	
Student Non-Use	
Concrete	
Purpose of Action	LEVEL 2
Deficiency Photo1

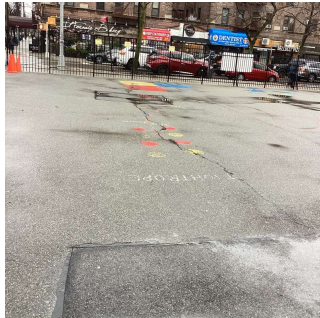
29th Street
Violations	No violations recorded.
Pavers	Does not Exist
Student Use	Inspected
Gravel Exists?	No
Asphalt	Inspected
Condition	3 - Fair
Deficiency	CRACKS - MAJOR
Deficiency Location/Instance	Near Exit 5
Deficiency Quantity	200
Quantity Uom	S.F.
Potential Action	REPLACE
Urgency of Action	PRIORITY 3
Purpose of Action	LEVEL 2
Deficiency Photo1

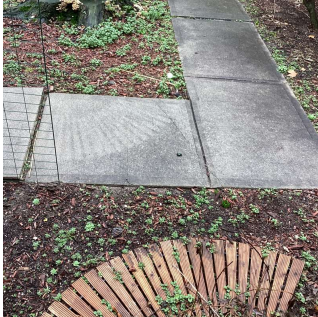
Near Exit 5
Violations	No violations recorded.
Concrete	Inspected
Condition	2 - Between Good and Fair
Deficiency	DAMAGED/DETERIORATED/MISSING SECTIONS
Deficiency Location/Instance	Courtyard
Deficiency Quantity	25
Quantity Uom	S.F.
Potential Action	REPLACE
Urgency of Action	PRIORITY 3
Purpose of Action	LEVEL 2

Question	Response
SITE	
PAVING	
Student Use	
Concrete	
Deficiency Photo1

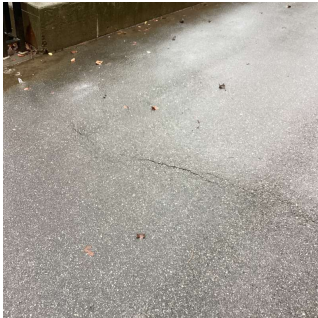
Violations	Near Exit 4A No violations recorded.
Concrete	Inspected
Condition	3 - Fair
Deficiency	DAMAGED/DETERIORATED/MISSING SECTIONS
Deficiency Location/Instance	Near Exits 1, 6
Deficiency Quantity	75
Quantity Uom	S.F.
Potential Action	REPLACE
Urgency of Action	PRIORITY 3
Purpose of Action	LEVEL 2

Violations	Courtyard No violations recorded.
Pavers	Does not Exist
Site Sidewalks & Walkways	Inspected
Asphalt	Inspected
Condition	2 - Between Good and Fair
Deficiency	CRACKS - MAJOR
Deficiency Location/Instance	Near Exit 4A
Deficiency Quantity	30
Quantity Uom	S.F.
Potential Action	REPLACE
Urgency of Action	PRIORITY 3
Purpose of Action	LEVEL 2
Deficiency Photo1

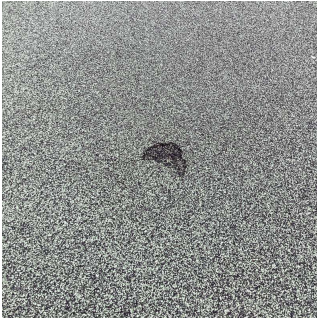
Question	Response
SITE	
PLAYGROUNDS	
Play Equipment	
Deficiency	No deficiencies recorded
Safety Surfacing	
Instance on Courtyard	Inspected
Condition	2 - Between Good and Fair
Deficiency	DETERIORATED/MISSING
Deficiency Location/Instance	Near center
Deficiency Quantity	10
Quantity Uom	S.F.
Potential Action	REPLACE
Urgency of Action	PRIORITY 3
Purpose of Action	LEVEL 2
Deficiency Photo1
