NYC Department of Education
Building Condition Assessment Survey 2023 - 2024

Architectural Inspection

Asset: P.S. 18 - QUEENS, 86-35 235 COURT, New York, 11427

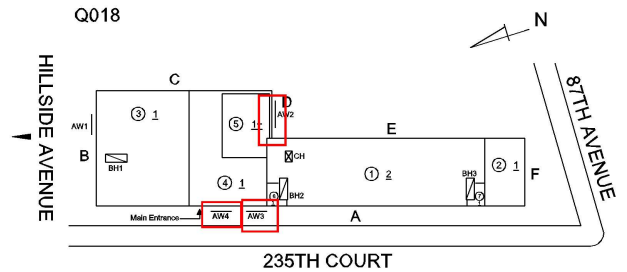
Facade A - AW4

Question	Response
Architectural	
EXTERIOR	Inspected
AREAWAY	Inspected
Instance on AW1-AW4	Inspected
Instance Condition	3 - Fair
Instance Quantity	4
Instance Quantity Uom	EACH
Deficiency	AREAWAY WALLS: CRACKS AND SPALLING
Roof Plan reference	Q018
Deficiency Quantity	30
Quantity Uom	S.F.
Potential Action	REPAIR
Urgency of Action	PRIORITY 3
Purpose of Action	LEVEL 2
Deficiency Photo1

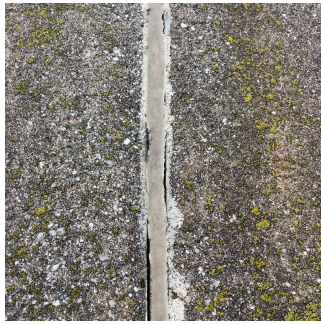
Question	Response
EXTERIOR	
AREAWAY	
Violations	No violations recorded.
AWNINGS AND CANOPIES	
Condition	Inspected
Deficiency	2 - Between Good and Fair
CHIMNEY	
Material Type(s)	Inspected
Condition	Masonry
Deficiency	2 - Between Good and Fair
COPING	
Condition	Inspected
Deficiency	3 - Fair
Roof Plan reference	CAST STONE: DETERIORATED TRANSVERSE JOINTS
Deficiency Quantity	30
Quantity Uom	L.F.
Potential Action	MAINTENANCE
Urgency of Action	PRIORITY 3
Purpose of Action	LEVEL 2
Deficiency Photo1

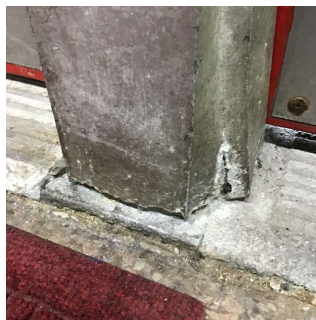
Facade A

METAL: DETERIORATED DOOR AND FRAME - MAJOR DETERIORATION

6
EACH
REPLACE
PRIORITY 4
LEVEL 2

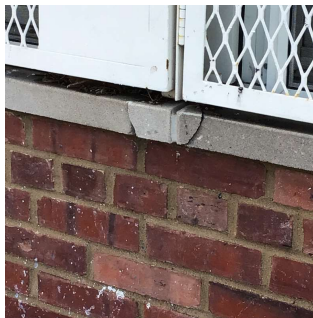
BRICK: DETERIORATED MASONRY SILLS - MINOR

20

REPAIR

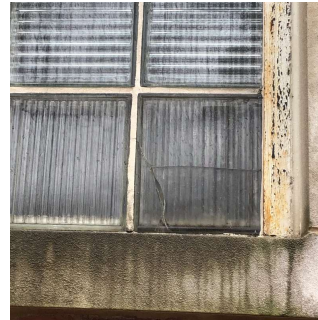
Facade A

GLASS BLOCK: CHIPPED/ BROKEN PIECES

10

REPLACE-IN-KIND

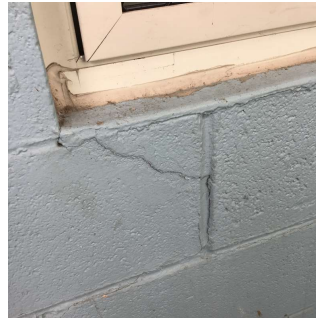
Roof 1 - Bulkhead 3

BULKHEAD/PENTHOUSE WALLS/INTERIOR: CMU
 CRACKS/SPALLING

20
 S.F.
 REPLACE
 PRIORITY 3
 LEVEL 2

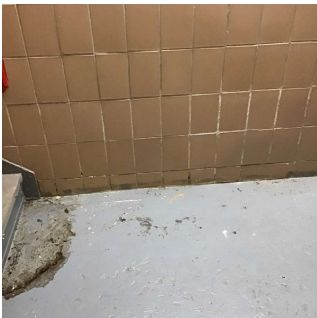
Question	Response
EXTERIOR	
WINDOWS	
WINDOWS	
Instance on Aluminum - Other: All Facades	Inspected
Instance Condition	3 - Fair
Instance Quantity	6,100
Instance Quantity Uom	S.F.
Are these windows insulated	Yes
Installation Year	2005
Source of Installation	Custodial Staff
Deficiency	No deficiencies recorded
INTERIOR	Inspected
POOLS	Does not Exist
STRUCTURAL	Inspected
COLUMNS/BEAMS/BEARING WALLS	Inspected
Condition	2 - Between Good and Fair
Deficiency	No deficiencies recorded
FLOOR STRUCTURE	Inspected
Condition	2 - Between Good and Fair
Deficiency	No deficiencies recorded
FOUNDATION WALLS	Inspected
Material Type(s)	Concrete
Condition	4 - Between Fair and Poor
Deficiency	CONCRETE: WATER INFILTRATION IN NON- INSTRUCTIONAL SPACE
Deficiency Location/Instance	Basement - North side Staircase
Deficiency Quantity	100
Quantity Uom	S.F.
Potential Action	INSTALL WATERPROOFING
Urgency of Action	PRIORITY 5
Purpose of Action	LEVEL 5
Deficiency Photo1

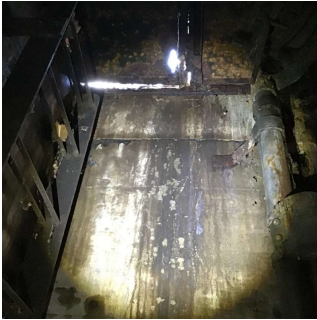
Question	Response
INTERIOR	
STRUCTURAL	
VAULTS-BUNKERS	
Slab Structure	Inspected
Condition	2 - Between Good and Fair
Deficiency	No deficiencies recorded
Vault/Ash Hoist Doors and Framing	Inspected
Condition	5 - Poor
Deficiency	WATER INFILTRATION
Deficiency Location/Instance	Basement - Ash Hoist Vault
Deficiency Quantity	10
Quantity Uom	S.F.
Potential Action	REPAIR
Urgency of Action	PRIORITY 5
Purpose of Action	LEVEL 2
Deficiency Photo1

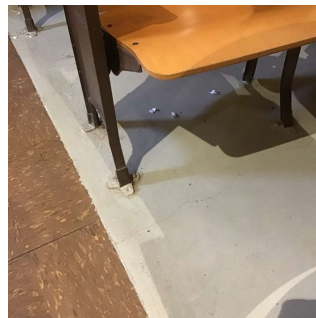
Deficiency	CONCRETE: CRACKS
------------	------------------

Deficiency Location/Instance	Near Seat O/1, Seat L/110
------------------------------	---------------------------

Deficiency Quantity	20
---------------------	----

Potential Action	REPLACE
------------------	---------

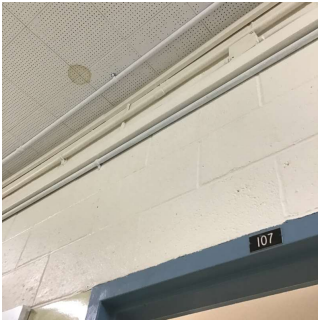
Violations	Near Entrance No violations recorded.
Window Curtains/Shades/Blinds	
Instance on 1st Floor	Does not Exist
CLASSROOMS/CORRIDORS/ADMIN SPACES	
Ceiling	Inspected
Condition	2 - Between Good and Fair
Deficiency	ACOUSTIC TILES ON PLASTER: DAMAGED/MISSING
Deficiency Location/Instance	Room 114, Corridor near Room 107
Deficiency Quantity	20
Quantity Uom	S.F.
Potential Action	REPLACE
Urgency of Action	PRIORITY 3
Purpose of Action	LEVEL 2
Deficiency Photo1

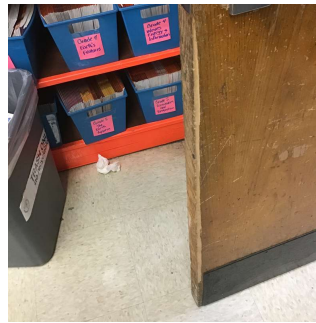
Room 214

Violations	Corridor near Room 107 No violations recorded.
Door(s)	
Condition	Inspected
Condition	5 - Poor
Deficiency	WOOD: DETERIORATED DOOR
Deficiency Location/Instance	Rooms B13, 114, 204, 207, 214, and others.
Deficiency Quantity	17
Quantity Uom	EACH
Potential Action	MAINTENANCE
Urgency of Action	PRIORITY 3
Purpose of Action	LEVEL 2

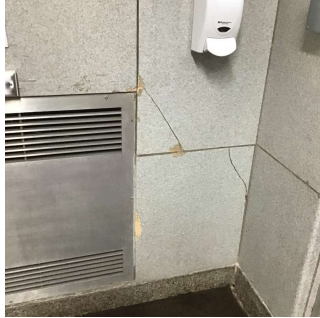
Question	Response
INTERIOR	
CLASSROOMS/CORRIDORS/ADMIN SPACES	
Floor Finish	Inspected
	Room 210
Violations	No violations recorded.
Walls	Inspected
Condition	2 - Between Good and Fair
Deficiency	GLAZED BLOCK: CRACKS/SPALLING
Deficiency Location/Instance	Main Entrance, Corridor near Room 119
Deficiency Quantity	30
Quantity Uom	S.F.
Potential Action	REPLACE
Urgency of Action	PRIORITY 3
Purpose of Action	LEVEL 2
Deficiency Photo1

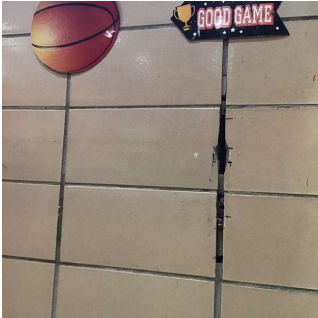
Question	Response
INTERIOR	
GYMNASIUM	
Seating	
Instance on 1st Floor	Inspected
Condition	2 - Between Good and Fair
Deficiency	No deficiencies recorded
Sliding-folding Partition	
Instance on 1st Floor	Does not Exist
Stage	
Instance on 1st Floor	Does not Exist
Walls	
Instance on 1st Floor	Inspected
Condition	2 - Between Good and Fair
Deficiency	GLAZED BLOCK: CRACKS/SPALLING
Deficiency Location/Instance	Near Windows, Drinking Fountain
Deficiency Quantity	20
Quantity Uom	S.F.
Potential Action	REPLACE
Urgency of Action	PRIORITY 3
Purpose of Action	LEVEL 2
Deficiency Photo1

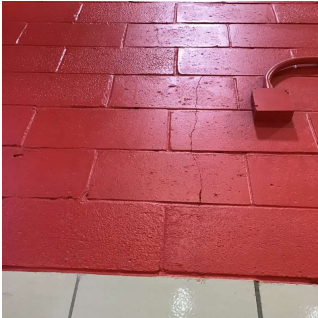
Violations	Near Windows No violations recorded.
Deficiency	MASONRY: CRACKS/SPALLING
Deficiency Location/Instance	Near Drinking Fountain, Storage Room
Deficiency Quantity	20
Quantity Uom	S.F.
Potential Action	REPLACE
Urgency of Action	PRIORITY 3
Purpose of Action	LEVEL 2
Deficiency Photo1

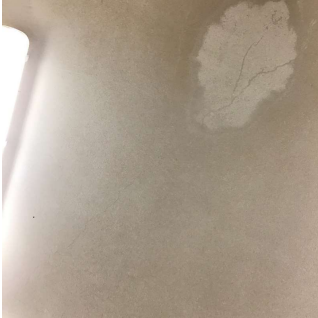
Question	Response
INTERIOR	
GYMNASIUM	Inspected
Window Curtains/Shades/Blinds	
Instance on 1st Floor	Does not Exist
INTERIOR DOOR HARDWARE	Inspected
Condition	3 - Fair
Deficiency	No deficiencies recorded
INTERIOR GUARDS	Inspected
Condition	2 - Between Good and Fair
Deficiency	No deficiencies recorded
KITCHEN	Inspected
Instance on 1st Floor	Inspected
Ceiling	
Instance on 1st Floor	Inspected
Condition	2 - Between Good and Fair
Deficiency	PLASTER: CRACKS/SPALLING
Deficiency Location/Instance	Near center
Deficiency Quantity	10
Quantity Uom	S.F.
Potential Action	REPLACE
Urgency of Action	PRIORITY 3
Purpose of Action	LEVEL 2
Deficiency Photo1

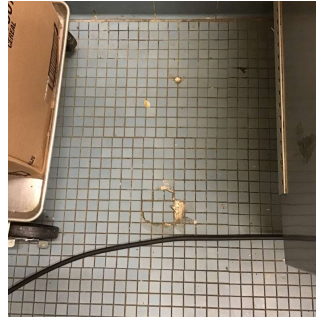
Near Serving Area

CERAMIC TILE: BROKEN/MISSING TILES

REPLACE

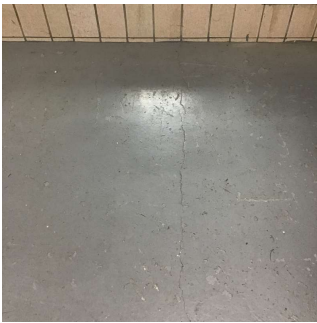
Question	Response
INTERIOR	
STAIRS/RAMPS: INTERIOR	
Stairs and Landings	Inspected
Deficiency Photo1

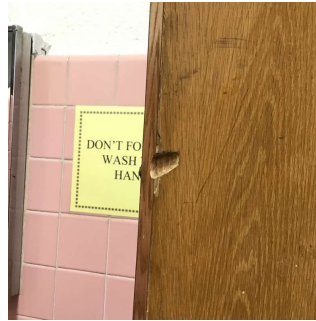
Room 216

Stair B/1 - Vestibule
Violations	No violations recorded.
TOILET ROOMS - STAFF	
	Inspected
Ceiling	Inspected
Condition	2 - Between Good and Fair
Deficiency	No deficiencies recorded
Door(s)	Inspected
Condition	5 - Poor
Deficiency	WOOD: DETERIORATED DOOR
Deficiency Location/Instance	RoomsB/11, 131, 216
Deficiency Quantity	3
Quantity Uom	EACH
Potential Action	MAINTENANCE
Urgency of Action	PRIORITY 3
Purpose of Action	LEVEL 2

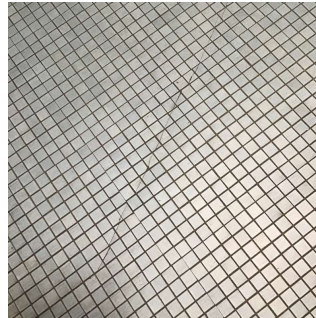
Room 132

CERAMIC TILE: BROKEN/MISSING TILES

REPLACE

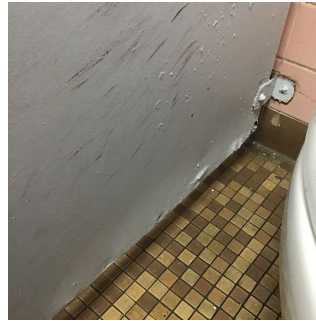
Room 133

RUST - MAJOR

REPLACE

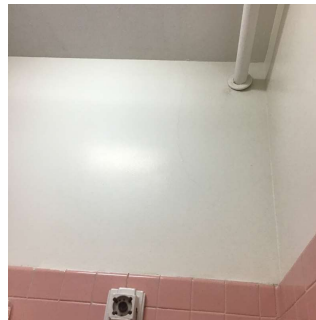
Room 114A

PLASTER: CRACKS/SPALLING

REPLACE

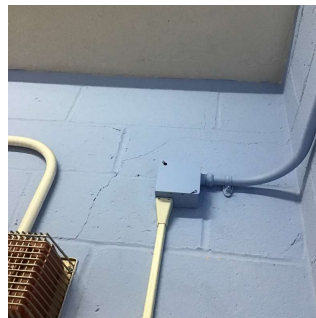
MASONRY: CRACKS/SPALLING

REPLACE

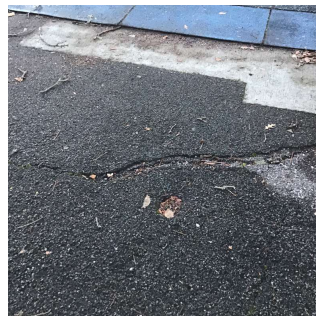
Student Use	
	Inspected
Gravel Exists?	No
Asphalt	
	Inspected
Condition	4 - Between Fair and Poor
Deficiency	CRACKS - MAJOR
Deficiency Location/Instance	Around Playground
Deficiency Quantity	500
Quantity Uom	S.F.
Potential Action	REPLACE
Urgency of Action	PRIORITY 3
Purpose of Action	LEVEL 2
Deficiency Photo1

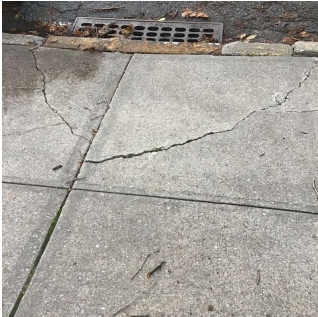
Question	Response
SITE	
PAVING	
Site Sidewalks & Walkways	Inspected
Concrete	Inspected
Violations	No violations recorded.
Pavers	Does not Exist
DOT Sidewalk	Inspected
Asphalt	Does not Exist
Concrete	Inspected
Condition	4 - Between Fair and Poor
Deficiency	DAMAGED/DETERIORATED/MISSING SECTIONS
Deficiency Location/Instance	87th Avenue, 235th Court.
Deficiency Quantity	750
Quantity Uom	S.F.
Potential Action	REPLACE
Urgency of Action	PRIORITY 3
Purpose of Action	LEVEL 2
Deficiency Photo1

235th Court
Violations	No violations recorded.
Deficiency	DAMAGED CURBS
Deficiency Location/Instance	87th Avenue, 235th Court
Deficiency Quantity	100
Quantity Uom	L.F.
Potential Action	REPLACE
Urgency of Action	PRIORITY 3
Purpose of Action	LEVEL 2
Deficiency Photo1

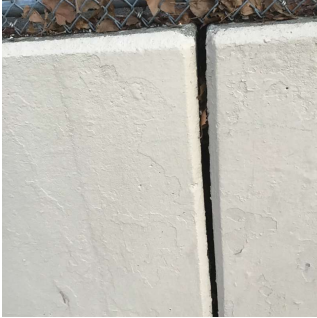
Question	Response
SITE	
PLAYGROUNDS	
Benches	
Instance on South Side	Does not Exist
Fence	
Instance on South Side	Does not Exist
Pavement	
Instance on South Side	Does not Exist
Play Equipment	
Instance on South Side	Inspected
Condition	2 - Between Good and Fair
Deficiency	No deficiencies recorded
Safety Surfacing	
Instance on South Side	Inspected
Condition	2 - Between Good and Fair
Deficiency	No deficiencies recorded
Unpaved Area	
Instance on South Side	Does not Exist
PLAYING SURFACE	Does not Exist
RETAINING WALLS	Inspected
Are there any Retaining Walls 6' OR higher facing public street/sidewalk?	No
Condition	3 - Fair
Deficiency	CAST IN PLACE CONCRETE: DETERIORATED CONTROL/EXPANSION JOINT
Deficiency Location/Instance	235th Court, 87th Avenue
Deficiency Quantity	10
Quantity Uom	L.F.
Potential Action	REPLACE
Urgency of Action	PRIORITY 3
Purpose of Action	LEVEL 2
Deficiency Photo1

235th Court
Violations	No violations recorded.

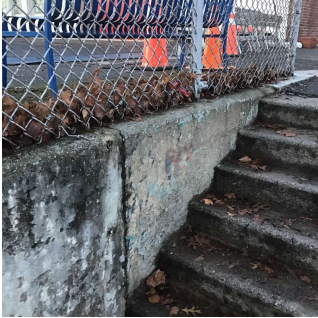
Question	Response
SITE	
RETAINING WALLS	
Deficiency Photo1	 
Violations	87th Avenue No violations recorded.
SEATING	Inspected
Benches	Inspected
Concrete	Does not Exist
Metal/Wood/Plastic	Inspected
Condition	2 - Between Good and Fair
Deficiency	No deficiencies recorded
Bleachers	Does not Exist
SITE WALLS (NOT RETAINING WALLS)	Does not Exist
STAIRS/RAMPS: EXTERIOR	Inspected
Railings	Inspected
Condition	3 - Fair
Deficiency	MISSING
Deficiency Location/Instance	Near Playground Stairs
Deficiency Quantity	10
Quantity Uom	L.F.
Potential Action	REPLACE
Urgency of Action	PRIORITY 5
Purpose of Action	LEVEL 6
Deficiency Photo1

Violations	Near Playground Stair No violations recorded.
Site Cheek/flank Walls	Inspected
Condition	2 - Between Good and Fair
Deficiency	No deficiencies recorded
Stairs/ramps	Inspected
Condition	2 - Between Good and Fair
Deficiency	CAST IN PLACE CONCRETE: CRACKS/SPALLING - MAJOR
Deficiency Location/Instance	Near Playground

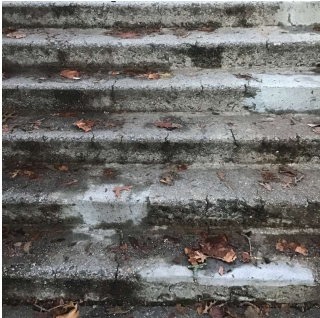
Question	Response
SITE	
STAIRS/RAMPS: EXTERIOR	
Stairs/ramps	
Deficiency Quantity	20
Quantity Uom	S.F.
Potential Action	REPLACE
Urgency of Action	PRIORITY 3
Purpose of Action	LEVEL 2
Deficiency Photo1

Violations	Near Playground No violations recorded.
ARTWORK	Does not Exist
