NYC Department of Education
Building Condition Assessment Survey 2023 - 2024

Architectural Inspection

Asset: P.S. 21 - QUEENS, 147-36 26TH AVENUE, New York, 11354

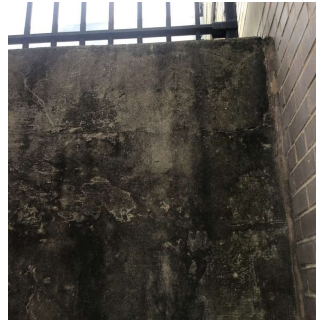
AW1
No violations recorded.

Question	Response
Architectural	
EXTERIOR	Inspected
AREAWAY	Inspected
Instance on AW1	Inspected
Instance Condition	3 - Fair
Instance Quantity	1
Instance Quantity Uom	EACH
Deficiency	AREAWAY WALLS: CRACKS AND SPALLING
Roof Plan reference	<div style="display: flex; align-items: center;"> <div style="margin-right: 10px;">Q021</div> </div>
Deficiency Quantity	20
Quantity Uom	S.F.
Potential Action	REPAIR
Urgency of Action	PRIORITY 3
Purpose of Action	LEVEL 2

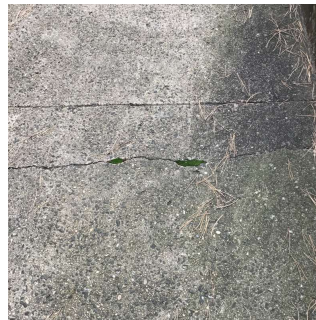
AW1
No violations recorded.

AREAWAY SLAB: CRACKS AND SPALLING

20
S.F.
REPAIR
PRIORITY 3
LEVEL 2

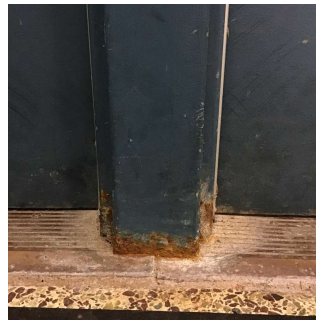
Facade A

METAL: DETERIORATED DOOR AND FRAME - MINOR DETERIORATION

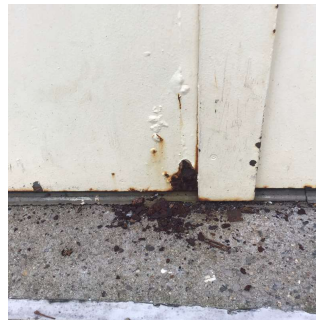
Facade A

METAL: DETERIORATED DOOR - MAJOR DETERIORATION

REPLACE

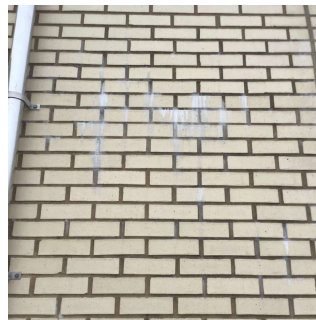
Facade A

BRICK: EFFLORESCENCE

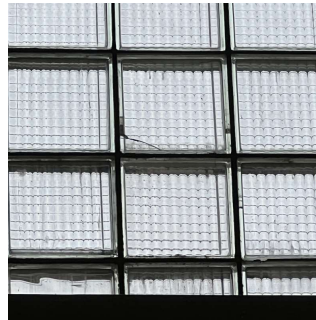
Facade C1 - Gymnasium

GLASS BLOCK: CHIPPED/ BROKEN PIECES

REPLACE-IN-KIND

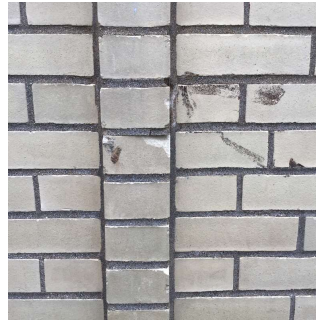
Facade A

BRICK: MINOR CRACKS AND SPALLING

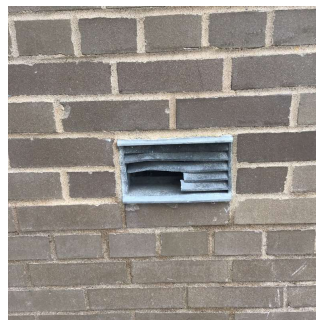
Facade E

BROKEN/ DENTED BLADES

REPLACE

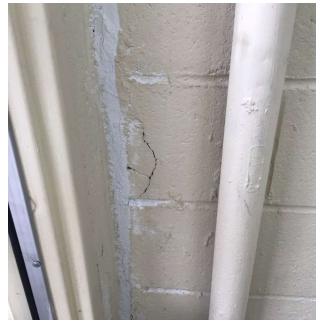
BH1
 No violations recorded.

Is/Are the roof(s) suitable for Solar Panel installation?	No
Installation Year	2016
Source of Installation	Custodial Staff
Deficiency	No deficiencies recorded
ROOFING DRAINS	Inspected
Condition	2 - Between Good and Fair
Deficiency	No deficiencies recorded
Specialties	Inspected
BULKHEAD/PENTHOUSE	Inspected
Condition	3 - Fair
Deficiency	BULKHEAD/PENTHOUSE WALLS/INTERIOR: CMU CRACKS/SPALLING

10
 S.F.
 REPLACE
 PRIORITY 3
 LEVEL 2

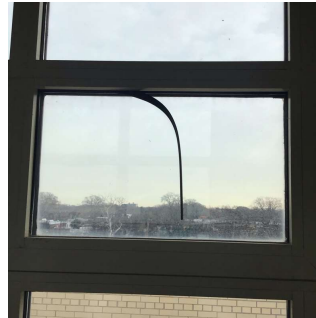
BH1

BULKHEAD/PENTHOUSE WINDOWS: DAMAGED, DETERIORATED WINDOWS

30
 S.F.
 REPLACE
 PRIORITY 4
 LEVEL 2

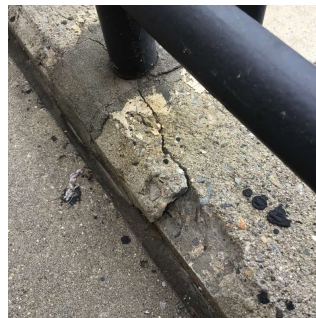
Facade H

CAST IN PLACE CONCRETE: CRACKS/SPALLING - MAJOR

REPLACE

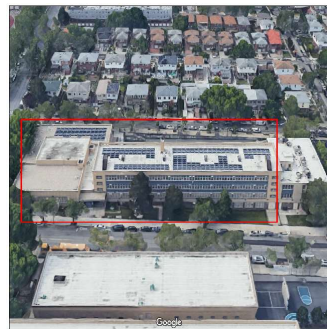
Instance Quantity Uom	Inspected
Are these windows insulated	S.F.
Installation Year	Yes
Source of Installation	2006
Deficiency	Custodial Staff
Roof Plan reference	ALUMINUM - DOUBLE HUNG: INOPERABLE BALANCE

40
EACH
REPLACE BALANCES
PRIORITY 3
LEVEL 2

Facade C - 1st Floor Cafeteria (other locations similar)
No violations recorded.

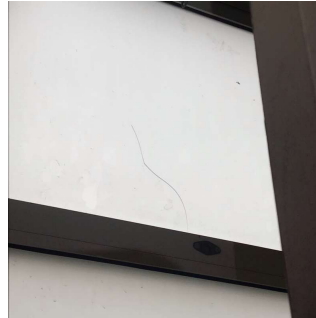
Facade A - near Boiler Room (Facade F - Room 226, through out original building similar)

Deficiency	ALUMINUM - DOUBLE HUNG: BROKEN PANE
Roof Plan reference	Q021

300
S.F.
MAINTENANCE
PRIORITY 3
LEVEL 2

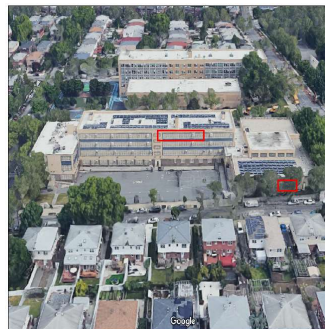
ALUMINUM - DOUBLE HUNG: DETERIORATED

150
S.F.
REPLACE WINDOW

Question	Response
EXTERIOR	
WINDOWS	
WINDOWS	
Urgency of Action	PRIORITY 4
Purpose of Action	LEVEL 2
Deficiency Photo1	 
	Facade F - 1st Floor Cafeteria (throughout original building similar)
Violations	No violations recorded.
INTERIOR	Inspected
POOLS	Does not Exist
STRUCTURAL	Inspected
COLUMNS/BEAMS/BEARING WALLS	Inspected
Condition	2 - Between Good and Fair
Deficiency	STEEL COLUMNS/BEAMS: DETERIORATED CONCRETE FIREPROOFING
Deficiency Location/Instance	Basement - Room B21
Deficiency Quantity	10
Quantity Uom	S.F.
Potential Action	REPLACE
Urgency of Action	PRIORITY 3
Purpose of Action	LEVEL 5
Deficiency Photo1	 
Violations	Basement - Room B21 No violations recorded.
FLOOR STRUCTURE	Inspected
Condition	3 - Fair
Deficiency	CONCRETE SLAB ON GRADE: THRU CRACKS
Deficiency Location/Instance	Boiler Room, Rooms B14, B24, B26
Deficiency Quantity	150
Quantity Uom	S.F.
Potential Action	REPAIR
Urgency of Action	PRIORITY 3
Purpose of Action	LEVEL 5

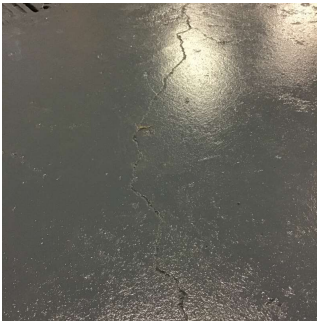
Question	Response
INTERIOR	
STRUCTURAL	
FLOOR STRUCTURE	
Deficiency Photo1

Violations	Boiler Room No violations recorded.
FOUNDATION WALLS	
Material Type(s)	Inspected Concrete
Condition	2 - Between Good and Fair
Deficiency	No deficiencies recorded
ROOF STRUCTURE	
Condition	Inspected 2 - Between Good and Fair
Deficiency	No deficiencies recorded
VAULTS-BUNKERS	
	Does not Exist
AUDITORIUM	
Instance on 1st Floor (416 Seats)	Inspected Inspected
Ceiling	
Instance on 1st Floor (416 Seats)	Inspected
Condition	2 - Between Good and Fair
Deficiency	PLASTER: CRACKS/SPALLING
Deficiency Location/Instance	Right Side Near Windows
Deficiency Quantity	20
Quantity Uom	S.F.
Potential Action	REPLACE
Urgency of Action	PRIORITY 3
Purpose of Action	LEVEL 2
Deficiency Photo1

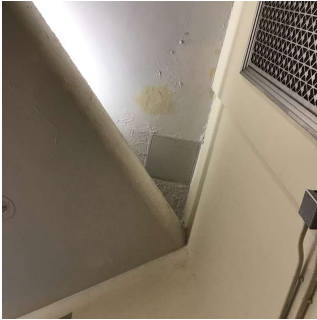
Violations	Right Side Near Windows No violations recorded.
Door(s)	
Instance on 1st Floor (416 Seats)	Inspected
Condition	2 - Between Good and Fair
Deficiency	No deficiencies recorded

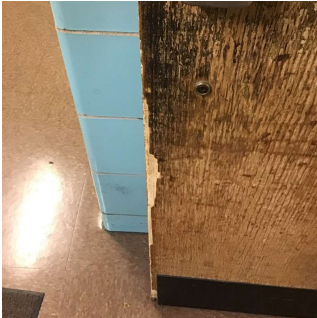
Question	Response
INTERIOR	
CAFETERIA	
Door(s)	
Deficiency	WOOD: DETERIORATED DOOR
Deficiency Location/Instance	Main Entrance
Deficiency Quantity	2
Quantity Uom	EACH
Potential Action	MAINTENANCE
Urgency of Action	PRIORITY 3
Purpose of Action	LEVEL 2
Deficiency Photo1

Violations	Main Entrance No violations recorded.
Fixed Equipment	
Instance on Basement (2000SF)	Does not Exist
Instance on 1st Floor	Does not Exist
Floor Finish	
Instance on Basement (2000SF)	Inspected
Condition	3 - Fair
Deficiency	VINYL TILES: DETERIORATED SUBSTRATE
Deficiency Location/Instance	Near Serving area, Near Entrance , Near Drinking Fountain, Left Side
Deficiency Quantity	70
Quantity Uom	S.F.
Potential Action	REPLACE
Urgency of Action	PRIORITY 3
Purpose of Action	LEVEL 2
Deficiency Photo1	 
Violations	Near Serving area No violations recorded.
Sliding-folding Partition	
Instance on Basement (2000SF)	Does not Exist
Instance on 1st Floor	Inaccessible

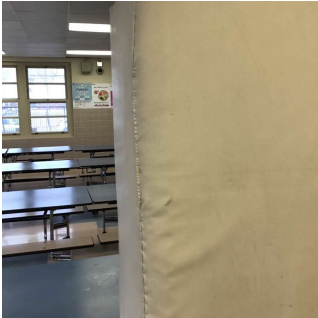
Question	Response
INTERIOR	
CAFETERIA	
Stage	
Instance on Basement (2000SF)	Does not Exist
Walls	
Instance on Basement (2000SF)	Inspected
Condition	2 - Between Good and Fair
Deficiency	WALL PADDING: DETERIORATED
Deficiency Location/Instance	Columns
Deficiency Quantity	40
Quantity Uom	S.F.
Potential Action	REPLACE
Urgency of Action	PRIORITY 3
Purpose of Action	LEVEL 2
Deficiency Photo1

Violations	Columns No violations recorded.
Deficiency	GYPSUM BOARD: DETERIORATED
Deficiency Location/Instance	Near Serving area, Near Windows
Deficiency Quantity	20
Quantity Uom	S.F.
Potential Action	REPLACE
Urgency of Action	PRIORITY 3
Purpose of Action	LEVEL 2
Deficiency Photo1

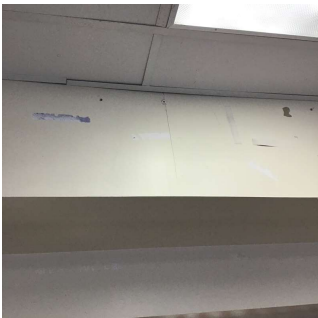
Violations	Near Serving area No violations recorded.
Instance on 1st Floor	Inspected
Condition	2 - Between Good and Fair
Deficiency	PLASTER: CRACKS/SPALLING
Deficiency Location/Instance	Near Servery, Near Entrance
Deficiency Quantity	20
Quantity Uom	S.F.

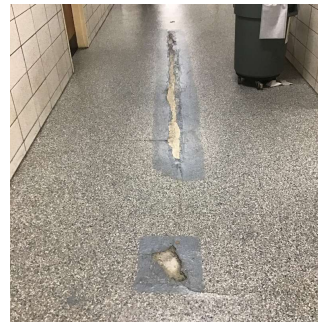
Corridor near Room B13

Room 300
Violations	No violations recorded.
Floor Finish	Inspected
Condition	2 - Between Good and Fair
Deficiency	EPOXY FLOORING: CRACKS/SPALLING
Deficiency Location/Instance	Corridor near Rooms B13, B12, B10, B9, B8, B2
Deficiency Quantity	300
Quantity Uom	S.F.
Potential Action	REPLACE
Urgency of Action	PRIORITY 3
Purpose of Action	LEVEL 2

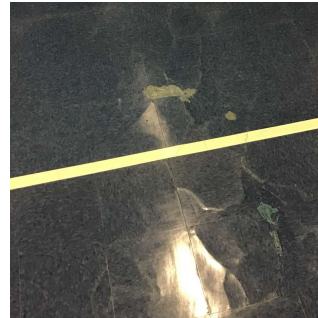
Corridor near Room 111

VINYL TILES: DETERIORATED SUBSTRATE

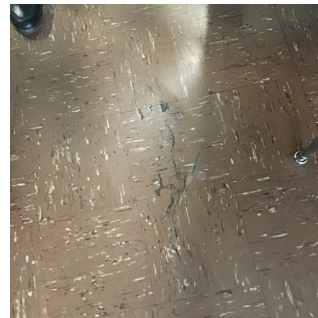
Room 309

VINYL TILES: BROKEN/DETERIORATED/MISSING TILES

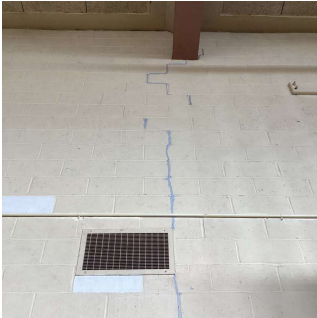
Question	Response
INTERIOR	
GYMNASIUM	
Stage	
Instance on 1st Floor	Does not Exist
Walls	
Instance on 1st Floor	Inspected
Condition	3 - Fair
Deficiency	MASONRY: CRACKS/SPALLING
Deficiency Location/Instance	Office, Left and Right Side, Near Entrance, Rear
Deficiency Quantity	350
Quantity Uom	S.F.
Potential Action	REPLACE
Urgency of Action	PRIORITY 3
Purpose of Action	LEVEL 2
Deficiency Photo1

Near Entrance
Violations	No violations recorded.
Window Curtains/Shades/Blinds	
Instance on 1st Floor	Does not Exist
INTERIOR DOOR HARDWARE	
Condition	Inspected
Deficiency	3 - Fair
Deficiency	No deficiencies recorded
INTERIOR GUARDS	
Condition	Inspected
Condition	2 - Between Good and Fair
Deficiency	DETERIORATED/TORN-OUT/MISSING
Deficiency Location/Instance	Stair H/1, 2
Deficiency Quantity	40
Quantity Uom	S.F.
Potential Action	REPLACE
Urgency of Action	PRIORITY 3
Purpose of Action	LEVEL 2
Deficiency Photo1

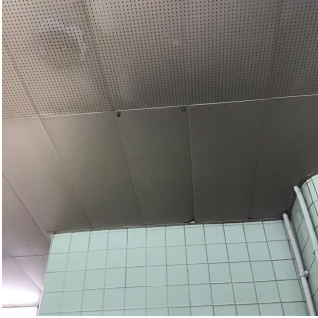
Question	Response
INTERIOR	
KITCHEN	Inspected
Instance on 1st Floor	Inspected
Instance on Basement	Inspected
Ceiling	
Instance on 1st Floor	Inspected
Condition	2 - Between Good and Fair
Deficiency	METAL PAN: DAMAGED/MISSING
Deficiency Location/Instance	Near Dry Storage Room
Deficiency Quantity	10
Quantity Uom	S.F.
Potential Action	REPLACE
Urgency of Action	PRIORITY 3
Purpose of Action	LEVEL 2
Deficiency Photo1

Near Dry Storage Room
Violations	No violations recorded.
Door(s)	
Instance on 1st Floor	Inspected
Condition	5 - Poor
Deficiency	METAL: DETERIORATED DOOR AND FRAME
Deficiency Location/Instance	Mop Room, Storage Room, Dry Storage Room, Main Entrance
Deficiency Quantity	5
Quantity Uom	EACH
Potential Action	MAINTENANCE
Urgency of Action	PRIORITY 3
Purpose of Action	LEVEL 2
Deficiency Photo1

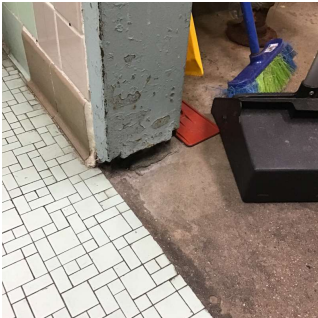
Mop Room
Violations	No violations recorded.
Deficiency	WOOD: DETERIORATED DOOR
Deficiency Location/Instance	Exit Door 143, Storage Room

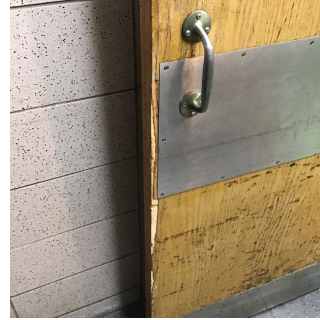
Exit Door 143

Deficiency Quantity	1
Quantity Uom	EACH

MAINTENANCE
PRIORITY 3
LEVEL 2

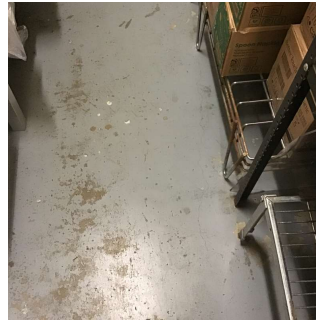
CONCRETE: CRACKS
Storage Room
25
S.F.
REPLACE
PRIORITY 3
LEVEL 2

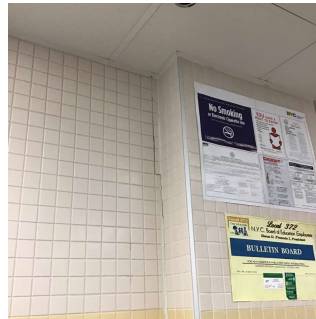
Instance on Basement	Inspected
Condition	2 - Between Good and Fair
Deficiency	CERAMIC TILE: BROKEN/ MISSING
Deficiency Location/Instance	Near Entrance
Deficiency Quantity	10
Quantity Uom	S.F.
Potential Action	REPLACE
Urgency of Action	PRIORITY 3
Purpose of Action	LEVEL 2
Deficiency Photo1

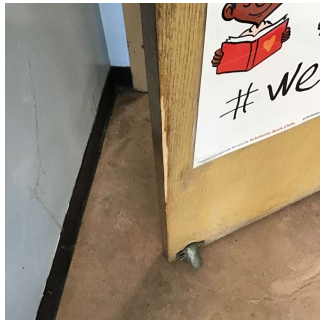
Question	Response
INTERIOR	
LIBRARY	
Built-in Furnishing	
Deficiency Photo1	 
	Near Entrance
Violations	No violations recorded.
Ceiling	
Instance on Room 225	Inspected
Condition	2 - Between Good and Fair
Deficiency	No deficiencies recorded
Door(s)	
Instance on Room 225	Inspected
Condition	3 - Fair
Deficiency	WOOD: DETERIORATED DOOR
Deficiency Location/Instance	Main Entrance
Deficiency Quantity	1
Quantity Uom	EACH
Potential Action	MAINTENANCE
Urgency of Action	PRIORITY 3
Purpose of Action	LEVEL 2
Deficiency Photo1

Main Entrance
Violations	No violations recorded.
Floor Finish	
Instance on Room 225	Inspected
Condition	2 - Between Good and Fair
Deficiency	SHEET VINYL: BROKEN/DETERIORATED
Deficiency Location/Instance	Center
Deficiency Quantity	10
Quantity Uom	S.F.
Potential Action	REPLACE
Urgency of Action	PRIORITY 3
Purpose of Action	LEVEL 2

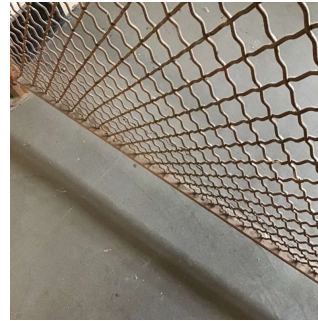
Question	Response
INTERIOR	
STAIRS/RAMPS: INTERIOR	
Ceiling	
Deficiency Photo1	 
Violations	Stair K/2 No violations recorded.
Door(s)	Inspected
Condition	2 - Between Good and Fair
Deficiency	METAL: DETERIORATED DOOR
Deficiency Location/Instance	Stair FG/3
Deficiency Quantity	1
Quantity Uom	EACH
Potential Action	MAINTENANCE
Urgency of Action	PRIORITY 3
Purpose of Action	LEVEL 2
Deficiency Photo1	 
Violations	Stair FG/3 No violations recorded.
Partition	Does not Exist
Railings	Inspected
Condition	2 - Between Good and Fair
Deficiency	No deficiencies recorded
Stairs and Landings	Inspected
Condition	2 - Between Good and Fair
Deficiency	CONCRETE: CRACKS/SPALLING - MAJOR
Deficiency Location/Instance	Stair LM/Bulkhead
Deficiency Quantity	25
Quantity Uom	S.F.
Potential Action	REPLACE
Urgency of Action	PRIORITY 3
Purpose of Action	LEVEL 2

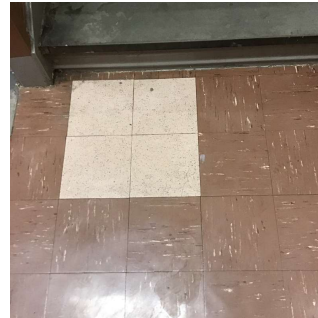
Stair LM/1

VINYL TILES: BROKEN/DETERIORATED/MISSING TILES

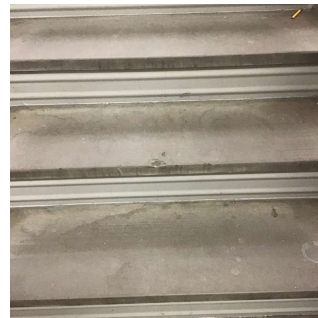
Stair FG/2

STONE: BROKEN/MISSING

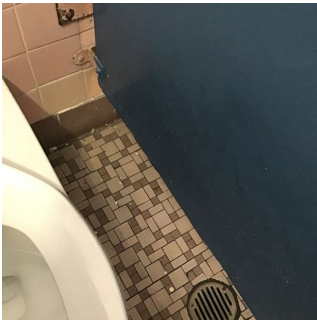
Question	Response
INTERIOR	
TOILET ROOMS - STUDENTS	
Floor Finish	Inspected
	Room 320
Violations	No violations recorded.
Stalls	Inspected
Condition	5 - Poor
Deficiency	RUST - MAJOR
Deficiency Location/Instance	Rooms 320, 220, 120
Deficiency Quantity	8
Quantity Uom	EACH
Potential Action	REPLACE
Urgency of Action	PRIORITY 3
Purpose of Action	LEVEL 2
Deficiency Photo1

Room 320
Violations	No violations recorded.
Walls	Inspected
Condition	2 - Between Good and Fair
Deficiency	GYPSUM BOARD: DETERIORATED
Deficiency Location/Instance	Rooms 204A, 101A
Deficiency Quantity	20
Quantity Uom	S.F.
Potential Action	REPLACE
Urgency of Action	PRIORITY 3
Purpose of Action	LEVEL 2
Deficiency Photo1

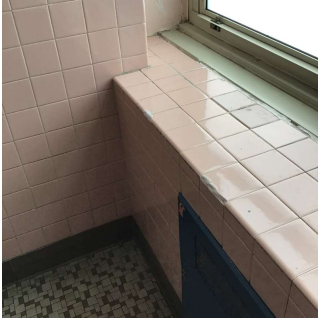
Question	Response
INTERIOR	
TOILET ROOMS - STUDENTS	
Walls	
Urgency of Action	PRIORITY 3
Purpose of Action	LEVEL 2
Deficiency Photo1

Room 320
Violations	No violations recorded.
LIFE SAFETY	Inspected
F.D. HOLDING AREA	Does not Exist
STEEL STAIRS	Does not Exist
SITE	Inspected
CONTAINERIZATION	Does not Exist
Drainage System for Asphalt	Does not Exist
Drainage System for Concrete	Inspected
Catch Basins/Manhole - Surrounded by concrete	Inspected
Condition	5 - Poor
Deficiency	BLOCKED
Deficiency Location/Instance	Near Exit 6
Deficiency Quantity	1
Quantity Uom	EACH
Potential Action	MAINTENANCE
Urgency of Action	PRIORITY 3
Purpose of Action	LEVEL 2
Deficiency Photo1	No photo recorded
Violations	No violations recorded.
Culverts - Concrete Covering	Does not Exist
Drainage System for Soil	Inspected
Catch Basins/Manhole - Surrounded by Soil	Inspected
Condition	2 - Between Good and Fair
Deficiency	No deficiencies recorded
Culverts - Soil Covering	Does not Exist

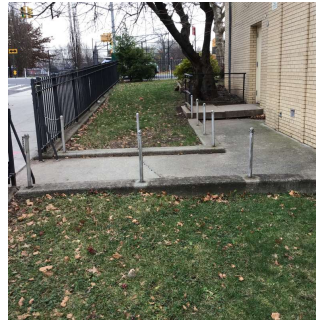
DRINKING FOUNTAINS	Does not Exist
FENCES	Inspected
Condition	3 - Fair
Deficiency	CHAIN LINK: DAMAGED POST/RAIL
Deficiency Location/Instance	26th Avenue
Deficiency Quantity	60
Quantity Uom	L.F.
Potential Action	REPLACE
Urgency of Action	PRIORITY 3

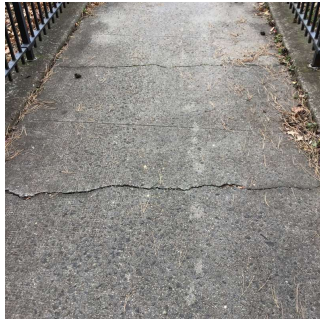
Question	Response
SITE	
IRRIGATION SYSTEM	Does not Exist
PAVING	Inspected
Student Non-Use	Inspected
Gravel Exists?	No
Asphalt	Does not Exist
Concrete	Inspected
Condition	2 - Between Good and Fair
Deficiency	No deficiencies recorded
Pavers	Does not Exist
Student Use	Does not Exist
Site Sidewalks & Walkways	Inspected
Asphalt	Does not Exist
Concrete	Inspected
Condition	3 - Fair
Deficiency	CRACKS - MAJOR
Deficiency Location/Instance	26th Avenue, Exits 11, 10, 5, 4 and others
Deficiency Quantity	350
Quantity Uom	S.F.
Potential Action	REPLACE
Urgency of Action	PRIORITY 3
Purpose of Action	LEVEL 2
Deficiency Photo1

Violations	26th Avenue No violations recorded.
Pavers	Does not Exist
DOT Sidewalk	Inspected
Asphalt	Does not Exist
Concrete	Inspected
Condition	4 - Between Fair and Poor
Deficiency	DAMAGED CURBS
Deficiency Location/Instance	26th Avenue, 27th Avenue, 149th Street
Deficiency Quantity	300
Quantity Uom	L.F.
Potential Action	REPLACE

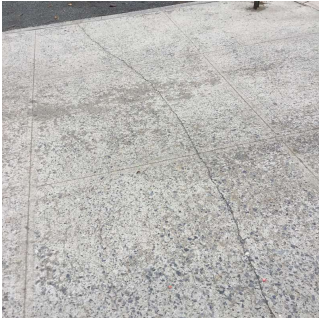
Violations	26th Avenue

Violations	27th Avenue No violations recorded.
Deficiency	DAMAGED/DETERIORATED/MISSING SECTIONS
Deficiency Location/Instance	26th Avenue, 27th Avenue, 149th Street
Deficiency Quantity	3,300
Quantity Uom	S.F.
Potential Action	REPLACE
Urgency of Action	PRIORITY 3
Purpose of Action	LEVEL 2
Deficiency Photo1

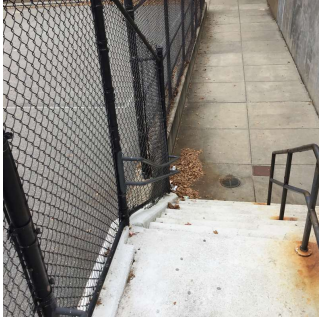
Violations	27th Avenue Near NYCPark No violations recorded.
Site Cheek/flank Walls	Inspected
Condition	2 - Between Good and Fair
Deficiency	CAST IN PLACE CONCRETE: CRACKS/SPALLING - MAJOR
Deficiency Location/Instance	Near Exit 9

Question	Response
SITE	
PAVING	Inspected
DOT Sidewalk	
Concrete	Inspected
Violations	No violations recorded.
Pavers	Does not Exist
PLAYGROUNDS	Does not Exist
PLAYING SURFACE	Does not Exist
RETAINING WALLS	Inspected
Are there any Retaining Walls 6' OR higher facing public street/sidewalk?	Yes
Condition	2 - Between Good and Fair
Deficiency	No deficiencies recorded
SEATING	Does not Exist
SITE WALLS (NOT RETAINING WALLS)	Does not Exist
STAIRS/RAMPS: EXTERIOR	Inspected
Railings	Inspected
Condition	3 - Fair
Deficiency	DAMAGED
Deficiency Location/Instance	27th Avenue Near NYCPark
Deficiency Quantity	10
Quantity Uom	L.F.
Potential Action	REPLACE
Urgency of Action	PRIORITY 3
Purpose of Action	LEVEL 2
Deficiency Photo1
