**NYC Department of Education**  
**Building Condition Assessment Survey 2023 - 2024**

Architectural Inspection

**Asset:** P.S. 28 (ECC) - QUEENS, 109-10 47TH AVE, New York, 11368

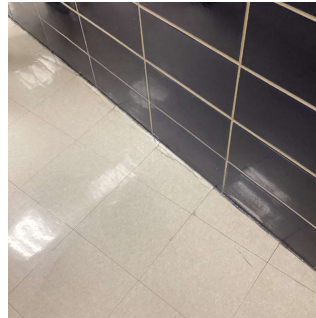
Corridor near Room 108

VINYL TILES: DETERIORATED SUBSTRATE

REPLACE
