**NYC Department of Education**  
**Building Condition Assessment Survey 2023 - 2024**

Architectural Inspection

**Asset:** P.S. 31 - QUEENS, 211-45 46 ROAD, New York, 11361

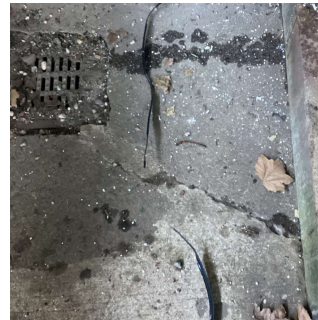
AW2  
No violations recorded.

AREAWAY SLAB: CRACKS AND SPALLING

20  
S.F.  
REPLACE  
PRIORITY 4  
LEVEL 2

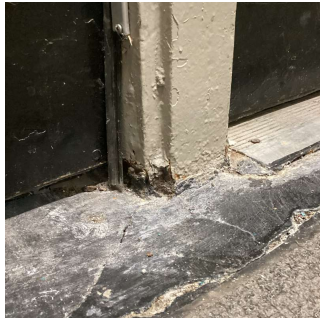
METAL CLAD: DETERIORATED DOOR AND FRAME - MAJOR DETERIORATION

8  
EACH  
REPLACE  
PRIORITY 4

Violations	Facade E - Exit 2 No violations recorded.
<b>DOOR HARDWARE</b>	
Condition	Inspected
Deficiency	3 - Fair
Deficiency	No deficiencies recorded
<b>LINTELS</b>	
Condition	Inspected
Deficiency	2 - Between Good and Fair
Deficiency	No deficiencies recorded
<b>TRANSOM/SIDE LIGHT</b>	
Condition	Inspected
Deficiency	5 - Poor
Deficiency	WOOD: BROKEN GLASS
Roof Plan reference

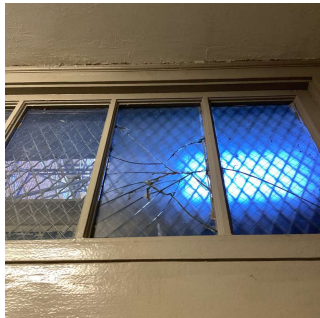
Violations	Facade J - Exit 8 No violations recorded.

Deficiency Quantity	60
Quantity Uom	S.F.
Potential Action	MAINTENANCE
Urgency of Action	PRIORITY 3
Purpose of Action	LEVEL 2
Deficiency Photo1

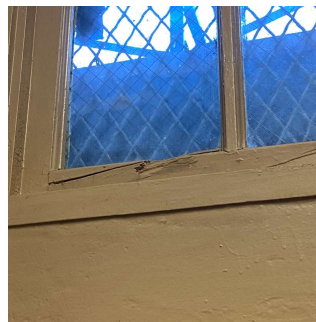
Facade F  
 No violations recorded.

WOOD: EXCESSIVELY WEATHERED

60  
 S.F.  
 REPLACE  
 PRIORITY 4  
 LEVEL 2

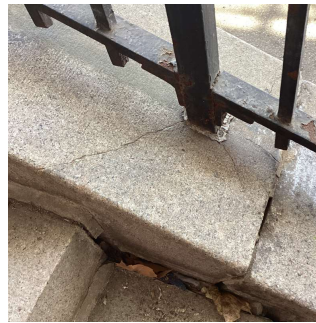
Facade B

**BRICK: DETERIORATED COPING STONE**

10  
 S.F.  
 REPLACE  
 PRIORITY 4  
 LEVEL 2

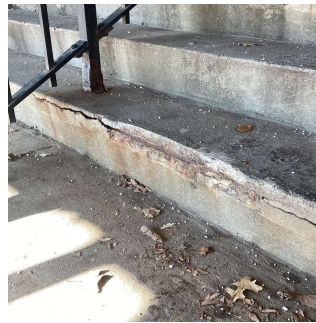
Facade A - Main Entrance

CONCRETE: CRACKS/SPALLING - MAJOR

20  
 S.F.  
 REPLACE  
 PRIORITY 5  
 LEVEL 6

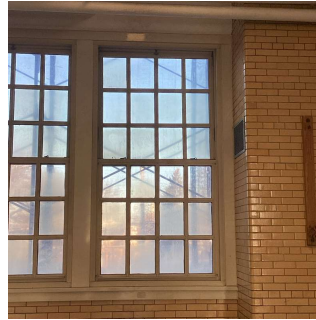
Facade E - Cafeteria (similar throughout)

EACH  
REPLACE BALANCES  
PRIORITY 3  
LEVEL 2

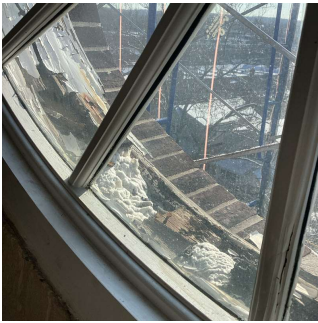
WOOD: DETERIORATED

100

Violations	Facade A - Computer Room 401 (Facade A - Basement similar) No violations recorded.
<b>INTERIOR</b>	
<b>POOLS</b>	
<b>STRUCTURAL</b>	
<b>COLUMNS/BEAMS/BEARING WALLS</b>	
Condition	3 - Fair
Deficiency	STEEL COLUMNS/BEAMS: DETERIORATED CONCRETE FIREPROOFING
Deficiency Location/Instance	Basement - Fan Room
Deficiency Quantity	20
Quantity Uom	S.F.
Potential Action	REPLACE
Urgency of Action	PRIORITY 4
Purpose of Action	LEVEL 5
Deficiency Photo1

REPLACE WINDOW

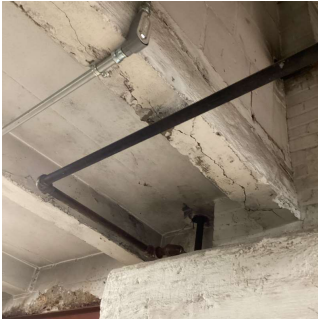
Violations	Basement - Fan Room No violations recorded.
Deficiency	STEEL COLUMNS/BEAMS: DETERIORATED CONCRETE FIREPROOFING
Deficiency Location/Instance	Basement - Fan Room
Deficiency Quantity	20
Quantity Uom	S.F.
Potential Action	REPLACE
Urgency of Action	PRIORITY 3
Purpose of Action	LEVEL 5

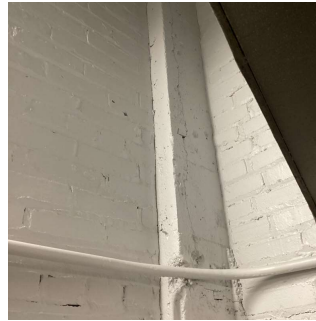
4th Floor Fan Room

Question	Response
<b>INTERIOR</b>	
<b>STRUCTURAL</b>	
<b>ROOF STRUCTURE</b>	
Deficiency Quantity	20
Quantity Uom	S.F.
Potential Action	REPAIR
Urgency of Action	PRIORITY 4
Purpose of Action	LEVEL 5
Deficiency Photo1	 
	Room 406
Violations	No violations recorded.
Deficiency	CINDER CONCRETE, FLAT SLAB: CRACKED/SPALLED/REINFORCEMENT EXPOSED
Deficiency Location/Instance	Computer Room (401), Room 406
Deficiency Quantity	60
Quantity Uom	S.F.
Potential Action	REPAIR
Urgency of Action	PRIORITY 3
Purpose of Action	LEVEL 5
Deficiency Photo1	 
	Computer Room 401
Violations	No violations recorded.
Deficiency	STEEL COLUMNS/BEAMS: DETERIORATED CONCRETE FIREPROOFING
Deficiency Location/Instance	4th Floor Fan Room, Computer Room (401), Room 406
Deficiency Quantity	40
Quantity Uom	S.F.
Potential Action	REPLACE
Urgency of Action	PRIORITY 3
Purpose of Action	LEVEL 5

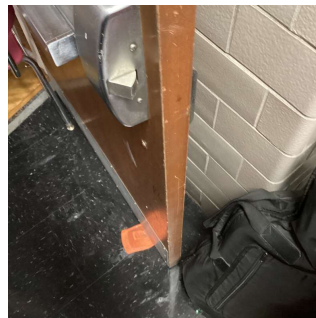
Left side

WOOD: DETERIORATED DOOR

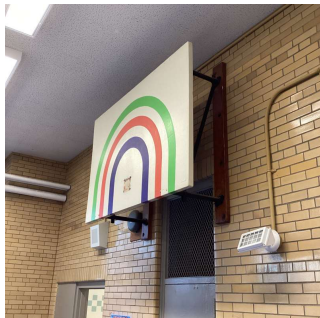
Violations	Near Stage No violations recorded.
<b>Window Curtains/Shades/Blinds</b>	
Instance on 1st Floor (500 Seats)	Inspected
Condition	2 - Between Good and Fair
Deficiency	No deficiencies recorded
<b>CAFETERIA</b>	
Instance on 1st Floor	Inspected
<b>Ceiling</b>	
Instance on 1st Floor	Inspected
Condition	2 - Between Good and Fair
Deficiency	No deficiencies recorded
<b>Door(s)</b>	
Instance on 1st Floor	Inspected
Condition	2 - Between Good and Fair
Deficiency	No deficiencies recorded
<b>Fixed Equipment</b>	
Instance on 1st Floor	Inspected
Condition	3 - Fair
Deficiency	DAMAGED/MISSING
Deficiency Location/Instance	Left , right side
Deficiency Quantity	2
Quantity Uom	EACH
Potential Action	MAINTENANCE
Urgency of Action	PRIORITY 3
Purpose of Action	LEVEL 2
Deficiency Photo1

Violations	Right side No violations recorded.
<b>Floor Finish</b>

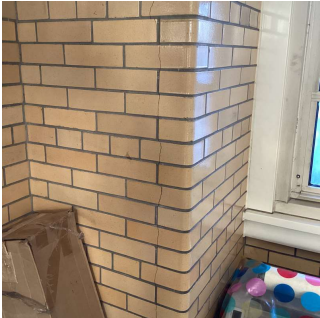
Question	Response
<b>INTERIOR</b>	
<b>CAFETERIA</b>	
<b>Floor Finish</b>	
Instance on 1st Floor	Inspected
Condition	2 - Between Good and Fair
Deficiency	No deficiencies recorded
<b>Sliding-folding Partition</b>	
Instance on 1st Floor	Does not Exist
<b>Stage</b>	
Instance on 1st Floor	Does not Exist
<b>Walls</b>	
Instance on 1st Floor	Inspected
Condition	2 - Between Good and Fair
Deficiency	SALT GLAZED BRICK: CRACKS/SPALLING
Deficiency Location/Instance	Near Windows
Deficiency Quantity	25
Quantity Uom	S.F.
Potential Action	REPLACE
Urgency of Action	PRIORITY 3
Purpose of Action	LEVEL 2
Deficiency Photo1

Near Windows
Violations	No violations recorded.
<b>Window Curtains/Shades/Blinds</b>	
Instance on 1st Floor	Does not Exist
<b>CLASSROOMS/CORRIDORS/ADMIN SPACES</b>	
	Inspected
<b>Ceiling</b>	
	Inspected
Condition	2 - Between Good and Fair
Deficiency	ACOUSTIC TILES: DAMAGED/MISSING
Deficiency Location/Instance	Corridor near Room 403

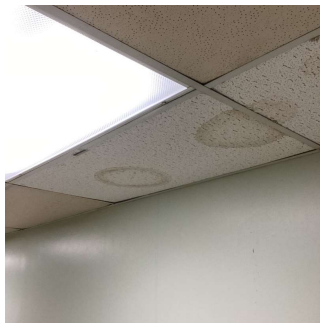
Deficiency Quantity	10
Quantity Uom	S.F.
Potential Action	REPLACE
Urgency of Action	PRIORITY 3
Purpose of Action	LEVEL 2

Corridor near Room 403
Violations	No violations recorded.
<b>Door(s)</b>	Inspected
Condition	5 - Poor
Deficiency	WOOD: DETERIORATED DOOR
Deficiency Location/Instance	Main Entrance Lobby(4)Room 114 and others
Deficiency Quantity	8
Quantity Uom	EACH
Potential Action	MAINTENANCE
Urgency of Action	PRIORITY 3
Purpose of Action	LEVEL 2
Deficiency Photo1

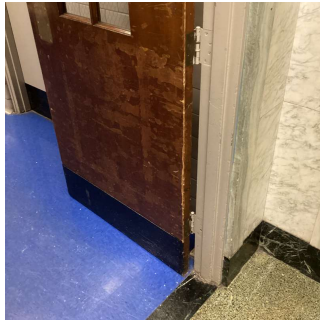
Main Entrance Lobby
Violations	No violations recorded.
<b>Floor Finish</b>	Inspected
Condition	2 - Between Good and Fair
Deficiency	SHEET VINYL: BROKEN/DETERIORATED
Deficiency Location/Instance	Room 100
Deficiency Quantity	200
Quantity Uom	S.F.
Potential Action	REPLACE
Urgency of Action	PRIORITY 5
Purpose of Action	LEVEL 6

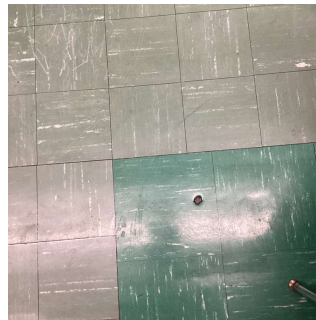
Room 300

VINYL TILES: BROKEN/DETERIORATED/MISSING TILES

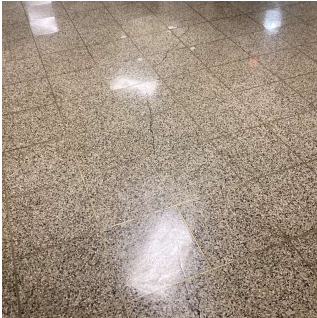
Question	Response
<b>INTERIOR</b>	
<b>CLASSROOMS/CORRIDORS/ADMIN SPACES</b>	
<b>Floor Finish</b>	
Deficiency	TERRAZZO: CRACKS
Deficiency Location/Instance	Main Entrance Lobby
Deficiency Quantity	150
Quantity Uom	S.F.
Potential Action	REPLACE
Urgency of Action	PRIORITY 3
Purpose of Action	LEVEL 2
Deficiency Photo1

Violations	Main Entrance Lobby No violations recorded.
<b>Walls</b>	
Condition	Inspected
Deficiency	2 - Between Good and Fair
Deficiency	BRICK: CRACKS/SPALLING
Deficiency Location/Instance	Room 405,401
Deficiency Quantity	50
Quantity Uom	S.F.
Potential Action	REPLACE
Urgency of Action	PRIORITY 3
Purpose of Action	LEVEL 2
Deficiency Photo1

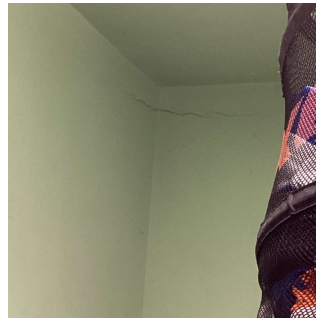
Storage Room

PLASTER: CRACKS/SPALLING

REPLACE

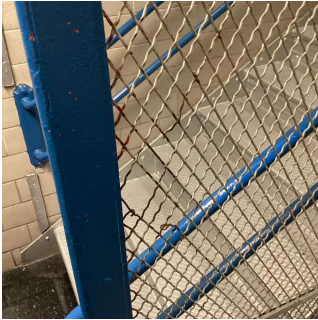
Question	Response
<b>INTERIOR</b>	
<b>GYMNASIUM</b>	Inspected
<b>Walls</b>	
Violations	No violations recorded.
<b>Window Curtains/Shades/Blinds</b>	
Instance on 3rd Floor	Does not Exist
<b>INTERIOR DOOR HARDWARE</b>	Inspected
Condition	3 - Fair
Deficiency	No deficiencies recorded
<b>INTERIOR GUARDS</b>	Inspected
Condition	2 - Between Good and Fair
Deficiency	DETERIORATED/TORN-OUT/MISSING
Deficiency Location/Instance	Stair B/3
Deficiency Quantity	10
Quantity Uom	S.F.
Potential Action	REPLACE
Urgency of Action	PRIORITY 3
Purpose of Action	LEVEL 2
Deficiency Photo1

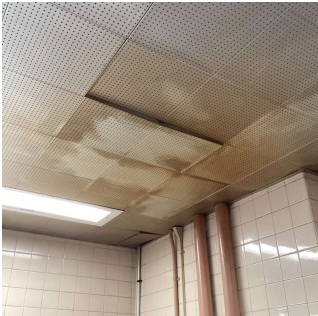
Violations	Stair B/3 No violations recorded.
<b>KITCHEN</b>	Inspected
Instance on 1st Floor	Inspected
<b>Ceiling</b>	
Instance on 1st Floor	Inspected
Condition	2 - Between Good and Fair
Deficiency	METAL PAN: DAMAGED/MISSING
Deficiency Location/Instance	Near Windows
Deficiency Quantity	20
Quantity Uom	S.F.
Potential Action	REPLACE
Urgency of Action	PRIORITY 3

Purpose of Action	LEVEL 2
Deficiency Photo1

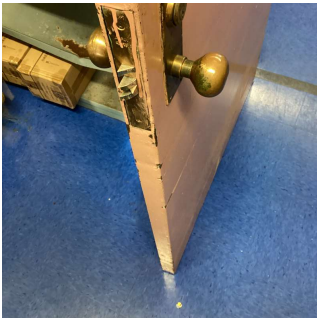
Question	Response
<b>INTERIOR</b>	
<b>KITCHEN</b>	
<b>Ceiling</b>	
Violations	Near Windows No violations recorded.
<b>Door(s)</b>	
Instance on 1st Floor	Inspected
Condition	3 - Fair
Deficiency	METAL: DETERIORATED DOOR
Deficiency Location/Instance	Storage Room
Deficiency Quantity	1
Quantity Uom	EACH
Potential Action	MAINTENANCE
Urgency of Action	PRIORITY 3
Purpose of Action	LEVEL 2
Deficiency Photo1

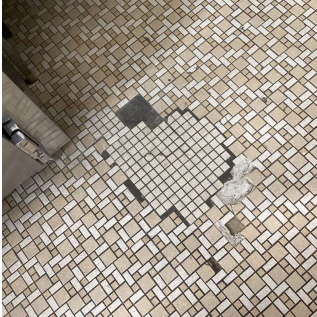
Violations	Storage Room No violations recorded.
<b>Floor Finish</b>	
Instance on 1st Floor	Inspected
Condition	2 - Between Good and Fair
Deficiency	CERAMIC TILE: BROKEN/MISSING TILES
Deficiency Location/Instance	Center
Deficiency Quantity	15
Quantity Uom	S.F.
Potential Action	REPLACE
Urgency of Action	PRIORITY 3
Purpose of Action	LEVEL 2
Deficiency Photo1

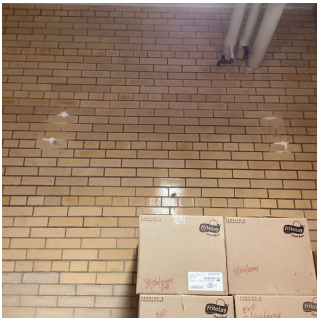
Question	Response
<b>INTERIOR</b>	
<b>KITCHEN</b>	
<b>Walls</b>	
Deficiency	CERAMIC TILE: BROKEN/ MISSING
Deficiency Location/Instance	Mop Room
Deficiency Quantity	10
Quantity Uom	S.F.
Potential Action	REPLACE
Urgency of Action	PRIORITY 3
Purpose of Action	LEVEL 2
Deficiency Photo1	 
	Mop Room
Violations	No violations recorded.
Deficiency	SALT GLAZED BRICK: CRACKS/SPALLING
Deficiency Location/Instance	Storage Room
Deficiency Quantity	15
Quantity Uom	S.F.
Potential Action	REPLACE
Urgency of Action	PRIORITY 3
Purpose of Action	LEVEL 2
Deficiency Photo1

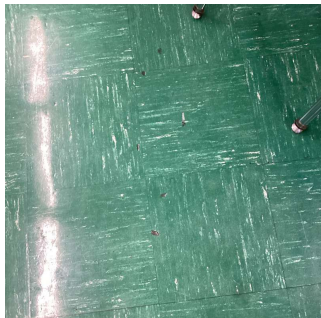
Instance on Room 206 (600sf)	Inspected
Condition	2 - Between Good and Fair
Deficiency	VINYL TILES: BROKEN/DETERIORATED/MISSING TILES
Deficiency Location/Instance	Center
Deficiency Quantity	10
Quantity Uom	S.F.
Potential Action	REPLACE
Urgency of Action	PRIORITY 3
Purpose of Action	LEVEL 2
Deficiency Photo1

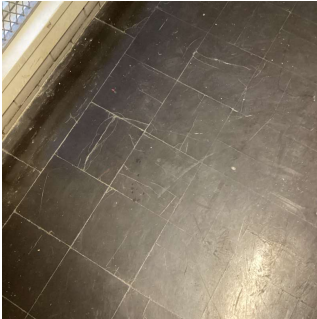
Question	Response
<b>INTERIOR</b>	
<b>STAIRS/RAMPS: INTERIOR</b>	
<b>Railings</b>	Inspected
Violations	No violations recorded.
<b>Stairs and Landings</b>	Inspected
Condition	3 - Fair
Deficiency	VINYL TILES: BROKEN/DETERIORATED/MISSING TILES
Deficiency Location/Instance	Stair B/1,2,3
Deficiency Quantity	200
Quantity Uom	S.F.
Potential Action	REPLACE
Urgency of Action	PRIORITY 3
Purpose of Action	LEVEL 2
Deficiency Photo1

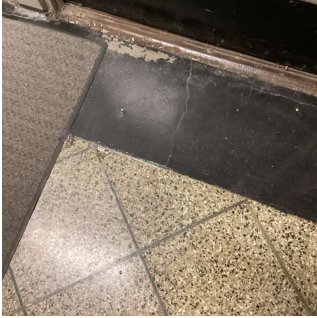
Violations	Stair B/1 No violations recorded.
Deficiency	TERRAZZO: CRACKS
Deficiency Location/Instance	Stair C Exit Vestibule
Deficiency Quantity	10
Quantity Uom	S.F.
Potential Action	REPLACE
Urgency of Action	PRIORITY 3
Purpose of Action	LEVEL 2
Deficiency Photo1

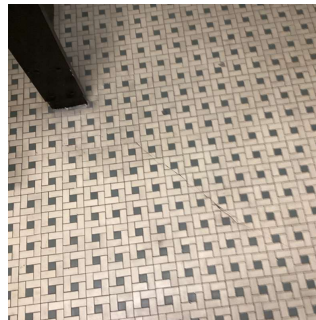
Room 325

CERAMIC TILE: BROKEN/MISSING TILES

REPLACE

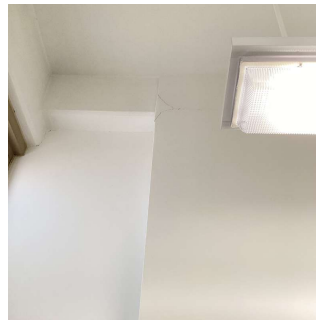
Room 101

PLASTER: CRACKS/SPALLING

REPLACE

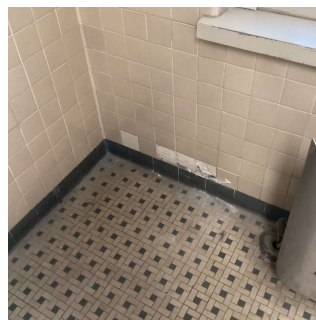
CERAMIC TILE: BROKEN/ MISSING

REPLACE

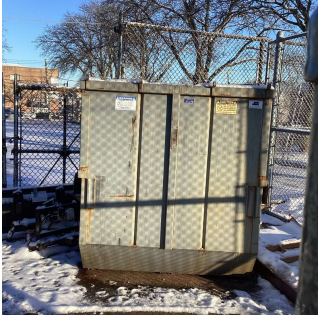
Question	Response
<b>INTERIOR</b>	Inspected
<b>TOILET ROOMS - STUDENTS</b>	Inspected
<b>Walls</b>	
Violations	Room 325 No violations recorded.
<b>LIFE SAFETY</b>	Inspected
<b>F.D. HOLDING AREA</b>	Does not Exist
<b>STEEL STAIRS</b>	Does not Exist
<b>SITE</b>	Inspected
<b>CONTAINERIZATION</b>	Inspected
Condition	5 - Poor
Deficiency	CONTAINER DAMAGED
Deficiency Location/Instance	46th Road
Deficiency Quantity	2
Quantity Uom	EACH
Potential Action	REPLACE
Urgency of Action	PRIORITY 3
Purpose of Action	LEVEL 2
Deficiency Photo1

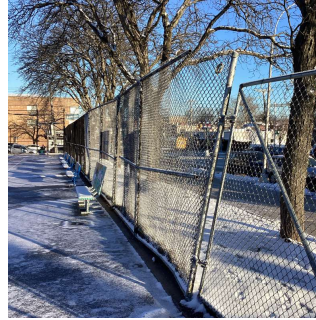
<b>FENCES</b>	Inspected
Condition	3 - Fair
Deficiency	CHAIN LINK: DAMAGED/DETERIORATED
Deficiency Location/Instance	Schoolyard
Deficiency Quantity	200
Quantity Uom	S.F.
Potential Action	REPLACE
Urgency of Action	PRIORITY 3
Purpose of Action	LEVEL 2

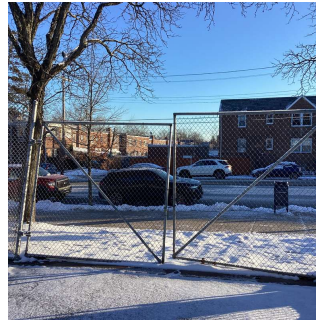
Schoolyard

**CHAIN LINK: DAMAGED POST/RAIL**

REPLACE

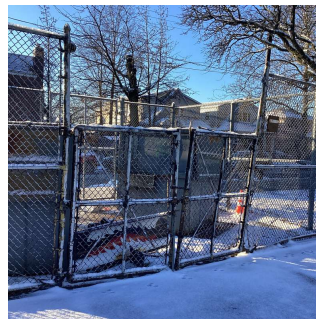
Schoolyard

**CHAIN LINK: MISSING SECTIONS**

REPLACE

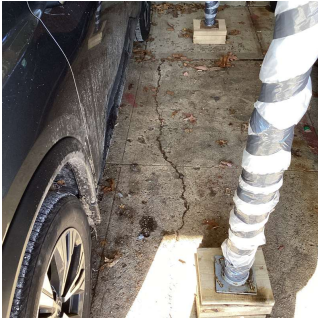
Question	Response
<b>SITE</b>	
<b>IRRIGATION SYSTEM</b>	Does not Exist
<b>PAVING</b>	Inspected
<b>Student Non-Use</b>	Inspected
Gravel Exists?	No
<b>Asphalt</b>	Does not Exist
<b>Concrete</b>	Inspected
Condition	3 - Fair
Deficiency	CRACKS - MAJOR
Deficiency Location/Instance	46th Road
Deficiency Quantity	50
Quantity Uom	S.F.
Potential Action	REPLACE
Urgency of Action	PRIORITY 3
Purpose of Action	LEVEL 2
Deficiency Photo1

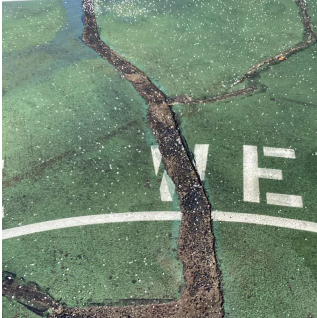
Question	Response
<b>SITE</b>	
<b>PAVING</b>	Inspected
<b>Student Use</b>	
<b>Asphalt</b>	
Deficiency Location/Instance	Schoolyard
Deficiency Quantity	400
Quantity Uom	S.F.
Potential Action	REPLACE
Urgency of Action	PRIORITY 5
Purpose of Action	LEVEL 6
Deficiency Photo1

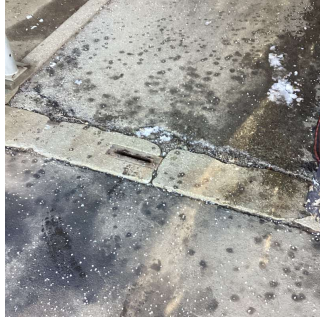
Violations	Exit 2 Walkway No violations recorded.
Deficiency	HEAVING
Deficiency Location/Instance	Near Playground
Deficiency Quantity	25
Quantity Uom	S.F.
Potential Action	REPLACE
Urgency of Action	PRIORITY 5

Question	Response
<b>SITE</b>	
<b>PAVING</b>	
<b>Site Sidewalks &amp; Walkways</b>	
<b>Asphalt</b>	
Purpose of Action	LEVEL 6
Deficiency Photo1

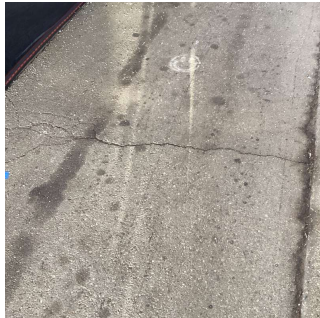
Near Playground
Violations	No violations recorded.
<b>Deficiency</b>	<b>CRACKS - MAJOR</b>
Deficiency Location/Instance	Near small Schoolyard
Deficiency Quantity	25
Quantity Uom	S.F.
Potential Action	REPLACE
Urgency of Action	PRIORITY 3
Purpose of Action	LEVEL 2
Deficiency Photo1
