NYC Department of Education
Building Condition Assessment Survey 2023 - 2024

Architectural Inspection

Asset: P.S. 32 - QUEENS, 171-11 35 AVENUE, New York, 11358

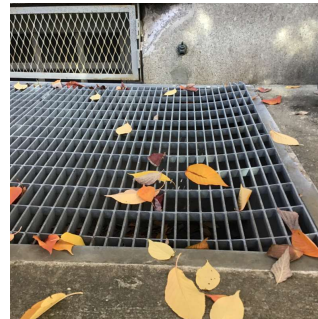
AW2

AREAWAY GRATINGS: MAJOR RUSTING / OR BROKEN

REPLACE

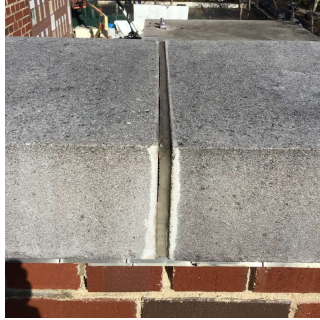
CAST STONE: DETERIORATED TRANSVERSE JOINTS

10
L.F.
MAINTENANCE
PRIORITY 3
LEVEL 2

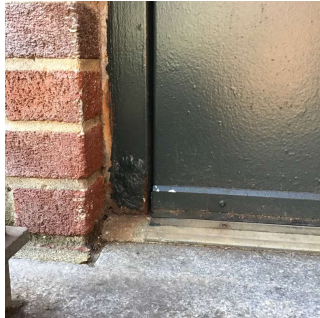
Violations	Roof 1 No violations recorded.
CORNICE	Inspected
Condition	2 - Between Good and Fair
Deficiency	No deficiencies recorded
DOORS	Inspected
DOORS AND FRAMES	Inspected
Condition	4 - Between Fair and Poor
Deficiency	METAL: DETERIORATED DOOR AND FRAME - MINOR DETERIORATION
Roof Plan reference	<p>Q032</p>

<p>171ST STREET</p> <p>35TH AVENUE</p> <p>172ND STREET</p>
Deficiency Quantity	2
Quantity Uom	EACH
Potential Action	MAINTENANCE
Urgency of Action	PRIORITY 3
Purpose of Action	LEVEL 2
Deficiency Photo1

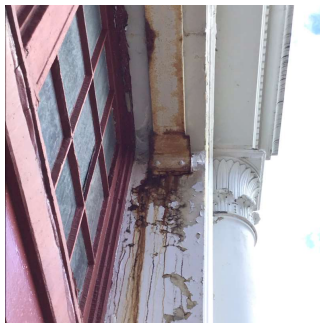
STEEL: MAJOR RUSTING

10
L.F.
REPLACE
PRIORITY 4
LEVEL 2

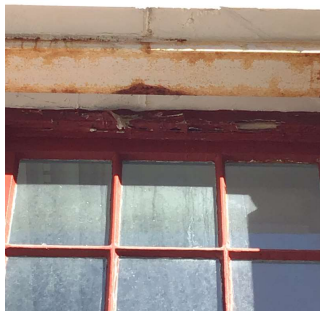
Violations	Facade A No violations recorded.
TRANSOM/SIDE LIGHT	Inspected
Condition	5 - Poor
Deficiency	WOOD: EXCESSIVELY WEATHERED
Roof Plan reference	<p>Q032</p>

Deficiency Quantity	50
Quantity Uom	S.F.
Potential Action	REPLACE
Urgency of Action	PRIORITY 4
Purpose of Action	LEVEL 2
Deficiency Photo1

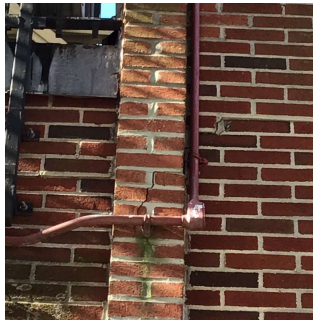
Facade H

BRICK: MAJOR / THRU CRACKS

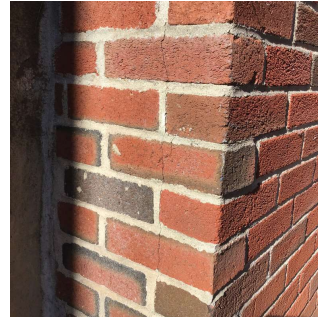
Facade H

BRICK: CRACKS/DISPLACED/SPALLED BRICK AT BUILDING CORNERS

REMOVE AND REBUILD
PRIORITY 4
LEVEL 2

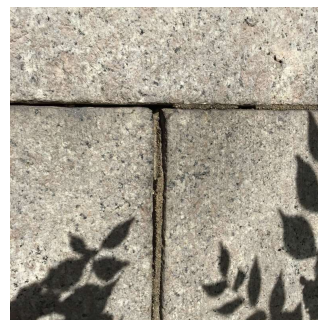
STONE: DETERIORATED JOINTS

40
L.F.
REPOINT
PRIORITY 3
LEVEL 2

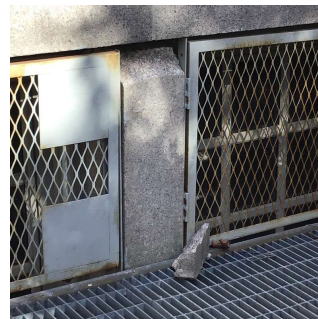
Facade A - AW9

STONE: CHIPPED/SPALLED/BROKEN PIECES - MAJOR

REPLACE

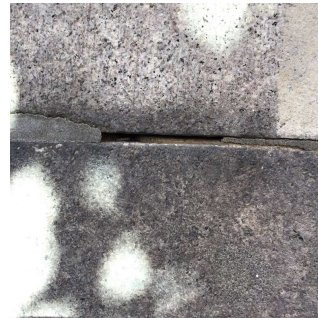
Facade A

STONE: DETERIORATED JOINTS

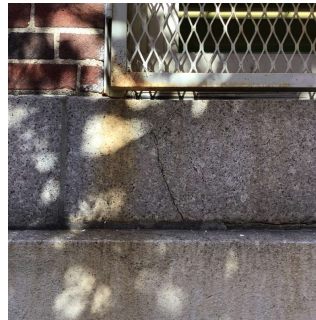
Facade A

STONE: CHIPPED/SPALLED/BROKEN PIECES - MINOR

REPAIR

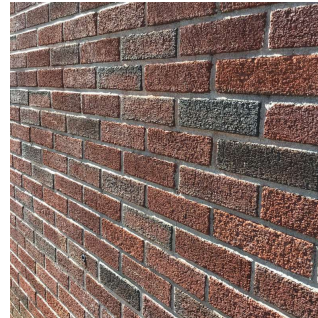
Facade H

BRICK: DETERIORATED JOINTS

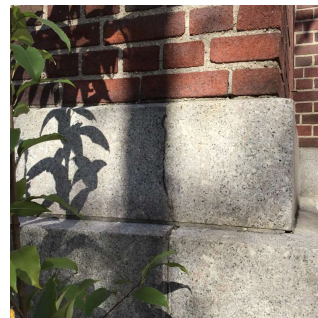
Facade A

STONE: CRACKS AT BUILDING CORNERS

REPLACE

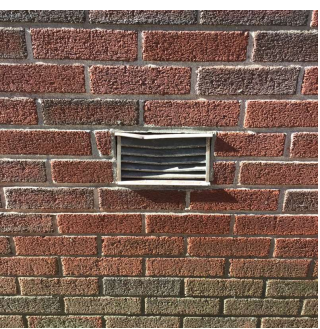
Violations	Facade H No violations recorded.
PARAPETS	
Material Type(s)	Inspected Masonry
Replacement Quantity	5,000

Question	Response
EXTERIOR	
EXTERIOR WALLS	
Violations	No violations recorded.
Instance on Facades C, D, E, F, G	Inaccessible
Instance Quantity	4,000
Instance Quantity Uom	S.F.
EXTERIOR SOFFITS	
	Does not Exist
LOADING DOCK	
	Does not Exist
LOUVER	
Condition	3 - Fair
Deficiency	BROKEN/ DENTED BLADES
Roof Plan reference	<p>Q032</p>

Deficiency Quantity	10
Quantity Uom	S.F.
Potential Action	REPLACE
Urgency of Action	PRIORITY 4
Purpose of Action	LEVEL 2
Deficiency Photo1

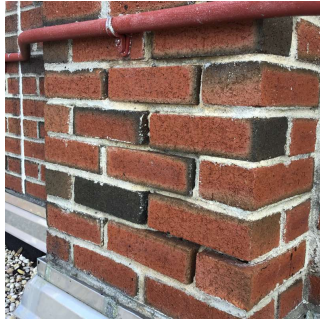
Violations	Roof 2 No violations recorded.
PLAZA DECK	Does not Exist
ROOF	Inspected
Roofing	Inspected
Replacement Quantity	35,000
Replacement Uom	S.F.
ROOF HATCH/SMOKE HATCH	Inspected
Condition	5 - Poor
Deficiency	INOPERABLE
Roof Plan reference	<p>Q032</p>

BRICK: DETERIORATED JOINTS

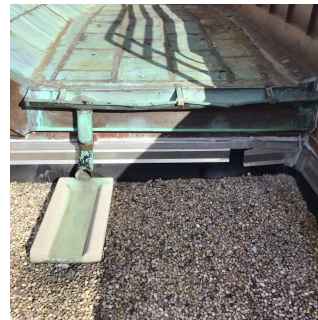
Roof 2 - BH2
 No violations recorded.

Violations	Roof 1 No violations recorded.
LEADERS, GUTTERS, DOWNSPOUTS, SCUPPERS	Inspected
Condition	3 - Fair
Deficiency	DAMAGED/MISSING

30
 L.F.
 REPLACE
 PRIORITY 4
 LEVEL 2

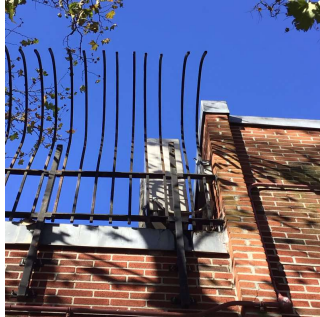
Violations	Roof 3 No violations recorded.
ROOF CAGE	Does not Exist
ROOFING	Inspected
Instance on Built-Up: All Roofs	Inspected
Instance Condition	3 - Fair
Instance Photo

BEAR CLAW/METAL BAR: DETERIORATED, MAJOR RUSTING

10
 S.F.
 REPLACE
 PRIORITY 4
 LEVEL 2

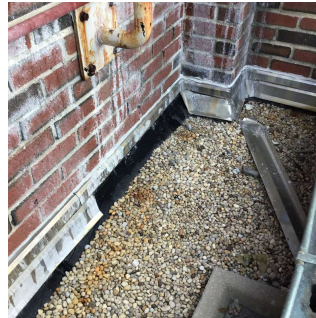
Roof 2

Roof 1
Instance Quantity	35,000
Instance Quantity Uom	S.F.
Does the roof have major mechanical equipment sitting on Dunnage Steel less than 18" above the Roofing?	No
Does this roof instance have a Sustainable Roof System?	No
Do solar panels exist on these roofs?	No
Is/Are the roof(s) suitable for Solar Panel installation?	Yes
Installation Year	2000
Source of Installation	Custodial Staff
Deficiency	BUILT-UP: FLASHING: CAP FLASHING MISSING
Roof Plan reference	Q032

Deficiency Quantity	10
Quantity Uom	L.F.
Potential Action	INSTALL NEW
Urgency of Action	PRIORITY 4
Purpose of Action	LEVEL 2

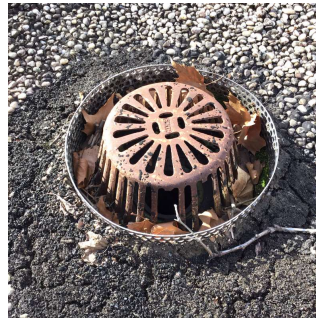
Roof 4

DETERIORATED

REPLACE

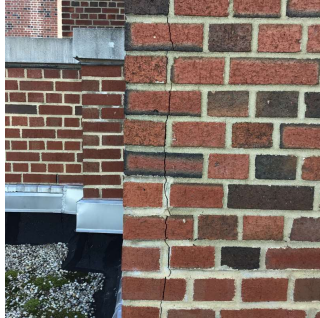
Violations	BH1 No violations recorded.
Deficiency	BULKHEAD/PENTHOUSE WALLS/EXTERIOR: DETERIORATED JOINTS
Roof Plan reference	Q032

**BULKHEAD/PENTHOUSE WALLS/EXTERIOR:
CRACKS/SPALLING - MAJOR**

20
S.F.
REPLACE
PRIORITY 4
LEVEL 2

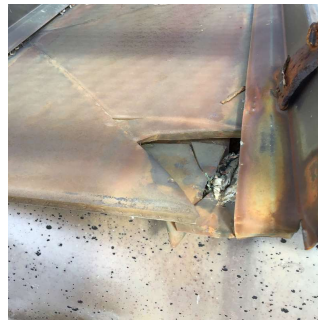
SK
No violations recorded.

Violations	BH2 No violations recorded.
CUPOLA/ SPIRES/ TOWERS	Does not Exist
DORMER	Does not Exist
DUNNAGE STEEL	Does not Exist
SKYLIGHT/ROOF VENT	Inspected
Material Type(s)	Glass
Condition	3 - Fair
Deficiency	BROKEN GLASS

10
S.F.
MAINTENANCE
PRIORITY 3
LEVEL 2

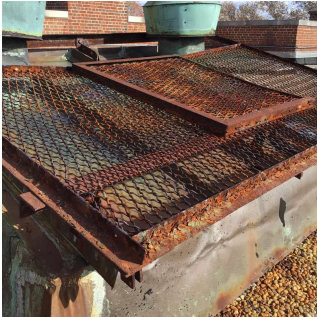
Violations	SK No violations recorded.
Deficiency	SHAFT VENTS DAMAGED
Roof Plan reference	Q032

DAMAGED GUARDS

20
S.F.
MAINTENANCE
PRIORITY 3
LEVEL 2

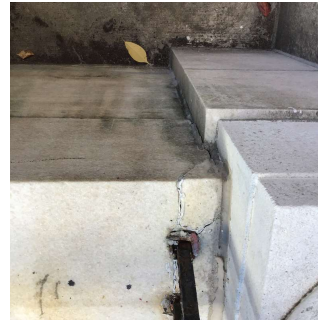
Facade A

STONE: CRACKS/SPALLING - MINOR

10
S.F.
REPAIR
PRIORITY 3
LEVEL 2

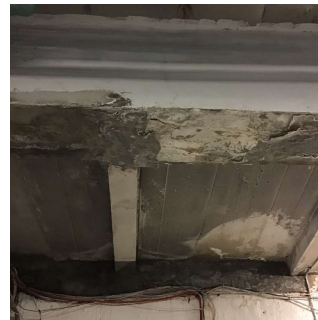
Boiler Room

STONE: WATER INFILTRATION IN NON-INSTRUCTIONAL SPACE BELOW

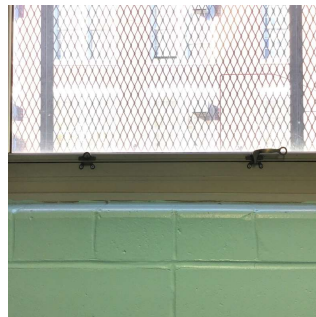
Facade F - Corridor near Auditorium

**ALUMINUM - OTHER: HARDWARE POOR
CONDITION/MISSING**

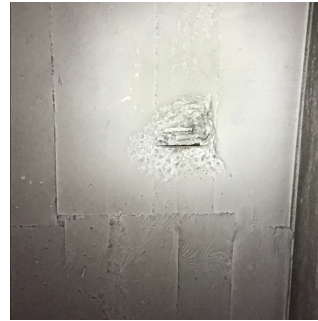
Boiler Room

FLOOR STRUCTURE

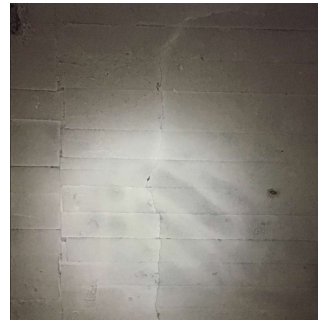
Boiler Room

CINDER CONCRETE FLAT SLAB:
CRACKED/SPALLED/REINFORCEMENT EXPOSED

REPAIR

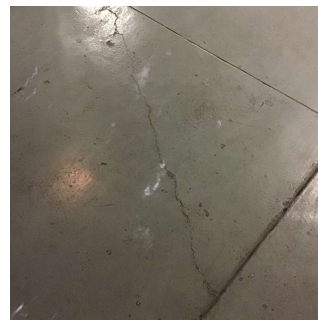
Boiler Room

CONCRETE SLAB ON GRADE: THRU CRACKS

REPAIR

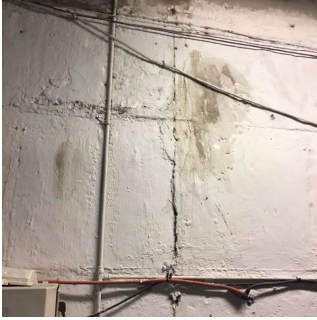
Question	Response
INTERIOR	
STRUCTURAL	
FLOOR STRUCTURE	Inspected
Violations	No violations recorded.
FOUNDATION WALLS	Inspected
Material Type(s)	Concrete, Masonry
Condition	4 - Between Fair and Poor
Deficiency	CONCRETE: CRACKED/SPALLED/REINFORCEMENT EXPOSED
Deficiency Location/Instance	Boiler Room
Deficiency Quantity	20
Quantity Uom	S.F.
Potential Action	REPAIR
Urgency of Action	PRIORITY 3
Purpose of Action	LEVEL 5
Deficiency Photo1

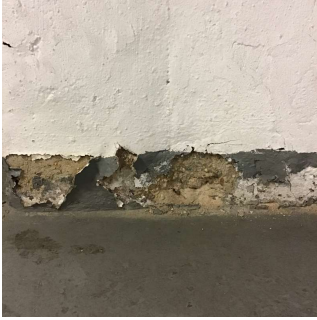
Violations	No violations recorded.
Deficiency	CONCRETE: CRACKED/SPALLED/REINFORCEMENT EXPOSED
Deficiency Location/Instance	Boiler Room
Deficiency Quantity	10
Quantity Uom	S.F.
Potential Action	REPAIR
Urgency of Action	PRIORITY 4
Purpose of Action	LEVEL 5
Deficiency Photo1

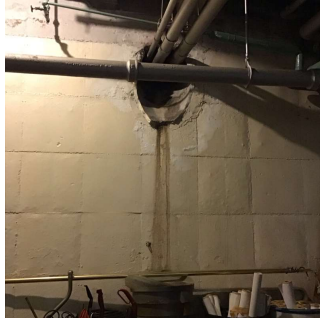
Violations	No violations recorded.
Deficiency	CONCRETE: WATER INFILTRATION IN NON- INSTRUCTIONAL SPACE
Deficiency Location/Instance	Basement - Old Coal Chute
Deficiency Quantity	100
Quantity Uom	S.F.
Potential Action	INSTALL WATERPROOFING

Question	Response
INTERIOR	
STRUCTURAL	
FOUNDATION WALLS	Inspected
Urgency of Action	PRIORITY 5
Purpose of Action	LEVEL 5
Deficiency Photo1

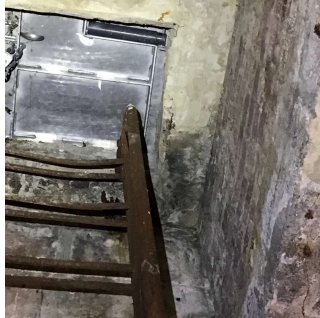
Violations	Basement - Old Coal Chute No violations recorded.
ROOF STRUCTURE	Inspected
Condition	2 - Between Good and Fair
Deficiency	No deficiencies recorded
VAULTS-BUNKERS	Inspected
Foundation Walls	Inspected
Condition	2 - Between Good and Fair
Deficiency	No deficiencies recorded
Slab Structure	Inspected
Condition	3 - Fair
Deficiency	STEEL COLUMNS/BEAMS: DETERIORATED CONCRETE FIREPROOFING
Deficiency Location/Instance	Ash Hoist Vault
Deficiency Quantity	10
Quantity Uom	S.F.
Potential Action	REPAIR
Urgency of Action	PRIORITY 4
Purpose of Action	LEVEL 5
Deficiency Photo1

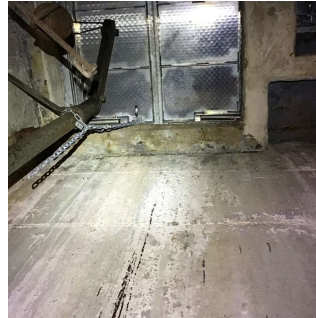
Violations	Ash Hoist Vault No violations recorded.
Vault/Ash Hoist Doors and Framing	Inspected
Condition	5 - Poor
Deficiency	WATER INFILTRATION
Deficiency Location/Instance	Ash Hoist Vault
Deficiency Quantity	10

Potential Action
Urgency of Action
Purpose of Action
Deficiency Photo1

REPAIR
PRIORITY 5
LEVEL 2

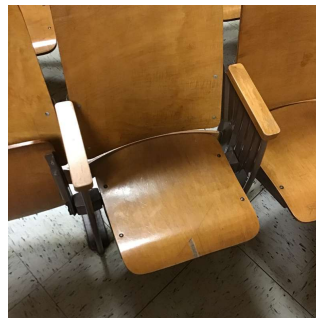
Seat I/7

DAMAGED/BROKEN/INOPERABLE

REPLACE

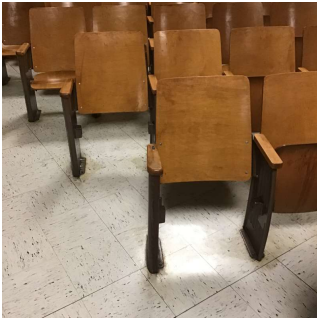
Question	Response
INTERIOR	
AUDITORIUM	
Fixed Seating	
Violations	No violations recorded.
Deficiency	DAMAGED/BROKEN/INOPERABLE
Deficiency Location/Instance	Seats H/1, I/1
Deficiency Quantity	2
Quantity Uom	EACH
Potential Action	REPLACE
Urgency of Action	PRIORITY 5
Purpose of Action	LEVEL 6
Deficiency Photo1

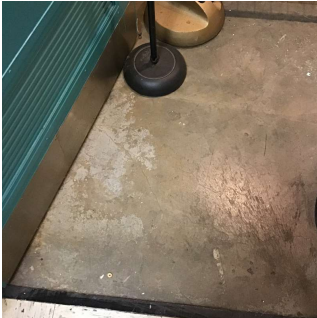
Seat H/1
Violations	No violations recorded.
Floor Finish	
Instance on 1st Floor (250 Seats)	Inspected
Condition	2 - Between Good and Fair
Deficiency	CONCRETE: CRACKS
Deficiency Location/Instance	Storage Room
Deficiency Quantity	25
Quantity Uom	S.F.
Potential Action	REPLACE
Urgency of Action	PRIORITY 3
Purpose of Action	LEVEL 2
Deficiency Photo1

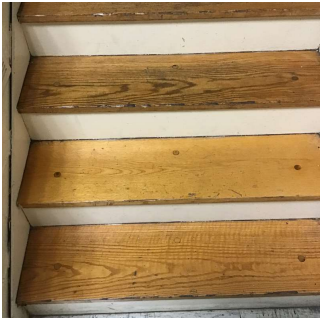
Question	Response
INTERIOR	
AUDITORIUM	
Stage	
Stage	
Instance on 1st Floor (250 Seats)	Inspected
Condition	2 - Between Good and Fair
Deficiency	DAMAGED STEPS
Deficiency Location/Instance	Left and Right Side
Deficiency Quantity	20
Quantity Uom	S.F.
Potential Action	REPLACE
Urgency of Action	PRIORITY 3
Purpose of Action	LEVEL 2
Deficiency Photo1

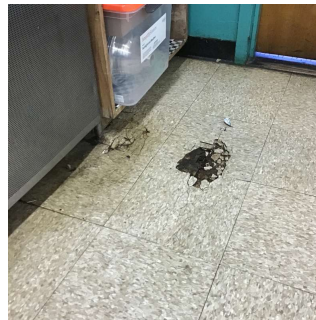
Room 102

VINYL TILES: DETERIORATED SUBSTRATE

REPLACE

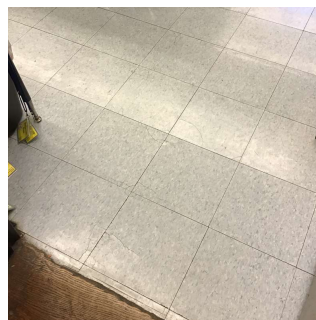
VINYL TILES: BROKEN/DETERIORATED/MISSING TILES

REPLACE

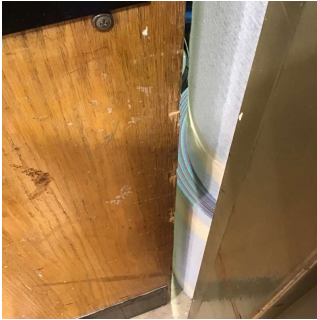
Question	Response
INTERIOR	
GYMNASIUM	
Ceiling	
Condition	2 - Between Good and Fair
Deficiency	No deficiencies recorded
Door(s)	
Instance on 1st Floor	Inspected
Condition	5 - Poor
Deficiency	WOOD: DETERIORATED DOOR
Deficiency Location/Instance	Emergency Exit, Main Entrance
Deficiency Quantity	4
Quantity Uom	EACH
Potential Action	MAINTENANCE
Urgency of Action	PRIORITY 3
Purpose of Action	LEVEL 2
Deficiency Photo1

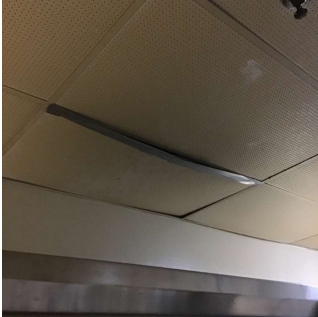
Question	Response
INTERIOR	
KITCHEN	Inspected
Instance on 1st Floor	Inspected
Ceiling	
Instance on 1st Floor	Inspected
Condition	2 - Between Good and Fair
Deficiency	METAL PAN: DAMAGED/MISSING
Deficiency Location/Instance	Near Freezers, near walking in
Deficiency Quantity	20
Quantity Uom	S.F.
Potential Action	REPLACE
Urgency of Action	PRIORITY 3
Purpose of Action	LEVEL 2
Deficiency Photo1

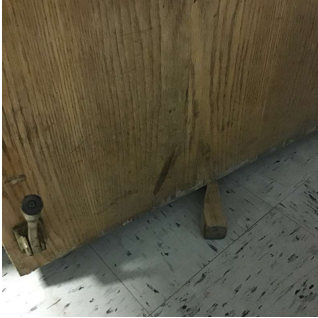
Near Freezers
Violations	No violations recorded.
Door(s)	
Instance on 1st Floor	Inspected
Condition	4 - Between Fair and Poor
Deficiency	WOOD: DETERIORATED DOOR
Deficiency Location/Instance	Female locker Room
Deficiency Quantity	1
Quantity Uom	EACH
Potential Action	MAINTENANCE
Urgency of Action	PRIORITY 3
Purpose of Action	LEVEL 2
Deficiency Photo1

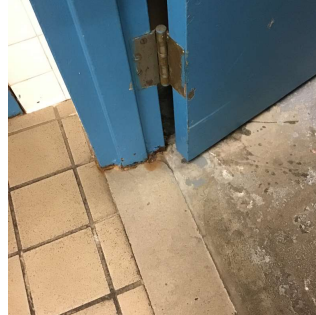
Female locker Room
Violations	No violations recorded.
Deficiency	METAL: DETERIORATED DOOR AND FRAME
Deficiency Location/Instance	Storage Room
Deficiency Quantity	1
Quantity Uom	EACH

Potential Action	MAINTENANCE

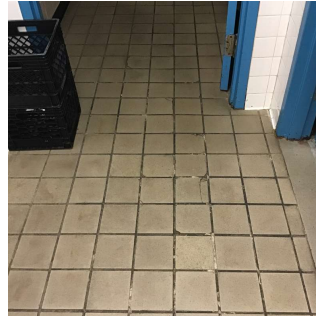
Near Female locker Room

QUARRY TILE: BROKEN/MISSING TILES

REPLACE

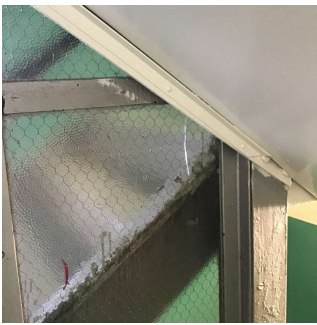
Near Room 161
Violations	No violations recorded.
Sliding-folding Partition	
Instance on 1st Floor	Does not Exist
Stage	
Instance on 1st Floor	Does not Exist
Walls	
Instance on 1st Floor	Inspected
Condition	2 - Between Good and Fair
Deficiency	No deficiencies recorded
Window Curtains/Shades/Blinds	
Instance on 1st Floor	Does not Exist
SCIENCE DEMO ROOM	Does not Exist
SCIENCE LAB	Does not Exist
SCIENCE PREP ROOM	Does not Exist
SHOWER ROOM	Does not Exist
STAIRS/RAMPS: INTERIOR	Inspected
Do Letter Stair Signs Exist?	Partially
Ceiling	Inspected
Condition	2 - Between Good and Fair
Deficiency	No deficiencies recorded
Door(s)	Inspected
Condition	2 - Between Good and Fair
Deficiency	No deficiencies recorded
Partition	Inspected
Condition	2 - Between Good and Fair
Deficiency	GLASS PANEL: DAMAGED/DETERIORATED
Deficiency Location/Instance	Stair EF/2

Deficiency Quantity	10
Quantity Uom	S.F.
Potential Action	REPLACE
Urgency of Action	PRIORITY 3
Purpose of Action	LEVEL 2

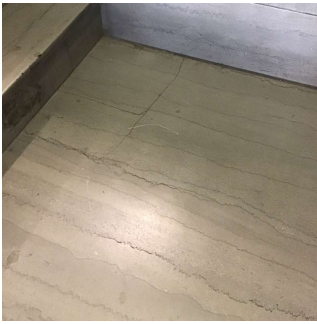
Violations	Stair EF/2 No violations recorded.
Railings	Inspected
Condition	2 - Between Good and Fair
Deficiency	No deficiencies recorded
Stairs and Landings	Inspected
Condition	5 - Poor
Deficiency	STONE: BROKEN/MISSING
Deficiency Location/Instance	Main Entrance Lobby
Deficiency Quantity	20
Quantity Uom	S.F.
Potential Action	REPLACE
Urgency of Action	PRIORITY 3
Purpose of Action	LEVEL 2
Deficiency Photo1

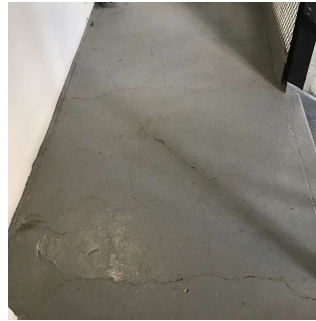
Stair EF/Bulkhead

Violations	Main Entrance Lobby No violations recorded.
Deficiency	ROLLED ASPHALT: CRACKS
Deficiency Location/Instance	Stairs EF/Bulkhead, 3, 2, 1, GH/3 and others
Deficiency Quantity	1,050
Quantity Uom	S.F.
Potential Action	REPLACE
Urgency of Action	PRIORITY 3
Purpose of Action	LEVEL 2

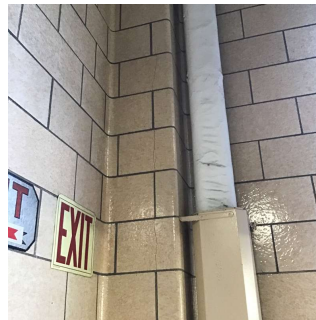
Stair CD/1

GLAZED BLOCK: CRACKS/SPALLING

REPLACE

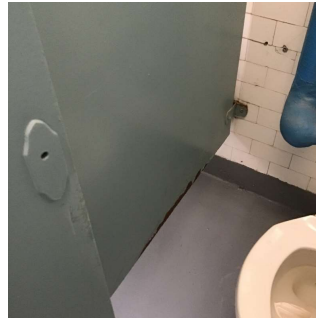
Room 266

RUST - MAJOR

REPLACE

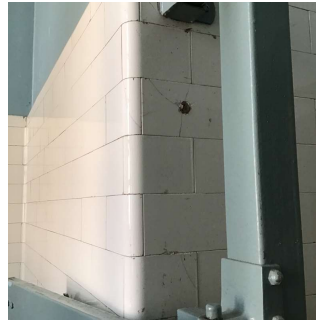
Room 358

CERAMIC TILE: BROKEN/ MISSING

REPLACE

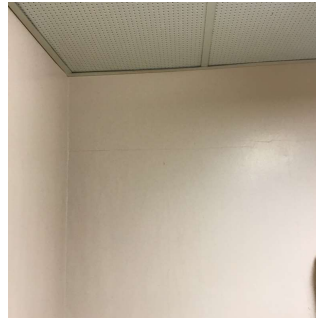
Womens Toilet Room Inside Kitchen

PLASTER: CRACKS/SPALLING

REPLACE

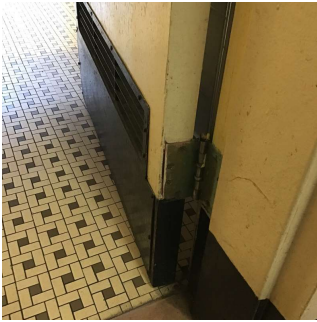
3rd Floor - Girls
Violations	No violations recorded.
Door(s)	Inspected
Condition	5 - Poor
Deficiency	WOOD: DETERIORATED DOOR
Deficiency Location/Instance	Rooms 355, 260, 161, 154, 3rd Floor - Girls and others
Deficiency Quantity	7
Quantity Uom	EACH
Potential Action	MAINTENANCE
Urgency of Action	PRIORITY 3
Purpose of Action	LEVEL 2
Deficiency Photo1

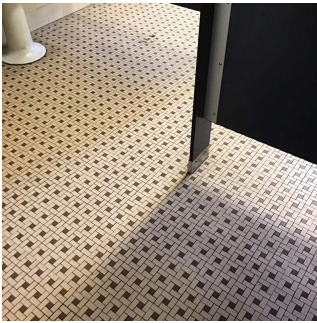
Room 161
Violations	No violations recorded.
Floor Finish	Inspected
Condition	2 - Between Good and Fair
Deficiency	CERAMIC TILE: BROKEN/MISSING TILES
Deficiency Location/Instance	Rooms 154, 161, 3rd Floor - Girls
Deficiency Quantity	30
Quantity Uom	S.F.
Potential Action	REPLACE
Urgency of Action	PRIORITY 3
Purpose of Action	LEVEL 2

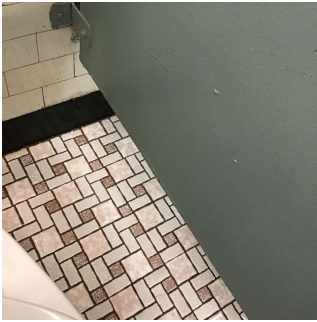
Room 161
Violations	No violations recorded.
Stalls	
Condition	Inspected
	5 - Poor
Deficiency	RUST - MAJOR
Deficiency Location/Instance	Room 260, 3rd Floor - Girls
Deficiency Quantity	6
Quantity Uom	EACH
Potential Action	REPLACE
Urgency of Action	PRIORITY 3
Purpose of Action	LEVEL 2
Deficiency Photo1

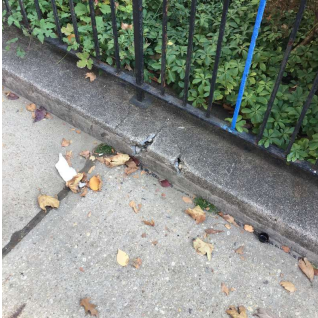
Deficiency	CONCRETE CURB: DAMAGED/DETERIORATED
Deficiency Location/Instance	35th Avenue

Question	Response
SITE	
FENCES	
Deficiency Quantity	20
Quantity Uom	S.F.
Potential Action	REPLACE
Urgency of Action	PRIORITY 3
Purpose of Action	LEVEL 2
Deficiency Photo1

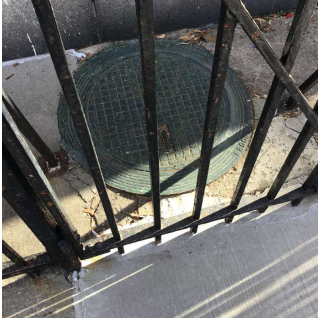
Violations	171st Street No violations recorded.
Pavers	Does not Exist
Student Use	Inspected
Gravel Exists?	No
Asphalt	Inaccessible
Concrete	Inaccessible
Pavers	Does not Exist

Violations	35th Avenue No violations recorded.
IRRIGATION SYSTEM	Does not Exist
PAVING	Inspected
Student Non-Use	Inspected
Gravel Exists?	No
Asphalt	Does not Exist
Concrete	Inspected
Condition	3 - Fair
Deficiency	CRACKS - MAJOR
Deficiency Location/Instance	171st Street, 172nd Street
Deficiency Quantity	75
Quantity Uom	S.F.
Potential Action	REPLACE
Urgency of Action	PRIORITY 3
Purpose of Action	LEVEL 2
Deficiency Photo1

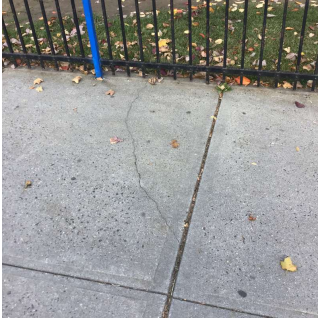
35th Avenue
Violations	No violations recorded.
Deficiency	DAMAGED CURBS
Deficiency Location/Instance	171st Street, 35th Avenue, 172nd Street

35th Avenue
Violations	No violations recorded.
Pavers	Does not Exist
DOT Sidewalk	Inspected
Asphalt	Does not Exist
Concrete	Inspected
Condition	3 - Fair
Deficiency	DAMAGED/DETERIORATED/MISSING SECTIONS
Deficiency Location/Instance	35th Avenue, 171st Street
Deficiency Quantity	50
Quantity Uom	S.F.
Potential Action	REPLACE
Urgency of Action	PRIORITY 3
Purpose of Action	LEVEL 2
Deficiency Photo1

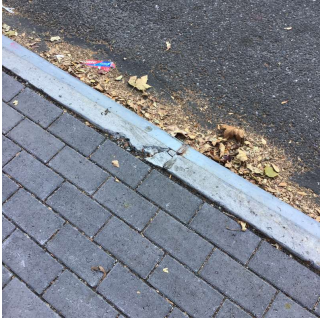
Question	Response
SITE	
PAVING	
DOT Sidewalk	
Concrete	
Deficiency Quantity	30
Quantity Uom	L.F.
Potential Action	REPLACE
Urgency of Action	PRIORITY 3
Purpose of Action	LEVEL 2
Deficiency Photo1
