NYC Department of Education
Building Condition Assessment Survey 2023 - 2024

Architectural Inspection

Q033

Asset: P.S. 33 - QUEENS, 91-37 222 STREET, New York, 11428

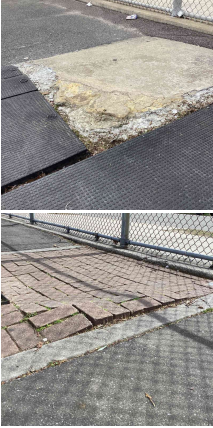
Yes	Tripping Hazard	Severely Heaving pavers in the schoolyard are a hazard Condition	SITE PAVING Student Use Pavers	Near 92nd Street, 224th Street	Parish Gaymon	Cleaner

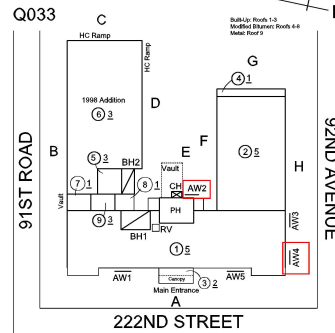
Roof Plan reference

AREAWAY WALLS: CRACKS AND SPALLING

REPAIR

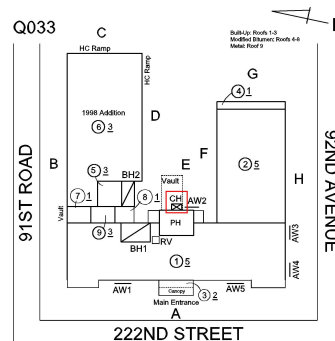
Roof Plan reference

BRICK: MINOR CRACKS AND SPALLING

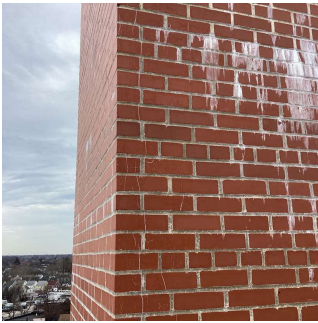
Question	Response
EXTERIOR	
CHIMNEY	
Purpose of Action	LEVEL 2
Deficiency Photo1

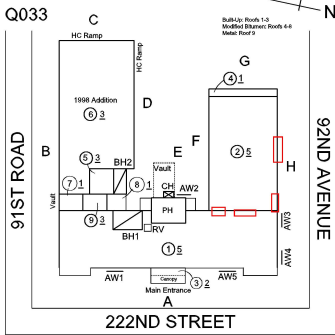
Violations	Roof 1 No violations recorded.
COPING	
Condition	Inspected 2 - Between Good and Fair
Deficiency	CAST STONE: DETERIORATED BED JOINT
Roof Plan reference	<p>Q033</p>

Deficiency Quantity	20
Quantity Uom	L.F.
Potential Action	REPOINT
Urgency of Action	PRIORITY 3
Purpose of Action	LEVEL 2
Deficiency Photo1

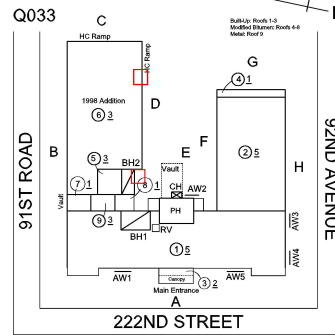
Roof Plan reference

METAL: DETERIORATED DOOR AND FRAME - MINOR DETERIORATION

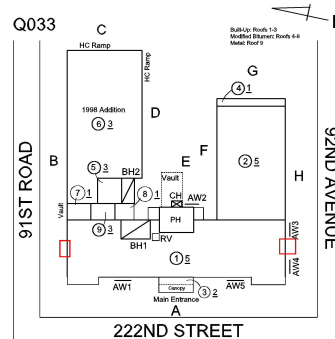
Roof Plan reference

METAL: DETERIORATED DOOR AND FRAME - MAJOR DETERIORATION

REPLACE

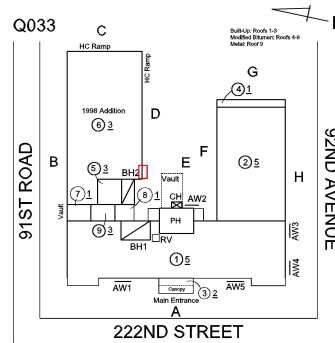
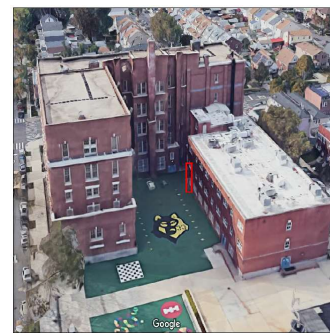
Roof Plan reference

BRICK: DETERIORATED CONTROL/EXPANSION JOINTS

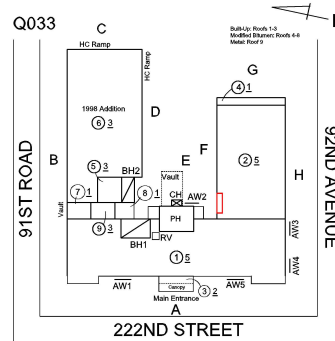
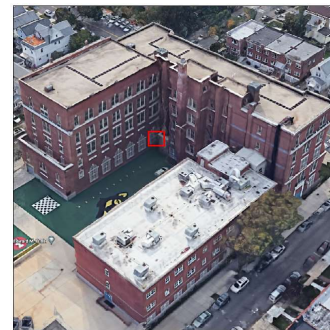
Roof Plan reference

BRICK: DETERIORATED MASONRY SILLS - MINOR

REPAIR

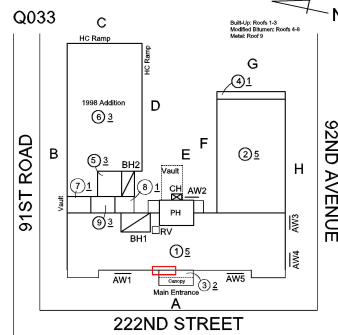
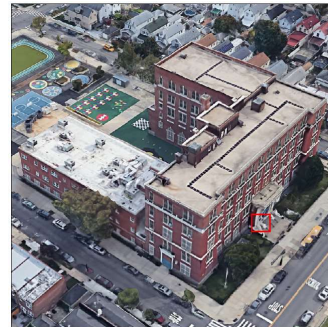
Roof Plan reference

STONE: CHIPPED/SPALLED/BROKEN PIECES - MAJOR

Potential Action	REPLACE
Urgency of Action	PRIORITY 4
Purpose of Action	LEVEL 2
Deficiency Photo1

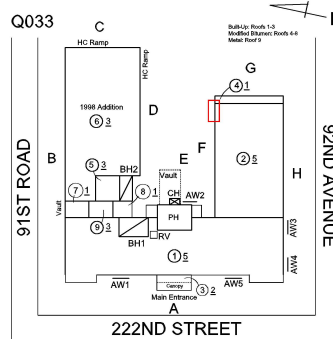
Roof Plan reference

No	Potential Falling Debris	Out of plumb masonry parapet wall is a potential falling debris hazard.	EXTERIOR PARAPETS	Northeast corner of Gymnasium roof facing schoolyard.	Parish Gaymon	Cleaner

Deficiency	BRICK: OUT OF PLUMB
------------	---------------------

Deficiency Quantity	20
Quantity Uom	C.F.
Potential Action	REMOVE AND REBUILD
Urgency of Action	PRIORITY 5
Purpose of Action	LEVEL 6

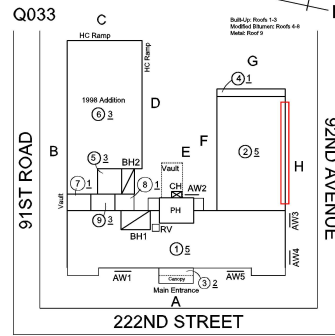
Roof Plan reference

BRICK: EFFLORESCENCE

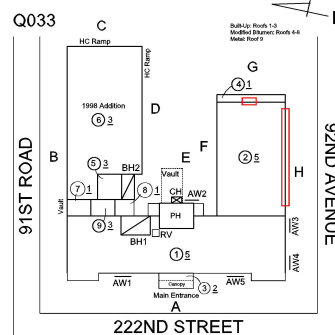
Roof Plan reference

BRICK: MAJOR DETERIORATION/CRACKS

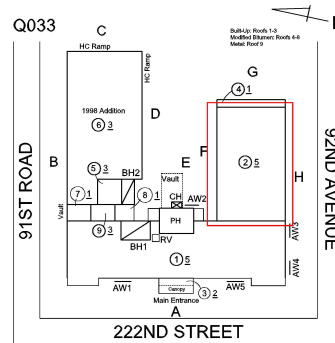
Roof Plan reference

BRICK: DETERIORATED JOINTS

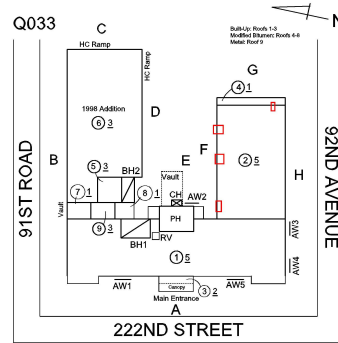
Roof Plan reference

BRICK: DETERIORATED CONTROL/EXPANSION JOINT

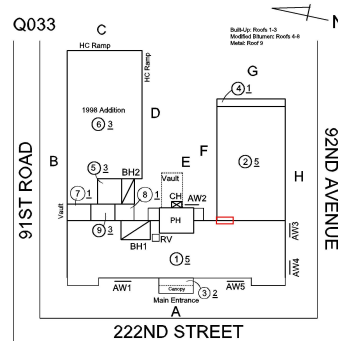
Roof Plan reference

BRICK: DETERIORATED JOINTS

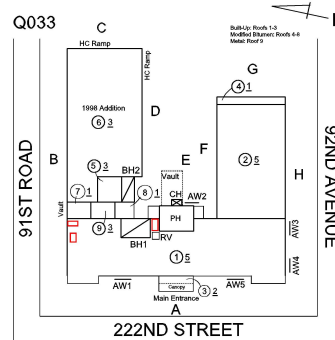
Roof Plan reference

Is/Are the roof(s) suitable for Solar Panel installation?	Yes
Installation Year	1998
Source of Installation	Custodial Staff
Deficiency	BUILT-UP: ROOFING: MAJOR ACTIVE ROOF LEAKS IN INSTRUCTIONAL SPACE

Roof 1 - Room 507, also Rooms 508, Staff Toilet Room 555
No violations recorded.

REPLACE ROOFING WITHOUT MAJOR EQUIPMENT REMOVAL

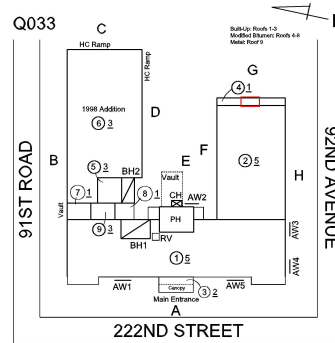
Roof Plan reference

MODIFIED BITUMEN: ROOFING: MAJOR ACTIVE ROOF LEAKS IN INSTRUCTIONAL SPACE

REPLACE ROOFING WITHOUT MAJOR EQUIPMENT REMOVAL

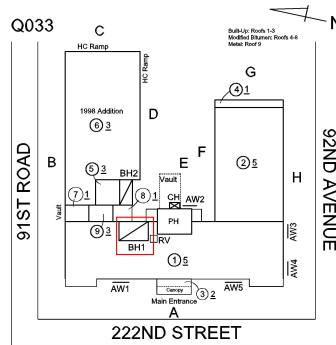
Roof Plan reference

Deficiency	BULKHEAD/PENTHOUSE WALLS/INTERIOR: PLASTER CRACKS/SPALLING
------------	--

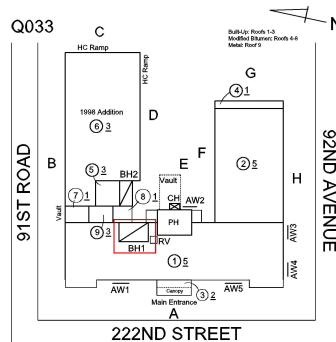
Roof Plan reference

Deficiency	BULKHEAD/PENTHOUSE WALLS/EXTERIOR: WATER INFILTRATION
------------	---

Question	Response
EXTERIOR	
ROOF	
Specialties	Inspected
BULKHEAD/PENTHOUSE	
Potential Action	REPAIR
Urgency of Action	PRIORITY 5
Purpose of Action	LEVEL 2
Deficiency Photo1

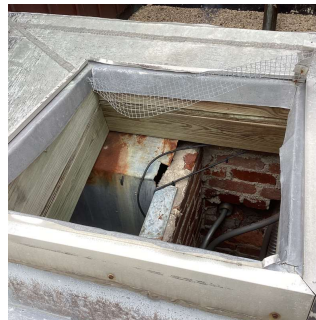
Roof 1 - Roof vent

No	Potential Falling Debris	Missing Skylight/Roof Vent cover is a potential safety hazard.	EXTERIOR ROOF Specialties SKYLIGHT/ROOF OF VENT	Main Roof adjacent to chimney.	Parish Gaymon	Cleaner

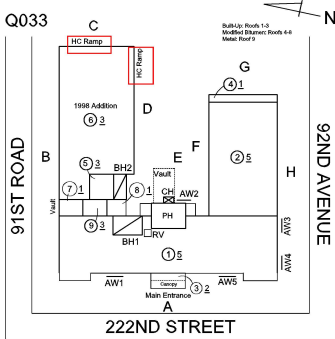
Violations	Roof 1 - Penthouse - Tank Room No violations recorded.
STAIRS/RAMPS: EXTERIOR	Inspected
BUILDING CHEEK/FLANK WALLS	Inspected
Condition	5 - Poor
Deficiency	CAST IN PLACE CONCRETE: CRACKS/SPALLING - MAJOR
Roof Plan reference

Deficiency Quantity	20
Quantity Uom	S.F.
Potential Action	REPLACE
Urgency of Action	PRIORITY 4
Purpose of Action	LEVEL 2
Deficiency Photo1

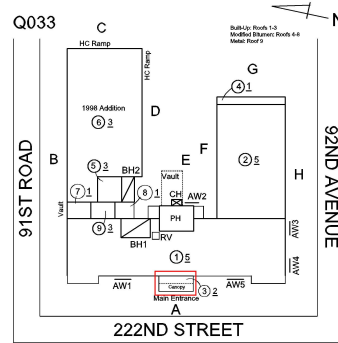
Violations	Facade D No violations recorded.
Deficiency	STONE: DETERIORATED JOINTS

10
 S.F.
 REPOINT
 PRIORITY 4
 LEVEL 2

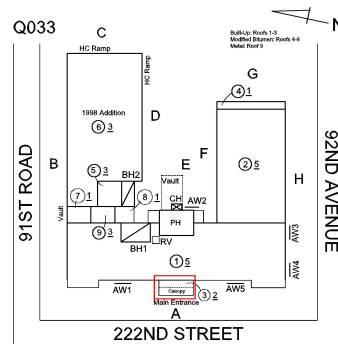
STONE: CRACKS/SPALLING - MINOR

10
 S.F.
 REPAIR
 PRIORITY 3
 LEVEL 2

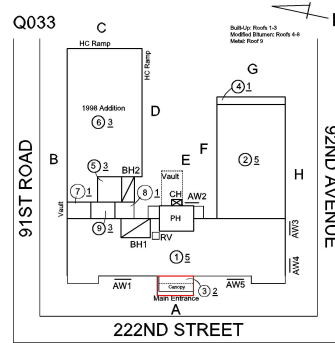
Violations	Facade A No violations recorded.
RAILINGS	
Condition	Inspected 3 - Fair
Deficiency	DAMAGED
Roof Plan reference	 
Deficiency Quantity	10
Quantity Uom	L.F.
Potential Action	REPLACE
Urgency of Action	PRIORITY 4
Purpose of Action	LEVEL 2
Deficiency Photo1	 
Violations	Facade A No violations recorded.
STAIRS/RAMPS	
Condition	Inspected 4 - Between Fair and Poor
Deficiency	CONCRETE: WORN-OUT TREAD/RISER/NOSING

20
 S.F.
 REPLACE
 PRIORITY 4
 LEVEL 2

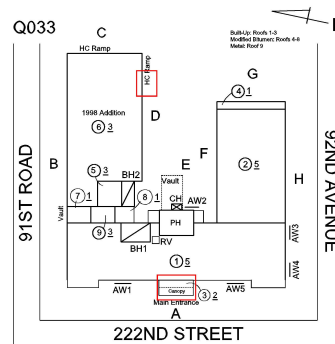
CONCRETE: CRACKS/SPALLING - MINOR

20
 S.F.
 REPAIR
 PRIORITY 3
 LEVEL 2

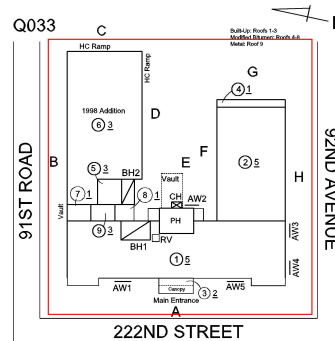
ALUMINUM - DOUBLE HUNG: INOPERABLE BALANCE

Deficiency Quantity	100
Quantity Uom	EACH
Potential Action	REPLACE BALANCES
Urgency of Action	PRIORITY 3
Purpose of Action	LEVEL 2
Deficiency Photo1	No photo recorded
Violations	No violations recorded.

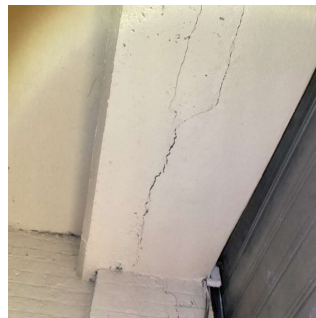
Basement - Boiler Room

Deficiency STEEL COLUMNS/BEAMS: DETERIORATED CONCRETE FIREPROOFING

Potential Action REPLACE

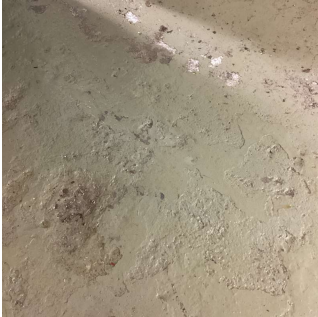
Violations	Basement - Corridor No violations recorded.
Deficiency	CONCRETE SLAB ON GRADE: THRU CRACKS
Deficiency Location/Instance	Basement - Corridor
Deficiency Quantity	30
Quantity Uom	S.F.
Potential Action	REPAIR
Urgency of Action	PRIORITY 3
Purpose of Action	LEVEL 5
Deficiency Photo1

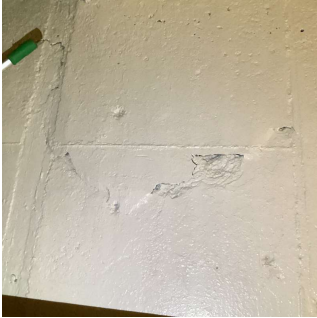
Violations	Basement - Corridor No violations recorded.
FOUNDATION WALLS	Inspected
Material Type(s)	Concrete
Condition	4 - Between Fair and Poor
Deficiency	CONCRETE: CRACKED/SPALLED/REINFORCEMENT EXPOSED
Deficiency Location/Instance	Basement - Boiler Room

Question	Response
INTERIOR	
STRUCTURAL	
FOUNDATION WALLS	
Potential Action	REPAIR
Urgency of Action	PRIORITY 3
Purpose of Action	LEVEL 5
Deficiency Photo1

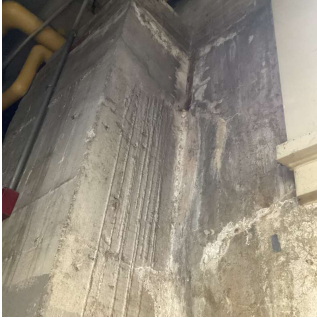
Basement - Boiler Room
Violations	No violations recorded.
Deficiency	CONCRETE: WATER INFILTRATION IN NON- INSTRUCTIONAL SPACE
Deficiency Location/Instance	Basement - Fan Area
Deficiency Quantity	100
Quantity Uom	S.F.
Potential Action	INSTALL WATERPROOFING
Urgency of Action	PRIORITY 5
Purpose of Action	LEVEL 5
Deficiency Photo1

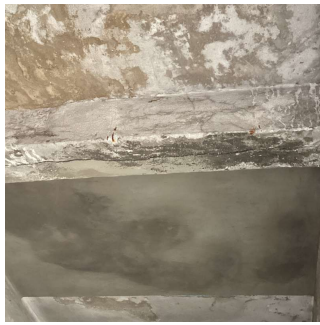
Basement - Fan Area
Violations	No violations recorded.
ROOF STRUCTURE	
	Inspected
Condition	2 - Between Good and Fair
Deficiency	STEEL COLUMNS/BEAMS: DETERIORATED CONCRETE FIREPROOFING
Deficiency Location/Instance	Roof 1 - Penthouse Tank Room
Deficiency Quantity	10
Quantity Uom	S.F.
Potential Action	REPLACE
Urgency of Action	PRIORITY 3
Purpose of Action	LEVEL 5

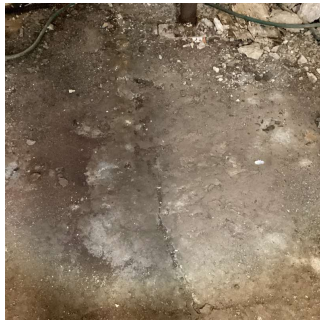
Violations	Roof 1 - Penthouse Tank Room No violations recorded.
VAULTS-BUNKERS	Inspected
Foundation Walls	Inspected
Condition	2 - Between Good and Fair
Deficiency	No deficiencies recorded
Slab Structure	Inspected
Condition	3 - Fair
Deficiency	CONCRETE SLAB ON GRADE: THRU CRACKS
Deficiency Location/Instance	Basement - Ash Hoist Vault
Deficiency Quantity	30
Quantity Uom	S.F.
Potential Action	REPLACE
Urgency of Action	PRIORITY 4
Purpose of Action	LEVEL 5
Deficiency Photo1

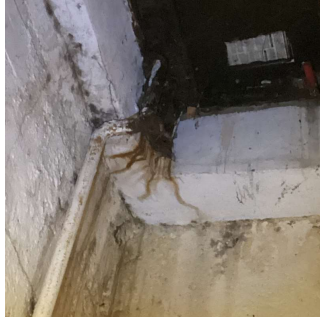
Violations	Basement - Ash Hoist Vault No violations recorded.
Vault/Ash Hoist Doors and Framing	Inspected
Condition	5 - Poor
Deficiency	WATER INFILTRATION
Deficiency Location/Instance	Basement - Ash Hoist Vault
Deficiency Quantity	10
Quantity Uom	S.F.
Potential Action	REPAIR
Urgency of Action	PRIORITY 5
Purpose of Action	LEVEL 2

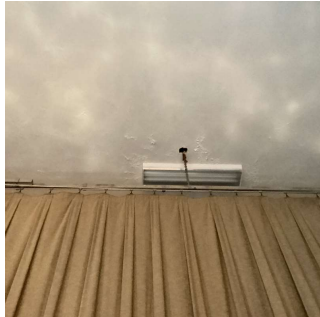
Violations	Basement - Ash Hoist Vault No violations recorded.
AUDITORIUM	
Instance on 1st Floor (631 seats)	Inspected
Condition	2 - Between Good and Fair
Deficiency	PLASTER: CRACKS/SPALLING - ACTIVE LEAK
Deficiency Location/Instance	Stage
Deficiency Quantity	20
Quantity Uom	S.F.
Potential Action	REPLACE
Urgency of Action	PRIORITY 5
Purpose of Action	LEVEL 2
Deficiency Photo1

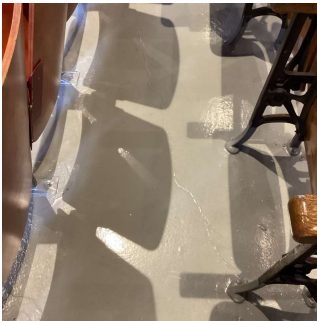
Question	Response
INTERIOR	
AUDITORIUM	
Fixed Seating	
Quantity Uom	EACH
Potential Action	REPLACE
Urgency of Action	PRIORITY 3
Purpose of Action	LEVEL 2
Deficiency Photo1	 
Violations	Seat Z/2 No violations recorded.
Floor Finish	
Instance on 1st Floor (631 seats)	Inspected
Condition	2 - Between Good and Fair
Deficiency	VINYL TILES: BROKEN/DETERIORATED/MISSING TILES
Deficiency Location/Instance	Near Seats G/2, R/2, Stage
Deficiency Quantity	30
Quantity Uom	S.F.
Potential Action	REPLACE
Urgency of Action	PRIORITY 3
Purpose of Action	LEVEL 2
Deficiency Photo1	 
Violations	Near Stage No violations recorded.
Deficiency	CONCRETE: CRACKS
Deficiency Location/Instance	Near Seats H/8, D/10, P/3, 23, S/24, and others
Deficiency Quantity	100
Quantity Uom	S.F.
Potential Action	REPLACE
Urgency of Action	PRIORITY 3
Purpose of Action	LEVEL 2

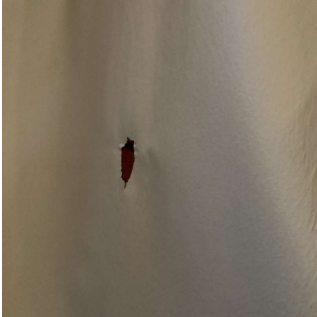
Near Seats S/24
Violations	No violations recorded.
Sliding-folding Partition	
Instance on 1st Floor (631 seats)	Does not Exist
Stage	
Instance on 1st Floor (631 seats)	Inspected
Stage	Inspected
Instance on 1st Floor (631 seats)	Inspected
Condition	2 - Between Good and Fair
Deficiency	No deficiencies recorded
Stage Curtain Rigging	
Instance on 1st Floor (631 seats)	Inspected
Condition	2 - Between Good and Fair
Deficiency	No deficiencies recorded
Stage Curtains	
Instance on 1st Floor (631 seats)	Inspected
Condition	3 - Fair
Deficiency	WORN/DETERIORATED
Deficiency Location/Instance	Main Right Side
Deficiency Quantity	100
Quantity Uom	S.F.
Potential Action	REPLACE
Urgency of Action	PRIORITY 3
Purpose of Action	LEVEL 2
Deficiency Photo1

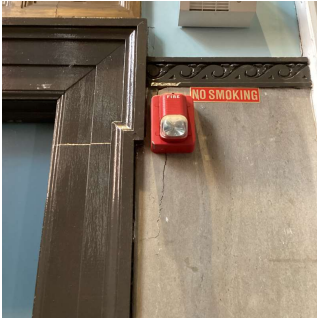
Question	Response
INTERIOR	
AUDITORIUM	
Walls	
Deficiency	STONE: CRACKS/SPALLING
Deficiency Location/Instance	Near Windows
Deficiency Quantity	20
Quantity Uom	S.F.
Potential Action	REPLACE
Urgency of Action	PRIORITY 3
Purpose of Action	LEVEL 2
Deficiency Photo1

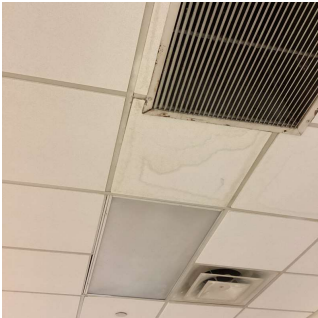
Violations	Near Windows No violations recorded.
Deficiency	STONE MOLDINGS: CRACKS/SPALLING
Deficiency Location/Instance	Near Windows
Deficiency Quantity	30
Quantity Uom	L.F.
Potential Action	REPLACE
Urgency of Action	PRIORITY 3
Purpose of Action	LEVEL 2
Deficiency Photo1	 
Violations	Near Windows No violations recorded.
Window Curtains/Shades/Blinds	
Instance on 1st Floor (631 seats)	Inspected
Condition	2 - Between Good and Fair
Deficiency	No deficiencies recorded
CAFETERIA	
Instance on 1st Floor	Inspected
Ceiling	
Instance on 1st Floor	Inspected
Condition	2 - Between Good and Fair
Deficiency	ACOUSTIC TILES: DAMAGED/MISSING
Deficiency Location/Instance	Near Serving Area

Question	Response
INTERIOR	
CAFETERIA	
Ceiling	
Deficiency Quantity	10
Quantity Uom	S.F.
Potential Action	REPLACE
Urgency of Action	PRIORITY 3
Purpose of Action	LEVEL 2
Deficiency Photo1

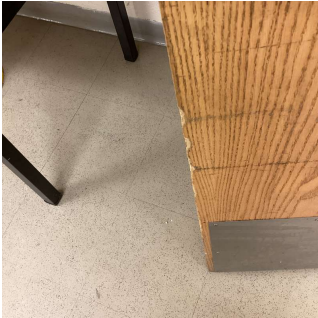
Near Serving Area
Violations	No violations recorded.
Door(s)	
Instance on 1st Floor	Inspected
Condition	3 - Fair
Deficiency	WOOD: DETERIORATED DOOR
Deficiency Location/Instance	Teacher Lounge
Deficiency Quantity	1
Quantity Uom	EACH
Potential Action	MAINTENANCE
Urgency of Action	PRIORITY 3
Purpose of Action	LEVEL 2
Deficiency Photo1

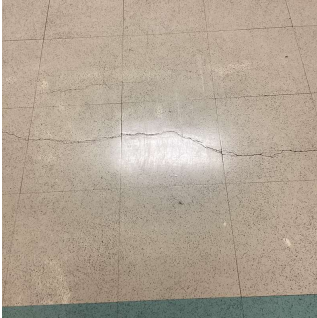
Teacher Lounge
Violations	No violations recorded.
Fixed Equipment	
Instance on 1st Floor	Does not Exist
Floor Finish	
Instance on 1st Floor	Inspected
Condition	5 - Poor
Deficiency	VINYL TILES: DETERIORATED SUBSTRATE
Deficiency Location/Instance	Near Entrance, Windows, Center
Deficiency Quantity	500
Quantity Uom	S.F.
Potential Action	REPLACE

Question	Response
INTERIOR	
CAFETERIA	
Floor Finish	
Urgency of Action	PRIORITY 3
Purpose of Action	LEVEL 2
Deficiency Photo1

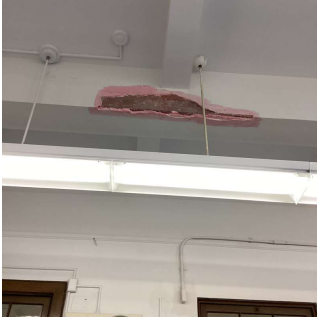
Near Entrance
Violations	No violations recorded.
Sliding-folding Partition	
Instance on 1st Floor	Does not Exist
Stage	
Instance on 1st Floor	Does not Exist
Walls	
Instance on 1st Floor	Inspected
Condition	2 - Between Good and Fair
Deficiency	GYPSON BOARD: DETERIORATED
Deficiency Location/Instance	Near Windows
Deficiency Quantity	20
Quantity Uom	S.F.
Potential Action	REPLACE
Urgency of Action	PRIORITY 3
Purpose of Action	LEVEL 2
Deficiency Photo1	 
	Near Windows
Violations	No violations recorded.
Window Curtains/Shades/Blinds	
Instance on 1st Floor	Does not Exist
CLASSROOMS/CORRIDORS/ADMIN SPACES	
	Inspected
Ceiling	
	Inspected
Condition	2 - Between Good and Fair
Deficiency	PLASTER: CRACKS/SPALLING
Deficiency Location/Instance	Rooms 408, 420
Deficiency Quantity	20
Quantity Uom	S.F.

Question	Response
INTERIOR	
CLASSROOMS/CORRIDORS/ADMIN SPACES	
Ceiling	
Potential Action	REPLACE
Urgency of Action	PRIORITY 3
Purpose of Action	LEVEL 2
Deficiency Photo1

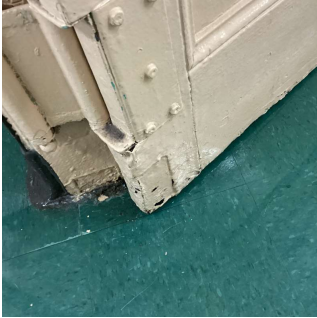
Room 408
Violations	No violations recorded.
Door(s)	Inspected
Condition	5 - Poor
Deficiency	METAL CLAD WOOD: DETERIORATED DOOR
Deficiency Location/Instance	Corridor near Rooms 256, 310
Deficiency Quantity	4
Quantity Uom	EACH
Potential Action	MAINTENANCE
Urgency of Action	PRIORITY 3
Purpose of Action	LEVEL 2
Deficiency Photo1

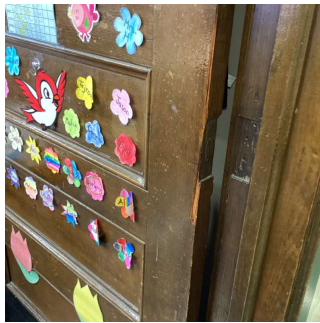
Corridor near Room 310
Violations	No violations recorded.
Deficiency	WOOD: DETERIORATED DOOR
Deficiency Location/Instance	Rooms 308, 313, 413, 509, 559, and others
Deficiency Quantity	16
Quantity Uom	EACH
Potential Action	MAINTENANCE
Urgency of Action	PRIORITY 3
Purpose of Action	LEVEL 2

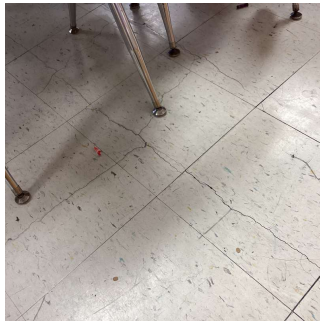
Violations	Room 313 No violations recorded.
Floor Finish	Inspected
Condition	2 - Between Good and Fair
Deficiency	VINYL TILES: DETERIORATED SUBSTRATE
Deficiency Location/Instance	Rooms A202, A304, A308, A309, Corridor near Elevator A/3, and others
Deficiency Quantity	700
Quantity Uom	S.F.
Potential Action	REPLACE
Urgency of Action	PRIORITY 3
Purpose of Action	LEVEL 2
Deficiency Photo1

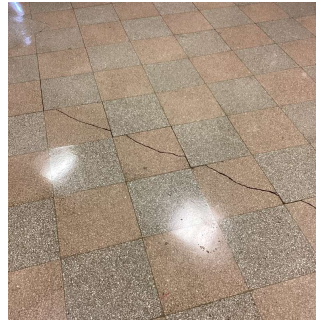
Near Exit 7

Violations	Room A308 No violations recorded.
Deficiency	TERRAZZO: CRACKS
Deficiency Location/Instance	Near Auditorium, Main Entrance Vestibule
Deficiency Quantity	30
Quantity Uom	S.F.
Potential Action	REPLACE
Urgency of Action	PRIORITY 3
Purpose of Action	LEVEL 2

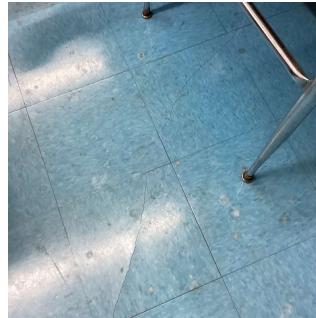
Room 412

VINYL TILES: BROKEN/DETERIORATED/MISSING TILES

REPLACE

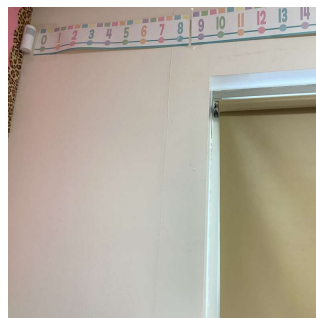
GYP SUM BOARD: DETERIORATED

REPLACE

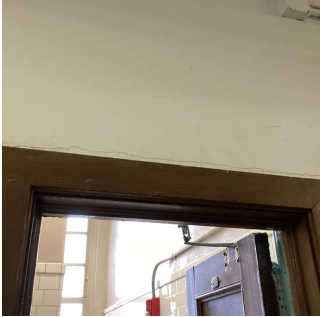
Question	Response
INTERIOR	
CLASSROOMS/CORRIDORS/ADMIN SPACES	
Walls	
Violations	Room A310 No violations recorded.
Deficiency	PLASTER: CRACKS/SPALLING
Deficiency Location/Instance	Corridor near Rooms 355, 508, 509, Corridor near Rooms 312, 354, And others
Deficiency Quantity	100
Quantity Uom	S.F.
Potential Action	REPLACE
Urgency of Action	PRIORITY 3
Purpose of Action	LEVEL 2
Deficiency Photo1

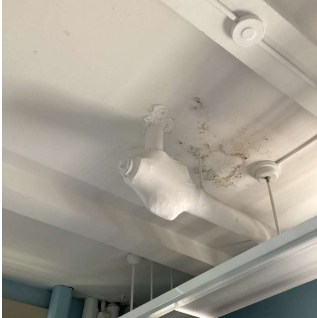
Violations	Room 507 No violations recorded.
Specialties	Does not Exist
GYMNASIUM	Inspected
Instance on 3rd Floor	Inspected
Instance on 5th Floor	Inspected
Ceiling	
Instance on 3rd Floor	Inspected
Condition	2 - Between Good and Fair
Deficiency	PLASTER: CRACKS/SPALLING

Question	Response
INTERIOR	
GYMNASIUM	
Ceiling	
Deficiency Location/Instance	Room 358
Deficiency Quantity	10
Quantity Uom	S.F.
Potential Action	REPLACE
Urgency of Action	PRIORITY 3
Purpose of Action	LEVEL 2
Deficiency Photo1

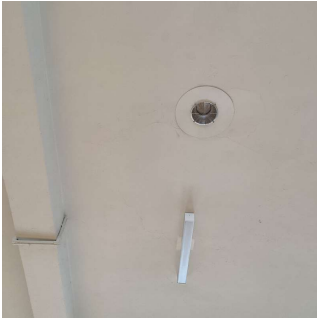
Room 358
Violations	No violations recorded.
Instance on 5th Floor	Inspected
Condition	2 - Between Good and Fair
Deficiency	PLASTER: CRACKS/SPALLING
Deficiency Location/Instance	Storage Room, Near center
Deficiency Quantity	40
Quantity Uom	S.F.
Potential Action	REPLACE
Urgency of Action	PRIORITY 3
Purpose of Action	LEVEL 2
Deficiency Photo1

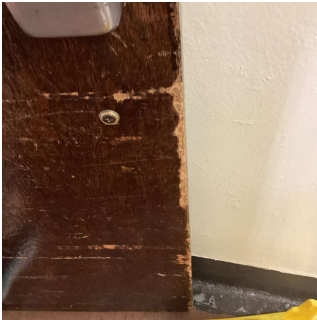
Question	Response
INTERIOR	
GYMNASIUM	
Door(s)	
Deficiency Photo1	 
	Room 358A
Violations	No violations recorded.
Instance on 5th Floor	Inspected
Condition	5 - Poor
Deficiency	WOOD: DETERIORATED DOOR
Deficiency Location/Instance	Entrances, Rooms 560, 561, 562
Deficiency Quantity	5
Quantity Uom	EACH
Potential Action	MAINTENANCE
Urgency of Action	PRIORITY 3
Purpose of Action	LEVEL 2
Deficiency Photo1

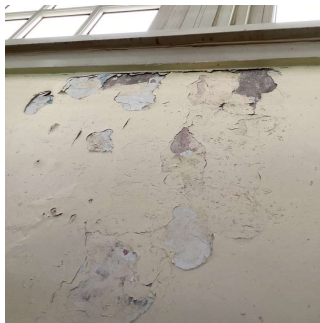
Question	Response
INTERIOR	
GYMNASIUM	
Door(s)	
Deficiency Photo1	 
Violations	Entrance No violations recorded.
Fixed Equipment	
Instance on 5th Floor	Inspected
Condition	1 - Good
Deficiency	No deficiencies recorded
Instance on 3rd Floor	Inspected
Condition	1 - Good
Deficiency	No deficiencies recorded
Floor Finish	
Instance on 3rd Floor	Inspected
Condition	2 - Between Good and Fair
Deficiency	No deficiencies recorded
Instance on 5th Floor	Inspected
Condition	2 - Between Good and Fair
Deficiency	No deficiencies recorded
Seating	
Instance on 3rd Floor	Does not Exist
Instance on 5th Floor	Does not Exist
Sliding-folding Partition	
Instance on 5th Floor	Does not Exist
Instance on 3rd Floor	Does not Exist
Stage	
Instance on 3rd Floor	Does not Exist
Instance on 5th Floor	Does not Exist
Walls	
Instance on 3rd Floor	Inspected
Condition	2 - Between Good and Fair
Deficiency	PLASTER: CRACKS/SPALLING
Deficiency Location/Instance	Near Windows

Deficiency Quantity	100
Quantity Uom	S.F.
Potential Action	REPLACE
Urgency of Action	PRIORITY 3
Purpose of Action	LEVEL 2

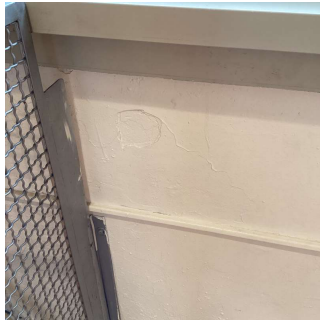
Violations	Near Windows No violations recorded.
Instance on 5th Floor	Inspected
Condition	2 - Between Good and Fair
Deficiency	PLASTER: CRACKS/SPALLING
Deficiency Location/Instance	Near Windows, Storage Room
Deficiency Quantity	40
Quantity Uom	S.F.
Potential Action	REPLACE
Urgency of Action	PRIORITY 3
Purpose of Action	LEVEL 2
Deficiency Photo1

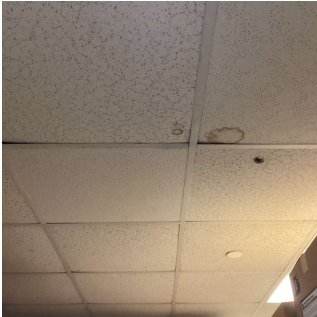
Violations	Near Windows No violations recorded.
Window Curtains/Shades/Blinds	
Instance on 3rd Floor	Does not Exist
Instance on 5th Floor	Does not Exist
INTERIOR DOOR HARDWARE	
Condition	Inspected
Deficiency	3 - Fair
Deficiency	No deficiencies recorded
INTERIOR GUARDS	
Condition	Inspected
Deficiency	2 - Between Good and Fair
Deficiency	No deficiencies recorded
KITCHEN	
Instance on 1st Floor	Inspected
Instance on 1st Floor	Inspected
Ceiling	
Instance on 1st Floor	Inspected
Condition	3 - Fair
Deficiency	ACOUSTIC TILES: DAMAGED/MISSING

Deficiency Location/Instance	Prep Area - Storage Room

Question	Response
INTERIOR	
KITCHEN	
Ceiling	
Deficiency Quantity	20
Quantity Uom	S.F.
Potential Action	REPLACE
Urgency of Action	PRIORITY 3
Purpose of Action	LEVEL 2
Deficiency Photo1

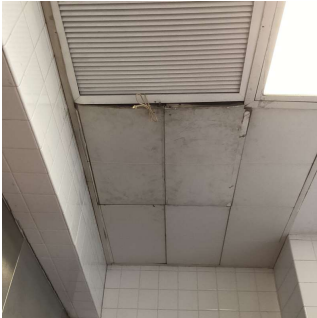
Prep Area - Storage Room
Violations	No violations recorded.
Deficiency	METAL PAN: DAMAGED/MISSING
Deficiency Location/Instance	Prep Area - Near Walking Fridge
Deficiency Quantity	10
Quantity Uom	S.F.
Potential Action	REPLACE
Urgency of Action	PRIORITY 5
Purpose of Action	LEVEL 6
Deficiency Photo1

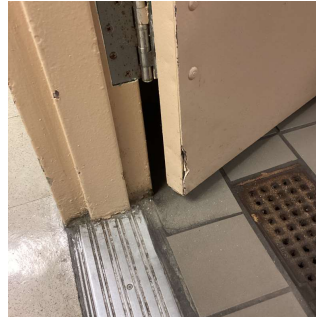
Right serving Area Entrance

METAL: DETERIORATED DOOR

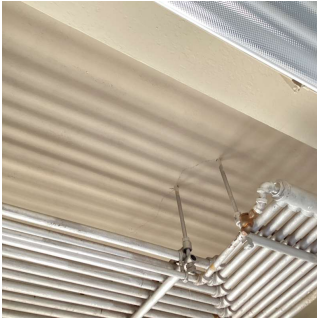
Violations	Near Windows No violations recorded.
LOCKER ROOM	
Instance on 3rd Floor	Inspected
Alternative use	Inspected
	Yes
Ceiling	
Instance on 3rd Floor	Inspected
Condition	2 - Between Good and Fair
Deficiency	PLASTER: CRACKS/SPALLING
Deficiency Location/Instance	Near center
Deficiency Quantity	10
Quantity Uom	S.F.
Potential Action	REPLACE
Urgency of Action	PRIORITY 3
Purpose of Action	LEVEL 2
Deficiency Photo1

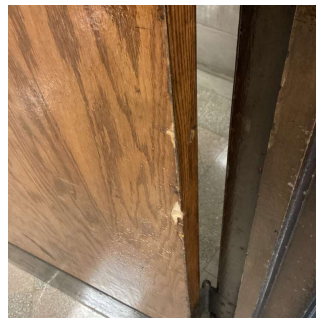
Entrance

WOOD: DETERIORATED DOOR

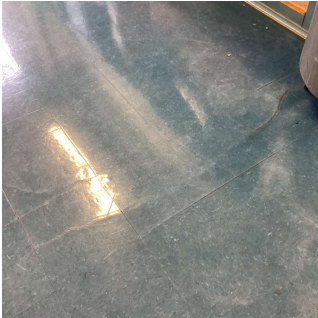
Question	Response
INTERIOR	
MULTI-PURPOSE ROOM	
Door(s)	
Violations	No violations recorded.
Fixed Equipment	
Instance on 1st Floor	Does not Exist
Floor Finish	
Instance on 1st Floor	Inspected
Condition	3 - Fair
Deficiency	VINYL TILES: BROKEN/DETERIORATED/MISSING TILES
Deficiency Location/Instance	Near Stair F, Center, Room 104
Deficiency Quantity	150
Quantity Uom	S.F.
Potential Action	REPLACE
Urgency of Action	PRIORITY 3
Purpose of Action	LEVEL 2
Deficiency Photo1

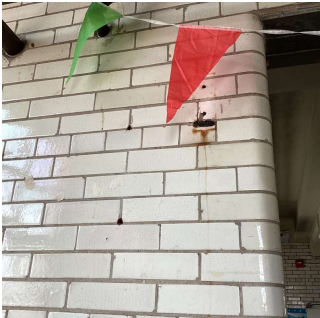
Question	Response
INTERIOR	
SHOWER ROOM	
Ceiling	
Instance on 3rd Floor	Inspected
Condition	3 - Fair
Deficiency	PLASTER: CRACKS/SPALLING
Deficiency Location/Instance	Near center
Deficiency Quantity	10
Quantity Uom	S.F.
Potential Action	REPLACE
Urgency of Action	PRIORITY 3
Purpose of Action	LEVEL 2
Deficiency Photo1	 
Violations	No violations recorded.
Door(s)	
Instance on 3rd Floor	Does not Exist
Floor Finish	
Instance on 3rd Floor	Inspected
Condition	2 - Between Good and Fair
Deficiency	No deficiencies recorded
Walls	
Instance on 3rd Floor	Inspected
Condition	2 - Between Good and Fair
Deficiency	CERAMIC TILE: BROKEN/ MISSING
Deficiency Location/Instance	Near Entrance
Deficiency Quantity	10
Quantity Uom	S.F.
Potential Action	REPLACE
Urgency of Action	PRIORITY 3
Purpose of Action	LEVEL 2
Deficiency Photo1

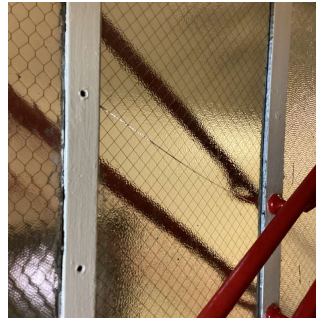
Stair FG/1

GLASS PANEL: DAMAGED/DETERIORATED

REPLACE

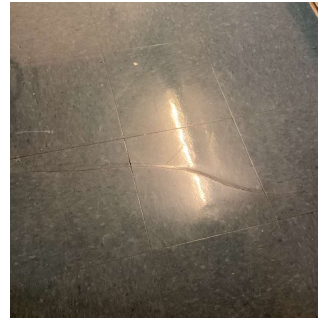
Stair CD/3

VINYL TILES: BROKEN/DETERIORATED/MISSING TILES

REPLACE

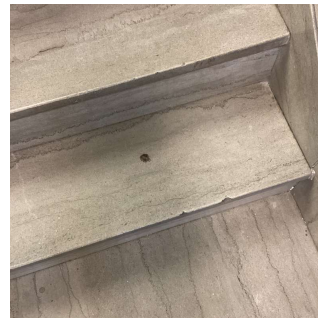
Main Entrance

STONE: BROKEN/MISSING

REPLACE

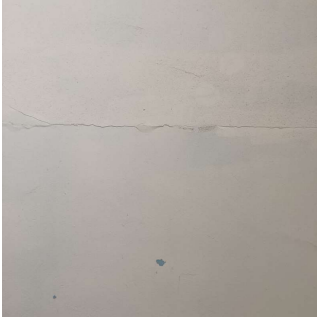
Question	Response
INTERIOR	
STAIRS/RAMPS: INTERIOR	
Walls	Inspected
Condition	2 - Between Good and Fair
Deficiency	PLASTER: CRACKS/SPALLING
Deficiency Location/Instance	Stair H/3
Deficiency Quantity	20
Quantity Uom	S.F.
Potential Action	REPLACE
Urgency of Action	PRIORITY 3
Purpose of Action	LEVEL 2
Deficiency Photo1

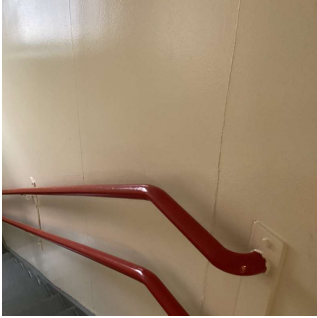
Violations	Stair H/3 No violations recorded.
Deficiency	GYPSUM BOARD: DETERIORATED
Deficiency Location/Instance	Stair A/1, 2, 3, B/1, 2, and others
Deficiency Quantity	250
Quantity Uom	S.F.
Potential Action	REPLACE
Urgency of Action	PRIORITY 3
Purpose of Action	LEVEL 2
Deficiency Photo1

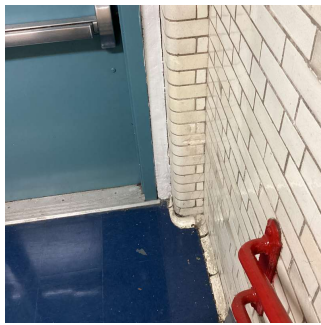
Violations	Stair A/3 No violations recorded.
Deficiency	CERAMIC TILE: BROKEN/ MISSING
Deficiency Location/Instance	Stairs CD/Vestibule , FG/Vestibule, H/Vestibule
Deficiency Quantity	50
Quantity Uom	S.F.
Potential Action	REPLACE
Urgency of Action	PRIORITY 3
Purpose of Action	LEVEL 2

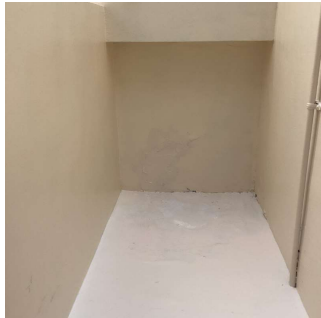
Violations	Stair CD/Vestibule No violations recorded.
TOILET ROOMS - STAFF	Inspected
Ceiling	Inspected
Condition	2 - Between Good and Fair
Deficiency	PLASTER: CRACKS/SPALLING - ACTIVE LEAK
Deficiency Location/Instance	Room 555
Deficiency Quantity	10
Quantity Uom	S.F.
Potential Action	REPLACE
Urgency of Action	PRIORITY 5
Purpose of Action	LEVEL 2
Deficiency Photo1

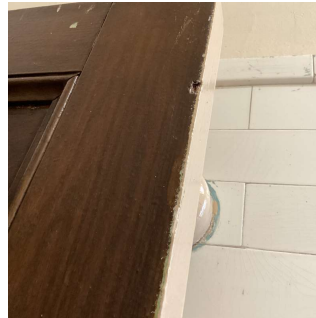
Room 555

WOOD: DETERIORATED DOOR

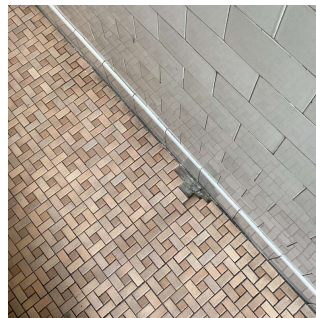
CERAMIC TILE: BROKEN/MISSING TILES

REPLACE

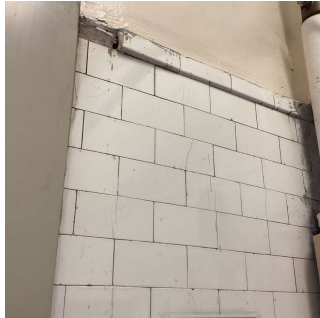
Question	Response
INTERIOR	
TOILET ROOMS - STAFF	
Floor Finish	Inspected
	Room 354
Violations	No violations recorded.
Stalls	Inspected
Condition	2 - Between Good and Fair
Deficiency	No deficiencies recorded
Walls	Inspected
Condition	2 - Between Good and Fair
Deficiency	PLASTER: CRACKS/SPALLING - ACTIVE LEAK
Deficiency Location/Instance	Room 555
Deficiency Quantity	10
Quantity Uom	S.F.
Potential Action	REPLACE
Urgency of Action	PRIORITY 5
Purpose of Action	LEVEL 2
Deficiency Photo1	 
	Room 555
Violations	No violations recorded.
Deficiency	CERAMIC TILE: BROKEN/ MISSING
Deficiency Location/Instance	Rooms 256, 456, 555
Deficiency Quantity	30
Quantity Uom	S.F.
Potential Action	REPLACE
Urgency of Action	PRIORITY 3
Purpose of Action	LEVEL 2
Deficiency Photo1

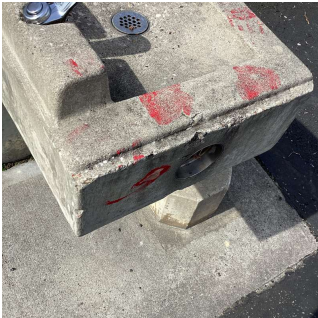
Culverts - Soil Covering	Does not Exist
DRINKING FOUNTAINS	Inspected
Condition	5 - Poor
Deficiency	INOPERABLE

Question	Response
SITE	
DRINKING FOUNTAINS	
Deficiency Location/Instance	Near Containerization Area
Deficiency Quantity	1
Quantity Uom	EACH
Potential Action	MAINTENANCE
Urgency of Action	PRIORITY 3
Purpose of Action	LEVEL 2
Deficiency Photo1

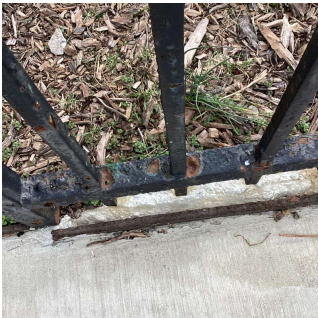
Violations	Near Containerization Area No violations recorded.
FENCES	
Condition	Inspected 5 - Poor
Deficiency	WROUGHT IRON: RUST - MAJOR
Deficiency Location/Instance	91st Road
Deficiency Quantity	40
Quantity Uom	S.F.
Potential Action	REPLACE
Urgency of Action	PRIORITY 3
Purpose of Action	LEVEL 2
Deficiency Photo1

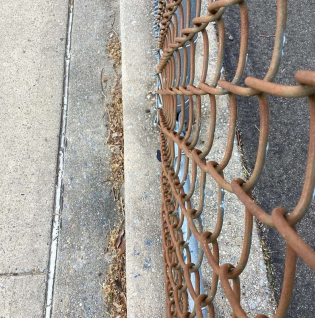
Violations	91st Road No violations recorded.
Deficiency	CHAIN LINK: RUST - MAJOR
Deficiency Location/Instance	92nd Avenue, 224th Street
Deficiency Quantity	4,500
Quantity Uom	S.F.
Potential Action	REPLACE
Urgency of Action	PRIORITY 3
Purpose of Action	LEVEL 2

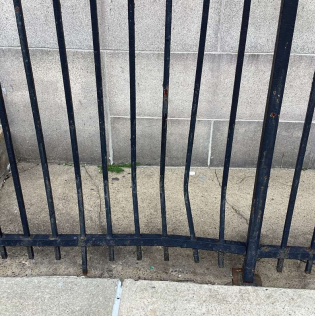
Violations	92nd Avenue No violations recorded.
Deficiency	WROUGHT IRON: DAMAGED/DETERIORATED
Deficiency Location/Instance	92nd Avenue
Deficiency Quantity	160
Quantity Uom	S.F.
Potential Action	REPLACE
Urgency of Action	PRIORITY 3
Purpose of Action	LEVEL 2
Deficiency Photo1

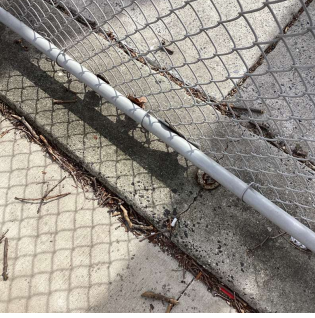
Violations	92nd Avenue No violations recorded.
Deficiency	CONCRETE CURB: DAMAGED/DETERIORATED
Deficiency Location/Instance	91st Street, 92nd Avenue, 222nd Street, 224th Street
Deficiency Quantity	350
Quantity Uom	S.F.
Potential Action	REPLACE
Urgency of Action	PRIORITY 3
Purpose of Action	LEVEL 2
Deficiency Photo1

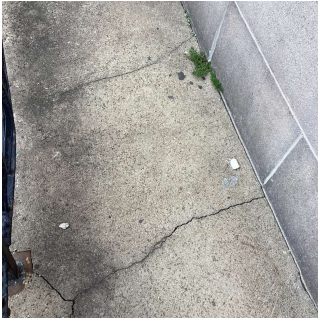
Question	Response
SITE	
IRRIGATION SYSTEM	Does not Exist
PAVING	Inspected
Student Non-Use	Inspected
Gravel Exists?	No
Asphalt	Does not Exist
Concrete	Inspected
Condition	3 - Fair
Deficiency	DAMAGED/DETERIORATED/MISSING SECTIONS
Deficiency Location/Instance	91St Road, 92nd Avenue
Deficiency Quantity	150
Quantity Uom	S.F.
Potential Action	REPLACE
Urgency of Action	PRIORITY 3
Purpose of Action	LEVEL 2
Deficiency Photo1

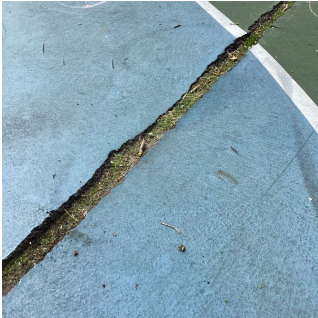
92nd Avenue
Violations	No violations recorded.
Pavers	Does not Exist
Student Use	Inspected
Gravel Exists?	No
Asphalt	Inspected
Condition	4 - Between Fair and Poor
Deficiency	CRACKS - MAJOR
Deficiency Location/Instance	Near Playing Field
Deficiency Quantity	50
Quantity Uom	S.F.
Potential Action	REPLACE
Urgency of Action	PRIORITY 5
Purpose of Action	LEVEL 6
Deficiency Photo1

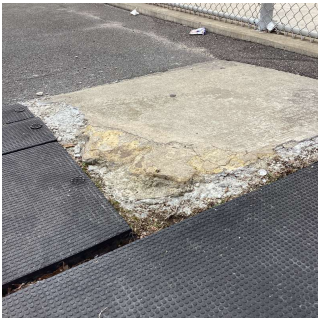
Question	Response
SITE	
PAVING	Inspected
Student Use	
Asphalt	
Deficiency Location/Instance	Near Center, Exits 5, 8, Containerization Area
Deficiency Quantity	600
Quantity Uom	S.F.
Potential Action	REPLACE
Urgency of Action	PRIORITY 3
Purpose of Action	LEVEL 2
Deficiency Photo1	 
Violations	Near Exit 5 No violations recorded.
Concrete	Inspected
Condition	2 - Between Good and Fair
Deficiency	DAMAGED/DETERIORATED/MISSING SECTIONS
Deficiency Location/Instance	Near playground/Containerization
Deficiency Quantity	25
Quantity Uom	S.F.
Potential Action	REPLACE
Urgency of Action	PRIORITY 5
Purpose of Action	LEVEL 6
Deficiency Photo1
