NYC Department of Education
Building Condition Assessment Survey 2023 - 2024

Architectural Inspection

Asset: P.S. 42 - QUEENS, 488 BEACH 66 STREET, New York, 11692

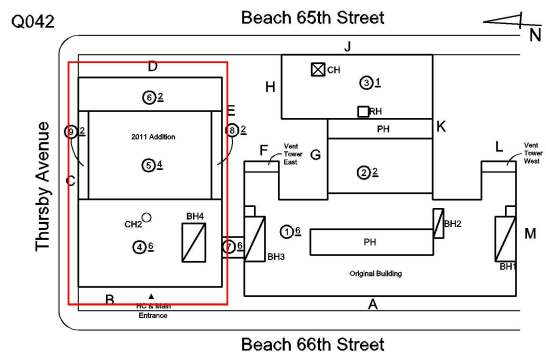
Question	Response
Architectural	
EXTERIOR	Inspected
AREAWAY	Does not Exist
AWNINGS AND CANOPIES	Inspected
Condition	2 - Between Good and Fair
Deficiency	No deficiencies recorded
CHIMNEY	Under Construction
COPING	Inspected
Condition	3 - Fair
Deficiency	CAST STONE: DETERIORATED TRANSVERSE JOINTS
Roof Plan reference	Q042

Deficiency Quantity
 Quantity Uom
 Potential Action
 Urgency of Action
 Purpose of Action

50
 L.F.
 MAINTENANCE
 PRIORITY 3
 LEVEL 2

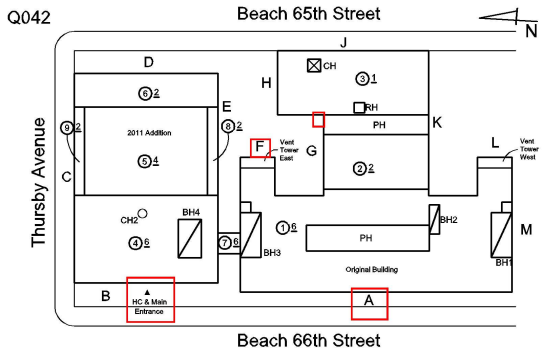
Violations	Facade A No violations recorded.
DOOR HARDWARE	Inspected
Condition	3 - Fair
Deficiency	No deficiencies recorded
LINTELS	Inspected
Condition	2 - Between Good and Fair

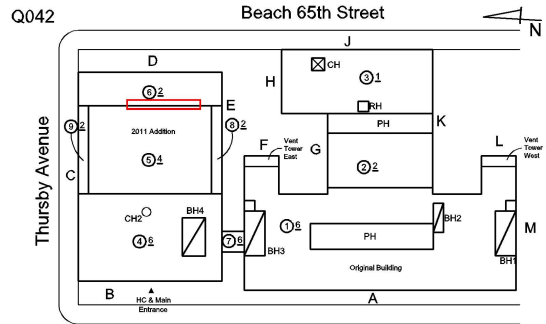
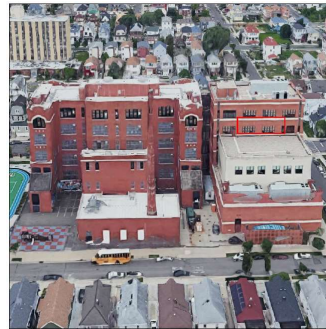
EXTERIOR WALLS

Deficiency Quantity
Quantity Uom
Potential Action
Urgency of Action
Purpose of Action
Deficiency Photo
Violations

30
S.F.
MAINTENANCE
PRIORITY 1
LEVEL 1
No photo recorded
No violations recorded.

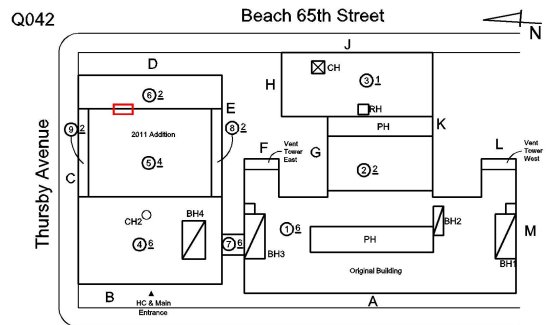
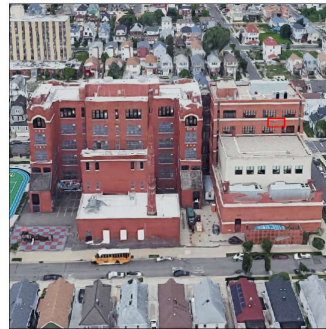
Deficiency

BRICK: WATER INFILTRATION IN INSTRUCTIONAL SPACE

Deficiency Quantity
Quantity Uom

100
S.F.

Question	Response
EXTERIOR	
EXTERIOR WALLS	
Potential Action	REPAIR
Urgency of Action	PRIORITY 5
Purpose of Action	LEVEL 2
Deficiency Photo1

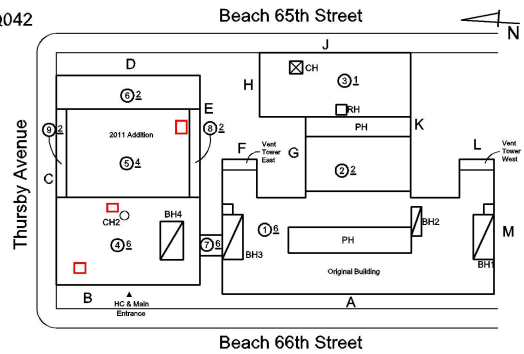
Condition	5 - Poor
-----------	----------

Deficiency	DETERIORATED
Roof Plan reference	Q042

Deficiency Quantity	3
Quantity Uom	EACH
Potential Action	REPLACE
Urgency of Action	PRIORITY 4
Purpose of Action	LEVEL 2
Deficiency Photo1

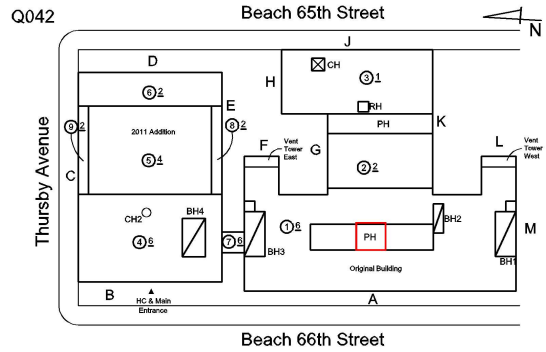
Specialties	Inspected
BULKHEAD/PENTHOUSE	Under Construction
CUPOLA/ SPIRES/ TOWERS	Does not Exist
DORMER	Does not Exist
DUNNAGE STEEL	Inspected
Condition	2 - Between Good and Fair
Deficiency	No deficiencies recorded
SKYLIGHT/ROOF VENT	Does not Exist
ROOF/GRAVITY TANK	Inspected
Condition	3 - Fair
Deficiency	TANK: NOT IN USE - MINOR DETERIORATION

ROOF/GRAVITY TANK

Deficiency Quantity
Quantity Uom
Potential Action
Urgency of Action
Purpose of Action
Deficiency Photo1

1
EACH
NO ACTION
PRIORITY 1
LEVEL 1

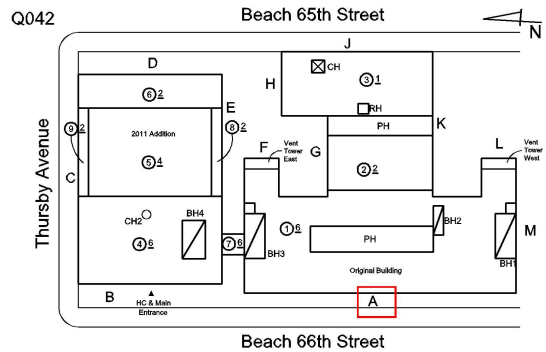
Deficiency

STONE: BULGING/DISPLACED

Deficiency Quantity
Quantity Uom
Potential Action
Urgency of Action
Purpose of Action

10
S.F.
REPLACE
PRIORITY 5
LEVEL 6

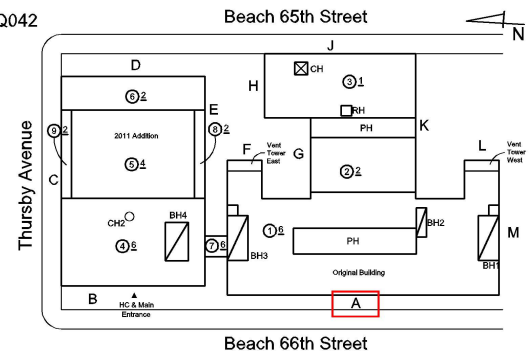
Deficiency

STONE: DETERIORATED JOINTS

Deficiency Quantity
Quantity Uom
Potential Action
Urgency of Action
Purpose of Action
Deficiency Photo1

10
S.F.
REPOINT
PRIORITY 4
LEVEL 2

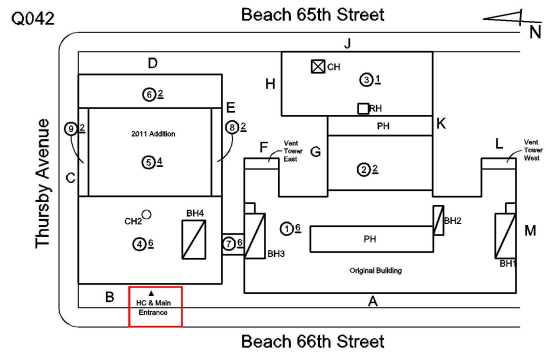
Deficiency

CAST IN PLACE CONCRETE: DETERIORATED COPING STONE

Deficiency Quantity
Quantity Uom
Potential Action
Urgency of Action
Purpose of Action
Deficiency Photo1

20
S.F.
REPAIR
PRIORITY 3
LEVEL 2

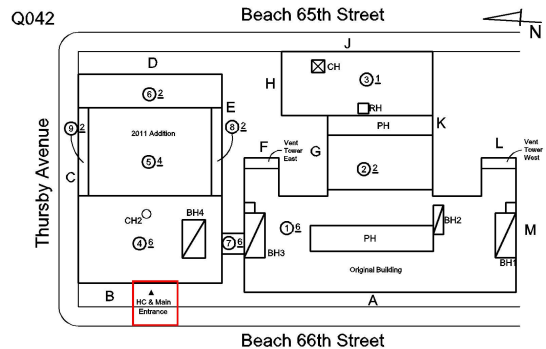
Deficiency

CONCRETE: WORN-OUT TREAD/RISER/NOSING

Deficiency Quantity
Quantity Uom
Potential Action
Urgency of Action
Purpose of Action

10
S.F.
REPLACE
PRIORITY 4
LEVEL 2

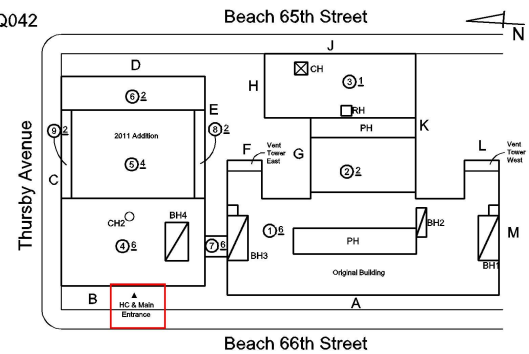
Deficiency

CONCRETE: WORN-OUT TREAD/RISER/NOSING

REPLACE

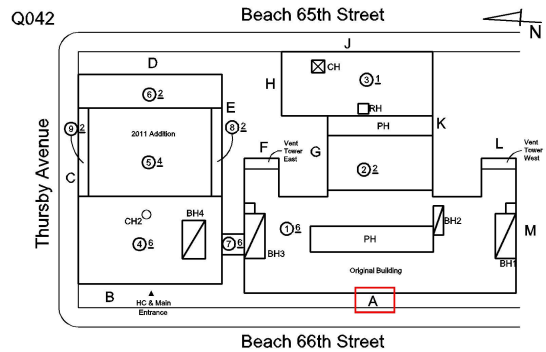
Deficiency

STONE: CRACKS/SPALLING - MINOR

Deficiency Quantity
Quantity Uom
Potential Action
Urgency of Action
Purpose of Action
Deficiency Photo1

10
S.F.
REPAIR
PRIORITY 3
LEVEL 2

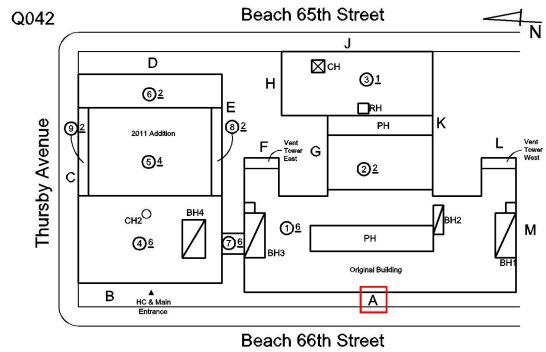
Deficiency

STONE: DETERIORATED JOINTS

Deficiency Quantity
Quantity Uom
Potential Action
Urgency of Action
Purpose of Action

20
L.F.
REPOINT
PRIORITY 4
LEVEL 2

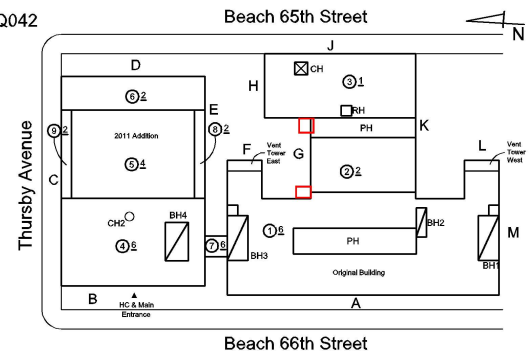
Deficiency

STONE: CRACKS/SPALLING - MAJOR

REPLACE

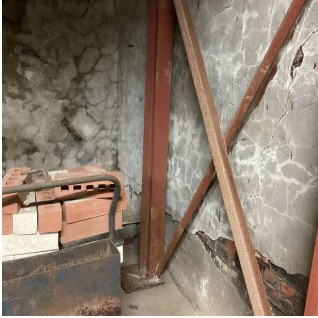
Question	Response
INTERIOR	
STRUCTURAL	
FLOOR STRUCTURE	Inspected
Violations	Basement - Fan Area No violations recorded.
FOUNDATION WALLS	Inspected
Material Type(s)	Concrete, Masonry
Condition	4 - Between Fair and Poor
Deficiency	CONCRETE: CRACKED/SPALLED/REINFORCEMENT EXPOSED
Deficiency Location/Instance	Basement - Vent Tower West
Deficiency Quantity	300
Quantity Uom	S.F.
Potential Action	REPAIR
Urgency of Action	PRIORITY 3
Purpose of Action	LEVEL 5
Deficiency Photo1

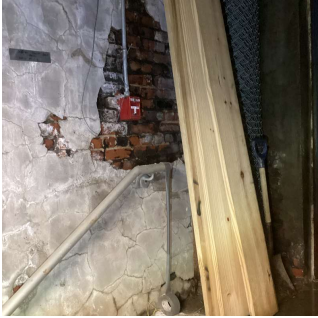
Violations	Basement - Vent Tower West No violations recorded.
Deficiency	BRICK: WATER INFILTRATION IN NON- INSTRUCTIONAL SPACE
Deficiency Location/Instance	Basement - Vent Tower
Deficiency Quantity	100
Quantity Uom	S.F.
Potential Action	INSTALL WATERPROOFING
Urgency of Action	PRIORITY 5
Purpose of Action	LEVEL 5
Deficiency Photo1

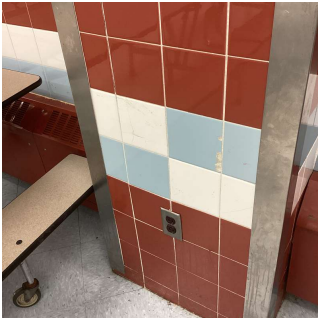
Violations	Near Windows No violations recorded.
Sliding-folding Partition	
Instance on 1st Floor	Does not Exist
Stage	
Instance on 1st Floor	Does not Exist
Walls	
Instance on 1st Floor	Inspected
Condition	2 - Between Good and Fair
Deficiency	CERAMIC TILE: BROKEN/ MISSING
Deficiency Location/Instance	Near Windows
Deficiency Quantity	10
Quantity Uom	S.F.
Potential Action	REPLACE
Urgency of Action	PRIORITY 3
Purpose of Action	LEVEL 2
Deficiency Photo1

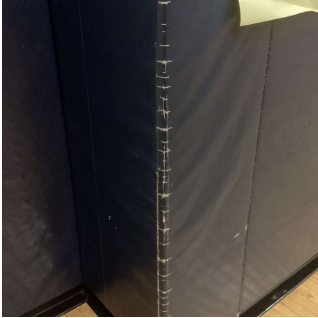
Question	Response
INTERIOR	
GYMNASIUM	Inspected
Sliding-folding Partition	
Instance on 3rd Floor	Inspected
Condition	2 - Between Good and Fair
Deficiency	No deficiencies recorded
Stage	
Instance on 3rd Floor	Does not Exist
Walls	
Instance on 3rd Floor	Inspected
Condition	2 - Between Good and Fair
Deficiency	WALL PADDING: DETERIORATED
Deficiency Location/Instance	Near Center, Room 306
Deficiency Quantity	140
Quantity Uom	S.F.
Potential Action	REPLACE
Urgency of Action	PRIORITY 3
Purpose of Action	LEVEL 2
Deficiency Photo1

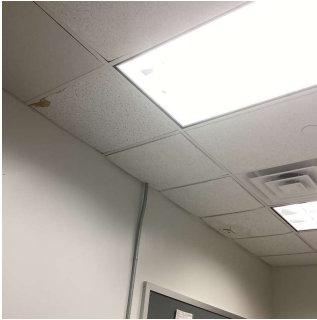
Question	Response
INTERIOR	
INTERIOR GUARDS	
Deficiency Photo1	 
Violations	Stair J1-2/4 No violations recorded.
KITCHEN	Inspected
Instance on 1st Floor	Inspected
Ceiling	
Instance on 1st Floor	Inspected
Condition	3 - Fair
Deficiency	ACOUSTIC TILES: DAMAGED/MISSING
Deficiency Location/Instance	Rooms 106A, 106F
Deficiency Quantity	40
Quantity Uom	S.F.
Potential Action	REPLACE
Urgency of Action	PRIORITY 3
Purpose of Action	LEVEL 2
Deficiency Photo1

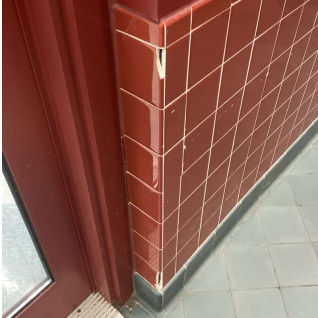
Violations	Room 106F No violations recorded.
Door(s)	
Instance on 1st Floor	Inspected
Condition	2 - Between Good and Fair
Deficiency	No deficiencies recorded
Floor Finish	
Instance on 1st Floor	Inspected
Condition	2 - Between Good and Fair
Deficiency	No deficiencies recorded
Walls	
Instance on 1st Floor	Inspected
Condition	2 - Between Good and Fair
Deficiency	CERAMIC TILE: BROKEN/ MISSING
Deficiency Location/Instance	Serving Area
Deficiency Quantity	10

Question	Response
INTERIOR	
KITCHEN	
Walls	
Quantity Uom	S.F.
Potential Action	REPLACE
Urgency of Action	PRIORITY 3
Purpose of Action	LEVEL 2
Deficiency Photo1

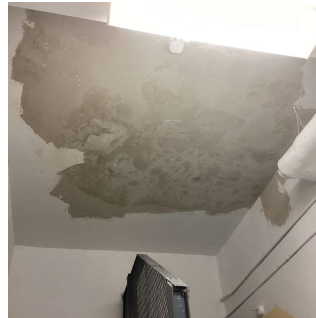
Stair C/6

PLASTER: CRACKS/SPALLING - ACTIVE LEAK

REPLACE

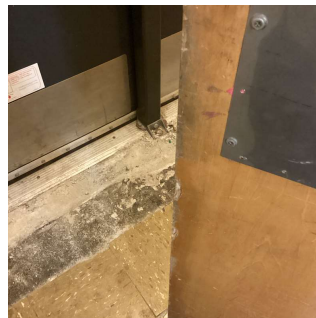
WOOD: DETERIORATED DOOR

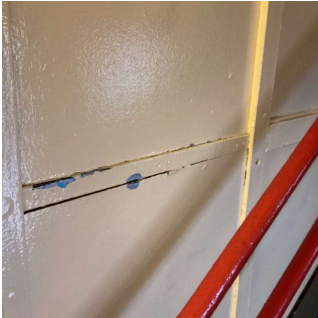
Question	Response
INTERIOR	
STAIRS/RAMPS: INTERIOR	
Door(s)	
Violations	Stair C/1 No violations recorded.
Deficiency	METAL CLAD WOOD: DETERIORATED DOOR
Deficiency Location/Instance	Stair C/3
Deficiency Quantity	1
Quantity Uom	EACH
Potential Action	MAINTENANCE
Urgency of Action	PRIORITY 3
Purpose of Action	LEVEL 2
Deficiency Photo1	 
Violations	Stair C/3 No violations recorded.
Partition	Inspected
Condition	3 - Fair
Deficiency	METAL FRAME: DAMAGED/DETERIORATED
Deficiency Location/Instance	Stair J1-2/2, 3, 4
Deficiency Quantity	50
Quantity Uom	L.F.
Potential Action	REPLACE
Urgency of Action	PRIORITY 3
Purpose of Action	LEVEL 2
Deficiency Photo1

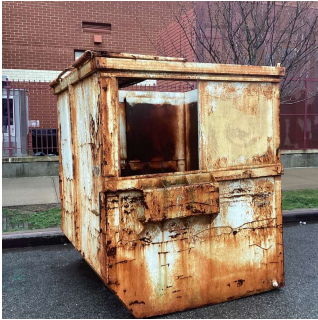
Question	Response
SITE	
CONTAINERIZATION	
Deficiency Photo1

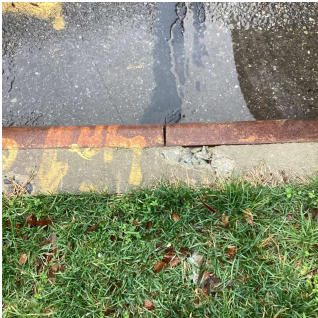
Question	Response
SITE	
PAVING	
DOT Sidewalk	
Concrete	
Deficiency	DAMAGED CURBS
Deficiency Location/Instance	Beach 65th street, Beach 66th street, thursby Avenue
Deficiency Quantity	30
Quantity Uom	L.F.
Potential Action	REPLACE
Urgency of Action	PRIORITY 3
Purpose of Action	LEVEL 2
Deficiency Photo1

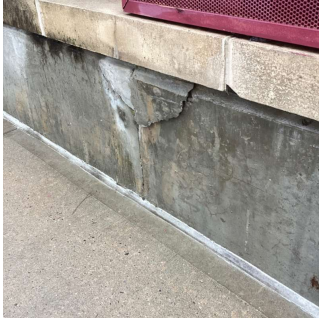
Question	Response
SITE	
PLAYGROUNDS	
Safety Surfacing	
Deficiency Quantity	60
Quantity Uom	S.F.
Potential Action	REPLACE
Urgency of Action	PRIORITY 3
Purpose of Action	LEVEL 2
Deficiency Photo1	 
Violations	Around Play Equipment No violations recorded.
Unpaved Area	
Instance on Along Beach 65 Street	Does not Exist
PLAYING SURFACE	Does not Exist
RETAINING WALLS	
Are there any Retaining Walls 6' OR higher facing public street/sidewalk?	Inspected No
Condition	2 - Between Good and Fair
Deficiency	No deficiencies recorded
SEATING	
SITE WALLS (NOT RETAINING WALLS)	Inspected
Condition	3 - Fair
Deficiency	CAST IN PLACE CONCRETE: DETERIORATED COPING STONE
Deficiency Location/Instance	Beach 65th Street, Beach 66th Street
Deficiency Quantity	30
Quantity Uom	S.F.
Potential Action	REPLACE
Urgency of Action	PRIORITY 3
Purpose of Action	LEVEL 2
Deficiency Photo1	 
Violations	Beach 65th Street No violations recorded.
Deficiency	CAST IN PLACE CONCRETE: CRACKS/SPALLING - MAJOR

Deficiency Location/Instance	Beach 65th Street, Beach 66th Street

Question	Response
SITE	
SITE WALLS (NOT RETAINING WALLS)	
Deficiency Quantity	50
Quantity Uom	S.F.
Potential Action	REPLACE
Urgency of Action	PRIORITY 3
Purpose of Action	LEVEL 2
Deficiency Photo1
