**NYC Department of Education**  
**Building Condition Assessment Survey 2023 - 2024**

Architectural Inspection

**Q043**

**Asset:** P.S. 43 - QUEENS, 160 BEACH 29TH STREET, New York, 11691

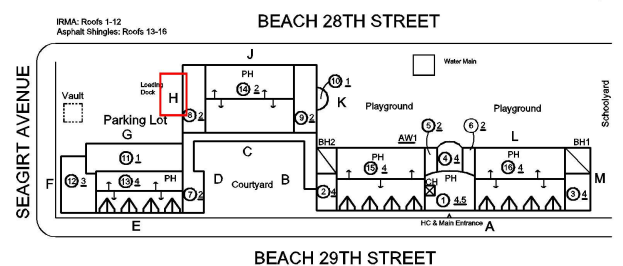
DETERIORATED CONCRETE PLATFORM WITH CRACKED, SPALLED CONCRETE OR EXPOSED REINFORCING

Question	Response
<b>EXTERIOR</b>	
<b>LOADING DOCK</b>	
Quantity Uom	S.F.
Potential Action	REPAIR
Urgency of Action	PRIORITY 3
Purpose of Action	LEVEL 2
Deficiency Photo1

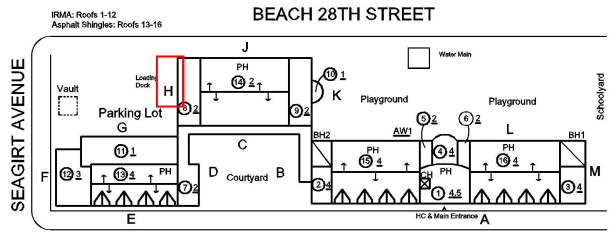
Violations	Facade H No violations recorded.
Deficiency	CHEEK WALL/CRACKS, SPALLING - MAJOR
Roof Plan reference	Q043

Deficiency Quantity	20
Quantity Uom	S.F.
Potential Action	REPLACE
Urgency of Action	PRIORITY 4
Purpose of Action	LEVEL 2
Deficiency Photo1

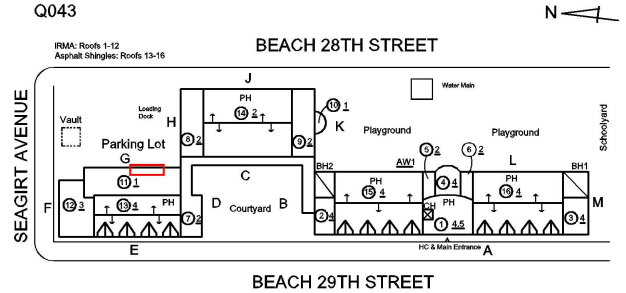
Instance Condition	2 - Between Good and Fair
Instance Quantity	12,000
Instance Quantity Uom	C.F.
Deficiency	BRICK: MINOR CRACKS, SPALLING
Roof Plan reference	Q043

Deficiency Quantity	20
Quantity Uom	S.F.
Potential Action	REPAIR
Urgency of Action	PRIORITY 3
Purpose of Action	LEVEL 2
Deficiency Photo1

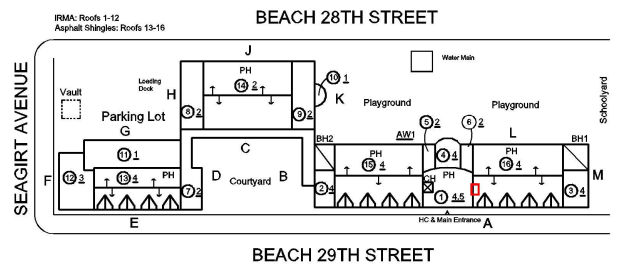
Deficiency	CONCRETE MASONRY UNITS: MINOR CRACKS, SPALLING
Roof Plan reference	Q043

Deficiency Quantity	10
Quantity Uom	S.F.
Potential Action	REPAIR
Urgency of Action	PRIORITY 3
Purpose of Action	LEVEL 2

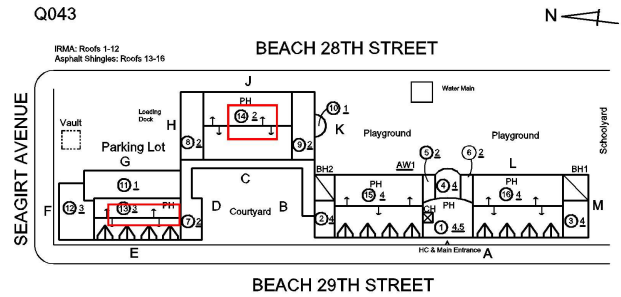
Do solar panels exist on these roofs?	No
Is/Are the roof(s) suitable for Solar Panel installation?	Yes
Installation Year	2017
Source of Installation	Custodial Staff
Deficiency	ASPHALT SHINGLE: ROOFING: MAJOR ACTIVE ROOF LEAKS IN INSTRUCTIONAL SPACE

REPLACE ROOFING

PRIORITY 5

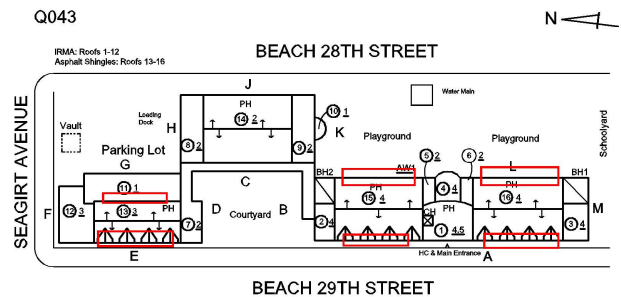
ASPHALT SHINGLE; ROOFING; MAJOR ACTIVE ROOF LEAKS IN NON-INSTRUCTIONAL SPACE

REPLACE ROOFING

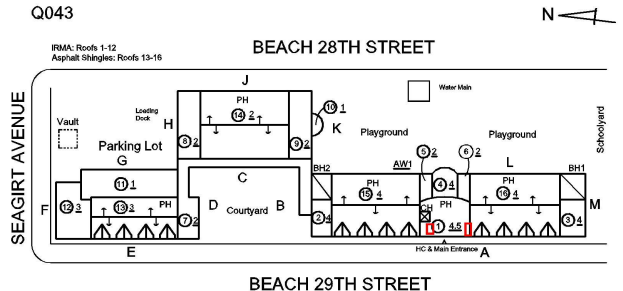
Violations	Roof 16 - Penthouse (two locations), also Roof 15 Penthouse (two locations), Roof 13 - Penthouse (two locations) 35671769Y
Instance on IRMA: Roof 1-12	Inspected
Instance Condition	4 - Between Fair and Poor
Instance Photo	 
Instance Quantity	Roof 1 15,000
Instance Quantity Uom	S.F.
Does the roof have major mechanical equipment sitting on Dunnage Steel less than 18" above the Roofing?	No
Does this roof instance have a Sustainable Roof System?	No
Do solar panels exist on these roofs?	No
Is/Are the roof(s) suitable for Solar Panel installation?	No
Installation Year	2017
Source of Installation	Custodial Staff
Deficiency	IRMA: ROOFING: MAJOR ACTIVE ROOF LEAKS IN INSTRUCTIONAL SPACE
Roof Plan reference	Q043

Deficiency Quantity	200
Quantity Uom	S.F.
Potential Action	REPLACE ROOFING WITHOUT MAJOR EQUIPMENT REMOVAL

Urgency of Action	PRIORITY 5
Purpose of Action	LEVEL 4

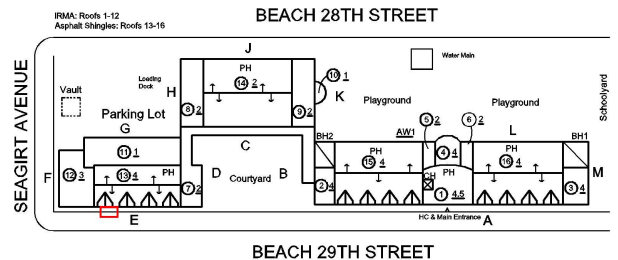
BRICK: DETERIORATED JOINTS AT COPING STONES

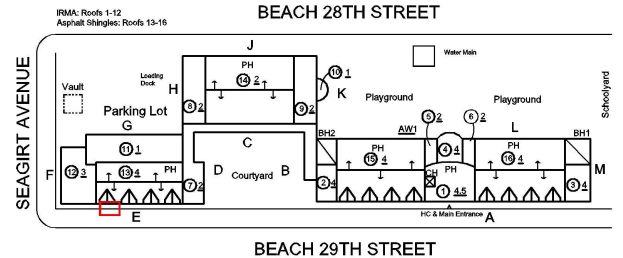
**BRICK: DETERIORATED JOINTS**

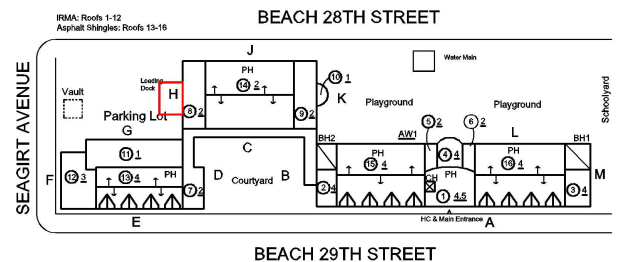
**BRICK: DETERIORATED COPING STONE**

S.F.  
 REPAIR  
 PRIORITY 3  
 LEVEL 2

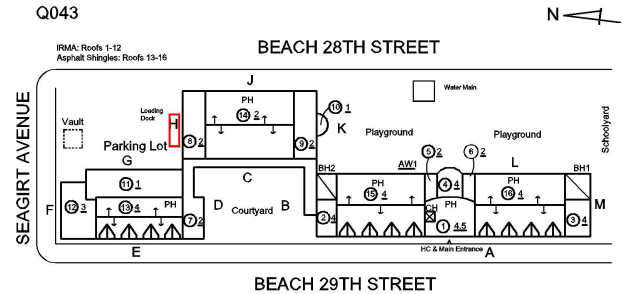
BRICK: CRACKS/SPALLING - MAJOR  
 Q043

10  
 S.F.  
 REPLACE  
 PRIORITY 4  
 LEVEL 2

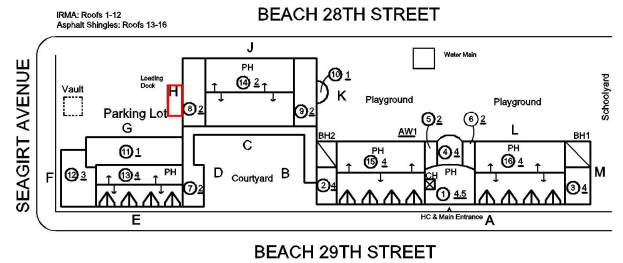
BRICK: CRACKS/SPALLING - MINOR

10  
 S.F.  
 REPAIR  
 PRIORITY 3  
 LEVEL 2

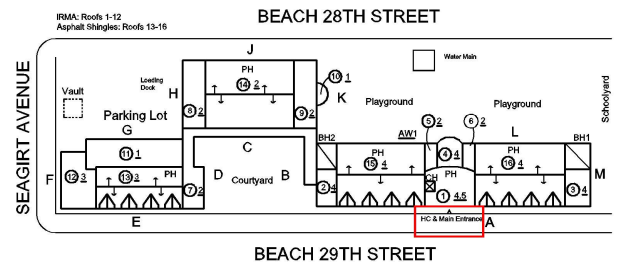
Inspected  
 5 - Poor  
 STONE: DETERIORATED JOINTS

20  
 L.F.  
 REPOINT  
 PRIORITY 4  
 LEVEL 2

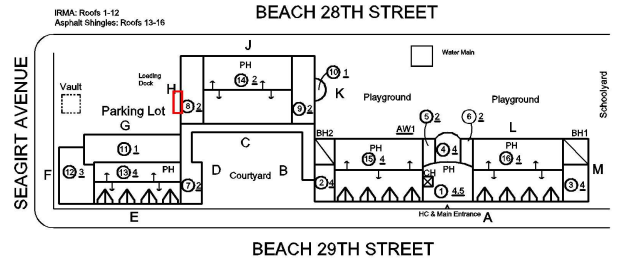
**CONCRETE: WORN-OUT TREAD/RISER/NOSING**

REPLACE

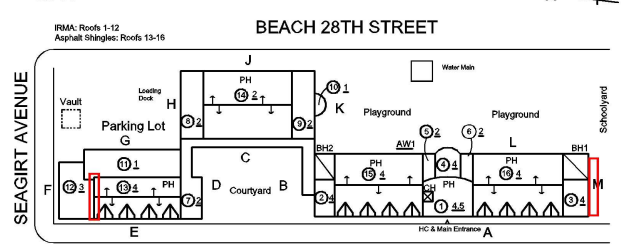
Question	Response
<b>EXTERIOR</b>	
<b>WINDOWS</b>	
<b>WINDOWS</b>	
Instance on Aluminum - Double Hung: All Facades	Inspected
Instance Condition	3 - Fair
Instance Quantity	23,000
Instance Quantity Uom	S.F.
Are these windows insulated	Yes
Installation Year	1996
Source of Installation	Custodial Staff
Deficiency	ALUMINUM - DOUBLE HUNG: AIR/WATER INFILTRATION
Roof Plan reference	Q043
Elevation

Deficiency Quantity	90
Quantity Uom	L.F.
Potential Action	REPLACE TRIM, SILLS OR WEATHERSTRIPPING
Urgency of Action	PRIORITY 5
Purpose of Action	LEVEL 4
Deficiency Photo1

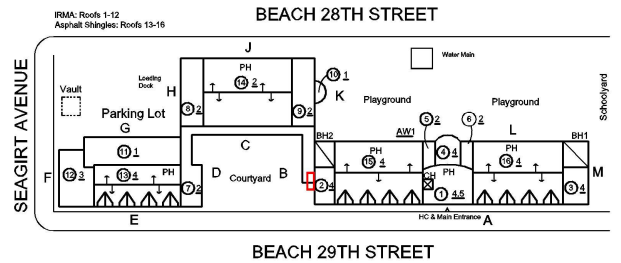
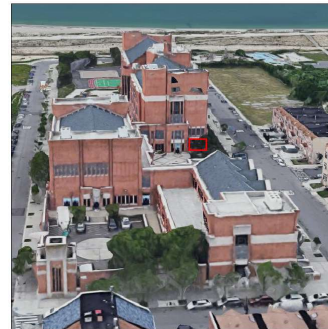
Violations	Facade M - Corridor near Stair C/4, also Corridor near Stair C/3, Facade F - Corridor near Stair G/2
Deficiency	35671769Y
	ALUMINUM - DOUBLE HUNG: BROKEN PANE

30  
S.F.  
MAINTENANCE  
PRIORITY 3  
LEVEL 2

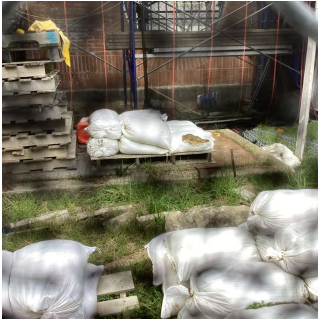
Question	Response
<b>INTERIOR</b>	
<b>STRUCTURAL</b>	
<b>VAULTS-BUNKERS</b>	
<b>Foundation Walls</b>	Inspected
Condition	2 - Between Good and Fair
Deficiency	No deficiencies recorded
<b>Slab Structure</b>	Inspected
Condition	2 - Between Good and Fair
Deficiency	No deficiencies recorded
<b>Vault/Ash Hoist Doors and Framing</b>	Inspected
Condition	5 - Poor
Deficiency	DETERIORATED/DAMAGED VAULT/ASH HOIST DOORS AND FRAMING
Deficiency Location/Instance	Parking Lot
Deficiency Quantity	2
Quantity Uom	EACH
Potential Action	REPLACE
Urgency of Action	PRIORITY 4
Purpose of Action	LEVEL 2
Deficiency Photo1

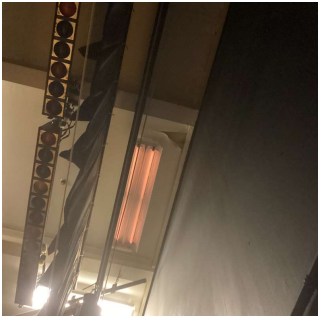
Violations	Parking Lot No violations recorded.
<b>AUDITORIUM</b>	Inspected
Instance on 2nd Floor (414 Seats)	Inspected
<b>Ceiling</b>	Inspected
Instance on 2nd Floor (414 Seats)	Inspected
Condition	2 - Between Good and Fair
Deficiency	GYP SUM BOARD: DAMAGED/DETERIORATED
Deficiency Location/Instance	Back stage
Deficiency Quantity	20

Quantity Uom	S.F.
Potential Action	REPLACE
Urgency of Action	PRIORITY 3
Purpose of Action	LEVEL 2
Deficiency Photo1

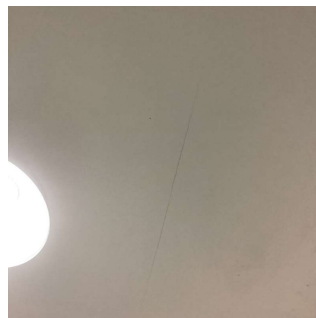
Near center

Instance on Room 131 - Students	Inspected
Condition	2 - Between Good and Fair
Deficiency	GYPSUM BOARD: DAMAGED/DETERIORATED
Deficiency Location/Instance	Near Center, Entrance, Windows
Deficiency Quantity	30
Quantity Uom	S.F.
Potential Action	REPLACE
Urgency of Action	PRIORITY 3
Purpose of Action	LEVEL 2
Deficiency Photo1

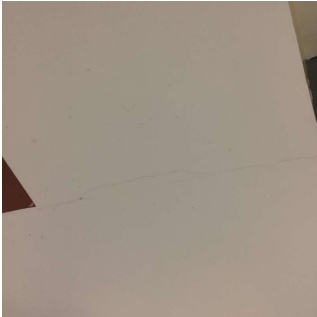
Question	Response
<b>INTERIOR</b>	
<b>CAFETERIA</b>	
<b>Ceiling</b>	
Violations	No violations recorded.
Instance on Room 125 - Students	Inspected
Condition	2 - Between Good and Fair
Deficiency	GYPSUM BOARD: DAMAGED/DETERIORATED
Deficiency Location/Instance	Near Entrance
Deficiency Quantity	10
Quantity Uom	S.F.
Potential Action	REPLACE
Urgency of Action	PRIORITY 3
Purpose of Action	LEVEL 2
Deficiency Photo1

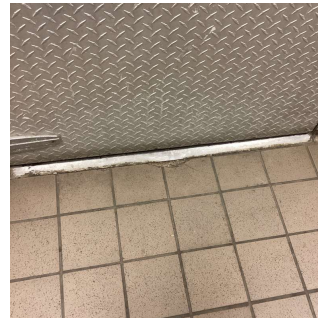
Near Walking Fridge

CERAMIC TILE: BROKEN/ MISSING

REPLACE

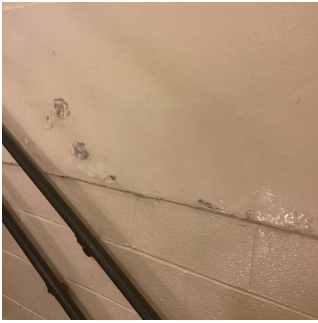
Deficiency	PLASTER: CRACKS/SPALLING
Deficiency Location/Instance	Stair B/2
Deficiency Quantity	10
Quantity Uom	S.F.
Potential Action	REPLACE
Urgency of Action	PRIORITY 3
Purpose of Action	LEVEL 2

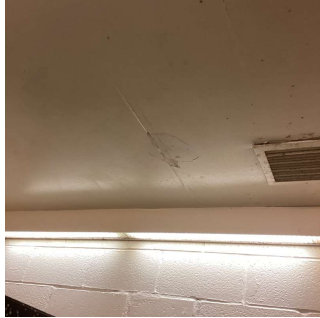
Question	Response
<b>INTERIOR</b>	
<b>TOILET ROOMS - STUDENTS</b>	
<b>Ceiling</b>	
Potential Action	REPLACE
Urgency of Action	PRIORITY 3
Purpose of Action	LEVEL 2
Deficiency Photo1

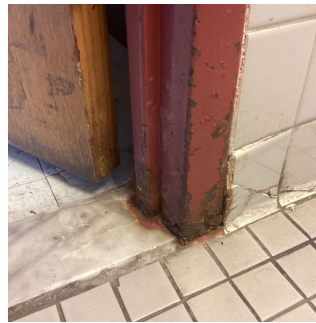
Room 147

Room 128
Violations	No violations recorded.
Deficiency	METAL: DETERIORATED DOOR AND FRAME
Deficiency Location/Instance	Rooms 141, 147
Deficiency Quantity	2
Quantity Uom	EACH
Potential Action	MAINTENANCE
Urgency of Action	PRIORITY 3
Purpose of Action	LEVEL 2

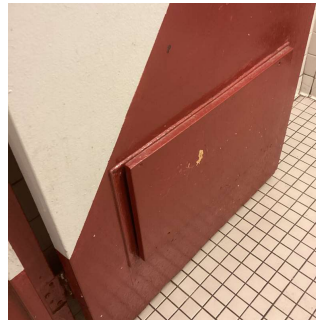
1st Floor - Boys Cafeteria

**METAL: DAMAGED LOUVER**

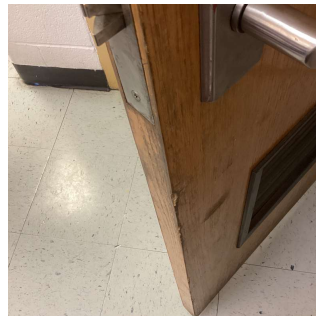
Room 203

**WOOD: DETERIORATED DOOR**

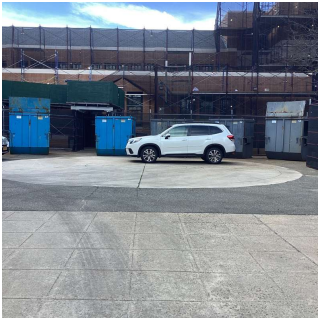
Question	Response
<b>LIFE SAFETY</b>	Inspected
<b>STEEL STAIRS</b>	Does not Exist
<b>SITE</b>	Inspected
<b>CONTAINERIZATION</b>	Inspected
Condition	5 - Poor
Deficiency	CONTAINER DAMAGED
Deficiency Location/Instance	Near Exit 10
Deficiency Quantity	6
Quantity Uom	EACH
Potential Action	REPLACE
Urgency of Action	PRIORITY 3
Purpose of Action	LEVEL 2
Deficiency Photo1

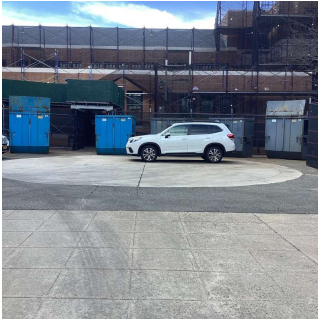
Violations	Near Exit 10 No violations recorded.
Deficiency	CONCRETE PAD MISSING
Deficiency Location/Instance	Near Exit 10
Deficiency Quantity	600
Quantity Uom	S.F.
Potential Action	INSTALL NEW
Urgency of Action	PRIORITY 3
Purpose of Action	LEVEL 2
Deficiency Photo1

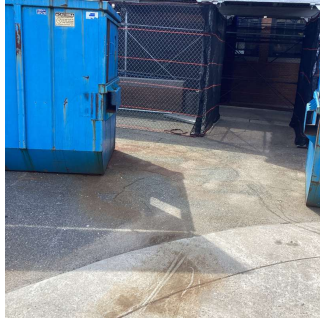
<b>FENCES</b>	Inaccessible
<b>IRRIGATION SYSTEM</b>	Does not Exist
<b>PAVING</b>	Inspected
<b>Student Non-Use</b>	Inspected
Gravel Exists?	No
<b>Asphalt</b>	Inspected
Condition	3 - Fair
Deficiency	CRACKS - MAJOR
Deficiency Location/Instance	Near Exit 10
Deficiency Quantity	200
Quantity Uom	S.F.
Potential Action	REPLACE
Urgency of Action	PRIORITY 3
Purpose of Action	LEVEL 2

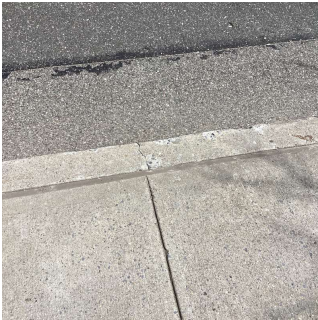
Question	Response
<b>SITE</b>	
<b>PAVING</b>	
<b>DOT Sidewalk</b>	
<b>Concrete</b>	
Deficiency	DAMAGED CURBS
Deficiency Location/Instance	Beach 28th Street, Beach 29th Street, Seagirt Avenue, Sandy Road
Deficiency Quantity	300
Quantity Uom	L.F.
Potential Action	REPLACE
Urgency of Action	PRIORITY 3
Purpose of Action	LEVEL 2
Deficiency Photo1

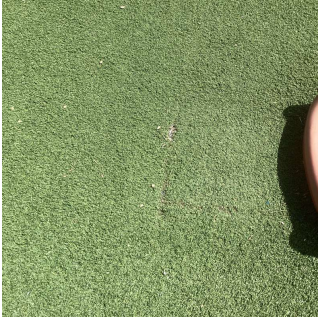
Question	Response
<b>SITE</b>	
<b>PLAYGROUNDS</b>	
<b>Safety Surfacing</b>	
Condition	2 - Between Good and Fair
Deficiency	DETERIORATED/MISSING
Deficiency Location/Instance	Near Exit 11
Deficiency Quantity	20
Quantity Uom	S.F.
Potential Action	REPLACE
Urgency of Action	PRIORITY 3
Purpose of Action	LEVEL 2
Deficiency Photo1

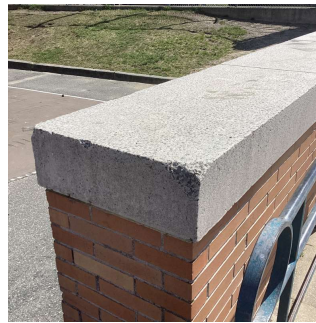
Ramp Near Sandy Road

Condition	3 - Fair
Deficiency	BRICK: DETERIORATED COPING STONE
Deficiency Location/Instance	Ramp Near Sandy Road, Stair Near Exit 15
Deficiency Quantity	50
Quantity Uom	S.F.
Potential Action	REPLACE
Urgency of Action	PRIORITY 3
Purpose of Action	LEVEL 2
