NYC Department of Education
Building Condition Assessment Survey 2023 - 2024

Architectural Inspection

Asset: P.S. 45 - QUEENS, 126-28 150 STREET, New York, 11436

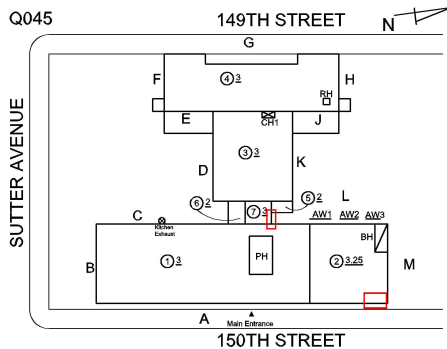
Violations	Facade H - Exit 7 No violations recorded.
Deficiency	METAL: DETERIORATED DOOR AND FRAME - MINOR DETERIORATION
Roof Plan reference	<p>Q045</p>

Deficiency Quantity	3
Quantity Uom	EACH
Potential Action	MAINTENANCE
Urgency of Action	PRIORITY 3
Purpose of Action	LEVEL 2
Deficiency Photo1	No photo recorded
Violations	No violations recorded.
DOOR HARDWARE	
Condition	Inspected
Deficiency	3 - Fair
LINTELS	
Condition	Inspected
Deficiency	3 - Fair
Deficiency	STEEL: MAJOR RUSTING

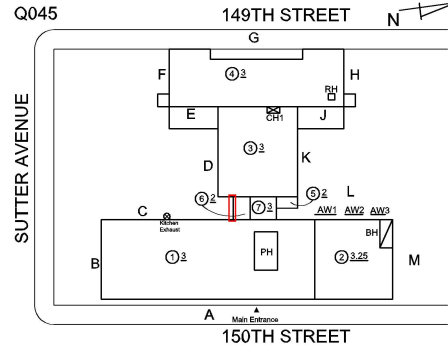
LINTELS

10
L.F.
REPLACE
PRIORITY 4
LEVEL 2

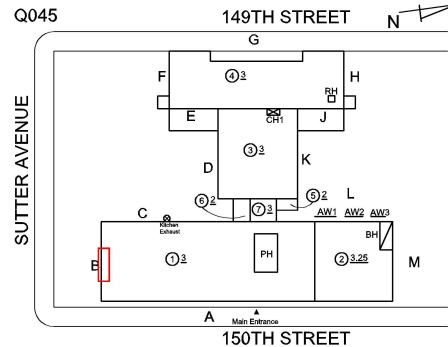
METAL: BROKEN GLASS

10
S.F.
MAINTENANCE
PRIORITY 3
LEVEL 2

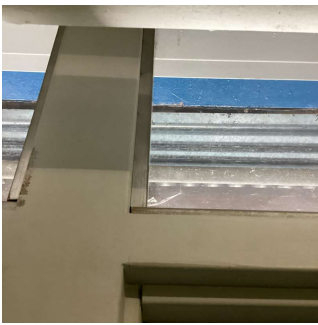
Question	Response
EXTERIOR	
DOORS	
TRANSOM/SIDE LIGHT	
Deficiency Photo1

Violations	Facade B - Exit 3 No violations recorded.
EXTERIOR WALLS	Inspected
Material Type(s)	Masonry
Replacement Quantity	23,000
Replacement Uom	S.F.
Instance on All Facades	Under Construction
Instance Quantity	23,000
Instance Quantity Uom	S.F.
EXTERIOR SOFFITS	Does not Exist
LOADING DOCK	Does not Exist
LOUVER	Inspected
Condition	2 - Between Good and Fair
Deficiency	No deficiencies recorded
PARAPETS	Inspected
Material Type(s)	Masonry
Replacement Quantity	7,000
Replacement Uom	C.F.
Instance on All Roofs	Under Construction
Instance Quantity	7,000
Instance Quantity Uom	C.F.
PLAZA DECK	Does not Exist
ROOF	Inspected
Roofing	Inspected
Replacement Quantity	23,400
Replacement Uom	S.F.
ROOF HATCH/SMOKE HATCH	Inspected
Condition	2 - Between Good and Fair
Deficiency	No deficiencies recorded
LEADERS, GUTTERS, DOWNSPOUTS, SCUPPERS	Inspected
Condition	2 - Between Good and Fair

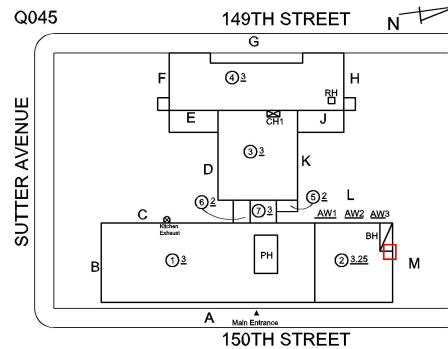
**BULKHEAD/PENTHOUSE WALLS/EXTERIOR:
CRACKS/SPALLING - MINOR**

REPAIR

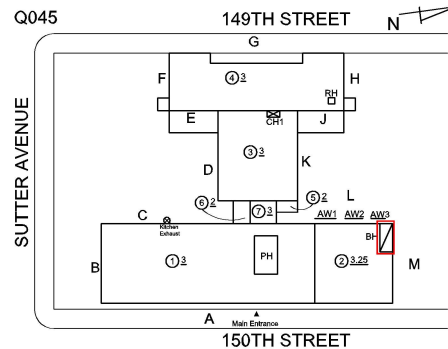
**BULKHEAD/PENTHOUSE WALLS/INTERIOR: PLASTER
CRACKS/SPALLING**

Deficiency Quantity	20
Quantity Uom	S.F.
Potential Action	REPLACE
Urgency of Action	PRIORITY 3
Purpose of Action	LEVEL 2
Deficiency Photo1

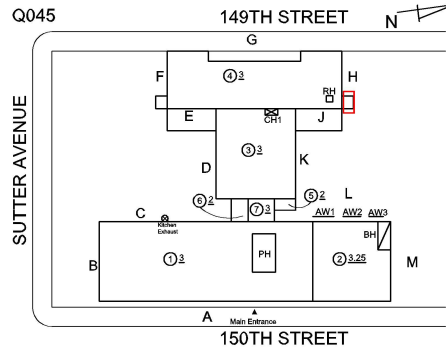
Deficiency	DAMAGED
------------	---------

Deficiency Quantity	10
Quantity Uom	L.F.
Potential Action	REPLACE
Urgency of Action	PRIORITY 4
Purpose of Action	LEVEL 2

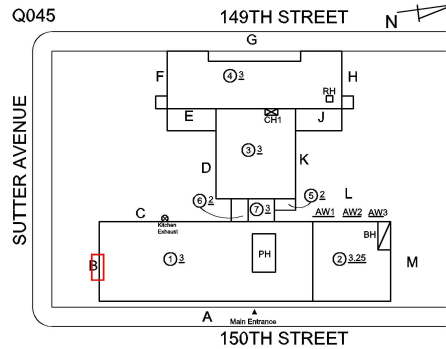
STONE: DETERIORATED JOINTS

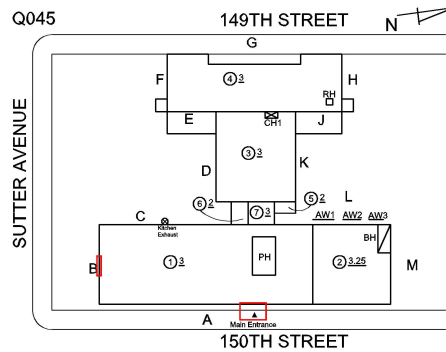
STONE: WORN-OUT TREAD/RISER/NOSING

10
S.F.
REPLACE
PRIORITY 4
LEVEL 2

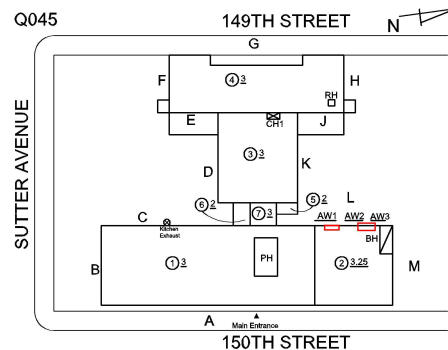
ALUMINUM - DOUBLE HUNG: DETERIORATED

Question	Response
EXTERIOR	
WINDOWS	
WINDOWS	
Elevation	 
Deficiency Quantity	300
Quantity Uom	S.F.
Potential Action	REPLACE WINDOW
Urgency of Action	PRIORITY 4
Purpose of Action	LEVEL 2
Deficiency Photo1	 
Violations	Facade L - Gymnasium (Facade L - Cafeteria similar throughout) No violations recorded.
Instance on Aluminum - Other: Facade B	Inspected
Instance Condition	3 - Fair
Instance Quantity	200
Instance Quantity Uom	S.F.
Are these windows insulated	Yes
Installation Year	2001
Source of Installation	Custodial Staff
Deficiency	No deficiencies recorded
INTERIOR	Inspected
POOLS	Does not Exist
STRUCTURAL	Inspected
COLUMNS/BEAMS/BEARING WALLS	Inspected
Condition	3 - Fair
Deficiency	STEEL COLUMNS/BEAMS: DETERIORATED CONCRETE FIREPROOFING
Deficiency Location/Instance	Boiler Room
Deficiency Quantity	20
Quantity Uom	S.F.
Potential Action	REPLACE
Urgency of Action	PRIORITY 3
Purpose of Action	LEVEL 5

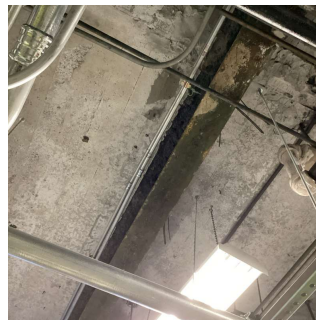
STEEL COLUMNS/BEAMS: DETERIORATED CONCRETE FIREPROOFING

REPLACE

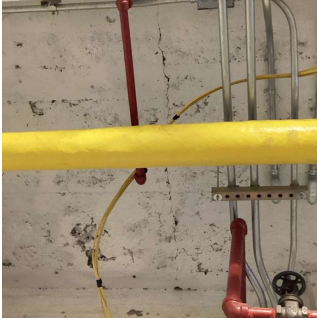
Question	Response
INTERIOR	
STRUCTURAL	
COLUMNS/BEAMS/BEARING WALLS	Inspected
	Basement - near Electrical Panel Room
Violations	No violations recorded.
FLOOR STRUCTURE	Inspected
Condition	3 - Fair
Deficiency	CINDER CONCRETE FLAT SLAB: CRACKED/SPALLED/REINFORCEMENT EXPOSED
Deficiency Location/Instance	Electrical Panel Room
Deficiency Quantity	40
Quantity Uom	S.F.
Potential Action	REPAIR
Urgency of Action	PRIORITY 3
Purpose of Action	LEVEL 5
Deficiency Photo1

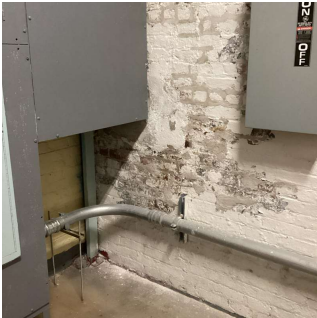
Electrical Panel Room
Violations	No violations recorded.
FOUNDATION WALLS	Inspected
Material Type(s)	Masonry
Condition	4 - Between Fair and Poor
Deficiency	BRICK: WATER INFILTRATION IN ELECTRICAL PANEL ROOM
Deficiency Location/Instance	Electrical Panel Room
Deficiency Quantity	100
Quantity Uom	S.F.
Potential Action	INSTALL WATERPROOFING
Urgency of Action	PRIORITY 5
Purpose of Action	LEVEL 6
Deficiency Photo1

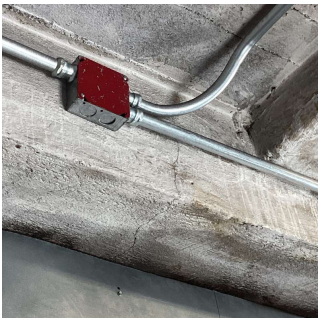
Question	Response
INTERIOR	
STRUCTURAL	
ROOF STRUCTURE	
Deficiency	STEEL COLUMNS/BEAMS: DETERIORATED CONCRETE FIREPROOFING
Deficiency Location/Instance	PH
Deficiency Quantity	20
Quantity Uom	S.F.
Potential Action	REPLACE
Urgency of Action	PRIORITY 3
Purpose of Action	LEVEL 5
Deficiency Photo1

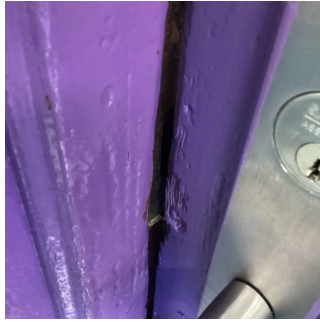
Room 215
Violations	No violations recorded.
Deficiency	METAL CLAD WOOD: DETERIORATED DOOR
Deficiency Location/Instance	Rooms 212, 213
Deficiency Quantity	2
Quantity Uom	EACH
Potential Action	MAINTENANCE
Urgency of Action	PRIORITY 3
Purpose of Action	LEVEL 2

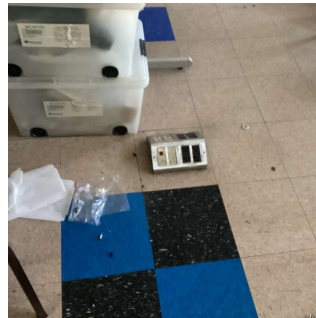
VINYL TILES: TRIPPING HAZARD - ELECTRICAL OUTLET

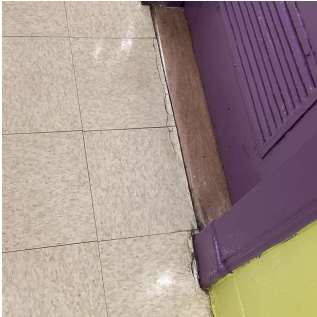
Question	Response
INTERIOR	
CLASSROOMS/CORRIDORS/ADMIN SPACES	
Floor Finish	
Violations	Room 103 No violations recorded.
Deficiency	VINYL TILES: BROKEN/DETERIORATED/MISSING TILES
Deficiency Location/Instance	Rooms 103, 104, Corridor near Rooms 102, 104, 158, and others
Deficiency Quantity	300
Quantity Uom	S.F.
Potential Action	REPLACE
Urgency of Action	PRIORITY 3
Purpose of Action	LEVEL 2
Deficiency Photo1

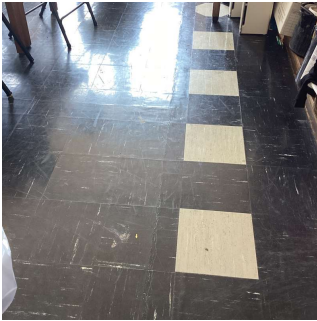
Violations	Corridor near Room 158 No violations recorded.
Deficiency	VINYL TILES: DETERIORATED SUBSTRATE
Deficiency Location/Instance	Rooms 117, 209, 217, Corridor near 1st Floor Boys Toilet Room
Deficiency Quantity	800
Quantity Uom	S.F.
Potential Action	REPLACE
Urgency of Action	PRIORITY 3
Purpose of Action	LEVEL 2
Deficiency Photo1

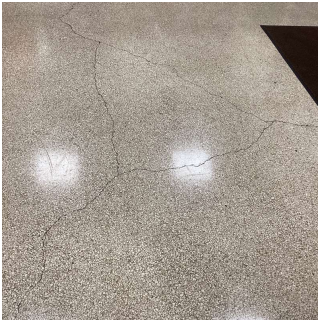
Violations	Room 217 No violations recorded.
Deficiency	TERRAZZO: CRACKS
Deficiency Location/Instance	Lobby, Main Entrance Vestibule, near Cafeteria
Deficiency Quantity	160

Quantity Uom	S.F.
Potential Action	REPLACE
Urgency of Action	PRIORITY 3
Purpose of Action	LEVEL 2

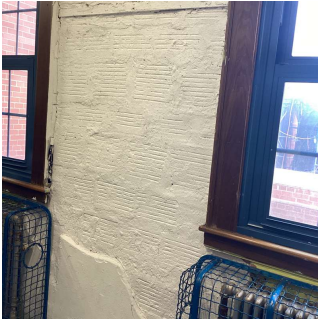
Violations	Lobby Area No violations recorded.
Walls	
Condition	Inspected 2 - Between Good and Fair
Deficiency	PLASTER: CRACKS/SPALLING
Deficiency Location/Instance	Rooms 202, 206, 209, Corridor near Room 258, Main Entrance Vestibule, and others
Deficiency Quantity	500
Quantity Uom	S.F.
Potential Action	REPLACE
Urgency of Action	PRIORITY 3
Purpose of Action	LEVEL 2
Deficiency Photo1

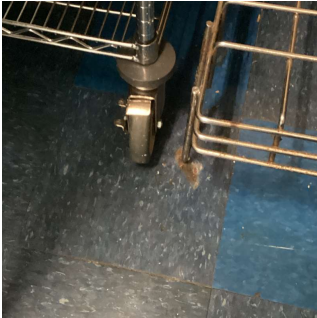
Instance on Basement	Inspected
Condition	2 - Between Good and Fair
Deficiency	VINYL TILES: BROKEN/DETERIORATED/MISSING TILES
Deficiency Location/Instance	Storage Room

Question	Response
INTERIOR	
KITCHEN	
Floor Finish	
Deficiency Quantity	10
Quantity Uom	S.F.
Potential Action	REPLACE
Urgency of Action	PRIORITY 3
Purpose of Action	LEVEL 2
Deficiency Photo1

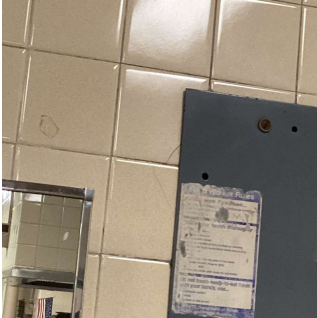
Storage Room
Violations	No violations recorded.
Walls	
Instance on Basement	Inspected
Condition	2 - Between Good and Fair
Deficiency	CERAMIC TILE: BROKEN/ MISSING
Deficiency Location/Instance	Food preparation area
Deficiency Quantity	10
Quantity Uom	S.F.
Potential Action	REPLACE
Urgency of Action	PRIORITY 3
Purpose of Action	LEVEL 2
Deficiency Photo1

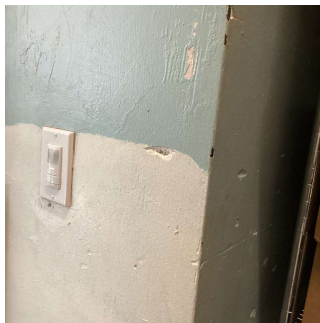
Food preparation area
Violations	No violations recorded.
Deficiency	PLASTER: CRACKS/SPALLING
Deficiency Location/Instance	Storage Room
Deficiency Quantity	10
Quantity Uom	S.F.
Potential Action	REPLACE
Urgency of Action	PRIORITY 3
Purpose of Action	LEVEL 2

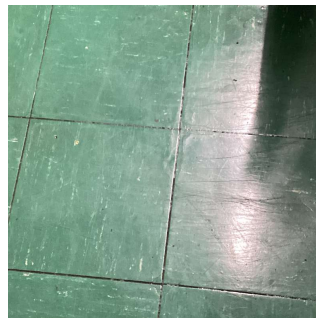
VINYL TILES: BROKEN/DETERIORATED/MISSING TILES

REPLACE

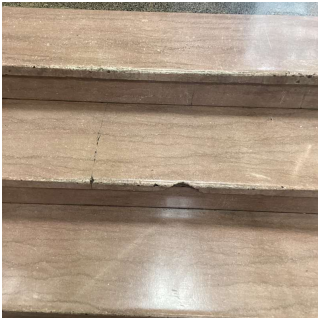
Question	Response
INTERIOR	
STAIRS/RAMPS: INTERIOR	
Stairs and Landings	
Violations	Stair A/Basement No violations recorded.
Deficiency	STONE: BROKEN/MISSING
Deficiency Location/Instance	Main Entrance Vestibule
Deficiency Quantity	40
Quantity Uom	S.F.
Potential Action	REPLACE
Urgency of Action	PRIORITY 3
Purpose of Action	LEVEL 2
Deficiency Photo1

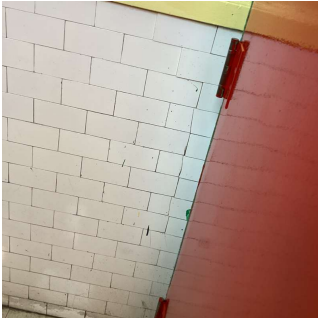
Violations	Main Entrance Vestibule No violations recorded.
Walls	Inspected
Condition	2 - Between Good and Fair
Deficiency	CERAMIC TILE: BROKEN/ MISSING
Deficiency Location/Instance	Stairs B/1,2, C/2
Deficiency Quantity	30
Quantity Uom	S.F.
Potential Action	REPLACE
Urgency of Action	PRIORITY 3
Purpose of Action	LEVEL 2
Deficiency Photo1

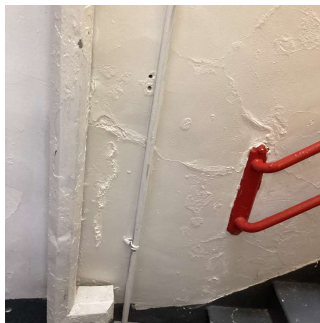
Violations	Stair B/1 No violations recorded.
Deficiency	PLASTER: CRACKS/SPALLING
Deficiency Location/Instance	Stair F/Basement
Deficiency Quantity	200
Quantity Uom	S.F.
Potential Action	REPLACE
Urgency of Action	PRIORITY 4
Purpose of Action	LEVEL 4

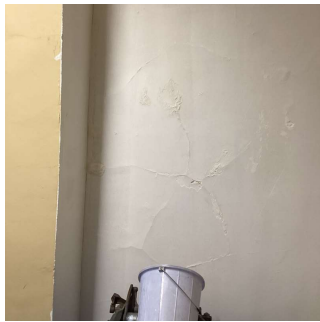
Stair F/Basement
Violations	35655440Z
Deficiency	PLASTER: CRACKS/SPALLING
Deficiency Location/Instance	Stair F/2
Deficiency Quantity	20
Quantity Uom	S.F.
Potential Action	REPLACE
Urgency of Action	PRIORITY 3
Purpose of Action	LEVEL 2
Deficiency Photo1

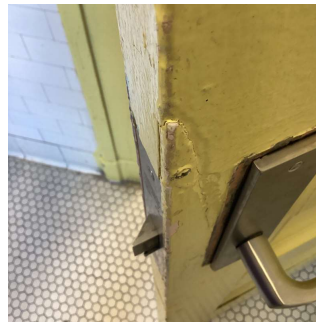
Stair F/2
Violations	No violations recorded.
TOILET ROOMS - STAFF	
	Inspected
Ceiling	Inspected
Condition	2 - Between Good and Fair
Deficiency	No deficiencies recorded
Door(s)	Inspected
Condition	5 - Poor
Deficiency	WOOD: DETERIORATED DOOR
Deficiency Location/Instance	Room 258
Deficiency Quantity	1
Quantity Uom	EACH
Potential Action	MAINTENANCE
Urgency of Action	PRIORITY 3
Purpose of Action	LEVEL 2

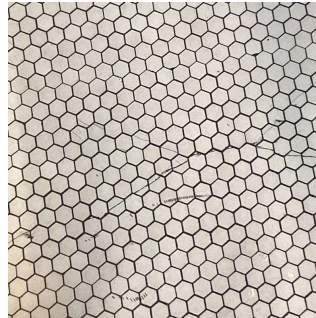
Room 258

CERAMIC TILE: BROKEN/MISSING TILES

REPLACE

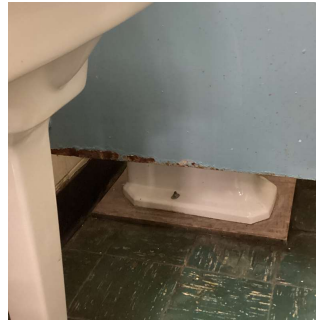
Kitchen Toilet Room

RUST - MAJOR

REPLACE

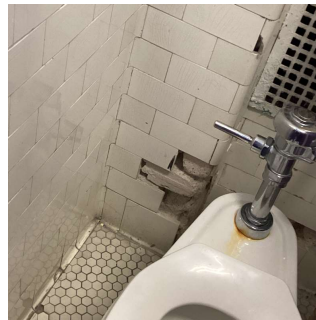
Room 258

CERAMIC TILE: BROKEN/ MISSING

REPLACE

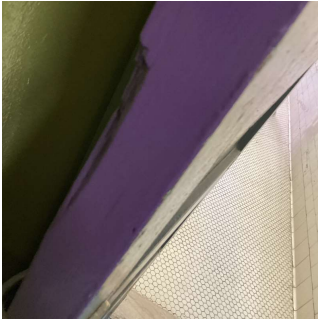
Question	Response
INTERIOR	
TOILET ROOMS - STAFF	Inspected
Walls	Inspected
Violations	Kitchen Toilet Room No violations recorded.
TOILET ROOMS - STUDENTS	Inspected
Ceiling	Inspected
Condition	2 - Between Good and Fair
Deficiency	No deficiencies recorded
Door(s)	Inspected
Condition	5 - Poor
Deficiency	WOOD: DETERIORATED DOOR
Deficiency Location/Instance	Room 256
Deficiency Quantity	1
Quantity Uom	EACH
Potential Action	MAINTENANCE
Urgency of Action	PRIORITY 3
Purpose of Action	LEVEL 2
Deficiency Photo1

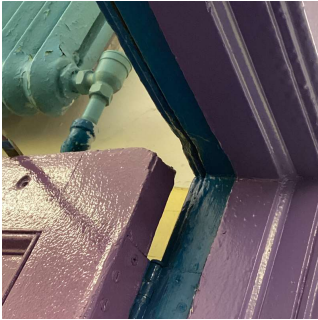
Violations	Room 256 No violations recorded.
Deficiency	WOOD: DETERIORATED DOOR AND FRAME
Deficiency Location/Instance	Rooms 156, 257
Deficiency Quantity	2
Quantity Uom	EACH
Potential Action	MAINTENANCE
Urgency of Action	PRIORITY 3
Purpose of Action	LEVEL 2
Deficiency Photo1

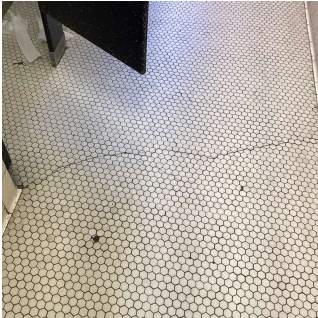
Question	Response
INTERIOR	
TOILET ROOMS - STUDENTS	Inspected
Floor Finish	
Deficiency	CERAMIC TILE: BROKEN/MISSING TILES
Deficiency Location/Instance	Rooms 256, 257
Deficiency Quantity	50
Quantity Uom	S.F.
Potential Action	REPLACE
Urgency of Action	PRIORITY 3
Purpose of Action	LEVEL 2
Deficiency Photo1

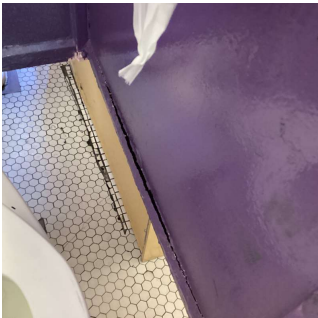
Room 256
Violations	No violations recorded.
Stalls	
	Inspected
Condition	3 - Fair
Deficiency	RUST - MAJOR
Deficiency Location/Instance	Room 156
Deficiency Quantity	1
Quantity Uom	EACH
Potential Action	REPLACE
Urgency of Action	PRIORITY 3
Purpose of Action	LEVEL 2
Deficiency Photo1

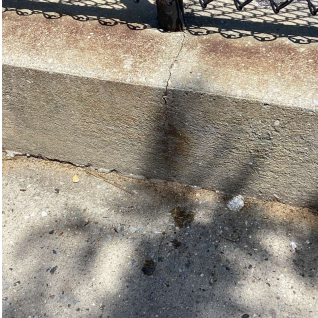
Deficiency Location/Instance	Near the Playground
Deficiency Quantity	1
Quantity Uom	EACH
Potential Action	MAINTENANCE
Urgency of Action	PRIORITY 3
Purpose of Action	LEVEL 2
Deficiency Photo1	No photo recorded
Violations	No violations recorded.
FENCES	Inspected
Condition	3 - Fair
Deficiency	CONCRETE CURB: DAMAGED/DETERIORATED
Deficiency Location/Instance	149th Street, 150th Street, Sutter Avenue

Question	Response
SITE	
FENCES	
Deficiency Quantity	150
Quantity Uom	S.F.
Potential Action	REPLACE
Urgency of Action	PRIORITY 3
Purpose of Action	LEVEL 2
Deficiency Photo1

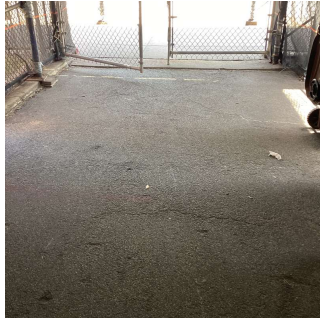
Question	Response
SITE	
PAVING	
Site Sidewalks & Walkways	Inspected
Asphalt	Inspected
Condition	3 - Fair
Deficiency	CRACKS - MAJOR
Deficiency Location/Instance	150th Street
Deficiency Quantity	50
Quantity Uom	S.F.
Potential Action	REPLACE
Urgency of Action	PRIORITY 3
Purpose of Action	LEVEL 2
Deficiency Photo1

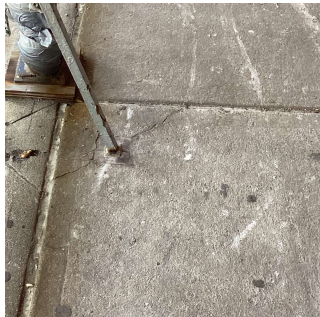
Violations	150th Street No violations recorded.
Concrete	Inspected
Condition	2 - Between Good and Fair
Deficiency	DAMAGED/DETERIORATED/MISSING SECTIONS
Deficiency Location/Instance	150th Street
Deficiency Quantity	25
Quantity Uom	S.F.
Potential Action	REPLACE
Urgency of Action	PRIORITY 3
Purpose of Action	LEVEL 2
Deficiency Photo1

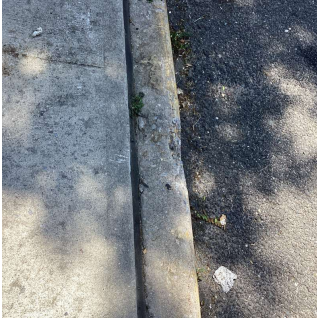
Violations	150th Street No violations recorded.
Pavers	Does not Exist
DOT Sidewalk	Inspected
Asphalt	Does not Exist
Concrete	Inspected
Condition	3 - Fair
Deficiency	DAMAGED CURBS
Deficiency Location/Instance	149th Street, 150th Street, Sutter Avenue

Question	Response
SITE	
PAVING	
DOT Sidewalk	
Concrete	
Deficiency Quantity	50
Quantity Uom	L.F.
Potential Action	REPLACE
Urgency of Action	PRIORITY 3
Purpose of Action	LEVEL 2
Deficiency Photo1

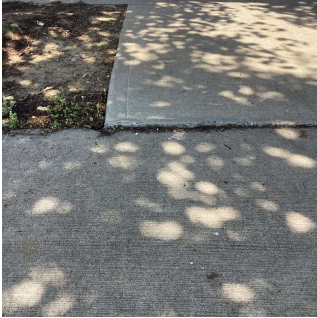
Sutter Avenue
Violations	No violations recorded.
Deficiency	HEAVING
Deficiency Location/Instance	149th Street, Sutter Avenue
Deficiency Quantity	50
Quantity Uom	S.F.
Potential Action	REPLACE
Urgency of Action	PRIORITY 3
Purpose of Action	LEVEL 2
Deficiency Photo1
