**NYC Department of Education**  
**Building Condition Assessment Survey 2023 - 2024**

Architectural Inspection

**Asset:** P.S. 46 - QUEENS, 64-45 218TH STREET, New York, 11364

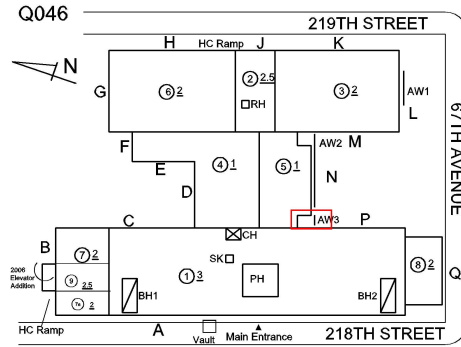
Roof Plan reference

Question	Response
<b>Architectural</b>	
<b>EXTERIOR</b>	Inspected
<b>AREAWAY</b>	Inspected
Instance on AW1-AW3	Inspected
Instance Condition	3 - Fair
Instance Quantity	3
Instance Quantity Uom	EACH
Deficiency	AREAWAY STAIRS: DETERIORATED MATERIAL SLIDE

25  
 S.F.  
 REPLACE  
 PRIORITY 3  
 LEVEL 2

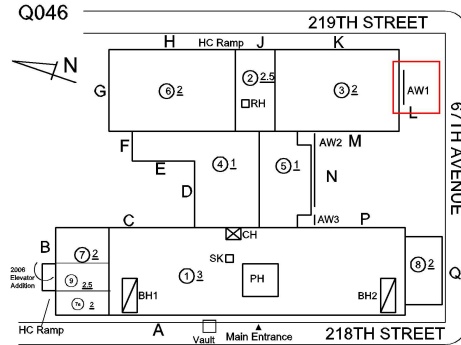
Roof Plan reference

AREAWAY WALLS: CRACKS AND SPALLING

10  
 S.F.  
 REPAIR  
 PRIORITY 3  
 LEVEL 2

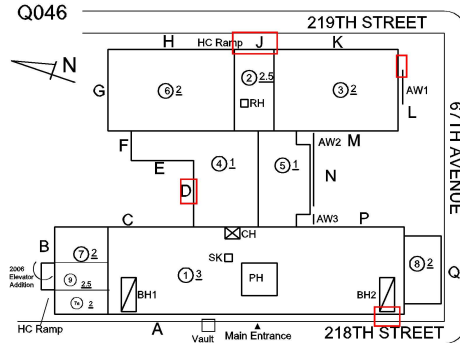
Roof Plan reference

METAL CLAD: DETERIORATED DOOR AND FRAME - MAJOR DETERIORATION

REPLACE

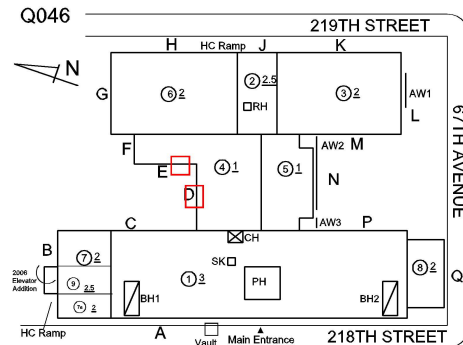
Roof Plan reference

WOOD: EXCESSIVELY WEATHERED

REPLACE

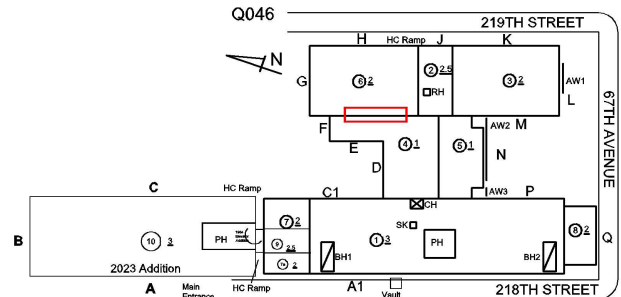
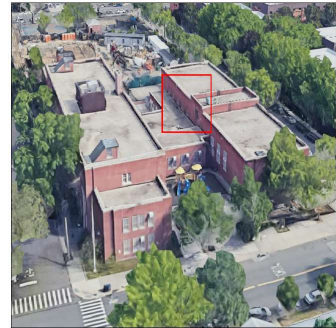
Question	Response
<b>EXTERIOR</b>	
<b>EXTERIOR WALLS</b>	
Material Type(s)	Masonry, Concrete
Replacement Quantity	49,300
Replacement Uom	S.F.
Instance on All Facades (Original Building)	Inspected
Instance Condition	3 - Fair
Instance Quantity	32,000
Instance Quantity Uom	S.F.
Deficiency	GLASS BLOCK: CHIPPED/ BROKEN PIECES
Roof Plan reference

Deficiency Quantity	50
Quantity Uom	S.F.
Potential Action	REPLACE-IN-KIND
Urgency of Action	PRIORITY 4
Purpose of Action	LEVEL 2
Deficiency Photo1

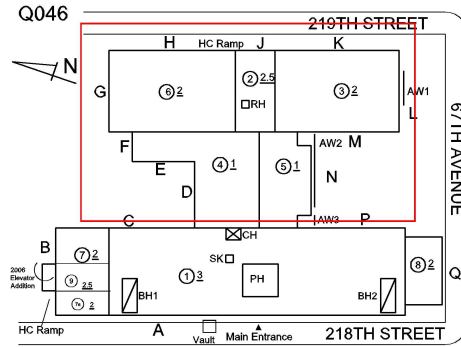
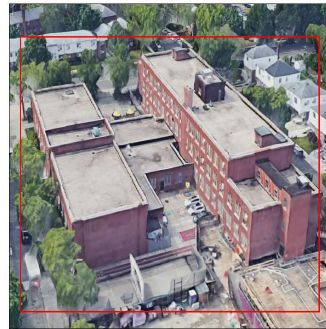
Roof Plan reference

Violations	Facade M No violations recorded.
Deficiency	BRICK: EFFLORESCENCE

500  
 S.F.  
 MAINTENANCE  
 PRIORITY 1  
 LEVEL 1  
 No photo recorded  
 No violations recorded.

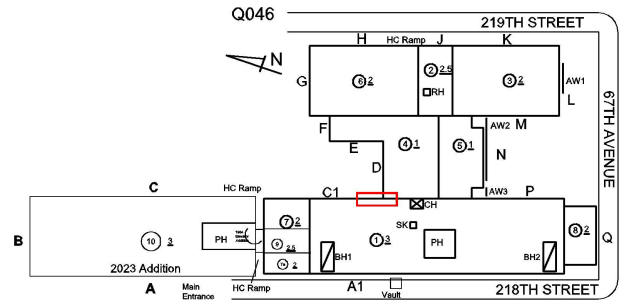
Roof Plan reference

BRICK: DETERIORATED JOINTS

30  
S.F.  
REPOINT  
PRIORITY 4  
LEVEL 2

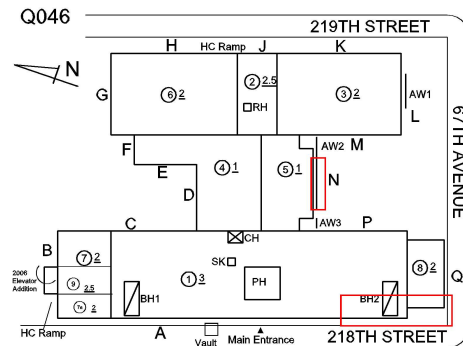
Roof Plan reference

**BRICK: DETERIORATED JOINTS**

200  
S.F.  
REPOINT  
PRIORITY 3  
LEVEL 2

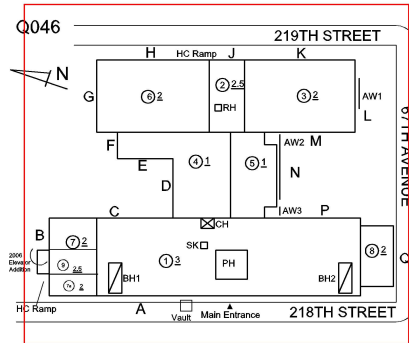
Violations	Roof 5 No violations recorded.
Deficiency	<b>BRICK: EFFLORESCENCE</b>
Roof Plan reference

Deficiency Quantity	3,000
Quantity Uom	S.F.
Potential Action	MAINTENANCE
Urgency of Action	PRIORITY 1
Purpose of Action	LEVEL 1
Deficiency Photo1	No photo recorded
Violations	No violations recorded.
Instance on 2023 Addition	Inspected
Instance Condition	1 - Good
Instance Quantity	1,900
Instance Quantity Uom	C.F.
Deficiency	No deficiencies recorded
<b>PLAZA DECK</b>	Does not Exist
<b>ROOF</b>	Inspected
<b>Roofing</b>	Inspected
Replacement Quantity	46,800
Replacement Uom	S.F.
<b>ROOF HATCH/SMOKE HATCH</b>	Inspected
Condition	2 - Between Good and Fair
Deficiency	No deficiencies recorded
<b>LEADERS, GUTTERS, DOWNSPOUTS, SCUPPERS</b>	Inspected
Condition	2 - Between Good and Fair
Deficiency	No deficiencies recorded
<b>ROOF BARRIER/FENCE</b>	Inspected

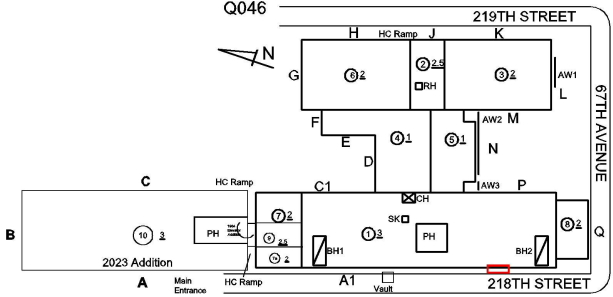
Question	Response
<b>EXTERIOR</b>	
<b>ROOF</b>	
<b>Roofing</b>	
<b>ROOF BARRIER/FENCE</b>	
Deficiency	RAILINGS/PANELS: DETERIORATED, MAJOR RUSTING
Roof Plan reference

Deficiency Quantity	20
Quantity Uom	S.F.
Potential Action	REPLACE
Urgency of Action	PRIORITY 4
Purpose of Action	LEVEL 2
Deficiency Photo1

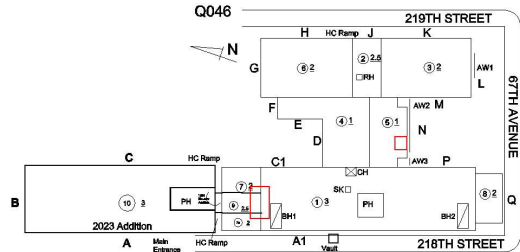
Roof Plan reference

Instance Quantity	Roof 1 32,500
Instance Quantity Uom	S.F.
Does the roof have major mechanical equipment sitting on Dunnage Steel less than 18" above the Roofing?	No
Does this roof instance have a Sustainable Roof System?	No
Do solar panels exist on these roofs?	No
Is/Are the roof(s) suitable for Solar Panel installation?	Yes
Installation Year	2008
Source of Installation	Custodial Staff
Deficiency	BUILT-UP: ROOFING: MAJOR ACTIVE ROOF LEAKS IN INSTRUCTIONAL SPACE

200  
S.F.  
REPLACE ROOFING WITHOUT MAJOR EQUIPMENT  
REMOVAL  
PRIORITY 5  
LEVEL 2

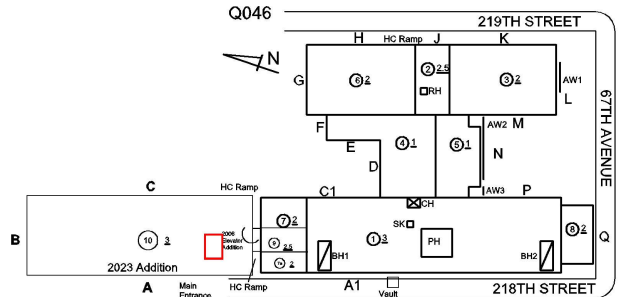
Roof 10
Instance Quantity	14,000
Instance Quantity Uom	S.F.
Does the roof have major mechanical equipment sitting on Dunnage Steel less than 18" above the Roofing?	No
Does this roof instance have a Sustainable Roof System?	Yes
Sustainable Roof Type	White Roof
Sustainable Roof Location (Roof Number)	Roof 10
Do solar panels exist on these roofs?	No
Is/Are the roof(s) suitable for Solar Panel installation?	No
Installation Year	2023
Source of Installation	Custodial Staff
Deficiency	MODIFIED BITUMEN: ROOFING: MAJOR ACTIVE ROOF LEAKS IN INSTRUCTIONAL SPACE
Roof Plan reference

Deficiency Quantity	400
Quantity Uom	S.F.
Potential Action	REPLACE ROOFING WITHOUT MAJOR EQUIPMENT REMOVAL
Urgency of Action	PRIORITY 5

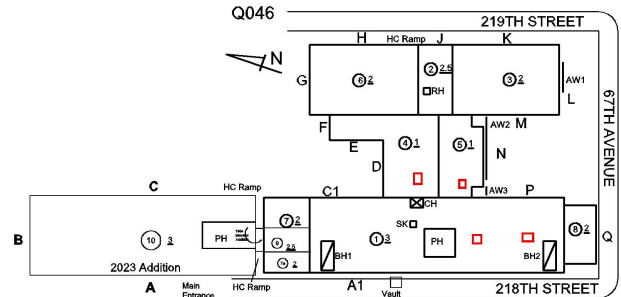
Question	Response
<b>EXTERIOR</b>	
<b>ROOF</b>	
<b>Roofing</b>	
<b>ROOFING DRAINS</b>	Inspected
Condition	5 - Poor
Deficiency	DETERIORATED
Roof Plan reference

Deficiency Quantity	4
Quantity Uom	EACH
Potential Action	REPLACE
Urgency of Action	PRIORITY 4
Purpose of Action	LEVEL 2
Deficiency Photo1

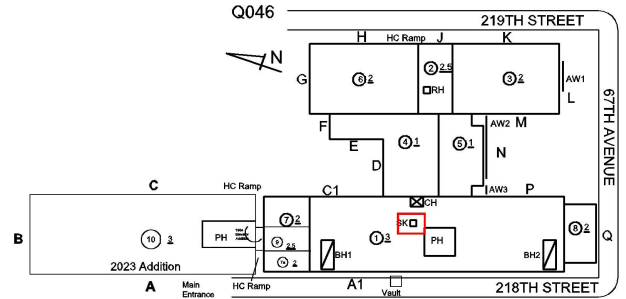
Violations	Roof 1 No violations recorded.
<b>Specialties</b>	Inspected
<b>BULKHEAD/PENTHOUSE</b>	Inspected
Condition	2 - Between Good and Fair
Deficiency	No deficiencies recorded
<b>CUOLA/ SPIRES/ TOWERS</b>	Does not Exist
<b>DORMER</b>	Does not Exist
<b>DUNNAGE STEEL</b>	Inspected
Condition	1 - Good
Deficiency	No deficiencies recorded
<b>SKYLIGHT/ROOF VENT</b>	Inspected
Material Type(s)	Glass
Condition	3 - Fair
Deficiency	BROKEN GLASS

15  
S.F.  
MAINTENANCE  
PRIORITY 3  
LEVEL 2

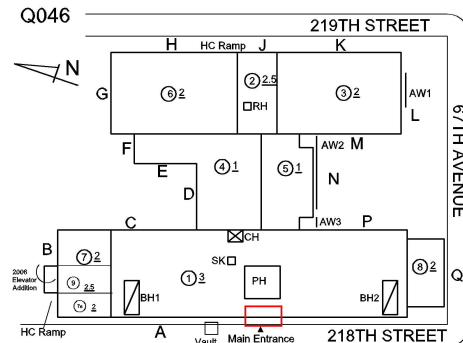
Roof Plan reference

STONE: DETERIORATED JOINTS

Quantity Uom	L.F.
Potential Action	REPOINT
Urgency of Action	PRIORITY 4
Purpose of Action	LEVEL 2
Deficiency Photo1

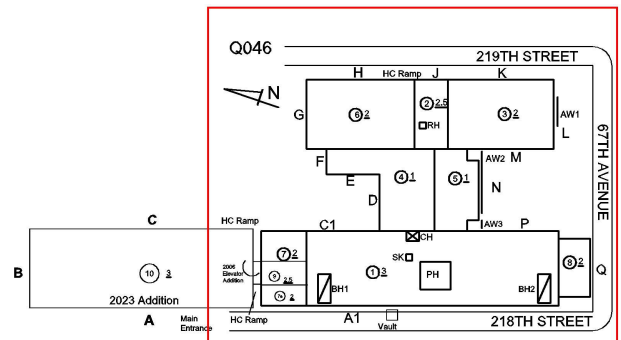
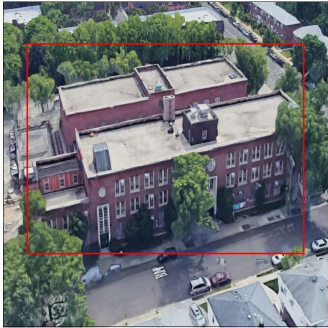
Material Type(s)	Aluminum
Instance on Aluminum - Double Hung: All Facades except Stairwell Facade and Loft above Gymnasium	Inspected
Instance Condition	3 - Fair
Instance Quantity	6,300
Instance Quantity Uom	S.F.
Are these windows insulated	Yes
Installation Year	2000
Source of Installation	Custodial Staff
Deficiency	ALUMINUM - DOUBLE HUNG: INOPERABLE BALANCE
Roof Plan reference

Deficiency Quantity	40
Quantity Uom	EACH
Potential Action	REPLACE BALANCES
Urgency of Action	PRIORITY 3
Purpose of Action	LEVEL 2
Deficiency Photo1	No photo recorded
Violations	No violations recorded.
Instance on Aluminum - Other: Stairwell Facades and Loft above Gymnasium	Inspected
Instance Condition	2 - Between Good and Fair
Instance Quantity	700
Instance Quantity Uom	S.F.
Are these windows insulated	Yes
Installation Year	2008
Source of Installation	Custodial Staff
Deficiency	No deficiencies recorded
Instance on Wood: Facade D	Inspected
Instance Condition	3 - Fair
Instance Quantity	30
Instance Quantity Uom	S.F.
Are these windows insulated	No
Installation Year	1950
Source of Installation	Custodial Staff
Deficiency	No deficiencies recorded
Instance on Aluminum - Other: All Facades (New Addition)	Inspected
Instance Condition	1 - Good
Instance Quantity	4,300

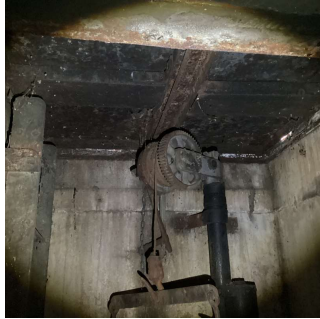
Basement - Ash Hoist Vault
Violations	No violations recorded.
Deficiency	DETERIORATED/DAMAGED VAULT/ASH HOIST DOORS AND FRAMING
Deficiency Location/Instance	Basement - Ash Hoist Vault
Deficiency Quantity	2
Quantity Uom	EACH
Potential Action	REPLACE
Urgency of Action	PRIORITY 4
Purpose of Action	LEVEL 2

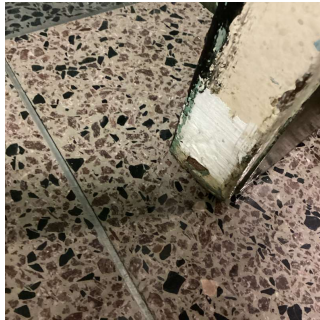
Violations	Basement - Ash Hoist Vault No violations recorded.
<b>AUDITORIUM</b>	
Instance on 1st Floor (412 Seats)	Inspected
Condition	Inspected
Deficiency	2 - Between Good and Fair
Deficiency	No deficiencies recorded
<b>Door(s)</b>	
Instance on 1st Floor (412 Seats)	Inspected
Condition	4 - Between Fair and Poor
Deficiency	METAL: DETERIORATED DOOR
Deficiency Location/Instance	Entrances
Deficiency Quantity	2
Quantity Uom	EACH
Potential Action	MAINTENANCE
Urgency of Action	PRIORITY 3
Purpose of Action	LEVEL 2
Deficiency Photo1

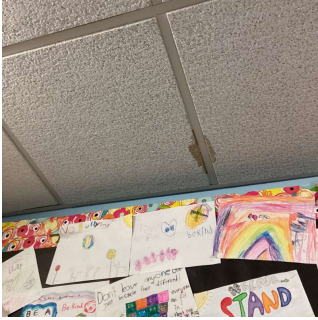
Corridor near Room 122
Violations	No violations recorded.
Deficiency	ACOUSTIC TILES: DAMAGED/MISSING - ACTIVE LEAK
Deficiency Location/Instance	Rooms 332, 321 - Closet, Corridor near Room 332.
Deficiency Quantity	50
Quantity Uom	S.F.
Potential Action	REPLACE
Urgency of Action	PRIORITY 5

Question	Response
<b>INTERIOR</b>	
<b>CAFETERIA</b>	
<b>Door(s)</b>	
Instance on Basement	Inspected
Condition	1 - Good
Deficiency	No deficiencies recorded
<b>Fixed Equipment</b>	
Instance on Basement	Does not Exist
<b>Floor Finish</b>	
Instance on Basement	Inspected
Condition	1 - Good
Deficiency	No deficiencies recorded
<b>Sliding-folding Partition</b>	
Instance on Basement	Does not Exist
<b>Stage</b>	
Instance on Basement	Does not Exist
<b>Walls</b>	
Instance on Basement	Inspected
Condition	1 - Good
Deficiency	No deficiencies recorded
<b>Window Curtains/Shades/Blinds</b>	
Instance on Basement	Does not Exist
<b>CLASSROOMS/CORRIDORS/ADMIN SPACES</b>	
<b>Ceiling</b>	Inspected
Condition	2 - Between Good and Fair
Deficiency	ACOUSTIC TILES: DAMAGED/MISSING
Deficiency Location/Instance	Room 200, Corridor near Rooms 109, 114, 122, Main entrance, and others.
Deficiency Quantity	250
Quantity Uom	S.F.
Potential Action	REPLACE
Urgency of Action	PRIORITY 3

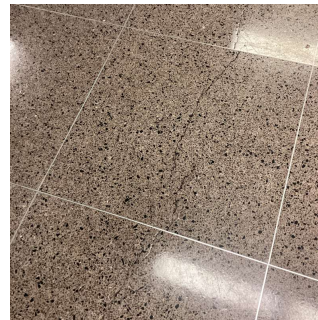
Near Exit 4

TERRAZZO: CRACKS

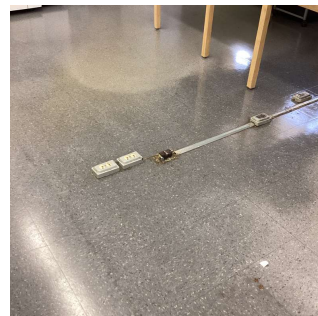
Question	Response
<b>INTERIOR</b>	
<b>CLASSROOMS/CORRIDORS/ADMIN SPACES</b>	
<b>Floor Finish</b>	
Violations	Room 103 No violations recorded.
Deficiency	VINYL TILES: BROKEN/DETERIORATED/MISSING TILES
Deficiency Location/Instance	Rooms 301, 302, 303, 304, Corridor near Exits 7, and others.
Deficiency Quantity	200
Quantity Uom	S.F.
Potential Action	REPLACE
Urgency of Action	PRIORITY 3
Purpose of Action	LEVEL 2
Deficiency Photo1

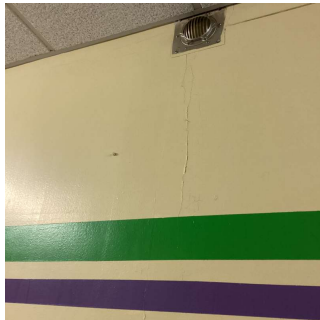
Violations	Room 124 No violations recorded.
Deficiency	PLASTER: CRACKS/SPALLING
Deficiency Location/Instance	Room 119, 200, Corridor near Rooms 118, 123, 315, and others.
Deficiency Quantity	300
Quantity Uom	S.F.
Potential Action	REPLACE
Urgency of Action	PRIORITY 3
Purpose of Action	LEVEL 2
Deficiency Photo1

Violations	Corridor near Room 315 No violations recorded.
<b>Specialties</b>	Does not Exist
<b>GYMNASIUM</b>	Inspected
Instance on 1st Floor	Inspected
<b>Ceiling</b>	
Instance on 1st Floor	Inspected
Condition	2 - Between Good and Fair
Deficiency	PLASTER: CRACKS/SPALLING
Deficiency Location/Instance	Near Windows
Deficiency Quantity	20
Quantity Uom	S.F.
Potential Action	REPLACE
Urgency of Action	PRIORITY 3
Purpose of Action	LEVEL 2

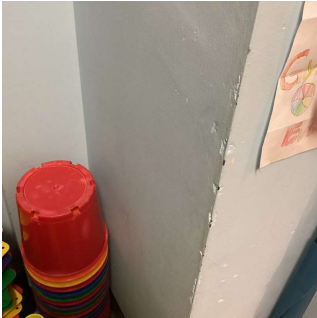
Question	Response
<b>INTERIOR</b>	
<b>GYMNASIUM</b>	
<b>Stage</b>	
Instance on 1st Floor	Does not Exist
<b>Walls</b>	
Instance on 1st Floor	Inspected
Condition	2 - Between Good and Fair
Deficiency	PLASTER: CRACKS/SPALLING
Deficiency Location/Instance	Storage Room
Deficiency Quantity	10
Quantity Uom	S.F.
Potential Action	REPLACE
Urgency of Action	PRIORITY 3
Purpose of Action	LEVEL 2
Deficiency Photo1

Violations	Storage Room No violations recorded.
Deficiency	GLAZED BLOCK: CRACKS/SPALLING
Deficiency Location/Instance	Near Entrance, windows, Drinking Fountains Area.
Deficiency Quantity	60
Quantity Uom	S.F.
Potential Action	REPLACE
Urgency of Action	PRIORITY 3
Purpose of Action	LEVEL 2
Deficiency Photo1

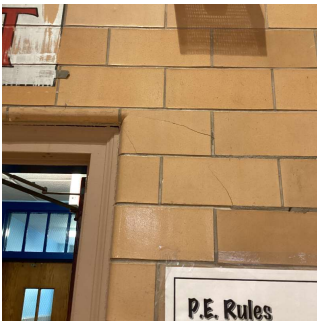
Violations	Near Entrance No violations recorded.
<b>Window Curtains/Shades/Blinds</b>	
Instance on 1st Floor	Does not Exist
<b>INTERIOR DOOR HARDWARE</b>	
Condition	Inspected
Deficiency	3 - Fair
Deficiency	No deficiencies recorded

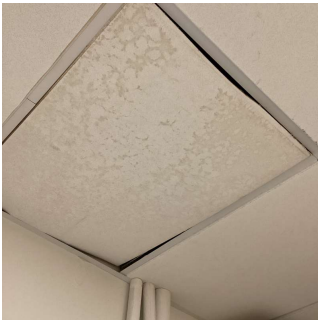
Question	Response
<b>INTERIOR</b>	
<b>INTERIOR GUARDS</b>	Inspected
Deficiency	No deficiencies recorded
<b>KITCHEN</b>	Inspected
Instance on Basement	Inspected
<b>Ceiling</b>	
Instance on Basement	Inspected
Condition	2 - Between Good and Fair
Deficiency	ACOUSTIC TILES: DAMAGED/MISSING
Deficiency Location/Instance	Room 004E
Deficiency Quantity	10
Quantity Uom	S.F.
Potential Action	REPLACE
Urgency of Action	PRIORITY 3
Purpose of Action	LEVEL 2
Deficiency Photo1

Room 004E
Violations	No violations recorded.
<b>Door(s)</b>	
Instance on Basement	Inspected
Condition	1 - Good
Deficiency	No deficiencies recorded
<b>Floor Finish</b>	
Instance on Basement	Inspected
Condition	1 - Good
Deficiency	No deficiencies recorded
<b>Walls</b>	
Instance on Basement	Inspected
Condition	1 - Good
Deficiency	No deficiencies recorded
<b>LIBRARY</b>	
Instance on Room 117	Inspected
<b>Built-in Furnishing</b>	
Instance on Room 117	Inspected
Condition	2 - Between Good and Fair

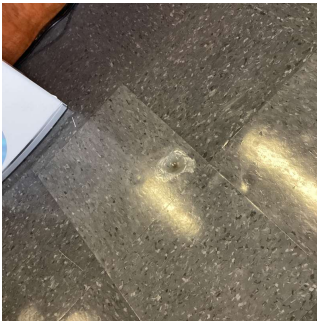
Question	Response
<b>INTERIOR</b>	
<b>LIBRARY</b>	
<b>Floor Finish</b>	
Deficiency Photo1

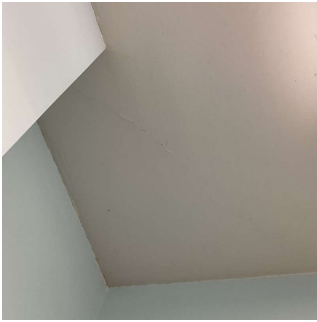
Near Windows
Violations	No violations recorded.
<b>Door(s)</b>	
Instance on 2nd Floor	Inspected
Condition	2 - Between Good and Fair
Deficiency	No deficiencies recorded
<b>Floor Finish</b>	
Instance on 2nd Floor	Inspected
Condition	2 - Between Good and Fair
Deficiency	No deficiencies recorded

Near Entrance
Violations	No violations recorded.
<b>Walls</b>	
Instance on Room 117	Inspected
Condition	2 - Between Good and Fair
Deficiency	No deficiencies recorded
<b>LOCKER ROOM</b>	
Instance on 2nd Floor	Inspected
Alternative use	Yes
<b>Ceiling</b>	
Instance on 2nd Floor	Inspected
Condition	2 - Between Good and Fair
Deficiency	PLASTER: CRACKS/SPALLING
Deficiency Location/Instance	Near Windows
Deficiency Quantity	10
Quantity Uom	S.F.
Potential Action	REPLACE
Urgency of Action	PRIORITY 3
Purpose of Action	LEVEL 2
Deficiency Photo1

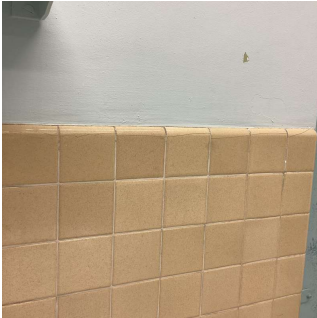
Question	Response
<b>INTERIOR</b>	
<b>LOCKER ROOM</b>	
<b>Locker Room Lockers</b>	
Instance on 2nd Floor	Does not Exist
<b>Walls</b>	
Instance on 2nd Floor	Inspected
Condition	2 - Between Good and Fair
Deficiency	CERAMIC TILE: BROKEN/ MISSING
Deficiency Location/Instance	Near Entrance
Deficiency Quantity	20
Quantity Uom	S.F.
Potential Action	REPLACE
Urgency of Action	PRIORITY 3
Purpose of Action	LEVEL 2
Deficiency Photo1

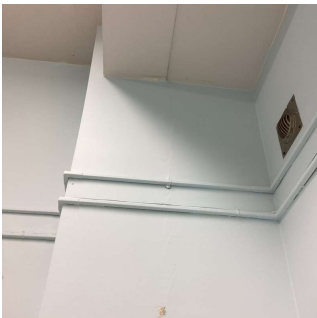
Violations	Near Entrance No violations recorded.
Deficiency	PLASTER: CRACKS/SPALLING
Deficiency Location/Instance	Near Entrance
Deficiency Quantity	10
Quantity Uom	S.F.
Potential Action	REPLACE
Urgency of Action	PRIORITY 3
Purpose of Action	LEVEL 2
Deficiency Photo1

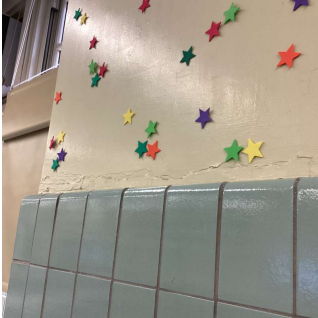
Question	Response
<b>INTERIOR</b>	
<b>MULTI-PURPOSE ROOM</b>	
<b>Door(s)</b>	
Deficiency Photo1	 
Violations	Entrance No violations recorded.
<b>Fixed Equipment</b>	
Instance on 1st Floor	Does not Exist
<b>Floor Finish</b>	
Instance on 1st Floor	Inspected
Condition	2 - Between Good and Fair
Deficiency	No deficiencies recorded
<b>Sliding-folding Partition</b>	
Instance on 1st Floor	Does not Exist
<b>Stage</b>	
Instance on 1st Floor	Does not Exist
<b>Walls</b>	
Instance on 1st Floor	Inspected
Condition	2 - Between Good and Fair
Deficiency	GLAZED BLOCK: CRACKS/SPALLING
Deficiency Location/Instance	Near Windows
Deficiency Quantity	10
Quantity Uom	S.F.
Potential Action	REPLACE
Urgency of Action	PRIORITY 3
Purpose of Action	LEVEL 2
Deficiency Photo1	 
Violations	Near Windows No violations recorded.
Deficiency	PLASTER: CRACKS/SPALLING
Deficiency Location/Instance	Near Windows, Entrance, Near Drinking Fountain
Deficiency Quantity	40

Quantity Uom	S.F.
Potential Action	REPLACE

Question	Response
<b>INTERIOR</b>	
<b>MULTI-PURPOSE ROOM</b>	
<b>Walls</b>	
Urgency of Action	PRIORITY 3
Purpose of Action	LEVEL 2
Deficiency Photo1

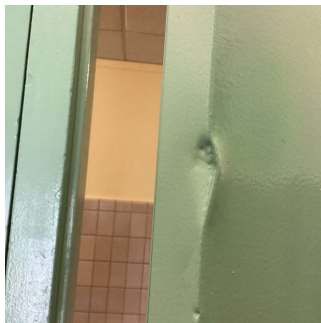
Violations	Near Windows No violations recorded.
<b>Window Curtains/Shades/Blinds</b>	
Instance on 1st Floor	Does not Exist
<b>SCIENCE DEMO ROOM</b>	Does not Exist
<b>SCIENCE LAB</b>	Inspected
Instance on Room 223	Inspected
Alternative use	No
<b>Fixed Equipment</b>	
Instance on Room 223	Inspected
Condition	1 - Good
Deficiency	No deficiencies recorded
<b>SCIENCE PREP ROOM</b>	Does not Exist
<b>SHOWER ROOM</b>	Inspected
Instance on 2nd Floor	Inaccessible
<b>STAIRS/RAMPS: INTERIOR</b>	Inspected
Do Letter Stair Signs Exist?	Yes
<b>Ceiling</b>	Inspected
Condition	2 - Between Good and Fair
Deficiency	No deficiencies recorded
<b>Door(s)</b>	Inspected
Condition	2 - Between Good and Fair
Deficiency	METAL: DETERIORATED DOOR
Deficiency Location/Instance	Stair C/2
Deficiency Quantity	1

Quantity Uom	EACH
Potential Action	MAINTENANCE
Urgency of Action	PRIORITY 3
Purpose of Action	LEVEL 2

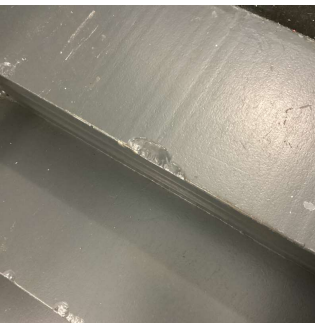
Violations	Auditorium right Side No violations recorded.
<b>Stairs and Landings</b>	Inspected
Condition	2 - Between Good and Fair
Deficiency	STONE: BROKEN/MISSING
Deficiency Location/Instance	Stairs B/1, D/1, 2, F/1, G/Basement
Deficiency Quantity	80
Quantity Uom	S.F.
Potential Action	REPLACE
Urgency of Action	PRIORITY 3
Purpose of Action	LEVEL 2

Question	Response
<b>INTERIOR</b>	
<b>STAIRS/RAMPS: INTERIOR</b>	
<b>Stairs and Landings</b>	
Deficiency Photo1           Violations

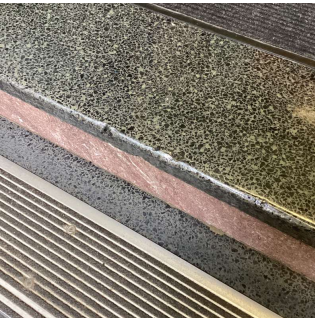
Stair D/2  No violations recorded.
Deficiency Deficiency Location/Instance Deficiency Quantity Quantity Uom Potential Action Urgency of Action Purpose of Action Deficiency Photo1           Violations	<b>TERRAZZO: CRACKS</b> Vestibule - Exit 4 10 S.F. REPLACE PRIORITY 3 LEVEL 2

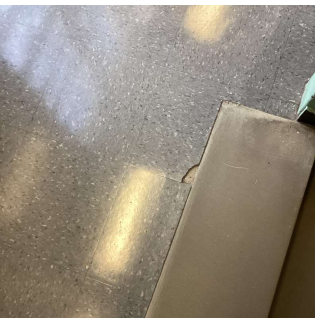
Stair B/1  No violations recorded.

Vestibule - Exit 4  No violations recorded.
Deficiency Deficiency Location/Instance Deficiency Quantity Quantity Uom Potential Action Urgency of Action Purpose of Action Deficiency Photo1           Violations	<b>VINYL TILES: BROKEN/DETERIORATED/MISSING TILES</b> Stair B/1 10 S.F. REPLACE PRIORITY 3 LEVEL 2

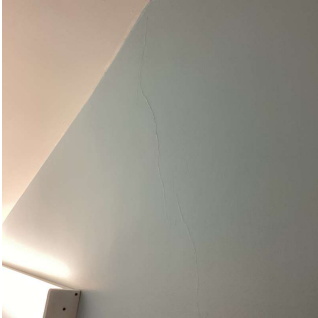
Question	Response
<b>INTERIOR</b>	
<b>STAIRS/RAMPS: INTERIOR</b>	
<b>Walls</b>	Inspected
Condition	2 - Between Good and Fair
Deficiency	PLASTER: CRACKS/SPALLING
Deficiency Location/Instance	Stair B/2, C/2, D/2, F/1
Deficiency Quantity	50
Quantity Uom	S.F.
Potential Action	REPLACE
Urgency of Action	PRIORITY 3
Purpose of Action	LEVEL 2
Deficiency Photo1

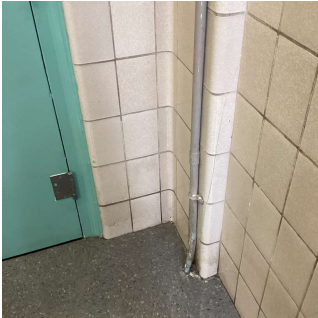
Violations	Stair D/2 No violations recorded.
Deficiency	GLAZED BLOCK: CRACKS/SPALLING
Deficiency Location/Instance	Stair C/1, D/2
Deficiency Quantity	20
Quantity Uom	S.F.
Potential Action	REPLACE
Urgency of Action	PRIORITY 3
Purpose of Action	LEVEL 2
Deficiency Photo1

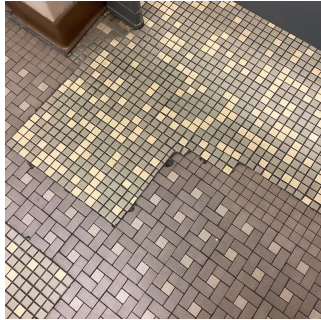
Room 113

Deficiency	CERAMIC TILE: BROKEN/MISSING TILES
Deficiency Location/Instance	Rooms 113, 114, Womens 1st Floor, Men Locker Room.
Deficiency Quantity	30
Quantity Uom	S.F.
Potential Action	REPLACE
Urgency of Action	PRIORITY 3
Purpose of Action	LEVEL 2
Deficiency Photo1

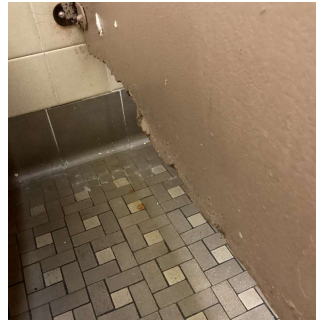
Room 307

Deficiency	RUST - MAJOR
Deficiency Location/Instance	Rooms 208, 307
Deficiency Quantity	2
Quantity Uom	EACH
Potential Action	REPLACE
Urgency of Action	PRIORITY 3
Purpose of Action	LEVEL 2

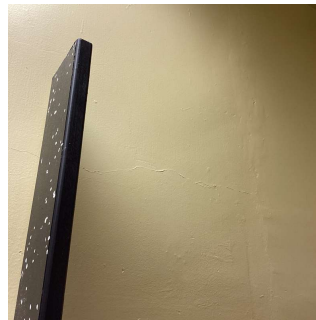
Women 1st Floor

PLASTER: CRACKS/SPALLING

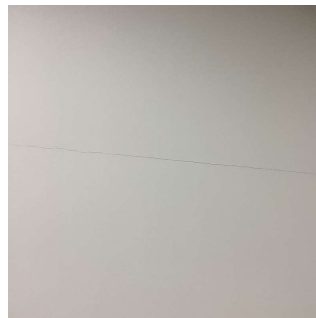
GYPSON BOARD: DETERIORATED

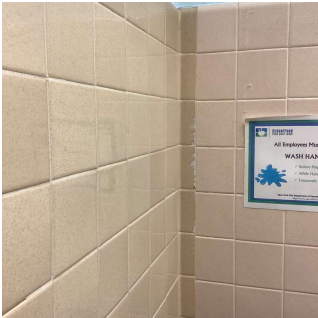
Question	Response
<b>INTERIOR</b>	
<b>TOILET ROOMS - STAFF</b>	
<b>Walls</b>	
Violations	Room 125C No violations recorded.
Deficiency	CERAMIC TILE: BROKEN/ MISSING
Deficiency Location/Instance	Rooms 113, 114, 116, Women 1st Floor, Men Locker Room.
Deficiency Quantity	30
Quantity Uom	S.F.
Potential Action	REPLACE
Urgency of Action	PRIORITY 3
Purpose of Action	LEVEL 2
Deficiency Photo1

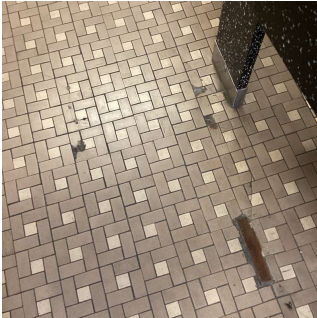
Question	Response
<b>INTERIOR</b>	
<b>TOILET ROOMS - STUDENTS</b>	
<b>Door(s)</b>	
Quantity Uom	EACH
Potential Action	MAINTENANCE
Urgency of Action	PRIORITY 3
Purpose of Action	LEVEL 2
Deficiency Photo1	 
	Room 210
Violations	No violations recorded.
<b>Floor Finish</b>	Inspected
Condition	2 - Between Good and Fair
Deficiency	CERAMIC TILE: BROKEN/MISSING TILES
Deficiency Location/Instance	Rooms 210, 212, 310, 312
Deficiency Quantity	20
Quantity Uom	S.F.
Potential Action	REPLACE
Urgency of Action	PRIORITY 3
Purpose of Action	LEVEL 2
Deficiency Photo1

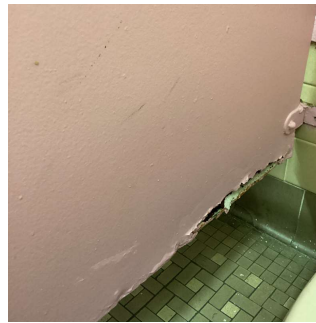
Room 312

Room 210
Violations	No violations recorded.
<b>Stalls</b>	Inspected
Condition	5 - Poor
Deficiency	RUST - MAJOR
Deficiency Location/Instance	Rooms 310, 312, 2nd Floor Locker Room.
Deficiency Quantity	4
Quantity Uom	EACH
Potential Action	REPLACE
Urgency of Action	PRIORITY 3
Purpose of Action	LEVEL 2

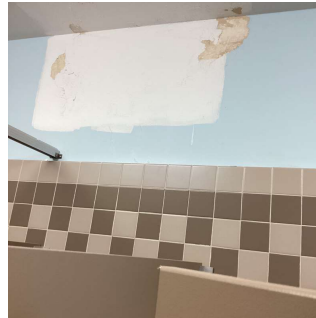
Room 122

PLASTER: CRACKS/SPALLING - ACTIVE LEAK

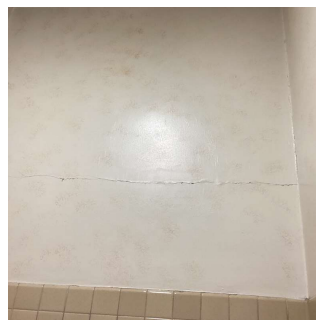
PLASTER: CRACKS/SPALLING

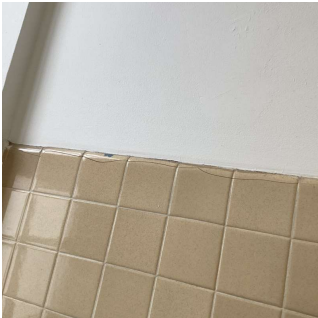
Question	Response
<b>INTERIOR</b>	
<b>TOILET ROOMS - STUDENTS</b>	
<b>Walls</b>	
Violations	2nd Floor Locker Room No violations recorded.
Deficiency	CERAMIC TILE: BROKEN/ MISSING
Deficiency Location/Instance	Rooms 210, 212, 310, 312, 102/111, and others.
Deficiency Quantity	30
Quantity Uom	S.F.
Potential Action	REPLACE
Urgency of Action	PRIORITY 3
Purpose of Action	LEVEL 2
Deficiency Photo1

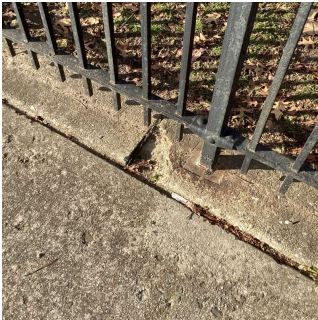
Question	Response
<b>SITE</b>	
<b>FENCES</b>	
Violations	No violations recorded.
Deficiency	CONCRETE CURB: DAMAGED/DETERIORATED
Deficiency Location/Instance	67th Avenue, 219th Street.
Deficiency Quantity	50
Quantity Uom	S.F.
Potential Action	REPLACE
Urgency of Action	PRIORITY 3
Purpose of Action	LEVEL 2
Deficiency Photo1

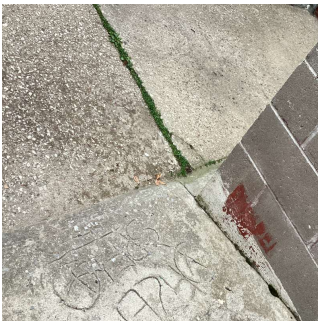
67th Avenue
Violations	No violations recorded.
<b>IRRIGATION SYSTEM</b>	Does not Exist
<b>PAVING</b>	Inspected
<b>Student Non-Use</b>	Inspected
Gravel Exists?	No
<b>Asphalt</b>	Does not Exist
<b>Concrete</b>	Inspected
Condition	2 - Between Good and Fair
Deficiency	DAMAGED/DETERIORATED/MISSING SECTIONS
Deficiency Location/Instance	Near Exit 8
Deficiency Quantity	25
Quantity Uom	S.F.
Potential Action	REPLACE
Urgency of Action	PRIORITY 3
Purpose of Action	LEVEL 2
Deficiency Photo1

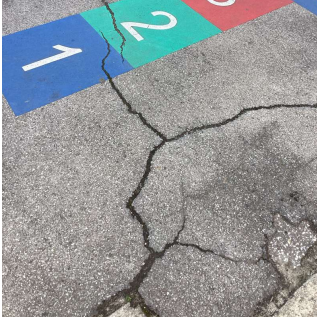
Question	Response
<b>SITE</b>	
<b>PAVING</b>	
<b>Student Use</b>	
<b>Asphalt</b>	Inspected
Condition	3 - Fair
Deficiency	CRACKS - MAJOR
Deficiency Location/Instance	Near Playground 67th Avenue
Deficiency Quantity	60
Quantity Uom	S.F.
Potential Action	REPLACE
Urgency of Action	PRIORITY 3
Purpose of Action	LEVEL 2
Deficiency Photo1

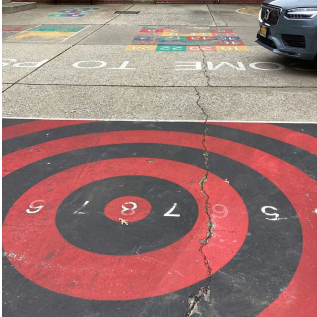
Violations	Near Playground 67th Avenue No violations recorded.
<b>Concrete</b>	Inspected
Condition	4 - Between Fair and Poor
Deficiency	DAMAGED/DETERIORATED/MISSING SECTIONS
Deficiency Location/Instance	Near Exit 8, Playground 67th Avenue
Deficiency Quantity	800
Quantity Uom	S.F.
Potential Action	REPLACE
Urgency of Action	PRIORITY 3
Purpose of Action	LEVEL 2
Deficiency Photo1

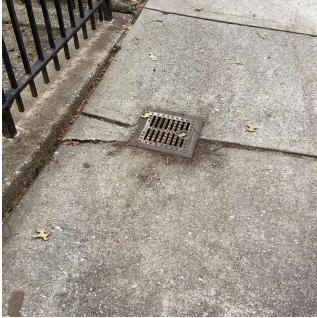
Violations	Near Exit 8 No violations recorded.
<b>Pavers</b>	Does not Exist
<b>Site Sidewalks &amp; Walkways</b>	Inspected
<b>Asphalt</b>	Does not Exist
<b>Concrete</b>	Inspected
Condition	3 - Fair
Deficiency	DAMAGED/DETERIORATED/MISSING SECTIONS

Deficiency Location/Instance	219th Street, near Exit 5 - 6

Question	Response
<b>SITE</b>	
<b>PAVING</b>	
<b>Site Sidewalks &amp; Walkways</b>	
<b>Concrete</b>	
Deficiency Quantity	50
Quantity Uom	S.F.
Potential Action	REPLACE
Urgency of Action	PRIORITY 3
Purpose of Action	LEVEL 2
Deficiency Photo1

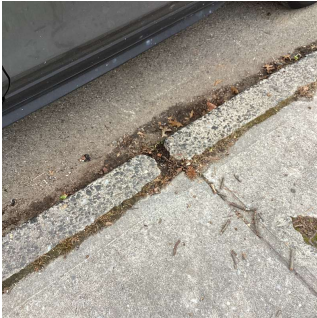
Near Playground 67th Avenue
Violations	No violations recorded.
<b>Pavers</b>	Does not Exist
<b>DOT Sidewalk</b>	Inspected
<b>Asphalt</b>	Does not Exist
<b>Concrete</b>	Inspected
Condition	3 - Fair
Deficiency	DAMAGED CURBS
Deficiency Location/Instance	218th Street, 219th Street, 67th Avenue.
Deficiency Quantity	125
Quantity Uom	L.F.
Potential Action	REPLACE
Urgency of Action	PRIORITY 3
Purpose of Action	LEVEL 2
Deficiency Photo1

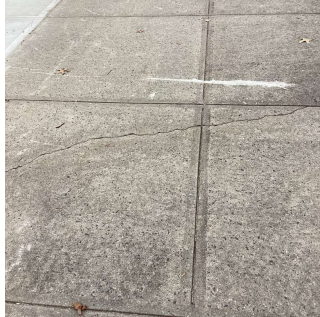
219th Street
Violations	No violations recorded.
Deficiency	DAMAGED/DETERIORATED/MISSING SECTIONS
Deficiency Location/Instance	218th Street, 219th Street, 67th Avenue.
Deficiency Quantity	225
Quantity Uom	S.F.
Potential Action	REPLACE
Urgency of Action	PRIORITY 3

Question	Response
<b>SITE</b>	
<b>PAVING</b>	
<b>DOT Sidewalk</b>	
<b>Concrete</b>	
Deficiency Photo1
