NYC Department of Education
Building Condition Assessment Survey 2023 - 2024

Architectural Inspection

Asset: P.S. 48 - QUEENS, 155-02 108 AVENUE, New York, 11433

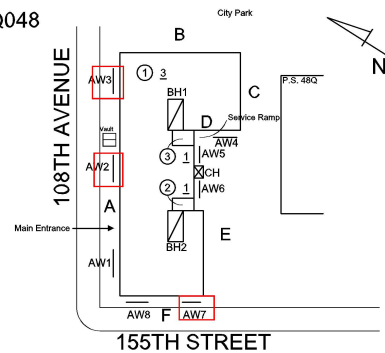
AREAWAY GRATINGS: MAJOR RUSTING / OR BROKEN

100

REPLACE

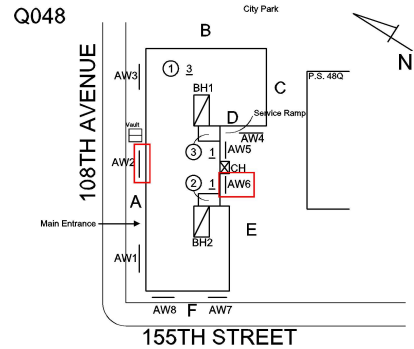
AREAWAY WALLS: CRACKS AND SPALLING

20

REPLACE

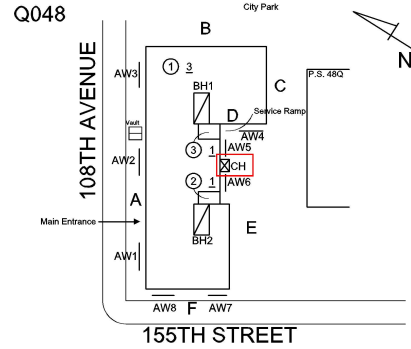
CHIMNEY

BRICK: MINOR CRACKS AND SPALLING

10
S.F.
RESTITCH
PRIORITY 3
LEVEL 2

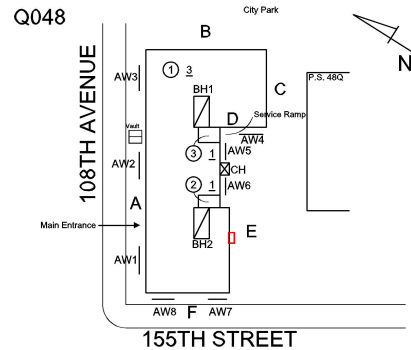
CAST STONE: DETERIORATED TRANSVERSE JOINTS

10
L.F.
MAINTENANCE
PRIORITY 3
LEVEL 2

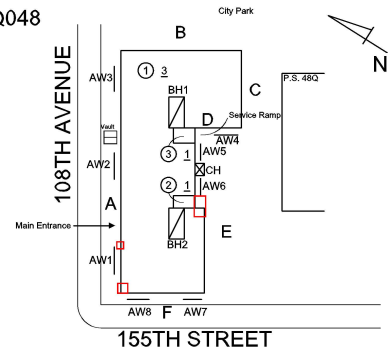
CAST STONE: CRACKED/BROKEN PIECES

20

REPLACE-IN-KIND

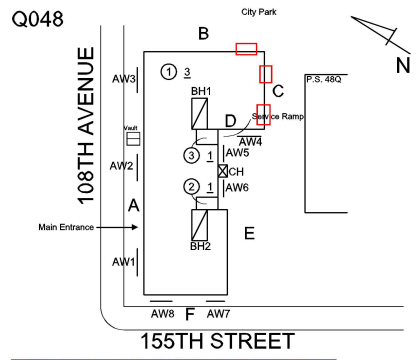
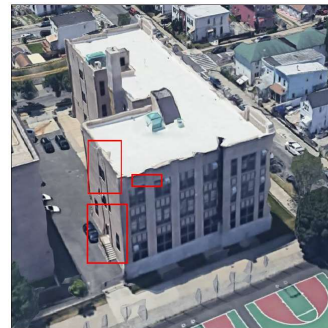
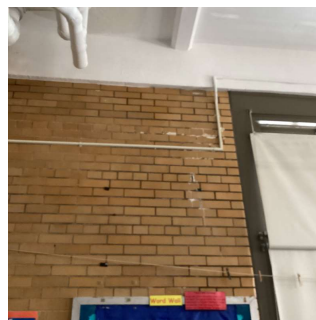
Question	Response
EXTERIOR	
DOORS	Inspected
LINTELS	Inspected
Deficiency	No deficiencies recorded
TRANSOM/SIDE LIGHT	Inspected
Condition	2 - Between Good and Fair
Deficiency	No deficiencies recorded
EXTERIOR WALLS	Inspected
Material Type(s)	Masonry
Replacement Quantity	22,000
Replacement Uom	S.F.
Instance on All Facades	Inspected
Instance Condition	4 - Between Fair and Poor
Instance Quantity	22,000
Instance Quantity Uom	S.F.
Deficiency	BRICK: WATER INFILTRATION IN INSTRUCTIONAL SPACE
Roof Plan reference	Q048

500
S.F.
REPAIR
PRIORITY 5
LEVEL 2

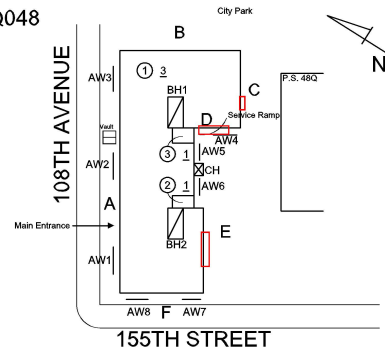
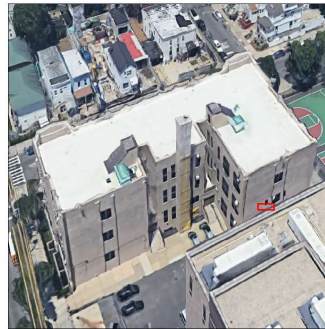
BRICK: DETERIORATED MASONRY SILLS - MINOR

40

REPAIR

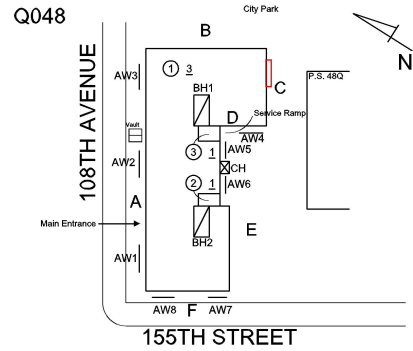
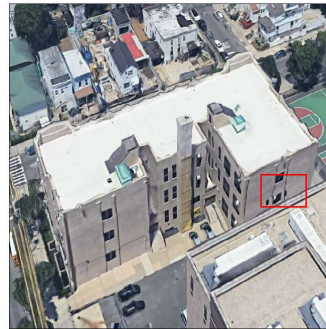
BRICK: MINOR CRACKS AND SPALLING

10

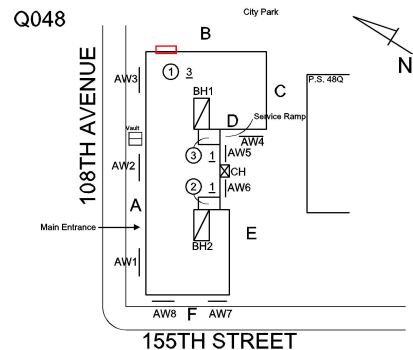
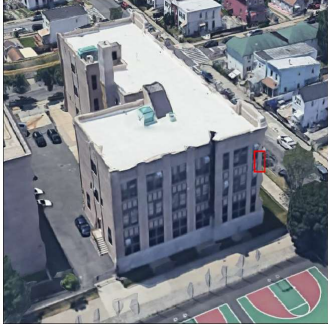
BRICK: EFFLORESCENCE

Deficiency Quantity	10
Quantity Uom	S.F.
Potential Action	MAINTENANCE
Urgency of Action	PRIORITY 1
Purpose of Action	LEVEL 1
Deficiency Photo	No photo recorded
Violations	No violations recorded.
EXTERIOR SOFFITS	Does not Exist
LOADING DOCK	Does not Exist
LOUVER	Inspected
Condition	2 - Between Good and Fair
Deficiency	No deficiencies recorded
PARAPETS	Inspected
Material Type(s)	Masonry
Replacement Quantity	4,400
Replacement Uom	C.F.
Instance on All Facades	Inspected
Instance Condition	3 - Fair
Instance Quantity	4,400
Instance Quantity Uom	C.F.
Deficiency	BRICK: MINOR CRACKS, SPALLING
Roof Plan reference	Q048

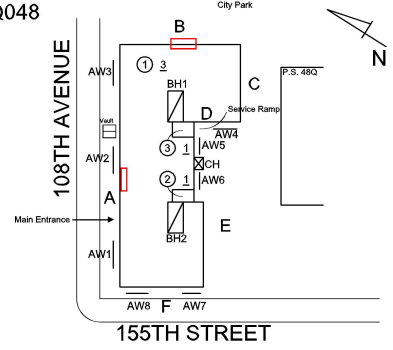
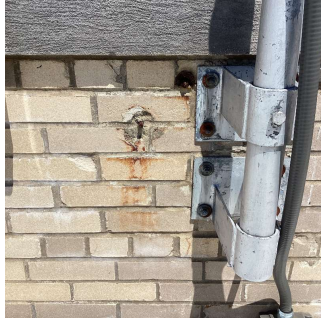
Deficiency Quantity	20
Quantity Uom	S.F.
Potential Action	REPAIR
Urgency of Action	PRIORITY 3
Purpose of Action	LEVEL 2

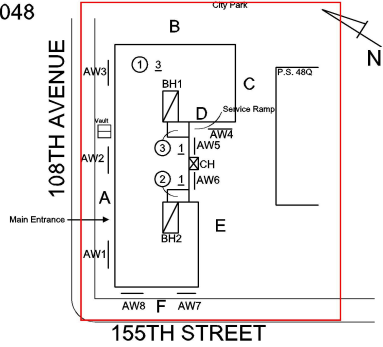
Violations	Roof 1 No violations recorded.
Deficiency	BRICK: EFFLORESCENCE
Roof Plan reference	Q048

Deficiency Quantity	2,000
Quantity Uom	S.F.
Potential Action	MAINTENANCE
Urgency of Action	PRIORITY 1
Purpose of Action	LEVEL 1
Deficiency Photo1	No photo recorded
Violations	No violations recorded.
PLAZA DECK	Does not Exist
ROOF	Inspected
Roofing	Inspected
Replacement Quantity	12,000
Replacement Uom	S.F.
ROOF HATCH/SMOKE HATCH	Does not Exist
LEADERS, GUTTERS, DOWNSPOUTS, SCUPPERS	Inspected
Condition	2 - Between Good and Fair
Deficiency	No deficiencies recorded
ROOF BARRIER/FENCE	Inspected
Condition	1 - Good
Deficiency	No deficiencies recorded
ROOF CAGE	Does not Exist
ROOFING	Inspected
Instance on Modified Bitumen: All Roofs	Inspected
Instance Condition	1 - Good

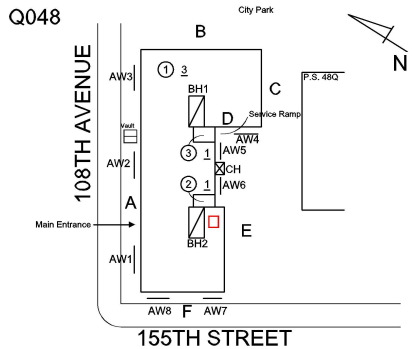
Deficiency	SHAFT VENTS DAMAGED
Roof Plan reference	Q048

Deficiency Quantity	1
Quantity Uom	EACH
Potential Action	MAINTENANCE
Urgency of Action	PRIORITY 3
Purpose of Action	LEVEL 2

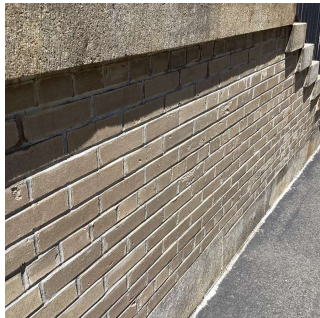
Violations	Roof 1 No violations recorded.
ROOF/GRAVITY TANK	Does not Exist
STAIRS/RAMPS: EXTERIOR	Inspected
BUILDING CHEEK/FLANK WALLS	Inspected
Condition	3 - Fair
Deficiency	BRICK: CRACKS/SPALLING - MINOR
Roof Plan reference	Q048
Deficiency Quantity	30
Quantity Uom	S.F.
Potential Action	REPAIR
Urgency of Action	PRIORITY 3
Purpose of Action	LEVEL 2
Deficiency Photo1

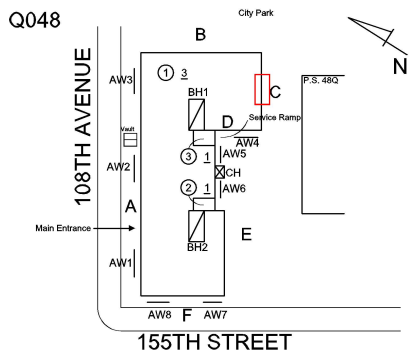
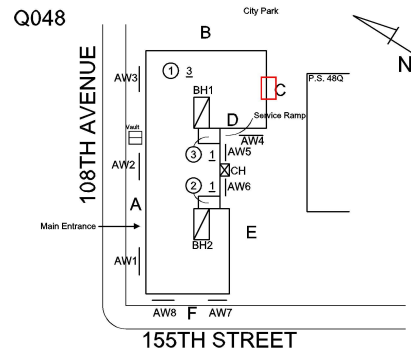
Violations	Facade C No violations recorded.
RAILINGS	Inspected
Condition	3 - Fair
Deficiency	DAMAGED

10
L.F.
REPLACE
PRIORITY 5
LEVEL 6

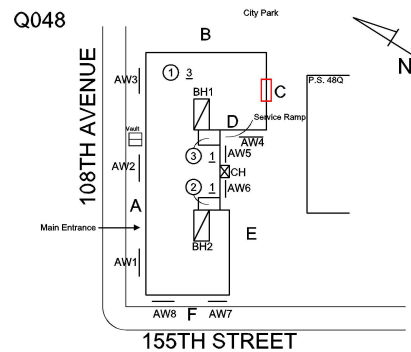
Yes	Protruding Elements	Damaged railing brackets with exposed edge is a protruding element hazard.	EXTERIOR STAIRS/RAMP S: EXTERIOR RAILINGS	Exit 3 Exterior Stair.	Francisco Ruviere	Fireman

BROKEN BRACKET

1
EACH
REPLACE
PRIORITY 4
LEVEL 2

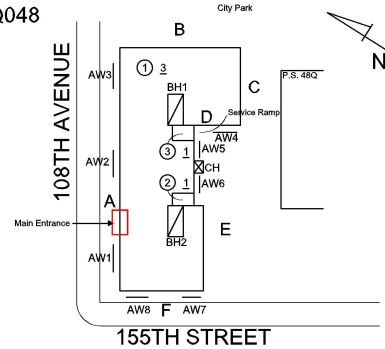
STONE: WORN-OUT TREAD/RISER/NOSING

10

REPLACE

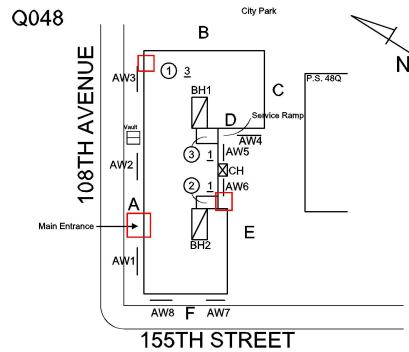
STONE: DETERIORATED JOINTS

20
 L.F.
 REPOINT
 PRIORITY 4
 LEVEL 2

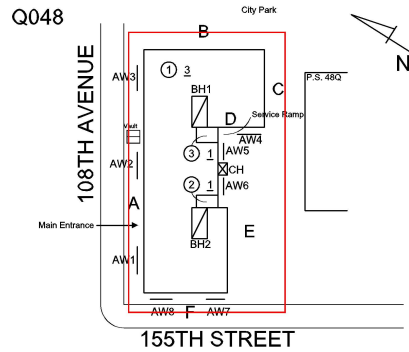
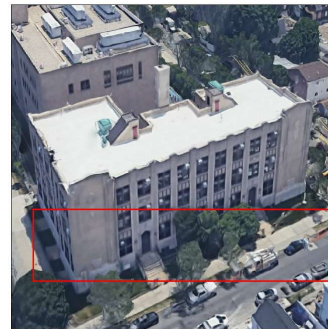
Deficiency WOOD: DETERIORATED

Deficiency Quantity	100
Quantity Uom	S.F.
Potential Action	REPLACE WINDOW
Urgency of Action	PRIORITY 4
Purpose of Action	LEVEL 2

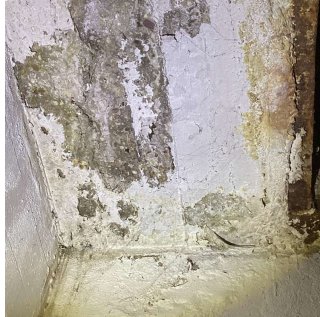
Question	Response
INTERIOR	
STRUCTURAL	
VAULTS-BUNKERS	
Slab Structure	
Deficiency Photo1

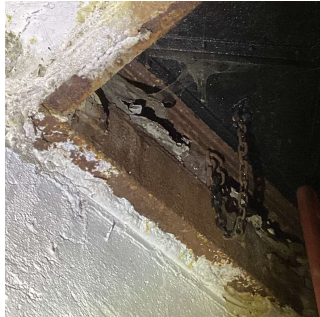
Violations	Basement - Ash Hoist Vault No violations recorded.
Vault/Ash Hoist Doors and Framing	Inspected
Condition	5 - Poor
Deficiency	WATER INFILTRATION
Deficiency Location/Instance	Basement - Ash Hoist Vault
Deficiency Quantity	10
Quantity Uom	S.F.
Potential Action	REPAIR
Urgency of Action	PRIORITY 5
Purpose of Action	LEVEL 2
Deficiency Photo1

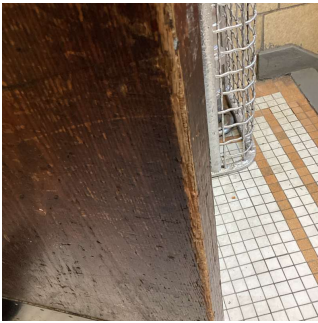
Question	Response
INTERIOR	
CAFETERIA	
Door(s)	
Deficiency Photo1

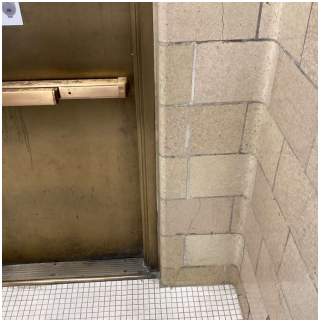
Vestibule Exit 1
Violations	No violations recorded.
Fixed Equipment	
Instance on 1st Floor	Inspected
Condition	2 - Between Good and Fair
Deficiency	No deficiencies recorded
Floor Finish	
Instance on 1st Floor	Inspected
Condition	2 - Between Good and Fair
Deficiency	No deficiencies recorded
Sliding-folding Partition	
Instance on 1st Floor	Does not Exist
Stage	
Instance on 1st Floor	Does not Exist
Walls	
Instance on 1st Floor	Inspected
Condition	5 - Poor
Deficiency	GLAZED BLOCK: CRACKS/SPALLING
Deficiency Location/Instance	Vestibule Exit 1
Deficiency Quantity	20
Quantity Uom	S.F.
Potential Action	REPLACE
Urgency of Action	PRIORITY 3
Purpose of Action	LEVEL 2
Deficiency Photo1

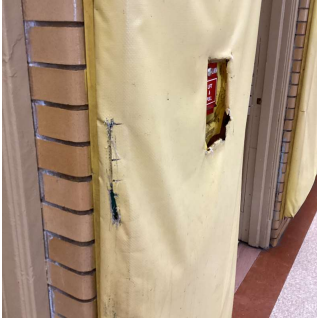
Near Room 122
Violations	No violations recorded.
Deficiency	BRICK: CRACKS/SPALLING
Deficiency Location/Instance	Near Drinking Fountain
Deficiency Quantity	10
Quantity Uom	S.F.
Potential Action	REPLACE
Urgency of Action	PRIORITY 3
Purpose of Action	LEVEL 2
Deficiency Photo1

Vestibule Exit 1
Violations	No violations recorded.
Deficiency	WALL PADDING: DETERIORATED
Deficiency Location/Instance	Columns, Near Room 122, Entrance, Windows, Stair A
Deficiency Quantity	520

Question	Response
INTERIOR	
CAFETERIA	
Walls	
Quantity Uom	S.F.
Potential Action	REPLACE
Urgency of Action	PRIORITY 3
Purpose of Action	LEVEL 2
Deficiency Photo1

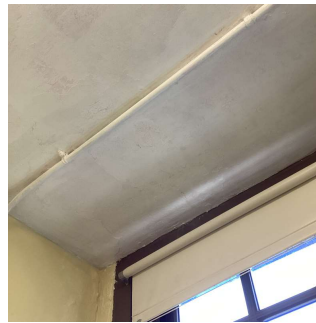
Near Drinking Fountain
Violations	No violations recorded.
Window Curtains/Shades/Blinds	
Instance on 1st Floor	Does not Exist
CLASSROOMS/CORRIDORS/ADMIN SPACES	
Ceiling	Inspected
Condition	2 - Between Good and Fair
Deficiency	PLASTER: CRACKS/SPALLING - ACTIVE LEAK
Deficiency Location/Instance	Room 230
Deficiency Quantity	20
Quantity Uom	S.F.
Potential Action	REPLACE
Urgency of Action	PRIORITY 5
Purpose of Action	LEVEL 2

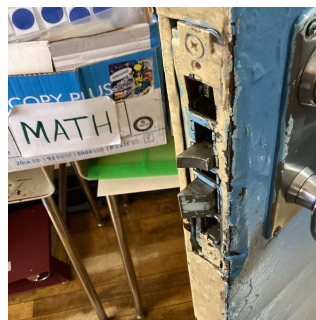
METAL: DETERIORATED DOOR

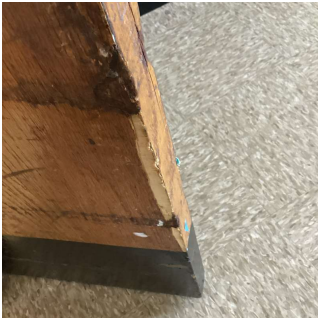
Question	Response
INTERIOR	
CLASSROOMS/CORRIDORS/ADMIN SPACES	
Door(s)	
	Room 327
Violations	No violations recorded.
Deficiency	WOOD: DETERIORATED DOOR
Deficiency Location/Instance	Rooms 113, 129, 215, 225, 323, and others
Deficiency Quantity	13
Quantity Uom	EACH
Potential Action	MAINTENANCE
Urgency of Action	PRIORITY 3
Purpose of Action	LEVEL 2
Deficiency Photo1

Room 129
Violations	No violations recorded.
Floor Finish	Inspected
Condition	2 - Between Good and Fair
Deficiency	TERRAZZO: CRACKS
Deficiency Location/Instance	Corridor near Room 113
Deficiency Quantity	30
Quantity Uom	S.F.
Potential Action	REPLACE
Urgency of Action	PRIORITY 3
Purpose of Action	LEVEL 2
Deficiency Photo1

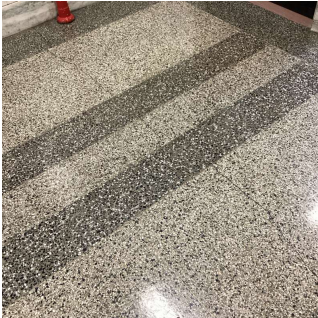
Corridor near Room 113
Violations	No violations recorded.
Deficiency	VINYL TILES: DETERIORATED SUBSTRATE
Deficiency Location/Instance	Room 317
Deficiency Quantity	50
Quantity Uom	S.F.
Potential Action	REPLACE
Urgency of Action	PRIORITY 5

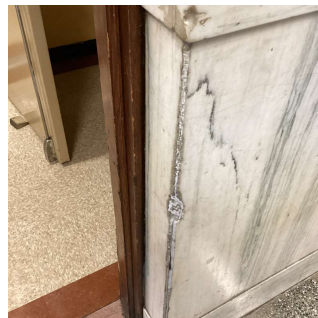
STONE: CRACKS/SPALLING

Question	Response
INTERIOR	
CLASSROOMS/CORRIDORS/ADMIN SPACES	
Walls	
Violations	Corridor near Room 113 No violations recorded.
Deficiency	PLASTER: CRACKS/SPALLING - ACTIVE LEAK
Deficiency Location/Instance	Rooms 230, 313, 325
Deficiency Quantity	70
Quantity Uom	S.F.
Potential Action	REPLACE
Urgency of Action	PRIORITY 5
Purpose of Action	LEVEL 2
Deficiency Photo1	 
Violations	Room 325 No violations recorded.
Deficiency	SALT GLAZED BRICK: CRACKS/SPALLING
Deficiency Location/Instance	Room 128, Corridor near Room 129
Deficiency Quantity	20
Quantity Uom	S.F.
Potential Action	REPLACE
Urgency of Action	PRIORITY 3
Purpose of Action	LEVEL 2
Deficiency Photo1	 
Violations	Corridor near Room 129 No violations recorded.
Deficiency	PLASTER: CRACKS/SPALLING
Deficiency Location/Instance	Rooms 310, 327, 329, Near Stair A/2
Deficiency Quantity	60
Quantity Uom	S.F.
Potential Action	REPLACE
Urgency of Action	PRIORITY 3
Purpose of Action	LEVEL 2

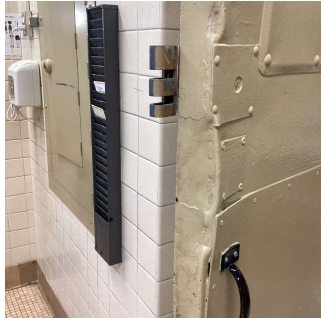
Question	Response
INTERIOR	
CLASSROOMS/CORRIDORS/ADMIN SPACES	
Walls	
Deficiency Photo1	 
Violations	Room 329 No violations recorded.
Specialties	Does not Exist
GYMNASIUM	Does not Exist
INTERIOR DOOR HARDWARE	Inspected
Condition	2 - Between Good and Fair
Deficiency	No deficiencies recorded
INTERIOR GUARDS	Inspected
Condition	2 - Between Good and Fair
Deficiency	No deficiencies recorded
KITCHEN	Inspected
Instance on 1st Floor	Inspected
Ceiling	
Instance on 1st Floor	Inspected
Condition	2 - Between Good and Fair
Deficiency	METAL PAN: DAMAGED/MISSING
Deficiency Location/Instance	Near Entrance
Deficiency Quantity	10
Quantity Uom	S.F.
Potential Action	REPLACE
Urgency of Action	PRIORITY 3
Purpose of Action	LEVEL 2
Deficiency Photo1	 
Violations	Near Entrance No violations recorded.
Door(s)	
Instance on 1st Floor	Inspected
Condition	3 - Fair
Deficiency	METAL: DETERIORATED DOOR
Deficiency Location/Instance	Entrance

Question	Response
INTERIOR	
KITCHEN	
Door(s)	
Deficiency Quantity	1
Quantity Uom	EACH
Potential Action	MAINTENANCE
Urgency of Action	PRIORITY 3
Purpose of Action	LEVEL 2
Deficiency Photo1

Entrance
Violations	No violations recorded.

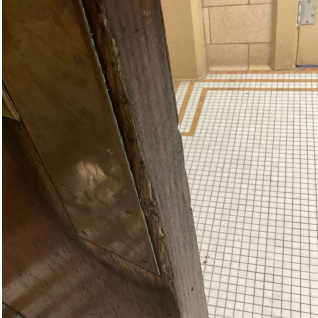
Question	Response
INTERIOR	
KITCHEN	
Walls	
Deficiency Photo1	 
Violations	Near Entrance No violations recorded.
LIBRARY	Does not Exist
LOCKER ROOM	Does not Exist
MULTI-PURPOSE ROOM	Does not Exist
SCIENCE DEMO ROOM	Does not Exist
SCIENCE LAB	Does not Exist
SCIENCE PREP ROOM	Does not Exist
SHOWER ROOM	Does not Exist
STAIRS/RAMPS: INTERIOR	Inspected
Do Letter Stair Signs Exist?	Yes
Ceiling	Inspected
Condition	2 - Between Good and Fair
Deficiency	No deficiencies recorded
Door(s)	Inspected
Condition	5 - Poor
Deficiency	METAL: DETERIORATED DOOR
Deficiency Location/Instance	Star A/Basement
Deficiency Quantity	1
Quantity Uom	EACH
Potential Action	MAINTENANCE
Urgency of Action	PRIORITY 3
Purpose of Action	LEVEL 2
Deficiency Photo1	 
Violations	Star A/Basement No violations recorded.
Deficiency	WOOD: DETERIORATED DOOR
Deficiency Location/Instance	Stair B/1
Deficiency Quantity	2

Question	Response
INTERIOR	
STAIRS/RAMPS: INTERIOR	
Door(s)	
Quantity Uom	EACH
Potential Action	MAINTENANCE
Urgency of Action	PRIORITY 3
Purpose of Action	LEVEL 2
Deficiency Photo1

Violations	Stair B/1 No violations recorded.
Partition	Inspected
Condition	2 - Between Good and Fair
Deficiency	GLASS PANEL: DAMAGED/DETERIORATED
Deficiency Location/Instance	Stairs A/1, 2, B/1
Deficiency Quantity	20
Quantity Uom	S.F.
Potential Action	REPLACE
Urgency of Action	PRIORITY 3
Purpose of Action	LEVEL 2
Deficiency Photo1

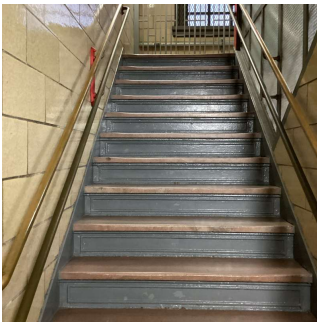
Violations	Stair A/2 No violations recorded.
Railings	Inspected
Condition	2 - Between Good and Fair
Deficiency	No deficiencies recorded
Stairs and Landings	Inspected
Condition	4 - Between Fair and Poor
Deficiency	STONE: WORN-OUT TREAD/NOSINGS
Deficiency Location/Instance	Stair B/1
Deficiency Quantity	130
Quantity Uom	S.F.
Potential Action	REPLACE
Urgency of Action	PRIORITY 3
Purpose of Action	LEVEL 2

Violations	Stair B/1 No violations recorded.
Walls	Inspected
Condition	2 - Between Good and Fair
Deficiency	No deficiencies recorded
TOILET ROOMS - STAFF	
Ceiling	Inspected
Condition	2 - Between Good and Fair
Deficiency	PLASTER: CRACKS/SPALLING
Deficiency Location/Instance	Room 114
Deficiency Quantity	10
Quantity Uom	S.F.
Potential Action	REPLACE
Urgency of Action	PRIORITY 3
Purpose of Action	LEVEL 2
Deficiency Photo1

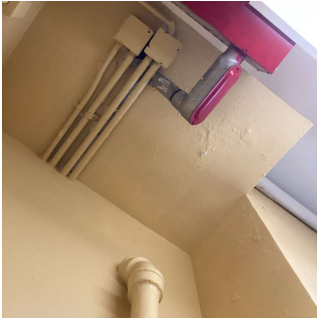
Violations	Room 114 No violations recorded.
Door(s)	Inspected
Condition	5 - Poor
Deficiency	METAL: DETERIORATED DOOR
Deficiency Location/Instance	Room 114
Deficiency Quantity	1
Quantity Uom	EACH
Potential Action	MAINTENANCE
Urgency of Action	PRIORITY 3
Purpose of Action	LEVEL 2

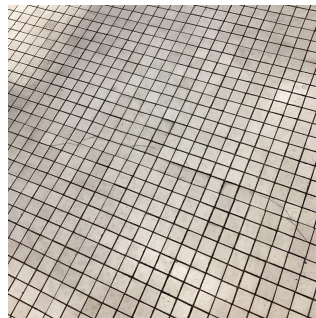
CERAMIC TILE: BROKEN/MISSING TILES

Question	Response
INTERIOR	
TOILET ROOMS - STAFF	
Floor Finish	Inspected
	Room 316
Violations	No violations recorded.
Stalls	Inspected
Condition	5 - Poor
Deficiency	RUST - MAJOR
Deficiency Location/Instance	Room 114
Deficiency Quantity	1
Quantity Uom	EACH
Potential Action	REPLACE
Urgency of Action	PRIORITY 3
Purpose of Action	LEVEL 2
Deficiency Photo1

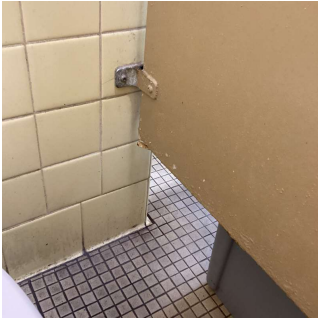
Room 114
Violations	No violations recorded.
Walls	Inspected
Condition	2 - Between Good and Fair
Deficiency	CERAMIC TILE: BROKEN/ MISSING
Deficiency Location/Instance	Rooms 214, 216, 316
Deficiency Quantity	30
Quantity Uom	S.F.
Potential Action	REPLACE
Urgency of Action	PRIORITY 3
Purpose of Action	LEVEL 2
Deficiency Photo1

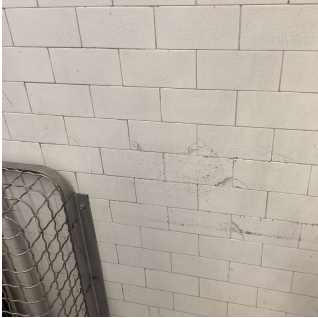
Room 316
Violations	No violations recorded.
TOILET ROOMS - STUDENTS	
	Inspected
Ceiling	Inspected
Condition	2 - Between Good and Fair
Deficiency	No deficiencies recorded
Door(s)	Inspected

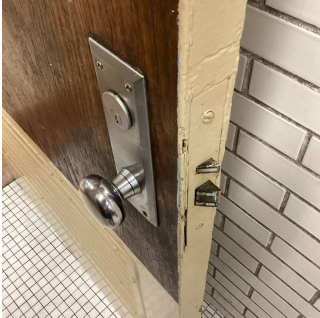
Question	Response
INTERIOR	
TOILET ROOMS - STUDENTS	
Door(s)	
Condition	5 - Poor
Deficiency	WOOD: DETERIORATED DOOR
Deficiency Location/Instance	Rooms 122, 220, 320
Deficiency Quantity	3
Quantity Uom	EACH
Potential Action	MAINTENANCE
Urgency of Action	PRIORITY 3
Purpose of Action	LEVEL 2
Deficiency Photo1

Room 122
Violations	No violations recorded.
Floor Finish	
Condition	Inspected
Condition	3 - Fair
Deficiency	CERAMIC TILE: BROKEN/MISSING TILES
Deficiency Location/Instance	Rooms 127, 220, 320
Deficiency Quantity	50
Quantity Uom	S.F.
Potential Action	REPLACE
Urgency of Action	PRIORITY 3
Purpose of Action	LEVEL 2
Deficiency Photo1

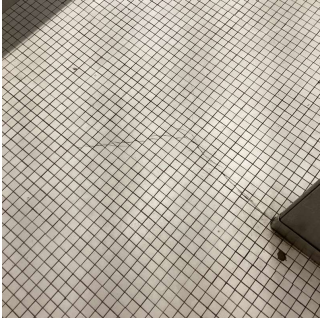
Room 127
Violations	No violations recorded.
Stalls	
Condition	Inspected
Condition	2 - Between Good and Fair
Deficiency	No deficiencies recorded
Walls	
Condition	Inspected
Condition	2 - Between Good and Fair
Deficiency	CERAMIC TILE: BROKEN/ MISSING
Deficiency Location/Instance	Rooms 122, 220, 320

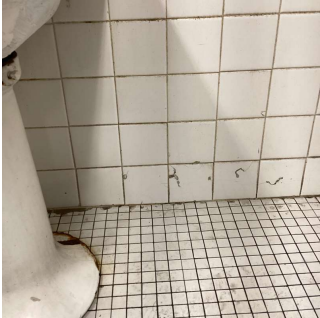
Question	Response
INTERIOR	
TOILET ROOMS - STUDENTS	
Walls	
Quantity Uom	S.F.
Potential Action	REPLACE
Urgency of Action	PRIORITY 3
Purpose of Action	LEVEL 2
Deficiency Photo1

Violations	Room 122 No violations recorded.
LIFE SAFETY	Inspected
F.D. HOLDING AREA	Does not Exist
STEEL STAIRS	Does not Exist
SITE	Inspected
CONTAINERIZATION	Does not Exist
Drainage System for Asphalt	Does not Exist
Drainage System for Concrete	Inspected
Catch Basins/Manhole - Surrounded by concrete	Inspected
Condition	2 - Between Good and Fair
Deficiency	No deficiencies recorded
Culverts - Concrete Covering	Does not Exist
Drainage System for Soil	Inspected
Catch Basins/Manhole - Surrounded by Soil	Inspected
Condition	2 - Between Good and Fair
Deficiency	No deficiencies recorded
Culverts - Soil Covering	Does not Exist
DRINKING FOUNTAINS	Does not Exist
FENCES	Inspected
Condition	4 - Between Fair and Poor
Deficiency	WROUGHT IRON: DAMAGED/DETERIORATED

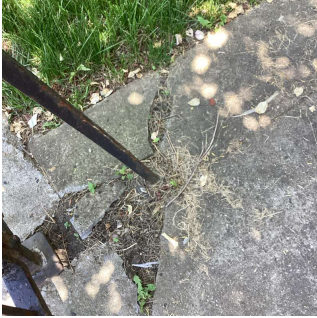
Question	Response
SITE	
FENCES	
Deficiency Photo1	 
	108th Avenue
Violations	No violations recorded.
Deficiency	CONCRETE CURB: DAMAGED/DETERIORATED
Deficiency Location/Instance	155th Street, Near Exit 2
Deficiency Quantity	220
Quantity Uom	S.F.
Potential Action	REPLACE
Urgency of Action	PRIORITY 3
Purpose of Action	LEVEL 2
Deficiency Photo1	 
	Near Exit 2
Violations	No violations recorded.
IRRIGATION SYSTEM	Does not Exist
PAVING	Inspected
Student Non-Use	Inspected
Gravel Exists?	No
Asphalt	Does not Exist
Concrete	Inspected
Condition	3 - Fair
Deficiency	DAMAGED/DETERIORATED/MISSING SECTIONS
Deficiency Location/Instance	108th Avenue, near NYC Park
Deficiency Quantity	100
Quantity Uom	S.F.
Potential Action	REPLACE
Urgency of Action	PRIORITY 3
Purpose of Action	LEVEL 2

Question	Response
SITE	
PAVING	
Student Non-Use	
Concrete	
Deficiency Photo1

Violations	108th Avenue No violations recorded.
Pavers	Does not Exist
Student Use	Does not Exist
Site Sidewalks & Walkways	Inspected
Asphalt	Does not Exist
Concrete	Inspected
Condition	4 - Between Fair and Poor
Deficiency	DAMAGED/DETERIORATED/MISSING SECTIONS
Deficiency Location/Instance	Near Exits 1, 2, 4, NYC Park
Deficiency Quantity	775
Quantity Uom	S.F.
Potential Action	REPLACE
Urgency of Action	PRIORITY 3
Purpose of Action	LEVEL 2
Deficiency Photo1

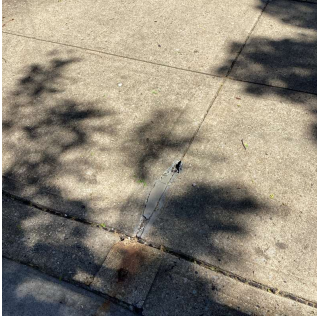
Violations	Near Exit 1 No violations recorded.
Pavers	Does not Exist
DOT Sidewalk	Inspected
Asphalt	Does not Exist
Concrete	Inspected
Condition	3 - Fair
Deficiency	DAMAGED/DETERIORATED/MISSING SECTIONS
Deficiency Location/Instance	108th Avenue
Deficiency Quantity	125
Quantity Uom	S.F.
Potential Action	REPLACE
