**NYC Department of Education**  
**Building Condition Assessment Survey 2023 - 2024**

Architectural Inspection

Q050

**Asset:** P.S. 50 - QUEENS, 143-26 101 AVENUE, New York, 11435

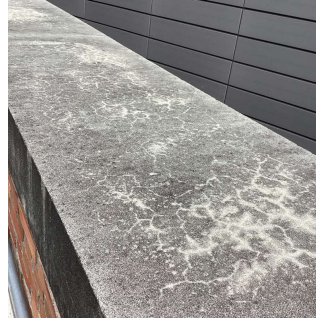
Roof 2

**COPING**

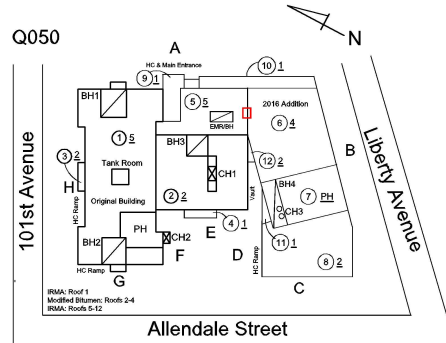
Roof Plan reference

**CAST STONE: CRACKED/BROKEN PIECES**

REPLACE-IN-KIND

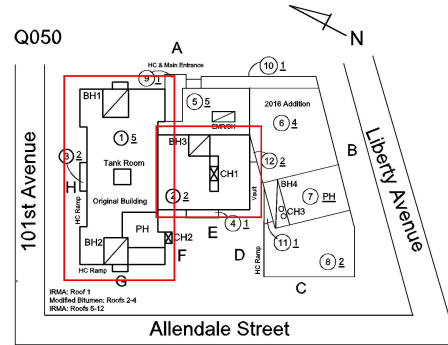
Roof Plan reference

**CAST STONE: DETERIORATED TRANSVERSE JOINTS**

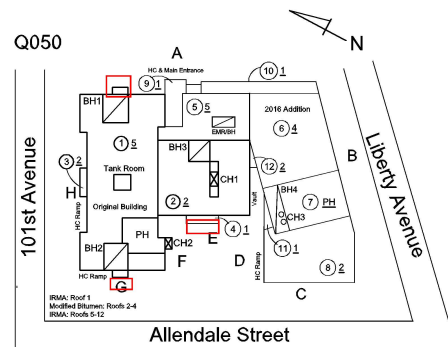
Roof Plan reference

METAL: DETERIORATED DOOR AND FRAME - MAJOR DETERIORATION

REPLACE

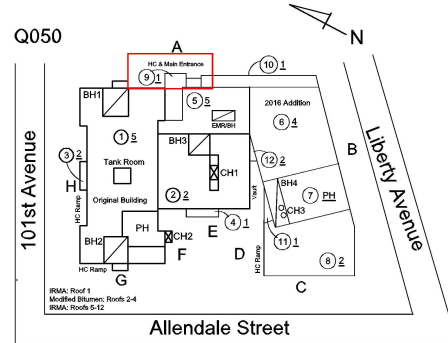
Roof Plan reference

**METAL: DETERIORATED DOOR AND FRAME - MINOR DETERIORATION**

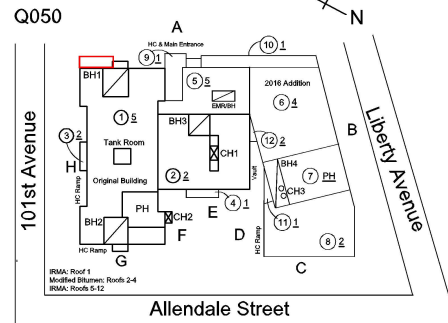
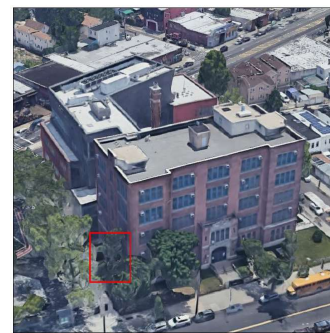
Roof Plan reference

**BRICK: DETERIORATED MASONRY SILLS - MINOR**

REPAIR

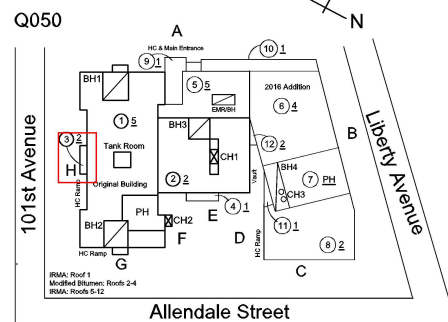
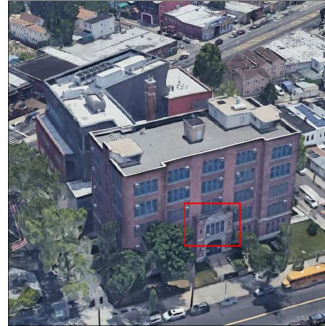
Roof Plan reference

**BRICK: EFFLORESCENCE**

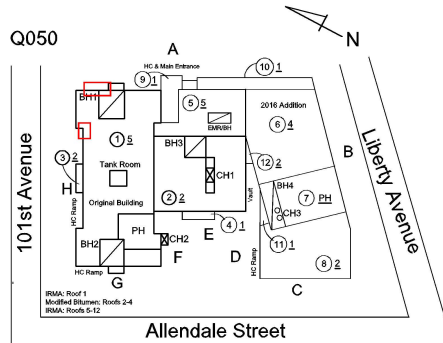
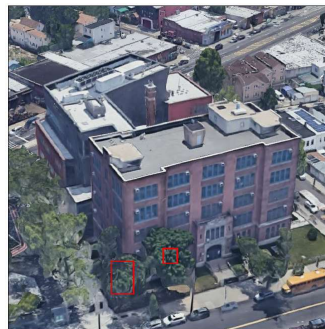
Roof Plan reference

STONE: CHIPPED/SPALLED/BROKEN PIECES - MAJOR

REPLACE

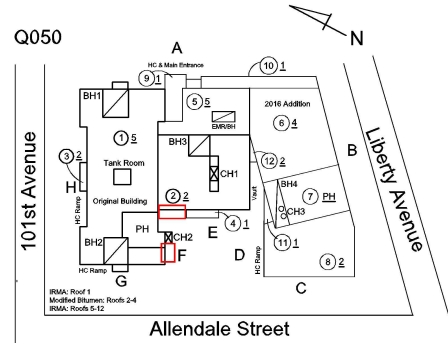
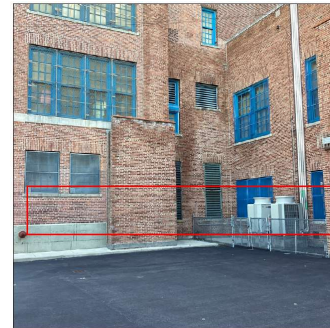
Roof Plan reference

**BRICK: DETERIORATED MASONRY SILLS - MAJOR**

REMOVE AND REPLACE

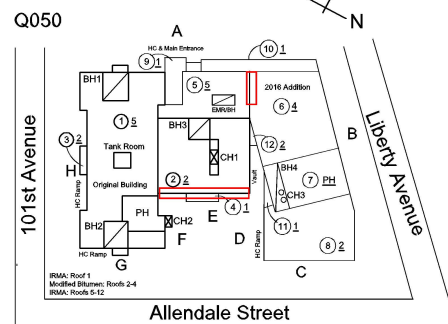
Roof Plan reference

BRICK: DETERIORATED JOINTS

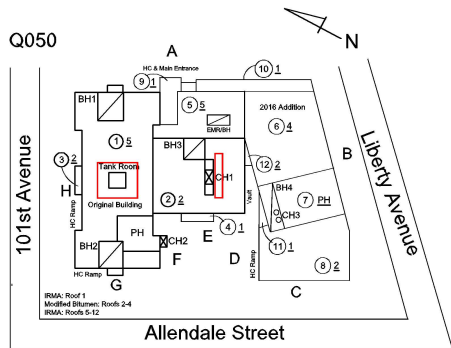
Violations	Facade E No violations recorded.
<b>PLAZA DECK</b>	Does not Exist
<b>ROOF</b>	Inspected
<b>Roofing</b>	Inspected
Replacement Quantity	27,000
Replacement Uom	S.F.
<b>ROOF HATCH/SMOKE HATCH</b>	Inspected
Condition	2 - Between Good and Fair
Deficiency	No deficiencies recorded
<b>LEADERS, GUTTERS, DOWNSPOUTS, SCUPPERS</b>	Inspected
Condition	3 - Fair
Deficiency	DAMAGED/MISSING
RooF Plan reference

Deficiency Quantity	30
Quantity Uom	L.F.
Potential Action	REPLACE
Urgency of Action	PRIORITY 4
Purpose of Action	LEVEL 2
Deficiency Photo1

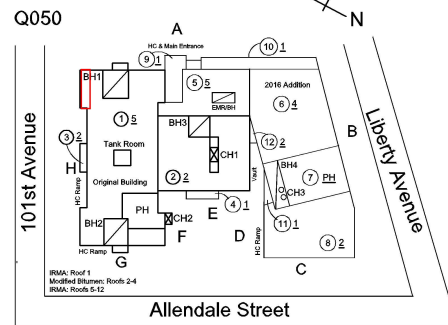
Roof Plan reference

IRMA: ROOFING: DAMAGED INSULATION

REPLACE

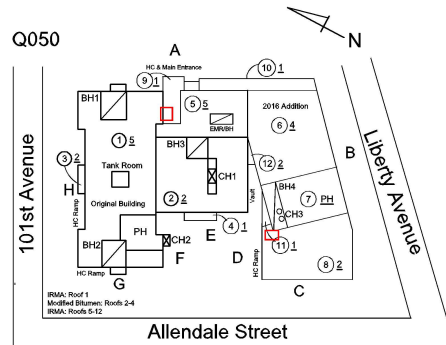
Roof Plan reference

Do solar panels exist on these roofs?	No
Is/Are the roof(s) suitable for Solar Panel installation?	No
Installation Year	2016
Source of Installation	Custodial Staff
Deficiency	IRMA: ROOFING: MAJOR ACTIVE ROOF LEAKS IN INSTRUCTIONAL SPACE

REPLACE ROOFING WITHOUT MAJOR EQUIPMENT REMOVAL

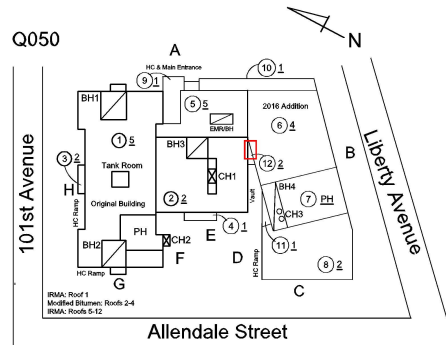
Roof Plan reference

IRMA: ROOFING: MAJOR ACTIVE ROOF LEAKS IN INSTRUCTIONAL SPACE

REPLACE ROOFING WITHOUT MAJOR EQUIPMENT REMOVAL

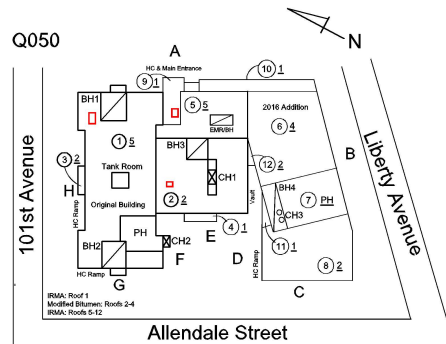
Roof Plan reference

DETERIORATED

REPLACE

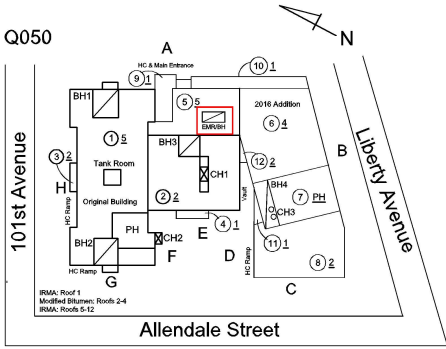
Roof 1	Roof 1
Violations	No violations recorded.
<b>Specialties</b>	Inspected
<b>BULKHEAD/PENTHOUSE</b>	Inspected
Condition	3 - Fair
Deficiency	BULKHEAD/PENTHOUSE WALLS/EXTERIOR: EFFLORESCENCE
Roof Plan reference

Deficiency Quantity	50
Quantity Uom	S.F.
Potential Action	MAINTENANCE
Urgency of Action	PRIORITY 1
Purpose of Action	LEVEL 1
Deficiency Photo1	No photo recorded
Violations	No violations recorded.
Deficiency	BULKHEAD/PENTHOUSE ROOF: MAJOR LEAKAGE
Roof Plan reference

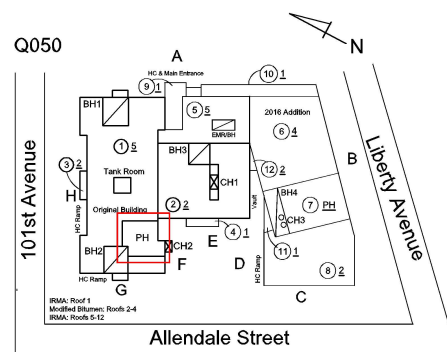
Roof Plan reference

**BULKHEAD/PENTHOUSE DOORS: DETERIORATED DOOR**

1  
EACH  
REPLACE DOOR  
PRIORITY 3  
LEVEL 2

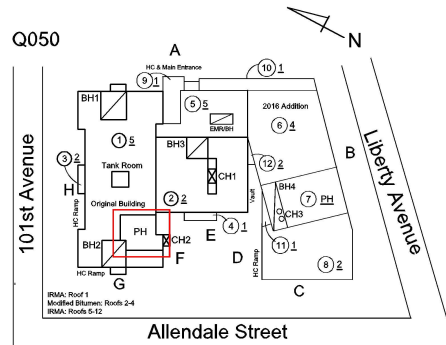
Roof Plan reference

**BULKHEAD/PENTHOUSE WALLS/INTERIOR: BRICK  
CRACKS/SPALLING**

10  
S.F.  
REPLACE  
PRIORITY 3  
LEVEL 2

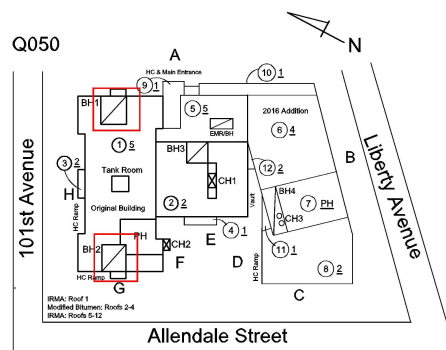
Roof Plan reference

**BULKHEAD/PENTHOUSE WALLS/INTERIOR: PLASTER  
CRACKS/SPALLING**

50  
S.F.  
REPLACE  
PRIORITY 3  
LEVEL 2

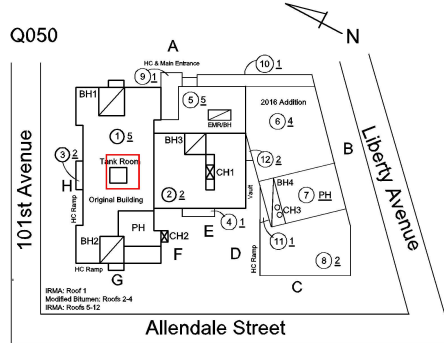
Roof Plan reference

Deficiency TANK: NOT IN USE - MINOR DETERIORATION

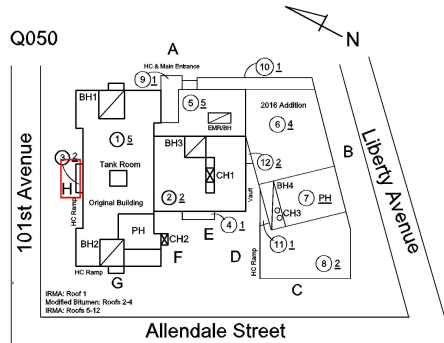
Roof Plan reference

Deficiency CAST IN PLACE CONCRETE: CRACKS/SPALLING - MINOR

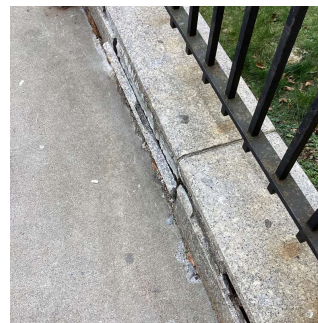
Facade H

STONE: DETERIORATED JOINTS

20  
S.F.  
REPOINT  
PRIORITY 4  
LEVEL 2

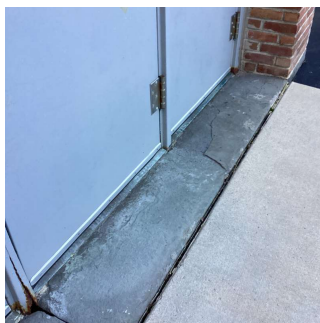
Violations	Facade H No violations recorded.
Deficiency	STONE: WORN-OUT TREAD/RISER/NOSING
Roof Plan reference	Q050
Deficiency Quantity	20
Quantity Uom	S.F.
Potential Action	REPLACE
Urgency of Action	PRIORITY 4
Purpose of Action	LEVEL 2
Deficiency Photo1

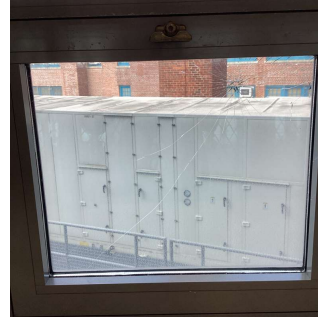
Facade E - Gymnasium  
No violations recorded.

Question	Response
<b>EXTERIOR</b>	
<b>WINDOWS</b>	
<b>WINDOWS</b>	Inspected
Material Type(s)	Aluminum
Instance on Aluminum - Double Hung: Original Building	Inspected
Instance Condition	3 - Fair
Instance Quantity	17,940
Instance Quantity Uom	S.F.
Are these windows insulated	No
Installation Year	1982
Source of Installation	Custodial Staff
Deficiency	No deficiencies recorded
Instance on Aluminum - Other: Original Building - Facade H	Inspected
Instance Condition	3 - Fair
Instance Quantity	60
Instance Quantity Uom	S.F.
Are these windows insulated	No
Installation Year	1982
Source of Installation	Custodial Staff
Deficiency	No deficiencies recorded
Instance on Aluminum - Other: 2016 Addition	Inspected
Instance Condition	3 - Fair
Instance Quantity	13,000
Instance Quantity Uom	S.F.
Are these windows insulated	Yes
Installation Year	2016
Source of Installation	Custodial Staff
Deficiency	ALUMINUM - OTHER: BROKEN PANE
Roof Plan reference	<p>Q050</p>

Elevation	
Deficiency Quantity	30
Quantity Uom	S.F.
Potential Action	MAINTENANCE

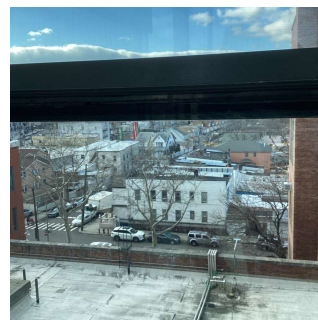
ALUMINUM - OTHER: AIR/WATER INFILTRATION

10  
L.F.  
REPLACE TRIM, SILLS OR WEATHERSTRIPPING  
PRIORITY 5  
LEVEL 2

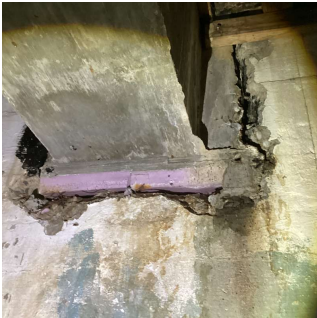
Violations	Roof 1 - Stair B/Bulkhead 1 35657752R
<b>VAULTS-BUNKERS</b>	
<b>Foundation Walls</b>	
Condition	Inspected 2 - Between Good and Fair
Deficiency	CRACKS, SPALLING
Deficiency Location/Instance	Basement - Vault
Deficiency Quantity	10
Quantity Uom	S.F.
Potential Action	REPAIR
Urgency of Action	PRIORITY 3
Purpose of Action	LEVEL 5

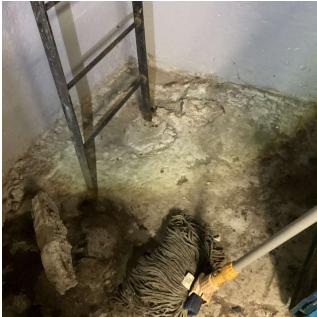
Violations	Basement - Vault No violations recorded.
<b>Slab Structure</b>	Inspected
Condition	3 - Fair
Deficiency	CONCRETE SLAB ON GRADE: THRU CRACKS
Deficiency Location/Instance	Basement - Vault
Deficiency Quantity	30
Quantity Uom	S.F.
Potential Action	REPLACE
Urgency of Action	PRIORITY 4
Purpose of Action	LEVEL 5
Deficiency Photo1

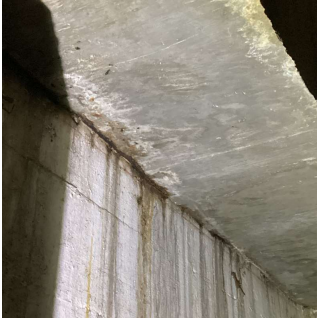
Violations	Basement - Vault No violations recorded.
Deficiency	CONCRETE: WATER INFILTRATION IN NON- INSTRUCTIONAL SPACE
Deficiency Location/Instance	Basement - Vault
Deficiency Quantity	50
Quantity Uom	S.F.
Potential Action	INSTALL WATERPROOFING
Urgency of Action	PRIORITY 5
Purpose of Action	LEVEL 5

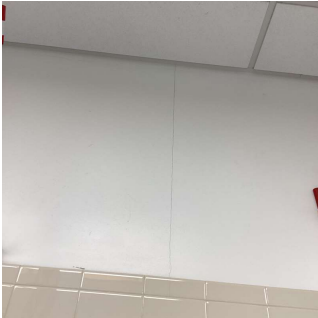
Question	Response
<b>INTERIOR</b>	
<b>CAFETERIA</b>	Inspected
<b>Stage</b>	
Instance on 1st Floor	Does not Exist
<b>Walls</b>	
Instance on 1st Floor	Inspected
Condition	2 - Between Good and Fair
Deficiency	GYPSUM BOARD: DETERIORATED
Deficiency Location/Instance	Near Entrances
Deficiency Quantity	20
Quantity Uom	S.F.
Potential Action	REPLACE
Urgency of Action	PRIORITY 3
Purpose of Action	LEVEL 2
Deficiency Photo1

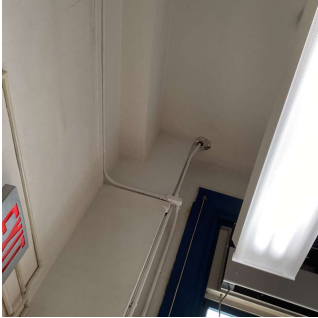
Violations	Room 409 No violations recorded.

Violations	Near Entrance No violations recorded.
<b>Window Curtains/Shades/Blinds</b>	
Instance on 1st Floor	Does not Exist
<b>CLASSROOMS/CORRIDORS/ADMIN SPACES</b>	Inspected
<b>Ceiling</b>	Inspected
Condition	2 - Between Good and Fair
Deficiency	PLASTER: CRACKS/SPALLING
Deficiency Location/Instance	Rooms 409, 452, Corridor near Rooms 306, 407
Deficiency Quantity	50
Quantity Uom	S.F.
Potential Action	REPLACE
Urgency of Action	PRIORITY 3
Purpose of Action	LEVEL 2
Deficiency Photo1

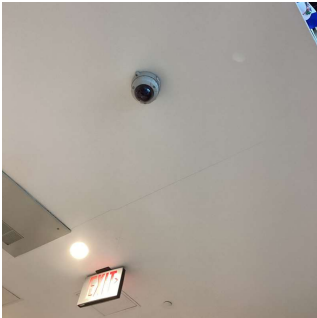
Deficiency	GYPSUM BOARD: DAMAGED/DETERIORATED
Deficiency Location/Instance	Main Lobby Area, Near Stair F/2, 3

Question	Response
<b>INTERIOR</b>	
<b>CLASSROOMS/CORRIDORS/ADMIN SPACES</b>	
<b>Ceiling</b>	
Deficiency Quantity	50
Quantity Uom	S.F.
Potential Action	REPLACE
Urgency of Action	PRIORITY 3
Purpose of Action	LEVEL 2
Deficiency Photo1

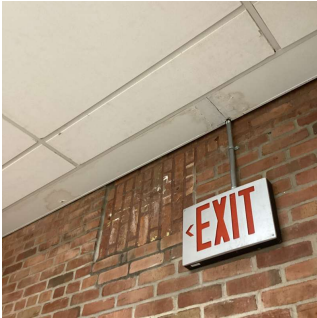
Violations	Main Lobby Area No violations recorded.
Deficiency	GYPSUM BOARD: DAMAGED/DETERIORATED - ACTIVE LEAK
Deficiency Location/Instance	Corridor near Exit 7
Deficiency Quantity	20
Quantity Uom	S.F.
Potential Action	REPLACE
Urgency of Action	PRIORITY 5
Purpose of Action	LEVEL 2
Deficiency Photo1

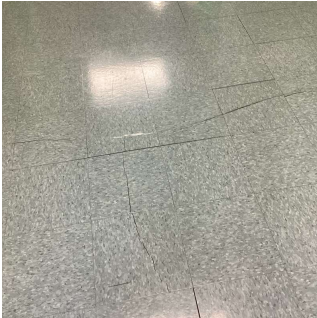
Question	Response
<b>INTERIOR</b>	
<b>CLASSROOMS/CORRIDORS/ADMIN SPACES</b>	
<b>Floor Finish</b>	
Deficiency	VINYL TILES: DETERIORATED SUBSTRATE
Deficiency Location/Instance	Rooms 306, 505, Corridor near Rooms 303, 408, 500B, and others.
Deficiency Quantity	150
Quantity Uom	S.F.
Potential Action	REPLACE
Urgency of Action	PRIORITY 3
Purpose of Action	LEVEL 2
Deficiency Photo1

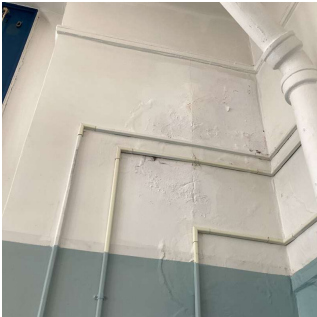
Corridor near Room 500B
Violations	No violations recorded.
<b>Walls</b>	
Condition	Inspected
Deficiency	PLASTER: CRACKS/SPALLING
Deficiency Location/Instance	Rooms 308, 404, 505, 507, 509, and others.
Deficiency Quantity	250
Quantity Uom	S.F.
Potential Action	REPLACE
Urgency of Action	PRIORITY 3
Purpose of Action	LEVEL 2
Deficiency Photo1

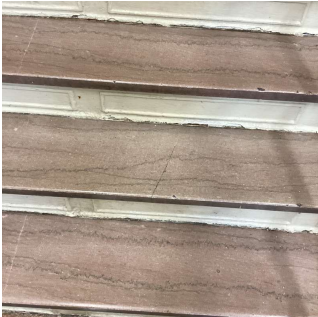
Question	Response
<b>INTERIOR</b>	
<b>STAIRS/RAMPS: INTERIOR</b>	
<b>Stairs and Landings</b>	
Violations	Stair G/2 No violations recorded.
Deficiency	STONE: BROKEN/MISSING
Deficiency Location/Instance	Near Exit 3 - Vestibule
Deficiency Quantity	20
Quantity Uom	S.F.
Potential Action	REPLACE
Urgency of Action	PRIORITY 3
Purpose of Action	LEVEL 2
Deficiency Photo1

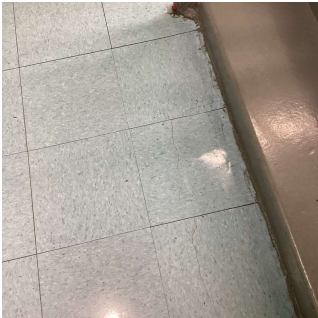
Violations	Near Exit 3 - Vestibule No violations recorded.
Deficiency	VINYL TILES: BROKEN/DETERIORATED/MISSING TILES
Deficiency Location/Instance	Stairs B/1 - Vestibule, 2, 3, E/2, 3, 4
Deficiency Quantity	60
Quantity Uom	S.F.
Potential Action	REPLACE
Urgency of Action	PRIORITY 3
Purpose of Action	LEVEL 2
Deficiency Photo1

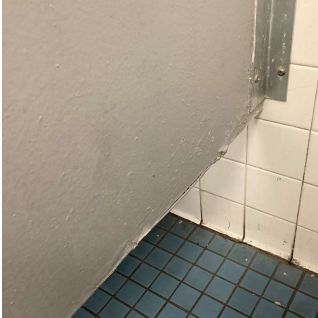
Question	Response
<b>INTERIOR</b>	
<b>TOILET ROOMS - STUDENTS</b>	
<b>Stalls</b>	
Quantity Uom	EACH
Potential Action	REPLACE
Urgency of Action	PRIORITY 3
Purpose of Action	LEVEL 2
Deficiency Photo1

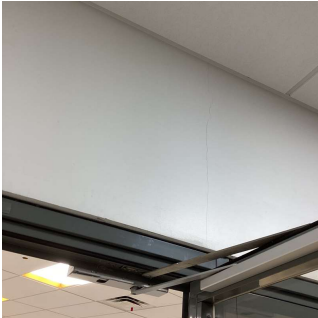
Room 361
Violations	No violations recorded.
<b>Walls</b>	Inspected
Condition	2 - Between Good and Fair
Deficiency	GYPSUM BOARD: DETERIORATED
Deficiency Location/Instance	Near Cafeteria
Deficiency Quantity	10
Quantity Uom	S.F.
Potential Action	REPLACE
Urgency of Action	PRIORITY 3
Purpose of Action	LEVEL 2
Deficiency Photo1

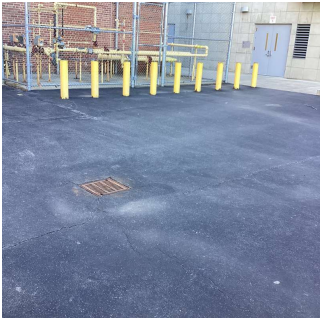
Question	Response
<b>SITE</b>	
<b>FENCES</b>	
Urgency of Action	PRIORITY 3
Purpose of Action	LEVEL 2
Deficiency Photo1	 
Violations	101 St Avenue No violations recorded.
<b>IRRIGATION SYSTEM</b>	Does not Exist
<b>PAVING</b>	Inspected
<b>Student Non-Use</b>	Inspected
Gravel Exists?	No
<b>Asphalt</b>	Inspected
Condition	3 - Fair
Deficiency	CRACKS - MAJOR
Deficiency Location/Instance	Near Exits 5, 8
Deficiency Quantity	140
Quantity Uom	S.F.
Potential Action	REPLACE
Urgency of Action	PRIORITY 3
Purpose of Action	LEVEL 2
Deficiency Photo1

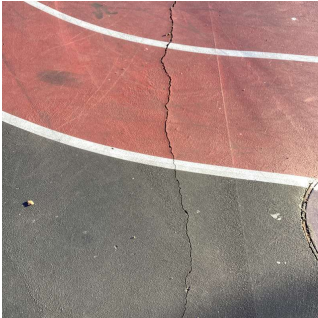
Question	Response
<b>SITE</b>	
<b>PAVING</b>	
<b>Student Use</b>	
<b>Asphalt</b>	
Deficiency Location/Instance	Near Main Entrance, 101St Avenue
Deficiency Quantity	150
Quantity Uom	S.F.
Potential Action	REPLACE
Urgency of Action	PRIORITY 3
Purpose of Action	LEVEL 2
Deficiency Photo1

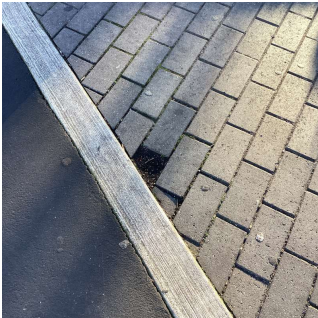
Violations	Near Main Entrance No violations recorded.
<b>Concrete</b>	Does not Exist
<b>Pavers</b>	Inspected
Condition	2 - Between Good and Fair
Deficiency	DAMAGED/MISSING
Deficiency Location/Instance	Near 101 Street Avenue
Deficiency Quantity	10
Quantity Uom	S.F.
Potential Action	REPLACE
Urgency of Action	PRIORITY 3
Purpose of Action	LEVEL 2
Deficiency Photo1
