**NYC Department of Education**  
**Building Condition Assessment Survey 2023 - 2024**

Architectural Inspection

**Asset:** P.S. 51 (ECC) - QUEENS, 87-45 117TH STREET, New York, 11418

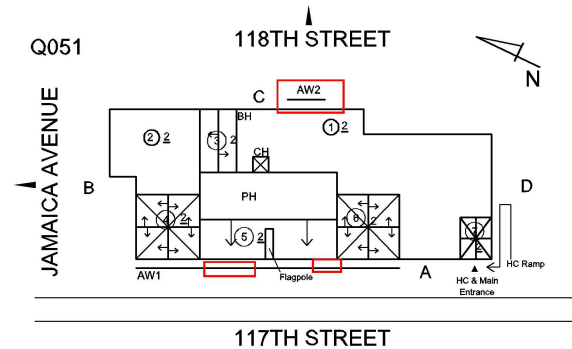
Roof Plan reference

AREAWAY WALLS: CRACKS AND SPALLING

30

REPAIR

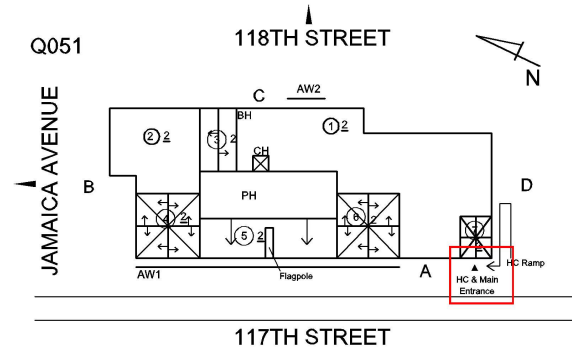
Roof Plan reference

METAL: DETERIORATED DOOR AND FRAME - MAJOR DETERIORATION

4

REPLACE

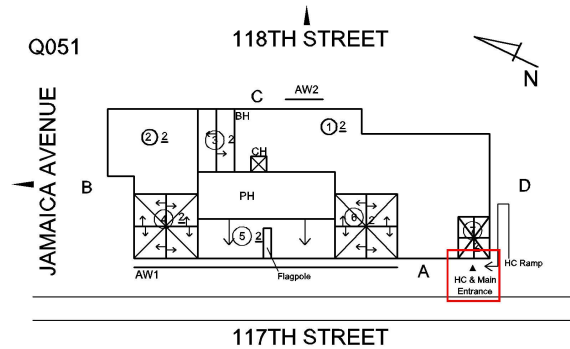
Question	Response
<b>EXTERIOR</b>	
<b>DOORS</b>	
<b>DOORS AND FRAMES</b>	Inspected
	Facade A
Violations	No violations recorded.
<b>DOOR HARDWARE</b>	Inspected
Condition	3 - Fair
Deficiency	No deficiencies recorded
<b>LINTELS</b>	Inspected
Condition	2 - Between Good and Fair
Deficiency	No deficiencies recorded
<b>TRANSOM/SIDE LIGHT</b>	Inspected
Condition	3 - Fair
Deficiency	METAL: DENTED, MAJOR RUSTING
Roof Plan reference

10  
S.F.  
REPLACE  
PRIORITY 4  
LEVEL 2

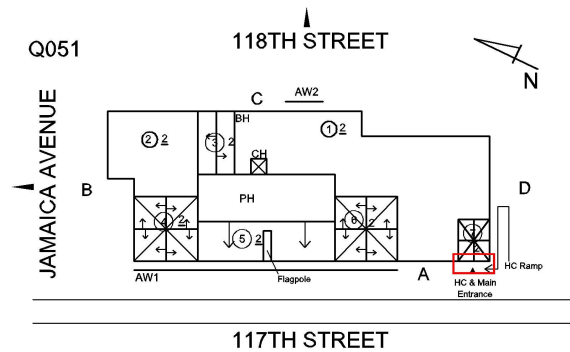
Roof Plan reference

Deficiency METAL: BROKEN GLASS

20  
S.F.  
MAINTENANCE  
PRIORITY 3  
LEVEL 2

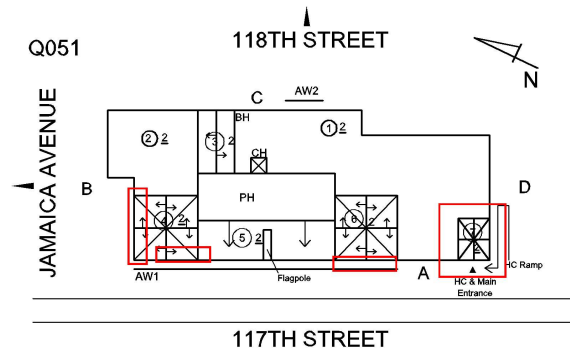
Inspected  
Masonry  
13,500  
S.F.  
Inspected  
3 - Fair  
13,500  
S.F.  
BRICK: EFFLORESCENCE

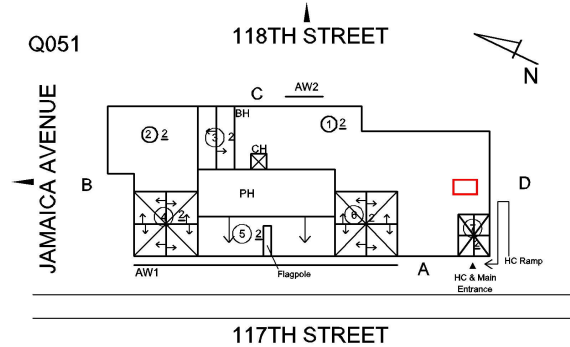
Roof Plan reference

Sustainable Roof Type	White Roof
Sustainable Roof Location (Roof Number)	Roofs 1, 2
Do solar panels exist on these roofs?	No
Is/Are the roof(s) suitable for Solar Panel installation?	No
Installation Year	2023
Source of Installation	Custodial Staff
Deficiency	MODIFIED BITUMEN: ROOFING: MAJOR ACTIVE ROOF LEAKS IN INSTRUCTIONAL SPACE

Roof 1 - Room 210  
 No violations recorded.

100  
 S.F.  
 REPLACE ROOFING WITHOUT MAJOR EQUIPMENT  
 REMOVAL  
 PRIORITY 5  
 LEVEL 2

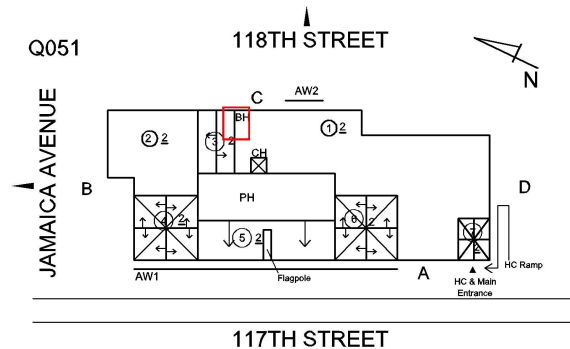
BULKHEAD/PENTHOUSE WALLS/INTERIOR: GYPSUM  
 BOARD DAMAGED/DETERIORATED

20  
 S.F.

Question	Response
<b>EXTERIOR</b>	
<b>ROOF</b>	
<b>Specialties</b>	
<b>BULKHEAD/PENTHOUSE</b>	
Potential Action	REPLACE
Urgency of Action	PRIORITY 3
Purpose of Action	LEVEL 2
Deficiency Photo1	 
Violations	BH No violations recorded.
Deficiency	BULKHEAD/PENTHOUSE WALLS/INTERIOR: CMU CRACKS/SPALLING
Roof Plan reference	 
Deficiency Quantity	20
Quantity Uom	S.F.
Potential Action	REPLACE
Urgency of Action	PRIORITY 3
Purpose of Action	LEVEL 2
Deficiency Photo1	 
Violations	BH No violations recorded.
Deficiency	BULKHEAD/PENTHOUSE WALLS/EXTERIOR: EFFLORESCENCE

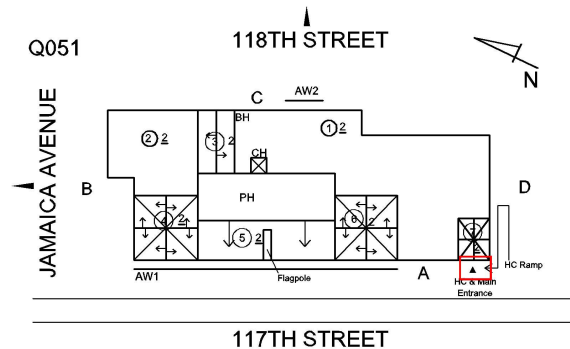
Roof Plan reference

BRICK: DETERIORATED JOINTS AT COPING STONES

Deficiency Quantity	10
Quantity Uom	L.F.
Potential Action	MAINTENANCE
Urgency of Action	PRIORITY 3
Purpose of Action	LEVEL 2

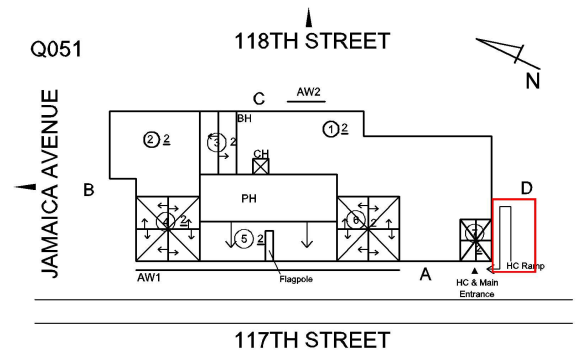
Roof Plan reference

**CAST IN PLACE CONCRETE: CRACKS/SPALLING - MAJOR**

20

REPLACE

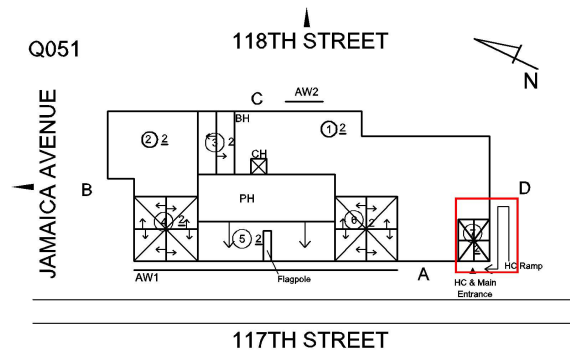
Roof Plan reference

**CAST IN PLACE CONCRETE: CRACKS/SPALLING - MINOR**

30  
 S.F.  
 REPAIR  
 PRIORITY 3  
 LEVEL 2

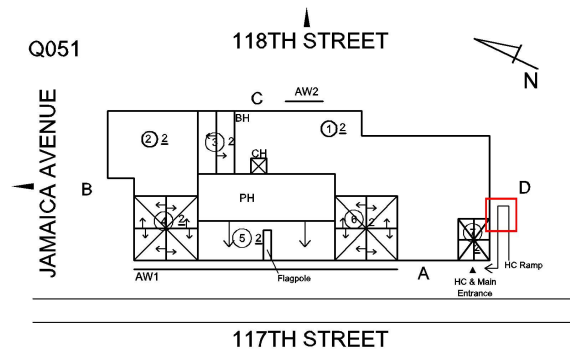
Roof Plan reference

CONCRETE: CRACKS/SPALLING - MAJOR

10  
 S.F.  
 REPLACE  
 PRIORITY 4  
 LEVEL 2

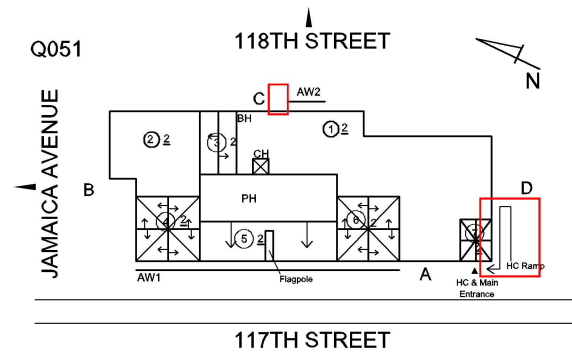
Roof Plan reference

CONCRETE: CRACKS/SPALLING - MINOR

30

REPAIR

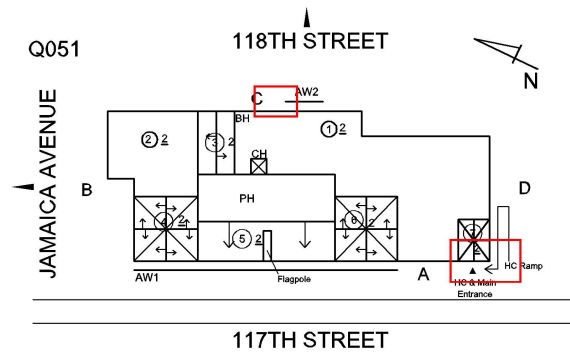
Roof Plan reference

CONCRETE: WORN-OUT TREAD/RISER/NOSING

20  
S.F.  
REPLACE  
PRIORITY 4  
LEVEL 2

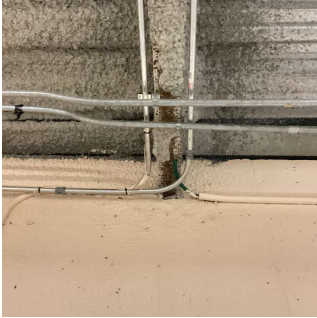
Question	Response
<b>EXTERIOR</b>	
<b>WINDOWS</b>	
<b>WINDOWS</b>	
Instance Quantity	100
Instance Quantity Uom	S.F.
Are these windows insulated	Yes
Installation Year	2023
Source of Installation	Custodial Staff
Deficiency	No deficiencies recorded
<b>INTERIOR</b>	Inspected
<b>POOLS</b>	Does not Exist
<b>STRUCTURAL</b>	Inspected
<b>COLUMNS/BEAMS/BEARING WALLS</b>	Inspected
Condition	2 - Between Good and Fair
Deficiency	STEEL COLUMNS/BEAMS: DETERIORATED/MISSING SPRAY-ON FIREPROOFING
Deficiency Location/Instance	Basement - Room 1C
Deficiency Quantity	10
Quantity Uom	S.F.
Potential Action	REPLACE
Urgency of Action	PRIORITY 3
Purpose of Action	LEVEL 5
Deficiency Photo1

Room 1C
Violations	No violations recorded.
<b>FLOOR STRUCTURE</b>	Inspected
Condition	2 - Between Good and Fair
Deficiency	CONCRETE SLAB ON GRADE: THRU CRACKS
Deficiency Location/Instance	Basement - Room 1C
Deficiency Quantity	20
Quantity Uom	S.F.
Potential Action	REPAIR

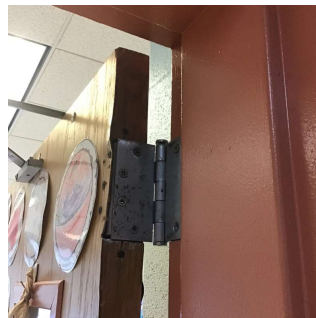
WOOD: DETERIORATED DOOR

Question	Response
<b>INTERIOR</b>	
<b>CLASSROOMS/CORRIDORS/ADMIN SPACES</b>	
<b>Door(s)</b>	Inspected
	Room 213
Violations	No violations recorded.
<b>Floor Finish</b>	Inspected
Condition	2 - Between Good and Fair
Deficiency	VINYL TILES: BROKEN/DETERIORATED/MISSING TILES
Deficiency Location/Instance	Rooms 203
Deficiency Quantity	10
Quantity Uom	S.F.
Potential Action	REPLACE
Urgency of Action	PRIORITY 3
Purpose of Action	LEVEL 2
Deficiency Photo1

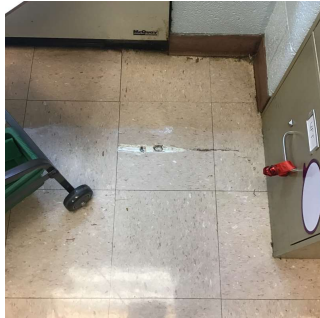
Room 203
Violations	No violations recorded.
Deficiency	VINYL TILES: DETERIORATED SUBSTRATE
Deficiency Location/Instance	Room 202, Main Entrance Lobby, corridor near Cafeteria, Corridor near staff basement restroom
Deficiency Quantity	150
Quantity Uom	S.F.
Potential Action	REPLACE
Urgency of Action	PRIORITY 3
Purpose of Action	LEVEL 2
Deficiency Photo1

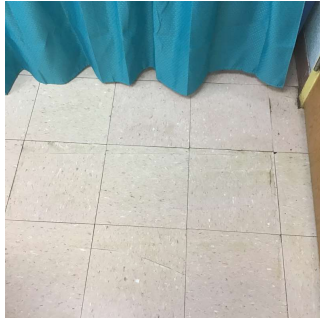
Room 202
Violations	No violations recorded.
<b>Walls</b>	Inspected
Condition	2 - Between Good and Fair
Deficiency	GYPSON BOARD: DETERIORATED

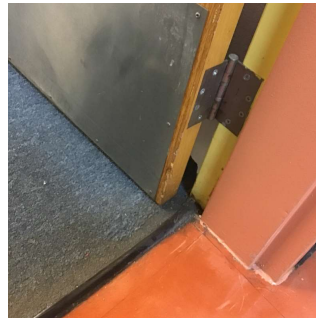
Entrance

WOOD: DETERIORATED DOOR

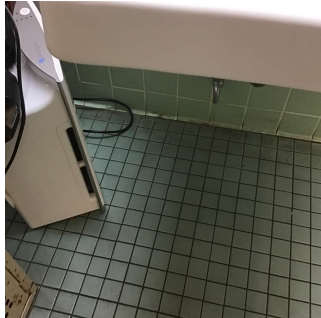
Question	Response
<b>INTERIOR</b>	
<b>TOILET ROOMS - STAFF</b>	
<b>Ceiling</b>	Inspected
Condition	2 - Between Good and Fair
Deficiency	No deficiencies recorded
<b>Door(s)</b>	Inspected
Condition	2 - Between Good and Fair
Deficiency	No deficiencies recorded
<b>Floor Finish</b>	Inspected
Condition	2 - Between Good and Fair
Deficiency	No deficiencies recorded
<b>Stalls</b>	Inspected
Condition	2 - Between Good and Fair
Deficiency	No deficiencies recorded
<b>Walls</b>	Inspected
Condition	2 - Between Good and Fair
Deficiency	CERAMIC TILE: BROKEN/ MISSING
Deficiency Location/Instance	Men's Locker Room, Basement Staff
Deficiency Quantity	20
Quantity Uom	S.F.
Potential Action	REPLACE
Urgency of Action	PRIORITY 3
Purpose of Action	LEVEL 2
Deficiency Photo1

Men's Locker Room
Violations	No violations recorded.
<b>TOILET ROOMS - STUDENTS</b>	
<b>Ceiling</b>	Inspected
Condition	2 - Between Good and Fair
Deficiency	No deficiencies recorded

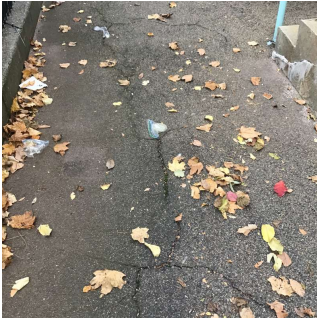
Violations	Near Playground No violations recorded.
<b>Pavers</b>	Does not Exist
<b>Site Sidewalks &amp; Walkways</b>	Inspected
<b>Asphalt</b>	Inspected
Condition	3 - Fair
Deficiency	CRACKS - MAJOR
Deficiency Location/Instance	Near Exit 2
Deficiency Quantity	150
Quantity Uom	S.F.
Potential Action	REPLACE
Urgency of Action	PRIORITY 3
Purpose of Action	LEVEL 2
Deficiency Photo1

Violations	Near Exit 2 No violations recorded.
<b>Concrete</b>	Inspected
Condition	3 - Fair
Deficiency	CRACKS - MAJOR
Deficiency Location/Instance	Near Exit 1
Deficiency Quantity	50

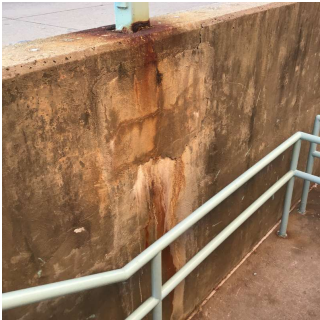
Question	Response
<b>SITE</b>	
<b>PLAYGROUNDS</b>	Inspected
<b>Unpaved Area</b>	
Instance on Rear of Building	Does not Exist
<b>PLAYING SURFACE</b>	Does not Exist
<b>RETAINING WALLS</b>	Inspected
Are there any Retaining Walls 6' OR higher facing public street/sidewalk?	No
Condition	3 - Fair
Deficiency	CAST IN PLACE CONCRETE: CRACKS/SPALLING - MAJOR
Deficiency Location/Instance	Near Exit 3
Deficiency Quantity	30
Quantity Uom	S.F.
Potential Action	REPLACE
Urgency of Action	PRIORITY 3
Purpose of Action	LEVEL 2
Deficiency Photo1

Near Exit 3	Near Exit 3
Violations	No violations recorded.
<b>SEATING</b>	Inspected
<b>Benches</b>	Inspected
<b>Concrete</b>	Does not Exist
<b>Metal/Wood/Plastic</b>	Inspected
Condition	2 - Between Good and Fair
Deficiency	No deficiencies recorded
<b>Bleachers</b>	Does not Exist
<b>SITE WALLS (NOT RETAINING WALLS)</b>	Does not Exist
<b>STAIRS/RAMPS: EXTERIOR</b>	Inspected
<b>Railings</b>	Inspected
