NYC Department of Education
Building Condition Assessment Survey 2023 - 2024

Architectural Inspection

Asset: P.S. 52 - QUEENS, 178-37 146 TERRACE, New York, 11434

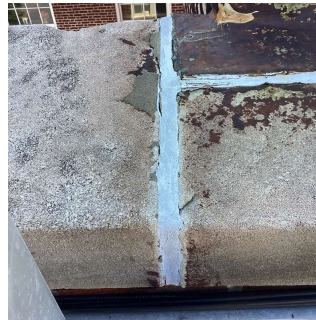
Roof 1
No violations recorded.

COPING

20
L.F.
MAINTENANCE
PRIORITY 3
LEVEL 2

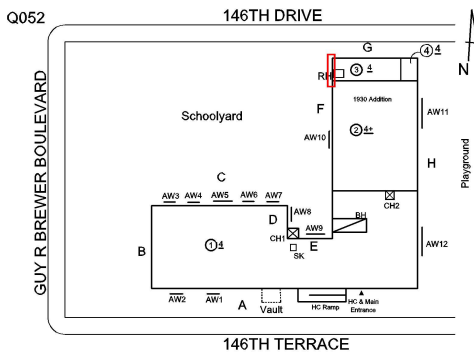
Violations	Facade F No violations recorded.
TRANSOM/SIDE LIGHT	Inspected
Condition	5 - Poor
Deficiency	METAL: DENTED, MAJOR RUSTING

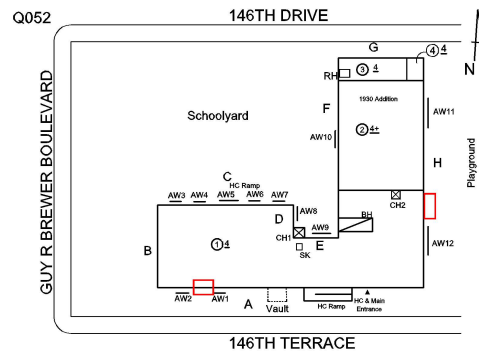
WOOD: EXCESSIVELY WEATHERED

60
S.F.
REPLACE
PRIORITY 4
LEVEL 2

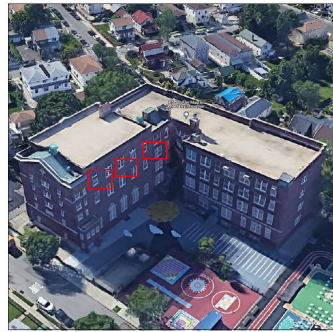
Violations	Facade H No violations recorded.
EXTERIOR WALLS	Inspected
Material Type(s)	Masonry
Replacement Quantity	30,000
Replacement Uom	S.F.
Instance on All Facades	Inspected
Instance Condition	4 - Between Fair and Poor
Instance Quantity	30,000
Instance Quantity Uom	S.F.
Deficiency	BRICK: WATER INFILTRATION IN INSTRUCTIONAL SPACE
Roof Plan reference	Q052
Elevation

Deficiency Quantity	400
Quantity Uom	S.F.
Potential Action	REPAIR
Urgency of Action	PRIORITY 5
Purpose of Action	LEVEL 2

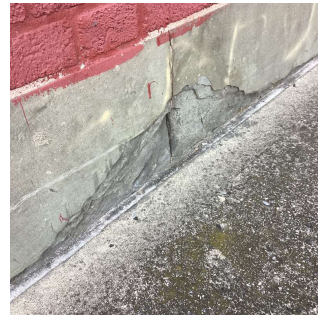
Facade B

STONE: CHIPPED/SPALLED/BROKEN PIECES - MAJOR

REPLACE

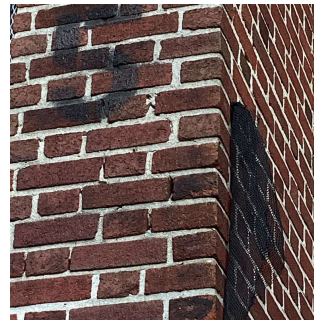
Facade E

BRICK: DETERIORATED JOINTS

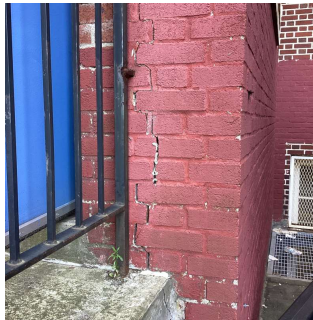
Facade E

BRICK: MAJOR / THRU CRACKS

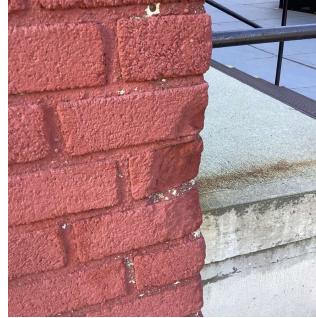
Facade G

BRICK: CRACKS/DISPLACED/SPALLED BRICK AT BUILDING CORNERS

REMOVE AND REBUILD
PRIORITY 4
LEVEL 2

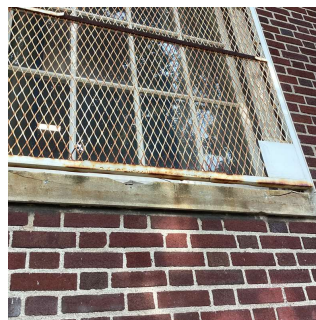
BRICK: DETERIORATED MASONRY SILLS - MAJOR

20
L.F.
REMOVE AND REPLACE
PRIORITY 4
LEVEL 2

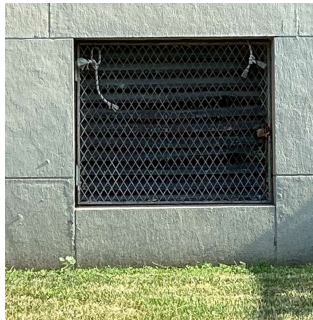
Facade A

BROKEN/ DENTED BLADES

REPLACE

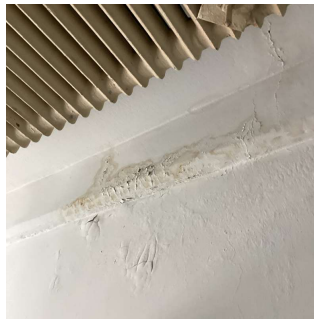
Roof 4 - Room 459
 No violations recorded.

Question	Response
EXTERIOR	
ROOF	
Roofing	
ROOFING	
Roof Plan reference	
Deficiency Quantity	100
Quantity Uom	S.F.
Potential Action	REPLACE
Urgency of Action	PRIORITY 5
Purpose of Action	LEVEL 2
Deficiency Photo1	
Violations	Roof 3 - Room 459 No violations recorded.
Instance on Modified Bitumen: Roof 4	Inspected
Instance Condition	5 - Poor
Instance Photo	
	Roof 4
Instance Quantity	500
Instance Quantity Uom	S.F.
Does the roof have major mechanical equipment sitting on Dunnage Steel less than 18" above the Roofing?	No
Does this roof instance have a Sustainable Roof System?	No
Do solar panels exist on these roofs?	No
Is/Are the roof(s) suitable for Solar Panel installation?	No
Installation Year	2018
Source of Installation	Custodial Staff
Deficiency	MODIFIED BITUMEN: ROOFING: MAJOR ACTIVE ROOF LEAKS IN INSTRUCTIONAL SPACE

100
 S.F.
 REPLACE ROOFING WITHOUT MAJOR EQUIPMENT
 REMOVAL
 PRIORITY 5
 LEVEL 2

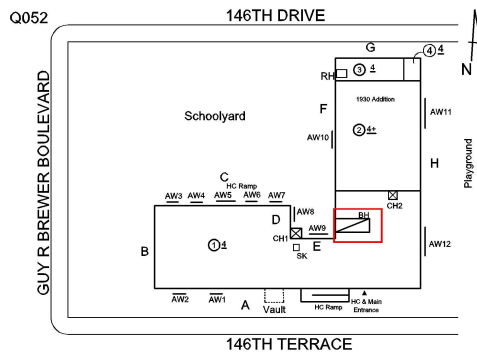
Violations	Roof 1 - Bulkhead No violations recorded.
Deficiency	BULKHEAD/PENTHOUSE WALLS/INTERIOR: PLASTER CRACKS/SPALLING

30
S.F.
REPLACE
PRIORITY 3
LEVEL 2

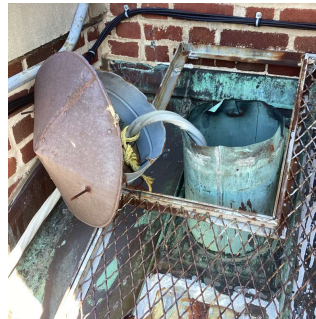
Roof 1
No violations recorded.

SHAFT VENTS DAMAGED

1
EACH
MAINTENANCE
PRIORITY 3
LEVEL 2

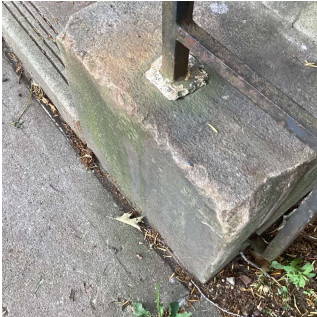
Question	Response
EXTERIOR	
STAIRS/RAMPS: EXTERIOR	
BUILDING CHEEK/FLANK WALLS	
Deficiency Quantity	10
Quantity Uom	S.F.
Potential Action	REPAIR
Urgency of Action	PRIORITY 3
Purpose of Action	LEVEL 2
Deficiency Photo1

Violations	Facade H No violations recorded.
Deficiency	STONE: DETERIORATED JOINTS
Roof Plan reference	Q052

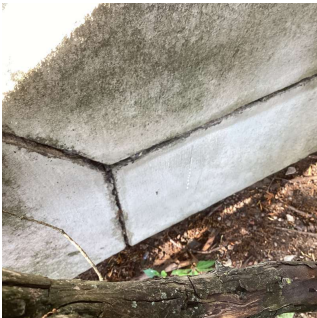
Deficiency Quantity	10
Quantity Uom	S.F.
Potential Action	REPOINT
Urgency of Action	PRIORITY 3
Purpose of Action	LEVEL 2
Deficiency Photo1

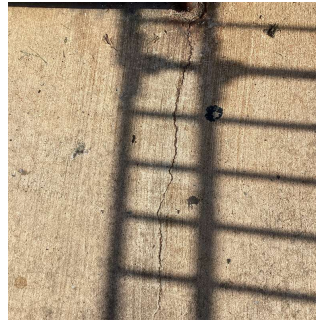
Facade A

CONCRETE: CRACKS/SPALLING - MINOR

20
S.F.
REPAIR
PRIORITY 3
LEVEL 2

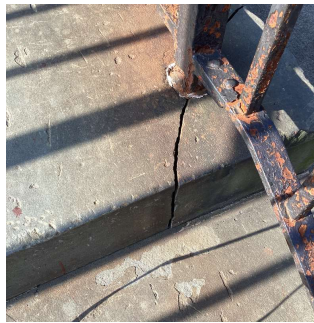
Facade G

STONE: CRACKS/SPALLING - MAJOR

10
S.F.
REPLACE
PRIORITY 4
LEVEL 2

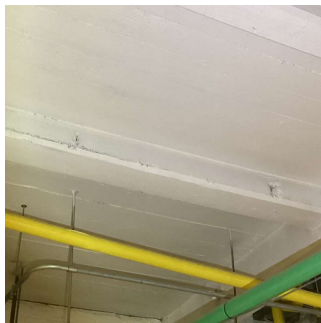
Basement - Adjacent to Fan Room

Question	Response
EXTERIOR	
WINDOWS	
EXTERIOR GUARDS	
Deficiency Photo1	 
Violations	Facade H No violations recorded.
LINTELS	Inspected
Condition	2 - Between Good and Fair
Deficiency	No deficiencies recorded
WINDOWS	Inspected
Material Type(s)	Solid Wood
Instance on Wood: All Facades	Inspected
Instance Condition	3 - Fair
Instance Quantity	8,000
Instance Quantity Uom	S.F.
Are these windows insulated	No
Installation Year	2006
Source of Installation	Custodial Staff
Deficiency	No deficiencies recorded
INTERIOR	Inspected
POOLS	Does not Exist
STRUCTURAL	Inspected
COLUMNS/BEAMS/BEARING WALLS	Inspected
Condition	2 - Between Good and Fair
Deficiency	CONCRETE COLUMNS/BEAMS: CRACKED/SPALLED/REINFORCEMENT EXPOSED
Deficiency Location/Instance	Basement - Adjacent to Fan Room, Boiler Room
Deficiency Quantity	10
Quantity Uom	S.F.
Potential Action	REPAIR
Urgency of Action	PRIORITY 3
Purpose of Action	LEVEL 5
Deficiency Photo1

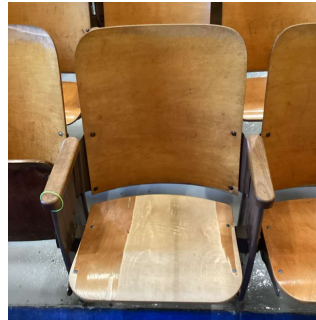
Seat A/13

DAMAGED/BROKEN/INOPERABLE

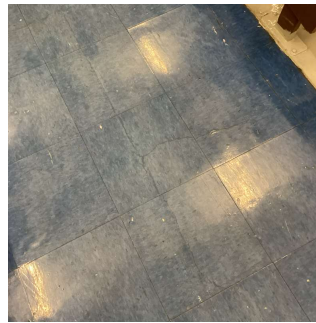
Center Aisle

VINYL TILES: DETERIORATED SUBSTRATE

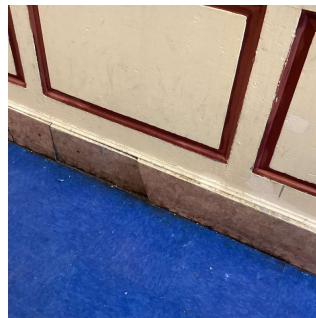
Front Stage

STONE MOLDINGS: CRACKS/SPALLING

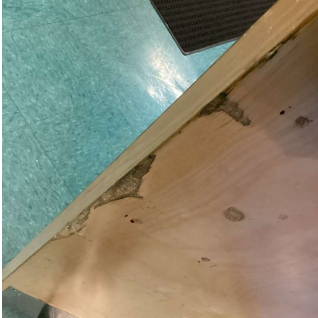
Question	Response
INTERIOR	
CAFETERIA	
Door(s)	
Condition	5 - Poor
Deficiency	WOOD: DETERIORATED DOOR
Deficiency Location/Instance	Main Entrance, Exit
Deficiency Quantity	4
Quantity Uom	EACH
Potential Action	MAINTENANCE
Urgency of Action	PRIORITY 3
Purpose of Action	LEVEL 2
Deficiency Photo1

Violations	Main Entrance No violations recorded.
Fixed Equipment	
Instance on 1st Floor	Does not Exist
Floor Finish	
Instance on 1st Floor	Inspected
Condition	2 - Between Good and Fair
Deficiency	VINYL TILES: DETERIORATED SUBSTRATE
Deficiency Location/Instance	Near Exits 5, 8, by Stair B, close to Room 161, next to Servery and others
Deficiency Quantity	100
Quantity Uom	S.F.
Potential Action	REPLACE
Urgency of Action	PRIORITY 3
Purpose of Action	LEVEL 2
Deficiency Photo1

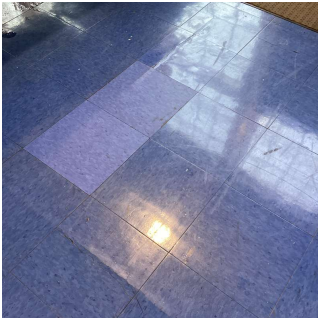
Violations	Near Exit 8 No violations recorded.
Sliding-folding Partition	
Instance on 1st Floor	Does not Exist
Stage	
Instance on 1st Floor	Does not Exist

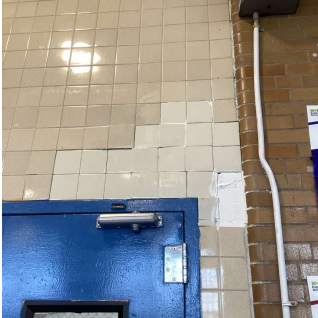
Question	Response
INTERIOR	
CAFETERIA	
Walls	
Instance on 1st Floor	Inspected
Condition	2 - Between Good and Fair
Deficiency	CERAMIC TILE: BROKEN/ MISSING
Deficiency Location/Instance	Near Servery
Deficiency Quantity	20
Quantity Uom	S.F.
Potential Action	REPLACE
Urgency of Action	PRIORITY 3
Purpose of Action	LEVEL 2
Deficiency Photo1

Violations	Near Servery No violations recorded.
Deficiency	SALT GLAZED BRICK: CRACKS/SPALLING
Deficiency Location/Instance	Near Left Side Windows, by Exit 5, next to Servery, close to Boys Toilet Room
Deficiency Quantity	50
Quantity Uom	S.F.
Potential Action	REPLACE
Urgency of Action	PRIORITY 3
Purpose of Action	LEVEL 2
Deficiency Photo1	 
Violations	Near Left Side Windows No violations recorded.
Window Curtains/Shades/Blinds	
Instance on 1st Floor	Does not Exist
CLASSROOMS/CORRIDORS/ADMIN SPACES	
Ceiling	
Condition	Inspected
Condition	2 - Between Good and Fair
Deficiency	PLASTER: CRACKS/SPALLING - ACTIVE LEAK

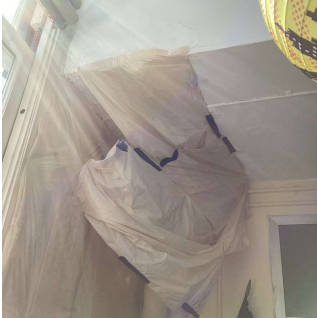
Deficiency Location/Instance	Rooms 401B, 409
Deficiency Quantity	80

Question	Response
INTERIOR	
CLASSROOMS/CORRIDORS/ADMIN SPACES	
Ceiling	
Quantity Uom	S.F.
Potential Action	REPLACE
Urgency of Action	PRIORITY 5
Purpose of Action	LEVEL 2
Deficiency Photo1

Room 401B
Violations	No violations recorded.
Door(s)	Inspected
Condition	5 - Poor
Deficiency	WOOD: DETERIORATED DOOR AND FRAME
Deficiency Location/Instance	Rooms 311, 252
Deficiency Quantity	2
Quantity Uom	EACH
Potential Action	MAINTENANCE
Urgency of Action	PRIORITY 3
Purpose of Action	LEVEL 2
Deficiency Photo1

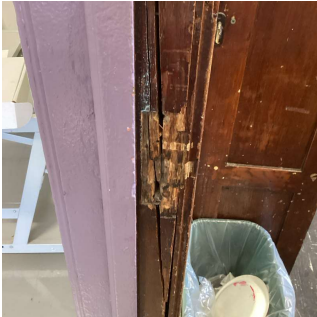
Room 311
Violations	No violations recorded.
Deficiency	WOOD: DETERIORATED DOOR
Deficiency Location/Instance	Rooms 405, 113, 112, Corridor near Auditorium, Exit 1 - Vestibule and others
Deficiency Quantity	12
Quantity Uom	EACH
Potential Action	MAINTENANCE
Urgency of Action	PRIORITY 3
Purpose of Action	LEVEL 2

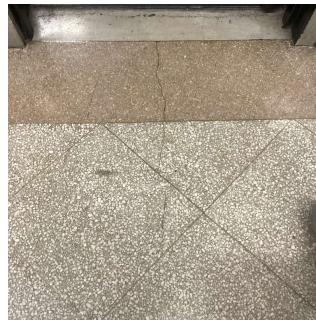
Corridor near Auditorium

TERRAZZO: CRACKS

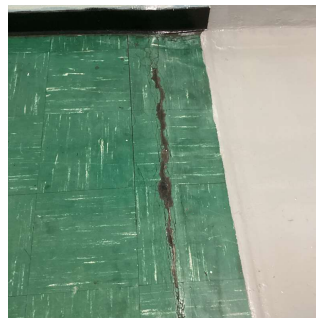
VINYL TILES: DETERIORATED SUBSTRATE

Question	Response
INTERIOR	
CLASSROOMS/CORRIDORS/ADMIN SPACES	
Floor Finish	
Violations	Corridor near Room 401F No violations recorded.
Deficiency	VINYL TILES: BROKEN/DETERIORATED/MISSING TILES
Deficiency Location/Instance	Rooms 311, 253, 208
Deficiency Quantity	450
Quantity Uom	S.F.
Potential Action	REPLACE
Urgency of Action	PRIORITY 3
Purpose of Action	LEVEL 2
Deficiency Photo1

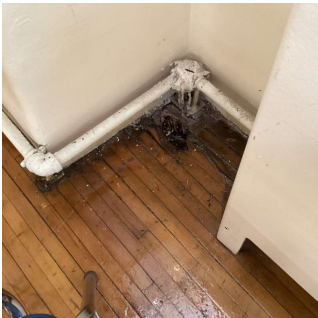
Violations	Room 311 No violations recorded.
Deficiency	WOOD: DAMAGED/DETERIORATED
Deficiency Location/Instance	Rooms 403, 401F, 309
Deficiency Quantity	120
Quantity Uom	S.F.
Potential Action	REPLACE
Urgency of Action	PRIORITY 3
Purpose of Action	LEVEL 2
Deficiency Photo1

Violations	Room 401F No violations recorded.
Walls	Inspected
Condition	2 - Between Good and Fair
Deficiency	PLASTER: CRACKS/SPALLING - ACTIVE LEAK
Deficiency Location/Instance	Rooms 401B, 401D, 401F, Corridor near Room 407
Deficiency Quantity	80
Quantity Uom	S.F.
Potential Action	REPLACE

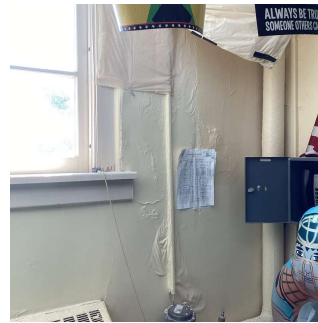
Rm401B

Urgency of Action	PRIORITY 5
Purpose of Action	LEVEL 2

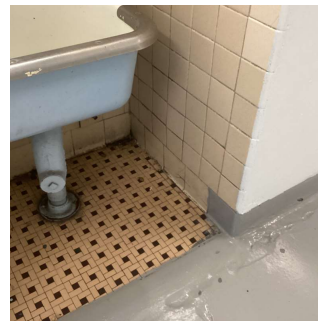
Corridor near Room 452

CERAMIC TILE: BROKEN/ MISSING

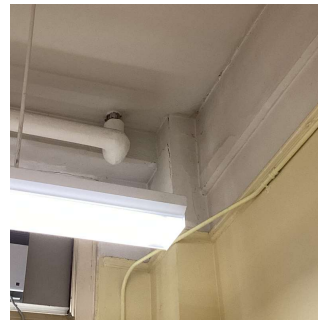
Room 113

PLASTER: CRACKS/SPALLING

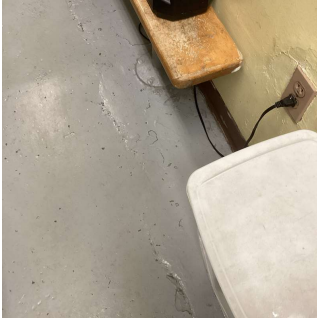
Question	Response
INTERIOR	
KITCHEN	
Floor Finish	
Instance on 1st Floor	Inspected
Condition	3 - Fair
Deficiency	CONCRETE: CRACKS
Deficiency Location/Instance	Kitchen Locker Room
Deficiency Quantity	25
Quantity Uom	S.F.
Potential Action	REPLACE
Urgency of Action	PRIORITY 3
Purpose of Action	LEVEL 2
Deficiency Photo1

Violations	Kitchen Locker Room No violations recorded.
Deficiency	QUARRY TILE: BROKEN/MISSING TILES
Deficiency Location/Instance	Preparation Area, Servery
Deficiency Quantity	20
Quantity Uom	S.F.
Potential Action	REPLACE
Urgency of Action	PRIORITY 3
Purpose of Action	LEVEL 2
Deficiency Photo1

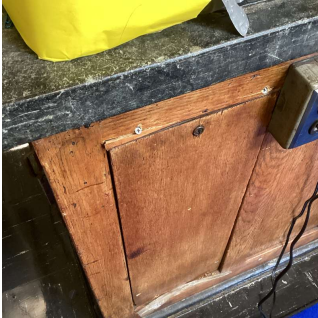
Question	Response
INTERIOR	
LOCKER ROOM	Does not Exist
MULTI-PURPOSE ROOM	Does not Exist
SCIENCE DEMO ROOM	Inspected
Instance on Room 311	Inspected
Alternative use	Yes
Instance on Room 112	Inspected
Alternative use	No
Fixed Equipment	
Instance on Room 311	Inspected
Condition	3 - Fair
Deficiency	CABINETS: MISSING/DAMAGED
Deficiency Location/Instance	Room 311
Deficiency Quantity	10
Quantity Uom	L.F.
Potential Action	REPLACE
Urgency of Action	PRIORITY 3
Purpose of Action	LEVEL 2
Deficiency Photo1

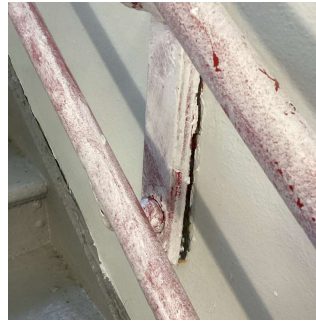
Stair B/1

Violations	Exit 4 - Vestibule No violations recorded.
Partition	Does not Exist
Railings	Inspected
Condition	3 - Fair
Deficiency	METAL: BROKEN BRACKET
Deficiency Location/Instance	Stair B/1(Loose)
Deficiency Quantity	1
Quantity Uom	EACH
Potential Action	REPLACE
Urgency of Action	PRIORITY 3
Purpose of Action	LEVEL 2

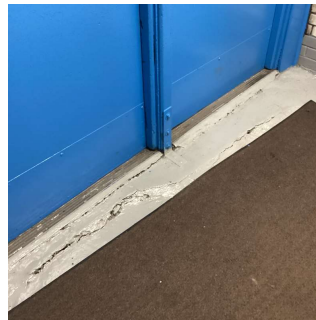
Exit 3 - Vestibule

CONCRETE: CRACKS/SPALLING - MAJOR

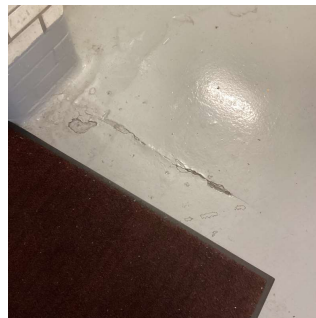
CONCRETE: CRACKS/SPALLING - MAJOR

REPLACE

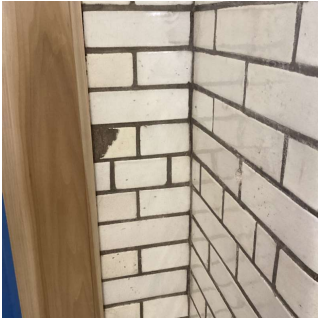
Question	Response
INTERIOR	
STAIRS/RAMPS: INTERIOR	
Stairs and Landings	Inspected
Violations	Exit 5 - Vestibule No violations recorded.
Walls	Inspected
Condition	2 - Between Good and Fair
Deficiency	BRICK: CRACKS/SPALLING
Deficiency Location/Instance	Exits 4, 5 - Vestibules
Deficiency Quantity	20
Quantity Uom	S.F.
Potential Action	REPLACE
Urgency of Action	PRIORITY 3
Purpose of Action	LEVEL 2
Deficiency Photo1

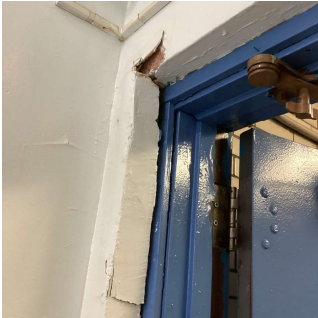
Violations	Exit 5 - Vestibule No violations recorded.
Deficiency	PLASTER: CRACKS/SPALLING
Deficiency Location/Instance	Exits 5, 7 - Vestibules, Stairs A/3, B/1
Deficiency Quantity	40
Quantity Uom	S.F.
Potential Action	REPLACE
Urgency of Action	PRIORITY 3
Purpose of Action	LEVEL 2
Deficiency Photo1

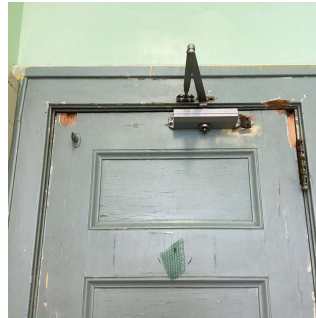
Room 455

WOOD: DETERIORATED DOOR

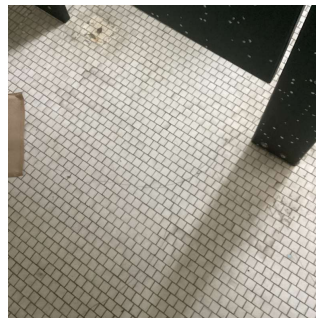
CERAMIC TILE: DETERIORATED SUBSTRATE

REPLACE

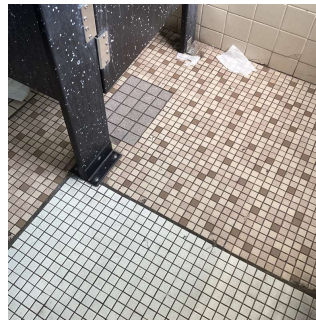
Room 354

CERAMIC TILE: BROKEN/MISSING TILES

REPLACE

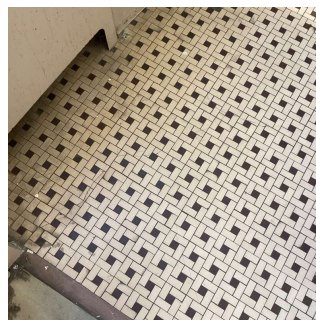
CERAMIC TILE: DETERIORATED SUBSTRATE

REPLACE

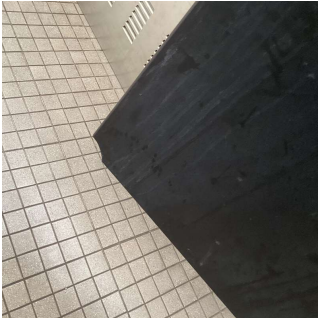
Question	Response
INTERIOR	
TOILET ROOMS - STUDENTS	
Floor Finish	
Violations	In Room 113 No violations recorded.
Deficiency	CERAMIC TILE: DETERIORATED SUBSTRATE
Deficiency Location/Instance	Room 454
Deficiency Quantity	10
Quantity Uom	S.F.
Potential Action	REPLACE
Urgency of Action	PRIORITY 5
Purpose of Action	LEVEL 6
Deficiency Photo1	 
Violations	Room 454 No violations recorded.
Stalls	Inspected
Condition	3 - Fair
Deficiency	BROKEN/MISSING
Deficiency Location/Instance	Girls Toilet Room - 1st Floor
Deficiency Quantity	1
Quantity Uom	EACH
Potential Action	REPLACE
Urgency of Action	PRIORITY 3
Purpose of Action	LEVEL 2
Deficiency Photo1

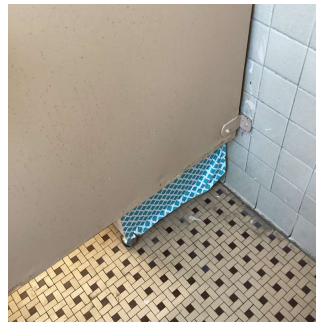
Violations	Girls Toilet Room - 1st Floor No violations recorded.
Deficiency	RUST - MAJOR
Deficiency Location/Instance	In Room 113
Deficiency Quantity	1
Quantity Uom	EACH
Potential Action	REPLACE
Urgency of Action	PRIORITY 3
Purpose of Action	LEVEL 2

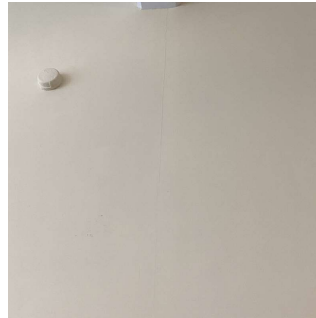
Girls Toilet Room - 1st Floor

GYP SUM BOARD: DETERIORATED

REPLACE

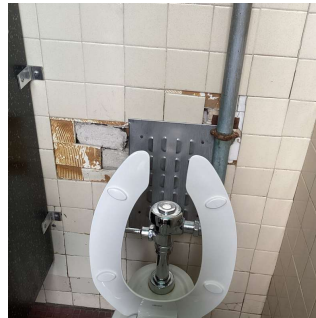
CERAMIC TILE: BROKEN/ MISSING

REPLACE

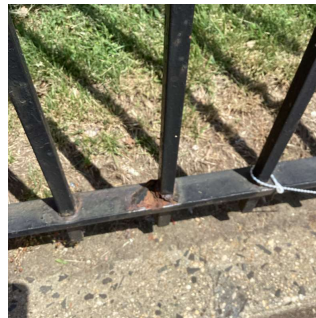
DRINKING FOUNTAINS	Inspected
Condition	2 - Between Good and Fair
Deficiency	No deficiencies recorded
FENCES	Inspected
Condition	3 - Fair
Deficiency	WROUGHT IRON: RUST - MAJOR
Deficiency Location/Instance	146th Terrace
Deficiency Quantity	40
Quantity Uom	S.F.
Potential Action	REPLACE
Urgency of Action	PRIORITY 3
Purpose of Action	LEVEL 2
Deficiency Photo1
