NYC Department of Education
Building Condition Assessment Survey 2023 - 2024

Architectural Inspection

Asset: P.S. 54 - QUEENS, 86-02 127 STREET, New York, 11418

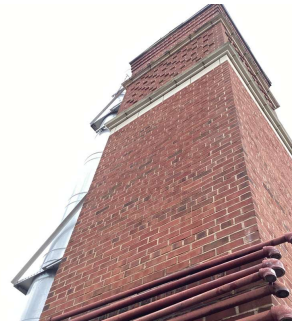
BRICK: DETERIORATED JOINTS

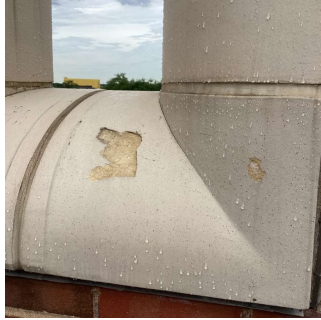
TERRA COTTA: CRACKED/BROKEN PIECES

REPLACE-IN-KIND

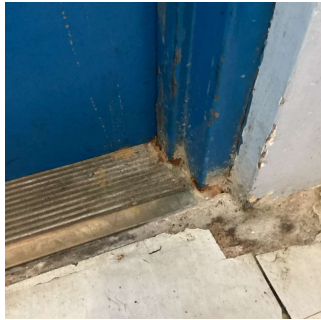
Violations	Roof 1 No violations recorded.
CORNICE	Inspected
Condition	2 - Between Good and Fair
Deficiency	No deficiencies recorded
DOORS	Inspected
DOORS AND FRAMES	Inspected
Condition	5 - Poor
Deficiency	METAL: DETERIORATED DOOR - MINOR DETERIORATION
Roof Plan reference	Q054
Deficiency Quantity	1
Quantity Uom	EACH
Potential Action	MAINTENANCE
Urgency of Action	PRIORITY 3
Purpose of Action	LEVEL 2
Deficiency Photo1

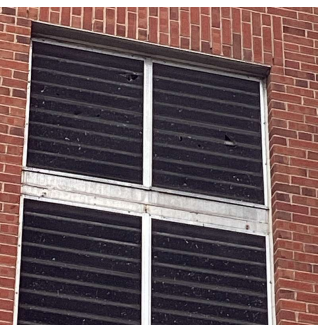
Question	Response
EXTERIOR	
EXTERIOR WALLS	Inspected
Condition	Facade F
Violations	No violations recorded.
EXTERIOR SOFFITS	Inspected
Condition	2 - Between Good and Fair
Deficiency	No deficiencies recorded
LOADING DOCK	Does not Exist
LOUVER	Inspected
Condition	3 - Fair
Deficiency	MISSING/DAMAGED SCREEN
Roof Plan reference	<p>Q054</p>

Deficiency Quantity	30
Quantity Uom	S.F.
Potential Action	REPLACE
Urgency of Action	PRIORITY 4
Purpose of Action	LEVEL 2
Deficiency Photo1

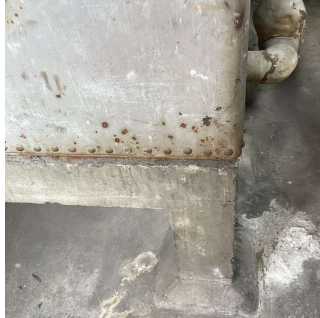
TANK: NOT IN USE - MINOR DETERIORATION

1
 EACH
 NO ACTION
 PRIORITY 1
 LEVEL 1

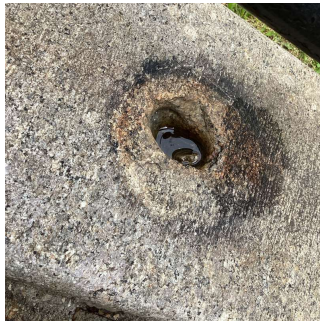
Violations	PH No violations recorded.
STAIRS/RAMPS: EXTERIOR	Inspected
BUILDING CHEEK/FLANK WALLS	Inspected
Condition	3 - Fair
Deficiency	STONE: CRACKS/SPALLING - MAJOR
Roof Plan reference	Q054
Deficiency Quantity	10
Quantity Uom	S.F.
Potential Action	REPLACE
Urgency of Action	PRIORITY 4
Purpose of Action	LEVEL 2
Deficiency Photo1

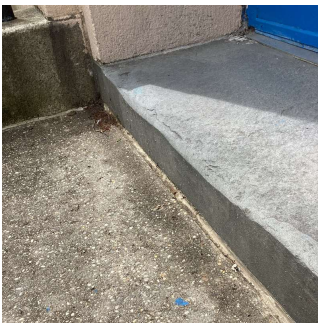
STONE: WORN-OUT TREAD/RISER/NOSING

10
S.F.
REPLACE
PRIORITY 4
LEVEL 2

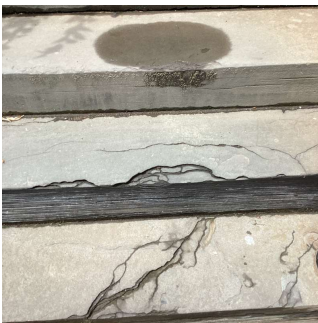
Violations	Facade K No violations recorded.
Deficiency	STONE: CRACKS/SPALLING - MAJOR
Roof Plan reference	Q054
Deficiency Quantity	15
Quantity Uom	S.F.
Potential Action	REPLACE
Urgency of Action	PRIORITY 4
Purpose of Action	LEVEL 2
Deficiency Photo1

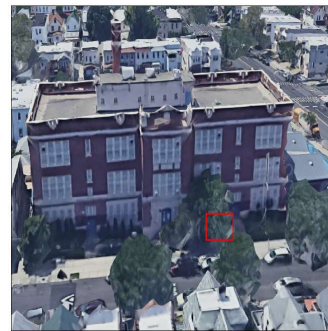
Elevation

Deficiency Quantity	100
Quantity Uom	S.F.
Potential Action	REPLACE WINDOW
Urgency of Action	PRIORITY 4
Purpose of Action	LEVEL 2
Deficiency Photo1	No photo recorded
Violations	No violations recorded.

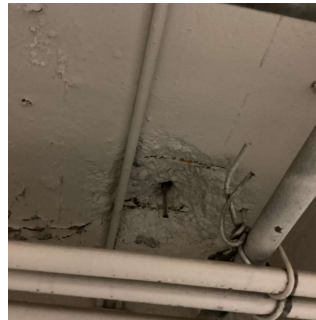
Basement - Boiler Room

CINDER CONCRETE FLAT SLAB:
CRACKED/SPALLED/REINFORCEMENT EXPOSED

REPAIR

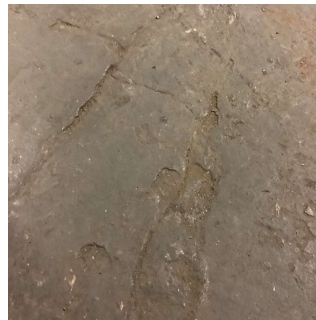
Basement - Boiler Room

CONCRETE SLAB ON GRADE: THRU CRACKS

REPAIR

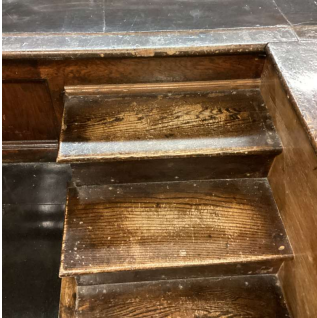
Question	Response
INTERIOR	
AUDITORIUM	
Stage	
Stage	
Potential Action	REPLACE
Urgency of Action	PRIORITY 3
Purpose of Action	LEVEL 2
Deficiency Photo1

Right Side
Violations	No violations recorded.
Deficiency	DAMAGED FLOOR
Deficiency Location/Instance	Center
Deficiency Quantity	20
Quantity Uom	S.F.
Potential Action	REPLACE
Urgency of Action	PRIORITY 3
Purpose of Action	LEVEL 2
Deficiency Photo1

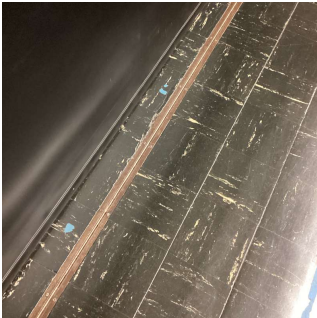
Center
Violations	No violations recorded.
Stage Curtain Rigging	Inspected
Instance on 2nd Floor (294 Seats)	Inspected
Condition	2 - Between Good and Fair
Deficiency	No deficiencies recorded
Stage Curtains	Inspected
Instance on 2nd Floor (294 Seats)	Inspected
Condition	1 - Good
Deficiency	No deficiencies recorded
Walls	
Instance on 2nd Floor (294 Seats)	Inspected
Condition	2 - Between Good and Fair
Deficiency	PLASTER: CRACKS/SPALLING
Deficiency Location/Instance	Right and Left Side
Deficiency Quantity	40

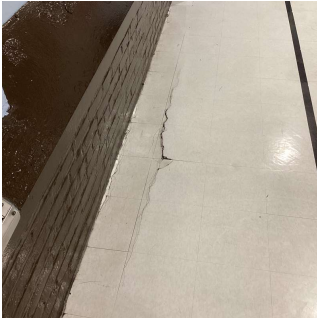
Question	Response
INTERIOR	
CAFETERIA	
Fixed Equipment	
Instance on 1st Floor	Inspected
Condition	2 - Between Good and Fair
Deficiency	No deficiencies recorded
Floor Finish	
Instance on 1st Floor	Inspected
Condition	2 - Between Good and Fair
Deficiency	VINYL TILES: DETERIORATED SUBSTRATE
Deficiency Location/Instance	Rear Near Basketball hoop, Near Exit 9, Near Serving Area, Near mini Building, Center and others
Deficiency Quantity	100
Quantity Uom	S.F.
Potential Action	REPLACE
Urgency of Action	PRIORITY 3
Purpose of Action	LEVEL 2
Deficiency Photo1

Violations	Rear Near Basketball hoop No violations recorded.
Sliding-folding Partition	
Instance on 1st Floor	Does not Exist
Stage	
Instance on 1st Floor	Does not Exist
Walls	
Instance on 1st Floor	Inspected
Condition	2 - Between Good and Fair
Deficiency	GYPSUM BOARD: DETERIORATED
Deficiency Location/Instance	Near Room 151
Deficiency Quantity	10
Quantity Uom	S.F.
Potential Action	REPLACE

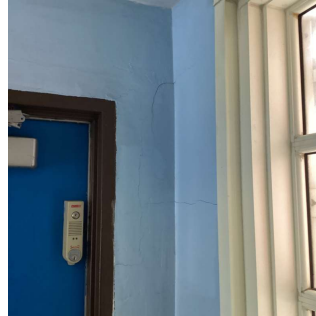
Exit 6 Vestibule

PLASTER: CRACKS/SPALLING

REPLACE

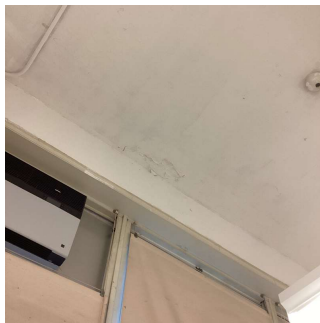
Question	Response
INTERIOR	
CLASSROOMS/CORRIDORS/ADMIN SPACES	
Ceiling	
Deficiency Photo1

Room 201
Violations	No violations recorded.
Door(s)	Inspected
Condition	5 - Poor
Deficiency	WOOD: DETERIORATED DOOR
Deficiency Location/Instance	Rooms 310, 257, 207, 205, 151 and others
Deficiency Quantity	7
Quantity Uom	EACH
Potential Action	MAINTENANCE
Urgency of Action	PRIORITY 3
Purpose of Action	LEVEL 2
Deficiency Photo1

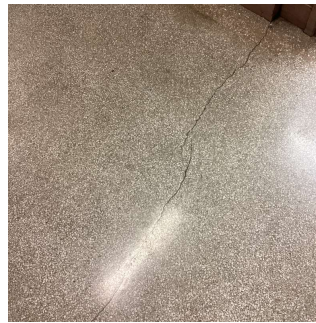
Room 151
Violations	No violations recorded.
Floor Finish	Inspected
Condition	5 - Poor
Deficiency	TERRAZZO: CRACKS
Deficiency Location/Instance	Main Entrance Lobby
Deficiency Quantity	60
Quantity Uom	S.F.
Potential Action	REPLACE
Urgency of Action	PRIORITY 3
Purpose of Action	LEVEL 2

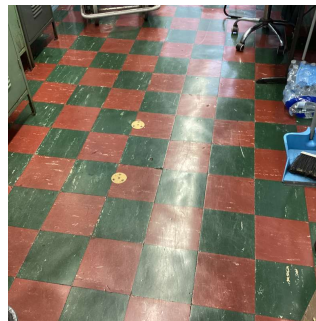
Room 151

VINYL TILES: BROKEN/DETERIORATED/MISSING TILES

REPLACE

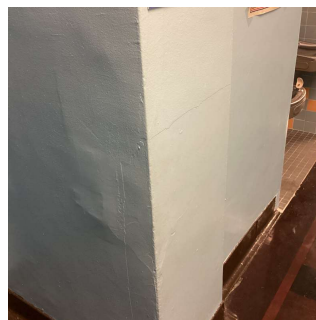
PLASTER: CRACKS/SPALLING

REPLACE

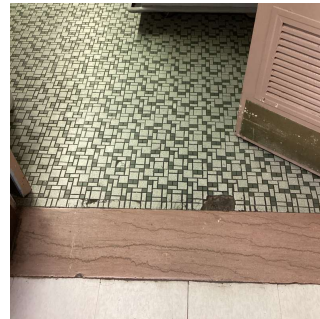
Instance on 1st Floor (500 SF)	Inspected
Condition	2 - Between Good and Fair
Deficiency	CERAMIC TILE: BROKEN/MISSING TILES
Deficiency Location/Instance	Near Entrance
Deficiency Quantity	10
Quantity Uom	S.F.
Potential Action	REPLACE
Urgency of Action	PRIORITY 3
Purpose of Action	LEVEL 2
Deficiency Photo1

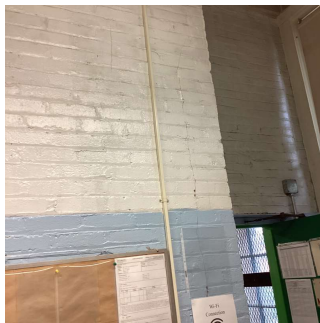
Instance on 1st Floor (500 SF)	Inspected
Condition	5 - Poor
Deficiency	BRICK: CRACKS/SPALLING
Deficiency Location/Instance	Office
Deficiency Quantity	20
Quantity Uom	S.F.
Potential Action	REPLACE
Urgency of Action	PRIORITY 3
Purpose of Action	LEVEL 2

Office
Violations	No violations recorded.
Deficiency	CERAMIC TILE: BROKEN/ MISSING
Deficiency Location/Instance	Near Entrance, Near Prep Area, Near Windows
Deficiency Quantity	80
Quantity Uom	S.F.
Potential Action	REPLACE
Urgency of Action	PRIORITY 3
Purpose of Action	LEVEL 2
Deficiency Photo1	 
	Near Entrance
Violations	No violations recorded.
LIBRARY	Inspected
Instance on Room 306A (600 SF)	Inspected
Built-in Furnishing	
Instance on Room 306A (600 SF)	Does not Exist
Ceiling	
Instance on Room 306A (600 SF)	Inspected
Condition	2 - Between Good and Fair
Deficiency	No deficiencies recorded
Door(s)	
Instance on Room 306A (600 SF)	Inspected
Condition	2 - Between Good and Fair
Deficiency	No deficiencies recorded
Floor Finish	
Instance on Room 306A (600 SF)	Inspected
Condition	2 - Between Good and Fair
Deficiency	No deficiencies recorded
Walls	
Instance on Room 306A (600 SF)	Inspected

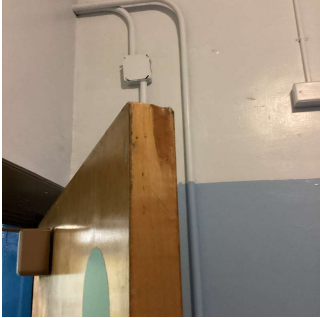
Question	Response
INTERIOR	
LIBRARY	Inspected
Walls	
Condition	2 - Between Good and Fair
Deficiency	No deficiencies recorded
LOCKER ROOM	Does not Exist
MULTI-PURPOSE ROOM	Does not Exist
SCIENCE DEMO ROOM	Does not Exist
SCIENCE LAB	Does not Exist
SCIENCE PREP ROOM	Does not Exist
SHOWER ROOM	Does not Exist
STAIRS/RAMPS: INTERIOR	Inspected
Do Letter Stair Signs Exist?	Yes
Ceiling	Inspected
Condition	2 - Between Good and Fair
Deficiency	No deficiencies recorded
Door(s)	Inspected
Condition	5 - Poor
Deficiency	WOOD: DETERIORATED DOOR
Deficiency Location/Instance	Stair B/3
Deficiency Quantity	1
Quantity Uom	EACH
Potential Action	MAINTENANCE
Urgency of Action	PRIORITY 3
Purpose of Action	LEVEL 2
Deficiency Photo1

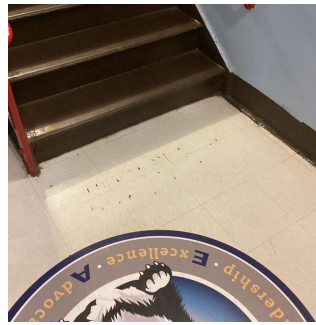
Violations	Stair B/1 No violations recorded.
Partition	Does not Exist
Railings	Inspected
Condition	2 - Between Good and Fair
Deficiency	No deficiencies recorded
Stairs and Landings	Inspected
Condition	4 - Between Fair and Poor
Deficiency	STONE: WORN-OUT TREAD/NOSINGS
Deficiency Location/Instance	Main Entrance Lobby
Deficiency Quantity	140
Quantity Uom	S.F.
Potential Action	REPLACE
Urgency of Action	PRIORITY 3
Purpose of Action	LEVEL 2
Deficiency Photo1	 
Violations	Main Entrance Lobby No violations recorded.
Deficiency	VINYL TILES: BROKEN/DETERIORATED/MISSING TILES
Deficiency Location/Instance	Stairs A/1, 2, A/1 Vestibule, B/1, B/1 Vestibule and others
Deficiency Quantity	100
Quantity Uom	S.F.
Potential Action	REPLACE
Urgency of Action	PRIORITY 3
Purpose of Action	LEVEL 2

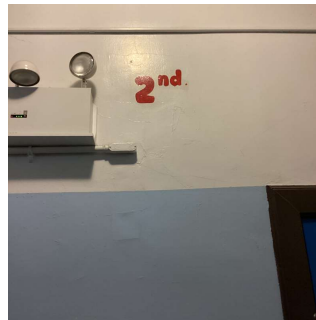
Stair B/2

PLASTER: CRACKS/SPALLING

REPLACE

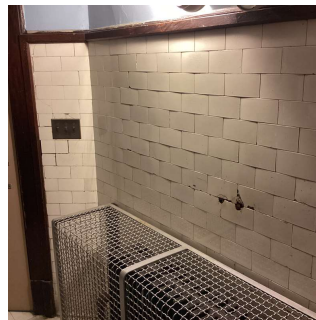
CERAMIC TILE: BROKEN/ MISSING

REPLACE

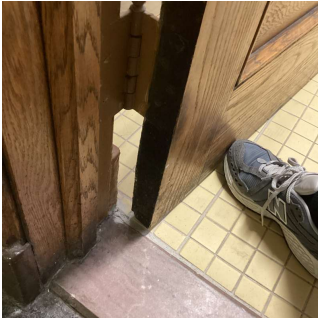
Question	Response
INTERIOR	
STAIRS/RAMPS: INTERIOR	Inspected
Walls	Inspected
Violations	Stair B/1 No violations recorded.
TOILET ROOMS - STAFF	Inspected
Ceiling	Inspected
Condition	2 - Between Good and Fair
Deficiency	No deficiencies recorded
Door(s)	Inspected
Condition	5 - Poor
Deficiency	WOOD: DETERIORATED DOOR
Deficiency Location/Instance	Room 252
Deficiency Quantity	1
Quantity Uom	EACH
Potential Action	MAINTENANCE
Urgency of Action	PRIORITY 3
Purpose of Action	LEVEL 2
Deficiency Photo1

Violations	Room 252 No violations recorded.
Deficiency	METAL CLAD WOOD: DETERIORATED DOOR
Deficiency Location/Instance	Room 256
Deficiency Quantity	1
Quantity Uom	EACH
Potential Action	MAINTENANCE
Urgency of Action	PRIORITY 3
Purpose of Action	LEVEL 2
Deficiency Photo1

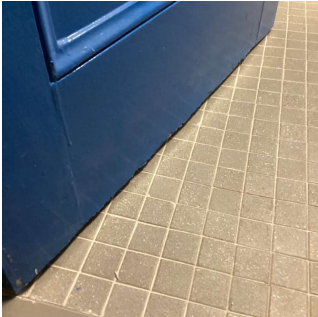
Violations	Room 256 No violations recorded.
Floor Finish	Inspected
Condition	2 - Between Good and Fair
Deficiency	No deficiencies recorded

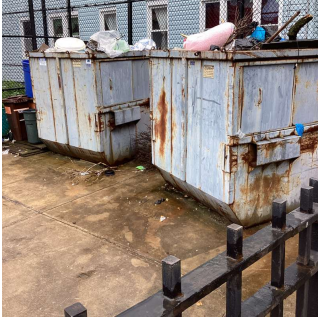
Deficiency	No deficiencies recorded
LIFE SAFETY	Inspected
F.D. HOLDING AREA	Does not Exist
STEEL STAIRS	Does not Exist
SITE	Inspected
CONTAINERIZATION	Inspected
Condition	5 - Poor
Deficiency	CONTAINER DAMAGED
Deficiency Location/Instance	126th Street
Deficiency Quantity	2

Question	Response
SITE	
CONTAINERIZATION	
Quantity Uom	EACH
Potential Action	REPLACE
Urgency of Action	PRIORITY 3
Purpose of Action	LEVEL 2
Deficiency Photo1

126th Street
Violations	No violations recorded.
Drainage System for Asphalt	Inspected
Catch Basins/Manhole - Surrounded by asphalt	Inspected
Condition	2 - Between Good and Fair
Deficiency	No deficiencies recorded
Culverts - Asphalt Covering	Does not Exist
Drainage System for Concrete	Inspected
Catch Basins/Manhole - Surrounded by concrete	Inspected
Condition	5 - Poor
Deficiency	BLOCKED
Deficiency Location/Instance	Exit 10
Deficiency Quantity	1
Quantity Uom	EACH
Potential Action	MAINTENANCE
Urgency of Action	PRIORITY 3
Purpose of Action	LEVEL 2
Deficiency Photo1	 
	Exit 10
Violations	No violations recorded.
Culverts - Concrete Covering	Does not Exist
Drainage System for Soil	Inspected
Catch Basins/Manhole - Surrounded by Soil	Inspected
Condition	2 - Between Good and Fair

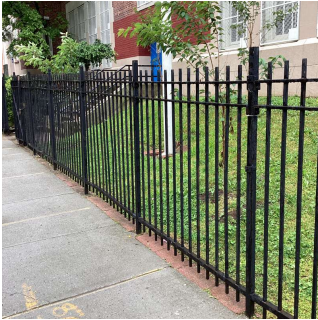
Violations	126th Street 35665294Z
Deficiency	WROUGHT IRON: DAMAGED/DETERIORATED
Deficiency Location/Instance	127th Street, 126th Street
Deficiency Quantity	280
Quantity Uom	S.F.
Potential Action	REPLACE
Urgency of Action	PRIORITY 3
Purpose of Action	LEVEL 2

Violations	127th Street No violations recorded.
IRRIGATION SYSTEM	Does not Exist
PAVING	Inspected
Student Non-Use	Inspected
Gravel Exists?	No
Asphalt	Does not Exist
Concrete	Inspected
Condition	1 - Good
Deficiency	No deficiencies recorded
Pavers	Does not Exist
Student Use	Inspected
Gravel Exists?	No
Asphalt	Inspected
Condition	3 - Fair
Deficiency	LOCALIZED SINK AREA
Deficiency Location/Instance	Schoolyard
Deficiency Quantity	50
Quantity Uom	S.F.
Potential Action	REPAIR
Urgency of Action	PRIORITY 3
Purpose of Action	LEVEL 2
Deficiency Photo1

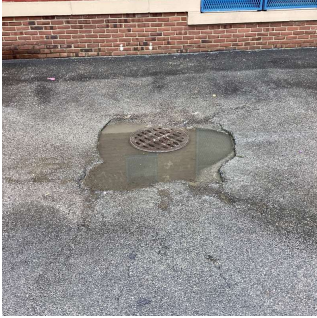
Violations	Schoolyard No violations recorded.
Deficiency	POTHoles
Deficiency Location/Instance	Schoolyard
Deficiency Quantity	100
Quantity Uom	S.F.
Potential Action	REPAIR

Question	Response
SITE	
PAVING	
Student Use	
Asphalt	
Urgency of Action	PRIORITY 5
Purpose of Action	LEVEL 6
Deficiency Photo1

Violations	Schoolyard No violations recorded.
Cracks	
Deficiency	CRACKS - MAJOR
Deficiency Location/Instance	Schoolyard
Deficiency Quantity	100
Quantity Uom	S.F.
Potential Action	REPLACE
Urgency of Action	PRIORITY 3
Purpose of Action	LEVEL 2
Deficiency Photo1

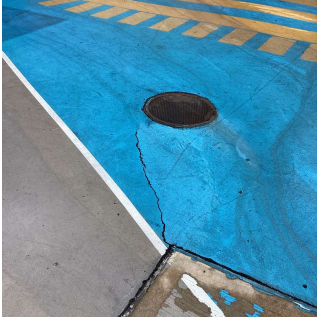
Violations	Schoolyard No violations recorded.
Concrete	Inspected
Condition	1 - Good
Deficiency	No deficiencies recorded
Pavers	Does not Exist
Site Sidewalks & Walkways	Inspected
Asphalt	Inspected
Condition	2 - Between Good and Fair
Deficiency	No deficiencies recorded
Concrete	Inspected
Condition	3 - Fair
Deficiency	CRACKS - MAJOR
Deficiency Location/Instance	Exits 2, 3, 8, Rear of Building
Deficiency Quantity	250
Quantity Uom	S.F.
Potential Action	REPLACE

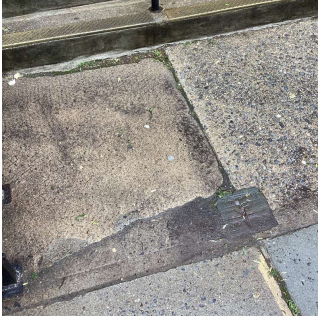
Question	Response
SITE	
PAVING	
Site Sidewalks & Walkways	
Concrete	
Urgency of Action	PRIORITY 3
Purpose of Action	LEVEL 2
Deficiency Photo1

Violations	Exit 3 No violations recorded.
Pavers	Does not Exist
DOT Sidewalk	Inspected
Asphalt	Does not Exist
Concrete	Inspected
Condition	4 - Between Fair and Poor
Deficiency	HEAVING
Deficiency Location/Instance	127th Street
Deficiency Quantity	50
Quantity Uom	S.F.
Potential Action	REPLACE
Urgency of Action	PRIORITY 5
Purpose of Action	LEVEL 6
Deficiency Photo1

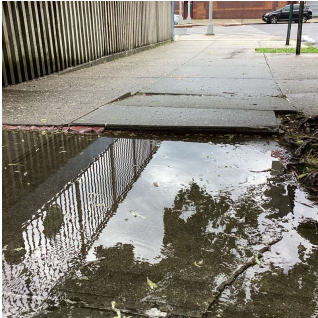
Violations	127th Street No violations recorded.
Deficiency	DAMAGED/DETERIORATED/MISSING SECTIONS
Deficiency Location/Instance	127th Street, 126th Street, Hillside Avenue
Deficiency Quantity	1,200
Quantity Uom	S.F.
Potential Action	REPLACE
Urgency of Action	PRIORITY 3
Purpose of Action	LEVEL 2

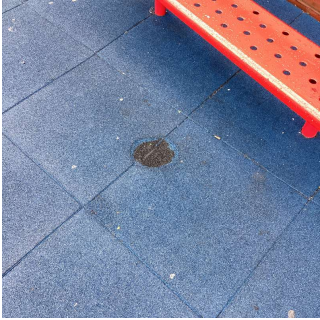
Question	Response
SITE	
PLAYGROUNDS	
Pavement	
Deficiency	No deficiencies recorded
Instance on South Side	Does not Exist
Play Equipment	
Instance on North Side	Inspected
Condition	1 - Good
Deficiency	No deficiencies recorded
Instance on South Side	Inspected
Condition	1 - Good
Deficiency	No deficiencies recorded
Safety Surfacing	
Instance on North Side	Inspected
Condition	2 - Between Good and Fair
Deficiency	DETERIORATED/MISSING
Deficiency Location/Instance	Center
Deficiency Quantity	10
Quantity Uom	S.F.
Potential Action	REPLACE
Urgency of Action	PRIORITY 3
Purpose of Action	LEVEL 2
Deficiency Photo1

Center	
Violations	No violations recorded.
Unpaved Area	
Instance on North Side	Does not Exist
Instance on South Side	Does not Exist
PLAYING SURFACE	Does not Exist
RETAINING WALLS	
Are there any Retaining Walls 6' OR higher facing public street/sidewalk?	Yes
Condition	3 - Fair
Deficiency	CAST IN PLACE CONCRETE: DETERIORATED CONTROL/EXPANSION JOINT
