**NYC Department of Education**  
**Building Condition Assessment Survey 2023 - 2024**

Architectural Inspection

**Asset:** P.S. 56 (OLD R HILL AX) - QUEENS, 86-10 114TH STREET, New York, 11419

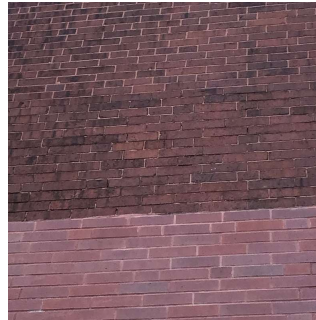
Facade D

BRICK: DETERIORATED JOINTS

30  
 S.F.  
 REPOINT  
 PRIORITY 3  
 LEVEL 2

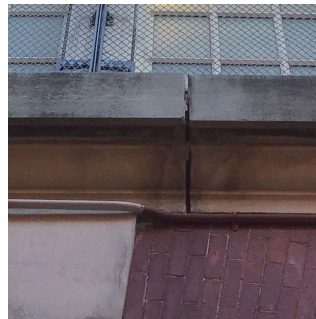
Facade C

STONE: DETERIORATED JOINTS

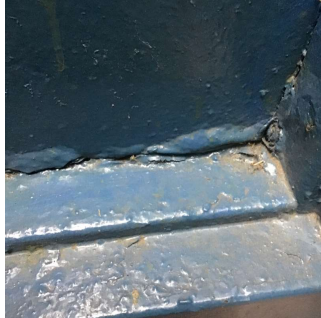
METAL: DENTED, MAJOR RUSTING

20  
 S.F.  
 REPLACE

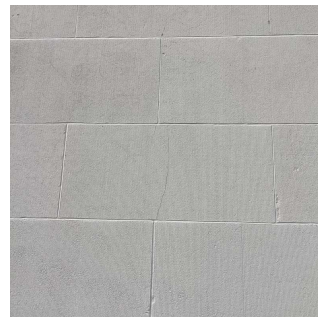
Facade B

STONE: CHIPPED/SPALLED/BROKEN PIECES - MINOR

REPAIR

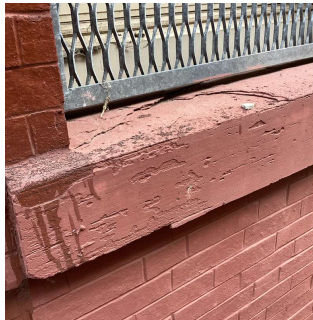
Facade C

BRICK: DETERIORATED MASONRY SILLS - MAJOR

REMOVE AND REPLACE

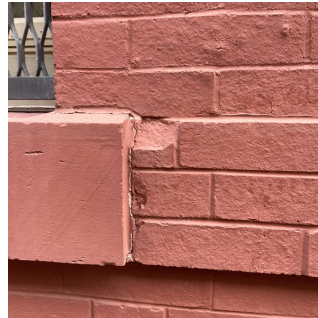
Facade C

BRICK: MAJOR / THRU CRACKS

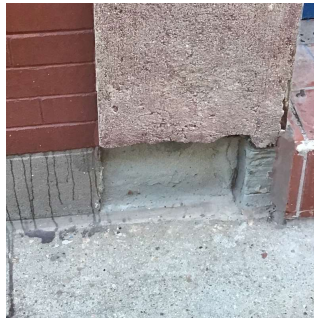
Facade C

CAST IN PLACE / PRE-CAST CONCRETE: MAJOR  
CRACKS/SPALLING

REPLACE

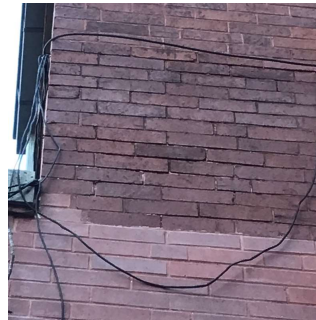
Facade D

BRICK: DETERIORATED JOINTS

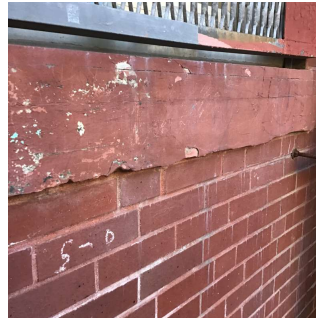
Facade D

BRICK: DETERIORATED MASONRY SILLS - MINOR

REPAIR

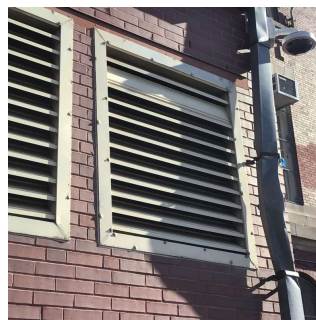
BROKEN/ DENTED BLADES

10  
S.F.  
REPLACE  
PRIORITY 4  
LEVEL 2

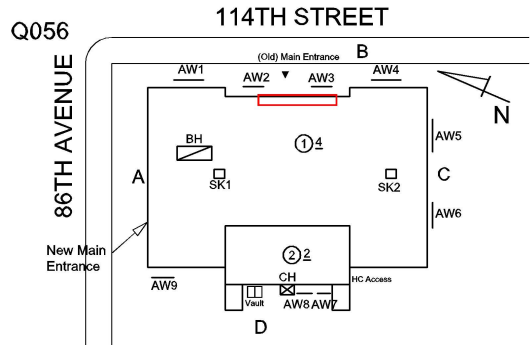
Roof Plan reference

Deficiency **BRICK: EFFLORESCENCE**

Deficiency Quantity	20
Quantity Uom	S.F.
Potential Action	MAINTENANCE
Urgency of Action	PRIORITY 1
Purpose of Action	LEVEL 1
Deficiency Photo1	No photo recorded
Violations	No violations recorded.

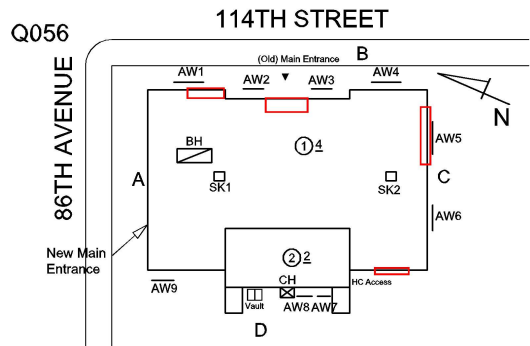
Roof Plan reference

Deficiency **BRICK: MINOR CRACKS, SPALLING**

Deficiency Quantity	100
Quantity Uom	S.F.
Potential Action	REPAIR
Urgency of Action	PRIORITY 3
Purpose of Action	LEVEL 2

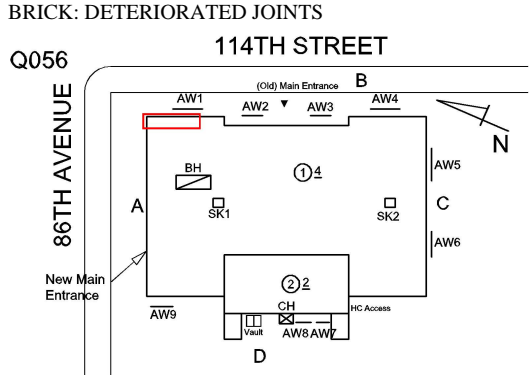
<p>Roof 1</p> <p>No violations recorded.</p>
Violations	BRICK: DETERIORATED JOINTS
Deficiency	
Roof Plan reference	<p>Q056</p>

Deficiency Quantity	20
Quantity Uom	S.F.
Potential Action	REPOINT
Urgency of Action	PRIORITY 4
Purpose of Action	LEVEL 2
Deficiency Photo1

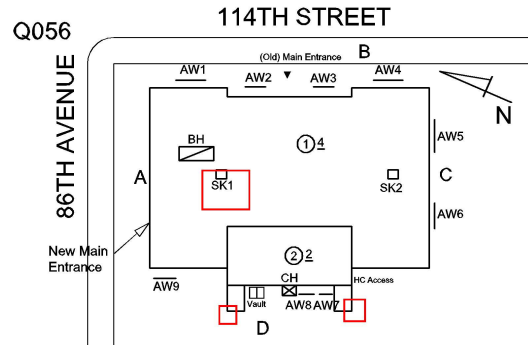
Roof Plan reference

**LEADERS, GUTTERS, DOWNSPOUTS, SCUPPERS**

30  
L.F.  
REPLACE  
PRIORITY 4  
LEVEL 2

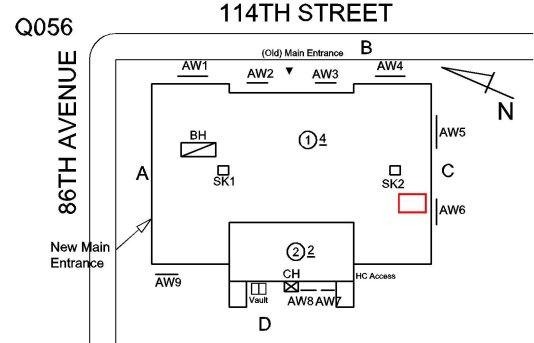
Roof Plan reference

BUILT-UP: ROOFING: MAJOR ACTIVE ROOF LEAKS IN INSTRUCTIONAL SPACE

100

REPLACE ROOFING WITHOUT MAJOR EQUIPMENT REMOVAL

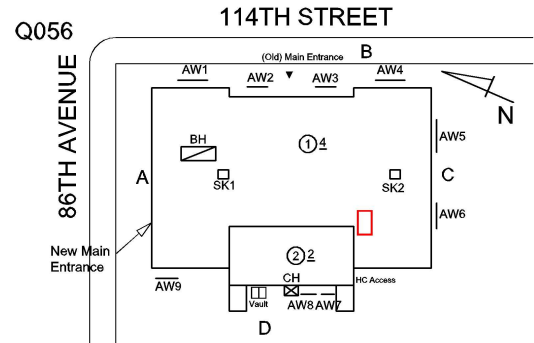
Roof Plan reference

BUILT-UP: ROOFING: LOSS OF GRAVEL

30

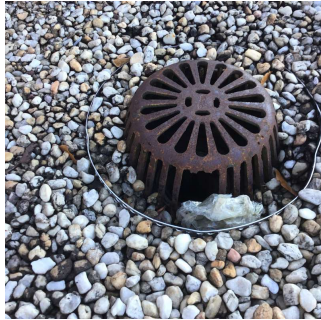
Question	Response
<b>EXTERIOR</b>	
<b>ROOF</b>	
<b>Roofing</b>	
<b>ROOFING DRAINS</b>	
Urgency of Action	PRIORITY 4
Purpose of Action	LEVEL 2
Deficiency Photo1

Violations	Roof 1 No violations recorded.
<b>Specialties</b>	Inspected
<b>BULKHEAD/PENTHOUSE</b>	Inspected
Condition	3 - Fair
Deficiency	BULKHEAD/PENTHOUSE WINDOWS: DAMAGED, DETERIORATED WINDOWS
Roof Plan reference

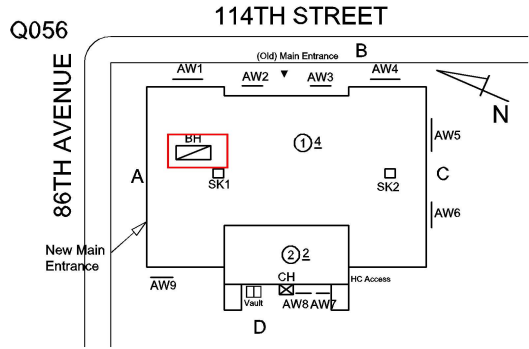
Deficiency Quantity	10
Quantity Uom	S.F.
Potential Action	REPLACE
Urgency of Action	PRIORITY 4
Purpose of Action	LEVEL 2
Deficiency Photo1

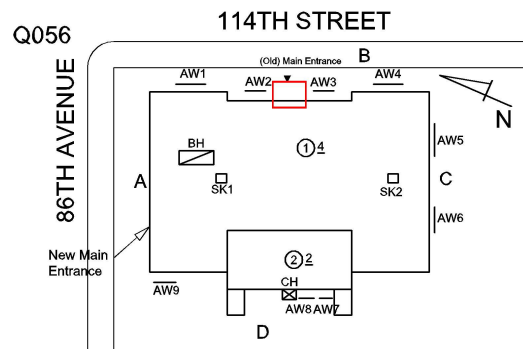
Question	Response
<b>EXTERIOR</b>	
<b>ROOF</b>	
<b>Specialties</b>	
<b>DUNNAGE STEEL</b>	Does not Exist
<b>SKYLIGHT/ROOF VENT</b>	Inspected
Material Type(s)	Glass
Condition	2 - Between Good and Fair
Deficiency	No deficiencies recorded
<b>ROOF/GRAVITY TANK</b>	Does not Exist
<b>STAIRS/RAMPS: EXTERIOR</b>	Inspected
<b>BUILDING CHEEK/FLANK WALLS</b>	Inspected
Condition	4 - Between Fair and Poor
Deficiency	STONE: CRACKS/SPALLING - MAJOR
Roof Plan reference

Deficiency Quantity	20
Quantity Uom	S.F.
Potential Action	REPLACE
Urgency of Action	PRIORITY 4
Purpose of Action	LEVEL 2
Deficiency Photo1

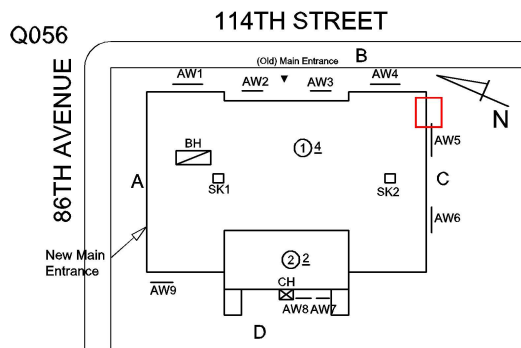
Roof Plan reference

Violations	Facade B No violations recorded.
<b>RAILINGS</b>	Inspected
Condition	2 - Between Good and Fair
Deficiency	No deficiencies recorded
<b>STAIRS/RAMPS</b>	Inspected
Condition	4 - Between Fair and Poor
Deficiency	STONE: WORN-OUT TREAD/RISER/NOSING

10  
 S.F.  
 REPLACE  
 PRIORITY 4  
 LEVEL 2

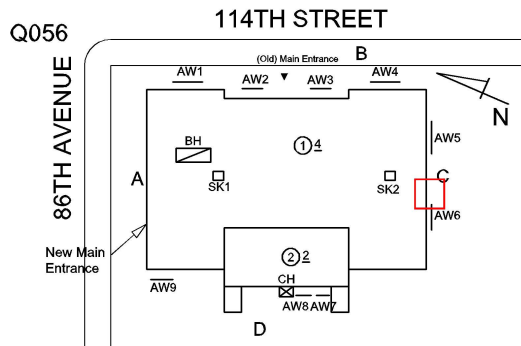
Roof Plan reference

**BRICK: WORN-OUT TREAD/RISER/NOSING**

10  
 S.F.  
 REPLACE  
 PRIORITY 4  
 LEVEL 2

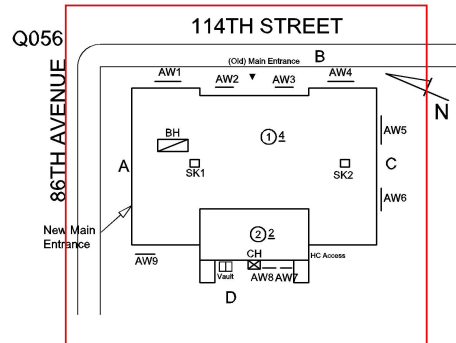
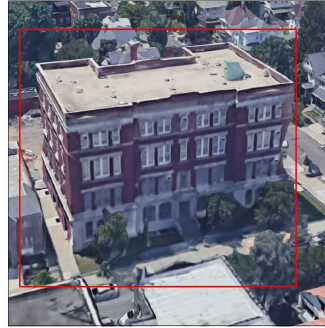
Roof Plan reference

ALUMINUM - DOUBLE HUNG: INOPERABLE BALANCE

30  
EACH  
REPLACE BALANCES  
PRIORITY 3  
LEVEL 2  
No photo recorded  
No violations recorded.

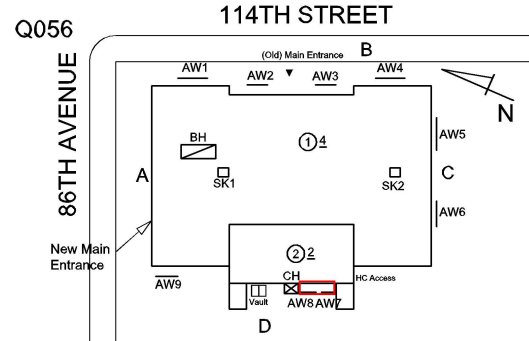
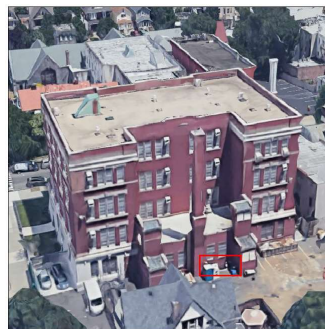
Roof Plan reference

WOOD: DETERIORATED

30  
S.F.  
REPLACE WINDOW

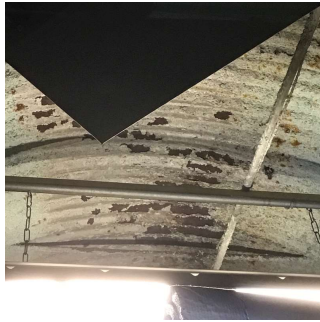
Violations	Basement - Boiler Room No violations recorded.
Deficiency	CINDER CONCRETE ARCH: METAL PAN DETERIORATED, SPALLED
Deficiency Location/Instance	Basement - Various locations
Deficiency Quantity	30
Quantity Uom	S.F.
Potential Action	REPAIR
Urgency of Action	PRIORITY 3
Purpose of Action	LEVEL 5
Deficiency Photo1

Violations	Basement - Boiler Room No violations recorded.
<b>FOUNDATION WALLS</b>	Inspected
Material Type(s)	Masonry
Condition	2 - Between Good and Fair
Deficiency	No deficiencies recorded
<b>ROOF STRUCTURE</b>	Inspected
Condition	2 - Between Good and Fair
Deficiency	No deficiencies recorded
<b>VAULTS-BUNKERS</b>	Inspected
<b>Foundation Walls</b>	Inspected
Condition	4 - Between Fair and Poor
Deficiency	WATER INFILTRATION IN NON- INSTRUCTIONAL SPACE
Deficiency Location/Instance	Basement - Ash Hoist Vault

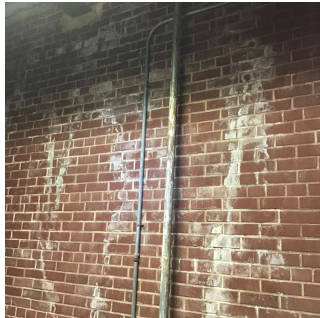
Deficiency Quantity	100
Quantity Uom	S.F.
Potential Action	INSTALL WATERPROOFING
Urgency of Action	PRIORITY 5
Purpose of Action	LEVEL 5

Violations	Basement - Ash Hoist Vault No violations recorded.
<b>Slab Structure</b>	Inspected
Condition	3 - Fair
Deficiency	STEEL COLUMNS/BEAMS: DETERIORATED/MISSING SPRAY-ON FIREPROOFING
Deficiency Location/Instance	Basement - Ash Hoist Vault
Deficiency Quantity	30
Quantity Uom	S.F.
Potential Action	REPLACE
Urgency of Action	PRIORITY 3
Purpose of Action	LEVEL 5
Deficiency Photo1

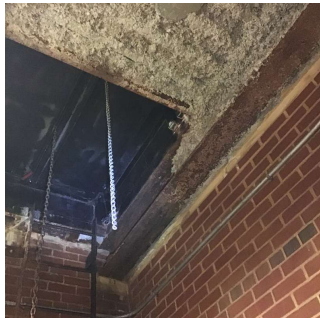
Violations	Basement - Ash Hoist Vault No violations recorded.
<b>Vault/Ash Hoist Doors and Framing</b>	Inspected
Condition	5 - Poor
Deficiency	WATER INFILTRATION
Deficiency Location/Instance	Basement - Ash Hoist Vault
Deficiency Quantity	10
Quantity Uom	S.F.
Potential Action	REPAIR
Urgency of Action	PRIORITY 5
Purpose of Action	LEVEL 2

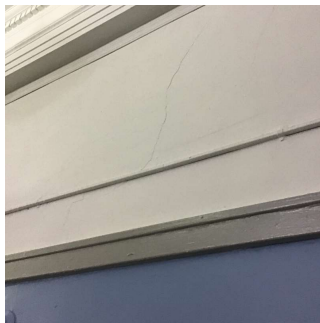
Question	Response
<b>INTERIOR</b>	
<b>AUDITORIUM</b>	
<b>Walls</b>	
Deficiency Photo1

Violations	Rear wall No violations recorded.
<b>Window Curtains/Shades/Blinds</b>	
Instance on Ground Floor (238 Seats)	Inspected
Condition	1 - Good
Deficiency	No deficiencies recorded
<b>CAFETERIA</b>	
Instance on Ground Floor	Inspected
<b>Ceiling</b>	
Instance on Ground Floor	Inspected
Condition	2 - Between Good and Fair
Deficiency	No deficiencies recorded
<b>Door(s)</b>	
Instance on Ground Floor	Inspected
Condition	2 - Between Good and Fair
Deficiency	No deficiencies recorded
<b>Fixed Equipment</b>	
Instance on Ground Floor	Inspected
Condition	3 - Fair
Deficiency	DAMAGED/MISSING
Deficiency Location/Instance	Near Exit 6
Deficiency Quantity	1
Quantity Uom	EACH
Potential Action	MAINTENANCE
Urgency of Action	PRIORITY 3
Purpose of Action	LEVEL 2
Deficiency Photo1

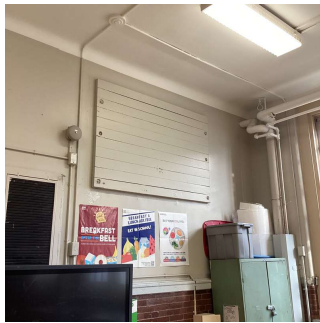
Violations	Near Exit 6 No violations recorded.
<b>Floor Finish</b>

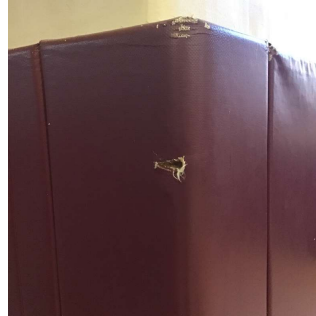
Near Stair A

WALL PADDING: DETERIORATED

REPLACE

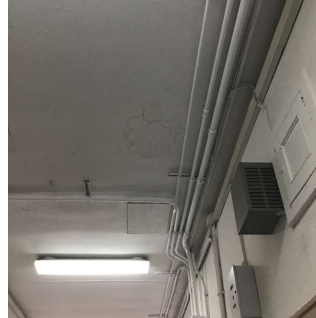
Corridor near room 303A

PLASTER: CRACKS/SPALLING

REPLACE

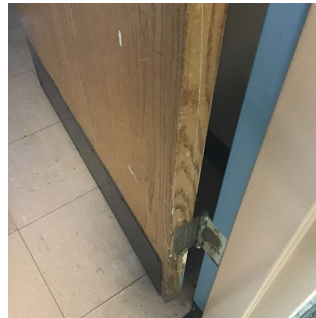
WOOD: DETERIORATED DOOR

Question	Response
<b>INTERIOR</b>	
<b>CLASSROOMS/CORRIDORS/ADMIN SPACES</b>	
<b>Door(s)</b>	Inspected
	Room 205
Violations	No violations recorded.
<b>Floor Finish</b>	Inspected
Condition	4 - Between Fair and Poor
Deficiency	VINYL TILES: BROKEN/DETERIORATED/MISSING TILES
Deficiency Location/Instance	Rooms 301, 302
Deficiency Quantity	20
Quantity Uom	S.F.
Potential Action	REPLACE
Urgency of Action	PRIORITY 3
Purpose of Action	LEVEL 2
Deficiency Photo1	 
	Room 301
Violations	No violations recorded.
Deficiency	VINYL TILES: DETERIORATED SUBSTRATE
Deficiency Location/Instance	Room 301, 303A, 306, 307, 308 and others
Deficiency Quantity	2,000
Quantity Uom	S.F.
Potential Action	REPLACE
Urgency of Action	PRIORITY 3
Purpose of Action	LEVEL 2
Deficiency Photo1

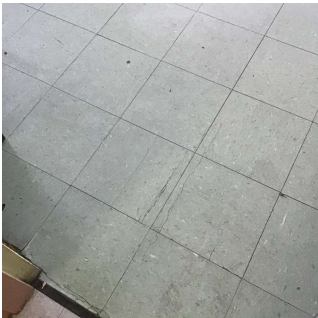
Room 301
Violations	No violations recorded.
<b>Walls</b>	Inspected
Condition	2 - Between Good and Fair
Deficiency	PLASTER: CRACKS/SPALLING - ACTIVE LEAK
Deficiency Location/Instance	Room 351

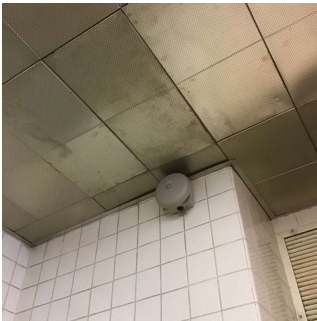
Question	Response
<b>INTERIOR</b>	
<b>KITCHEN</b>	
<b>Ceiling</b>	
Deficiency Photo1

Near Entrance
Violations	No violations recorded.
<b>Door(s)</b>	
Instance on Ground Floor	Inspected
Condition	2 - Between Good and Fair
Deficiency	No deficiencies recorded
<b>Floor Finish</b>	
Instance on Ground Floor	Inspected
Condition	3 - Fair
Deficiency	VINYL TILES: DETERIORATED SUBSTRATE
Deficiency Location/Instance	Room B109, B112
Deficiency Quantity	60
Quantity Uom	S.F.
Potential Action	REPLACE
Urgency of Action	PRIORITY 3
Purpose of Action	LEVEL 2
Deficiency Photo1

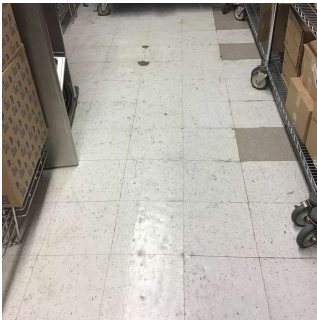
Room B109
Violations	No violations recorded.
<b>Walls</b>	
Instance on Ground Floor	Inspected
Condition	2 - Between Good and Fair
Deficiency	PLASTER: CRACKS/SPALLING
Deficiency Location/Instance	Room B109
Deficiency Quantity	25
Quantity Uom	S.F.
Potential Action	REPLACE
Urgency of Action	PRIORITY 3
Purpose of Action	LEVEL 2

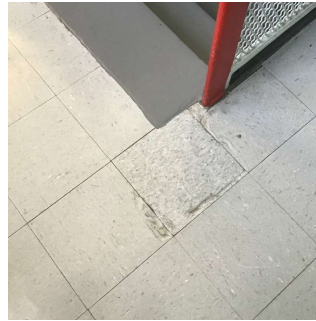
Stair AB/2

**Stairs and Landings**

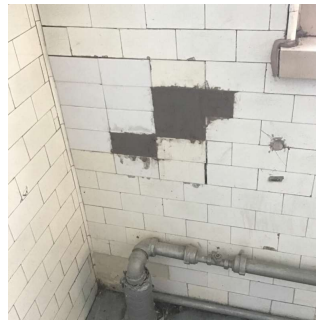
Stair AB/3

CERAMIC TILE: BROKEN/ MISSING

REPLACE

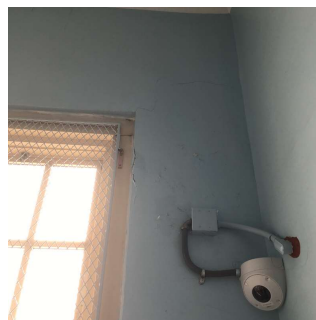
PLASTER: CRACKS/SPALLING

Question	Response
<b>INTERIOR</b>	
<b>STAIRS/RAMPS: INTERIOR</b>	Inspected
<b>Walls</b>	Inspected
Violations	Stair CD/3 No violations recorded.
<b>TOILET ROOMS - STAFF</b>	Inspected
<b>Ceiling</b>	Inspected
Condition	2 - Between Good and Fair
Deficiency	No deficiencies recorded
<b>Door(s)</b>	Inspected
Condition	5 - Poor
Deficiency	WOOD: DETERIORATED DOOR
Deficiency Location/Instance	Room 351, 251N, 102A
Deficiency Quantity	3
Quantity Uom	EACH
Potential Action	MAINTENANCE
Urgency of Action	PRIORITY 3
Purpose of Action	LEVEL 2
Deficiency Photo1

REPLACE

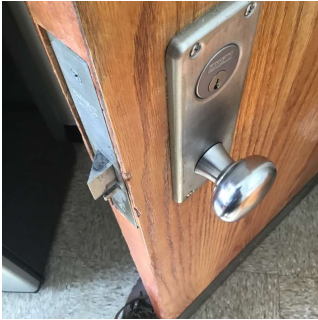
Violations	Room 351 No violations recorded.
<b>Floor Finish</b>	Inspected
Condition	5 - Poor
Deficiency	CERAMIC TILE: BROKEN/MISSING TILES
Deficiency Location/Instance	Kitchen Staff Restroom, 2nd Floor Nurse, 102A
Deficiency Quantity	30
Quantity Uom	S.F.
Potential Action	REPLACE
Urgency of Action	PRIORITY 3
Purpose of Action	LEVEL 2
Deficiency Photo1

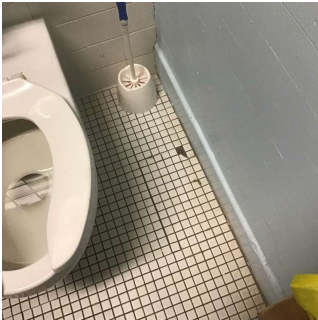
Violations	Kitchen Staff Restroom No violations recorded.

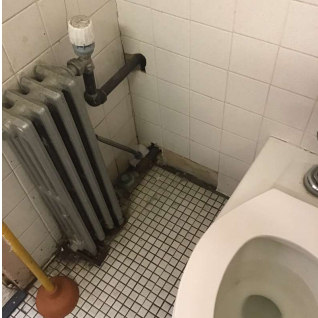
Question	Response
<b>INTERIOR</b>	
<b>TOILET ROOMS - STAFF</b>	Inspected
<b>Stalls</b>	Does not Exist
<b>Walls</b>	Inspected
Condition	2 - Between Good and Fair
Deficiency	CERAMIC TILE: BROKEN/ MISSING
Deficiency Location/Instance	Rooms 351, 102A,100A
Deficiency Quantity	30
Quantity Uom	S.F.
Potential Action	REPLACE
Urgency of Action	PRIORITY 3
Purpose of Action	LEVEL 2
Deficiency Photo1

Violations	3rd Floor Staff No violations recorded.
Deficiency	PLASTER: CRACKS/SPALLING
Deficiency Location/Instance	Room 351
Deficiency Quantity	20
Quantity Uom	S.F.
Potential Action	REPLACE
Urgency of Action	PRIORITY 3
Purpose of Action	LEVEL 2
Deficiency Photo1
