NYC Department of Education
Building Condition Assessment Survey 2023 - 2024

Architectural Inspection

Asset: P.S. 64 - QUEENS, 82-01 101 AVENUE, New York, 11416

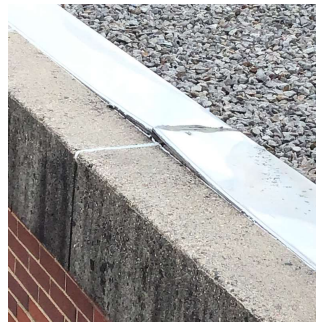
Penthouse Roof

Question	Response
Architectural	
EXTERIOR	Inspected
AREAWAY	Inspected
Instance on AW1-AW9	Inspected
Instance Condition	2 - Between Good and Fair
Instance Quantity	9
Instance Quantity Uom	EACH
Deficiency	No deficiencies recorded
AWNINGS AND CANOPIES	Does not Exist
CHIMNEY	Inspected
Material Type(s)	Masonry
Condition	2 - Between Good and Fair
Deficiency	No deficiencies recorded
COPING	Inspected
Condition	3 - Fair
Deficiency	METAL: DETERIORATED
Roof Plan reference	
Deficiency Quantity	10
Quantity Uom	L.F.
Potential Action	REPLACE-IN-KIND
Urgency of Action	PRIORITY 4

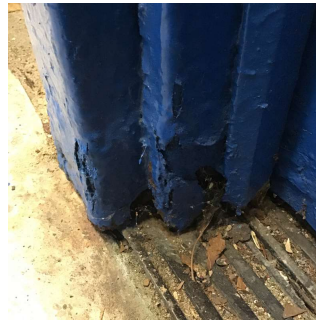
Facade A

METAL: DETERIORATED DOOR AND FRAME - MAJOR DETERIORATION

Deficiency Quantity	4
Quantity Uom	EACH
Potential Action	REPLACE
Urgency of Action	PRIORITY 4
Purpose of Action	LEVEL 2
Deficiency Photo1

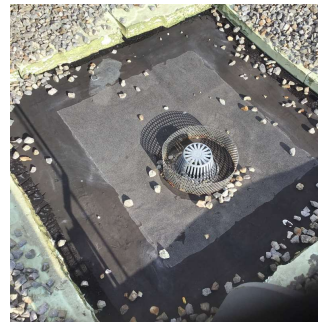
Roof 4 - Bulkhead 2

IRMA: ROOFING: LOSS OF GRAVEL

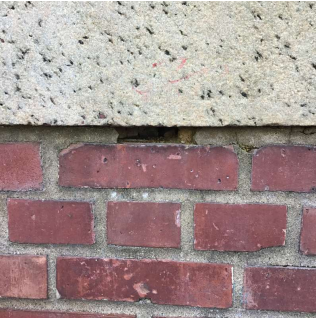
Violations	Facade D No violations recorded.

Question	Response
EXTERIOR	
ROOF	Inspected
Specialties	Inspected
SKYLIGHT/ROOF VENT	Inspected
Condition	2 - Between Good and Fair
Deficiency	No deficiencies recorded
ROOF/GRAVITY TANK	Does not Exist
STAIRS/RAMPS: EXTERIOR	Inspected
BUILDING CHEEK/FLANK WALLS	Inspected
Condition	3 - Fair
Deficiency	BRICK: DETERIORATED JOINTS
Roof Plan reference

<p align="center">Q064 82ND STREET 101ST AVENUE 83RD STREET</p>
Deficiency Quantity	10
Quantity Uom	S.F.
Potential Action	REPOINT
Urgency of Action	PRIORITY 4
Purpose of Action	LEVEL 2
Deficiency Photo1

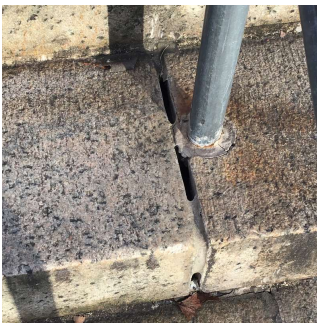
STONE: DETERIORATED JOINTS

10
 L.F.
 REPOINT
 PRIORITY 4
 LEVEL 2

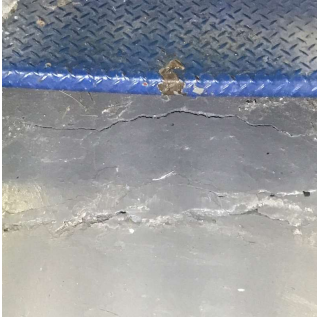
Question	Response
INTERIOR	Inspected
POOLS	Does not Exist
STRUCTURAL	Inspected
COLUMNS/BEAMS/BEARING WALLS	Inspected
Condition	2 - Between Good and Fair
Deficiency	No deficiencies recorded
FLOOR STRUCTURE	Inspected
Condition	3 - Fair
Deficiency	CONCRETE SLAB ON GRADE: THRU CRACKS
Deficiency Location/Instance	Basement - Boiler Room
Deficiency Quantity	30
Quantity Uom	S.F.
Potential Action	REPAIR
Urgency of Action	PRIORITY 3
Purpose of Action	LEVEL 5
Deficiency Photo1

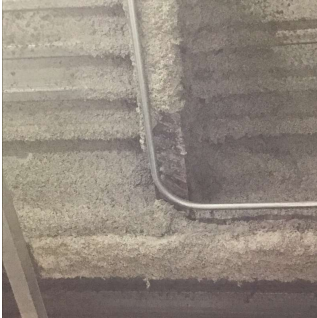
Violations	Basement - Boiler Room No violations recorded.
FOUNDATION WALLS	Inspected
Material Type(s)	Concrete
Condition	2 - Between Good and Fair
Deficiency	No deficiencies recorded
ROOF STRUCTURE	Inspected
Condition	3 - Fair
Deficiency	STEEL COLUMNS/BEAMS: DETERIORATED/MISSING SPRAY-ON FIREPROOFING
Deficiency Location/Instance	Penthouse Roof
Deficiency Quantity	30
Quantity Uom	S.F.
Potential Action	REPLACE
Urgency of Action	PRIORITY 3
Purpose of Action	LEVEL 5

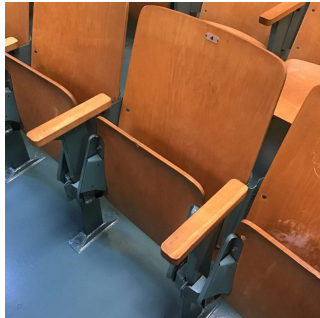
Seat L/4
Violations	No violations recorded.
Floor Finish	
Instance on 1st Floor (350 Seats)	Inspected
Condition	2 - Between Good and Fair
Deficiency	TERRAZZO: CRACKS
Deficiency Location/Instance	Vestibule 2

Question	Response
INTERIOR	
AUDITORIUM	
Instance on 1st Floor (350 Seats)	Inspected
Ceiling	
Instance on 1st Floor (350 Seats)	Inspected
Condition	2 - Between Good and Fair
Deficiency	No deficiencies recorded
Door(s)	
Instance on 1st Floor (350 Seats)	Inspected
Condition	2 - Between Good and Fair
Deficiency	No deficiencies recorded
Fixed H/C Lift	
Instance on 1st Floor (350 Seats)	Does not Exist
Fixed Seating	
Instance on 1st Floor (350 Seats)	Inspected
Condition	2 - Between Good and Fair
Deficiency	DAMAGED/BROKEN/INOPERABLE
Deficiency Location/Instance	Seat L/C, F/104, F/111
Deficiency Quantity	3
Quantity Uom	EACH
Potential Action	REPLACE
Urgency of Action	PRIORITY 3
Purpose of Action	LEVEL 2
Deficiency Photo1

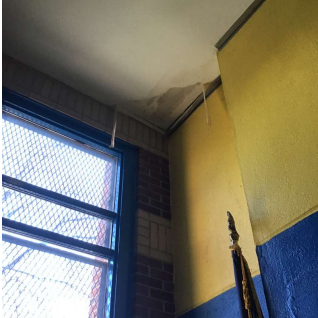
Question	Response
INTERIOR	
CAFETERIA	Inspected
Walls	
Deficiency	No deficiencies recorded
Window Curtains/Shades/Blinds	
Instance on 1st Floor	Does not Exist
CLASSROOMS/CORRIDORS/ADMIN SPACES	Inspected
Ceiling	Inspected
Condition	2 - Between Good and Fair
Deficiency	GYPSUM BOARD: DAMAGED/DETERIORATED - ACTIVE LEAK
Deficiency Location/Instance	Main Entrance Lobby, Exit 6/7 Vestibule,
Deficiency Quantity	30
Quantity Uom	S.F.
Potential Action	REPLACE
Urgency of Action	PRIORITY 5
Purpose of Action	LEVEL 2
Deficiency Photo1

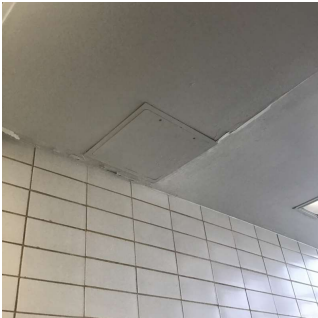
Violations	Main Entrance Lobby No violations recorded.
Deficiency	GYPSUM BOARD: DAMAGED/DETERIORATED
Deficiency Location/Instance	Corridor near rooms 260, 257, 252
Deficiency Quantity	30
Quantity Uom	S.F.
Potential Action	REPLACE
Urgency of Action	PRIORITY 3
Purpose of Action	LEVEL 2
Deficiency Photo1

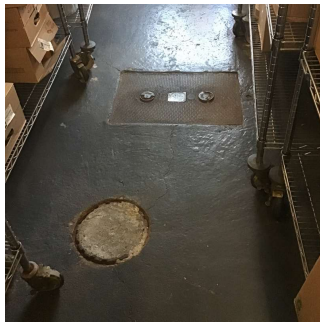
Question	Response
INTERIOR	
KITCHEN	
Ceiling	
Violations	No violations recorded.
Door(s)	
Instance on 1st Floor	Inspected
Condition	2 - Between Good and Fair
Deficiency	No deficiencies recorded
Floor Finish	
Instance on 1st Floor	Inspected
Condition	2 - Between Good and Fair
Deficiency	CONCRETE: CRACKS
Deficiency Location/Instance	Storage Room
Deficiency Quantity	30
Quantity Uom	S.F.
Potential Action	REPLACE
Urgency of Action	PRIORITY 3
Purpose of Action	LEVEL 2
Deficiency Photo1

Storage Room
Violations	No violations recorded.
Walls	
Instance on 1st Floor	Inspected
Condition	2 - Between Good and Fair
Deficiency	PLASTER: CRACKS/SPALLING
Deficiency Location/Instance	Storage Room
Deficiency Quantity	20
Quantity Uom	S.F.
Potential Action	REPLACE
Urgency of Action	PRIORITY 3
Purpose of Action	LEVEL 2
Deficiency Photo1	 
	Storage Room
Violations	No violations recorded.

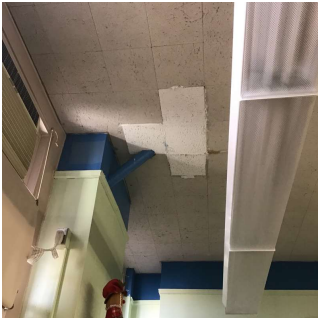
Question	Response
INTERIOR	
KITCHEN	
Walls	
Deficiency	BRICK: CRACKS/SPALLING
Deficiency Location/Instance	Storage Room
Deficiency Quantity	25
Quantity Uom	S.F.
Potential Action	REPLACE
Urgency of Action	PRIORITY 3
Purpose of Action	LEVEL 2
Deficiency Photo1	 
	Storage Room
Violations	No violations recorded.
LIBRARY	
	Inspected
Instance on Room 334	Inspected
Built-in Furnishing	
Instance on Room 334	Does not Exist
Ceiling	
Instance on Room 334	Inspected
Condition	2 - Between Good and Fair
Deficiency	ACOUSTIC TILES ON PLASTER: DAMAGED/MISSING
Deficiency Location/Instance	Near Windows
Deficiency Quantity	10
Quantity Uom	S.F.
Potential Action	REPLACE
Urgency of Action	PRIORITY 3
Purpose of Action	LEVEL 2
Deficiency Photo1

Near Windows
Violations	No violations recorded.
Door(s)	
Instance on Room 334	Inspected
Condition	2 - Between Good and Fair
Deficiency	No deficiencies recorded

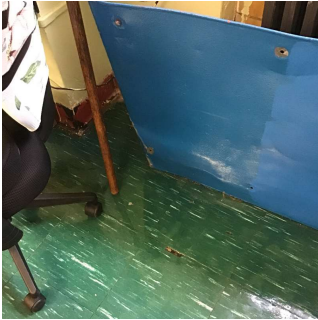
Question	Response
INTERIOR	
LIBRARY	
Floor Finish	
Instance on Room 334	Inspected
Condition	2 - Between Good and Fair
Deficiency	VINYL TILES: BROKEN/DETERIORATED/MISSING TILES
Deficiency Location/Instance	Near Windows, Center
Deficiency Quantity	15
Quantity Uom	S.F.
Potential Action	REPLACE
Urgency of Action	PRIORITY 3
Purpose of Action	LEVEL 2
Deficiency Photo1

Violations	Near Windows No violations recorded.
Walls	
Instance on Room 334	Inspected
Condition	2 - Between Good and Fair
Deficiency	No deficiencies recorded
LOCKER ROOM	Does not Exist
MULTI-PURPOSE ROOM	Does not Exist
SCIENCE DEMO ROOM	Does not Exist
SCIENCE LAB	Does not Exist
SCIENCE PREP ROOM	Does not Exist
SHOWER ROOM	Does not Exist
STAIRS/RAMPS: INTERIOR	
Do Letter Stair Signs Exist?	Yes
Ceiling	
Instance on Room 334	Inspected
Condition	2 - Between Good and Fair
Deficiency	No deficiencies recorded
Door(s)	
Instance on Room 334	Inspected
Condition	5 - Poor

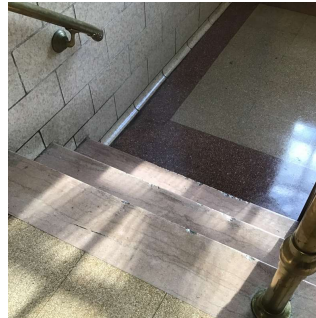
Vestibule near room 113

STONE: BROKEN/MISSING

REPLACE

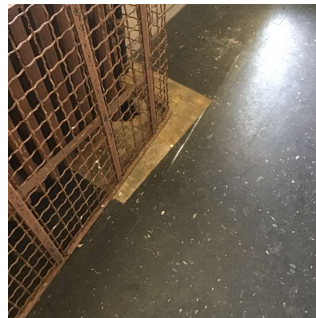
Stair G/Bulkhead

VINYL TILES: BROKEN/DETERIORATED/MISSING TILES

REPLACE

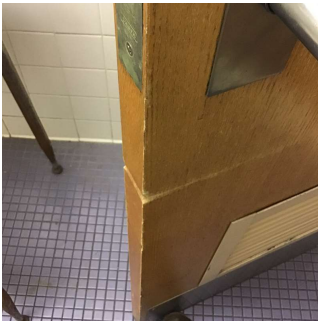
Violations	Room 259 No violations recorded.
Door(s)	Inspected
Condition	5 - Poor
Deficiency	WOOD: DETERIORATED DOOR
Deficiency Location/Instance	3rd Floor Staff, Principal
Deficiency Quantity	2
Quantity Uom	EACH
Potential Action	MAINTENANCE
Urgency of Action	PRIORITY 3
Purpose of Action	LEVEL 2
Deficiency Photo1

Violations	3rd Floor Staff No violations recorded.
Floor Finish	Inspected
Condition	2 - Between Good and Fair
Deficiency	No deficiencies recorded
Stalls	Inspected

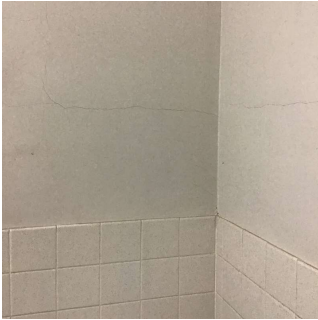
Question	Response
INTERIOR	
TOILET ROOMS - STAFF	Inspected
Stalls	Inspected
Condition	2 - Between Good and Fair
Deficiency	No deficiencies recorded
Walls	Inspected
Condition	2 - Between Good and Fair
Deficiency	GYPSON BOARD: DETERIORATED
Deficiency Location/Instance	Room 160, 159
Deficiency Quantity	25
Quantity Uom	S.F.
Potential Action	REPLACE
Urgency of Action	PRIORITY 3
Purpose of Action	LEVEL 2
Deficiency Photo1

Violations	Room 160 No violations recorded.
Deficiency	CERAMIC TILE: BROKEN/ MISSING
Deficiency Location/Instance	Kitchen Staff
Deficiency Quantity	10
Quantity Uom	S.F.
Potential Action	REPLACE
Urgency of Action	PRIORITY 3
Purpose of Action	LEVEL 2
Deficiency Photo1

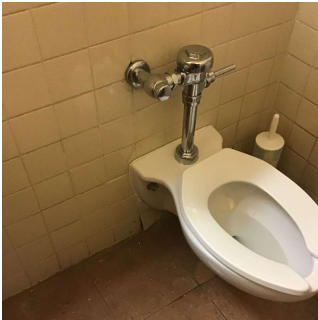
Violations	Kitchen Staff No violations recorded.
TOILET ROOMS - STUDENTS	Inspected
Ceiling	Inspected
Condition	2 - Between Good and Fair
Deficiency	No deficiencies recorded
Door(s)	Inspected
Condition	5 - Poor
Deficiency	WOOD: DETERIORATED DOOR

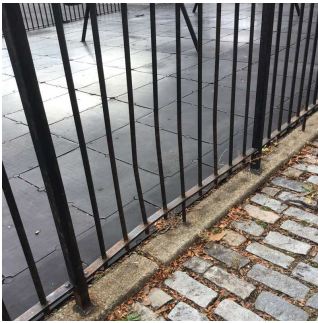
Question	Response
SITE	
CONTAINERIZATION	Does not Exist
Drainage System for Asphalt	Inspected
Catch Basins/Manhole - Surrounded by asphalt	Inspected
Condition	2 - Between Good and Fair
Deficiency	No deficiencies recorded
Culverts - Asphalt Covering	Does not Exist
Drainage System for Concrete	Inspected
Catch Basins/Manhole - Surrounded by concrete	Inspected
Condition	2 - Between Good and Fair
Deficiency	No deficiencies recorded
Culverts - Concrete Covering	Does not Exist
Drainage System for Soil	Inspected
Catch Basins/Manhole - Surrounded by Soil	Inspected
Condition	2 - Between Good and Fair
Deficiency	No deficiencies recorded
Culverts - Soil Covering	Does not Exist
DRINKING FOUNTAINS	Does not Exist
FENCES	Inspected
Condition	4 - Between Fair and Poor
Deficiency	WROUGHT IRON: DAMAGED/DETERIORATED
Deficiency Location/Instance	Near NYC Park
Deficiency Quantity	80
Quantity Uom	S.F.
Potential Action	REPLACE
Urgency of Action	PRIORITY 3

Near NYC Park
Violations	No violations recorded.
Deficiency	CONCRETE CURB: DAMAGED/DETERIORATED
Deficiency Location/Instance	Schoolyard, 82nd Street, 83rd Street
Deficiency Quantity	75
Quantity Uom	S.F.
Potential Action	REPLACE
Urgency of Action	PRIORITY 3
Purpose of Action	LEVEL 2

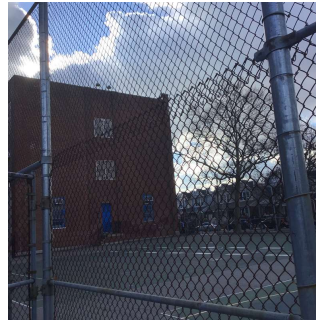
Schoolyard

CHAIN LINK: DAMAGED POST/RAIL

REPLACE

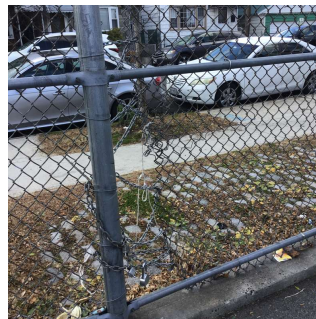
Schoolyard

CHAIN LINK: DAMAGED/DETERIORATED

REPLACE

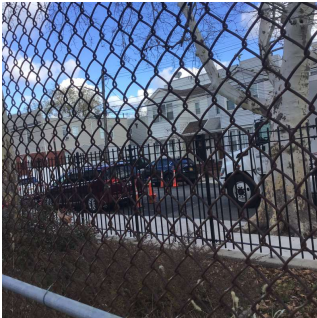
CHAIN LINK: RUST - MAJOR

Question	Response
SITE	
FENCES	
Deficiency Location/Instance	Schoolyard
Deficiency Quantity	2,300
Quantity Uom	S.F.
Potential Action	REPLACE
Urgency of Action	PRIORITY 3
Purpose of Action	LEVEL 2
Deficiency Photo1

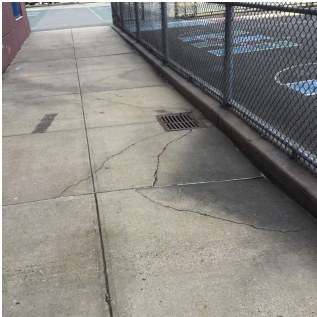
Question	Response
SITE	
PAVING	
Student Use	
Concrete	Inspected
Condition	2 - Between Good and Fair
Deficiency	No deficiencies recorded
Pavers	Does not Exist
Site Sidewalks & Walkways	Inspected
Asphalt	Does not Exist
Concrete	Inspected
Condition	3 - Fair
Deficiency	CRACKS - MAJOR
Deficiency Location/Instance	Near Schoolyard
Deficiency Quantity	125
Quantity Uom	S.F.
Potential Action	REPLACE
Urgency of Action	PRIORITY 3
Purpose of Action	LEVEL 2
Deficiency Photo1

Near Schoolyard
Violations	No violations recorded.
Pavers	Inspected
Condition	2 - Between Good and Fair
Deficiency	DAMAGED/MISSING
Deficiency Location/Instance	Near NYC Parks
Deficiency Quantity	15
Quantity Uom	S.F.
Potential Action	REPLACE
Urgency of Action	PRIORITY 3
Purpose of Action	LEVEL 2
Deficiency Photo1

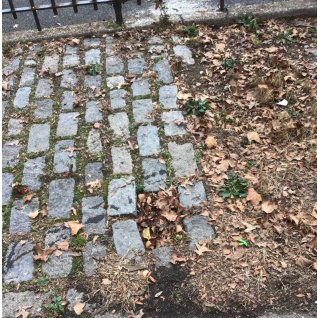
Near NYC Parks
Violations	No violations recorded.
DOT Sidewalk	Inspected

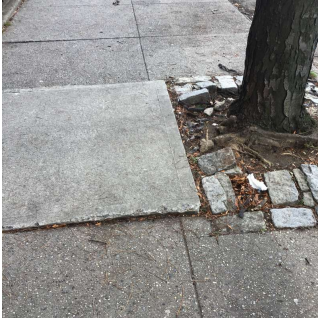
Question	Response
SITE	
PAVING	
DOT Sidewalk	
Asphalt	Does not Exist
Concrete	Inspected
Condition	3 - Fair
Deficiency	HEAVING
Deficiency Location/Instance	82nd Street
Deficiency Quantity	200
Quantity Uom	S.F.
Potential Action	REPLACE
Urgency of Action	PRIORITY 3
Purpose of Action	LEVEL 2
Deficiency Photo1

82nd Street
Violations	No violations recorded.
Deficiency	DAMAGED CURBS
Deficiency Location/Instance	82nd Street , 83rd Street
Deficiency Quantity	60
Quantity Uom	L.F.
Potential Action	REPLACE
Urgency of Action	PRIORITY 3
Purpose of Action	LEVEL 2
Deficiency Photo1

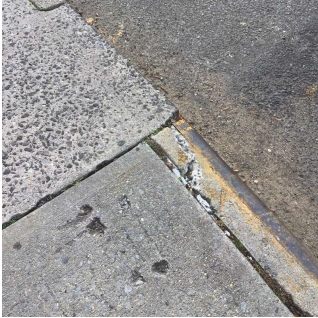
82nd Street
Violations	No violations recorded.
Deficiency	DAMAGED/DETERIORATED/MISSING SECTIONS
Deficiency Location/Instance	82nd Street , 83rd Street
Deficiency Quantity	200
Quantity Uom	S.F.
Potential Action	REPLACE
Urgency of Action	PRIORITY 3
Purpose of Action	LEVEL 2

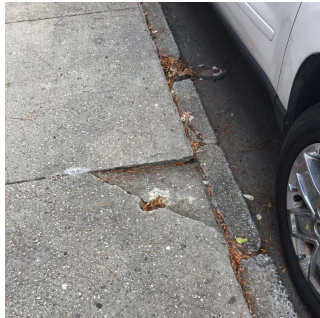
Violations	82nd Street No violations recorded.
Pavers	Inspected
Condition	3 - Fair
Deficiency	DAMAGED/MISSING
Deficiency Location/Instance	82nd Street
Deficiency Quantity	400
Quantity Uom	S.F.
Potential Action	REPLACE
Urgency of Action	PRIORITY 3
Purpose of Action	LEVEL 2
Deficiency Photo1

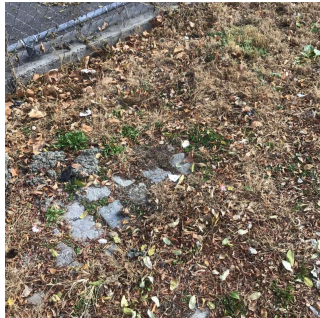
Violations	82nd Street No violations recorded.
PLAYGROUNDS	Does not Exist
PLAYING SURFACE	Does not Exist
RETAINING WALLS	Does not Exist
SEATING	Inspected
Benches	Inspected
Concrete	Does not Exist
Metal/Wood/Plastic	Inspected
Condition	5 - Poor
Deficiency	DAMAGED/DETERIORATED
Deficiency Location/Instance	Schoolyard
Deficiency Quantity	3
Quantity Uom	EACH
Potential Action	REPLACE
Urgency of Action	PRIORITY 3
