NYC Department of Education
Building Condition Assessment Survey 2023 - 2024

Architectural Inspection

Asset: P.S. 66 - QUEENS, 85-11 102 STREET, New York, 11418

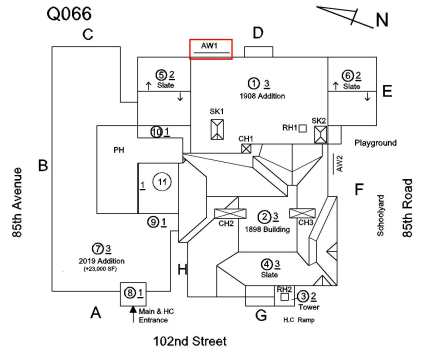
Deficiency	AREAWAY SLAB: CRACKS AND SPALLING
Roof Plan reference

10
S.F.
REPAIR
PRIORITY 3
LEVEL 2

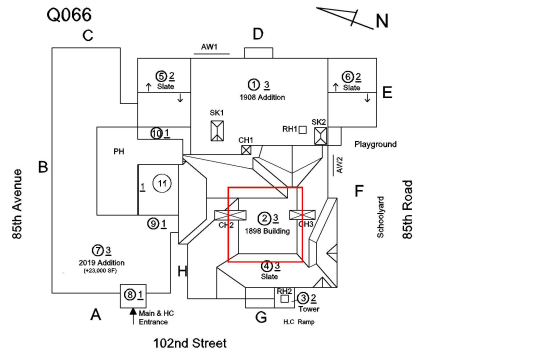
Deficiency	CAST STONE: DETERIORATED TRANSVERSE JOINTS
------------	--

Deficiency Quantity	30
Quantity Uom	L.F.
Potential Action	MAINTENANCE
Urgency of Action	PRIORITY 3
Purpose of Action	LEVEL 2
Deficiency Photo1

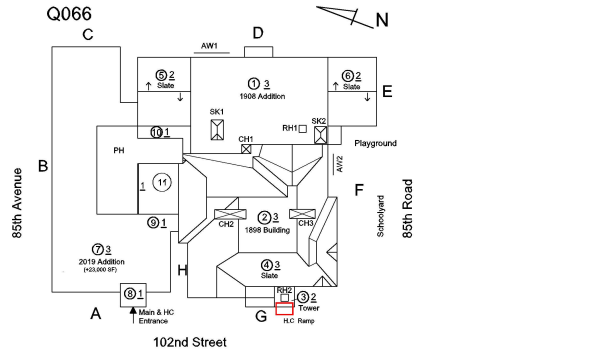
WOOD: DETERIORATED DOOR - MAJOR DETERIORATION

Deficiency Quantity	2
Quantity Uom	EACH
Potential Action	REPLACE
Urgency of Action	PRIORITY 4
Purpose of Action	LEVEL 2
Deficiency Photo1

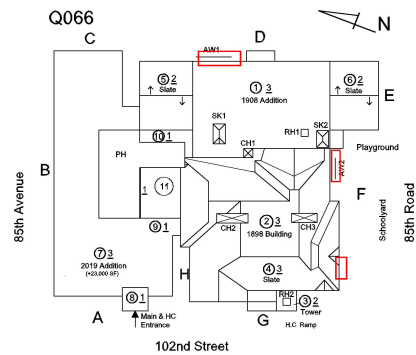
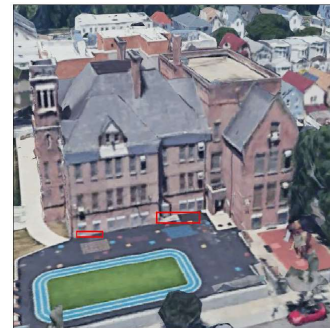
BRICK: DETERIORATED MASONRY SILLS - MINOR

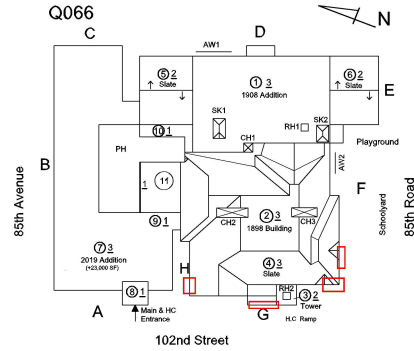
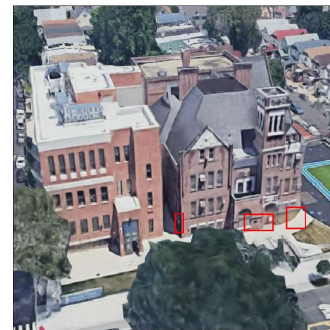
BRICK: DETERIORATED JOINTS

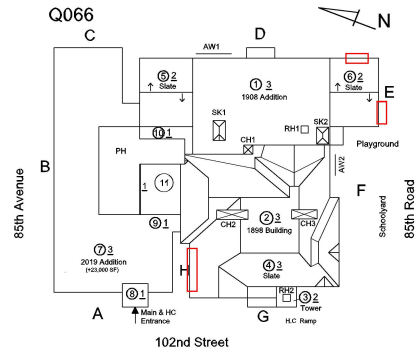
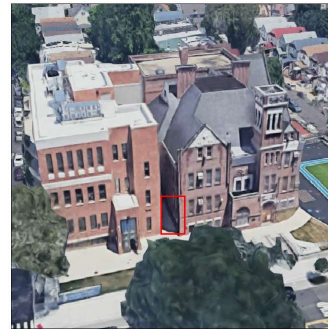
BRICK: DETERIORATED MASONRY SILLS - MAJOR

20
L.F.
REMOVE AND REPLACE
PRIORITY 4
LEVEL 2

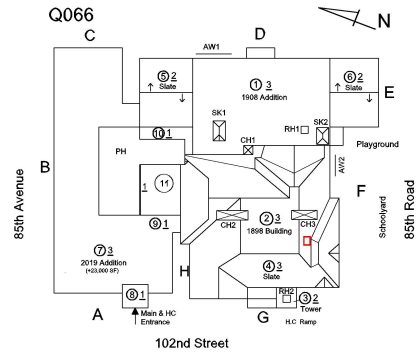
SLATE ROOF: ROOFING: MAJOR ACTIVE ROOF LEAKS IN NON-INSTRUCTIONAL SPACE

100
S.F.
REPLACE ROOFING
PRIORITY 5
LEVEL 2
No photo recorded
No violations recorded.

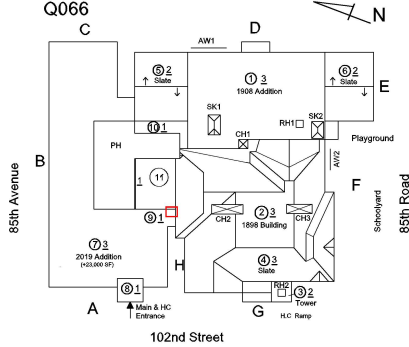
Roof 7
Instance Quantity	5,600
Instance Quantity Uom	S.F.
Does the roof have major mechanical equipment sitting on Dunnage Steel less than 18" above the Roofing?	No
Does this roof instance have a Sustainable Roof System?	No
Do solar panels exist on these roofs?	No
Is/Are the roof(s) suitable for Solar Panel installation?	No
Installation Year	2019
Source of Installation	Custodial Staff
Deficiency	IRMA: FLASHING: CAP FLASHING DAMAGED
Roof Plan reference

Deficiency Quantity	10
Quantity Uom	L.F.
Potential Action	REPLACE
Urgency of Action	PRIORITY 4
Purpose of Action	LEVEL 2
Deficiency Photo1

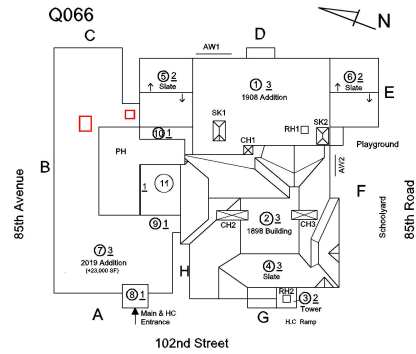
Roof 7 - Corridor near Stair D/3, also Room 322, Stair E/2
No violations recorded.

Roof 7
Violations	No violations recorded.
Deficiency	IRMA: ROOFING: MAJOR ACTIVE ROOF LEAKS IN INSTRUCTIONAL SPACE

300
S.F.
REPLACE ROOFING WITHOUT MAJOR EQUIPMENT
REMOVAL
PRIORITY 5
LEVEL 2

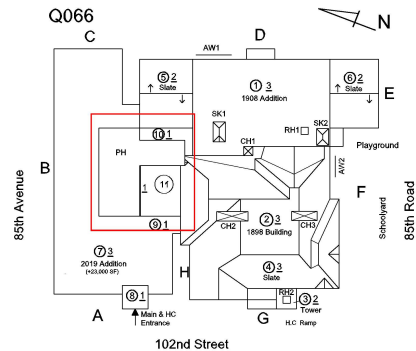
BULKHEAD/PENTHOUSE WALLS/EXTERIOR:
EFFLORESCENCE

100
S.F.

Potential Action	MAINTENANCE
Urgency of Action	PRIORITY 1
Purpose of Action	LEVEL 1
Deficiency Photo1	No photo recorded
Violations	No violations recorded.

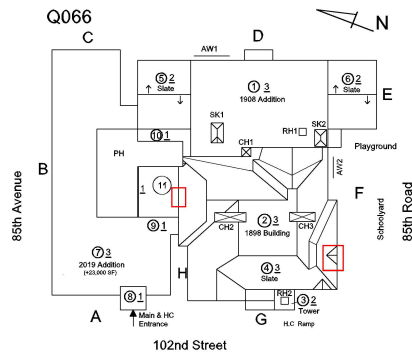
Inspected	Inspected
Condition	3 - Fair
Deficiency	LOSS OF PAINT
Roof Plan reference

Deficiency Quantity	200
Quantity Uom	S.F.
Potential Action	MAINTENANCE
Urgency of Action	PRIORITY 3
Purpose of Action	LEVEL 2
Deficiency Photo1

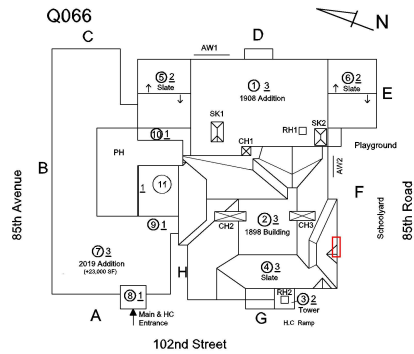
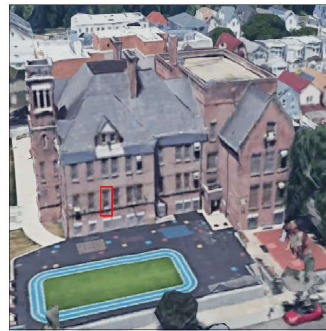
Facade F
No violations recorded.

DETERIORATED/TORN-OUT/MISSING

20
S.F.
REPLACE
PRIORITY 4
LEVEL 2

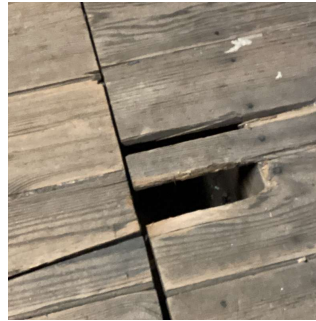
Yes	Tripping Hazard	Deteriorated wood flooring is a potential tripping hazard.	INTERIOR STRUCTURAL FLOOR STRUCTURE	Attic	Haresh Dhanraj	Handyman

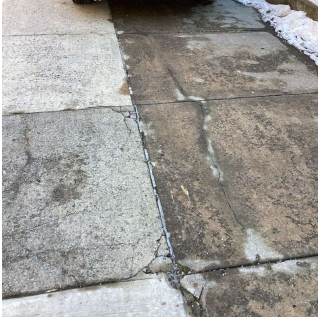
Question	Response
SITE	
PAVING	
Student Non-Use	
Concrete	
Urgency of Action	PRIORITY 3
Purpose of Action	LEVEL 2
Deficiency Photo1

Driveway on East Side of Building
Violations	No violations recorded.
Pavers	Does not Exist
Student Use	Inspected
Gravel Exists?	No
Asphalt	Inspected
Condition	3 - Fair
Deficiency	CRACKS - MAJOR
Deficiency Location/Instance	Schoolyard
Deficiency Quantity	150
Quantity Uom	S.F.
Potential Action	REPLACE
Urgency of Action	PRIORITY 3
Purpose of Action	LEVEL 2
Deficiency Photo1

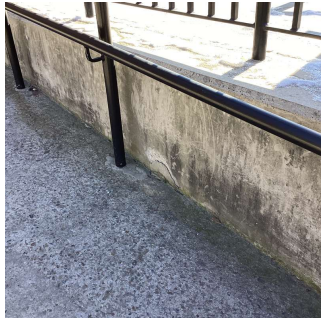
Question	Response
SITE	
SEATING	
Benches	
Concrete	Does not Exist
Metal/Wood/Plastic	Inspected
Condition	2 - Between Good and Fair
Deficiency	No deficiencies recorded
Bleachers	Does not Exist
SITE WALLS (NOT RETAINING WALLS)	Does not Exist
STAIRS/RAMPS: EXTERIOR	Inspected
Railings	Inspected
Condition	2 - Between Good and Fair
Deficiency	No deficiencies recorded
Site Cheek/flank Walls	Inspected
Condition	2 - Between Good and Fair
Deficiency	CAST IN PLACE CONCRETE: CRACKS/SPALLING - MAJOR
Deficiency Location/Instance	102nd Street
Deficiency Quantity	10
Quantity Uom	S.F.
Potential Action	REPLACE
Urgency of Action	PRIORITY 3
Purpose of Action	LEVEL 2
Deficiency Photo1

102nd Street
Violations	No violations recorded.
Stairs/ramps	Inspected
Condition	2 - Between Good and Fair
Deficiency	CAST IN PLACE CONCRETE: CRACKS/SPALLING - MAJOR
Deficiency Location/Instance	85th Road
Deficiency Quantity	20
Quantity Uom	S.F.
Potential Action	REPLACE
