NYC Department of Education
Building Condition Assessment Survey 2023 - 2024

Architectural Inspection

Asset: J.H.S. 67 - QUEENS, 51-60 MARATHON PKWY, New York, 11362

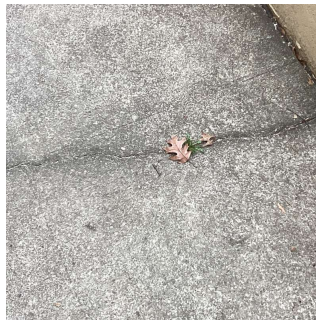
Facade C

Instance Condition	3 - Fair
Instance Quantity	1
Instance Quantity Uom	EACH
Deficiency	AREAWAY SLAB: CRACKS AND SPALLING
Roof Plan reference	Q067

Deficiency Quantity	30
Quantity Uom	S.F.
Potential Action	REPAIR
Urgency of Action	PRIORITY 3
Purpose of Action	LEVEL 2
Deficiency Photo1

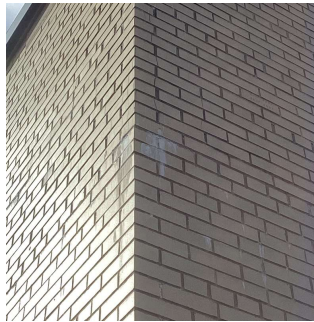
Roof 1 No violations recorded.
Violations	BRICK: MINOR CRACKS AND SPALLING
Deficiency

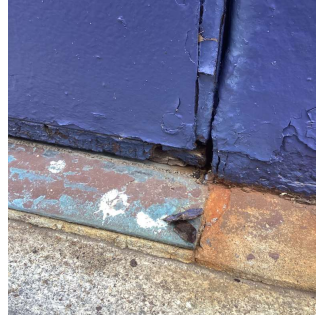
Facade D

Deficiency Quantity	3
Quantity Uom	EACH
Potential Action	MAINTENANCE
Urgency of Action	PRIORITY 3
Purpose of Action	LEVEL 2
Deficiency Photo1	No photo recorded
Violations	No violations recorded.
Deficiency	METAL CLAD: DETERIORATED DOOR AND FRAME - MAJOR DETERIORATION
Roof Plan reference	Q067

Deficiency Quantity	7
Quantity Uom	EACH
Potential Action	REPLACE

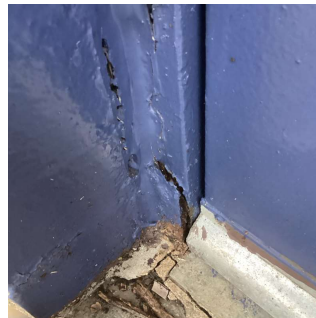
Facade C

METAL: DETERIORATED DOOR AND FRAME - MAJOR DETERIORATION

2
EACH
REPLACE
PRIORITY 4
LEVEL 2

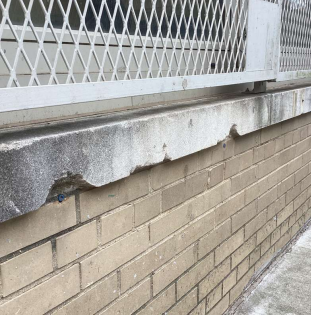
Question	Response
EXTERIOR	
DOORS	Inspected
TRANSOM/SIDE LIGHT	
Condition	2 - Between Good and Fair
Deficiency	No deficiencies recorded
EXTERIOR WALLS	Inspected
Material Type(s)	Masonry
Replacement Quantity	50,000
Replacement Uom	S.F.
Instance on All Facades	Inspected
Instance Condition	3 - Fair
Instance Quantity	50,000
Instance Quantity Uom	S.F.
Deficiency	BRICK: DETERIORATED MASONRY SILLS - MAJOR
Roof Plan reference	Q067
Elevation

Deficiency Quantity	10
Quantity Uom	L.F.
Potential Action	REMOVE AND REPLACE
Urgency of Action	PRIORITY 4
Purpose of Action	LEVEL 2
Deficiency Photo1

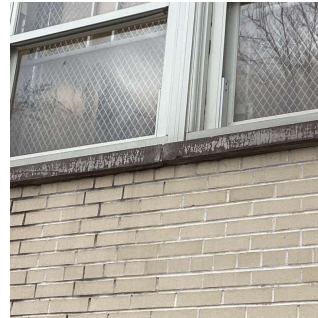
Facade E

BRICK: DETERIORATED MASONRY SILLS - MINOR

PRIORITY 3
LEVEL 2

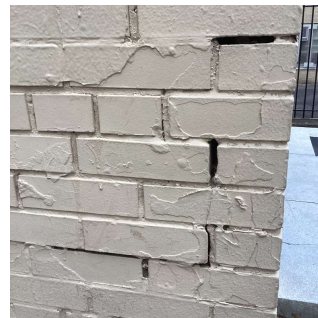
Facade E

BRICK: DETERIORATED JOINTS

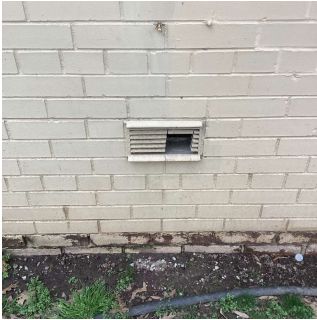
Violations	Facade C No violations recorded.
EXTERIOR SOFFITS	Inspected
Condition	2 - Between Good and Fair
Deficiency	No deficiencies recorded
LOADING DOCK	Does not Exist
LOUVER	Inspected
Condition	3 - Fair
Deficiency	BROKEN/ DENTED BLADES
Roof Plan reference	Q067
Elevation

Deficiency Quantity	50
Quantity Uom	S.F.
Potential Action	REPLACE
Urgency of Action	PRIORITY 4
Purpose of Action	LEVEL 2

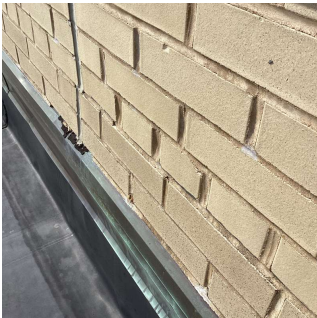
Violations	Facade C No violations recorded.
PARAPETS	
Material Type(s)	Inspected Masonry
Replacement Quantity	7,000
Replacement Uom	C.F.
Instance on All Facades	Inspected
Instance Condition	3 - Fair
Instance Quantity	7,000
Instance Quantity Uom	C.F.
Deficiency	BRICK: DETERIORATED JOINTS
Roof Plan reference	Q067

Deficiency Quantity	150
Quantity Uom	S.F.
Potential Action	REPOINT
Urgency of Action	PRIORITY 3
Purpose of Action	LEVEL 2
Deficiency Photo1

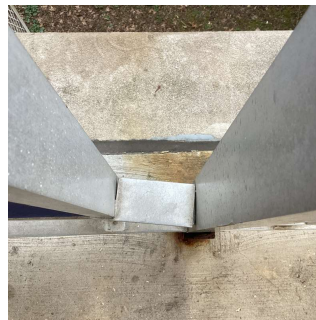
Facade A - Loggia

RAILINGS/PANELS: DETERIORATED, MAJOR RUSTING

REPLACE

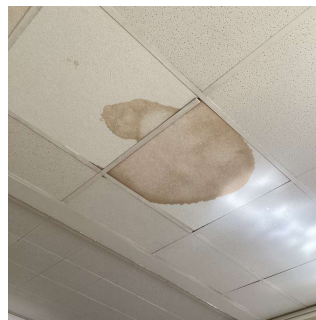
BUILT-UP: ROOFING: MAJOR ACTIVE ROOF LEAKS IN INSTRUCTIONAL SPACE

REPLACE ROOFING WITHOUT MAJOR EQUIPMENT REMOVAL

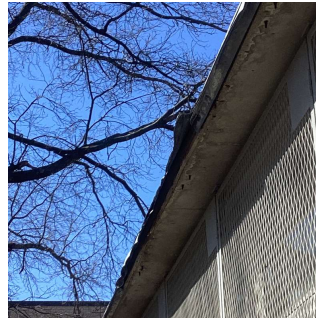
Facade C

Deficiency	BUILT-UP: FLASHING: DRIP EDGE/GRAVEL STOP DAMAGED
Roof Plan reference	Q067

Deficiency Quantity	100
Quantity Uom	L.F.
Potential Action	REPLACE
Urgency of Action	PRIORITY 4
Purpose of Action	LEVEL 2

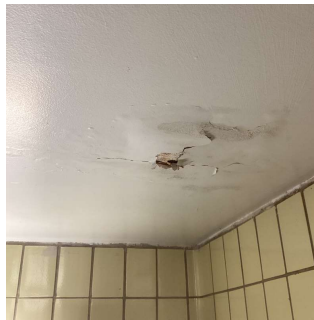
Roof 1 - Bulkhead 1

10
S.F.
REPLACE
PRIORITY 3
LEVEL 2

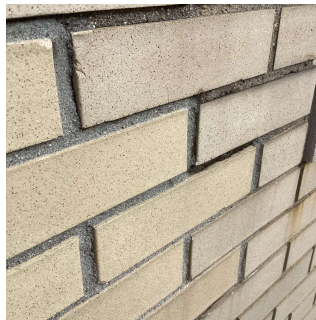
Roof 1 - Bulkhead 1

200
 S.F.
 REPOINT
 PRIORITY 3
 LEVEL 2

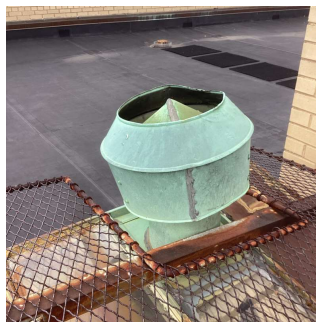
Roof 1 - Skylight 1

3
EACH
MAINTENANCE
PRIORITY 3
LEVEL 2

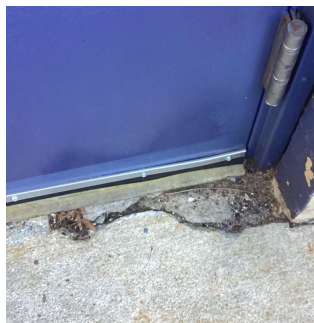
10
S.F.
REPAIR
PRIORITY 3
LEVEL 2

Facade J
No violations recorded.

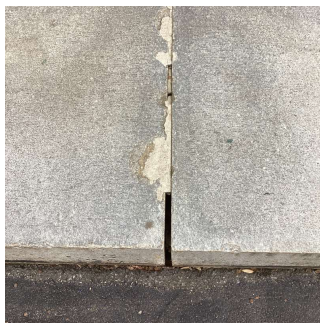
Violations	Facade L No violations recorded.
Deficiency	STONE: DETERIORATED JOINTS
Roof Plan reference	Q067
Deficiency Quantity	50
Quantity Uom	L.F.
Potential Action	REPOINT
Urgency of Action	PRIORITY 4
Purpose of Action	LEVEL 2
Deficiency Photo1

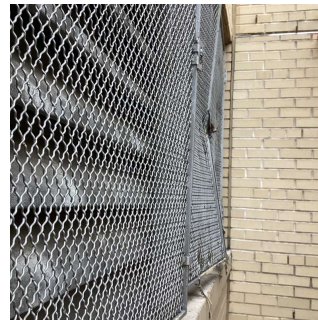
Deficiency Quantity
 Quantity Uom
 Potential Action
 Urgency of Action
 Purpose of Action
 Deficiency Photo1

40
 S.F.
 REPLACE
 PRIORITY 4
 LEVEL 2

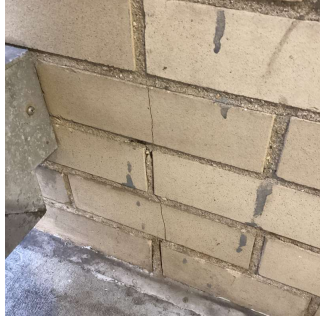
<p>Facade M - Room 325, also various Facades and Rooms including Rooms B18, 135A, 146, 218, 325, Library</p> <p>No violations recorded.</p>
INTERIOR	Inspected
POOLS	Does not Exist
STRUCTURAL	Inspected
COLUMNS/BEAMS/BEARING WALLS	Inspected
Condition	2 - Between Good and Fair
Deficiency	STEEL COLUMNS/BEAMS: DETERIORATED MASONRY FIREPROOFING
Deficiency Location/Instance	Loggia
Deficiency Quantity	10
Quantity Uom	S.F.

Question	Response
INTERIOR	
STRUCTURAL	
COLUMNS/BEAMS/BEARING WALLS	
Potential Action	REPLACE
Urgency of Action	PRIORITY 3
Purpose of Action	LEVEL 5
Deficiency Photo1

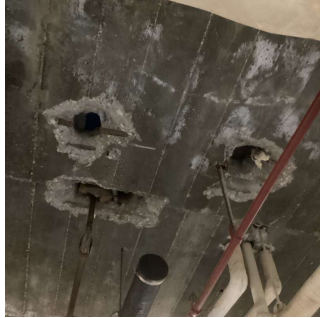
Violations	Loggia No violations recorded.
FLOOR STRUCTURE	
Condition	Inspected 2 - Between Good and Fair
Deficiency	CONCRETE: CRACKS/SPALLED/REINFORCEMENT EXPOSED
Deficiency Location/Instance	Basement - Electrical Panel Room, Sub- Basement - Oil Tank Room
Deficiency Quantity	10
Quantity Uom	S.F.
Potential Action	REPAIR
Urgency of Action	PRIORITY 3
Purpose of Action	LEVEL 5
Deficiency Photo1

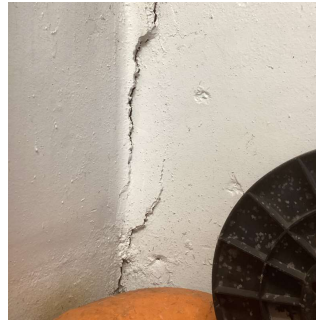
Violations	Sub-Basement - Oil Tank Room No violations recorded.
FOUNDATION WALLS	
Material Type(s)	Inspected Concrete
Condition	4 - Between Fair and Poor
Deficiency	CONCRETE: CRACKED/SPALLED/REINFORCEMENT EXPOSED
Deficiency Location/Instance	Sub-Basement - Boiler Room
Deficiency Quantity	10
Quantity Uom	S.F.
Potential Action	REPAIR
Urgency of Action	PRIORITY 3

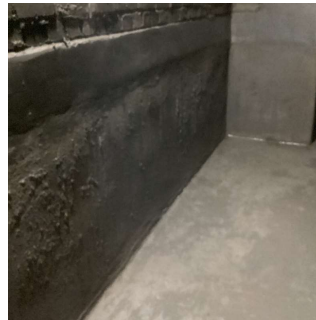
Sub-Basement - Oil Tank Room

CONCRETE: WATER INFILTRATION IN NON- INSTRUCTIONAL SPACE

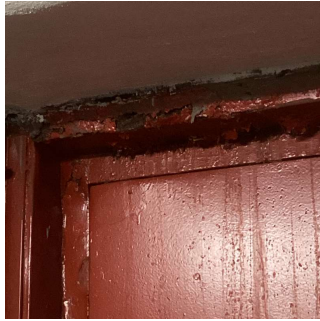
Roof 2
Violations	No violations recorded.
VAULTS-BUNKERS	
Foundation Walls	Inspected
Slab Structure	Inaccessible
Condition	Inspected
Condition	2 - Between Good and Fair
Deficiency	No deficiencies recorded
Vault/Ash Hoist Doors and Framing	Inspected
Condition	5 - Poor
Deficiency	WATER INFILTRATION
Deficiency Location/Instance	Sub-Basement - Sidewalk Elevator
Deficiency Quantity	10
Quantity Uom	S.F.
Potential Action	REPAIR
Urgency of Action	PRIORITY 5
Purpose of Action	LEVEL 2
Deficiency Photo1

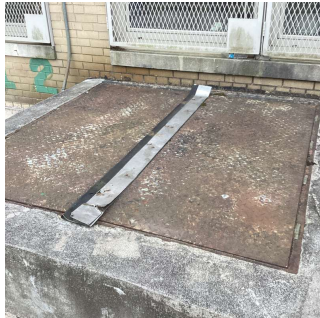
Sub-Basement - Sidewalk Elevator
Violations	No violations recorded.
Deficiency	DETERIORATED/DAMAGED VAULT/ASH HOIST DOORS AND FRAMING
Deficiency Location/Instance	Facade L
Deficiency Quantity	2
Quantity Uom	EACH
Potential Action	REPLACE
Urgency of Action	PRIORITY 4
Purpose of Action	LEVEL 2

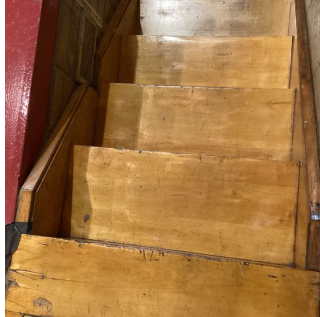
Condition	2 - Between Good and Fair
Deficiency	DAMAGED STEPS
Deficiency Location/Instance	Right Side
Deficiency Quantity	10
Quantity Uom	S.F.
Potential Action	REPLACE
Urgency of Action	PRIORITY 3
Purpose of Action	LEVEL 2

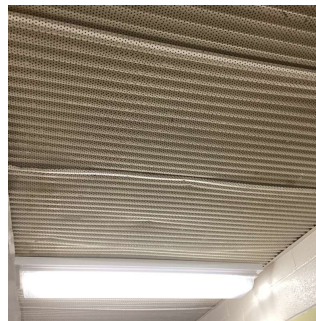
Corridor near Room B19

METAL PAN: DAMAGED/MISSING

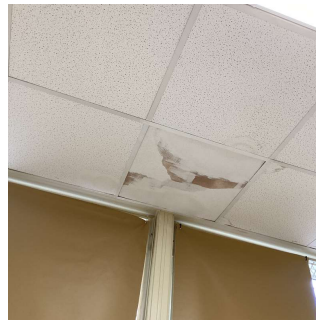
Corridor near Elevator A/1

ACOUSTIC TILES: DAMAGED/MISSING

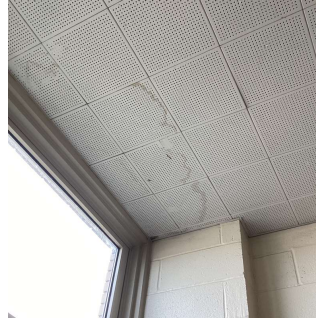
Corridor near Room 216

Deficiency	ACOUSTIC TILES ON PLASTER: DAMAGED/MISSING
Deficiency Location/Instance	Corridor near Rooms B31, B45, 216
Deficiency Quantity	60
Quantity Uom	S.F.
Potential Action	REPLACE
Urgency of Action	PRIORITY 3
Purpose of Action	LEVEL 2
Deficiency Photo1

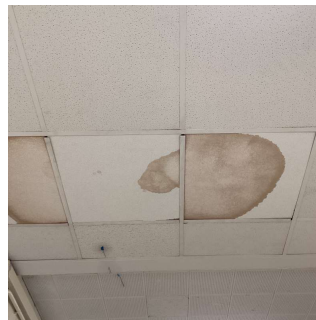
Deficiency	ACOUSTIC TILES: DAMAGED/MISSING - ACTIVE LEAK
Deficiency Location/Instance	Corridor near Room 327
Deficiency Quantity	20
Quantity Uom	S.F.
Potential Action	REPLACE
Urgency of Action	PRIORITY 5
Purpose of Action	LEVEL 2
Deficiency Photo1

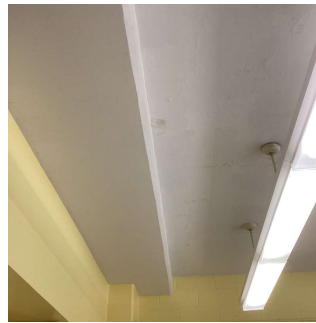
Room 326

Deficiency	PLASTER: CRACKS/SPALLING
Deficiency Location/Instance	Rooms 325, 326, 327
Deficiency Quantity	40
Quantity Uom	S.F.
Potential Action	REPLACE
Urgency of Action	PRIORITY 3
Purpose of Action	LEVEL 2

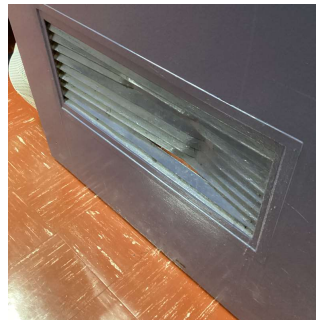
Room SB34

METAL: DAMAGED LOUVER

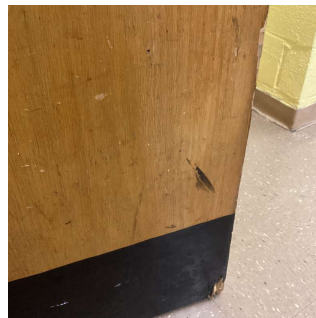
WOOD: DETERIORATED DOOR

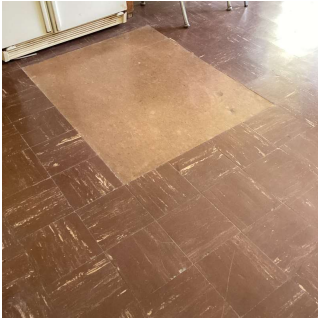
Question	Response
INTERIOR	
CLASSROOMS/CORRIDORS/ADMIN SPACES	
Door(s)	Inspected
	Room B17
Violations	No violations recorded.
Floor Finish	Inspected
Condition	3 - Fair
Deficiency	VINYL TILES: BROKEN/DETERIORATED/MISSING TILES
Deficiency Location/Instance	Rooms 137, 218, 227, 305, 316, and others
Deficiency Quantity	3,700
Quantity Uom	S.F.
Potential Action	REPLACE
Urgency of Action	PRIORITY 3
Purpose of Action	LEVEL 2
Deficiency Photo1

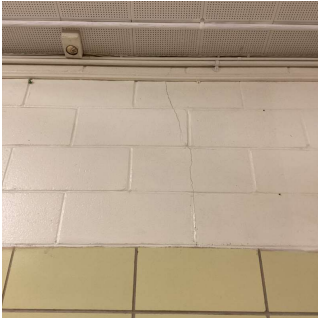
Room 305
Violations	No violations recorded.
Walls	Inspected
Condition	2 - Between Good and Fair
Deficiency	MASONRY: CRACKS/SPALLING
Deficiency Location/Instance	Corridor near Stair C/Basement
Deficiency Quantity	10
Quantity Uom	S.F.
Potential Action	REPLACE
Urgency of Action	PRIORITY 3
Purpose of Action	LEVEL 2
Deficiency Photo1

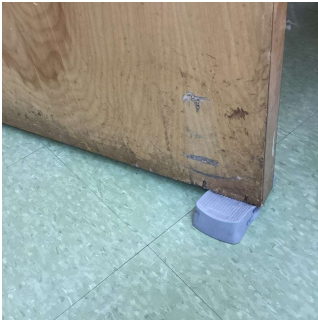
Question	Response
INTERIOR	
LIBRARY	
Ceiling	
Deficiency Photo1	 
	Near Windows
Violations	No violations recorded.
Door(s)	
Instance on Room 213	Inspected
Condition	3 - Fair
Deficiency	WOOD: DETERIORATED DOOR
Deficiency Location/Instance	Entrance
Deficiency Quantity	1
Quantity Uom	EACH
Potential Action	MAINTENANCE
Urgency of Action	PRIORITY 3
Purpose of Action	LEVEL 2
Deficiency Photo1

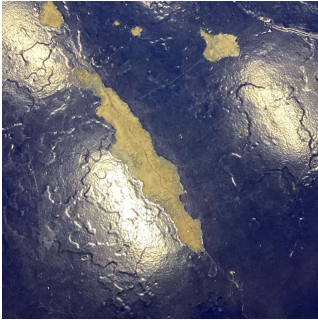
Instance on Sub-Basement - Boys (738 Lockers)	Inspected
Condition	4 - Between Fair and Poor
Deficiency	CONCRETE: CRACKS
Deficiency Location/Instance	Near Center, Windows
Deficiency Quantity	120
Quantity Uom	S.F.
Potential Action	REPLACE
Urgency of Action	PRIORITY 3
Purpose of Action	LEVEL 2
Deficiency Photo1

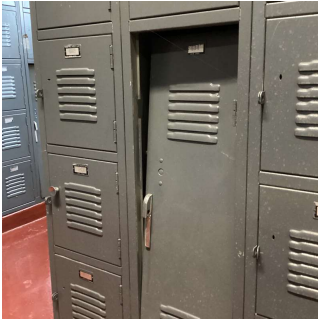
Instance on Sub-Basement - Girls (1379 Lockers)	Inspected
Condition	2 - Between Good and Fair
Deficiency	DAMAGED UNITS
Deficiency Location/Instance	Lockers 284, 434, 454, 609, 919, and others
Deficiency Quantity	18
Quantity Uom	EACH
Potential Action	REPLACE
Urgency of Action	PRIORITY 3
Purpose of Action	LEVEL 2
Deficiency Photo1

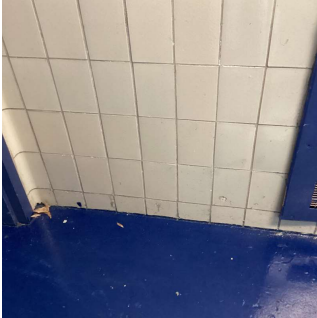
Instance on Sub-Basement - Boys (738 Lockers)	Inspected
Condition	2 - Between Good and Fair
Deficiency	GLAZED BLOCK: CRACKS/SPALLING
Deficiency Location/Instance	Near Windows
Deficiency Quantity	10

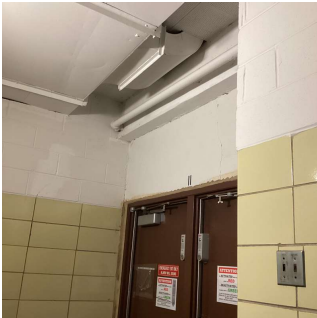
Near Windows
Violations	No violations recorded.
Deficiency	PLASTER: CRACKS/SPALLING
Deficiency Location/Instance	Vestibule Exit 11
Deficiency Quantity	10
Quantity Uom	S.F.
Potential Action	REPLACE
Urgency of Action	PRIORITY 3
Purpose of Action	LEVEL 2
Deficiency Photo1

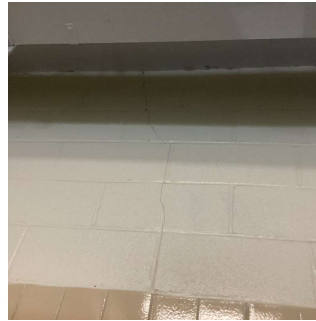
Near Locker 146

Vestibule Exit 11
Violations	No violations recorded.
Deficiency	MASONRY: CRACKS/SPALLING
Deficiency Location/Instance	Near Entrance, Locker 146
Deficiency Quantity	20
Quantity Uom	S.F.
Potential Action	REPLACE
Urgency of Action	PRIORITY 3
Purpose of Action	LEVEL 2

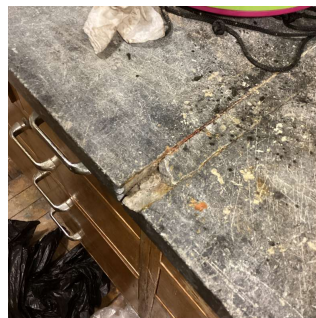
DEMO TABLE: DAMAGED/DETERIORATED

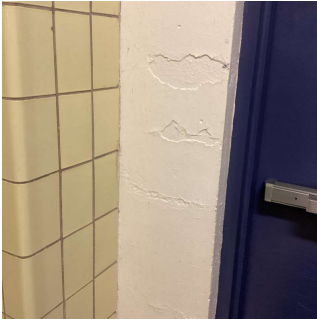
Question	Response
INTERIOR	
STAIRS/RAMPS: INTERIOR	
Stairs and Landings	
Deficiency Photo1	 
Violations	Stairs Near Auditorium Stage No violations recorded.
Walls	
Condition	Inspected 2 - Between Good and Fair
Deficiency	PLASTER: CRACKS/SPALLING
Deficiency Location/Instance	Stair AB/Vestibule
Deficiency Quantity	10
Quantity Uom	S.F.
Potential Action	REPLACE
Urgency of Action	PRIORITY 3
Purpose of Action	LEVEL 2
Deficiency Photo1

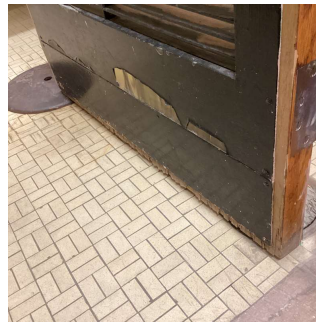
Violations	Stair AB/Vestibule No violations recorded.
TOILET ROOMS - STAFF	
Ceiling	
Condition	Inspected 2 - Between Good and Fair
Deficiency	No deficiencies recorded
Door(s)	
Condition	Inspected 5 - Poor
Deficiency	WOOD: DETERIORATED DOOR
Deficiency Location/Instance	Room SB34
Deficiency Quantity	1
Quantity Uom	EACH
Potential Action	MAINTENANCE
Urgency of Action	PRIORITY 3
Purpose of Action	LEVEL 2

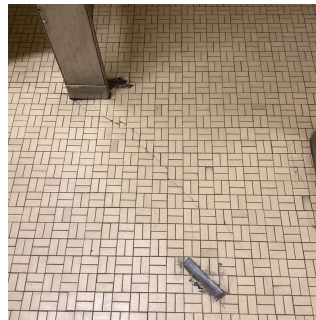
Women- 1st Floor

CERAMIC TILE: BROKEN/MISSING TILES

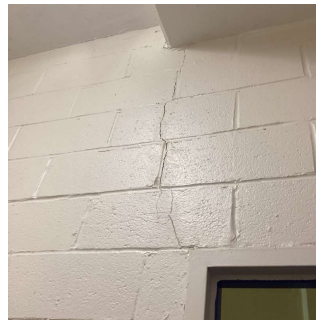
Room 305

MASONRY: CRACKS/SPALLING

REPLACE

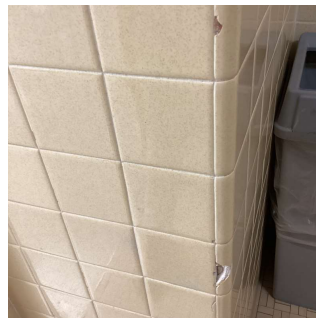
CERAMIC TILE: BROKEN/ MISSING

REPLACE

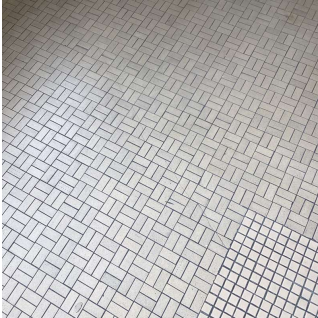
Deficiency	CERAMIC TILE: BROKEN/MISSING TILES

Question	Response
INTERIOR	
TOILET ROOMS - STUDENTS	Inspected
Floor Finish	
Deficiency Location/Instance	1st Floor - Girls, 3rd Floor - Girls
Deficiency Quantity	20
Quantity Uom	S.F.
Potential Action	REPLACE
Urgency of Action	PRIORITY 3
Purpose of Action	LEVEL 2
Deficiency Photo1

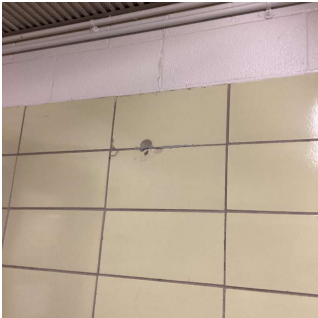
3rd Floor - Girls
Violations	No violations recorded.
Stalls	Inspected
Condition	2 - Between Good and Fair
Deficiency	No deficiencies recorded
Walls	Inspected
Condition	2 - Between Good and Fair
Deficiency	GLAZED BLOCK: CRACKS/SPALLING
Deficiency Location/Instance	Corridor near Room B15
Deficiency Quantity	10
Quantity Uom	S.F.
Potential Action	REPLACE
Urgency of Action	PRIORITY 3
Purpose of Action	LEVEL 2
Deficiency Photo1

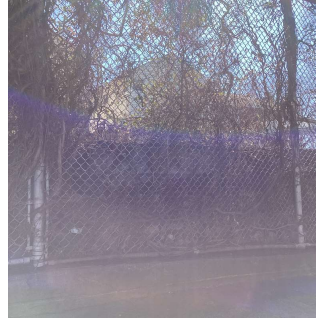
Near Student Use Area
No violations recorded.

Purpose of Action	LEVEL 2
Deficiency Photo1	No photo recorded
Violations	No violations recorded.
FENCES	Inspected
Condition	4 - Between Fair and Poor
Deficiency	CHAIN LINK: DAMAGED POST/RAIL
Deficiency Location/Instance	Near Student Use Area
Deficiency Quantity	10
Quantity Uom	L.F.
Potential Action	REPLACE
Urgency of Action	PRIORITY 3
Purpose of Action	LEVEL 2

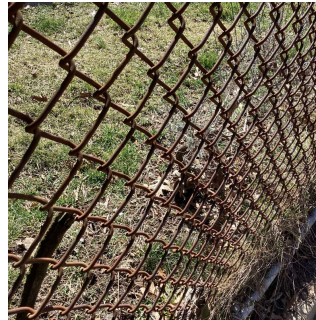
Near Marathon Parkway
No violations recorded.

CHAIN LINK: RUST - MAJOR

REPLACE

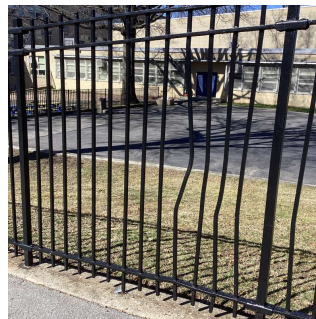
Near Student Use Area
No violations recorded.

WROUGHT IRON: DAMAGED/DETERIORATED

REPLACE

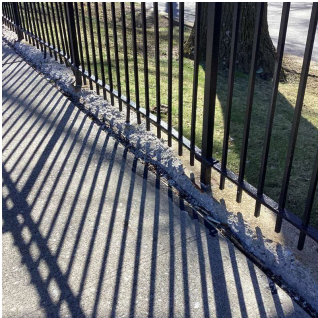
CONCRETE CURB: DAMAGED/DETERIORATED

Question	Response
SITE	
FENCES	
Deficiency Location/Instance	Marathon Parkway
Deficiency Quantity	100
Quantity Uom	S.F.
Potential Action	REPLACE
Urgency of Action	PRIORITY 3
Purpose of Action	LEVEL 2
Deficiency Photo1

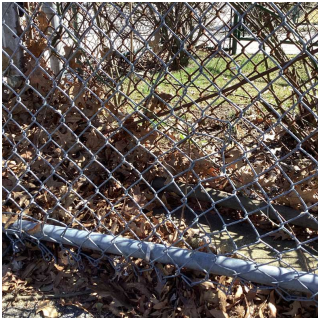
Violations	Marathon Parkway No violations recorded.
Deficiency	CHAIN LINK: DAMAGED/DETERIORATED
Deficiency Location/Instance	Marathon Parkway
Deficiency Quantity	20
Quantity Uom	S.F.
Potential Action	REPLACE
Urgency of Action	PRIORITY 3
Purpose of Action	LEVEL 2
Deficiency Photo1

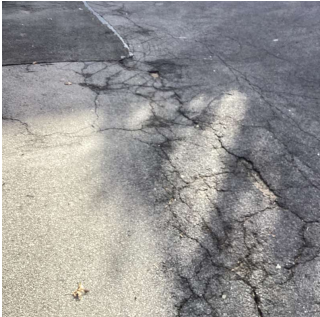
Violations	Marathon Parkway No violations recorded.
IRRIGATION SYSTEM	Does not Exist
PAVING	Inspected
Student Non-Use	Inspected
Gravel Exists?	No
Asphalt	Inspected
Condition	4 - Between Fair and Poor
Deficiency	CRACKS - MAJOR
Deficiency Location/Instance	Driveway to Park
Deficiency Quantity	1,000
Quantity Uom	S.F.
Potential Action	REPLACE
Urgency of Action	PRIORITY 3
Purpose of Action	LEVEL 2

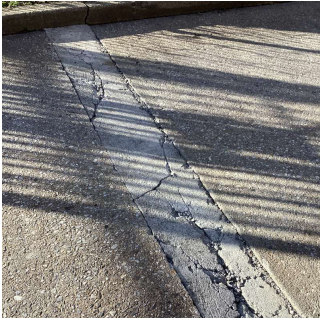
Violations	Driveway No violations recorded.
Concrete	Inspected
Condition	4 - Between Fair and Poor
Deficiency	CRACKS - MAJOR
Deficiency Location/Instance	Driveway to Containers
Deficiency Quantity	500
Quantity Uom	S.F.
Potential Action	REPLACE
Urgency of Action	PRIORITY 3
Purpose of Action	LEVEL 2
Deficiency Photo1

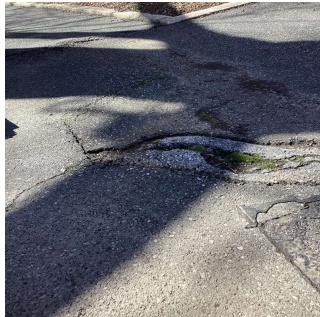
Violations	Driveway to Containers No violations recorded.
Pavers	Does not Exist
Student Use	Inspected
Gravel Exists?	No
Asphalt	Inspected
Condition	4 - Between Fair and Poor
Deficiency	CRACKS - MAJOR
Deficiency Location/Instance	Near Exit 1, Seats
Deficiency Quantity	40
Quantity Uom	S.F.
Potential Action	REPLACE
Urgency of Action	PRIORITY 5
Purpose of Action	LEVEL 6

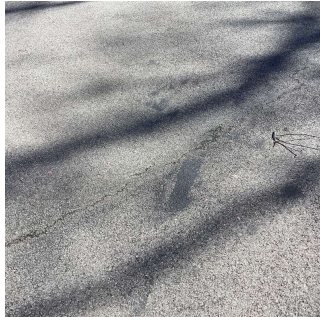
Violations	Near Exit 1 No violations recorded.
Deficiency	CRACKS - MAJOR
Deficiency Location/Instance	Near Exit 1, Benches
Deficiency Quantity	600
Quantity Uom	S.F.
Potential Action	REPLACE
Urgency of Action	PRIORITY 3
Purpose of Action	LEVEL 2
Deficiency Photo1

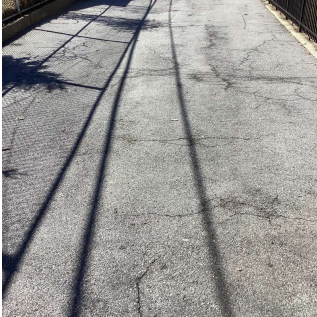
Violations	Near Exit 1 No violations recorded.
Concrete	Does not Exist
Pavers	Does not Exist
Site Sidewalks & Walkways	Inspected
Asphalt	Inspected
Condition	4 - Between Fair and Poor
Deficiency	CRACKS - MAJOR
Deficiency Location/Instance	Near Marathon Parkway, NYC park, Exit 14
Deficiency Quantity	3,000
Quantity Uom	S.F.
Potential Action	REPLACE
Urgency of Action	PRIORITY 3
Purpose of Action	LEVEL 2

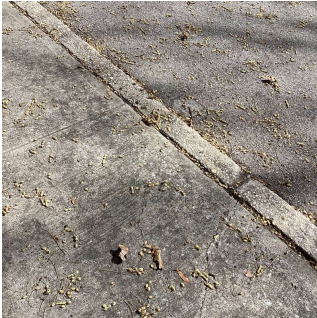
Violations	Near Marathon Parkway No violations recorded.
Concrete	
Condition	Inspected 4 - Between Fair and Poor
Deficiency	DAMAGED CURBS
Deficiency Location/Instance	Near Student Use Area
Deficiency Quantity	250
Quantity Uom	L.F.
Potential Action	REPLACE
Urgency of Action	PRIORITY 3
Purpose of Action	LEVEL 2
Deficiency Photo1

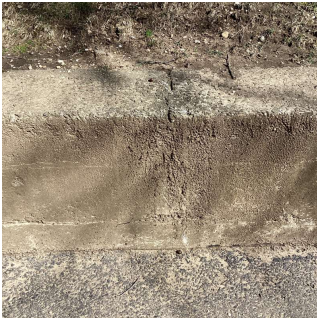
Question	Response
SITE	
PAVING	
Site Sidewalks & Walkways	
Concrete	Inspected
Deficiency Photo1	 
	Near Main Entrance
Violations	No violations recorded.
Pavers	Does not Exist
DOT Sidewalk	Inspected
Asphalt	Does not Exist
Concrete	Inspected
Condition	3 - Fair
Deficiency	DAMAGED/DETERIORATED/MISSING SECTIONS
Deficiency Location/Instance	Marathon parkway
Deficiency Quantity	175
Quantity Uom	S.F.
Potential Action	REPLACE
Urgency of Action	PRIORITY 3
Purpose of Action	LEVEL 2
Deficiency Photo1	 
	Marathon parkway
Violations	No violations recorded.
Pavers	Does not Exist
PLAYGROUNDS	Does not Exist
PLAYING SURFACE	Does not Exist
RETAINING WALLS	Inspected
Are there any Retaining Walls 6' OR higher facing public street/sidewalk?	No
Condition	3 - Fair
Deficiency	CAST IN PLACE CONCRETE: CRACKS/SPALLING - MAJOR
Deficiency Location/Instance	Near Exit 3
Deficiency Quantity	30
Quantity Uom	S.F.
Potential Action	REPLACE

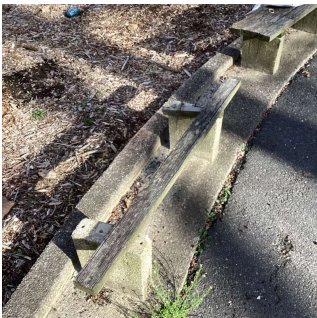
Near Exit 3
Violations	No violations recorded.
SEATING	Inspected
Benches	Inspected
Concrete	Does not Exist
Metal/Wood/Plastic	Inspected
Condition	5 - Poor
Deficiency	DAMAGED/DETERIORATED
Deficiency Location/Instance	Student Use Area
Deficiency Quantity	3
Quantity Uom	EACH
Potential Action	REPLACE
Urgency of Action	PRIORITY 5
Purpose of Action	LEVEL 6
Deficiency Photo1
