**NYC Department of Education  
Building Condition Assessment Survey 2023 - 2024**

Architectural Inspection

**Asset:** P.S. 71 - QUEENS, 62-85 FOREST AVENUE, New York, 11385

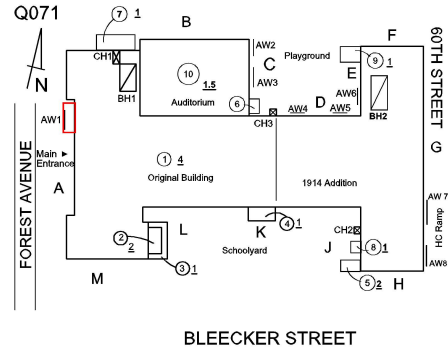
Roof Plan reference

Question	Response
<b>Architectural</b>	
<b>EXTERIOR</b>	Inspected
<b>AREAWAY</b>	Inspected
Instance on AW1-AW6, AW8	Inspected
Instance Condition	3 - Fair
Instance Quantity	7
Instance Quantity Uom	EACH
Deficiency	AREAWAY SLAB: CRACKS AND SPALLING

10  
S.F.  
REPLACE  
PRIORITY 4  
LEVEL 2

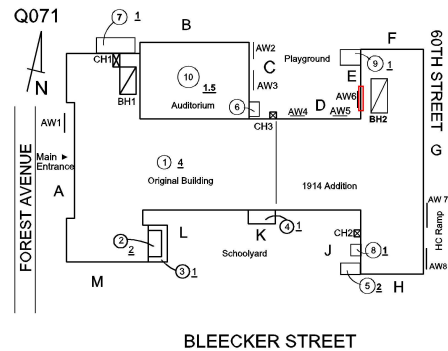
Roof Plan reference

**AREAWAY STAIRS: DETERIORATED TREADS/RISERS/NOSINGS**

20  
S.F.  
REPAIR  
PRIORITY 3  
LEVEL 2

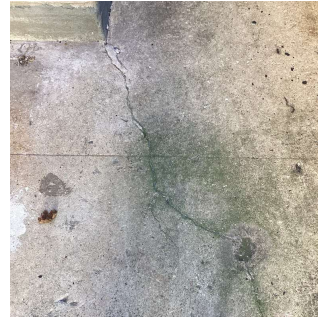
AW1

**AREAWAY SLAB: CRACKS AND SPALLING**

20

REPAIR

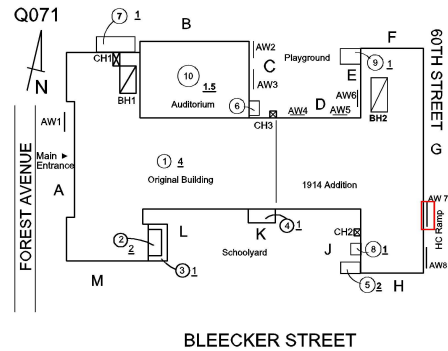
Roof Plan reference

AREAWAY STAIRS: DETERIORATED TREADS/RISERS/NOSINGS

30  
 S.F.  
 REPLACE  
 PRIORITY 4  
 LEVEL 2

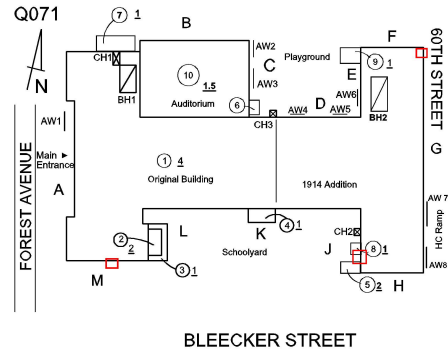
Roof Plan reference

CAST STONE: CRACKED/BROKEN PIECES

20  
 L.F.  
 REPLACE-IN-KIND  
 PRIORITY 4  
 LEVEL 2

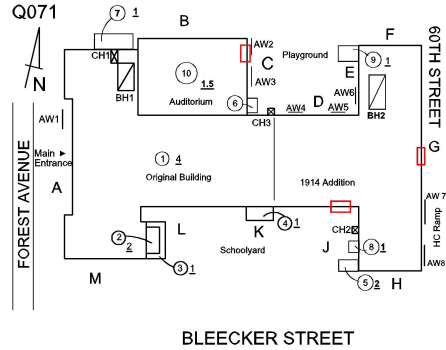
Roof Plan reference

Deficiency METAL CLAD: DETERIORATED DOOR AND FRAME - MAJOR DETERIORATION

Deficiency Quantity	5
Quantity Uom	EACH
Potential Action	REPLACE
Urgency of Action	PRIORITY 4
Purpose of Action	LEVEL 2
Deficiency Photo1

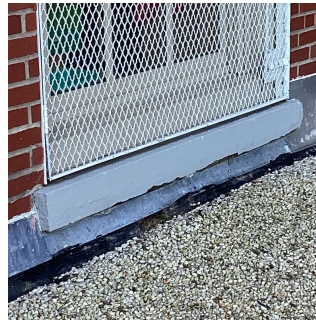
Facade C

BRICK: DETERIORATED MASONRY SILLS - MINOR

40

REPAIR

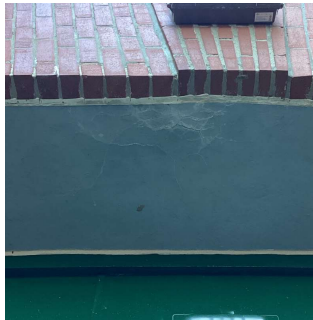
Facade A

STUCCO/PLASTER: MINOR CRACKS/SPALLING

10

REPAIR

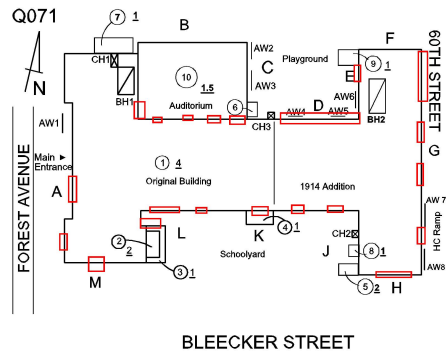
Roof Plan reference

**BRICK: DETERIORATED JOINTS**

Deficiency Quantity	100
Quantity Uom	S.F.
Potential Action	REPOINT
Urgency of Action	PRIORITY 3
Purpose of Action	LEVEL 2
Deficiency Photo1

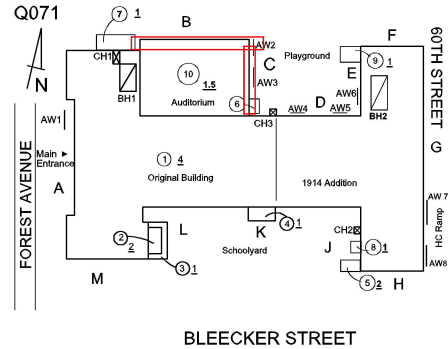
Roof Plan reference

Instance on Roof 10	Inspected
Instance Condition	5 - Poor
Instance Quantity	700
Instance Quantity Uom	C.F.
Deficiency	<b>BRICK: DETERIORATED JOINTS</b>

100  
S.F.  
REPOINT  
PRIORITY 3  
LEVEL 2

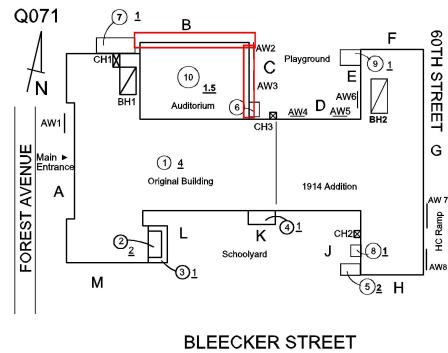
Roof Plan reference

**BRICK: DETERIORATED JOINTS**

60  
S.F.  
REPOINT  
PRIORITY 4  
LEVEL 2

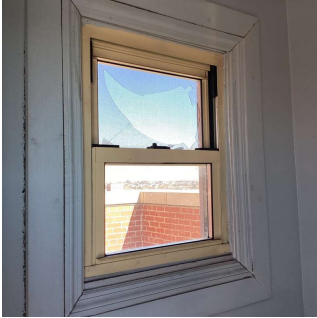
Installation Year	2003
Source of Installation	Custodial Staff
Deficiency	No deficiencies recorded
<b>ROOFING DRAINS</b>	
	Inspected
Condition	1 - Good
Deficiency	No deficiencies recorded
<b>Specialties</b>	
	Inspected
<b>BULKHEAD/PENTHOUSE</b>	
	Inspected
Condition	3 - Fair
Deficiency	BULKHEAD/PENTHOUSE WINDOWS: DAMAGED, DETERIORATED WINDOWS
Roof Plan reference

BH1
Violations	No violations recorded.
<b>CUPOLA/ SPIRES/ TOWERS</b>	Does not Exist
<b>DORMER</b>	Does not Exist
<b>DUNNAGE STEEL</b>	Does not Exist
<b>SKYLIGHT/ROOF VENT</b>	Does not Exist
<b>ROOF/GRAVITY TANK</b>	Does not Exist
<b>STAIRS/RAMPS: EXTERIOR</b>	Inspected
<b>BUILDING CHEEK/FLANK WALLS</b>	Inspected
Condition	4 - Between Fair and Poor
Deficiency	BRICK: CRACKS/SPALLING - MINOR
Roof Plan reference	<p>Q071</p>

Deficiency Quantity	10
Quantity Uom	S.F.

Question	Response
<b>EXTERIOR</b>	
<b>ROOF</b>	
<b>Specialties</b>	
<b>BULKHEAD/PENTHOUSE</b>	
Potential Action	REPLACE
Urgency of Action	PRIORITY 4
Purpose of Action	LEVEL 2
Deficiency Photo1

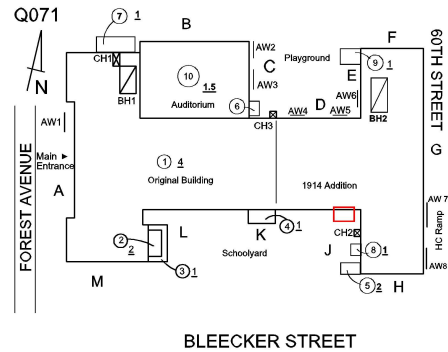
Roof Plan reference

**CAST IN PLACE CONCRETE: CRACKS/SPALLING - MINOR**

10  
S.F.  
REPAIR  
PRIORITY 3  
LEVEL 2

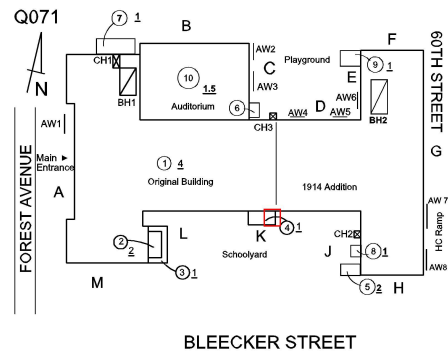
Roof Plan reference

**BRICK: DETERIORATED JOINTS**

10  
S.F.  
REPOINT  
PRIORITY 4  
LEVEL 2

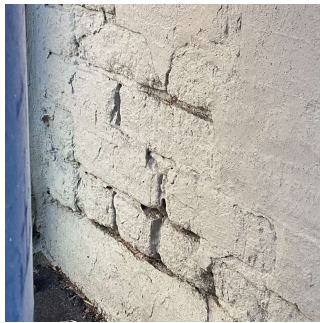
Question	Response
<b>EXTERIOR</b>	
<b>STAIRS/RAMPS: EXTERIOR</b>	
<b>BUILDING CHEEK/FLANK WALLS</b>	
Deficiency Photo1

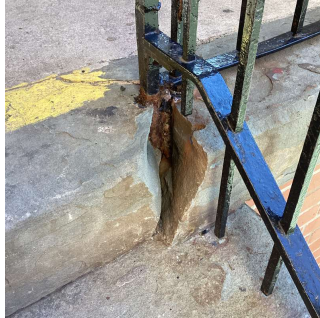
Violations	Facade K No violations recorded.
<b>RAILINGS</b>	
Condition	Inspected 2 - Between Good and Fair
Deficiency	No deficiencies recorded
<b>STAIRS/RAMPS</b>	
Condition	Inspected 4 - Between Fair and Poor
Deficiency	STONE: CRACKS/SPALLING - MAJOR
RooF Plan reference	Q071
Deficiency Quantity	10
Quantity Uom	S.F.
Potential Action	REPLACE
Urgency of Action	PRIORITY 4
Purpose of Action	LEVEL 2
Deficiency Photo1

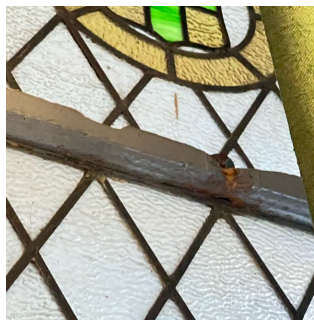
Facade C - Auditorium

Instance Quantity Uom	S.F.
Are these windows insulated	No
Installation Year	1914
Source of Installation	Custodial Staff
Deficiency	<b>WOOD: DETERIORATED</b>
Roof Plan reference	Q071

Deficiency Quantity	400
Quantity Uom	S.F.
Potential Action	REPLACE WINDOW
Urgency of Action	PRIORITY 4
Purpose of Action	LEVEL 2
Deficiency Photo1

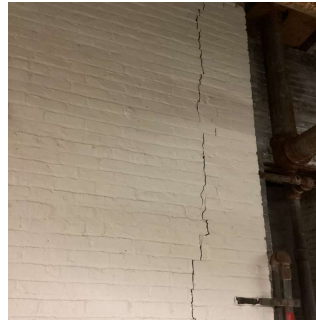
Deficiency	STEEL COLUMNS/BEAMS: DETERIORATED MASONRY FIREPROOFING
------------	---

Question	Response
<b>INTERIOR</b>	
<b>STRUCTURAL</b>	
<b>COLUMNS/BEAMS/BEARING WALLS</b>	
Deficiency Location/Instance	Boiler Room
Deficiency Quantity	40
Quantity Uom	S.F.
Potential Action	REPLACE
Urgency of Action	PRIORITY 3
Purpose of Action	LEVEL 5
Deficiency Photo1	 
Violations	Boiler Room No violations recorded.
Deficiency	STEEL COLUMNS/BEAMS: DETERIORATED MASONRY FIREPROOFING
Deficiency Location/Instance	Boiler Room
Deficiency Quantity	40
Quantity Uom	S.F.
Potential Action	REPLACE
Urgency of Action	PRIORITY 4
Purpose of Action	LEVEL 5
Deficiency Photo1	 
Violations	Boiler Room No violations recorded.
Deficiency	MASONRY BEARING WALL: CRACKED/SPALLED
Deficiency Location/Instance	Basement - Old Boiler Room
Deficiency Quantity	20
Quantity Uom	S.F.
Potential Action	RESTITCH
Urgency of Action	PRIORITY 4
Purpose of Action	LEVEL 5

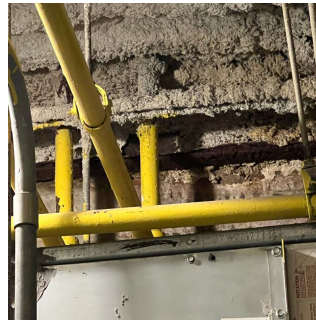
Basement - Gas Meter Room

**STEEL COLUMNS/BEAMS: DETERIORATED/MISSING SPRAY-ON FIREPROOFING**

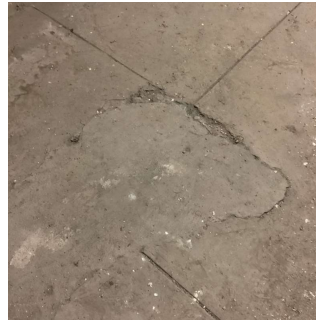
Basement - Boiler Room

**CONCRETE SLAB ON GRADE: THRU CRACKS**

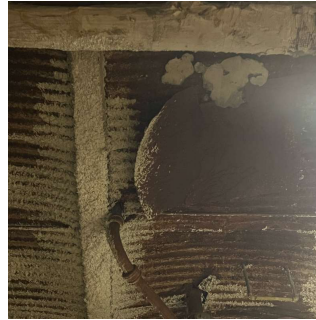
Basement - Fan Area

CINDER CONCRETE ARCH: METAL PAN DETERIORATED, SPALLED

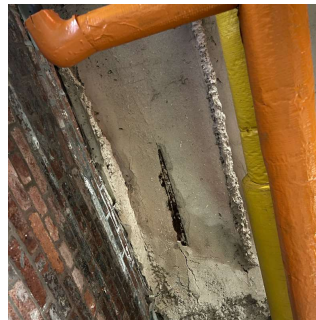
Basement - Old Boiler Room

CONCRETE: CRACKS/SPALLED/REINFORCEMENT EXPOSED

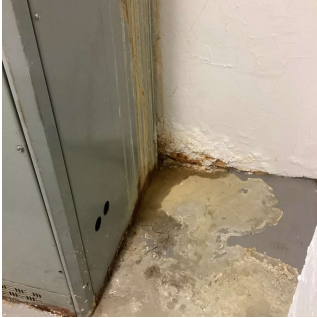
Question	Response
<b>INTERIOR</b>	
<b>STRUCTURAL</b>	
<b>FLOOR STRUCTURE</b>	Inspected
Violations	No violations recorded.
<b>FOUNDATION WALLS</b>	Inspected
Material Type(s)	Concrete, Masonry
Condition	4 - Between Fair and Poor
Deficiency	CONCRETE: WATER INFILTRATION IN ELECTRICAL PANEL ROOM
Deficiency Location/Instance	Basement - Electrical Panel Room
Deficiency Quantity	100
Quantity Uom	S.F.
Potential Action	INSTALL WATERPROOFING
Urgency of Action	PRIORITY 5
Purpose of Action	LEVEL 6
Deficiency Photo1

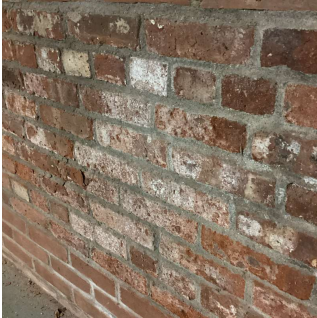
Basement - Electrical Panel Room
Violations	No violations recorded.
Deficiency	BRICK: CRACKED/SPALLED
Deficiency Location/Instance	Boiler Room
Deficiency Quantity	60
Quantity Uom	S.F.
Potential Action	RESTITCH
Urgency of Action	PRIORITY 3
Purpose of Action	LEVEL 5
Deficiency Photo1

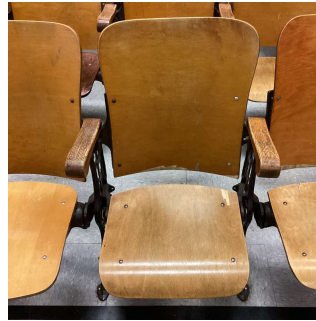
Seat D/111

<b>Fixed Seating</b>	
Instance on 1st Floor (500 Seats)	Inspected
Condition	5 - Poor
Deficiency	DAMAGED/BROKEN/INOPERABLE
Deficiency Location/Instance	Seats D/102, 103, 111, 112, 113 and others
Deficiency Quantity	133
Quantity Uom	EACH
Potential Action	REPLACE
Urgency of Action	PRIORITY 3
Purpose of Action	LEVEL 2

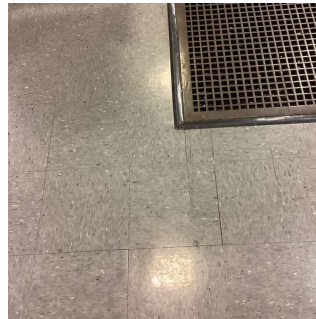
Instance on 1st Floor (500 Seats)	Inspected
Condition	2 - Between Good and Fair
Deficiency	VINYL TILES: DETERIORATED SUBSTRATE
Deficiency Location/Instance	Near Entrance
Deficiency Quantity	10
Quantity Uom	S.F.
Potential Action	REPLACE
Urgency of Action	PRIORITY 3
Purpose of Action	LEVEL 2
Deficiency Photo1

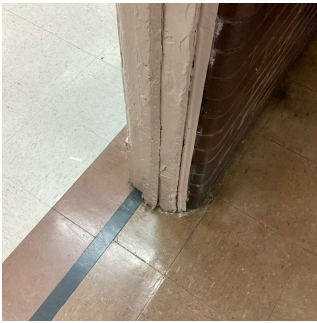
Violations	Exit to Exit 3 No violations recorded.
Deficiency	METAL CLAD WOOD: DETERIORATED DOOR AND FRAME
Deficiency Location/Instance	Main Entrance
Deficiency Quantity	1
Quantity Uom	EACH

Potential Action	MAINTENANCE
Urgency of Action	PRIORITY 3
Purpose of Action	LEVEL 2

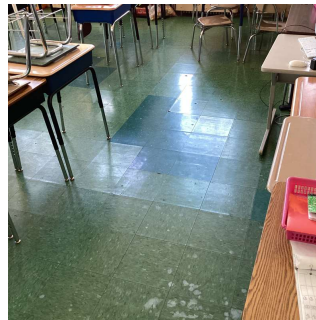
Room 416

VINYL TILES: BROKEN/DETERIORATED/MISSING TILES

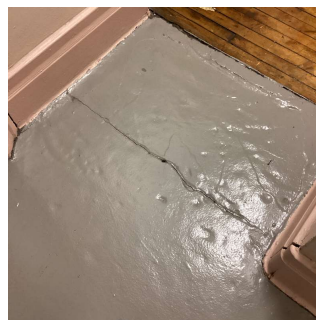
ROLLED ASPHALT: CRACKS

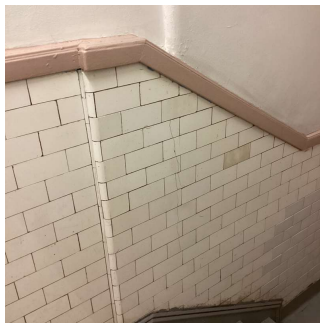
Question	Response
<b>INTERIOR</b>	
<b>CLASSROOMS/CORRIDORS/ADMIN SPACES</b>	
<b>Floor Finish</b>	
Violations	Corridor near Room 409B No violations recorded.
Deficiency	WOOD: DAMAGED/DETERIORATED
Deficiency Location/Instance	Corridor near Room 405, Rooms 405, 306, 303, 301 and others
Deficiency Quantity	500
Quantity Uom	S.F.
Potential Action	REPLACE
Urgency of Action	PRIORITY 3
Purpose of Action	LEVEL 2
Deficiency Photo1	 
Violations	Corridor near Room 405 No violations recorded.
Deficiency	VINYL TILES: DETERIORATED SUBSTRATE
Deficiency Location/Instance	Corridor near Rooms 404, 364, 363, 315, Room 365 and others
Deficiency Quantity	600
Quantity Uom	S.F.
Potential Action	REPLACE
Urgency of Action	PRIORITY 3
Purpose of Action	LEVEL 2
Deficiency Photo1	 
Violations	Corridor near Room 404 No violations recorded.
<b>Walls</b>	Inspected
Condition	2 - Between Good and Fair
Deficiency	CERAMIC TILE: BROKEN/ MISSING
Deficiency Location/Instance	Exit 7 Vestibule

Deficiency Quantity	20
Quantity Uom	S.F.
Potential Action	REPLACE
Urgency of Action	PRIORITY 3
Purpose of Action	LEVEL 2

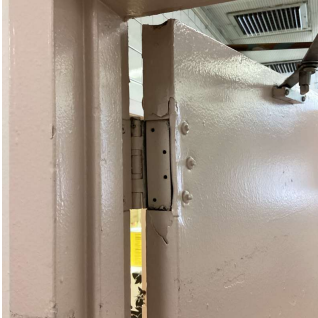
Instance on 1st Floor	Inspected
Condition	5 - Poor
Deficiency	METAL: DETERIORATED DOOR

Question	Response
<b>INTERIOR</b>	
<b>KITCHEN</b>	
<b>Door(s)</b>	
Deficiency Location/Instance	Main Entrance
Deficiency Quantity	1
Quantity Uom	EACH
Potential Action	MAINTENANCE
Urgency of Action	PRIORITY 3
Purpose of Action	LEVEL 2
Deficiency Photo1

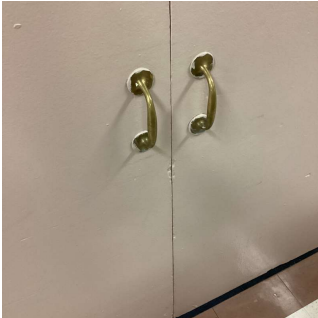
Violations	Main Entrance No violations recorded.
Deficiency	WOOD: DETERIORATED DOOR
Deficiency Location/Instance	Serving Area (2), Exit 3 (2), Storage Room, Freezers Room
Deficiency Quantity	6
Quantity Uom	EACH
Potential Action	MAINTENANCE
Urgency of Action	PRIORITY 3
Purpose of Action	LEVEL 2
Deficiency Photo1

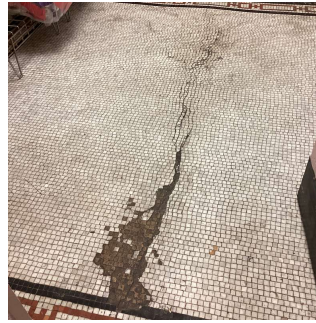
Violations	Serving Area No violations recorded.
<b>Floor Finish</b>	
Instance on 1st Floor	Inspected
Condition	5 - Poor
Deficiency	CERAMIC TILE: DETERIORATED SUBSTRATE
Deficiency Location/Instance	Exit 3 Vestibule
Deficiency Quantity	40
Quantity Uom	S.F.
Potential Action	REPLACE
Urgency of Action	PRIORITY 3
Purpose of Action	LEVEL 2

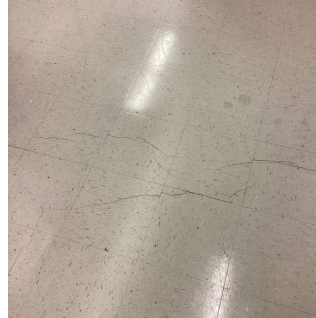
Serving area

VINYL TILES: DETERIORATED SUBSTRATE

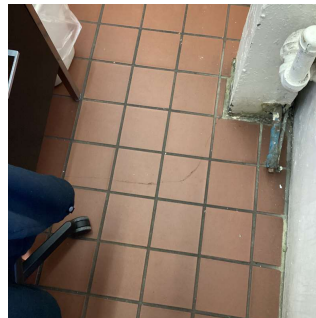
Office

QUARRY TILE: BROKEN/MISSING TILES

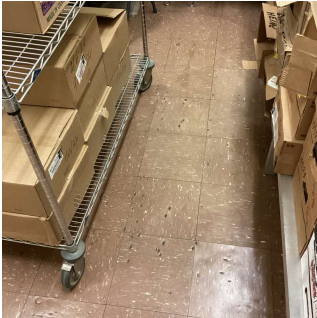
Question	Response
<b>INTERIOR</b>	
<b>KITCHEN</b>	
<b>Floor Finish</b>	
Deficiency	VINYL TILES: BROKEN/DETERIORATED/MISSING TILES
Deficiency Location/Instance	Storage Room, Freezers Room
Deficiency Quantity	60
Quantity Uom	S.F.
Potential Action	REPLACE
Urgency of Action	PRIORITY 3
Purpose of Action	LEVEL 2
Deficiency Photo1

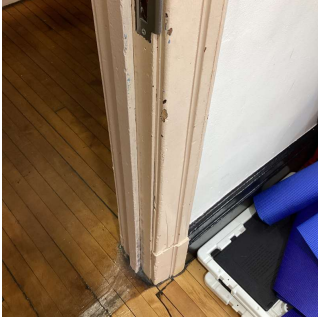
Question	Response
<b>INTERIOR</b>	
<b>MULTI-PURPOSE ROOM</b>	
<b>Door(s)</b>	
Instance on 4th Floor	Inspected
Condition	3 - Fair
Deficiency	WOOD: DETERIORATED DOOR
Deficiency Location/Instance	Main Entrance
Deficiency Quantity	1
Quantity Uom	EACH
Potential Action	MAINTENANCE
Urgency of Action	PRIORITY 3
Purpose of Action	LEVEL 2
Deficiency Photo1

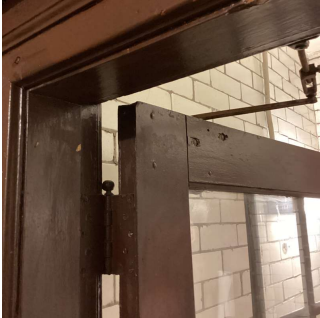
Stair AB/4
Violations	No violations recorded.
<b>Door(s)</b>	
Condition	Inspected 5 - Poor
Deficiency	WOOD: DETERIORATED DOOR
Deficiency Location/Instance	Stairs AB/4, 2, FG/1 Vestibule, HI/1 Vestibule
Deficiency Quantity	6

Quantity Uom	EACH
Potential Action	MAINTENANCE

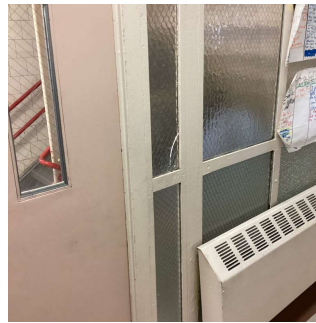
Stair CD/3

Stair FG/2
Violations	No violations recorded.
<b>Partition</b>	Inspected
Condition	3 - Fair
Deficiency	GLASS PANEL: DAMAGED/DETERIORATED
Deficiency Location/Instance	Stair AB/3, 2, CD/3, 4, FG/3and others
Deficiency Quantity	50
Quantity Uom	S.F.
Potential Action	REPLACE
Urgency of Action	PRIORITY 3
Purpose of Action	LEVEL 2

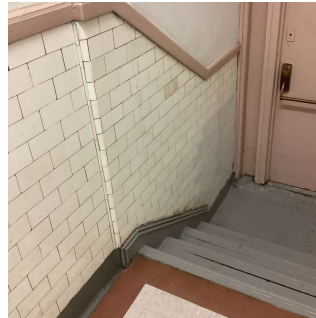
Exit 7 Vestibule

METAL: MISSING

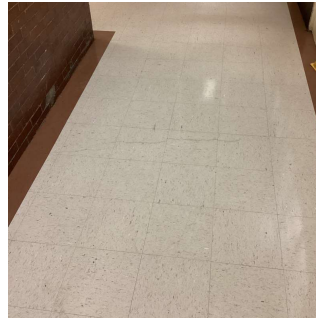
Stair E/1

VINYL TILES: DETERIORATED SUBSTRATE

REPLACE

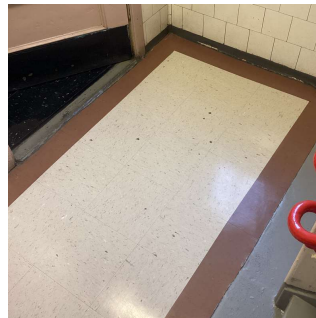
Stair AB/3

VINYL TILES: BROKEN/DETERIORATED/MISSING TILES

REPLACE

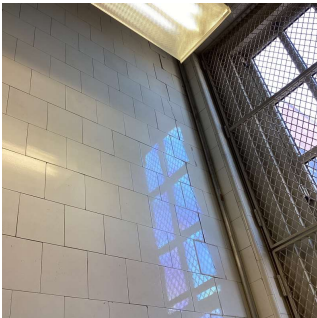
Question	Response
<b>INTERIOR</b>	
<b>STAIRS/RAMPS: INTERIOR</b>	
<b>Stairs and Landings</b>	
Deficiency	ROLLED ASPHALT: CRACKS
Deficiency Location/Instance	Stairs AB/1, E/2, FG/4, 3, HI/3 and others
Deficiency Quantity	300
Quantity Uom	S.F.
Potential Action	REPLACE
Urgency of Action	PRIORITY 3
Purpose of Action	LEVEL 2
Deficiency Photo1	 
Violations	Stair FG/4 No violations recorded.
<b>Walls</b>	Inspected
Condition	2 - Between Good and Fair
Deficiency	CERAMIC TILE: BROKEN/ MISSING
Deficiency Location/Instance	Stairs AB/3, CD/4, 3, FG/4, HI/4 and others
Deficiency Quantity	250
Quantity Uom	S.F.
Potential Action	REPLACE
Urgency of Action	PRIORITY 3
Purpose of Action	LEVEL 2
Deficiency Photo1

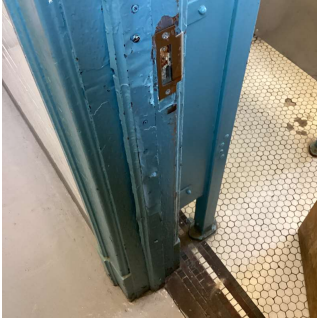
Deficiency	METAL CLAD WOOD: DETERIORATED DOOR
Deficiency Location/Instance	Room 451
Deficiency Quantity	1

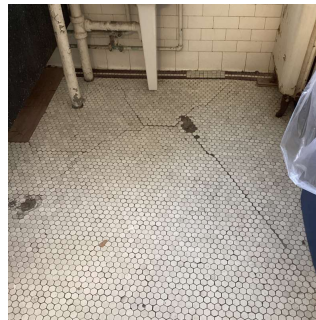
Room 351

CERAMIC TILE: DETERIORATED SUBSTRATE

REPLACE

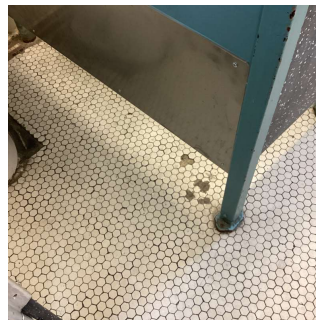
CERAMIC TILE: BROKEN/MISSING TILES

REPLACE

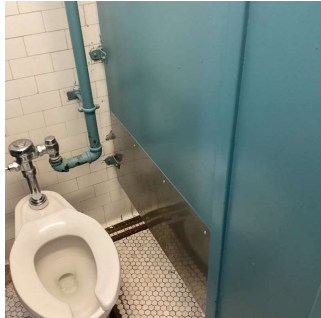
Question	Response
<b>INTERIOR</b>	
<b>TOILET ROOMS - STAFF</b>	
<b>Floor Finish</b>	Inspected
	Room 451
Violations	No violations recorded.
<b>Stalls</b>	Inspected
Condition	5 - Poor
Deficiency	RUST - MAJOR
Deficiency Location/Instance	Rooms 451
Deficiency Quantity	1
Quantity Uom	EACH
Potential Action	REPLACE
Urgency of Action	PRIORITY 3
Purpose of Action	LEVEL 2
Deficiency Photo1

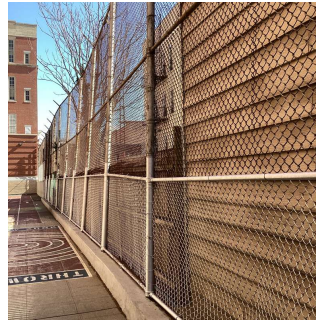
Schoolyard

**CHAIN LINK: DAMAGED POST/RAIL**

REPLACE

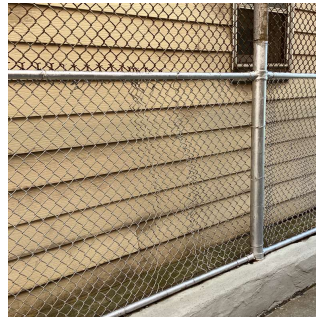
Schoolyard

**CHAIN LINK: DAMAGED/DETERIORATED**

REPLACE

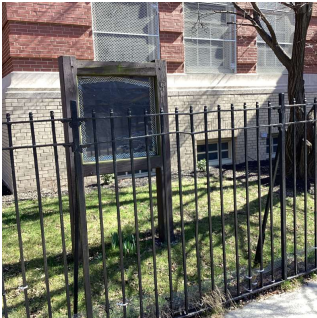
**WROUGHT IRON: DAMAGED/DETERIORATED**

Question	Response
<b>SITE</b>	
<b>FENCES</b>	
Deficiency Location/Instance	Forest Avenue
Deficiency Quantity	80
Quantity Uom	S.F.
Potential Action	REPLACE
Urgency of Action	PRIORITY 3
Purpose of Action	LEVEL 2
Deficiency Photo1

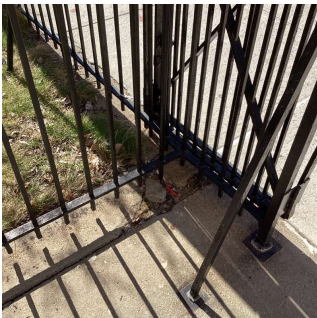
Violations	Forest Avenue No violations recorded.
Deficiency	CONCRETE CURB: DAMAGED/DETERIORATED
Deficiency Location/Instance	Forest Avenue
Deficiency Quantity	20
Quantity Uom	S.F.
Potential Action	REPLACE
Urgency of Action	PRIORITY 3
Purpose of Action	LEVEL 2
Deficiency Photo1

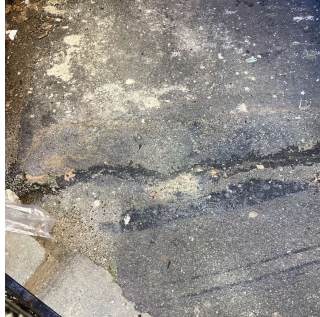
Violations	Forest Avenue No violations recorded.
<b>IRRIGATION SYSTEM</b>	Does not Exist
<b>PAVING</b>	Inspected
<b>Student Non-Use</b>	Inspected
Gravel Exists?	No
<b>Asphalt</b>	Inspected
Condition	2 - Between Good and Fair
Deficiency	CRACKS - MAJOR
Deficiency Location/Instance	Schoolyard
Deficiency Quantity	20
Quantity Uom	S.F.
Potential Action	REPLACE
Urgency of Action	PRIORITY 3
Purpose of Action	LEVEL 2

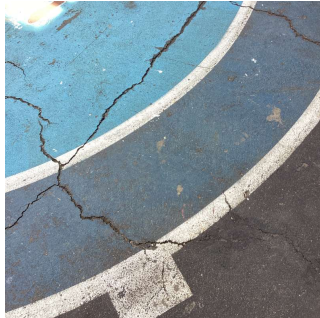
Violations	Schoolyard No violations recorded.
<b>Concrete</b>	Inspected
Condition	2 - Between Good and Fair
Deficiency	No deficiencies recorded
<b>Pavers</b>	Does not Exist
<b>Student Use</b>	Inspected
Gravel Exists?	No
<b>Asphalt</b>	Inspected
Condition	4 - Between Fair and Poor
Deficiency	CRACKS - MAJOR
Deficiency Location/Instance	Schoolyard, Near Playground
Deficiency Quantity	1,800
Quantity Uom	S.F.
Potential Action	REPLACE
Urgency of Action	PRIORITY 3
Purpose of Action	LEVEL 2
Deficiency Photo1

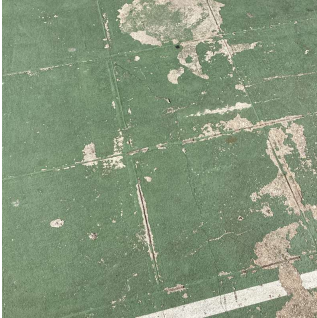
Violations	Schoolyard No violations recorded.
<b>Concrete</b>	Inspected
Condition	3 - Fair
Deficiency	CRACKS - MAJOR
Deficiency Location/Instance	Schoolyard
Deficiency Quantity	75
Quantity Uom	S.F.
Potential Action	REPLACE
Urgency of Action	PRIORITY 3
Purpose of Action	LEVEL 2

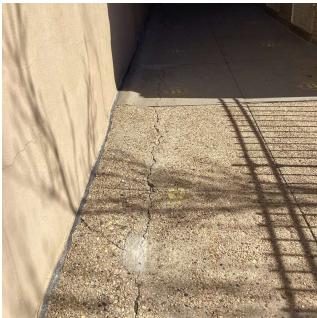
Violations	Schoolyard No violations recorded.
<b>Pavers</b>	Does not Exist
<b>Site Sidewalks &amp; Walkways</b>	Inspected
<b>Asphalt</b>	Inspected
Condition	2 - Between Good and Fair
Deficiency	No deficiencies recorded
<b>Concrete</b>	Inspected
Condition	3 - Fair
Deficiency	CRACKS - MAJOR
Deficiency Location/Instance	Exits 11, 3, Near Schoolyard
Deficiency Quantity	375
Quantity Uom	S.F.
Potential Action	REPLACE
Urgency of Action	PRIORITY 3
Purpose of Action	LEVEL 2
Deficiency Photo1

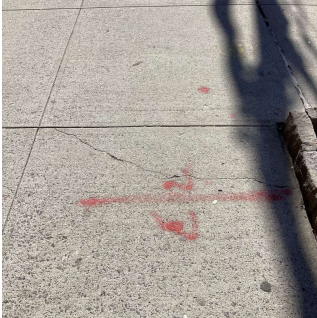
Violations	Exit 11 No violations recorded.
<b>Pavers</b>	Does not Exist
<b>DOT Sidewalk</b>	Inspected
<b>Asphalt</b>	Does not Exist
<b>Concrete</b>	Inspected
Condition	3 - Fair
Deficiency	DAMAGED/DETERIORATED/MISSING SECTIONS
Deficiency Location/Instance	Forest Avenue, 60th Street
Deficiency Quantity	200
Quantity Uom	S.F.

Question	Response
<b>SITE</b>	
<b>PAVING</b>	
<b>DOT Sidewalk</b>	
<b>Concrete</b>	
Potential Action	REPLACE
Urgency of Action	PRIORITY 3
Purpose of Action	LEVEL 2
Deficiency Photo1

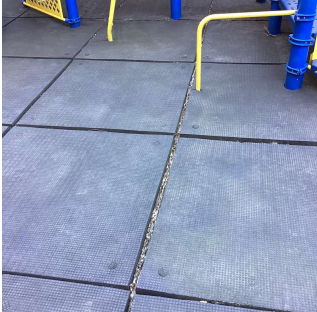
Forest Avenue
Violations	No violations recorded.
<b>Pavers</b>	Does not Exist
<b>PLAYGROUNDS</b>	Inspected
Instance on Schoolyard	Inspected
<b>Benches</b>	
Instance on Schoolyard	Does not Exist
<b>Fence</b>	
Instance on Schoolyard	Does not Exist
<b>Pavement</b>	
Instance on Schoolyard	Does not Exist
<b>Play Equipment</b>	
Instance on Schoolyard	Inspected
Condition	2 - Between Good and Fair
Deficiency	No deficiencies recorded
<b>Safety Surfacing</b>	
Instance on Schoolyard	Inspected
Condition	3 - Fair
Deficiency	DETERIORATED/MISSING
Deficiency Location/Instance	Center, Left and Right Side, Rear
Deficiency Quantity	140
Quantity Uom	S.F.
Potential Action	REPLACE
Urgency of Action	PRIORITY 3
Purpose of Action	LEVEL 2
Deficiency Photo1

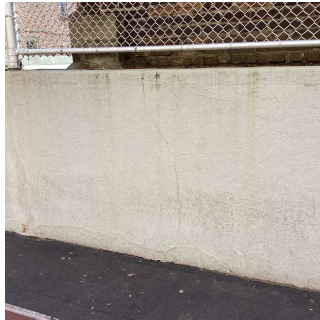
Question	Response
<b>SITE</b>	
<b>PLAYGROUNDS</b>	
<b>Safety Surfacing</b>	
Center	Center
Violations	No violations recorded.
<b>Unpaved Area</b>	
Instance on Schoolyard	Does not Exist
<b>PLAYING SURFACE</b>	Does not Exist
<b>RETAINING WALLS</b>	Inspected
Are there any Retaining Walls 6' OR higher facing public street/sidewalk?	No
Condition	3 - Fair
Deficiency	CAST IN PLACE CONCRETE: CRACKS/SPALLING - MAJOR
Deficiency Location/Instance	Schoolyard
Deficiency Quantity	40
Quantity Uom	S.F.
Potential Action	REPLACE
Urgency of Action	PRIORITY 3
Purpose of Action	LEVEL 2
Deficiency Photo1
