**NYC Department of Education**  
**Building Condition Assessment Survey 2023 - 2024**

Architectural Inspection

**Asset: J.H.S. 72 - QUEENS, 133-25 GUY R. BREWER, New York, 11434**

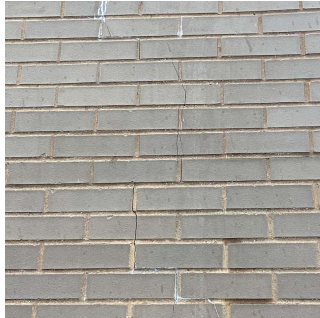
Question	Response
<b>EXTERIOR</b>	
<b>CHIMNEY</b>	
Deficiency Photo1

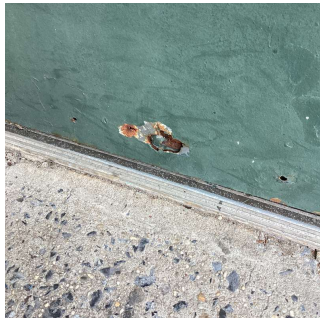
Violations	Roof 1 No violations recorded.
<b>COPING</b>	Does not Exist
<b>CORNICE</b>	Does not Exist
<b>DOORS</b>	Inspected
<b>DOORS AND FRAMES</b>	Inspected
Condition	5 - Poor
Deficiency	METAL CLAD: DETERIORATED DOOR AND FRAME - MAJOR DETERIORATION
Roof Plan reference	Q072
Deficiency Quantity	8
Quantity Uom	EACH
Potential Action	REPLACE
Urgency of Action	PRIORITY 4
Purpose of Action	LEVEL 2
Deficiency Photo1

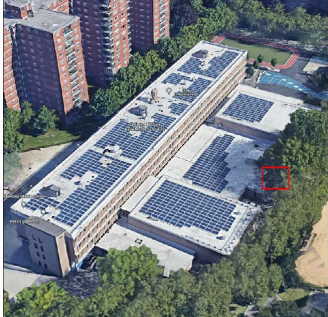
Question	Response
<b>EXTERIOR</b>	
<b>DOORS</b>	
<b>LINTELS</b>	Inspected
Condition	2 - Between Good and Fair
Deficiency	No deficiencies recorded
<b>TRANSOM/SIDE LIGHT</b>	Inspected
Condition	2 - Between Good and Fair
Deficiency	No deficiencies recorded
<b>EXTERIOR WALLS</b>	Inspected
Material Type(s)	Masonry, Concrete
Replacement Quantity	43,000
Replacement Uom	S.F.
Instance on All Facades	Inspected
Instance Condition	3 - Fair
Instance Quantity	43,000
Instance Quantity Uom	S.F.
Deficiency	CAST IN PLACE / PRE-CAST CONCRETE: MAJOR CRACKS/SPALLING
Roof Plan reference	<p>Q072</p>

Deficiency Quantity	40
Quantity Uom	S.F.
Potential Action	REPLACE
Urgency of Action	PRIORITY 4
Purpose of Action	LEVEL 2

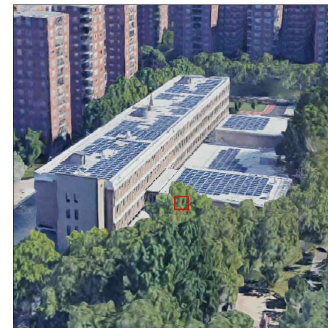
**CAST IN PLACE / PRE-CAST CONCRETE: DETERIORATED CONTROL/EXPANSION JOINTS**

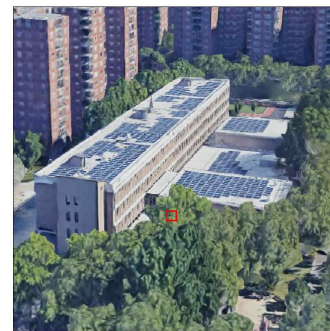
CAST IN PLACE / PRE-CAST CONCRETE: MINOR CRACKS/SPALLING

REPAIR

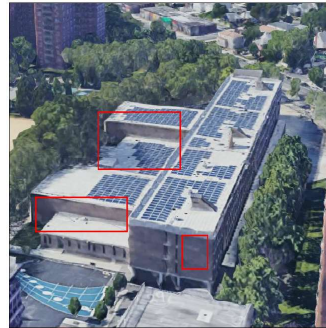
BRICK: EFFLORESCENCE

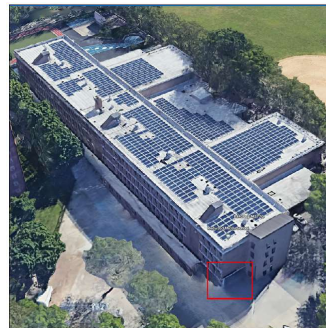
CONCRETE: WATER PENETRATION

REPAIR

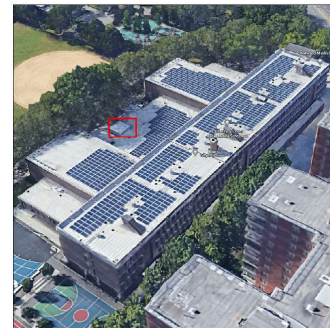
BROKEN/ DENTED BLADES

REPLACE

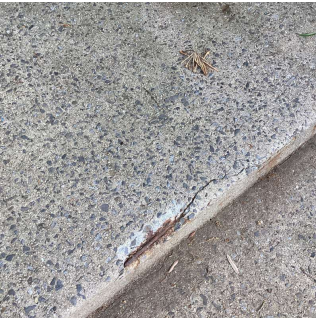
Question	Response
<b>EXTERIOR</b>	
<b>ROOF</b>	
<b>Specialties</b>	
<b>DORMER</b>	Does not Exist
<b>DUNNAGE STEEL</b>	Does not Exist
<b>SKYLIGHT/ROOF VENT</b>	Inspected
Material Type(s)	Glass
Condition	2 - Between Good and Fair
Deficiency	No deficiencies recorded
<b>ROOF/GRAVITY TANK</b>	Does not Exist
<b>STAIRS/RAMPS: EXTERIOR</b>	Inspected
<b>BUILDING CHEEK/FLANK WALLS</b>	Does not Exist
<b>RAILINGS</b>	Inspected
Condition	1 - Good
Deficiency	No deficiencies recorded
<b>STAIRS/RAMPS</b>	Inspected
Condition	5 - Poor
Deficiency	CONCRETE: WORN-OUT TREAD/RISER/NOSING
Roof Plan reference

Deficiency Quantity	30
Quantity Uom	S.F.
Potential Action	REPLACE
Urgency of Action	PRIORITY 4
Purpose of Action	LEVEL 2
Deficiency Photo1

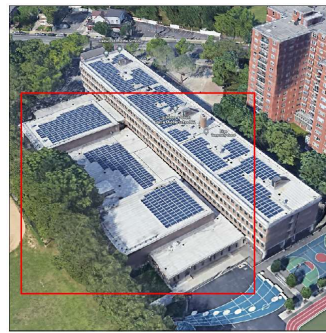
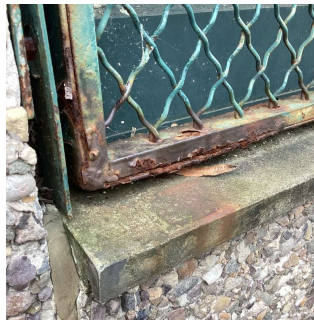
Facade C

Violations	Facade F No violations recorded.
<b>WINDOWS</b>	Inspected
Replacement Quantity	7,300
Replacement Uom	S.F.
<b>EXTERIOR GUARDS</b>	Inspected
Condition	5 - Poor
Deficiency	RUST - MAJOR

1,000  
S.F.  
REPLACE  
PRIORITY 4  
LEVEL 2

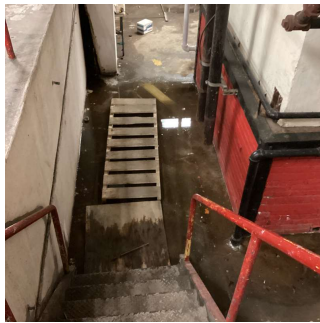
Question	Response
<b>EXTERIOR</b>	
<b>WINDOWS</b>	
<b>WINDOWS</b>	
Deficiency	No deficiencies recorded
Instance on Aluminum - Double Hung: 2011 Addition	Inspected
Instance Condition	2 - Between Good and Fair
Instance Quantity	300
Instance Quantity Uom	S.F.
Are these windows insulated	Yes
Installation Year	2011
Source of Installation	Custodial Staff
Deficiency	No deficiencies recorded
<b>INTERIOR</b>	Inspected
<b>POOLS</b>	Does not Exist
<b>STRUCTURAL</b>	Inspected
<b>COLUMNS/BEAMS/BEARING WALLS</b>	Inspected
Condition	2 - Between Good and Fair
Deficiency	No deficiencies recorded
<b>FLOOR STRUCTURE</b>	Inspected
Condition	4 - Between Fair and Poor
Deficiency	CONCRETE SLAB ON GRADE: WATER INFILTRATION IN NON-INSTRUCTIONAL SPACE
Deficiency Location/Instance	Basement - Boiler Room Pit
Deficiency Quantity	100
Quantity Uom	S.F.
Potential Action	INSTALL WATERPROOFING
Urgency of Action	PRIORITY 5
Purpose of Action	LEVEL 5
Deficiency Photo1

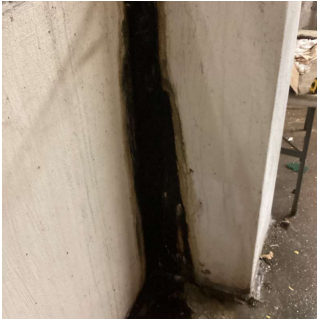
Question	Response
<b>INTERIOR</b>	
<b>STRUCTURAL</b>	
<b>FOUNDATION WALLS</b>	
Deficiency Photo1	 
Violations	Basement - Corridor No violations recorded.
Deficiency	CONCRETE: WATER INFILTRATION IN NON- INSTRUCTIONAL SPACE
Deficiency Location/Instance	Basement - Boiler Room Pit
Deficiency Quantity	100
Quantity Uom	S.F.
Potential Action	INSTALL WATERPROOFING
Urgency of Action	PRIORITY 5
Purpose of Action	LEVEL 5
Deficiency Photo1

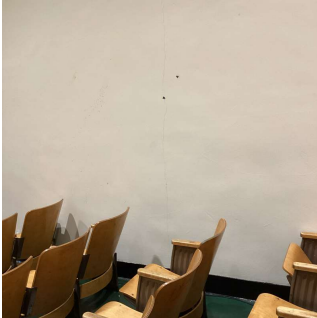
Question	Response
<b>INTERIOR</b>	
<b>AUDITORIUM</b>	
<b>Walls</b>	
Condition	2 - Between Good and Fair
Deficiency	PLASTER: CRACKS/SPALLING
Deficiency Location/Instance	Near Seat E/12, Stairs E, F
Deficiency Quantity	80
Quantity Uom	S.F.
Potential Action	REPLACE
Urgency of Action	PRIORITY 3
Purpose of Action	LEVEL 2
Deficiency Photo1

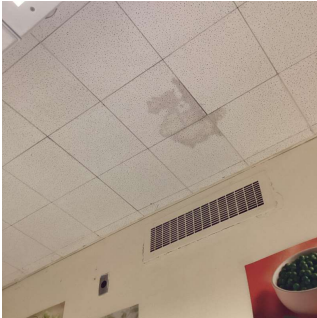
Violations	Near Seat E/12 No violations recorded.
<b>Window Curtains/Shades/Blinds</b>	
Instance on 1st Floor (600 Seats)	Does not Exist
<b>CAFETERIA</b>	
Instance on 1st Floor - Staff (600SF)	Inspected
Instance on 1st Floor -Students	Inspected
<b>Ceiling</b>	
Instance on 1st Floor - Staff (600SF)	Inspected
Condition	2 - Between Good and Fair
Deficiency	ACOUSTIC TILES ON PLASTER: DAMAGED/MISSING
Deficiency Location/Instance	Near Center, Serving Area
Deficiency Quantity	10
Quantity Uom	S.F.
Potential Action	REPLACE
Urgency of Action	PRIORITY 3
Purpose of Action	LEVEL 2
Deficiency Photo1

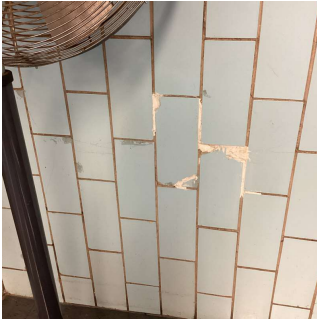
Question	Response
<b>INTERIOR</b>	
<b>CAFETERIA</b>	
<b>Walls</b>	
Violations	No violations recorded.
Instance on 1st Floor -Students	Inspected
Condition	2 - Between Good and Fair
Deficiency	GLAZED BLOCK: CRACKS/SPALLING
Deficiency Location/Instance	Near Entrances, Kitchen
Deficiency Quantity	20
Quantity Uom	S.F.
Potential Action	REPLACE
Urgency of Action	PRIORITY 3
Purpose of Action	LEVEL 2
Deficiency Photo1

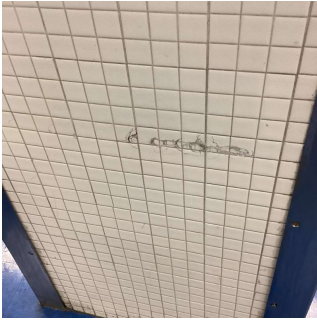
Violations	Near Entrance No violations recorded.
Deficiency	CERAMIC TILE: BROKEN/ MISSING
Deficiency Location/Instance	Columns, Serving Area
Deficiency Quantity	30
Quantity Uom	S.F.
Potential Action	REPLACE
Urgency of Action	PRIORITY 3
Purpose of Action	LEVEL 2
Deficiency Photo1

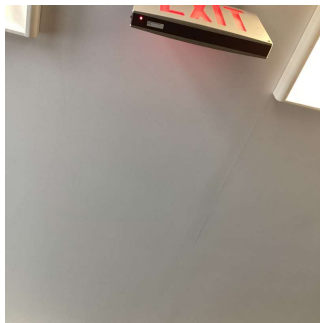
Question	Response
<b>INTERIOR</b>	
<b>CLASSROOMS/CORRIDORS/ADMIN SPACES</b>	
<b>Ceiling</b>	
Deficiency Photo1

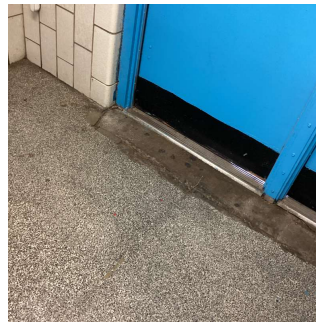
Violations	Room 401 No violations recorded.
<b>Floor Finish</b>	Inspected
Condition	2 - Between Good and Fair
Deficiency	TERRAZZO: CRACKS
Deficiency Location/Instance	Vestibule Exit 9
Deficiency Quantity	10
Quantity Uom	S.F.
Potential Action	REPLACE
Urgency of Action	PRIORITY 3

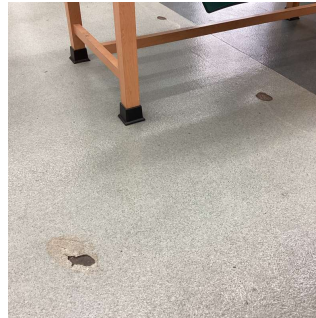
Room 332

**EPOXY FLOORING: CRACKS/SPALLING**

REPLACE

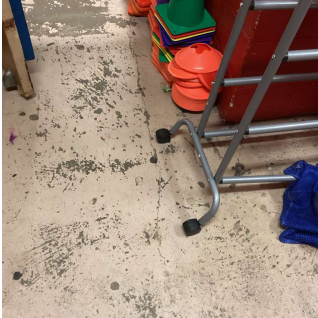
Deficiency	CONCRETE: CRACKS

Question	Response
<b>INTERIOR</b>	
<b>GYMNASIUM</b>	
<b>Floor Finish</b>	
Deficiency Location/Instance	Storage Room
Deficiency Quantity	10
Quantity Uom	S.F.
Potential Action	REPLACE
Urgency of Action	PRIORITY 3
Purpose of Action	LEVEL 2
Deficiency Photo1

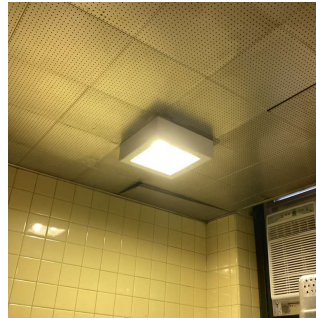
Near Windows

Question	Response
<b>INTERIOR</b>	
<b>GYMNASIUM</b>	
<b>Walls</b>	
Deficiency Photo1	 
Violations	Near Boys Locker Room No violations recorded.
<b>Window Curtains/Shades/Blinds</b>	
Instance on 1st Floor	Does not Exist
<b>INTERIOR DOOR HARDWARE</b>	
Condition	Inspected 3 - Fair
Deficiency	No deficiencies recorded
<b>INTERIOR GUARDS</b>	
Condition	Inspected 3 - Fair
Deficiency	DETERIORATED/TORN-OUT/MISSING
Deficiency Location/Instance	Stairs A/3, C/3
Deficiency Quantity	50
Quantity Uom	S.F.
Potential Action	REPLACE
Urgency of Action	PRIORITY 3
Purpose of Action	LEVEL 2
Deficiency Photo1	 
Violations	Stair C/4 No violations recorded.
<b>KITCHEN</b>	
Instance on 1st Floor	Inspected Inspected
<b>Ceiling</b>	
Instance on 1st Floor	Inspected
Condition	2 - Between Good and Fair
Deficiency	METAL PAN: DAMAGED/MISSING
Deficiency Location/Instance	Near Center, Windows
Deficiency Quantity	10
Quantity Uom	S.F.
Potential Action	REPLACE

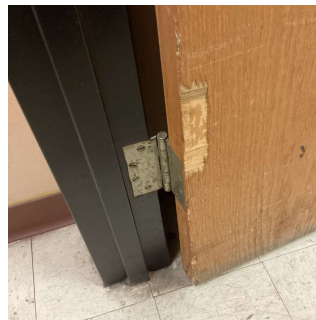
Instance on 1st Floor	Inspected
Condition	5 - Poor
Deficiency	WOOD: DETERIORATED DOOR
Deficiency Location/Instance	Room 123 (outside Kitchen)
Deficiency Quantity	1
Quantity Uom	EACH
Potential Action	MAINTENANCE
Urgency of Action	PRIORITY 3
Purpose of Action	LEVEL 2
Deficiency Photo1

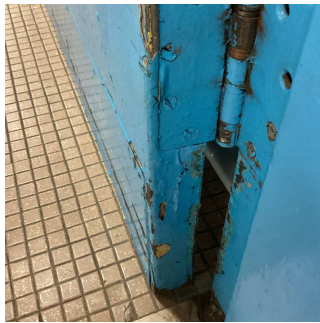
Deficiency	METAL: DETERIORATED DOOR
Deficiency Location/Instance	Near Exit Emergency, Serving Area
Deficiency Quantity	2
Quantity Uom	EACH
Potential Action	MAINTENANCE
Urgency of Action	PRIORITY 3
Purpose of Action	LEVEL 2

Question	Response
<b>INTERIOR</b>	
<b>KITCHEN</b>	
<b>Door(s)</b>	
Deficiency Photo1

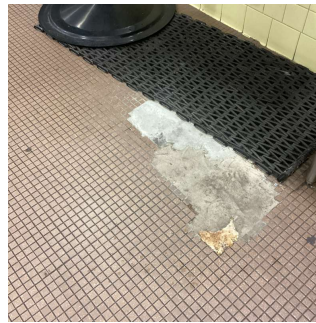
Sink Prep Area

Violations	Near Hot Water Sink No violations recorded.
Deficiency	CERAMIC TILE: BROKEN/MISSING TILES
Deficiency Location/Instance	Serving Room Area, Storage Room, Near Emergency Exit
Deficiency Quantity	40
Quantity Uom	S.F.
Potential Action	REPLACE
Urgency of Action	PRIORITY 3
Purpose of Action	LEVEL 2

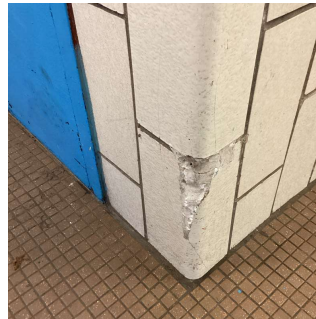
Condition	3 - Fair
-----------	----------

Deficiency GLAZED BLOCK: CRACKS/SPALLING

Deficiency Location/Instance Near Emergency Exit

Deficiency Quantity 10

Potential Action REPLACE

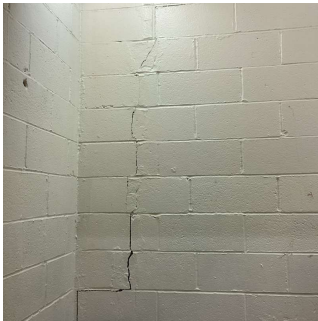
Question	Response
<b>INTERIOR</b>	
<b>LOCKER ROOM</b>	
<b>Door(s)</b>	
Deficiency Photo1	 
Violations	Office No violations recorded.
Deficiency	METAL: MISSING DOOR
Deficiency Location/Instance	Entrance
Deficiency Quantity	1
Quantity Uom	EACH
Potential Action	MAINTENANCE
Urgency of Action	PRIORITY 3
Purpose of Action	LEVEL 2
Deficiency Photo1	 
Violations	Entrance No violations recorded.
<b>Floor Finish</b>	
Instance on 1st Floor - Girls (32 Lockers)	Inspected
Condition	2 - Between Good and Fair
Deficiency	No deficiencies recorded
<b>Locker Room Lockers</b>	
Instance on 1st Floor - Girls (32 Lockers)	Inspected
Condition	2 - Between Good and Fair
Deficiency	No deficiencies recorded
<b>Walls</b>	
Instance on 1st Floor - Girls (32 Lockers)	Inspected
Condition	2 - Between Good and Fair
Deficiency	MASONRY: CRACKS/SPALLING
Deficiency Location/Instance	Near Entrance
Deficiency Quantity	10
Quantity Uom	S.F.
Potential Action	REPLACE

Question	Response
<b>INTERIOR</b>	
<b>LOCKER ROOM</b>	
<b>Walls</b>	
Deficiency Photo1

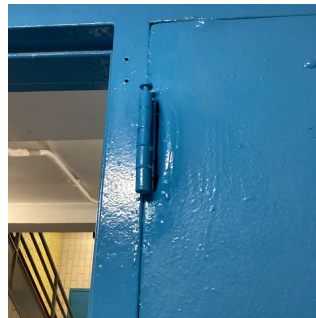
Stair C/Vestibule

<b>Door(s)</b>	Inspected
Condition	4 - Between Fair and Poor
Deficiency	METAL: DETERIORATED DOOR
Deficiency Location/Instance	Stairs A/3, B/3, C/Vestibule, 1
Deficiency Quantity	4
Quantity Uom	EACH
Potential Action	MAINTENANCE
Urgency of Action	PRIORITY 3
Purpose of Action	LEVEL 2
Deficiency Photo1

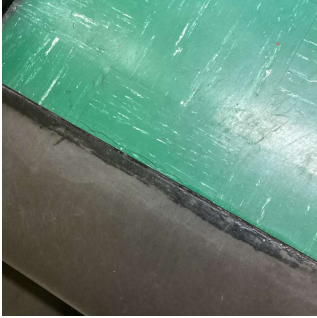
Question	Response
<b>INTERIOR</b>	
<b>STAIRS/RAMPS: INTERIOR</b>	
<b>Door(s)</b>	Inspected
Violations	No violations recorded.
<b>Partition</b>	Does not Exist
<b>Railings</b>	Inspected
Condition	3 - Fair
Deficiency	METAL: BROKEN BRACKET
Deficiency Location/Instance	Stair A/3
Deficiency Quantity	1
Quantity Uom	EACH
Potential Action	REPLACE
Urgency of Action	PRIORITY 3
Purpose of Action	LEVEL 2
Deficiency Photo1	 
Violations	Stair A/3 No violations recorded.
Deficiency	METAL: MISSING
Deficiency Location/Instance	Stair E/1, Auditorium Stage
Deficiency Quantity	15
Quantity Uom	L.F.
Potential Action	REPLACE
Urgency of Action	PRIORITY 5
Purpose of Action	LEVEL 6
Deficiency Photo1	 
Violations	Stair E/1 No violations recorded.
<b>Stairs and Landings</b>	Inspected
Condition	2 - Between Good and Fair
Deficiency	VINYL TILES: BROKEN/DETERIORATED/MISSING TILES
Deficiency Location/Instance	Stairs A/3, /1
Deficiency Quantity	20
Quantity Uom	S.F.

Question	Response
<b>INTERIOR</b>	
<b>STAIRS/RAMPS: INTERIOR</b>	
<b>Stairs and Landings</b>	
Potential Action	REPLACE
Urgency of Action	PRIORITY 3
Purpose of Action	LEVEL 2
Deficiency Photo1

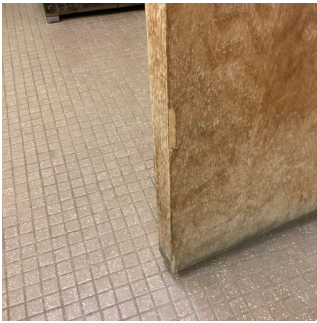
Question	Response
<b>INTERIOR</b>	
<b>TOILET ROOMS - STAFF</b>	
<b>Door(s)</b>	
Deficiency Photo1

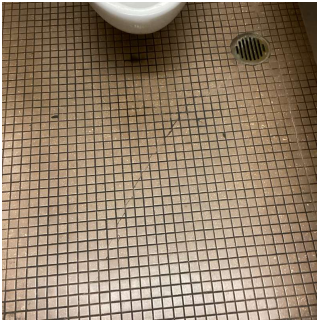
Violations	Kitchen Locker Room No violations recorded.
<b>Floor Finish</b>	Inspected
Condition	2 - Between Good and Fair
Deficiency	CERAMIC TILE: BROKEN/MISSING TILES
Deficiency Location/Instance	Rooms 216, 138, 426
Deficiency Quantity	20
Quantity Uom	S.F.
Potential Action	REPLACE
Urgency of Action	PRIORITY 3
Purpose of Action	LEVEL 2
Deficiency Photo1

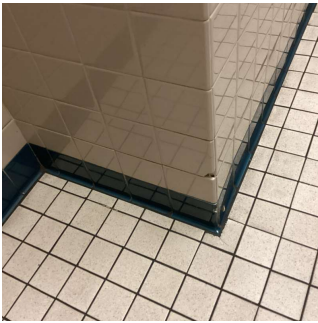
Question	Response
<b>INTERIOR</b>	
<b>TOILET ROOMS - STUDENTS</b>	
<b>Walls</b>	
Deficiency Photo1

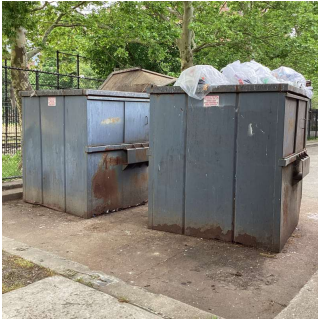
Violations	Room 226 No violations recorded.
<b>LIFE SAFETY</b>	Inspected
<b>F.D. HOLDING AREA</b>	Does not Exist
<b>STEEL STAIRS</b>	Does not Exist
<b>SITE</b>	Inspected
<b>CONTAINERIZATION</b>	Inspected
Condition	5 - Poor
Deficiency	CONCRETE PAD DAMAGED
Deficiency Location/Instance	Near Exit 10
Deficiency Quantity	100
Quantity Uom	S.F.
Potential Action	REPAIR
Urgency of Action	PRIORITY 3
Purpose of Action	LEVEL 2
Deficiency Photo1	 
Violations	Near Exit 10 No violations recorded.
Deficiency	CONTAINER DAMAGED
Deficiency Location/Instance	Near Exit 10
Deficiency Quantity	4
Quantity Uom	EACH
Potential Action	REPLACE
Urgency of Action	PRIORITY 3
Purpose of Action	LEVEL 2

Question	Response
<b>SITE</b>	
<b>CONTAINERIZATION</b>	
Deficiency Photo1

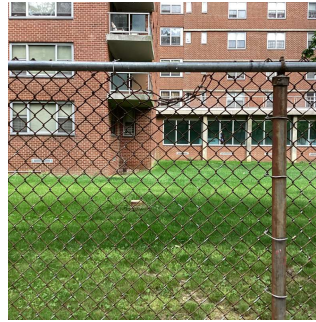
<b>FENCES</b>	Inspected
Condition	4 - Between Fair and Poor
Deficiency	CHAIN LINK: DAMAGED/DETERIORATED
Deficiency Location/Instance	Near Exit 6/7
Deficiency Quantity	50
Quantity Uom	S.F.
Potential Action	REPLACE
Urgency of Action	PRIORITY 3
Purpose of Action	LEVEL 2

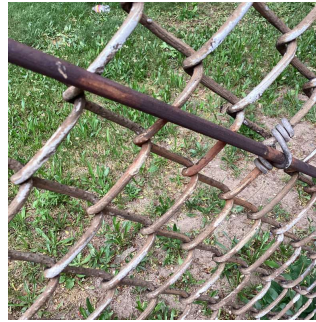
Near Exit 4/5

**CHAIN LINK: RUST - MAJOR**

REPLACE

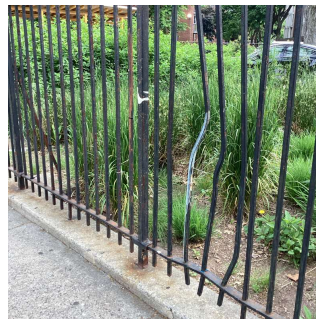
Guy R Brewer Boulevard

**WROUGHT IRON: DAMAGED/DETERIORATED**

REPLACE

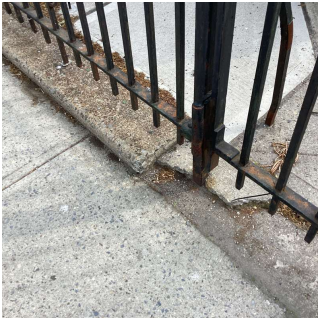
**CONCRETE CURB: DAMAGED/DETERIORATED**

Question	Response
<b>SITE</b>	
<b>FENCES</b>	
Deficiency Location/Instance	Guy R Brewer Boulevard, near NYC Park
Deficiency Quantity	350
Quantity Uom	S.F.
Potential Action	REPLACE
Urgency of Action	PRIORITY 3
Purpose of Action	LEVEL 2
Deficiency Photo1

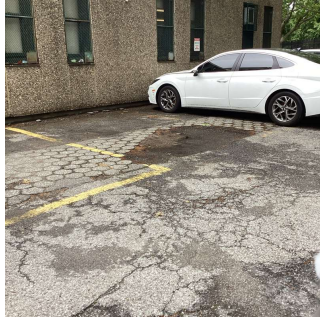
Question	Response
<b>SITE</b>	
<b>PAVING</b>	
<b>Student Non-Use</b>	
<b>Concrete</b>	
Urgency of Action	PRIORITY 3
Purpose of Action	LEVEL 2
Deficiency Photo1	 
	Near Exit 10
Violations	No violations recorded.
<b>Pavers</b>	Inspected
Condition	3 - Fair
Deficiency	DAMAGED/MISSING
Deficiency Location/Instance	Parking Area
Deficiency Quantity	100
Quantity Uom	S.F.
Potential Action	REPLACE
Urgency of Action	PRIORITY 3
Purpose of Action	LEVEL 2
Deficiency Photo1

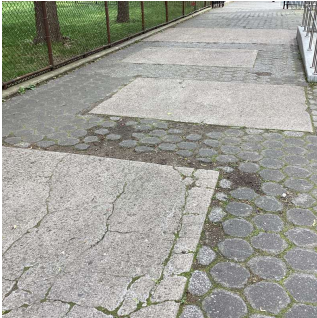
Question	Response
<b>SITE</b>	
<b>PAVING</b>	
<b>Site Sidewalks &amp; Walkways</b>	
<b>Concrete</b>	
Deficiency Quantity	1,375
Quantity Uom	S.F.
Potential Action	REPLACE
Urgency of Action	PRIORITY 3
Purpose of Action	LEVEL 2
Deficiency Photo1	 
	Near Exit 2/3
Violations	No violations recorded.
<b>Pavers</b>	Inspected
Condition	3 - Fair
Deficiency	DAMAGED/MISSING
Deficiency Location/Instance	Near Exit 6/7
Deficiency Quantity	50
Quantity Uom	S.F.
Potential Action	REPLACE
Urgency of Action	PRIORITY 3
Purpose of Action	LEVEL 2
Deficiency Photo1
