NYC Department of Education
Building Condition Assessment Survey 2023 - 2024

Architectural Inspection

Asset: P.S. 76 - QUEENS, 36-36 10 STREET, New York, 11106

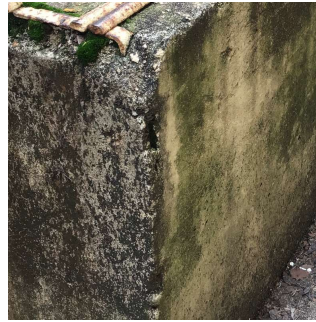
AW1

Question	Response
Architectural	
EXTERIOR	Inspected
AREAWAY	Inspected
Instance on AW1-AW3	Inspected
Instance Condition	4 - Between Fair and Poor
Instance Quantity	3
Instance Quantity Uom	EACH
Deficiency	AREAWAY WALLS: CRACKS AND SPALLING
Roof Plan reference	Q076
Deficiency Quantity	15
Quantity Uom	S.F.
Potential Action	REPAIR
Urgency of Action	PRIORITY 3
Purpose of Action	LEVEL 2

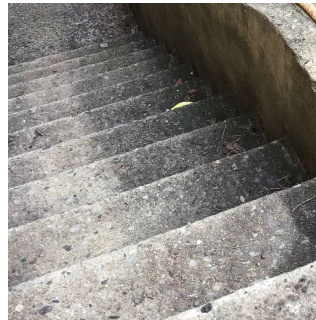
AW1

AREAWAY STAIRS: DETERIORATED TREADS/RISERS/NOSINGS

REPAIR

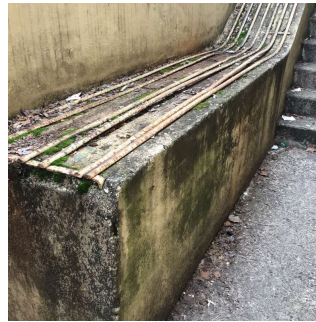
AW1
No violations recorded.

AREAWAY STAIRS: DETERIORATED MATERIAL SLIDE

30
S.F.
REPAIR
PRIORITY 3
LEVEL 2

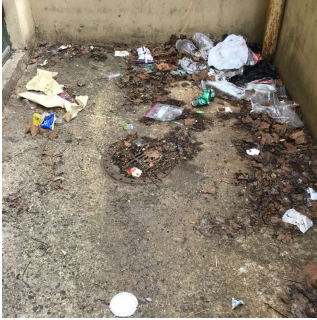
AREAWAY DRAINS: DETERIORATED

2
EACH
REPLACE
PRIORITY 4
LEVEL 2

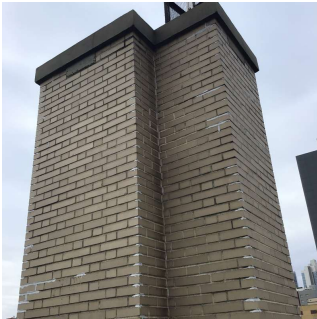
Violations	AW1 No violations recorded.
AWNINGS AND CANOPIES	
	Does not Exist
CHIMNEY	
Material Type(s)	Inspected Masonry
Condition	3 - Fair
Deficiency	BRICK: DETERIORATED JOINTS
Roof Plan reference	Q076
Deficiency Quantity	50
Quantity Uom	S.F.
Potential Action	REPOINT
Urgency of Action	PRIORITY 3
Purpose of Action	LEVEL 2
Deficiency Photo1

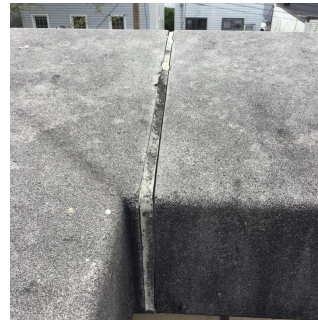
Roof 1
No violations recorded.

CAST STONE: DETERIORATED TRANSVERSE JOINTS

80
L.F.
MAINTENANCE
PRIORITY 3
LEVEL 2

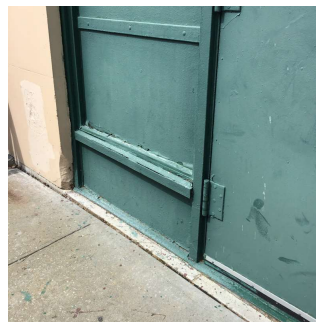
Facade D
 No violations recorded.

METAL: DENTED, MAJOR RUSTING

20
 S.F.
 REPLACE
 PRIORITY 4
 LEVEL 2

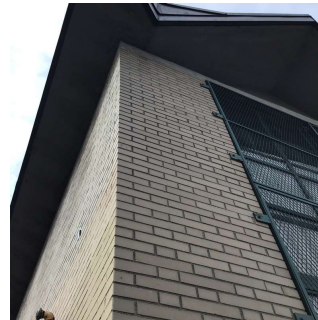
Facade A

BRICK: DETERIORATED JOINTS

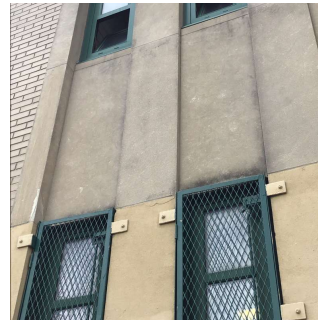
Facade C

CAST IN PLACE / PRE-CAST CONCRETE: MINOR
CRACKS/SPALLING

REPAIR

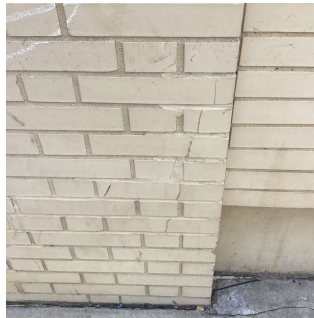
Facade A

BRICK: MINOR CRACKS AND SPALLING

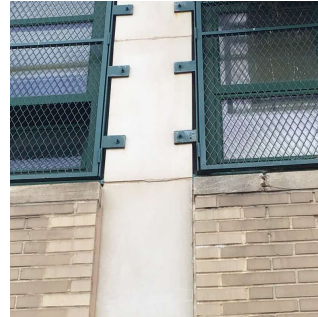
Facade B

CAST IN PLACE / PRE-CAST CONCRETE: DETERIORATED JOINTS

REPOINT
PRIORITY 3
LEVEL 2

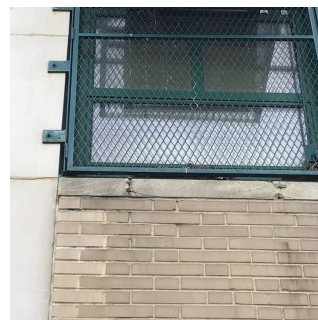
**BRICK: DETERIORATED MASONRY SILLS - MAJOR
Q076**

30
L.F.
REMOVE AND REPLACE
PRIORITY 4
LEVEL 2

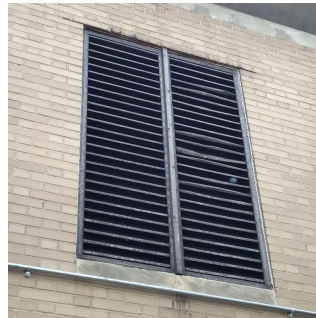
Facade G

Question	Response
EXTERIOR	
EXTERIOR WALLS	
Violations	Facade B No violations recorded.
Deficiency	BRICK: DETERIORATED JOINTS
Roof Plan reference	Q076
Elevation	
Deficiency Quantity	50
Quantity Uom	S.F.
Potential Action	REPOINT
Urgency of Action	PRIORITY 4
Purpose of Action	LEVEL 2
Deficiency Photo1	
Violations	Facade F Roof 2 No violations recorded.
EXTERIOR SOFFITS	
Condition	Inspected
Deficiency	2 - Between Good and Fair
Deficiency	No deficiencies recorded
LOADING DOCK	
Condition	Does not Exist
LOUVER	
Condition	Inspected
Deficiency	3 - Fair
Deficiency	BROKEN/ DENTED BLADES

LOUVER

REPLACE

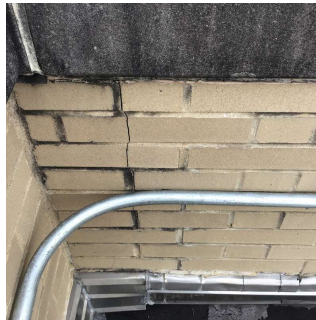
Roof 1

BRICK: MAJOR DETERIORATION/CRACKS

PARAPETS

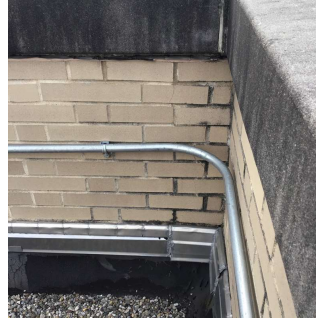
Roof 1 Facade E

BRICK: MINOR CRACKS, SPALLING

PARAPETS

REPAIR

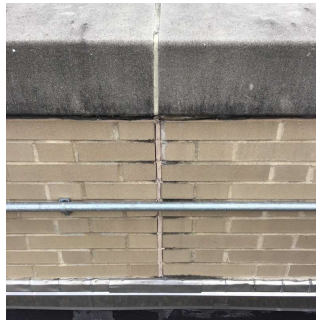
Roof 1
No violations recorded.

BRICK: DETERIORATED CONTROL/EXPANSION JOINT

20
L.F.
MAINTENANCE
PRIORITY 3
LEVEL 2

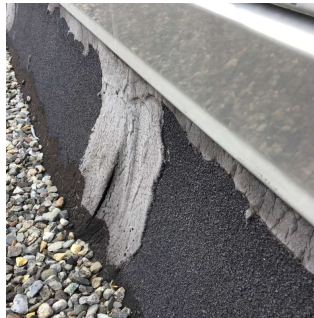
Roof 1 Facade D

Deficiency	BUILT-UP: FLASHING: DETERIORATED JOINTS
Roof Plan reference	Q076

50
L.F.
MAINTENANCE
PRIORITY 3
LEVEL 2

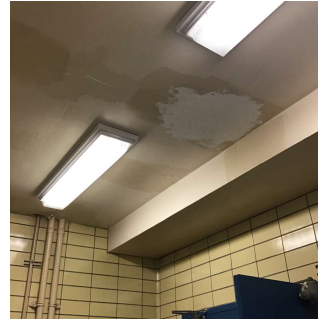
Roof 1 - Stair F/3
No violations recorded.

Deficiency	BUILT-UP: ROOFING: MINOR LEAKAGE
Roof Plan reference	Q076

50
S.F.

REPAIR
PRIORITY 5
LEVEL 2

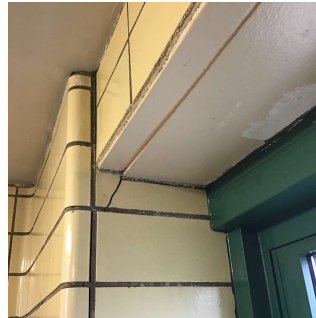
Roof 1 BH2

**BULKHEAD/PENTHOUSE WALLS/INTERIOR: GLAZED BLOCK
CRACKS/SPALLING**

REPLACE

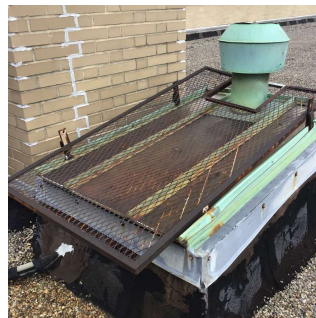
Roof 1 SK

DAMAGED GUARDS

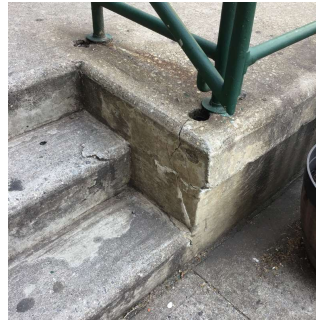
Facade A

CAST IN PLACE CONCRETE: CRACKS/SPALLING - MINOR
 Q076

REPAIR

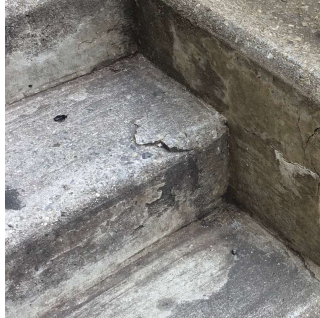
CONCRETE: CRACKS/SPALLING - MAJOR
 Q076

REPLACE

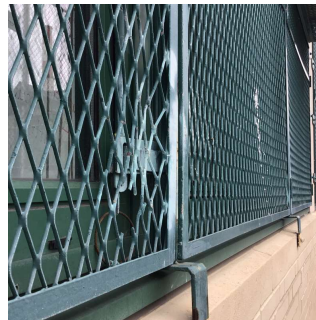
Facade B
No violations recorded.

Violations	Facade F No violations recorded.
WINDOWS	
Replacement Quantity	Inspected
Replacement Uom	11,000
EXTERIOR GUARDS	
Condition	Inspected
Deficiency	3 - Fair DETERIORATED/TORN-OUT/MISSING

30
S.F.
REPLACE
PRIORITY 4
LEVEL 2

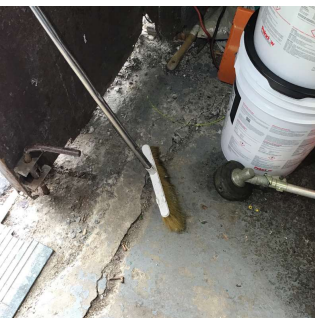
CONCRETE: CRACKS/SPALLED/REINFORCEMENT EXPOSED

Question	Response
INTERIOR	
STRUCTURAL	
FLOOR STRUCTURE	
Quantity Uom Potential Action Urgency of Action Purpose of Action Deficiency Photo1	S.F. REPAIR PRIORITY 4 LEVEL 5

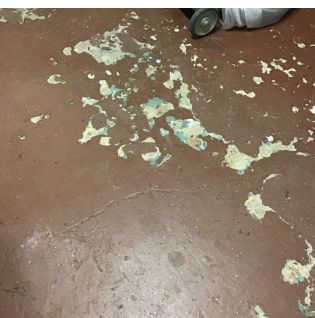
Violations	Yard Equipment Storage Room No violations recorded.
Deficiency Deficiency Location/Instance Deficiency Quantity Quantity Uom Potential Action Urgency of Action Purpose of Action Deficiency Photo1	CONCRETE SLAB ON GRADE: THRU CRACKS Basement Storage Room, Boiler Room, Room B3 40 S.F. REPAIR PRIORITY 3 LEVEL 5

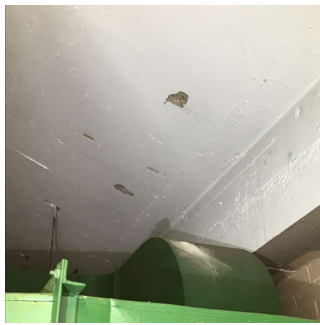
Question	Response
INTERIOR	
STRUCTURAL	
FOUNDATION WALLS	
Deficiency Photo1	 
Violations	Facade D AW1 No violations recorded.
ROOF STRUCTURE	
Condition	Inspected 3 - Fair
Deficiency	CONCRETE: CRACKED/SPALLED/REINFORCEMENT EXPOSED
Deficiency Location/Instance	Roof 4
Deficiency Quantity	30
Quantity Uom	S.F.
Potential Action	REPAIR
Urgency of Action	PRIORITY 4
Purpose of Action	LEVEL 5
Deficiency Photo1	 
Violations	Roof 4 overhang No violations recorded.
Deficiency	CONCRETE: CRACKED/SPALLED/REINFORCEMENT EXPOSED
Deficiency Location/Instance	Roof 4
Deficiency Quantity	15
Quantity Uom	S.F.
Potential Action	REPAIR
Urgency of Action	PRIORITY 3
Purpose of Action	LEVEL 5

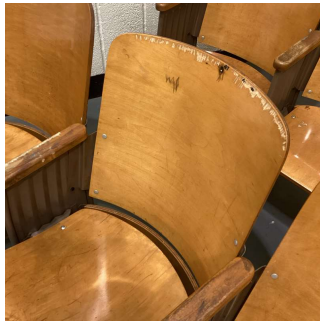
Seat Q/10
Violations	No violations recorded.
Floor Finish

Auditorium Fan Room
Violations	No violations recorded.
VAULTS-BUNKERS	Does not Exist
AUDITORIUM	Inspected
Instance on 1st Floor (400 Seats)	Inspected
Ceiling	
Instance on 1st Floor (400 Seats)	Inspected
Condition	2 - Between Good and Fair
Deficiency	No deficiencies recorded
Door(s)	
Instance on 1st Floor (400 Seats)	Inspected
Condition	2 - Between Good and Fair
Deficiency	No deficiencies recorded
Fixed H/C Lift	
Instance on 1st Floor (400 Seats)	Does not Exist
Fixed Seating	
Instance on 1st Floor (400 Seats)	Inspected
Condition	2 - Between Good and Fair
Deficiency	DAMAGED/BROKEN/INOPERABLE
Deficiency Location/Instance	Seats A/1, H/106, N/2, Q/10
Deficiency Quantity	4
Quantity Uom	EACH
Potential Action	REPLACE
Urgency of Action	PRIORITY 3
Purpose of Action	LEVEL 2
Deficiency Photo1

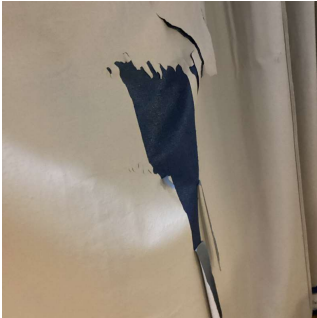
Main Right Side
Violations	No violations recorded.
Walls	
Instance on 1st Floor (400 Seats)	Inspected
Condition	2 - Between Good and Fair
Deficiency	PLASTER: CRACKS/SPALLING
Deficiency Location/Instance	Near Stage
Deficiency Quantity	20

Left Side
Violations	No violations recorded.
Stage Curtain Rigging	Inspected
Instance on 1st Floor (400 Seats)	Inspected
Condition	2 - Between Good and Fair
Deficiency	No deficiencies recorded
Stage Curtains	Inspected
Instance on 1st Floor (400 Seats)	Inspected
Condition	3 - Fair
Deficiency	WORN/DETERIORATED
Deficiency Location/Instance	Main Right Side
Deficiency Quantity	100
Quantity Uom	S.F.
Potential Action	REPLACE
Urgency of Action	PRIORITY 3
Purpose of Action	LEVEL 2
Deficiency Photo1

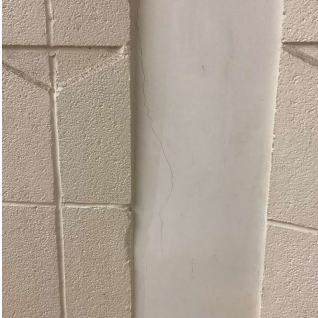
Question	Response
INTERIOR	
AUDITORIUM	
Walls	
Quantity Uom	S.F.
Potential Action	REPLACE
Urgency of Action	PRIORITY 3
Purpose of Action	LEVEL 2
Deficiency Photo1

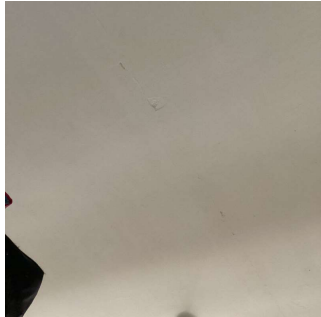
Question	Response
INTERIOR	
CLASSROOMS/CORRIDORS/ADMIN SPACES	
Ceiling	
Purpose of Action	LEVEL 2
Deficiency Photo1

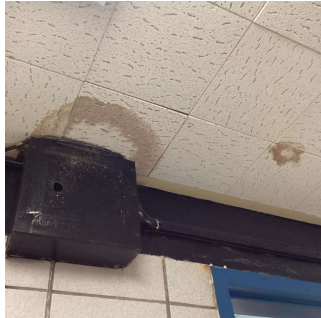
Violations	Room 211 No violations recorded.
Deficiency	ACOUSTIC TILES ON PLASTER: DAMAGED/MISSING
Deficiency Location/Instance	Room 203, Corridor near Rooms 109, 128, 306, 310, and others
Deficiency Quantity	50
Quantity Uom	S.F.
Potential Action	REPLACE
Urgency of Action	PRIORITY 3
Purpose of Action	LEVEL 2
Deficiency Photo1

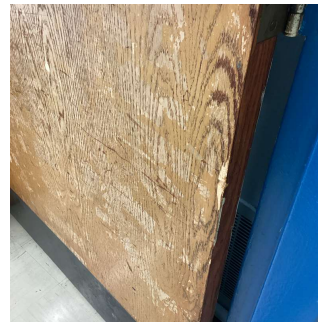
Room 205

Violations	Corridor near Room 306 No violations recorded.
Door(s)	Inspected
Condition	5 - Poor
Deficiency	WOOD: DETERIORATED DOOR
Deficiency Location/Instance	Rooms 103, 205, 226, 302, 326, and others
Deficiency Quantity	18
Quantity Uom	EACH
Potential Action	MAINTENANCE
Urgency of Action	PRIORITY 3
Purpose of Action	LEVEL 2

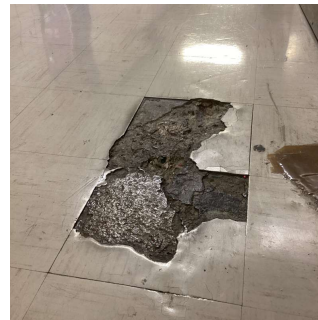
Corridor near Room 304

VINYL TILES: DETERIORATED SUBSTRATE

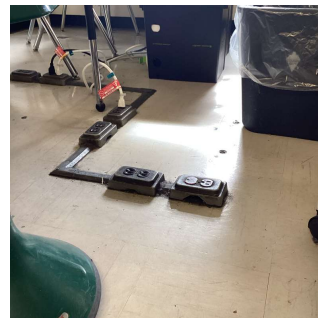
VINYL TILES: TRIPPING HAZARD - ELECTRICAL OUTLET

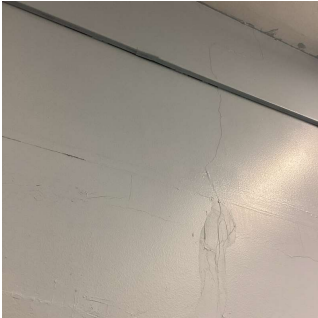
Room 313
Violations	No violations recorded.
Specialties	Does not Exist
GYMNASIUM	Inspected
Instance on 1st Floor	Inspected
Ceiling	
Instance on 1st Floor	Inspected
Condition	2 - Between Good and Fair

Question	Response
INTERIOR	
CLASSROOMS/CORRIDORS/ADMIN SPACES	
Floor Finish	Inspected
	Room 305
Violations	No violations recorded.
Deficiency	VINYL TILES: BROKEN/DETERIORATED/MISSING TILES
Deficiency Location/Instance	Rooms 103, 207, 305, 319, 328, and others
Deficiency Quantity	800
Quantity Uom	S.F.
Potential Action	REPLACE
Urgency of Action	PRIORITY 3
Purpose of Action	LEVEL 2
Deficiency Photo1	 
	Room 103
Violations	No violations recorded.
Walls	Inspected
Condition	2 - Between Good and Fair
Deficiency	PLASTER: CRACKS/SPALLING
Deficiency Location/Instance	Rooms 101, 124, 210, 307, 313, and others
Deficiency Quantity	200
Quantity Uom	S.F.
Potential Action	REPLACE
Urgency of Action	PRIORITY 3
Purpose of Action	LEVEL 2
Deficiency Photo1

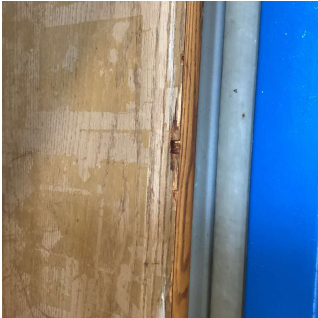
Question	Response
INTERIOR	
GYMNASIUM	
Ceiling	
Deficiency	No deficiencies recorded
Door(s)	
Instance on 1st Floor	Inspected
Condition	3 - Fair
Deficiency	WOOD: DETERIORATED DOOR
Deficiency Location/Instance	Storage Room
Deficiency Quantity	1
Quantity Uom	EACH
Potential Action	MAINTENANCE
Urgency of Action	PRIORITY 3
Purpose of Action	LEVEL 2
Deficiency Photo1

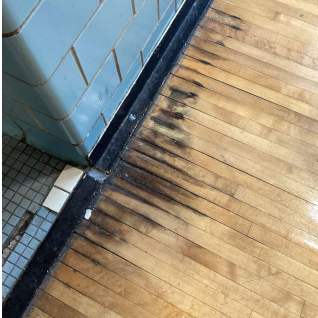
Drinking Fountain Area
Violations	No violations recorded.

Storage Room
Violations	No violations recorded.
Fixed Equipment	
Instance on 1st Floor	Inspected
Condition	2 - Between Good and Fair
Deficiency	No deficiencies recorded
Floor Finish	
Instance on 1st Floor	Inspected
Condition	2 - Between Good and Fair
Deficiency	WOOD: DAMAGED/DETERIORATED
Deficiency Location/Instance	Drinking Fountain Area
Deficiency Quantity	30
Quantity Uom	S.F.
Potential Action	REPLACE
Urgency of Action	PRIORITY 3
Purpose of Action	LEVEL 2
Deficiency Photo1

Question	Response
INTERIOR	
GYMNASIUM	
Floor Finish	
Deficiency	CERAMIC TILE: BROKEN/MISSING TILES
Deficiency Location/Instance	Drinking Fountain Area
Deficiency Quantity	10
Quantity Uom	S.F.
Potential Action	REPLACE
Urgency of Action	PRIORITY 3
Purpose of Action	LEVEL 2
Deficiency Photo1	 
Violations	Drinking Fountain Area No violations recorded.
Seating	
Instance on 1st Floor	Inspected
Condition	5 - Poor
Deficiency	DAMAGED FIXED SEATING
Deficiency Location/Instance	Near Windows
Deficiency Quantity	5
Quantity Uom	EACH
Potential Action	REPLACE
Urgency of Action	PRIORITY 3
Purpose of Action	LEVEL 2
Deficiency Photo1	 
Violations	Near Windows No violations recorded.
Sliding-folding Partition	
Instance on 1st Floor	Does not Exist
Stage	
Instance on 1st Floor	Does not Exist
Walls	
Instance on 1st Floor	Inspected
Condition	2 - Between Good and Fair
Deficiency	GLAZED BLOCK: CRACKS/SPALLING

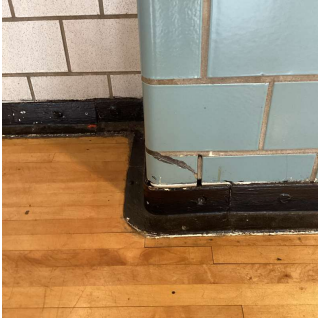
Violations	Near Entrance No violations recorded.
Deficiency	MASONRY: CRACKS/SPALLING
Deficiency Location/Instance	Near Entrance
Deficiency Quantity	10
Quantity Uom	S.F.
Potential Action	REPLACE
Urgency of Action	PRIORITY 3
Purpose of Action	LEVEL 2
Deficiency Photo1

Question	Response
INTERIOR	
GYMNASIUM	
Walls	
Deficiency Location/Instance	Near Entrance, Windows
Deficiency Quantity	30
Quantity Uom	S.F.
Potential Action	REPLACE
Urgency of Action	PRIORITY 3
Purpose of Action	LEVEL 2
Deficiency Photo1

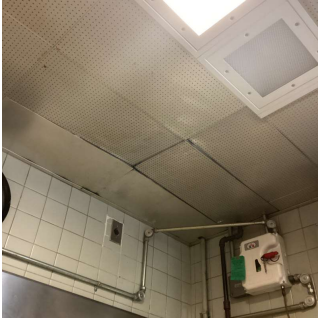
Question	Response
INTERIOR	
KITCHEN	
Ceiling	
Condition	2 - Between Good and Fair
Deficiency	METAL PAN: DAMAGED/MISSING
Deficiency Location/Instance	Near Oven Area
Deficiency Quantity	10
Quantity Uom	S.F.
Potential Action	REPLACE
Urgency of Action	PRIORITY 3
Purpose of Action	LEVEL 2
Deficiency Photo1

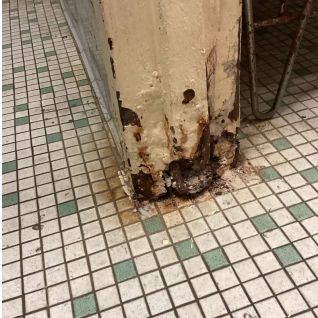
Violations	Mop Room No violations recorded.
Deficiency	WOOD: DETERIORATED DOOR
Deficiency Location/Instance	Entrance, Locker Room (Outside Cafeteria room 136)
Deficiency Quantity	5
Quantity Uom	EACH
Potential Action	MAINTENANCE
Urgency of Action	PRIORITY 3
Purpose of Action	LEVEL 2

Violations	Near Oven Area No violations recorded.
Door(s)	
Instance on 1st Floor	Inspected
Condition	5 - Poor
Deficiency	METAL: DETERIORATED DOOR AND FRAME
Deficiency Location/Instance	Mop Room , Storage Room
Deficiency Quantity	2
Quantity Uom	EACH
Potential Action	MAINTENANCE
Urgency of Action	PRIORITY 3
Purpose of Action	LEVEL 2
Deficiency Photo1

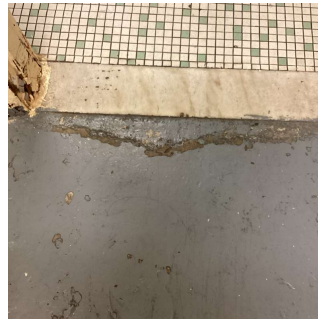
Storage Room

Deficiency CONCRETE: CRACKS

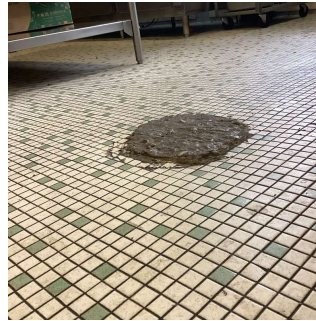
Near center

Deficiency CERAMIC TILE: BROKEN/MISSING TILES

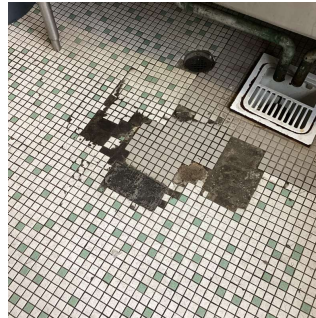
Near Windows

CERAMIC TILE: BROKEN/MISSING TILES

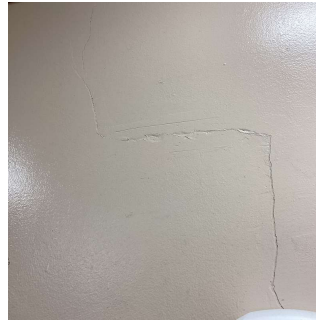
Locker Room (Outside Cafeteria room 136)

PLASTER: CRACKS/SPALLING

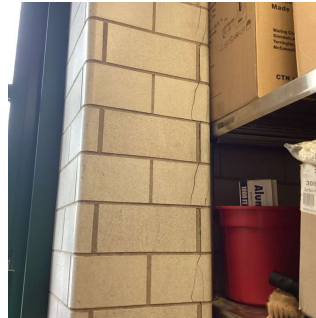
Mop Room

GLAZED BLOCK: CRACKS/SPALLING

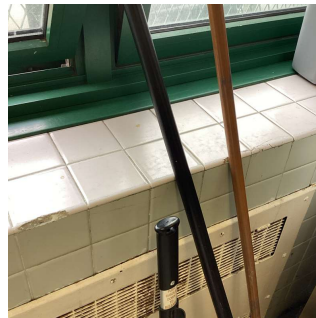
Near Windows

CERAMIC TILE: BROKEN/ MISSING

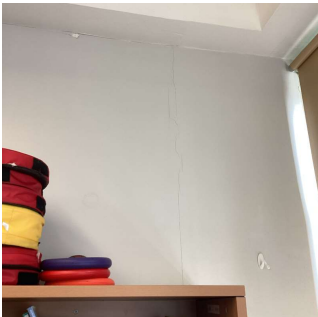
Near Windows
Violations	No violations recorded.
LOCKER ROOM	Inspected
Instance on 1st Floor	Inspected
Alternative use	Yes
Ceiling	
Instance on 1st Floor	Inspected

Question	Response
INTERIOR	
LIBRARY	Inspected
Instance on Room 215	Inspected
Built-in Furnishing	
Instance on Room 215	Does not Exist
Ceiling	
Instance on Room 215	Inspected
Condition	2 - Between Good and Fair
Deficiency	No deficiencies recorded
Door(s)	
Instance on Room 215	Inspected
Condition	2 - Between Good and Fair
Deficiency	No deficiencies recorded
Floor Finish	
Instance on Room 215	Inspected
Condition	2 - Between Good and Fair
Deficiency	No deficiencies recorded
Walls	
Instance on Room 215	Inspected
Condition	2 - Between Good and Fair
Deficiency	PLASTER: CRACKS/SPALLING
Deficiency Location/Instance	Near Entrance, Windows
Deficiency Quantity	20
Quantity Uom	S.F.
Potential Action	REPLACE
Urgency of Action	PRIORITY 3
Purpose of Action	LEVEL 2
Deficiency Photo1

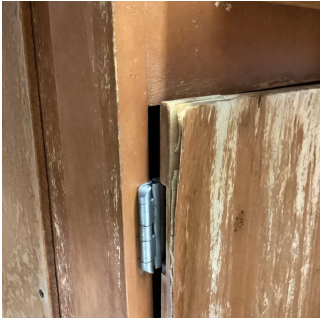
Question	Response
INTERIOR	
SCIENCE DEMO ROOM	
Fixed Equipment	
Instance on Room 204	Inspected
Condition	2 - Between Good and Fair
Deficiency	No deficiencies recorded
SCIENCE LAB	Does not Exist
SCIENCE PREP ROOM	Inspected
Instance on Room 314	Inspected
Alternative use	Yes
Fixed Equipment	
Instance on Room 314	Inspected
Condition	3 - Fair
Deficiency	CABINETS: MISSING/DAMAGED
Deficiency Location/Instance	Room 314
Deficiency Quantity	10
Quantity Uom	L.F.
Potential Action	REPLACE
Urgency of Action	PRIORITY 3
Purpose of Action	LEVEL 2
Deficiency Photo1

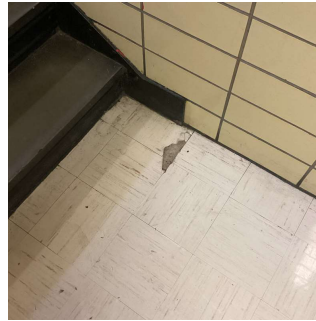
Question	Response
INTERIOR	
STAIRS/RAMPS: INTERIOR	
Ceiling	
Deficiency Photo1	 
Violations	Stair C/2 No violations recorded.
Deficiency	PLASTER: CRACKS/SPALLING - ACTIVE LEAK
Deficiency Location/Instance	Stair FG/3
Deficiency Quantity	20
Quantity Uom	S.F.
Potential Action	REPLACE
Urgency of Action	PRIORITY 5
Purpose of Action	LEVEL 2
Deficiency Photo1	 
Violations	Stair FG/3 No violations recorded.
Door(s)	Inspected
Condition	2 - Between Good and Fair
Deficiency	No deficiencies recorded
Partition	Does not Exist
Railings	Inspected
Condition	2 - Between Good and Fair
Deficiency	No deficiencies recorded
Stairs and Landings	Inspected
Condition	3 - Fair
Deficiency	VINYL TILES: BROKEN/DETERIORATED/MISSING TILES
Deficiency Location/Instance	Stairs C/2, FG/3
Deficiency Quantity	20
Quantity Uom	S.F.
Potential Action	REPLACE
Urgency of Action	PRIORITY 3
Purpose of Action	LEVEL 2

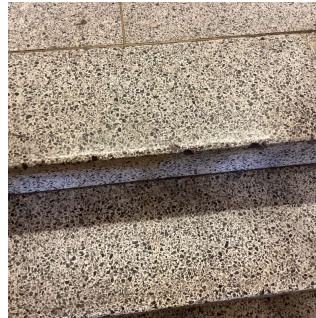
Stair AB/1

TERRAZZO: CRACKS

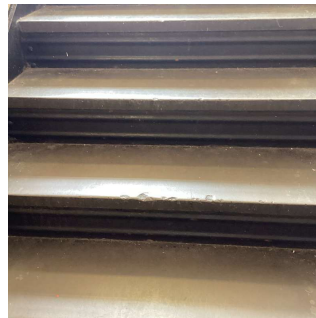
Stair AB/1

STONE: BROKEN/MISSING

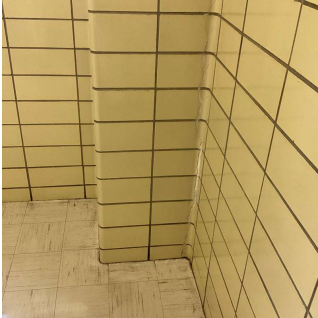
Question	Response
INTERIOR	
STAIRS/RAMPS: INTERIOR	
Walls	Inspected
Condition	2 - Between Good and Fair
Deficiency	GLAZED BLOCK: CRACKS/SPALLING
Deficiency Location/Instance	Stairs AB/Vestibule, 2, 3, FG/Vestibule, 1, 2
Deficiency Quantity	50
Quantity Uom	S.F.
Potential Action	REPLACE
Urgency of Action	PRIORITY 3
Purpose of Action	LEVEL 2
Deficiency Photo1

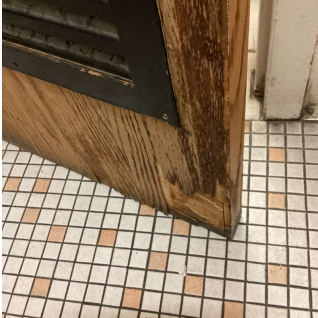
Violations	Kitchen Locker Room No violations recorded.
Floor Finish	Inspected
Condition	2 - Between Good and Fair

Violations	Stair FG/2 No violations recorded.
TOILET ROOMS - STAFF	
Ceiling	Inspected
Condition	2 - Between Good and Fair
Deficiency	No deficiencies recorded
Door(s)	Inspected
Condition	5 - Poor
Deficiency	WOOD: DETERIORATED DOOR
Deficiency Location/Instance	Rooms 128, 214, 313, 316, Kitchen Locker Room, and others
Deficiency Quantity	8
Quantity Uom	EACH
Potential Action	MAINTENANCE
Urgency of Action	PRIORITY 3
Purpose of Action	LEVEL 2
Deficiency Photo1

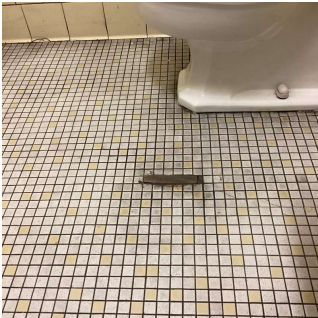
Deficiency	CERAMIC TILE: BROKEN/MISSING TILES
Deficiency Location/Instance	Rooms 313, 316

Question	Response
INTERIOR	
TOILET ROOMS - STAFF	
Floor Finish	
Deficiency Quantity	10
Quantity Uom	S.F.
Potential Action	REPLACE
Urgency of Action	PRIORITY 3
Purpose of Action	LEVEL 2
Deficiency Photo1

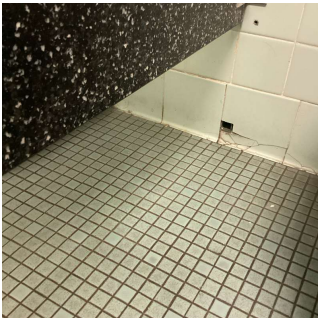
Room 128
Violations	No violations recorded.
TOILET ROOMS - STUDENTS	
	Inspected
Ceiling	Inspected
Condition	2 - Between Good and Fair
Deficiency	PLASTER: CRACKS/SPALLING
Deficiency Location/Instance	Room 118
Deficiency Quantity	10
Quantity Uom	S.F.
Potential Action	REPLACE

Room 313
Violations	No violations recorded.
Stalls	Inspected
Condition	2 - Between Good and Fair
Deficiency	No deficiencies recorded
Walls	Inspected
Condition	2 - Between Good and Fair
Deficiency	CERAMIC TILE: BROKEN/ MISSING
Deficiency Location/Instance	Rooms 128, 130, 313
Deficiency Quantity	20
Quantity Uom	S.F.
Potential Action	REPLACE
Urgency of Action	PRIORITY 3
Purpose of Action	LEVEL 2
Deficiency Photo1

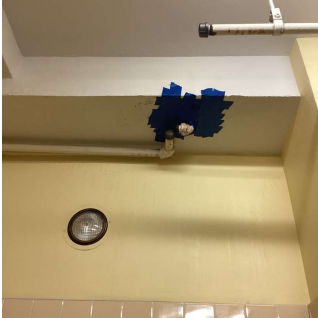
Question	Response
INTERIOR	
TOILET ROOMS - STUDENTS	
Ceiling	
Urgency of Action	PRIORITY 3
Purpose of Action	LEVEL 2
Deficiency Photo1

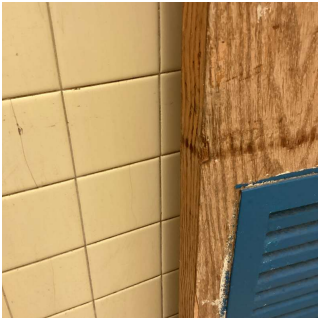
Room 118
Violations	No violations recorded.
Door(s)	
Condition	Inspected
Deficiency	5 - Poor
Deficiency Location/Instance	WOOD: DETERIORATED DOOR
Deficiency Quantity	Rooms 39, 40, 126, 222, 324, 320
Quantity Uom	6
Potential Action	EACH
Urgency of Action	MAINTENANCE
Purpose of Action	PRIORITY 3
Deficiency Photo1	LEVEL 2

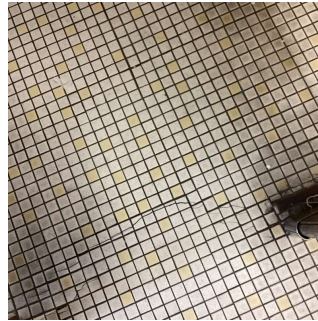
Room 324
Violations	No violations recorded.
Floor Finish	
Condition	Inspected
Deficiency	2 - Between Good and Fair
Deficiency Location/Instance	CERAMIC TILE: BROKEN/MISSING TILES
Deficiency Quantity	Rooms 40, 222, 324
Quantity Uom	30
Potential Action	S.F.
Urgency of Action	REPLACE
Purpose of Action	PRIORITY 3
	LEVEL 2

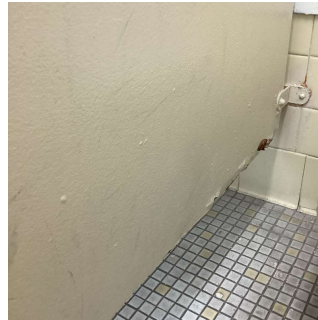
Room 222

RUST - MAJOR

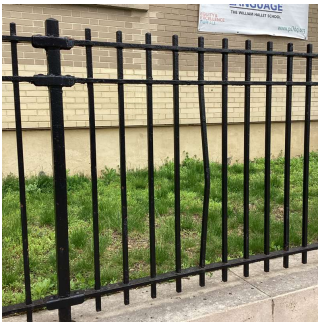
37th Avenue
Violations	No violations recorded.
Deficiency	CONCRETE CURB: DAMAGED/DETERIORATED
Deficiency Location/Instance	10th Street
Deficiency Quantity	70
Quantity Uom	S.F.
Potential Action	REPLACE
Urgency of Action	PRIORITY 3
Purpose of Action	LEVEL 2
Deficiency Photo1

Question	Response
SITE	
Drainage System for Soil	Inspected
Culverts - Soil Covering	Does not Exist
DRINKING FOUNTAINS	Does not Exist
FENCES	Inspected
Condition	3 - Fair
Deficiency	WROUGHT IRON: DAMAGED/DETERIORATED
Deficiency Location/Instance	37th Avenue
Deficiency Quantity	40
Quantity Uom	S.F.
Potential Action	REPLACE
Urgency of Action	PRIORITY 3
Purpose of Action	LEVEL 2
Deficiency Photo1

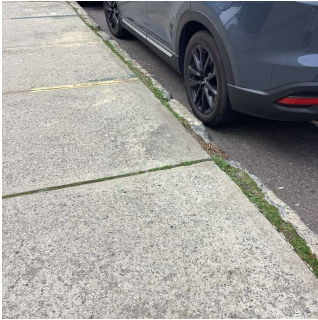
Question	Response
SITE	
PAVING	
DOT Sidewalk	
Concrete	
Violations	9th Street No violations recorded.
Deficiency	DAMAGED CURBS
Deficiency Location/Instance	9th Street, 10th Street, 37th Avenue
Deficiency Quantity	290
Quantity Uom	L.F.
Potential Action	REPLACE
Urgency of Action	PRIORITY 3
Purpose of Action	LEVEL 2
Deficiency Photo1

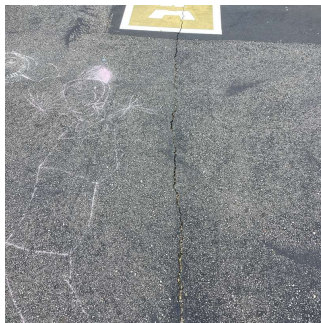
Violations	9th Street No violations recorded.
Pavers	Does not Exist
PLAYGROUNDS	
Instance on Along 37th Avenue	Inspected
Benches	
Instance on Along 37th Avenue	Inspected
Condition	2 - Between Good and Fair
Deficiency	No deficiencies recorded
Fence	
Instance on Along 37th Avenue	Inspected
Condition	2 - Between Good and Fair
Deficiency	No deficiencies recorded
Pavement	
Instance on Along 37th Avenue	Inspected
Condition	3 - Fair
Deficiency	ASPHALT: CRACKS - MAJOR
Deficiency Location/Instance	Near Fences, Center, Exit 3
Deficiency Quantity	100
Quantity Uom	S.F.
Potential Action	REPLACE
Urgency of Action	PRIORITY 3

Question	Response
SITE	
PLAYGROUNDS	
Pavement	
Deficiency Photo1

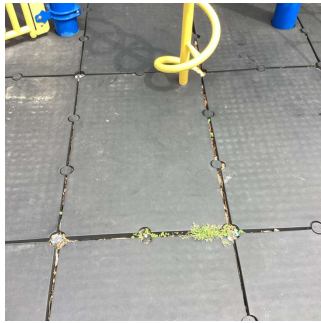
Violations	Near Fence No violations recorded.
Play Equipment	
Instance on Along 37th Avenue	Inspected
Condition	2 - Between Good and Fair
Deficiency	No deficiencies recorded
Safety Surfacing	
Instance on Along 37th Avenue	Inspected
Condition	3 - Fair
Deficiency	DETERIORATED/MISSING
Deficiency Location/Instance	Near Seats
Deficiency Quantity	50
Quantity Uom	S.F.
Potential Action	REPLACE
Urgency of Action	PRIORITY 3
Purpose of Action	LEVEL 2
Deficiency Photo1

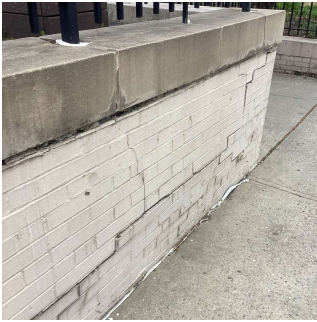
Violations	37th Avenue No violations recorded.
Deficiency	STONE: DETERIORATED COPING STONE
Deficiency Location/Instance	37th Avenue
Deficiency Quantity	80
Quantity Uom	S.F.
Potential Action	REPLACE
Urgency of Action	PRIORITY 3
Purpose of Action	LEVEL 2

Violations	Near Ramp No violations recorded.
Unpaved Area	
Instance on Along 37th Avenue	Does not Exist
PLAYING SURFACE	Does not Exist
RETAINING WALLS	Inspected
Are there any Retaining Walls 6' OR higher facing public street/sidewalk?	No
Condition	3 - Fair
Deficiency	BRICK: BULGING/DISPLACED
Deficiency Location/Instance	37th Avenue
Deficiency Quantity	60
Quantity Uom	S.F.
Potential Action	REPLACE
Urgency of Action	PRIORITY 3
Purpose of Action	LEVEL 2
Deficiency Photo1

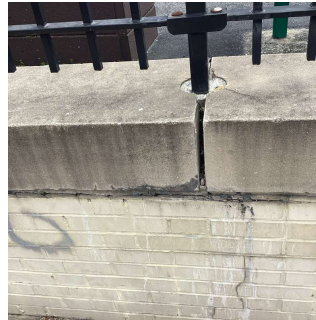
9th Street

STONE: DETERIORATED JOINT AT COPING STONE

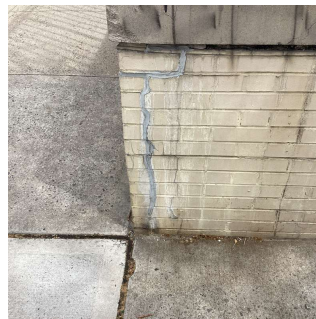
37th Avenue

BRICK: CRACKS/SPALLING - MAJOR

REPLACE
