NYC Department of Education
Building Condition Assessment Survey 2023 - 2024

Architectural Inspection

Q079

Asset: P.S. 79 - QUEENS, 147-27 15 DRIVE, New York, 11357

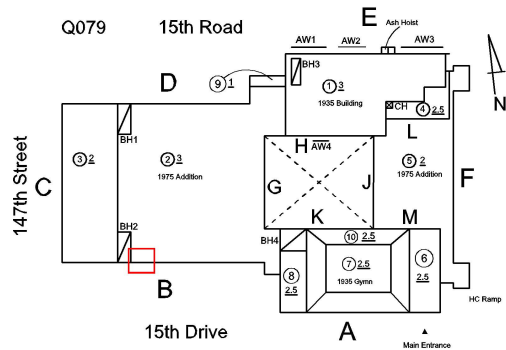
Roof Plan reference

ROLL-UP DOOR: DETERIORATED DOOR AND FRAME - MAJOR DETERIORATION

300
S.F.
REPLACE
PRIORITY 4
LEVEL 2

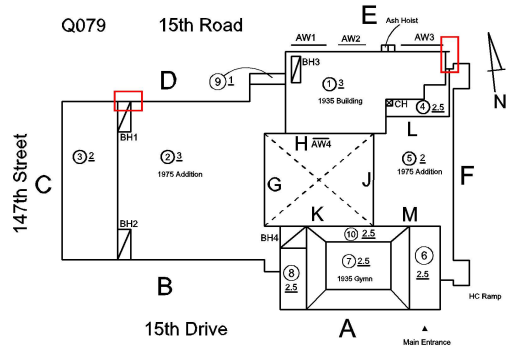
Roof Plan reference

METAL CLAD: DETERIORATED DOOR AND FRAME - MAJOR DETERIORATION

4
EACH
REPLACE
PRIORITY 4

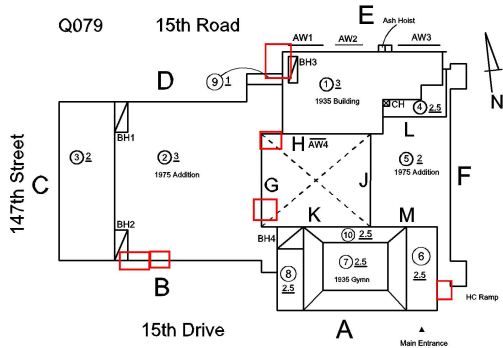
Violations	Facade F No violations recorded.
Deficiency	METAL: DETERIORATED DOOR AND FRAME - MAJOR DETERIORATION
Roof Plan reference

Deficiency Quantity	12
Quantity Uom	EACH
Potential Action	REPLACE
Urgency of Action	PRIORITY 4
Purpose of Action	LEVEL 2
Deficiency Photo1

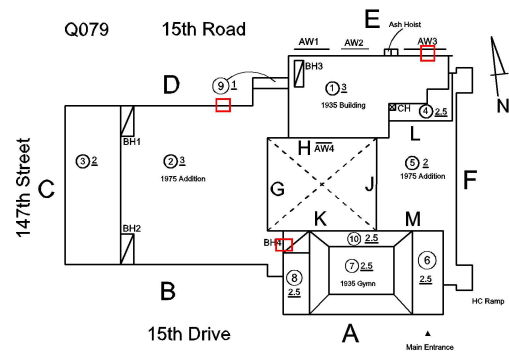
Question	Response
EXTERIOR	
DOORS	Inspected
TRANSOM/SIDE LIGHT	
Deficiency	No deficiencies recorded
EXTERIOR WALLS	Inspected
Material Type(s)	Masonry
Replacement Quantity	43,000
Replacement Uom	S.F.
Instance on All Facades	Inspected
Instance Condition	2 - Between Good and Fair
Instance Quantity	43,000
Instance Quantity Uom	S.F.
Deficiency	No deficiencies recorded
EXTERIOR SOFFITS	Inspected
Condition	2 - Between Good and Fair
Deficiency	No deficiencies recorded
LOADING DOCK	Does not Exist
LOUVER	Inspected
Condition	2 - Between Good and Fair
Deficiency	No deficiencies recorded
PARAPETS	Inspected
Material Type(s)	Masonry
Replacement Quantity	8,000
Replacement Uom	C.F.
Instance on All Facades	Inspected
Instance Condition	3 - Fair
Instance Quantity	8,000
Instance Quantity Uom	C.F.
Deficiency	BRICK: MINOR CRACKS, SPALLING
Roof Plan reference

25
S.F.
REPAIR
PRIORITY 3
LEVEL 2

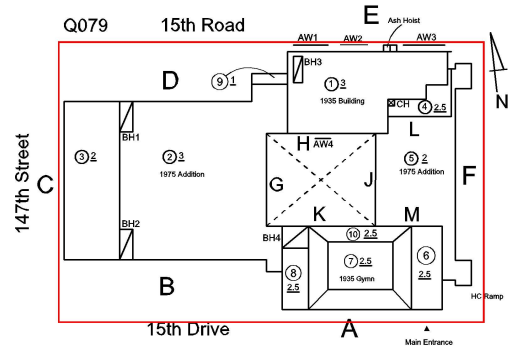
Roof Plan reference

BRICK: EFFLORESCENCE

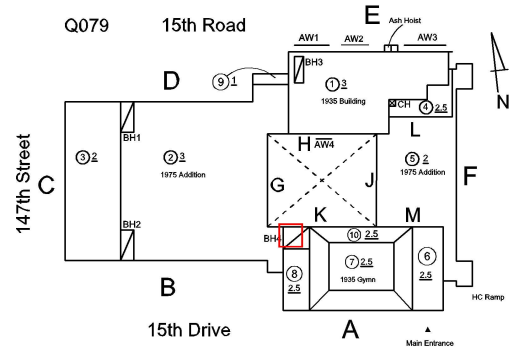
Roof Plan reference

DAMAGED/MISSING

LEADERS, GUTTERS, DOWNSPOUTS, SCUPPERS

10
L.F.
REPLACE
PRIORITY 4
LEVEL 2

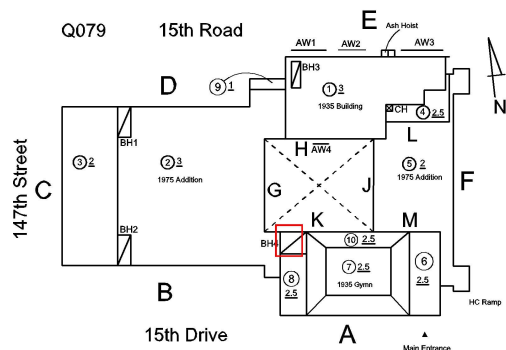
Roof Plan reference

Condition	3 - Fair
Deficiency	BULKHEAD/PENTHOUSE WALLS/INTERIOR: PLASTER CRACKS/SPALLING

Deficiency Quantity	30
Quantity Uom	S.F.

Question	Response
EXTERIOR	
ROOF	
Specialties	
BULKHEAD/PENTHOUSE	
Potential Action	REPLACE
Urgency of Action	PRIORITY 3
Purpose of Action	LEVEL 2
Deficiency Photo1

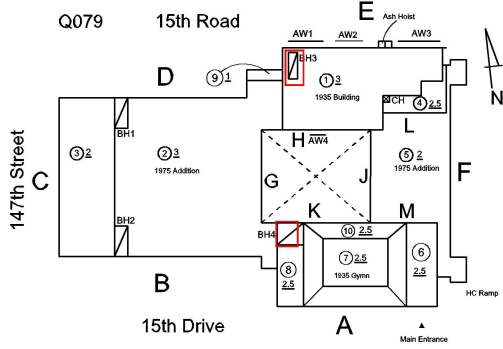
BH4
Violations	No violations recorded.
Deficiency	BULKHEAD/PENTHOUSE WALLS/EXTERIOR: CRACKS/SPALLING - MINOR
Roof Plan reference

Deficiency Quantity	35
Quantity Uom	S.F.
Potential Action	REPAIR
Urgency of Action	PRIORITY 3
Purpose of Action	LEVEL 2
Deficiency Photo1

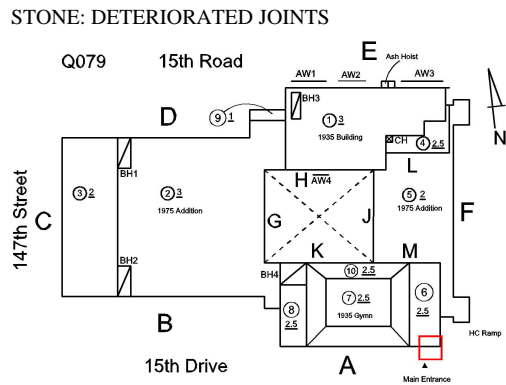
Deficiency
 Roof Plan reference

Question	Response
EXTERIOR	
ROOF	Inspected
Specialties	Inspected
DUNNAGE STEEL	Inspected
Deficiency	No deficiencies recorded
SKYLIGHT/ROOF VENT	Does not Exist
ROOF/GRAVITY TANK	Does not Exist
STAIRS/RAMPS: EXTERIOR	Inspected
BUILDING CHEEK/FLANK WALLS	Inspected
Condition	5 - Poor

20
 S.F.
 REPOINT
 PRIORITY 4
 LEVEL 2

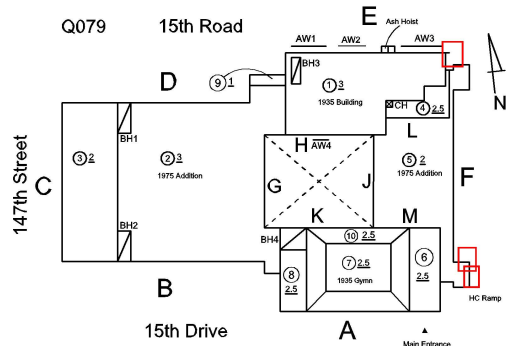
Deficiency
 Roof Plan reference

CAST IN PLACE CONCRETE: CRACKS/SPALLING - MINOR

60
 S.F.

Question	Response
EXTERIOR	
STAIRS/RAMPS: EXTERIOR	Inspected
BUILDING CHEEK/FLANK WALLS	Inspected
Potential Action	REPAIR
Urgency of Action	PRIORITY 3
Purpose of Action	LEVEL 2
Deficiency Photo1

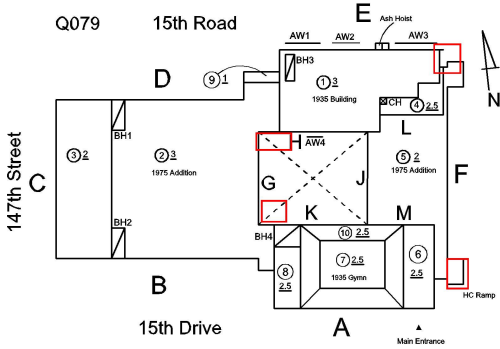
Violations	Facade F No violations recorded.
Deficiency	CAST IN PLACE CONCRETE: CRACKS/SPALLING - MAJOR
Roof Plan reference

Deficiency Quantity	80
Quantity Uom	S.F.
Potential Action	REPLACE
Urgency of Action	PRIORITY 4
Purpose of Action	LEVEL 2
Deficiency Photo1

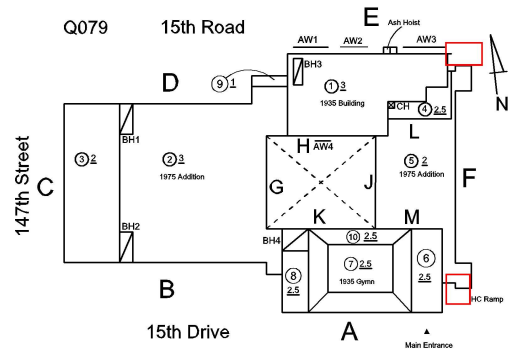
Roof Plan reference

Violations	Facade G No violations recorded.
RAILINGS	Inspected
Condition	5 - Poor
Deficiency	RUST - MAJOR

RAILINGS

30
L.F.
REPLACE
PRIORITY 4
LEVEL 2

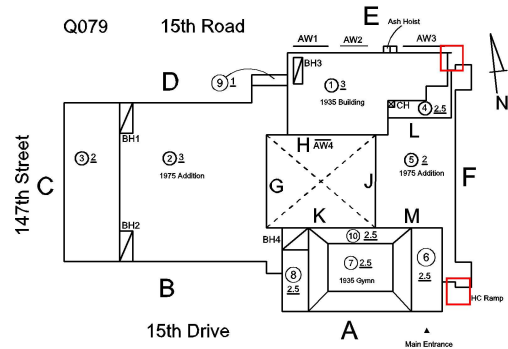
Roof Plan reference

CONCRETE: WORN-OUT TREAD/RISER/NOSING

20
S.F.
REPLACE
PRIORITY 4
LEVEL 2

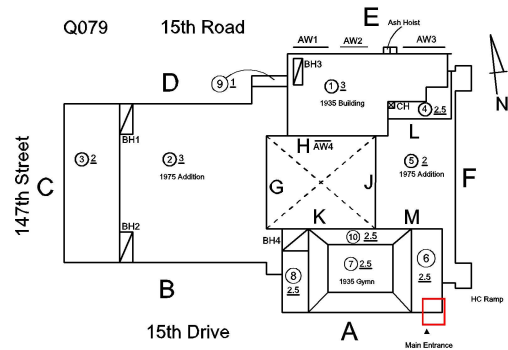
Roof Plan reference

STONE: DETERIORATED JOINTS

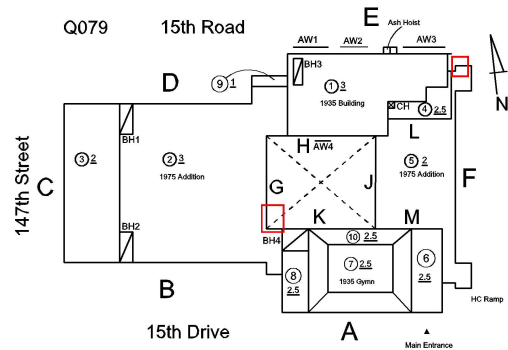
Roof Plan reference

CONCRETE: CRACKS/SPALLING - MAJOR

STAIRS/RAMPS

30
S.F.
REPLACE
PRIORITY 4
LEVEL 2

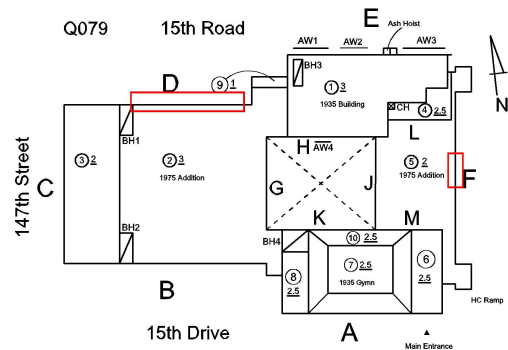
Roof Plan reference

DETERIORATED/TORN-OUT/MISSING

Question	Response
EXTERIOR	
WINDOWS	
EXTERIOR GUARDS	
Elevation	 
Deficiency Quantity	180
Quantity Uom	S.F.
Potential Action	REPLACE
Urgency of Action	PRIORITY 4
Purpose of Action	LEVEL 2
Deficiency Photo1	 
Violations	Facade D No violations recorded.
LINTELS	Inspected
Condition	2 - Between Good and Fair
Deficiency	No deficiencies recorded
WINDOWS	Inspected
Material Type(s)	Aluminum
Instance on Aluminum - Double Hung: 1975 Addition	Inspected
Instance Condition	2 - Between Good and Fair
Instance Quantity	6,000
Instance Quantity Uom	S.F.
Are these windows insulated	Yes
Installation Year	2014
Source of Installation	Custodial Staff
Deficiency	ALUMINUM - DOUBLE HUNG: BROKEN PANE

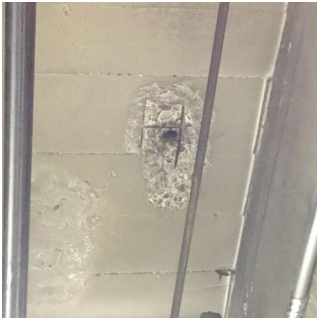
Violations	Basement Dry Storage Room (Hot Water Heater Room, Boiler Room similar) No violations recorded.
FLOOR STRUCTURE	
Condition	Inspected
Condition	4 - Between Fair and Poor
Deficiency	CONCRETE: CRACKS/SPALLED/REINFORCEMENT EXPOSED
Deficiency Location/Instance	Basement
Deficiency Quantity	50

Quantity Uom	S.F.
Potential Action	REPAIR
Urgency of Action	PRIORITY 4

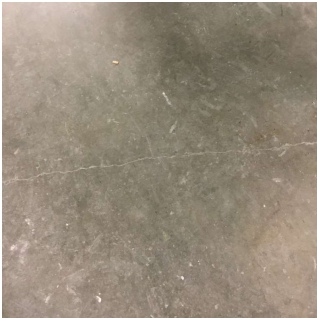
Question	Response
INTERIOR	
STRUCTURAL	
FLOOR STRUCTURE	
Violations	Gas Meter Room (Basement Storage Room similar) No violations recorded.
Deficiency	CONCRETE SLAB ON GRADE: THRU CRACKS
Deficiency Location/Instance	Basement
Deficiency Quantity	280
Quantity Uom	S.F.
Potential Action	REPAIR
Urgency of Action	PRIORITY 3
Purpose of Action	LEVEL 5
Deficiency Photo1

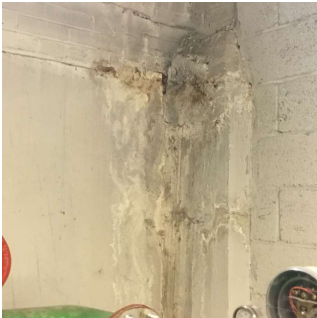
Violations	Room C23 (Basement Corridor, Basement Dry Storage Room, Boiler Room similar) No violations recorded.
FOUNDATION WALLS	
Material Type(s)	Inspected Concrete
Condition	4 - Between Fair and Poor
Deficiency	CONCRETE: WATER INFILTRATION IN NON- INSTRUCTIONAL SPACE
Deficiency Location/Instance	Basement
Deficiency Quantity	200
Quantity Uom	S.F.
Potential Action	INSTALL WATERPROOFING
Urgency of Action	PRIORITY 5
Purpose of Action	LEVEL 5
Deficiency Photo1

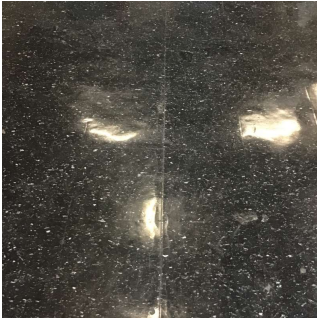
Question	Response
INTERIOR	
AUDITORIUM	
Fixed Seating	
Violations	No violations recorded.
Floor Finish	
Instance on 1st Floor (480 Seats)	Inspected
Condition	2 - Between Good and Fair
Deficiency	VINYL TILES: DETERIORATED SUBSTRATE
Deficiency Location/Instance	Near stage right
Deficiency Quantity	20
Quantity Uom	S.F.
Potential Action	REPLACE
Urgency of Action	PRIORITY 3
Purpose of Action	LEVEL 2
Deficiency Photo1

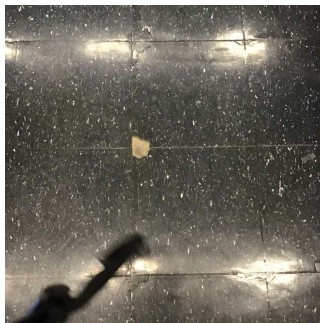
Violations	No violations recorded.
Deficiency	VINYL TILES: BROKEN/DETERIORATED/MISSING TILES
Deficiency Location/Instance	Near Entrance, center
Deficiency Quantity	10
Quantity Uom	S.F.
Potential Action	REPLACE
Urgency of Action	PRIORITY 3

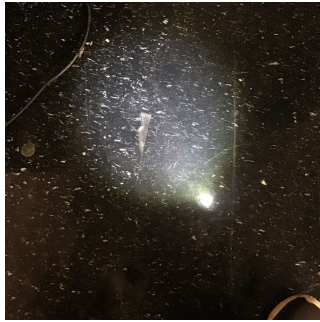
Near center
Violations	No violations recorded.
Sliding-folding Partition	
Instance on 1st Floor (480 Seats)	Does not Exist
Stage	
Instance on 1st Floor (480 Seats)	Inspected
Stage	Inspected
Instance on 1st Floor (480 Seats)	Inspected
Condition	3 - Fair
Deficiency	DAMAGED FLOOR
Deficiency Location/Instance	Near right side, left side, center
Deficiency Quantity	20
Quantity Uom	S.F.
Potential Action	REPLACE
Urgency of Action	PRIORITY 3
Purpose of Action	LEVEL 2
Deficiency Photo1

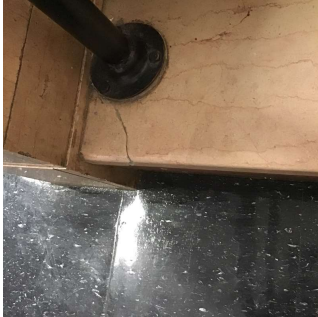
Near right side
Violations	No violations recorded.
Deficiency	DAMAGED STEPS
Deficiency Location/Instance	Left side
Deficiency Quantity	10
Quantity Uom	S.F.
Potential Action	REPLACE
Urgency of Action	PRIORITY 3
Purpose of Action	LEVEL 2

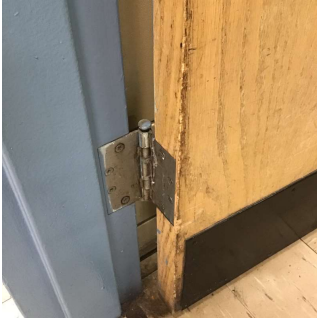
Room 129
Violations	No violations recorded.
Instance on 1st Floor - Students	Inspected
Condition	3 - Fair
Deficiency	WOOD: DETERIORATED DOOR
Deficiency Location/Instance	Near Entrance
Deficiency Quantity	1
Quantity Uom	EACH
Potential Action	MAINTENANCE
Urgency of Action	PRIORITY 3
Purpose of Action	LEVEL 2
Deficiency Photo1

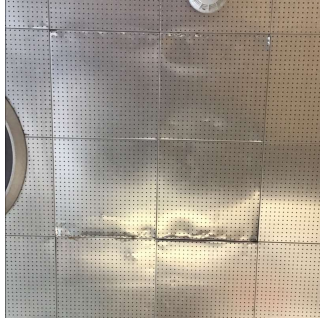
Question	Response
INTERIOR	
KITCHEN	
Ceiling	
Quantity Uom	S.F.
Potential Action	REPLACE
Urgency of Action	PRIORITY 3
Purpose of Action	LEVEL 2
Deficiency Photo1

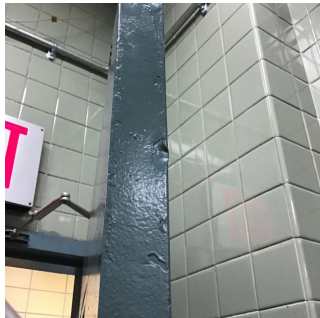
Near center
Violations	No violations recorded.
Door(s)	
Instance on 1st Floor	Inspected
Condition	3 - Fair
Deficiency	METAL: DETERIORATED DOOR
Deficiency Location/Instance	Near stair 3C/1 Vestibule
Deficiency Quantity	1
Quantity Uom	EACH
Potential Action	MAINTENANCE
Urgency of Action	PRIORITY 3
Purpose of Action	LEVEL 2
Deficiency Photo1

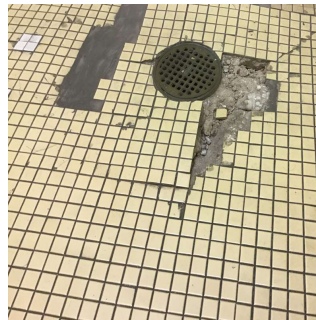
Room 136

CERAMIC TILE: DETERIORATED SUBSTRATE

REPLACE

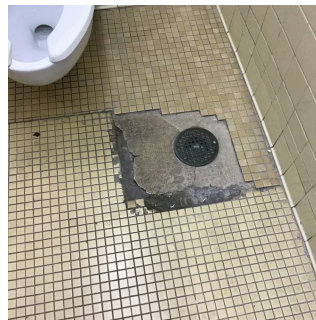
CERAMIC TILE: BROKEN/MISSING TILES

REPLACE

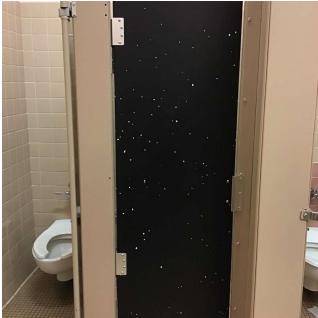
Room 221
Violations	No violations recorded.
Deficiency	RUST - MAJOR
Deficiency Location/Instance	Room 323
Deficiency Quantity	2
Quantity Uom	EACH
Potential Action	REPLACE
Urgency of Action	PRIORITY 3
Purpose of Action	LEVEL 2
Deficiency Photo1

Question	Response
INTERIOR	
TOILET ROOMS - STUDENTS	
Floor Finish	Inspected
	Room 134
Violations	No violations recorded.
Stalls	Inspected
Condition	3 - Fair
Deficiency	BROKEN/MISSING
Deficiency Location/Instance	Room 221
Deficiency Quantity	1
Quantity Uom	EACH
Potential Action	REPLACE
Urgency of Action	PRIORITY 3
Purpose of Action	LEVEL 2
Deficiency Photo1

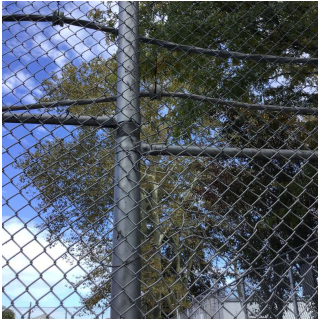
Violations	Southwest Schoolyard No violations recorded.

Question	Response
LIFE SAFETY	Inspected
STEEL STAIRS	Does not Exist
SITE	Inspected
CONTAINERIZATION	Does not Exist
Drainage System for Asphalt	Inspected
Catch Basins/Manhole - Surrounded by asphalt	Inspected
Condition	2 - Between Good and Fair
Deficiency	No deficiencies recorded
Culverts - Asphalt Covering	Does not Exist
Drainage System for Concrete	Inspected
Catch Basins/Manhole - Surrounded by concrete	Inspected
Condition	2 - Between Good and Fair
Deficiency	No deficiencies recorded
Culverts - Concrete Covering	Does not Exist
Drainage System for Soil	Does not Exist
DRINKING FOUNTAINS	Does not Exist
FENCES	Inspected
Condition	4 - Between Fair and Poor
Deficiency	CHAIN LINK: DAMAGED/DETERIORATED
Deficiency Location/Instance	Southwest Schoolyard
Deficiency Quantity	45
Quantity Uom	S.F.
Potential Action	REPLACE
Urgency of Action	PRIORITY 3
Purpose of Action	LEVEL 2
Deficiency Photo1

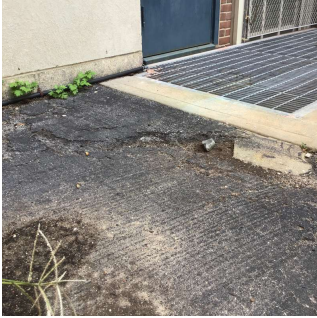
Courtyard
Violations	No violations recorded.
Deficiency	POTHOLES
Deficiency Location/Instance	Courtyard
Deficiency Quantity	10
Quantity Uom	S.F.
Potential Action	REPAIR
Urgency of Action	PRIORITY 3
Purpose of Action	LEVEL 2
Deficiency Photo1

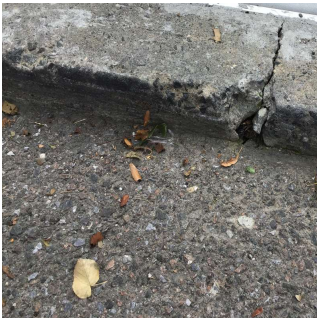
Question	Response
SITE	
PAVING	
DOT Sidewalk	
Concrete	
Deficiency Location/Instance	Along 15th Road
Deficiency Quantity	10
Quantity Uom	L.F.
Potential Action	REPLACE
Urgency of Action	PRIORITY 5
Purpose of Action	LEVEL 6
Deficiency Photo1	 
Violations	Along 15th Road No violations recorded.
Deficiency	DAMAGED CURBS
Deficiency Location/Instance	Along 149th Street, 147th Street, 15th Drive, 15th Road
Deficiency Quantity	300
Quantity Uom	L.F.
Potential Action	REPLACE
Urgency of Action	PRIORITY 3
Purpose of Action	LEVEL 2
Deficiency Photo1

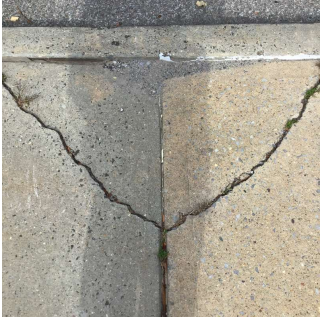
Question	Response
SITE	
PAVING	
DOT Sidewalk	
Concrete	
Deficiency Photo1
