**NYC Department of Education  
Building Condition Assessment Survey 2023 - 2024**

Architectural Inspection

**Asset:** P.S. 80 - QUEENS, 171-05 137 AVENUE, New York, 11434

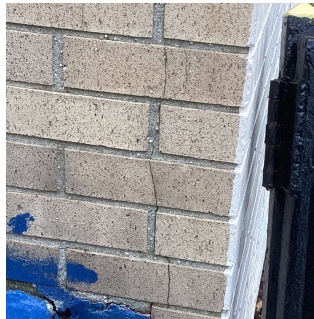
Facade B

BRICK: CRACKS/DISPLACED/SPALLED BRICK AT BUILDING CORNERS

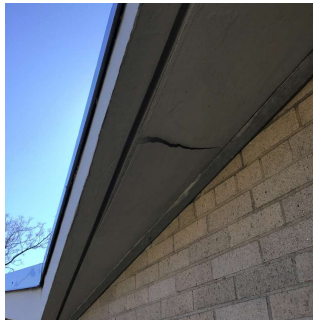
Roof 3

CONCRETE: MINOR CRACKS/SPALLING

REPAIR

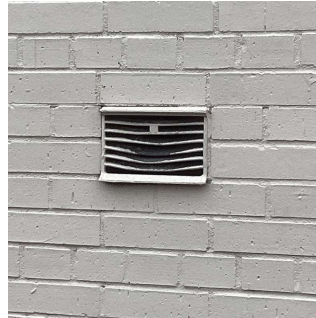
Facade B  
No violations recorded.

BROKEN/ DENTED BLADES

Deficiency Quantity	20
Quantity Uom	S.F.
Potential Action	REPLACE
Urgency of Action	PRIORITY 4
Purpose of Action	LEVEL 2
Deficiency Photo1

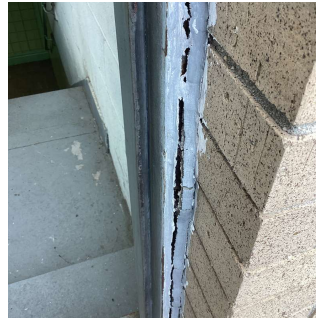
Roof 1 - Bulkhead 2

**BULKHEAD/PENTHOUSE WALLS/INTERIOR: CMU  
CRACKS/SPALLING**

REPLACE

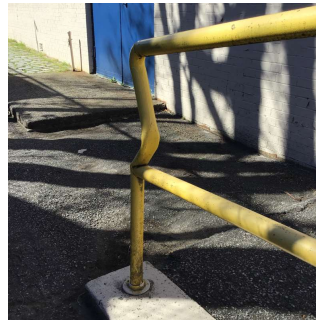
Facade F

MISSING RAILING

10  
L.F.  
REPLACE  
PRIORITY 5  
LEVEL 6

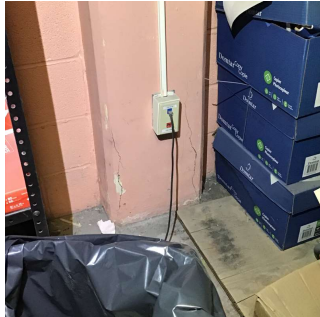
Question	Response
<b>INTERIOR</b>	
<b>STRUCTURAL</b>	
<b>COLUMNS/BEAMS/BEARING WALLS</b>	
Purpose of Action	LEVEL 5
Deficiency Photo1

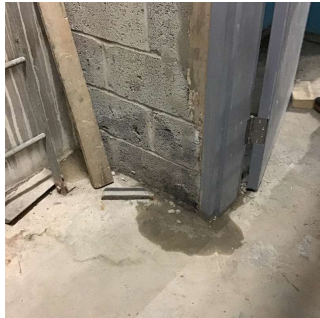
Room B21
Violations	No violations recorded.
<b>FLOOR STRUCTURE</b>	
Condition	Inspected
Deficiency	4 - Between Fair and Poor
Deficiency Location/Instance	CONCRETE SLAB ON GRADE: WATER INFILTRATION IN NON-INSTRUCTIONAL SPACE
Deficiency Quantity	Basement Oil Tank Room, Corridors, Boiler Room
Quantity Uom	200
Potential Action	S.F.
Urgency of Action	INSTALL WATERPROOFING
Purpose of Action	PRIORITY 5
Deficiency Photo1	LEVEL 5

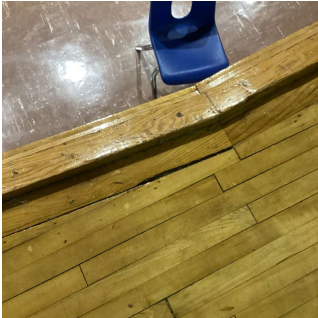
Near Audience
Violations	No violations recorded.
Deficiency	DAMAGED FASCIA
Deficiency Location/Instance	Near Stairs Right Side
Deficiency Quantity	20
Quantity Uom	S.F.
Potential Action	REPLACE
Urgency of Action	PRIORITY 3
Purpose of Action	LEVEL 2
Deficiency Photo1

Question	Response
<b>INTERIOR</b>	
<b>AUDITORIUM</b>	
<b>Floor Finish</b>	
Instance on 1st Floor (418 Seats)	Inspected
Condition	2 - Between Good and Fair
Deficiency	No deficiencies recorded
<b>Sliding-folding Partition</b>	
Instance on 1st Floor (418 Seats)	Does not Exist
<b>Stage</b>	
Instance on 1st Floor (418 Seats)	Inspected
<b>Stage</b>	Inspected
Instance on 1st Floor (418 Seats)	Inspected
Condition	3 - Fair
Deficiency	DAMAGED FLOOR
Deficiency Location/Instance	Near Audience
Deficiency Quantity	30
Quantity Uom	S.F.
Potential Action	REPLACE
Urgency of Action	PRIORITY 3
Purpose of Action	LEVEL 2
Deficiency Photo1

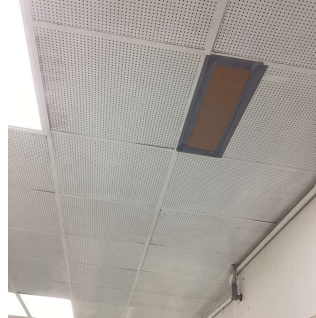
Main Entrance Area

Deficiency	ACOUSTIC TILES: DAMAGED/MISSING
Deficiency Location/Instance	Main Entrance Area, Corridor near Room 345
Deficiency Quantity	20
Quantity Uom	S.F.
Potential Action	REPLACE
Urgency of Action	PRIORITY 3
Purpose of Action	LEVEL 2
Deficiency Photo1

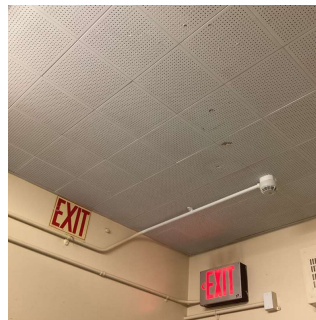
Deficiency	ACOUSTIC TILES ON PLASTER: DAMAGED/MISSING
Deficiency Location/Instance	Corridor near Stair BC/2
Deficiency Quantity	10
Quantity Uom	S.F.
Potential Action	REPLACE
Urgency of Action	PRIORITY 3
Purpose of Action	LEVEL 2
Deficiency Photo1

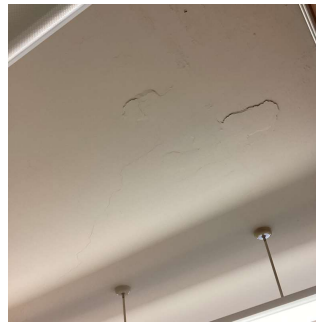
Room 353

Deficiency	PLASTER: CRACKS/SPALLING
Deficiency Location/Instance	Rooms 128, 247, 253, 353
Deficiency Quantity	100
Quantity Uom	S.F.
Potential Action	REPLACE
Urgency of Action	PRIORITY 3
Purpose of Action	LEVEL 2

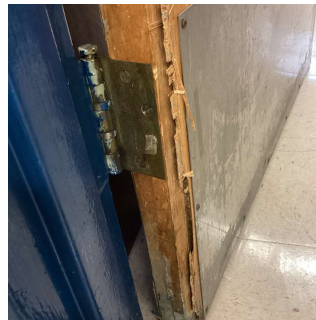
Room 135A

WOOD: DETERIORATED DOOR

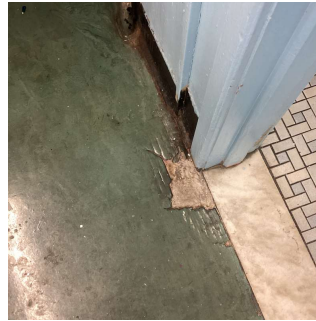
Room 148

SHEET VINYL: BROKEN/DETERIORATED

REPLACE

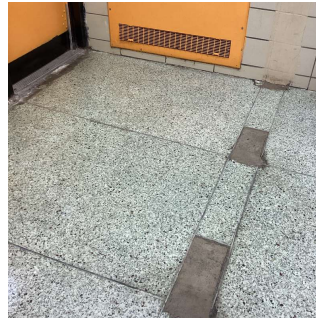
Main Entrance

TERRAZZO: CRACKS

REPLACE

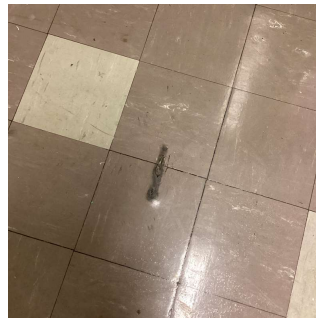
Corridor near Room 336

VINYL TILES: BROKEN/DETERIORATED/MISSING TILES

REPLACE

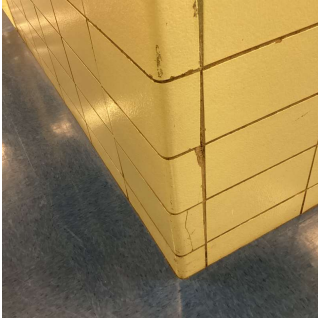
Question	Response
<b>INTERIOR</b>	
<b>CLASSROOMS/CORRIDORS/ADMIN SPACES</b>	
<b>Walls</b>	Inspected
Condition	2 - Between Good and Fair
Deficiency	GLAZED BLOCK: CRACKS/SPALLING
Deficiency Location/Instance	Main Entrance, Corridor near Stair DE/2
Deficiency Quantity	20
Quantity Uom	S.F.
Potential Action	REPLACE
Urgency of Action	PRIORITY 3
Purpose of Action	LEVEL 2
Deficiency Photo1

Violations	Corridor near Stair DE/2 No violations recorded.
Deficiency	PLASTER: CRACKS/SPALLING
Deficiency Location/Instance	Rooms 149, 219, 317, 322, Corridor near Room 353, and others.
Deficiency Quantity	200
Quantity Uom	S.F.
Potential Action	REPLACE
Urgency of Action	PRIORITY 3
Purpose of Action	LEVEL 2
Deficiency Photo1

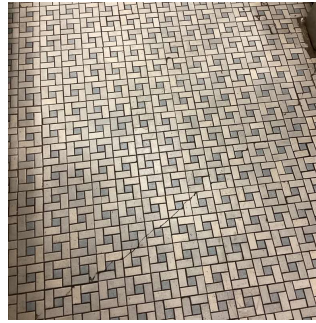
Near Emergency Exit - Vestibule

Emergency Exit
Violations	No violations recorded.
<hr/>	
<b>Floor Finish</b>	
Instance on 1st Floor	Inspected
Condition	2 - Between Good and Fair
Deficiency	CERAMIC TILE: BROKEN/MISSING TILES
Deficiency Location/Instance	Near Center, Emergency Exit - Vestibule , Entrances, Sink Area
Deficiency Quantity	30
Quantity Uom	S.F.
Potential Action	REPLACE
Urgency of Action	PRIORITY 3
Purpose of Action	LEVEL 2

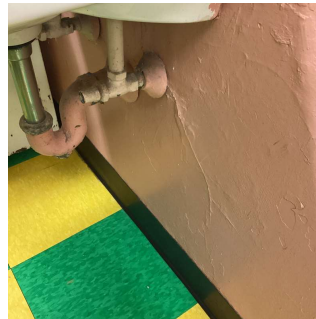
Deficiency	PLASTER: CRACKS/SPALLING
------------	--------------------------

Deficiency Location/Instance	Storage Room - Inside Cafeteria
------------------------------	---------------------------------

Deficiency Quantity	10
---------------------	----

Potential Action	REPLACE
------------------	---------

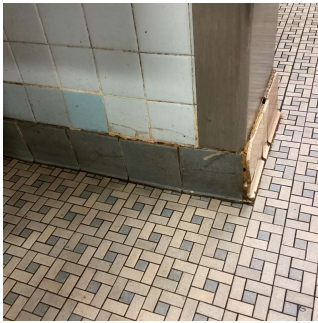
Deficiency	CERAMIC TILE: BROKEN/ MISSING
------------	-------------------------------

Deficiency Location/Instance	Mop Room, Near Sink
------------------------------	---------------------

Near Sink
Violations	No violations recorded.
<b>LIBRARY</b>	Inspected
Instance on Room 213	Inspected
<b>Built-in Furnishing</b>	
Instance on Room 213	Inspected
Condition	2 - Between Good and Fair
Deficiency	No deficiencies recorded
<b>Ceiling</b>	
Instance on Room 213	Inspected
Condition	2 - Between Good and Fair
Deficiency	No deficiencies recorded
<b>Door(s)</b>	
Instance on Room 213	Inspected
Condition	3 - Fair
Deficiency	WOOD: DETERIORATED DOOR
Deficiency Location/Instance	Entrance
Deficiency Quantity	1
Quantity Uom	EACH
Potential Action	MAINTENANCE
Urgency of Action	PRIORITY 3
Purpose of Action	LEVEL 2
Deficiency Photo1	 
	Entrance
Violations	No violations recorded.
<b>Floor Finish</b>	
Instance on Room 213	Inspected
Condition	2 - Between Good and Fair
Deficiency	VINYL TILES: TRIPPING HAZARD - ELECTRICAL OUTLET
Deficiency Location/Instance	Near center

Potential Action	REPLACE
------------------	---------

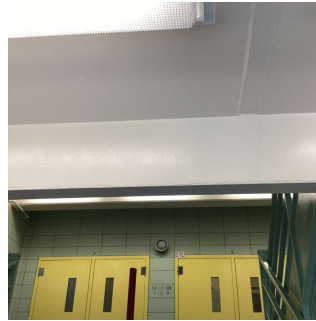
Question	Response
<b>INTERIOR</b>	
<b>STAIRS/RAMPS: INTERIOR</b>	
<b>Ceiling</b>	
Deficiency Photo1	 
Violations	Stair BC/3 No violations recorded.
<b>Door(s)</b>	Inspected
Condition	2 - Between Good and Fair
Deficiency	No deficiencies recorded
<b>Partition</b>	Does not Exist
<b>Railings</b>	Inspected
Condition	2 - Between Good and Fair
Deficiency	No deficiencies recorded
<b>Stairs and Landings</b>	Inspected
Condition	2 - Between Good and Fair
Deficiency	STONE: BROKEN/MISSING
Deficiency Location/Instance	Stairs BC/1, DE/1, FG/1, KL - Vestibule
Deficiency Quantity	70
Quantity Uom	S.F.
Potential Action	REPLACE
Urgency of Action	PRIORITY 3
Purpose of Action	LEVEL 2
Deficiency Photo1	 
Violations	Stair KL - Vestibule No violations recorded.
<b>Walls</b>	Inspected
Condition	2 - Between Good and Fair
Deficiency	PLASTER: CRACKS/SPALLING
Deficiency Location/Instance	Stair FG/1
Deficiency Quantity	10
Quantity Uom	S.F.
Potential Action	REPLACE

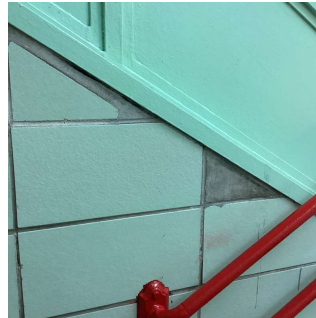
Stair FG/1

GLAZED BLOCK: CRACKS/SPALLING

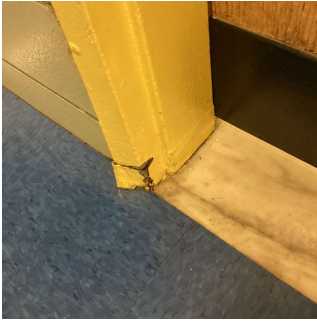
Question	Response
<b>INTERIOR</b>	
<b>TOILET ROOMS - STAFF</b>	
<b>Ceiling</b>	Inspected
Deficiency Photo1	 
	Women - 1st Floor
Violations	No violations recorded.
<b>Door(s)</b>	Inspected
Condition	5 - Poor
Deficiency	METAL: DETERIORATED DOOR AND FRAME
Deficiency Location/Instance	Room 215
Deficiency Quantity	1
Quantity Uom	EACH
Potential Action	MAINTENANCE
Urgency of Action	PRIORITY 3
Purpose of Action	LEVEL 2
Deficiency Photo1

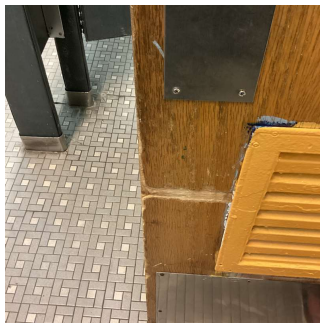
Room 215
Violations	No violations recorded.
Deficiency	WOOD: DETERIORATED DOOR
Deficiency Location/Instance	Room 326, Men - 1st Floor, Women - 1st Floor, Kitchen - Inside Cafeteria, and others
Deficiency Quantity	6
Quantity Uom	EACH
Potential Action	MAINTENANCE
Urgency of Action	PRIORITY 3
Purpose of Action	LEVEL 2

Violations	Men - 1st Floor No violations recorded.
<b>Floor Finish</b>	Inspected
Condition	4 - Between Fair and Poor
Deficiency	CERAMIC TILE: BROKEN/MISSING TILES
Deficiency Location/Instance	Rooms 226, 330, Men - 1st Floor, Women - 1st Floor
Deficiency Quantity	40
Quantity Uom	S.F.
Potential Action	REPLACE
Urgency of Action	PRIORITY 3
Purpose of Action	LEVEL 2
Deficiency Photo1

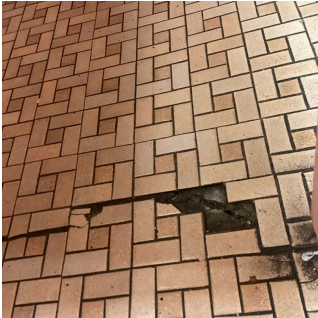
Question	Response
<b>INTERIOR</b>	
<b>TOILET ROOMS - STUDENTS</b>	Inspected
<b>Floor Finish</b>	
Deficiency	CERAMIC TILE: DETERIORATED SUBSTRATE
Deficiency Location/Instance	Girls - 2nd Floor
Deficiency Quantity	10
Quantity Uom	S.F.
Potential Action	REPLACE
Urgency of Action	PRIORITY 3
Purpose of Action	LEVEL 2
Deficiency Photo1

Violations	Girls - 2nd Floor No violations recorded.
Deficiency	CERAMIC TILE: BROKEN/MISSING TILES
Deficiency Location/Instance	Boys - 2nd Floor Girls - 2nd Floor, Boys - 3rd Floor,
Deficiency Quantity	30
Quantity Uom	S.F.
Potential Action	REPLACE
Urgency of Action	PRIORITY 3
Purpose of Action	LEVEL 2
Deficiency Photo1

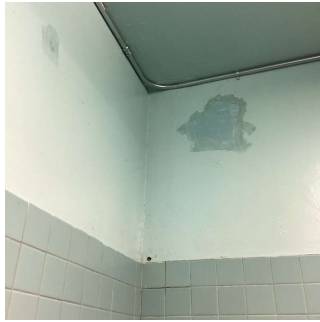
Violations	Girls - 2nd Floor No violations recorded.
<b>Walls</b>	
Condition	Inspected 2 - Between Good and Fair
Deficiency	PLASTER: CRACKS/SPALLING
Deficiency Location/Instance	Girls - 2nd Floor
Deficiency Quantity	10
Quantity Uom	S.F.
Potential Action	REPLACE
Urgency of Action	PRIORITY 3
Purpose of Action	LEVEL 2
Deficiency Photo1

Violations	Girls - 2nd Floor No violations recorded.
<b>LIFE SAFETY</b>	
<b>F.D. HOLDING AREA</b>	
Condition	Inspected 2 - Between Good and Fair
Deficiency	No deficiencies recorded
<b>STEEL STAIRS</b>	
Does not Exist	
<b>SITE</b>	
Inspected	
<b>CONTAINERIZATION</b>	
Condition	Inspected 5 - Poor
Deficiency	FENCING MISSING
Deficiency Location/Instance	137th Avenue
Deficiency Quantity	450
Quantity Uom	S.F.
Potential Action	INSTALL NEW
Urgency of Action	PRIORITY 3
Purpose of Action	LEVEL 2

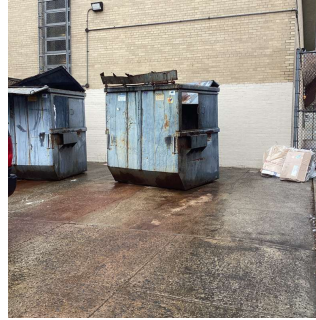
137th Avenue

**CONTAINERIZATION**

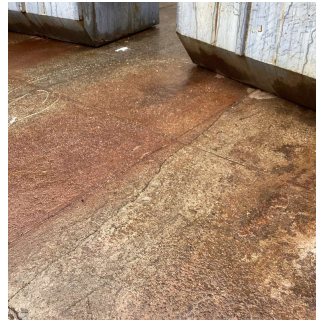
137th Avenue

**CONCRETE PAD DAMAGED**

REPAIR

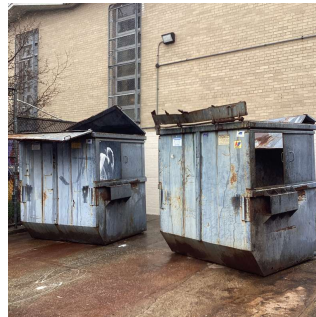
137th Avenue

**CONTAINER DAMAGED**

REPLACE

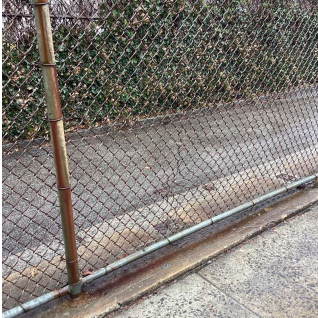
Question	Response
<b>SITE</b>	
<b>Drainage System for Asphalt</b>	
<b>Catch Basins/Manhole - Surrounded by asphalt</b>	Inspected
Condition	2 - Between Good and Fair
Deficiency	No deficiencies recorded
<b>Culverts - Asphalt Covering</b>	Does not Exist
<b>Drainage System for Concrete</b>	Inspected
<b>Catch Basins/Manhole - Surrounded by concrete</b>	Inspected
Condition	2 - Between Good and Fair
Deficiency	No deficiencies recorded
<b>Culverts - Concrete Covering</b>	Does not Exist
<b>Drainage System for Soil</b>	Does not Exist
<b>DRINKING FOUNTAINS</b>	Inspected
Condition	2 - Between Good and Fair
Deficiency	No deficiencies recorded
<b>FENCES</b>	Inspected
Condition	4 - Between Fair and Poor
Deficiency	CHAIN LINK: DAMAGED/DETERIORATED
Deficiency Location/Instance	Near Exit 3, Containerization Area
Deficiency Quantity	650
Quantity Uom	S.F.
Potential Action	REPLACE
Urgency of Action	PRIORITY 3
Purpose of Action	LEVEL 2

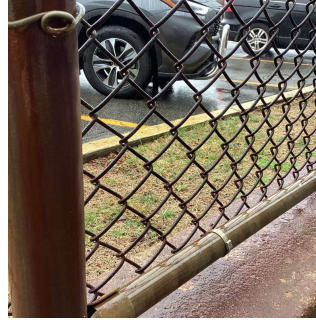
Near Exit 3

Violations	Near Containerization Area No violations recorded.
Deficiency	CHAIN LINK: RUST - MAJOR
Deficiency Location/Instance	Near Exit 3, Containerization Area
Deficiency Quantity	3,000
Quantity Uom	S.F.
Potential Action	REPLACE
Urgency of Action	PRIORITY 3
Purpose of Action	LEVEL 2

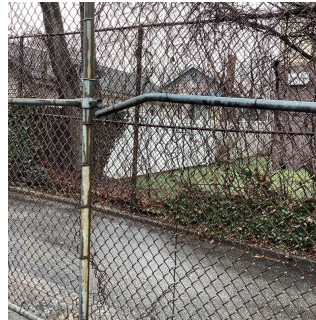
Near Containerization Area

**CHAIN LINK: DAMAGED POST/RAIL**

REPLACE

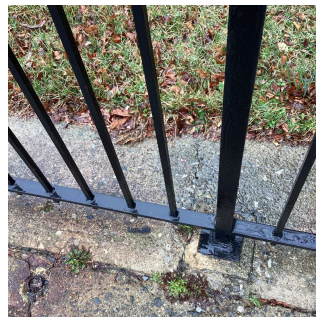
Near Exit 2

**CONCRETE CURB: DAMAGED/DETERIORATED**

REPLACE

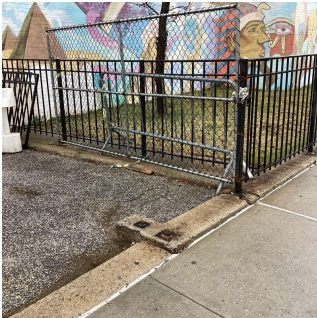
**WROUGHT IRON: MISSING SECTIONS**

Question	Response
<b>SITE</b>	
<b>FENCES</b>	
Deficiency Location/Instance	137th Avenue
Deficiency Quantity	40
Quantity Uom	S.F.
Potential Action	REPLACE
Urgency of Action	PRIORITY 3
Purpose of Action	LEVEL 2
Deficiency Photo1

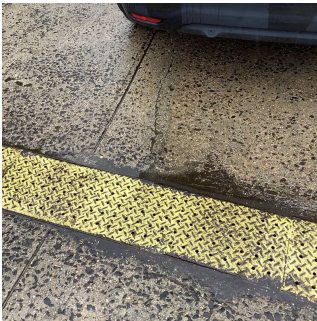
Violations	137th Avenue No violations recorded.
<b>IRRIGATION SYSTEM</b>	Does not Exist
<b>PAVING</b>	Inspected
<b>Student Non-Use</b>	Inspected
Gravel Exists?	No
<b>Asphalt</b>	Does not Exist
<b>Concrete</b>	Inspected
Condition	3 - Fair
Deficiency	DAMAGED/DETERIORATED/MISSING SECTIONS
Deficiency Location/Instance	137th Avenue
Deficiency Quantity	100
Quantity Uom	S.F.
Potential Action	REPLACE
Urgency of Action	PRIORITY 3
Purpose of Action	LEVEL 2
Deficiency Photo1

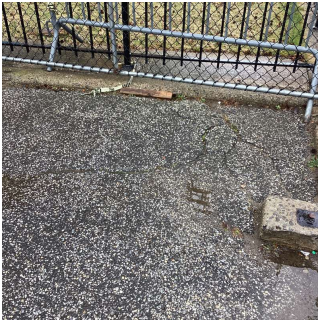
Question	Response
<b>SITE</b>	
<b>PAVING</b>	
<b>Site Sidewalks &amp; Walkways</b>	
<b>Asphalt</b>	
Deficiency	CRACKS - MAJOR
Deficiency Location/Instance	Near 137th Avenue, Exits 3, 5, 9, 11
Deficiency Quantity	600
Quantity Uom	S.F.
Potential Action	REPLACE
Urgency of Action	PRIORITY 3
Purpose of Action	LEVEL 2
Deficiency Photo1

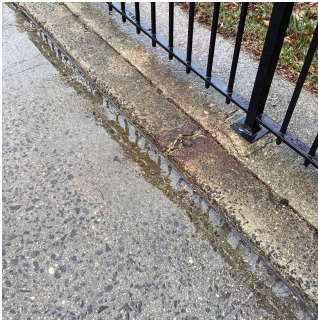
Violations	Near 137th Avenue No violations recorded.
<b>Concrete</b>	
Condition	Inspected 3 - Fair
Deficiency	DAMAGED CURBS
Deficiency Location/Instance	Near Exit 2
Deficiency Quantity	20
Quantity Uom	L.F.
Potential Action	REPLACE
Urgency of Action	PRIORITY 3
Purpose of Action	LEVEL 2
Deficiency Photo1

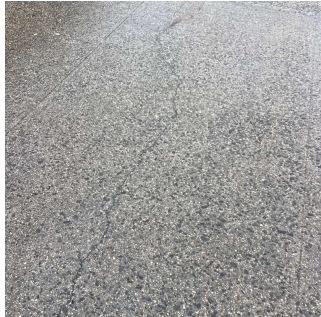
Violations	Near Exit 2 No violations recorded.
Deficiency	DAMAGED/DETERIORATED/MISSING SECTIONS
Deficiency Location/Instance	Near Exits 1, 2, Main Entrance Fences
Deficiency Quantity	350
Quantity Uom	S.F.
Potential Action	REPLACE
Urgency of Action	PRIORITY 3
Purpose of Action	LEVEL 2

Near Exit 1
Violations	No violations recorded.
<b>Pavers</b>	Inspected
Condition	2 - Between Good and Fair
Deficiency	No deficiencies recorded
<b>DOT Sidewalk</b>	Inspected
<b>Asphalt</b>	Does not Exist
<b>Concrete</b>	Inspected
Condition	4 - Between Fair and Poor
Deficiency	DAMAGED/DETERIORATED/MISSING SECTIONS
Deficiency Location/Instance	137th Avenue
Deficiency Quantity	1,100
Quantity Uom	S.F.
Potential Action	REPLACE
Urgency of Action	PRIORITY 3
Purpose of Action	LEVEL 2
Deficiency Photo1	 
	137th Avenue
Violations	No violations recorded.
Deficiency	DAMAGED CURBS
Deficiency Location/Instance	137th Avenue
Deficiency Quantity	120
Quantity Uom	L.F.
Potential Action	REPLACE
Urgency of Action	PRIORITY 3
Purpose of Action	LEVEL 2

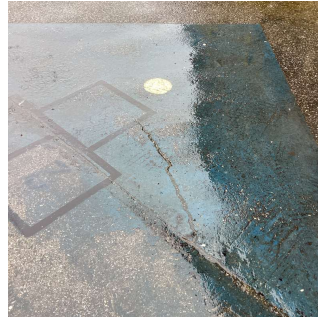
Near Exit 6

ASPHALT: CRACKS - MAJOR

REPLACE

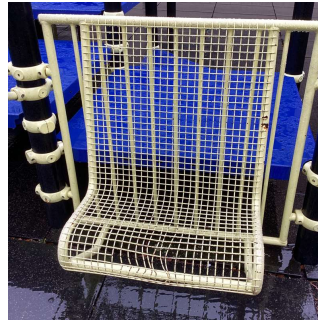
Near Slide

**Play Equipment**

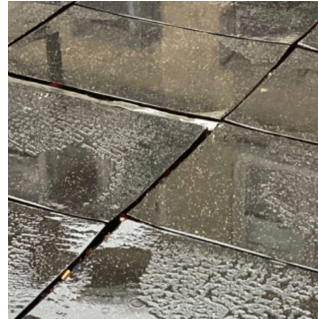
Condition	4 - Between Fair and Poor
-----------	---------------------------

Deficiency	DETERIORATED/MISSING
------------	----------------------

Deficiency Location/Instance	Near center , Exits 6, 7
------------------------------	--------------------------

Deficiency Quantity	300
---------------------	-----

Potential Action	REPLACE
------------------	---------
